APPENDIX B

Geomorphological Assessment

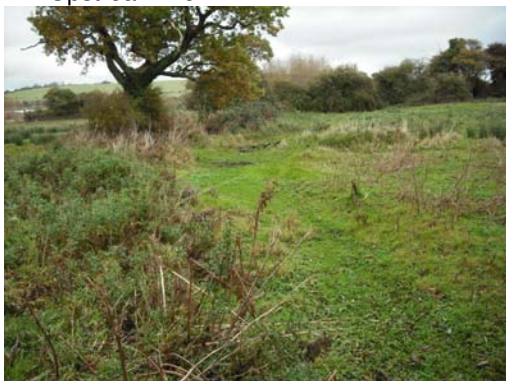
A – Upstream view

Conservation Status	8 – High	
Channel type	Spring-fed chalk stream (winterbourne)	
Baseline Geomorphological Characteristics		
<ul style="list-style-type: none">• Reach 1 is an ephemeral stream with a very shallow channel and low banks.• Bed and banks consist of earth and colonised by grass with some aquatic plants in damper areas.• Flow conditioned primarily by groundwater, either from a spring or from higher groundwater levels in the chalk aquifer below. No known abstractions locally.• Channel location conditioned by geology, as on border of chalk (baseflow fed) but then flows over Lambeth clays.• No evidence of active channel processes due to limited discharge and flow capacity and low gradient.• No channel modifications, but flow conditions may have been modified by the construction of ponds and highways drainage upstream of headwaters, which could modify the amount of baseflow present.• On day of visit the stretch was predominantly dry with only small areas of shallow standing water observed.• Riparian vegetation is a mixture of grass and scrub herbs, with patches of hedgerow, and scattered trees and shrubs.

Does the geomorphology support good ecology (for WFD)?		
<ul style="list-style-type: none">• The shallow channel and intermittent flow of the headwater reach naturally reduce the potential for diverse aquatic habitats. Stream cover from marginal shading and input of woody debris from surrounding trees contribute to some habitat complexity.• Due to the sporadic drying of the channel it is unlikely that habitats within this reach can sustain year round water-dependent plant communities. However ephemeral flow is a natural characteristic of headwater chalk-fed streams and adapted vegetation communities and invertebrates could be present.		
Restoration Recommendations / Opportunities for long list		
<ul style="list-style-type: none">• None proposed – conservation status typical of small chalk stream headwater.• Other potential actions - Potential to investigate impacts of highways drainage and pond construction if this is affecting groundwater patterns local to the stream.

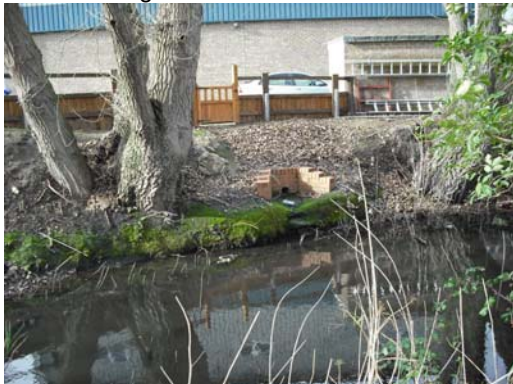
Reach reference	3 (GSK to Deacon Way culvert)	<div>A – Left to right bank downstream of GSK</div>

Conservation Status	3 – Low	
Channel type	Modified channel – realigned and widened	
Baseline Geomorphological Characteristics		
<ul style="list-style-type: none">• Reach 3 is a modified reach which runs between the GSK site and Deacon Way culvert, with the landfill site on the left bank.• This section was not fully accessed during the site walkover.• The channel is a mostly straight, overwide and overdeep course with steep banks.• There is a substantial depth of water in the channel but visible flow is negligible, being ponded by the very low bed gradient and control of Deacon Way culvert at the downstream end which represents a topographic high point in the bed• There is likely to be a considerable depth of fine sediment on the bed due to the low flow velocity, sourced from a combination of runoff from neighbouring agricultural and urban areas• Extensive reed growth in channel potentially slows flow and traps fine sediment.

Does the geomorphology support good ecology (for WFD)?		
<ul style="list-style-type: none">• The very limited flow velocities observed mean that this section of channel provides a standing water rather than flowing water habitat type.• Reed beds and other aquatic plants are present which would provide potential cover for fish.• Extensive fine sediments mean only silt-tolerant species are likely to be present.• Potential water quality issues would limit ecology due to lack of pollutant dispersal resulting from sluggish flow.		
Restoration Recommendations / Opportunities for long list		
<ul style="list-style-type: none">• Re-route channel to east of landfill (meandering channel with marginal and wetland habitats).• Create managed reedbed at upstream end.• Block Deacon Way culvert inlet.• Retain channel as a backwater linked to new channel.• Retain channel as an isolated standing water habitat (not connected to new channel).

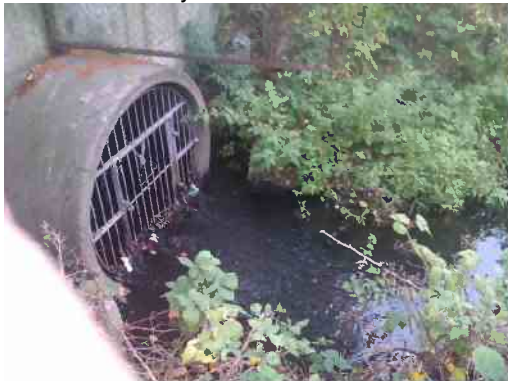
Reach reference	4 (Deacon Way culvert)	<p>A – Deacon Way culvert outlet</p>

Conservation Status	1 – Culverted	
Channel type	Culverted	
Baseline Geomorphological Characteristics		
<ul style="list-style-type: none">Reach 4 comprises Deacon Way culvert, which takes the flow of Teville Stream through a rectangular box culvert inlet with trash screen and exits from a pipe culvert at Willowbrook Road.Significant urban drainage connections in culvert increase discharge through this section.		
Does the geomorphology support good ecology (for WFD)?		
<ul style="list-style-type: none">Culvert is likely to act as a significant disruption to hydromorphological and ecological continuity in the stream, no fauna and flora likely to be present in the culverted section due to shading and lack of substrate		
Restoration Recommendations / Opportunities for long list		
<ul style="list-style-type: none">Block Deacon Way culvert inlet.Re-route channel to east of landfill (meandering channel with marginal and wetland habitats).Retain channel downstream of culvert along Willowbrook Road as a backwater and potential reedbed, and also to maintain discharge of surface water drainage from within culvert.

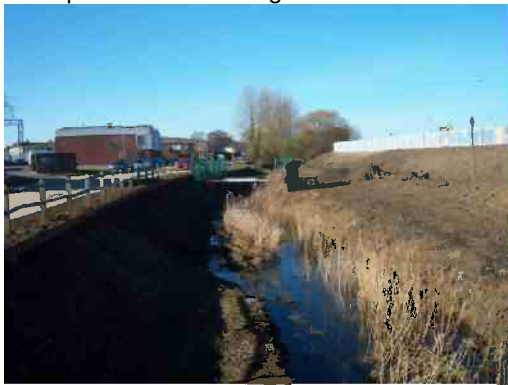
Reach reference	5 (Deacon Way culvert to railway line – Willowbrook Road)	A – Upstream view along Willowbrook Road

Conservation Status	3 – Low	
Channel type	Realigned, overdeepened	
Baseline Geomorphological Characteristics		
<ul style="list-style-type: none">• Reach 5 flows between the Deacon Way culvert outlet and the railway culvert.• The channel has been straightened and is constrained by Willowbrook Road on the right bank and the new amenity tip (on landfill) on the left bank.• Recent bank profiling works undertaken on left bank associated with development of amenity tip.• Substantial reed growth in channel further downstream where flow becomes slower.• Likely to be significant fine sediment on bed due to slow flows, low gradient and wide channel.• Short section of meandering channel upstream of railway culvert.		
Does the geomorphology support good ecology (for WFD)?		
<ul style="list-style-type: none">• Culverts at either end of reach are likely to act as significant disruptions to hydromorphological and ecological continuity in the stream.• The very limited flow velocities observed in the downstream section of this reach provide standing water rather than flowing water habitat type.• Reed beds and other aquatic plants are present which would provide potential cover for fish.• Extensive fine sediments mean only silt-tolerant species are likely to be present.• Potential water quality issues would limit ecology due to lack of pollutant dispersal resulting from sluggish flow.

Restoration Recommendations / Opportunities for long list		
<ul style="list-style-type: none">• Block Deacon Way culvert inlet.• Re-route channel to east of landfill (meandering channel with marginal and wetland habitats).• Retain channel along Willowbrook Road as a backwater and potential reedbed, and also to maintain discharge of surface water drainage from within culvert.

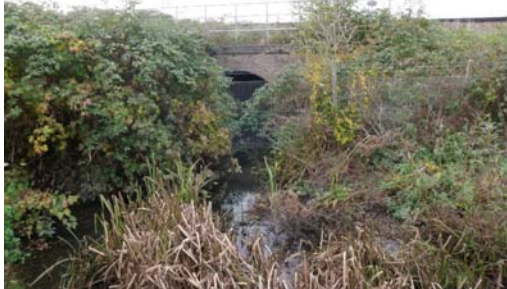
Reach reference	6 (Railway line to landfill culvert)	<div>A – Upstream view to railway culvert</div>

Conservation Status	3 – Low	
Channel type	Realigned, overdeepened	
Baseline Geomorphological Characteristics		
<ul style="list-style-type: none">• Reach 6 flows between the railway culvert and the culvert at the landfill site.• The channel has been straightened and deepened.• Allotments line the right bank while the left bank is wooded and grassland.• Scrubby vegetation and trees line both banks, with some overhanging into the channel.• Some patches of reeds in channel but less extensive than upstream reaches.• Likely to be significant fine sediment on bed due to slow flows, low gradient and wide channel.		
Does the geomorphology support good ecology (for WFD)?		
<ul style="list-style-type: none">• Culverts at either end of reach are likely to act as significant disruptions to hydromorphological and ecological continuity in the stream.• The limited flow velocities observed in the downstream section of this reach provide standing water rather than flowing water habitat type.• Bankside vegetation and reed beds are present which would provide potential cover for fish.• Extensive fine sediments mean only silt-tolerant species are likely to be present.• Potential water quality issues would limit ecology due to lack of pollutant dispersal resulting from sluggish flow.

Restoration Recommendations / Opportunities for long list		
<ul style="list-style-type: none">• Re-meander channel in more natural planform to land on east side – this would need to be a lined channel due to historic landfill.• Vegetation management.

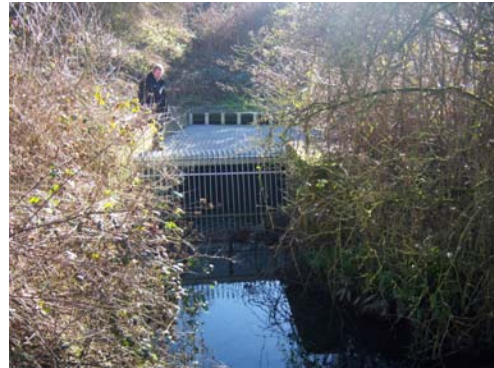
A – Culvert inlet

Reach reference	7 (Landfill culvert and STW)
Conservation Status	1 – Culverted
Channel type	Culverted
Baseline Geomorphological Characteristics	
<ul style="list-style-type: none"> • Reach 7 consists of the culverts running through the landfill and STW. • The culvert inlet is at a relatively new grill screen. • The culvert is understood to be in relatively poor condition and ownership is unclear. • At outlet, stream flows through a number of structures at STW, flow is very ponded and water quality appears poor. • Channel then culverted to Brooklands Park. 	
Does the geomorphology support good ecology (for WFD)?	
<ul style="list-style-type: none"> • Culvert is likely to act as a significant disruption to hydromorphological and ecological continuity in the stream, no fauna and flora likely to be present in the culverted section due to shading and lack of substrate. • Potential water quality issues would limit ecology (dead fish observed by EA on site visit in Oct 2011).

Restoration Recommendations / Opportunities for long list	
<ul style="list-style-type: none"> • De-culverting (although likely to be significant constraints on feasibility). • Investigations into impacts on water quality and fish passage through structures at the STW.

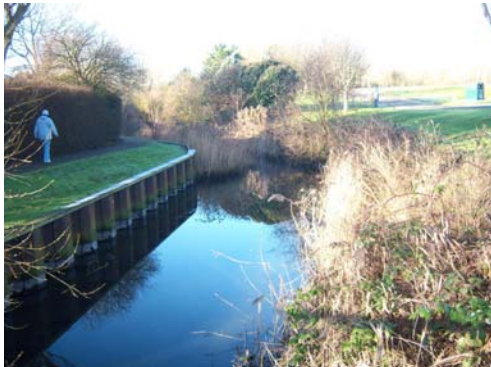
A – Channel in Brooklands Park

Conservation Status	4 – Moderate	
Channel type	Low gradient and tide-locked	
Baseline Geomorphological Characteristics		
<ul style="list-style-type: none">• Reach 8 flows through Brooklands Park, an area of public access / amenity value.• Banks are extensively reinforced by a combination of gabions and steel sheet piling.• Channel alignment also constrained by local ground levels (probably previous landscaping / earthworks resulting from lake dredging).• Reed growth evident.• Likely to be significant fine sediment on bed due to slow flows, low gradient and wide channel.• Water levels and flows are controlled in this section by the tidal flap discharge from Brooklands Lake.		
Does the geomorphology support good ecology (for WFD)?		
<ul style="list-style-type: none">• This area of the stream would naturally be a type of tidal creek, but is now constrained by bank protection and by lake level control at Brooklands.• The very limited flow velocities observed in the reach provide standing water rather than flowing water habitat type.• Reed beds and other aquatic plants are present which would provide potential cover for fish.• Extensive fine sediments mean only silt-tolerant species are likely to be present.• Potential water quality issues would limit ecology due to lack of pollutant dispersal resulting from sluggish flow.

Restoration Recommendations / Opportunities for long list		
<ul style="list-style-type: none">• Replacement of hard bank protection with soft engineering, or 'greening' of bank protection.• Removal of hard bank protection to allow more natural tidal habitats to form – this would probably require a change in land use in the park area.• Any restoration needs to be taken in context of tidal and fluvial flows including future management of Brooklands Lake.

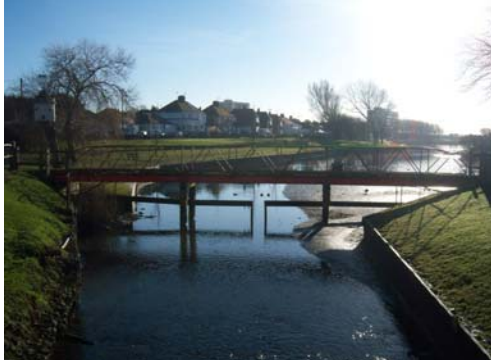
Reach reference	9 (Brooklands Lake and outfall)	<p>A – Channel entering Brooklands Lake</p>

Conservation Status	Not scored – artificial lake	
Channel type	Lake	
Baseline Geomorphological Characteristics		
<ul style="list-style-type: none">• Reach 9 comprises Brooklands Lake and the outfall into the sea.• The lake was created in the late 1950s as part of the restoration of a previous waste site.• Lake levels are influenced by tide-locking – it can only discharge through its outlet when the tidal flap is open. It can also be controlled by the outlet structure.• When levels are lower, exposed mudflats are present and there are also extensive reed beds at the margins of the lake.• The outlet is through a culvert under the A259 and shingle beach, and then through a piped structure out to the beach foreshore.		<p>B – Outlet sluice from Brooklands Lake</p>
