## **SITE PHOTOGRAPHS**

Photographs of site taken on 3 January 2019, route walked from the northern end car park in a southerly direction.

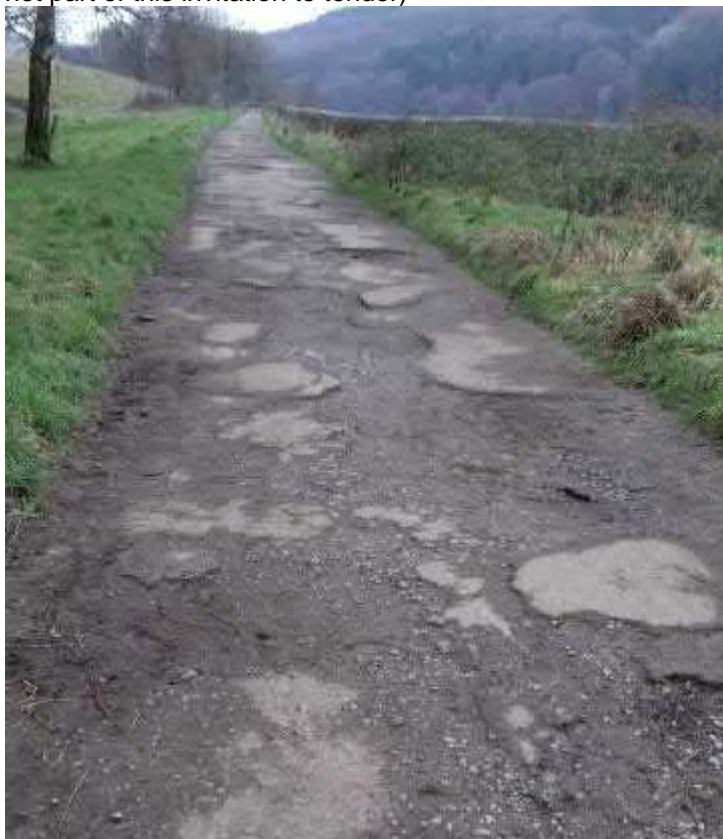
Figure 1. Unadopted road section showing nature of existing surface with potholes (Phase 2 works, not part of this invitation to tender)

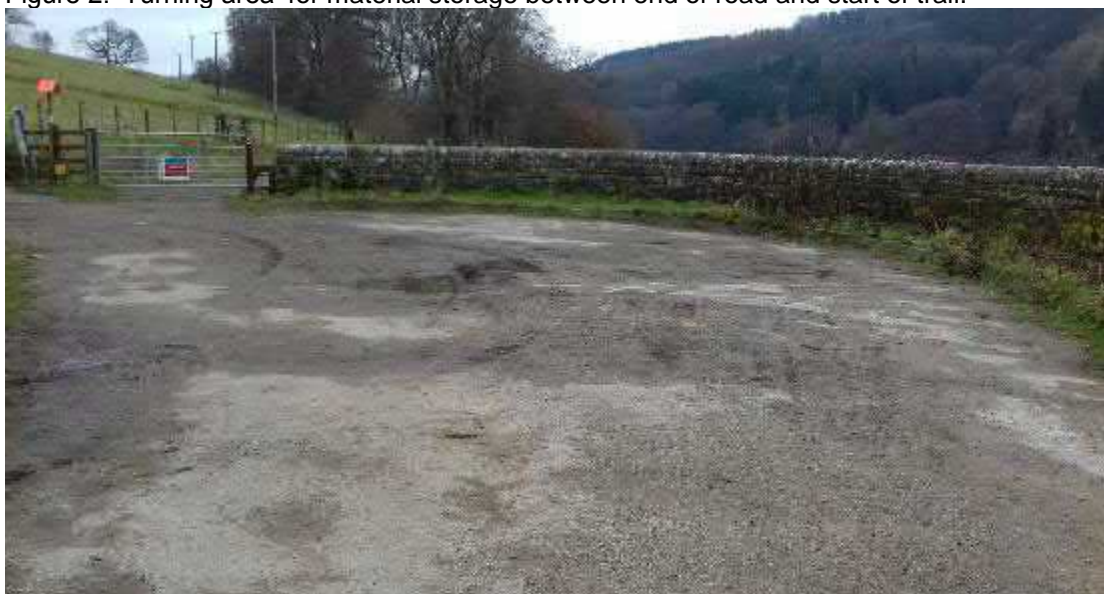
Figure 2. 'Turning area' for material storage between end of road and start of trail.

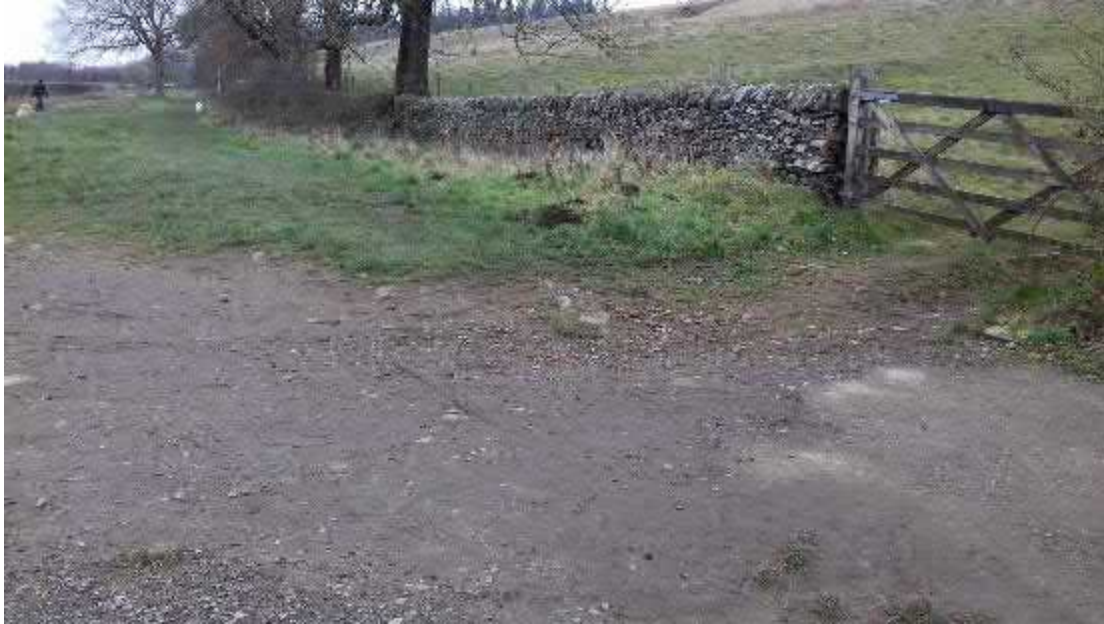
Figure 3. Entrance to farm track leading from road. (Phase 2 works, not part of this invitation to tender)

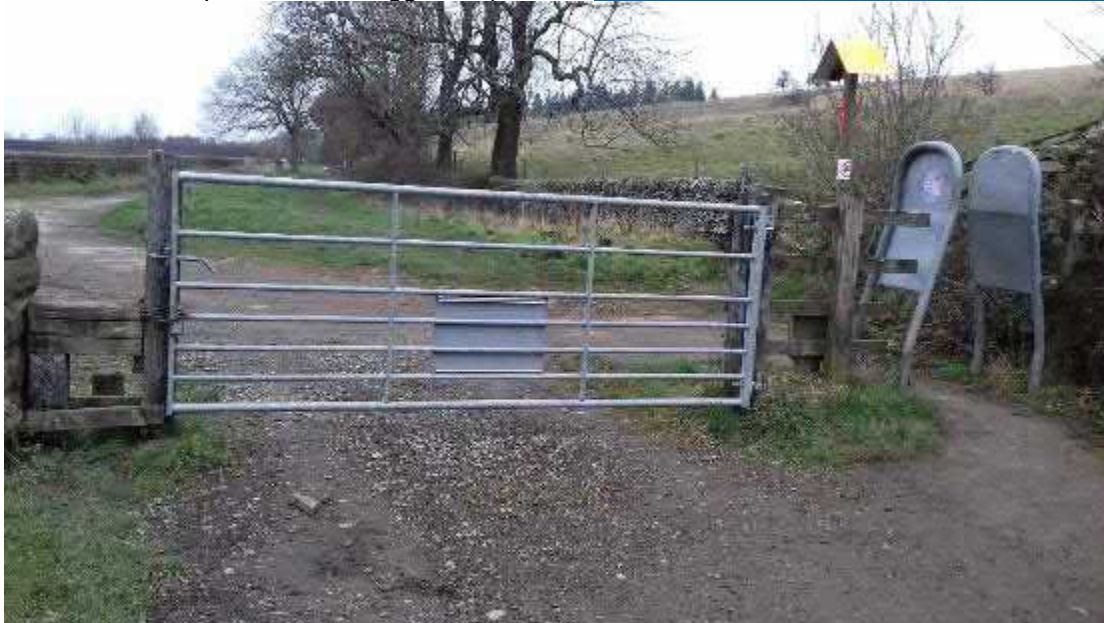
Figure 4. Gated barrier shown below currently comprises: dry stone wall from reservoir side, next to a small wooden stile (redundant), next to a metal vehicle gate with chain and 3 separate padlocks for different users, attached to wooden posts at either end, with a section of post and rail fencing, gas pipeline marker, adjacent to A-shaped 'squeeze barrier' to prevent trail bike usage. This barrier needs replacement: remove wooden stile, move vehicle gate along to abut wall, remove wooden post and rail fencing and squeeze barrier and replace with an accessible gate with radar key access for wheelchairs and pushchairs. Suggested product: <https://centrewire.com/products/woodstock-large/>

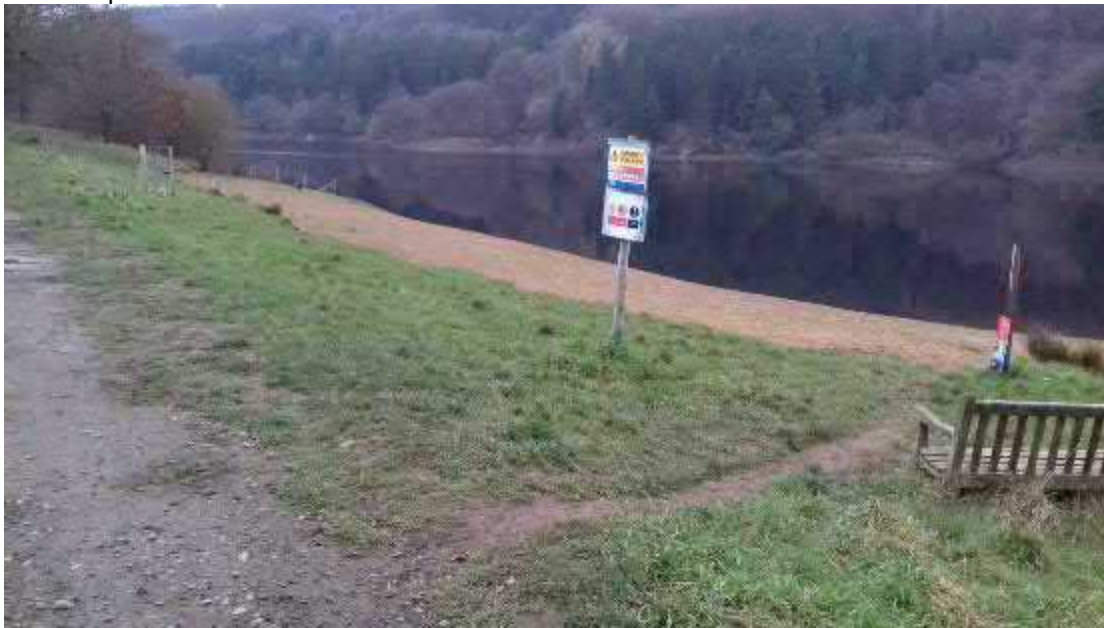
Figure 5. Existing benches here are off the trail and not easily accessed by people with mobility or visual impairment.

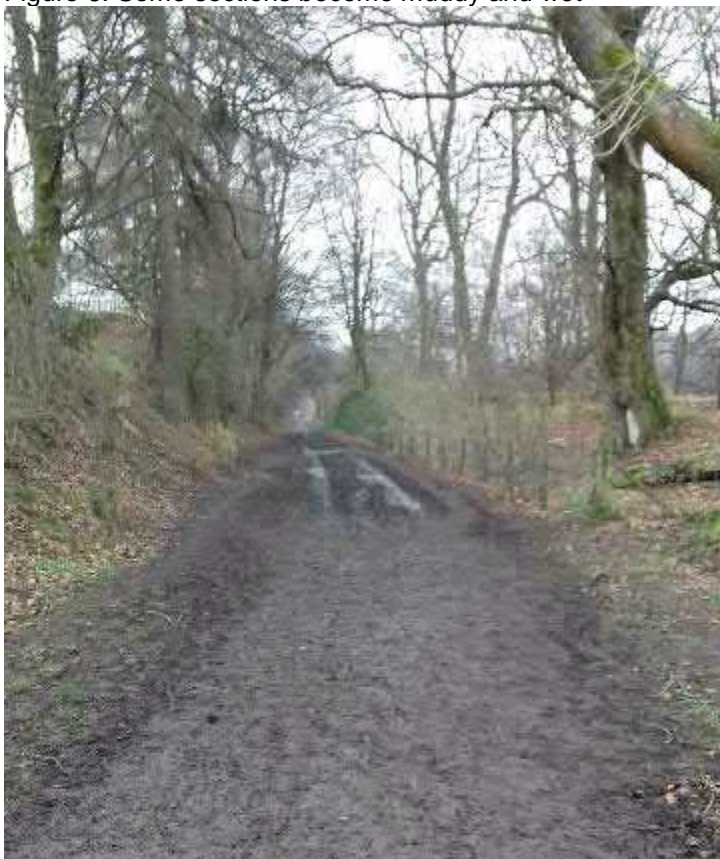
Figure 6. Some sections become muddy and wet

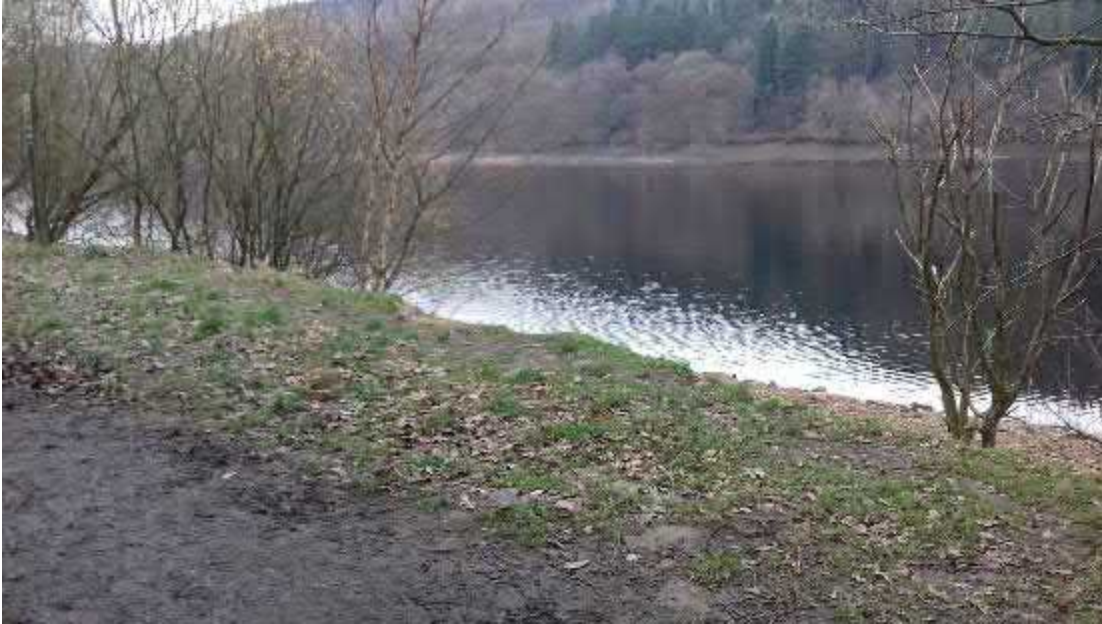
Figure 7. Location to install new bench at 273m.

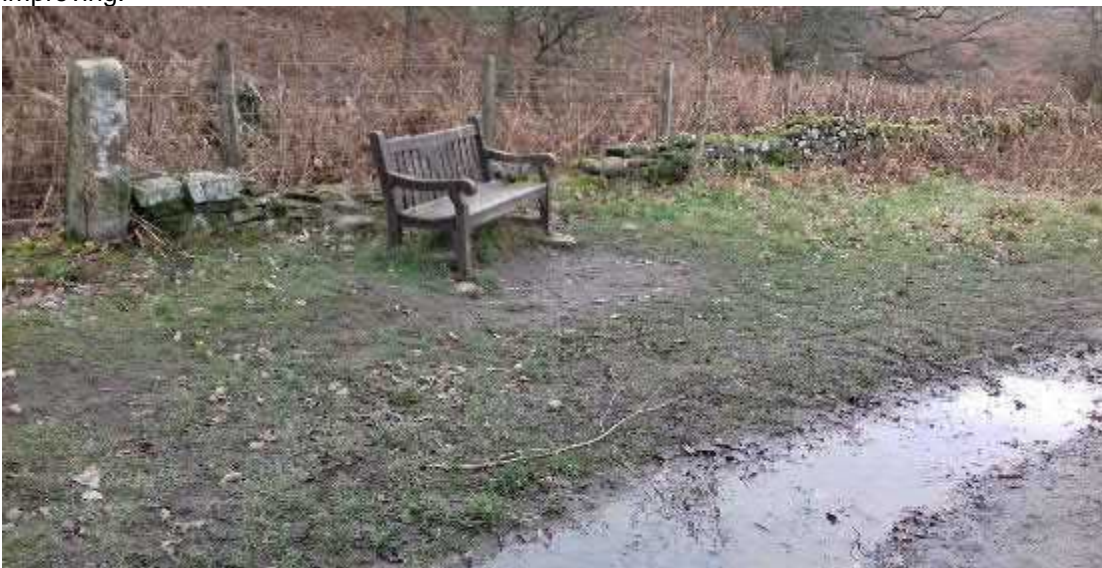
Figure 8. Existing bench at 493m is a memorial bench in reasonable condition, but access needs improving.

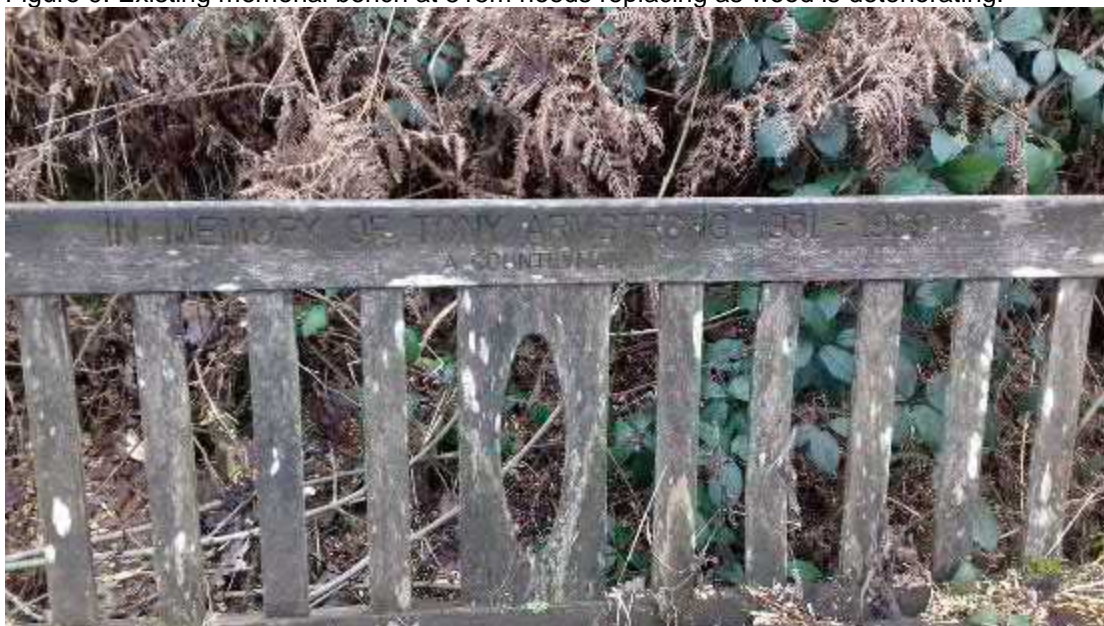
Figure 9. Existing memorial bench at 815m needs replacing as wood is deteriorating.

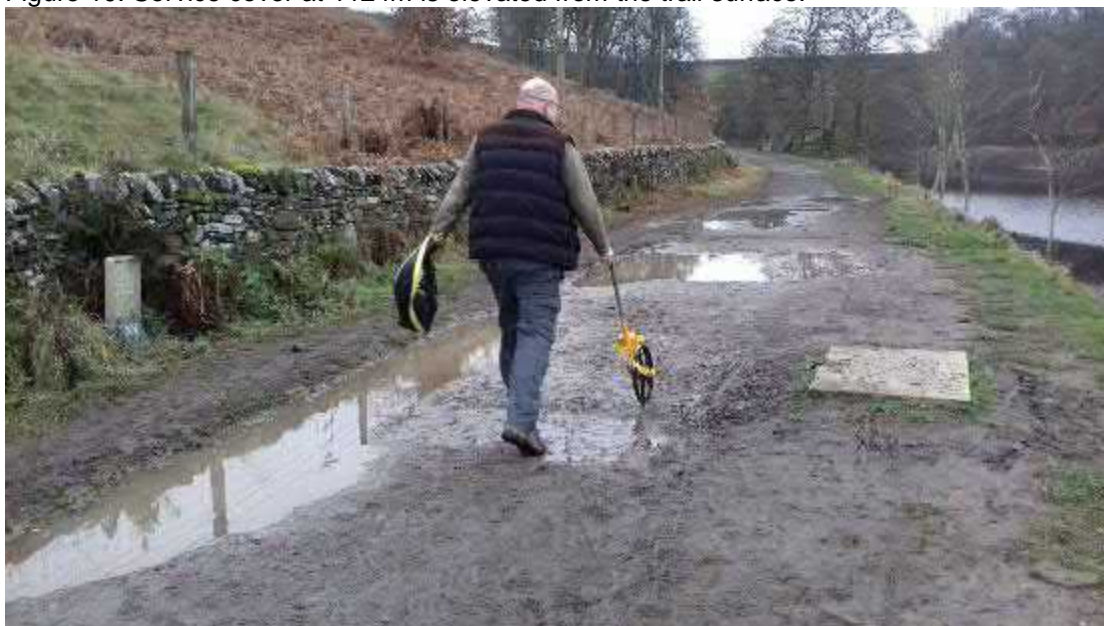
Figure 10. Service cover at 1124m is elevated from the trail surface.

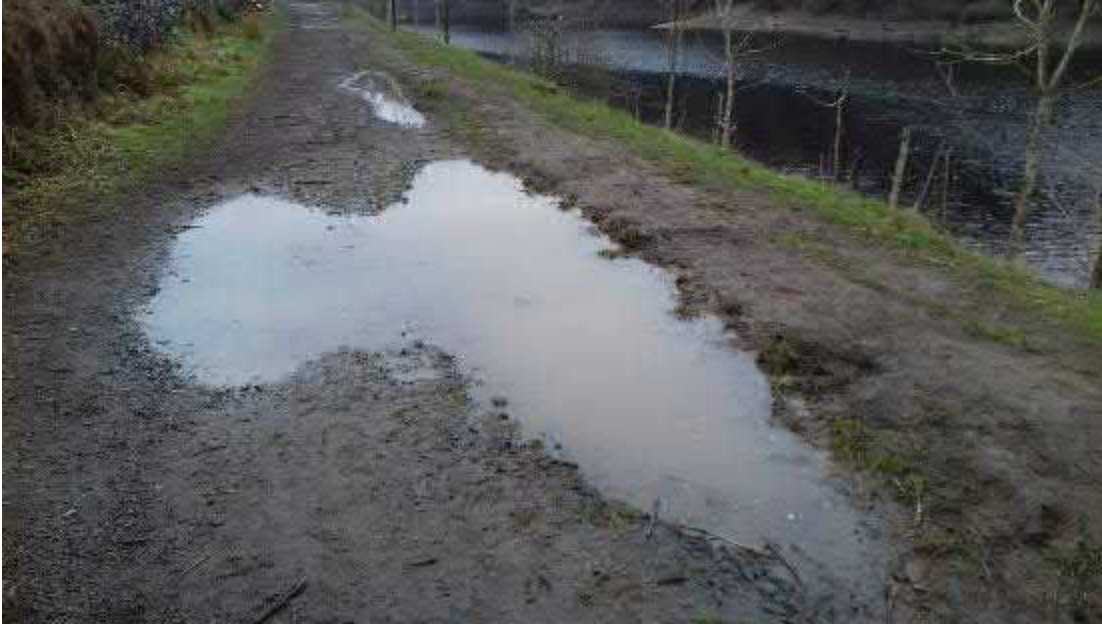
Figure 11. Potholes and puddles are substantial in places.

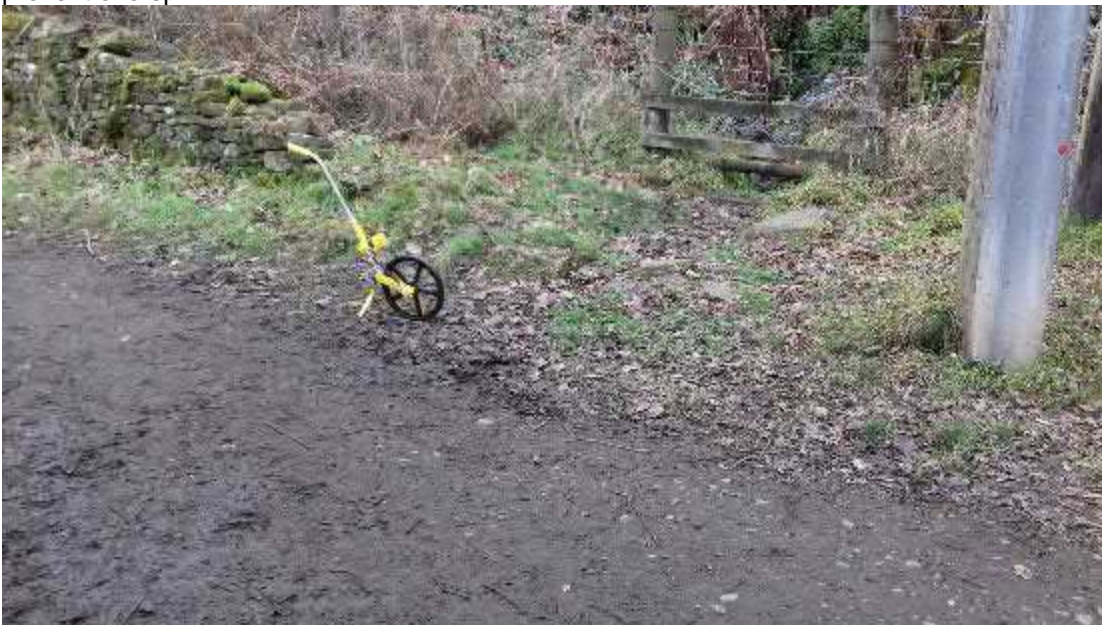
Figure 12. A piped culvert at 1295m is quite close beneath the current trail surface and risks overflowing, the culvert should be cleared out and the trail surface could be raised here to help prevent overspill.

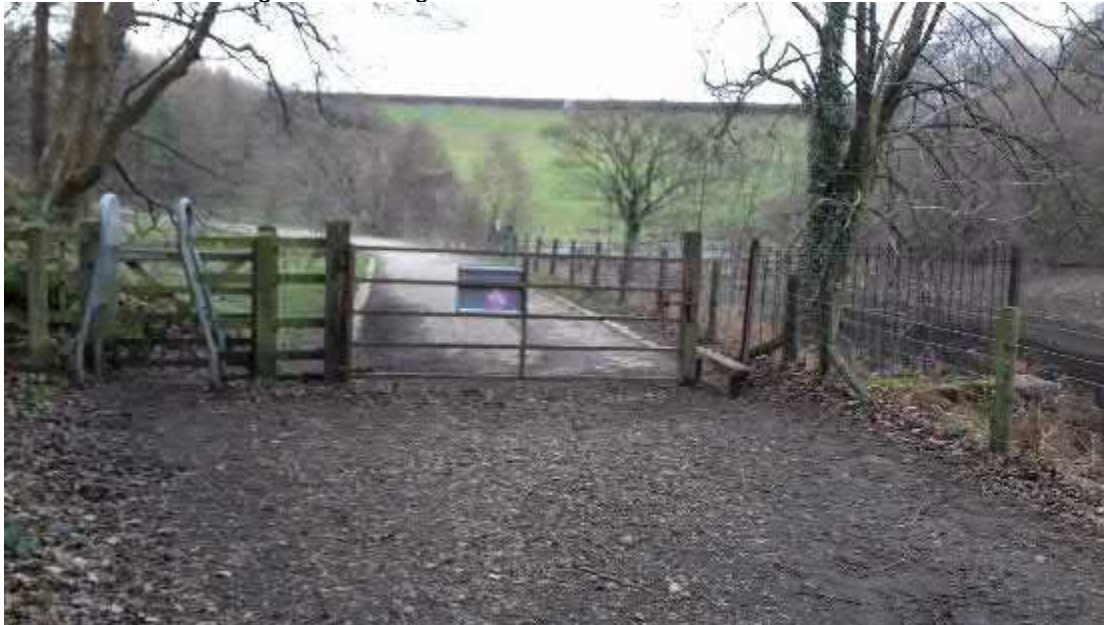
Figure 13. At the end of the trail, at 1343m, is a gated barrier. This is the point at which the re-surfacing will stop (the remainder of the route is adequately surfaced but also has a steep incline which will make it less suitable for some users). Replacement of these barriers is required as at the northern end, retaining the vehicle gate.
