Dwg No. IRR.UGR.01 shows the location of the photographs shown below.

2.3 Annotated photographs

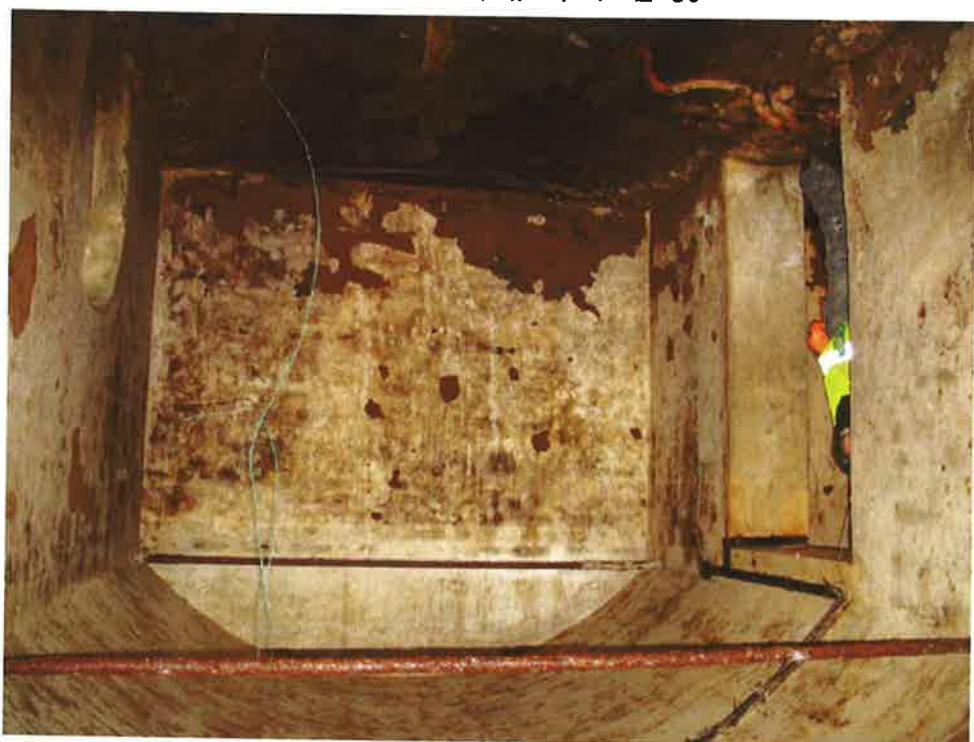
02: Typical cell showing tie bars

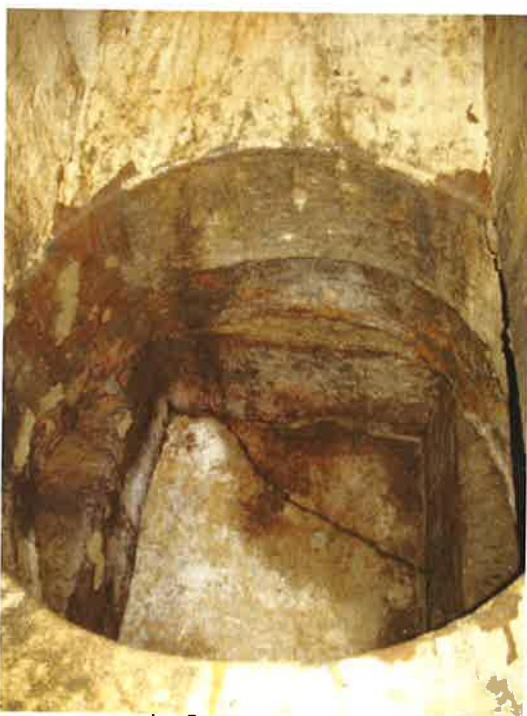
It is not possible (or readily so) to open this entrance from above.

01: Western entrance to reservoir.

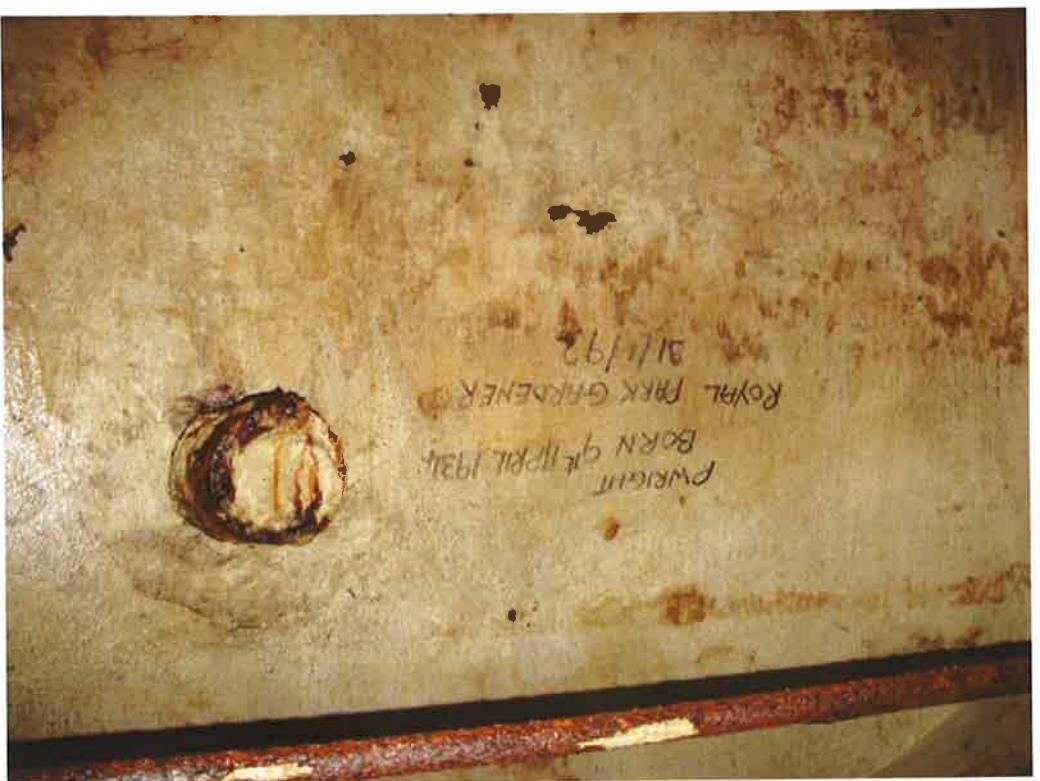
04: Overflow(?) from header tank adjacent, plus graffiti

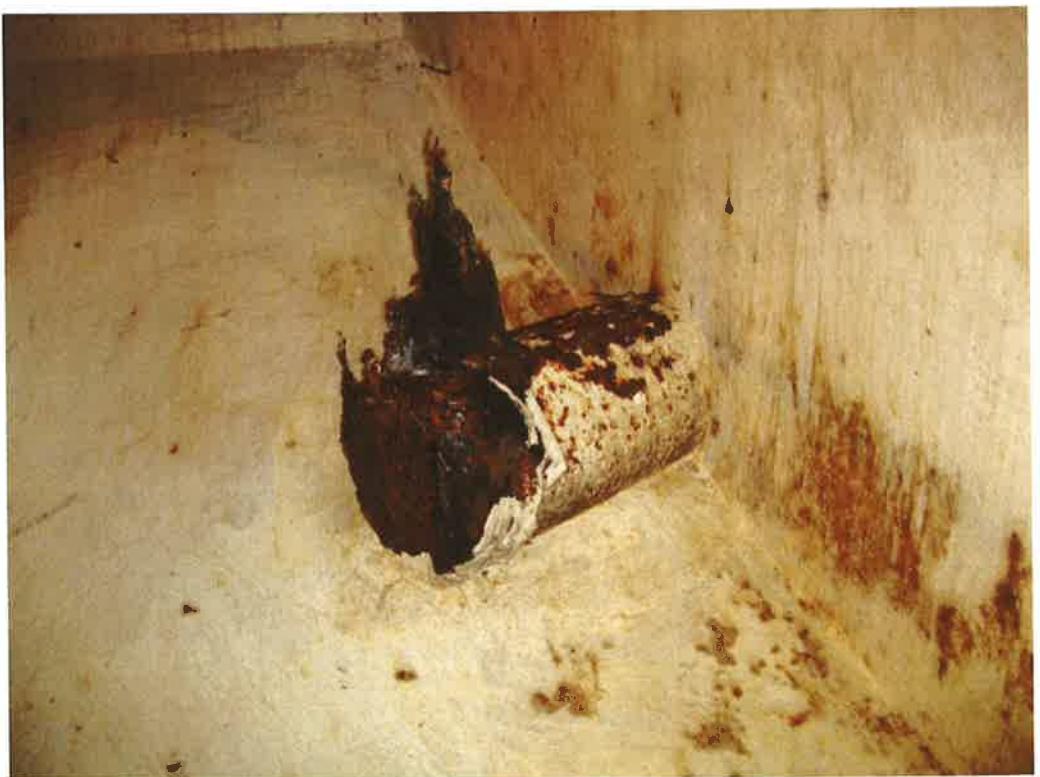
03: High level protrusion

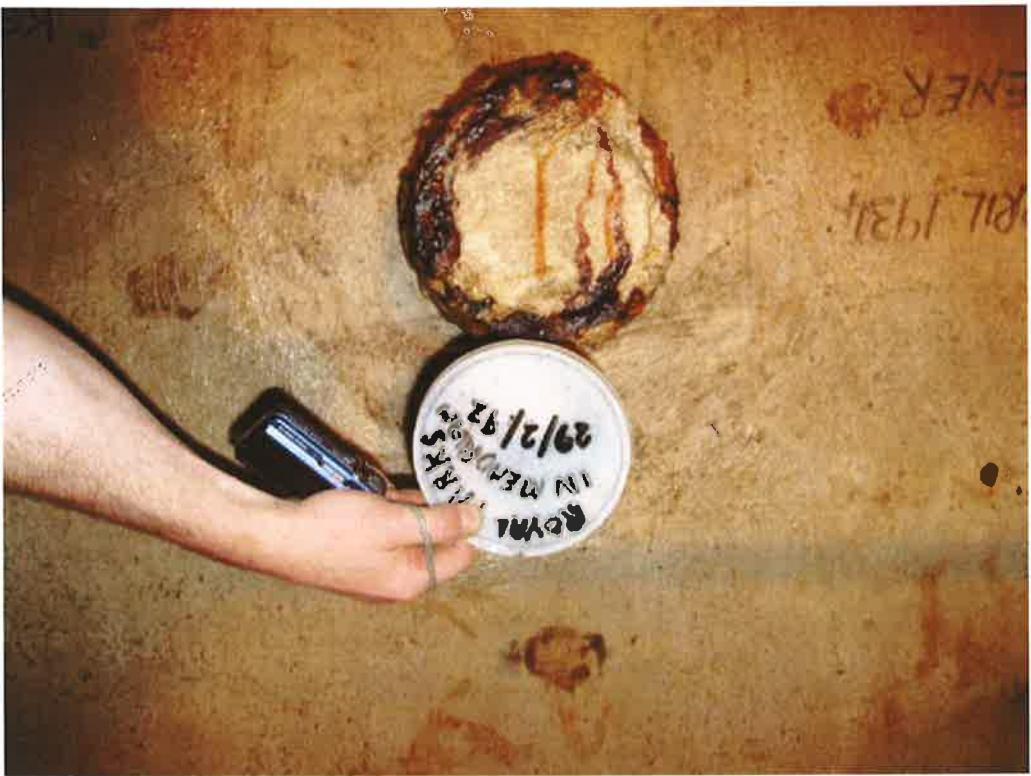
06: Not opened!

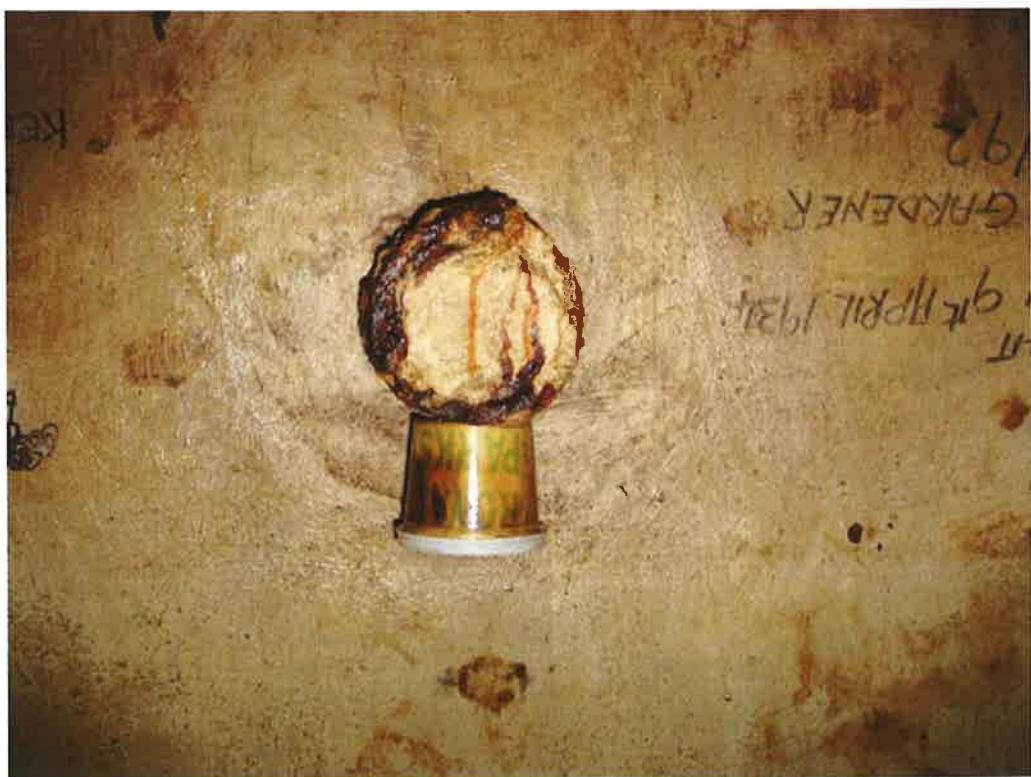
05: Time capsule?

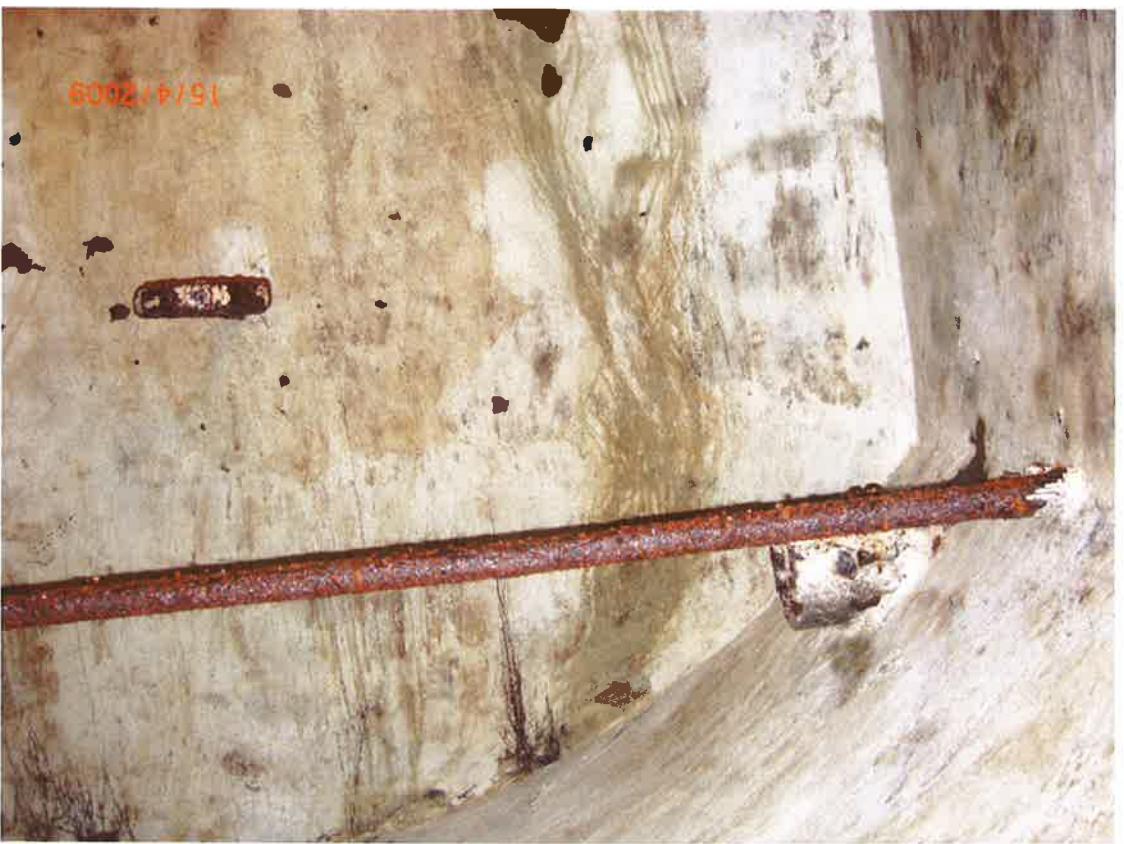
08: Different connecting pipe. Note the Munson ring showing that the pipe turned downwards

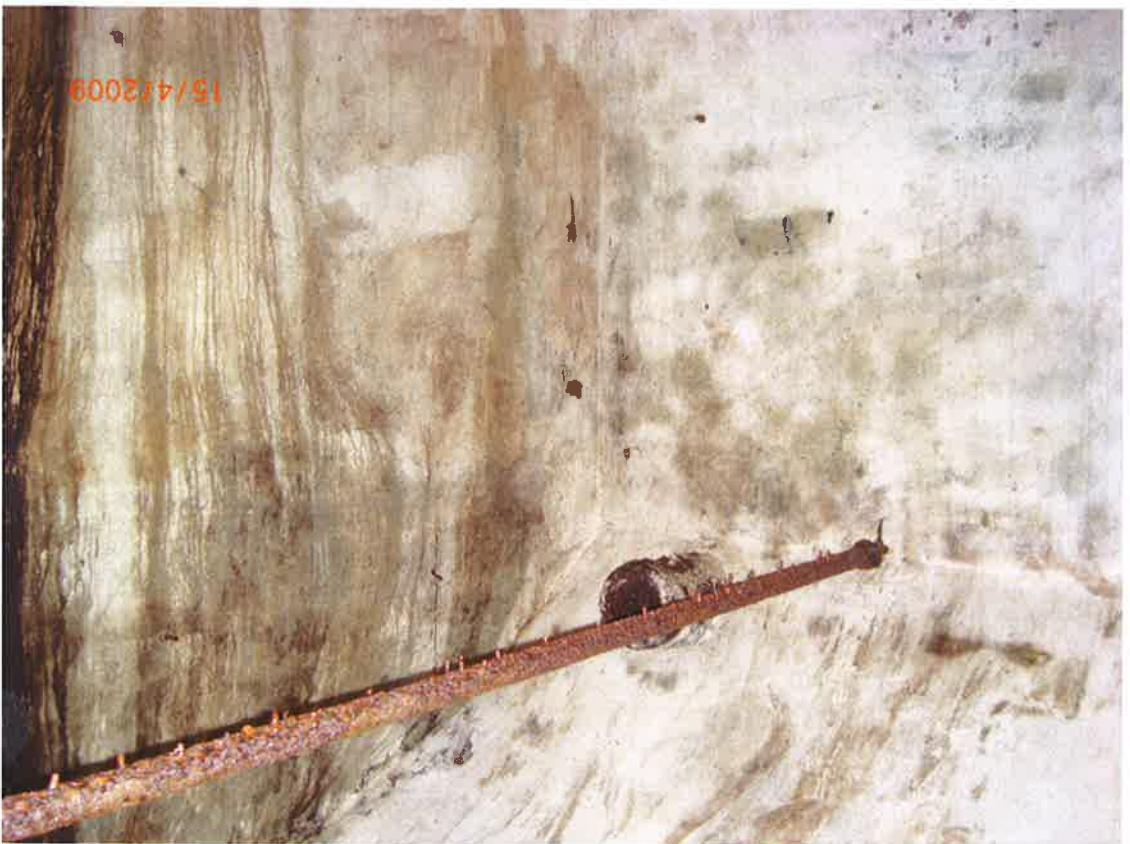
07: Pipe connecting cells

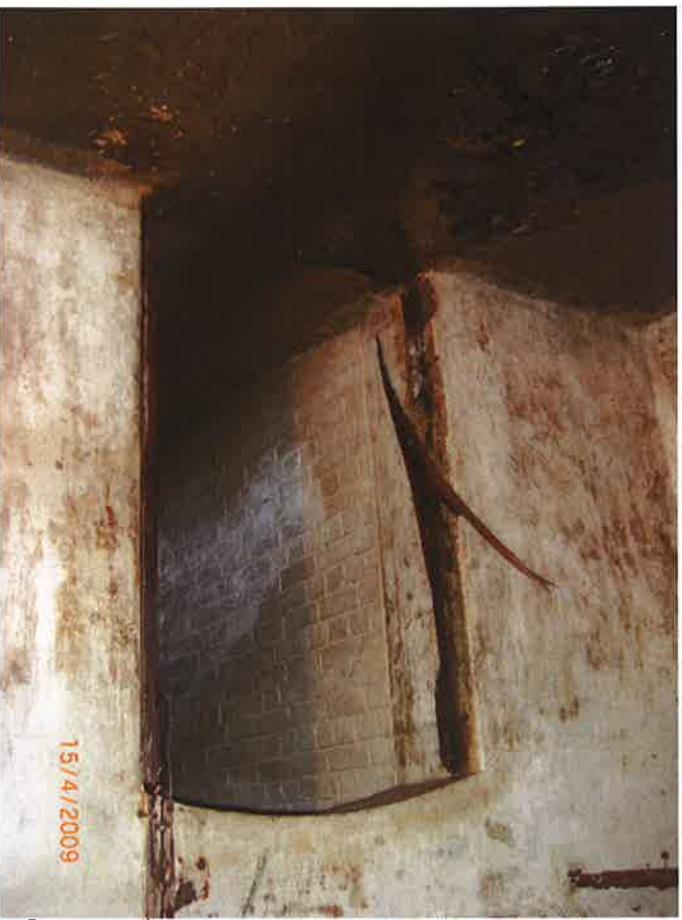
10: View into Eastern end-cell showing new brickwork separating entrance chamber from cell

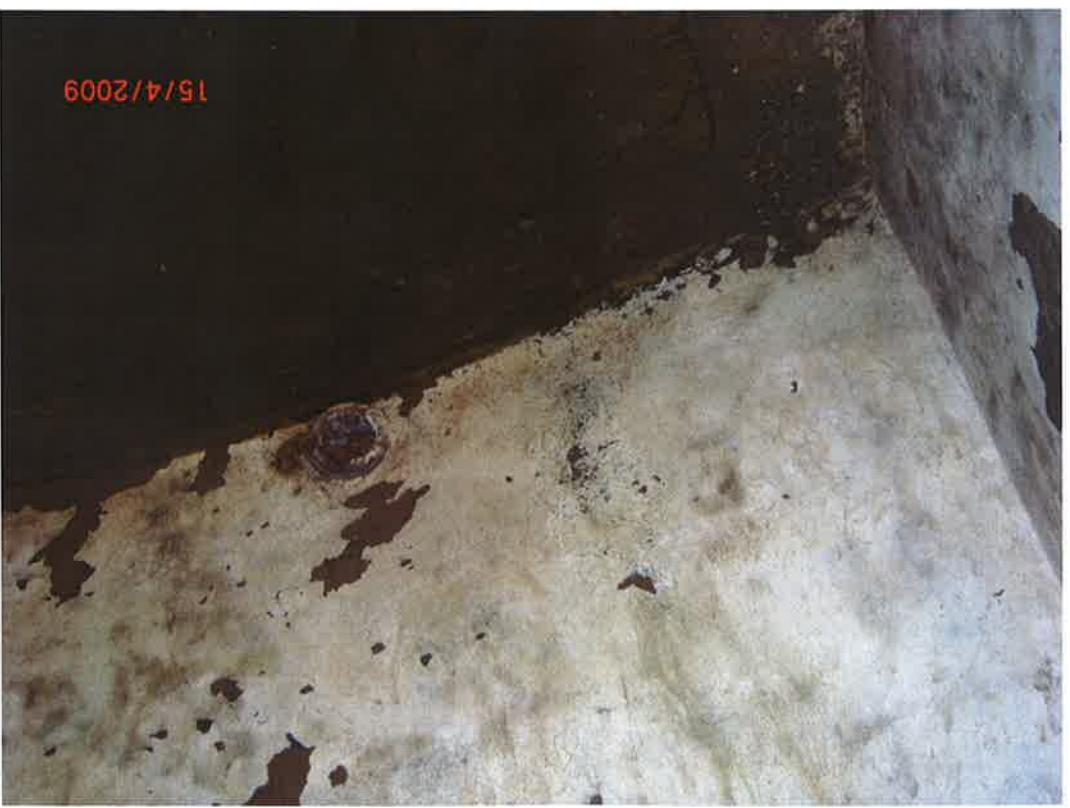
09: The bottom of the end wall also shown in 08, clearly showing a low level exit pipe

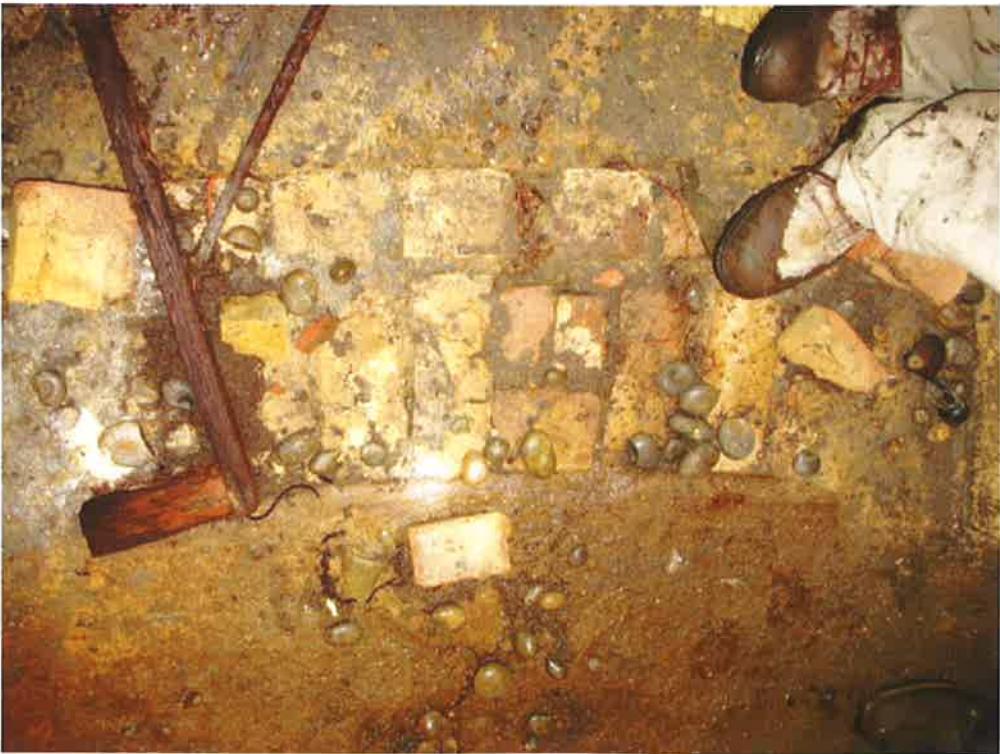
the (concave) floors of most of the cells, though this is consistent with seepage. which is some distance from any known in-flow pipe. There is however up to 100mm of water on post-war ingress at a rate to carry these stones in and to this location within the reservoir shelter as otherwise they would have been a 'trip-hazard' in the dark. There is no evidence of the rounded pebbles have arrived there but logically this would be after the construction of the place where the air raid shelter entrance ('lobby') has been installed. It is not clear how the 11: View of brickwork forming original end-cell end-wall on Eastern end-cell. This marks the

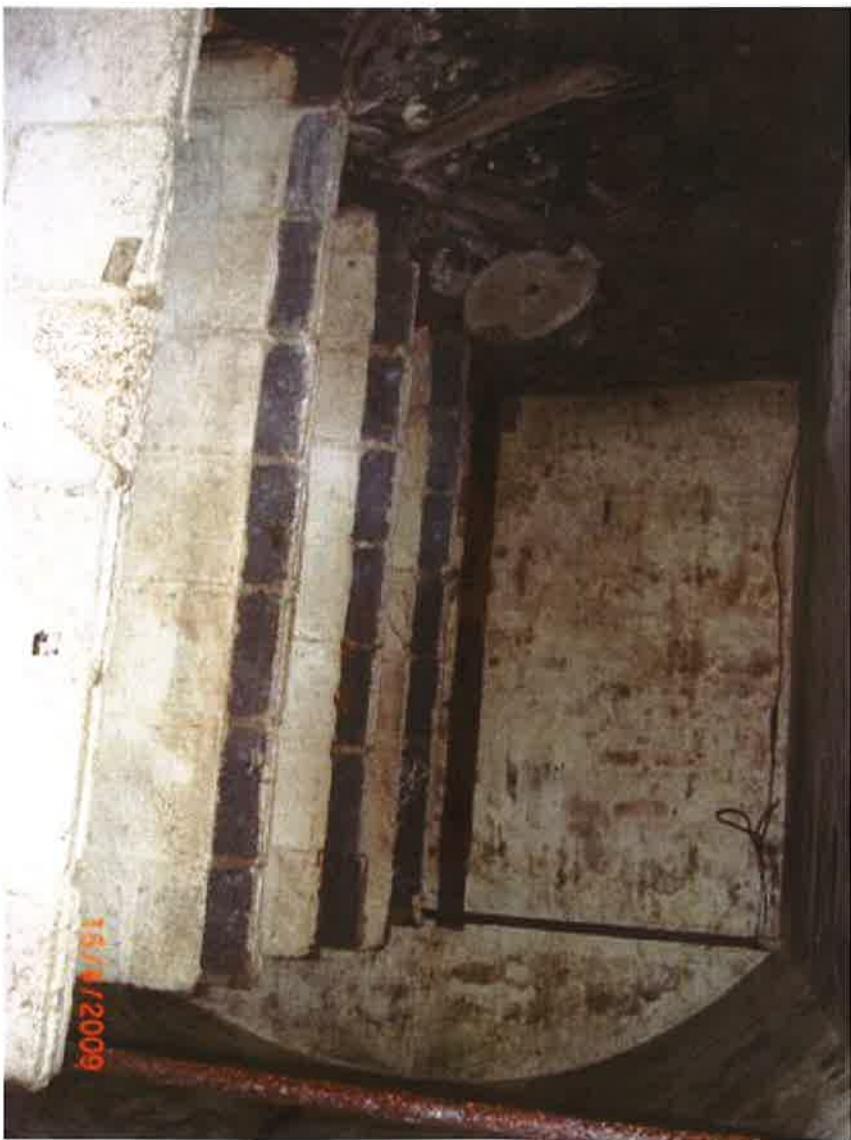
12: Toilet cubicles constructed from rudimentary blockwork in Western end-cell. Toilets would appear to be 'rubber' lined boxes with a wooden seat.

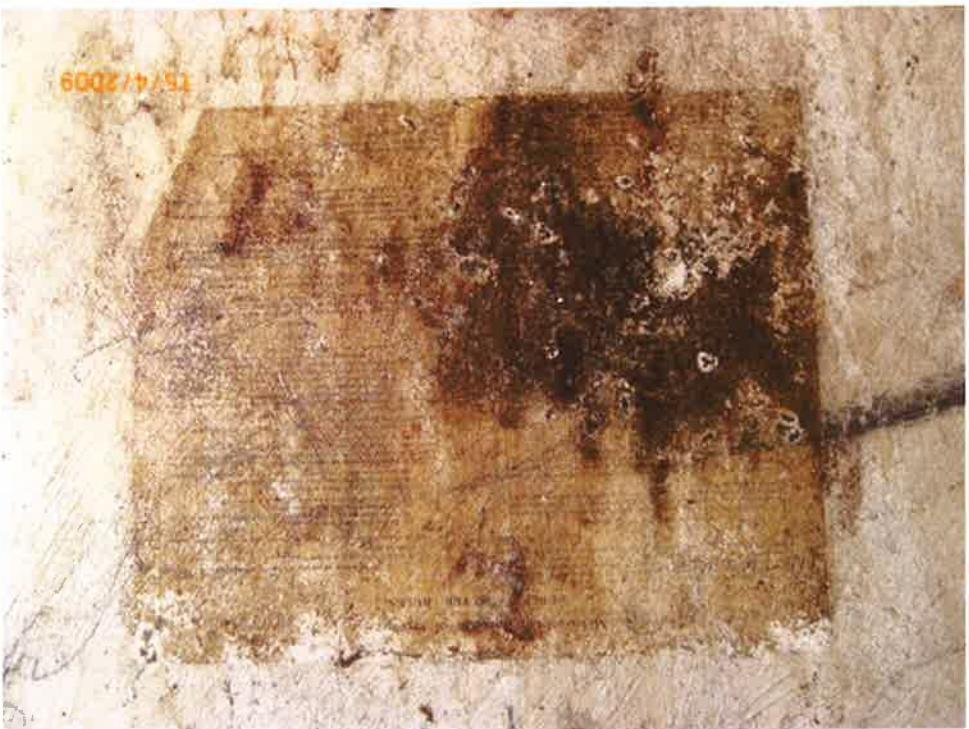
14: Air raid shelter rules (largely illegible)

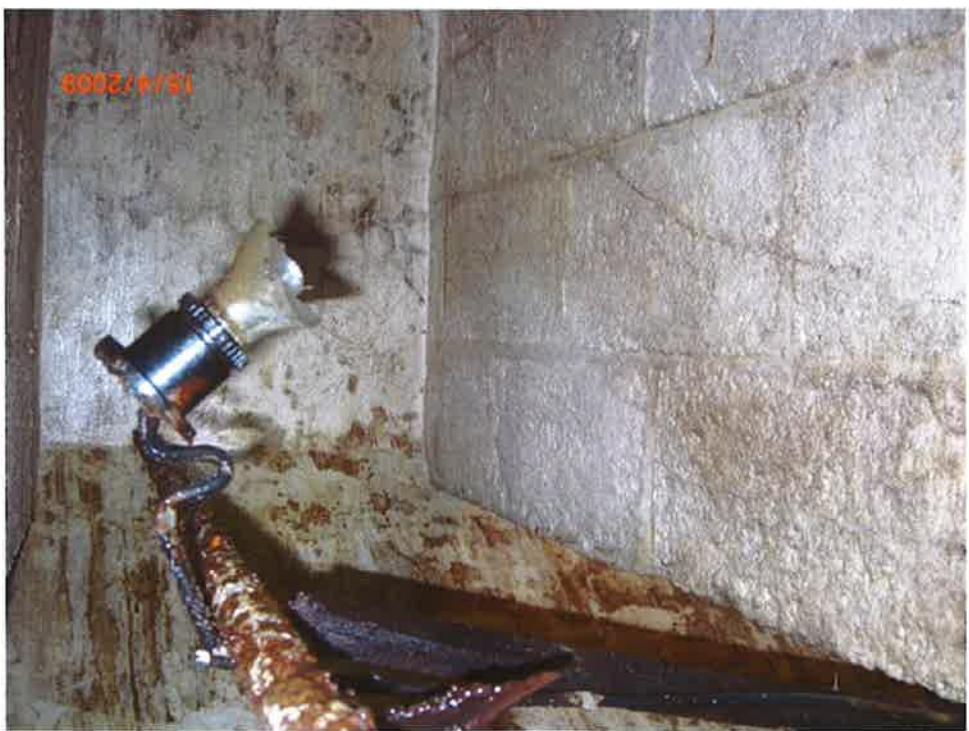
13: Remains of war-time cabling and lighting

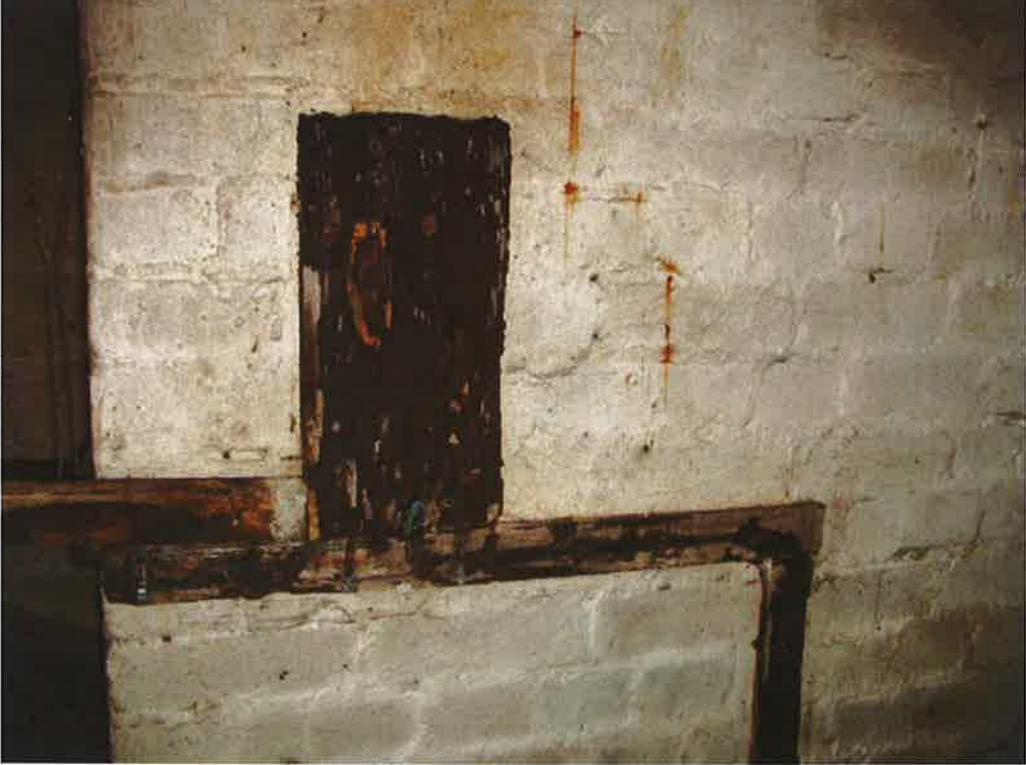
16: Surface strips for cabling and switching fixes

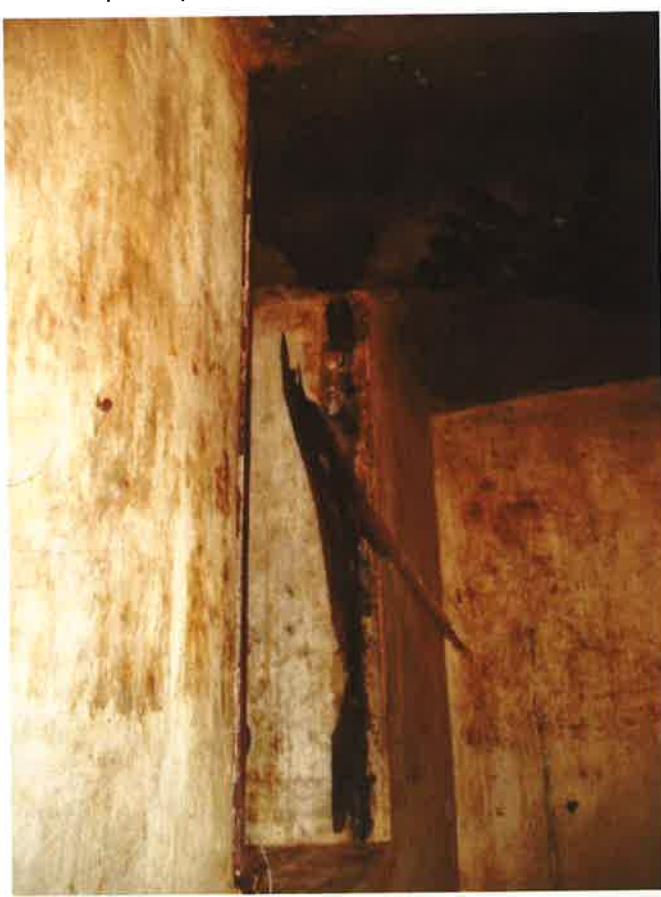
18: View of doorway relating to door above

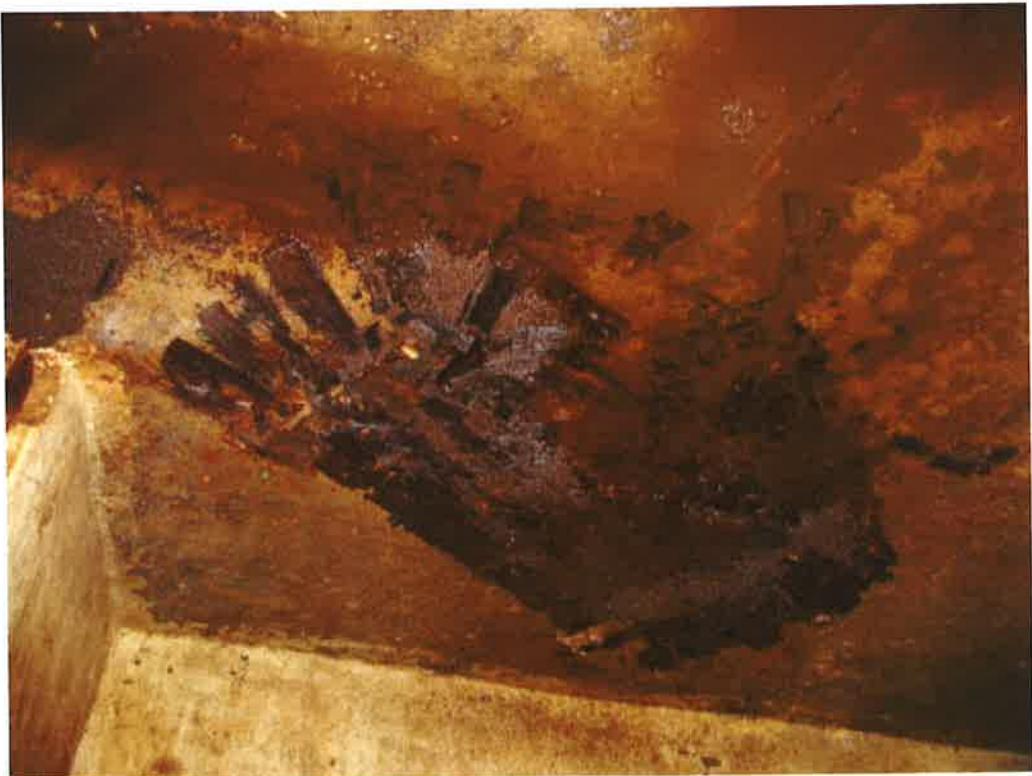
17: Door between Eastern cell (toilets) and adjacent cell - rotten where fallen.

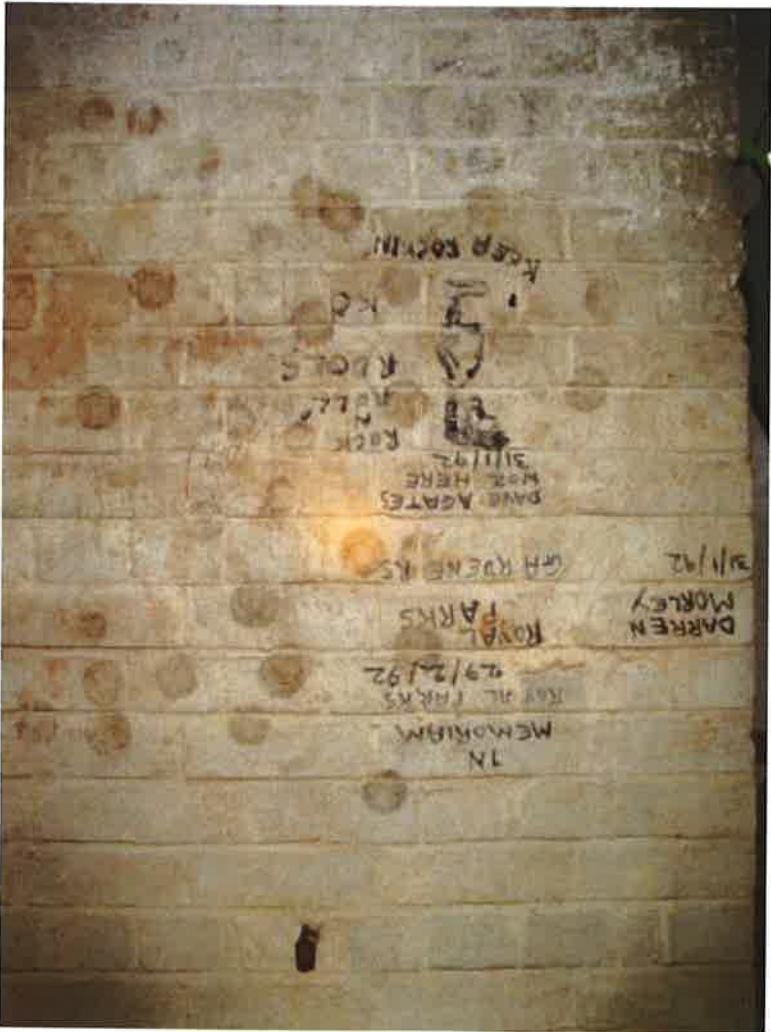
19: 1992 Graffiti and ball-bounce marks. The Cooler King?

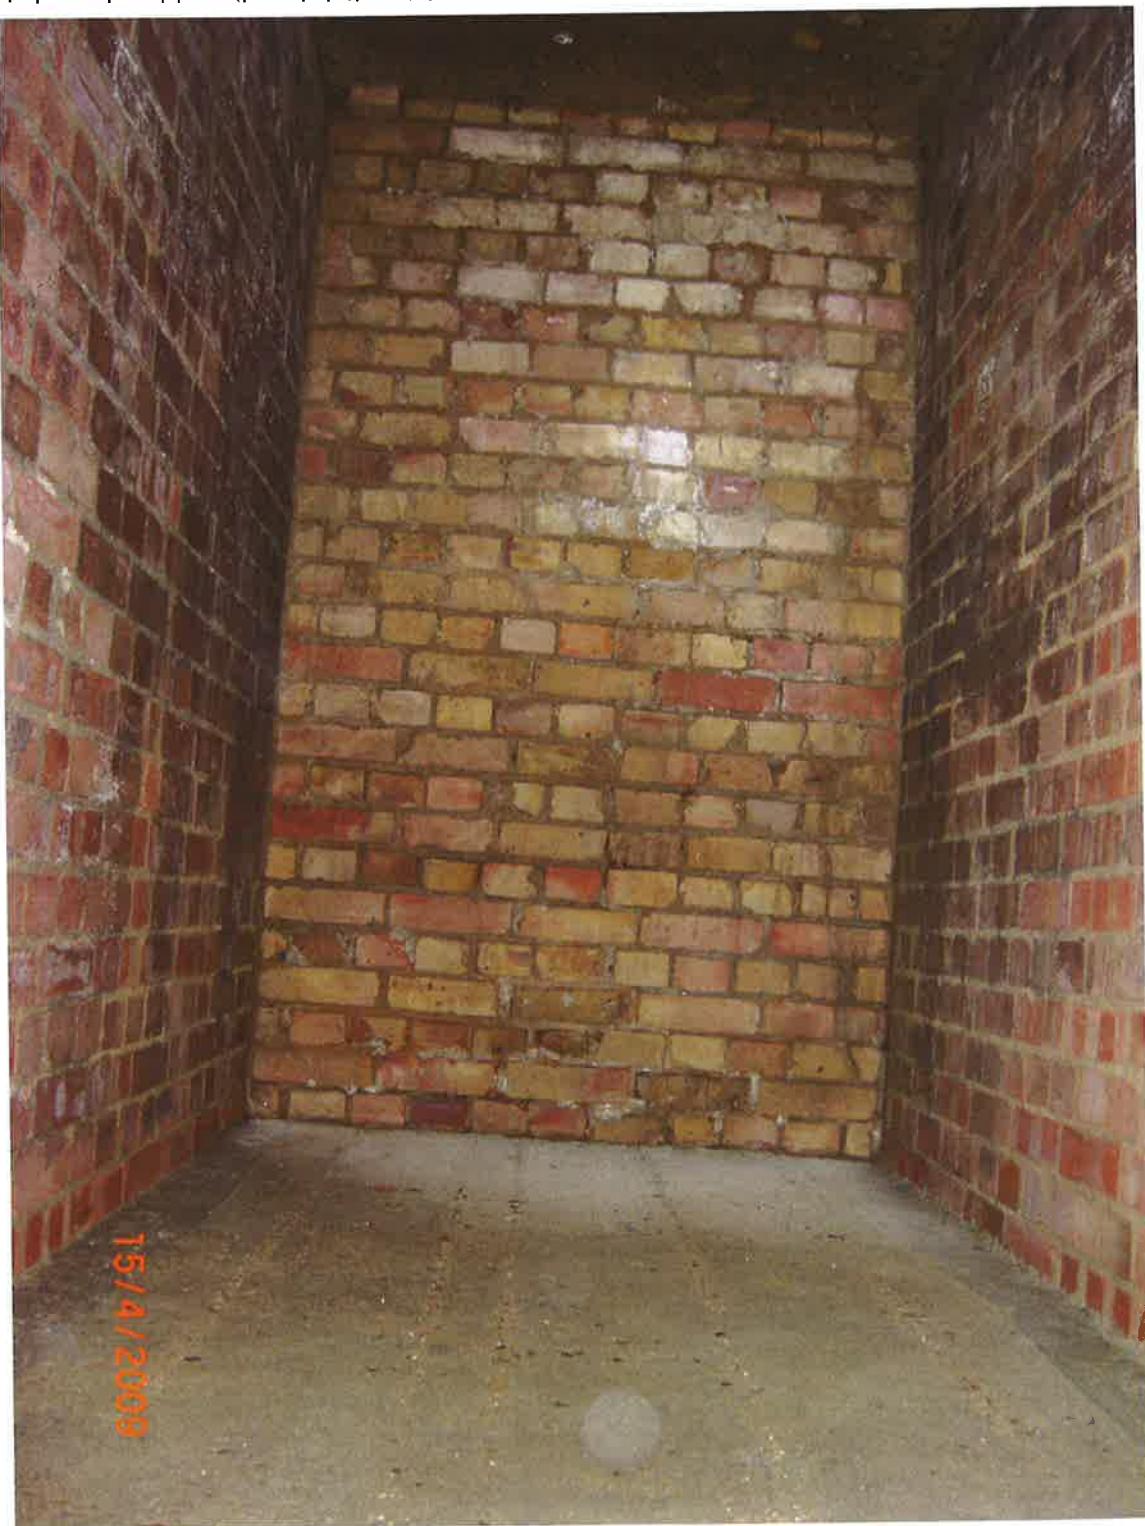
future use of the reservoir.

decommissioning work and not load bearing. This may have a bearing on further work to and air raid shelter. The face-on brick wall above therefore is merely part of the shelter walls which were, together with the slab, part of the adaptations to the reservoir to make it an form outside (no pointing or scraping from within). A concrete slab is laid on top of the side 20: End-cell entrance, 'lobby'; brickwork is double skinned (English bond) and has been bricked

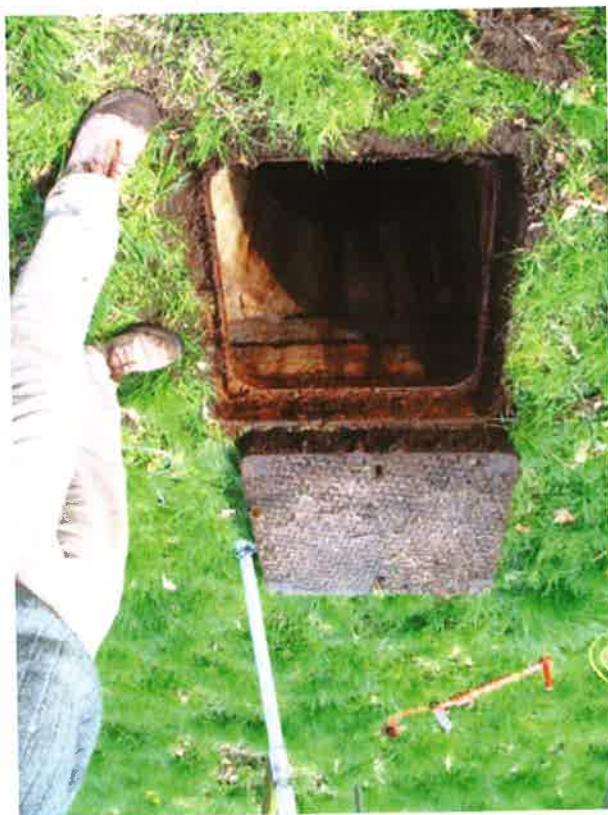
21: Entrance made through this man-hole as shown on Dwg. No. IRR.UGR.01
