Earthwork Inspection 5 Chain Record

Earthwork Type	Soil Cutting - SCHI
Route	
Operational Route	LNE
Strategic Route	G - East Coast and North East
SRS	G.03 - Hertford Loop
Territory (Pre-Nov 2011)	LNER
Earthwork Management Area	3
Classification	London and SE Commuter

Line					
ELR	HDB				
Route Description	Hertford Nth Loop				
Reverse Mileage	False				
Start Mileage (Miles.Yards)	7.1320	End Mileage	7.1430	Side	Down
Start Easting	531,513	Northing	194,503		
End Easting	531,545	Northing	194,597		
Length (Mile.Yards)	0.0109				
Track Name	NT - Not 6ft or 10ft Earthwork	Track ID	2200 Down Slow/Local/Relief		
Reverse Mileage	False				
Disused Line	Open

Earthwork Type	Soil Cutting - SCHI
Earthwork Name	-
Inspection Season	Winter 2012/2013
Inspection Type	Cyclical Examination
Weather Conditions	Overcast; Calm
Competence Certificate No.	66020703
EE Recommendations	None
EE Inspection By	[REDACTED], Amey (LNE and Midlands)
EE Inspection Date	19 March 2013
EE Inspection Time	16:04
Last Modified By	[REDACTED], Amey (LNE and Midlands)
Last Modified Date	19 March 2013
Last Modified Time	16:04

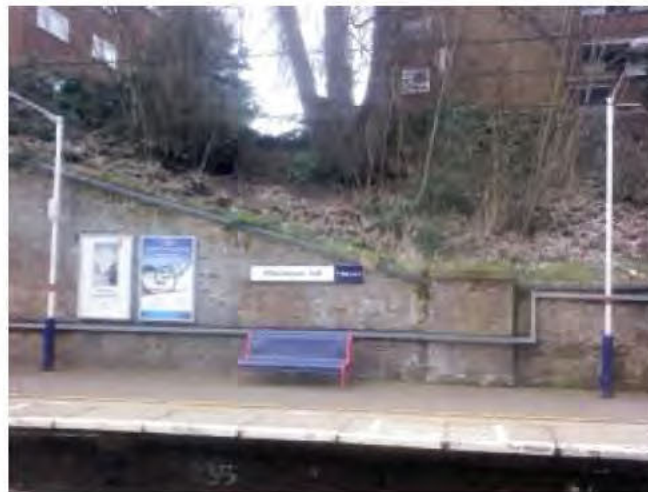
HDB_7.1357_D_531537_194530_19_03_2013_14_02_18

Subject	cutting above wall
Taken Date	19 March 2013
Taken Time	14:02
Filename	FO:LNE:jpg:1441231751
Orientation	Away from line
Description	-

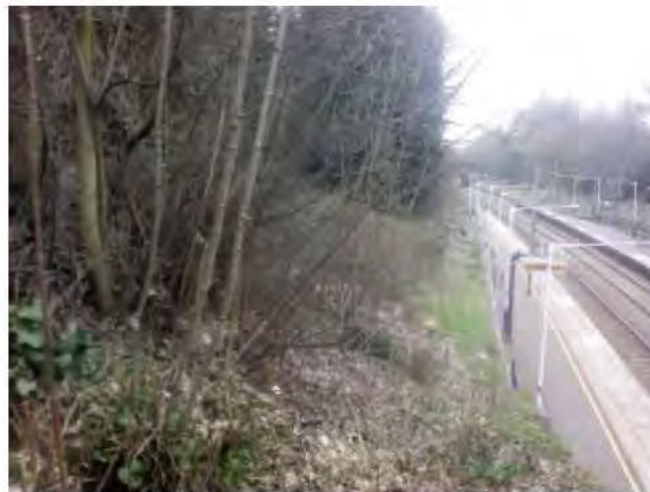
HDB_7.1345_D_531524_194523_19_03_2013_15_52_43

Subject	cutting
Taken Date	19 March 2013
Taken Time	15:52
Filename	FO:LNE:jpg:1441259206
Orientation	Down line
Description	-

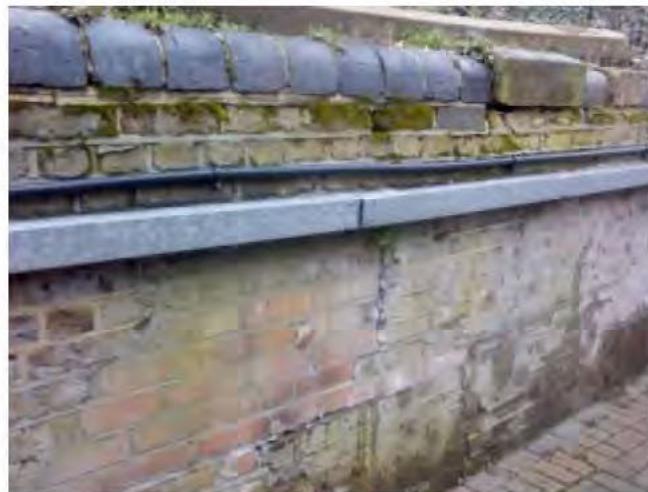
HDB_7.1392_D_531541_194562_19_03_2013_16_02_45

EE: layers of dead vegetation cause difficulty in assessing what is superficial veg cover and what is earth. monitor brick retaining wall at cutting toe which is cracked and bulges out slightly due to burden of slope. [REDACTED], Amey (LNE and Midlands): 19/03/13:

Subject	Structure Defect
Taken Date	19 March 2013
Taken Time	16:03
Filename	FO:LNE:jpg:1441202994
Orientation	Away from line
Description	mortar cracks within retaining wall. bulging here. [REDACTED], Amey (LNE and Midlands): 19/03/13:

ELR	Start Mileage	End Mileage	Side	Retaining Wall Material	Retaining Wall >= 1m
HDB	7.1348	7.1430	Down	Brick	Minor distress - spalling, pointing etc (C4)

Current Season Comments -
Historic Comments 2013:
 EE: monitor brick retaining wall at cutting toe which bulges out slightly. [REDACTED], Amey (LNE and Midlands): 19/03/13:
