Hilbre Island Defence Inspection and Report **July 2016**

Draft Report

September 2016

Hilbre Island Inspection and Report – July 2016 September 2016

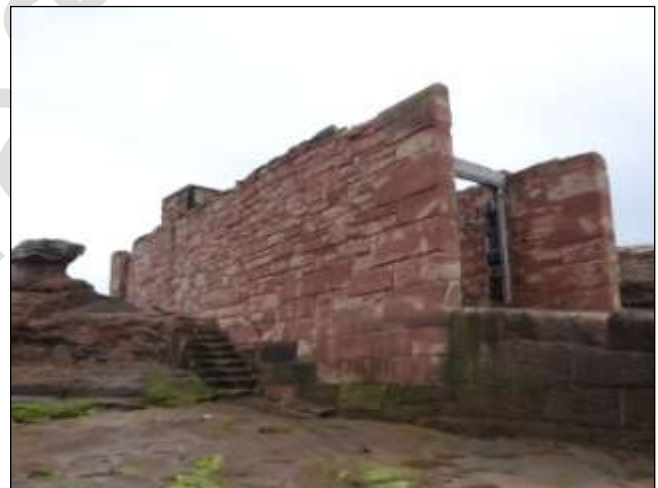
Frame HI_190728_046

There is some local damage to the blockwork infill on the east side of the lifeboat ramp (highlighted on plate 46 below). The infill on the west side is in reasonable condition with perhaps only a little pointing required.

- Repairing the damaged section of infill wall on the east side (ref plate 46); and
- Sealing the exposed edges of the lifeboat slipway (ref plate 49). This is not essential but, if left unchecked, would lead to undermining of the walls to the lifeboat station/bird hide eventually.

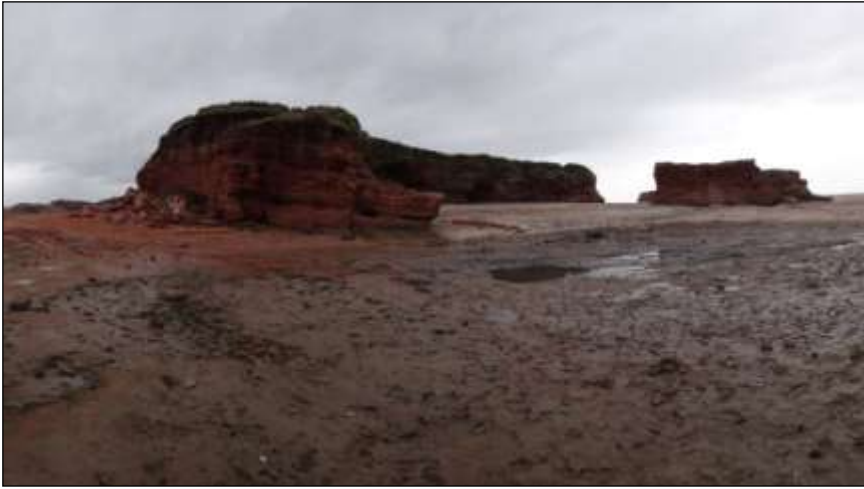
Frame HI_190728_103					
DISCUSSION/MANAGEMENT OPTIONS					
No specific management actions – watching brief for changes

The sandstone cliffs are only between 3 and 5 metres in height at this end of the island and there are no artificial defence measures.

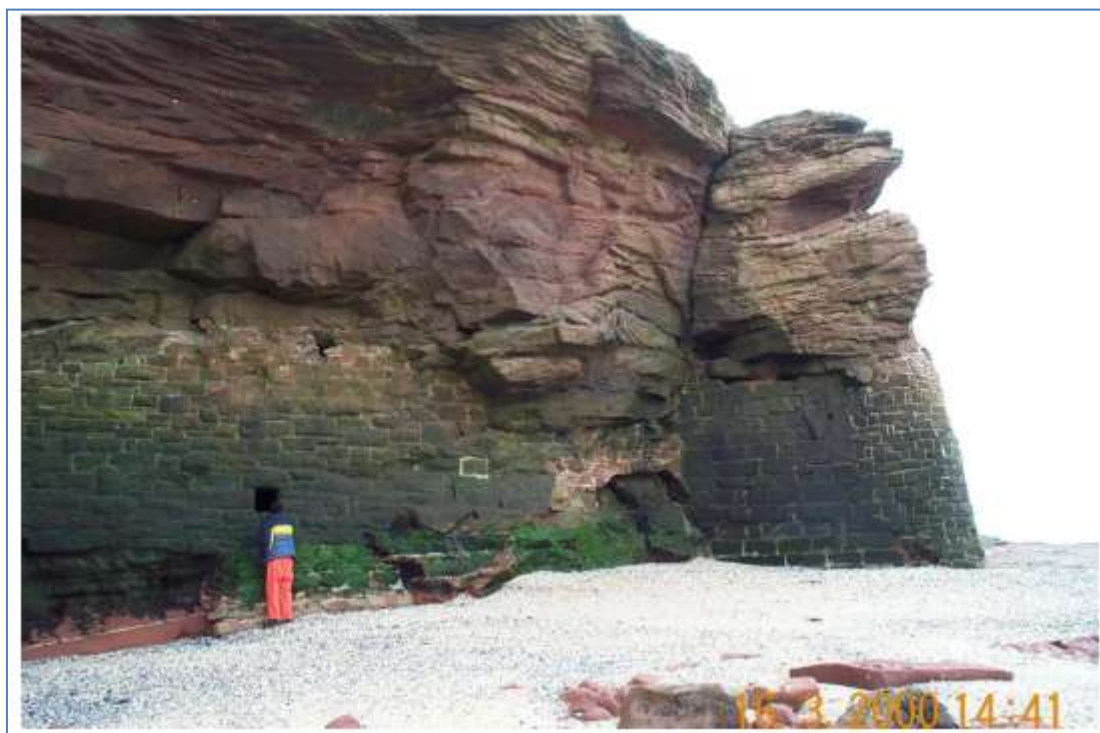
NW Corner Defences 2000

The failure of the wall section has taken place in the past ten years. Photos from inspections in 2000 and 2005 (ref Appendix III) indicate the section to be intact at those times. The historical and contemporary photos (particularly plates 57, 61 & 64) show that the promontory adjacent to the cavern appears to be supporting a piece of rock cliff that is separate to the main cliff with a clear fault line between the two (as shown on plate 57 below). Reference to recent (2015) oblique aerial photographs (Appendix IV) suggests that the walls were constructed to prevent undercutting continuing. The cavern that has been created following the failure of the section of wall appears to be partially undercutting the main cliff and partially the outer piece primarily under the main cliff. If the wall fails at the corner and the rock above shears away from the main rock cliff, it will likely compromise the integrity of all the masonry infill to the south, destabilising the main cliff across this section.
