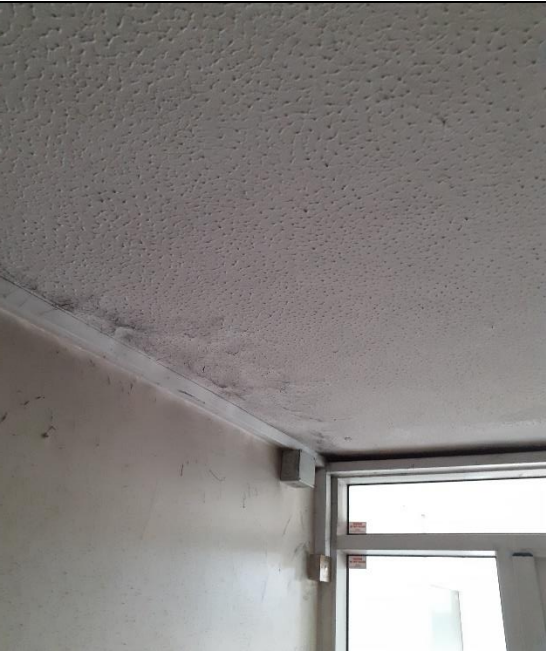
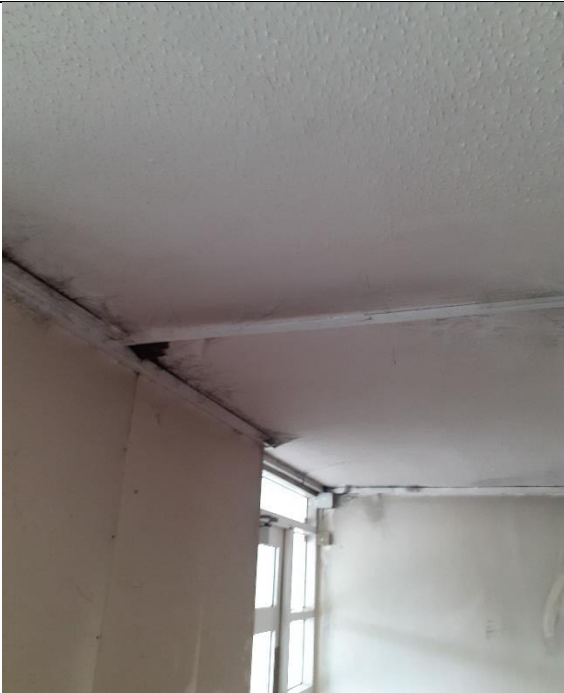
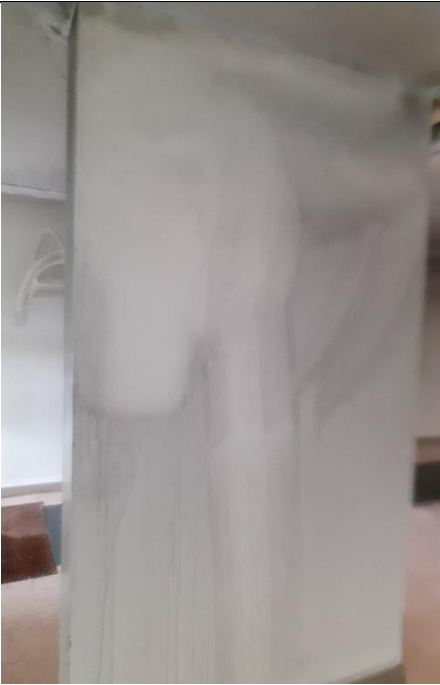
Fire originated to front left hand side wall, corner area.	View of smoke damage to right hand side entrance wall.	Fire doors from main lobby area to ground floor flats, 1-12.

L 15.05 x W 5.5. View of front entrance doors taken from rear of lobby.	Ceiling height 2.3m. Damage to ceiling.	L 1.6 x W 3.7. Fire doors from main lobby area to rear left hand side ground floor flats. Possible damage to pipe cladding tbc. And quoted for by Stonegrove Ltd. Currently on site.

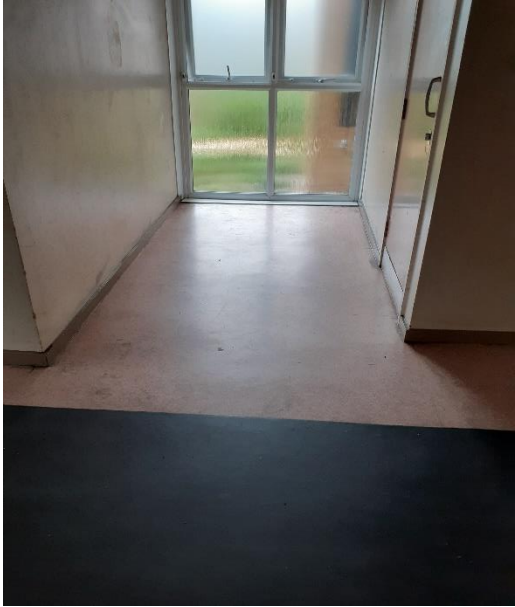
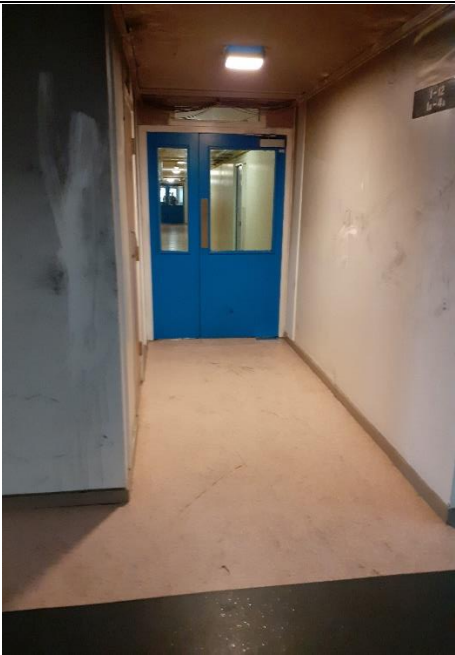
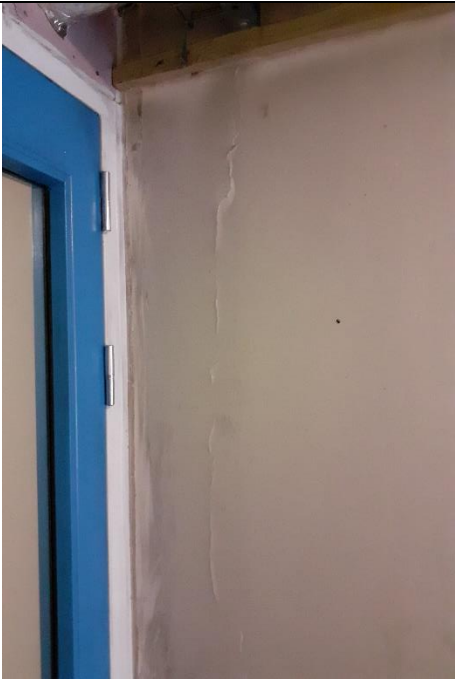
Damage to floors, possibly caused during clean up process.	Damage to floors, possibly caused during clean-up process.	Smoke damage to walls.

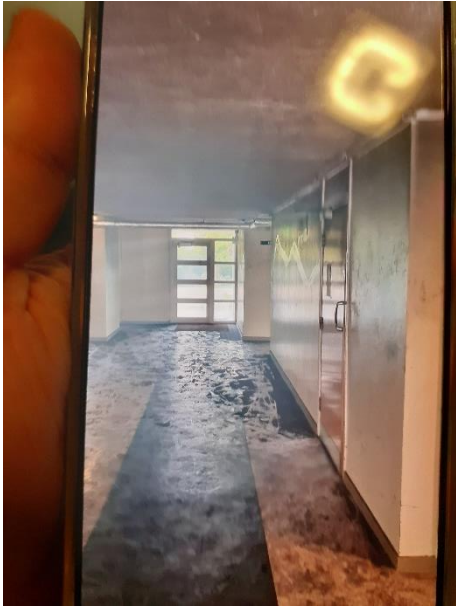
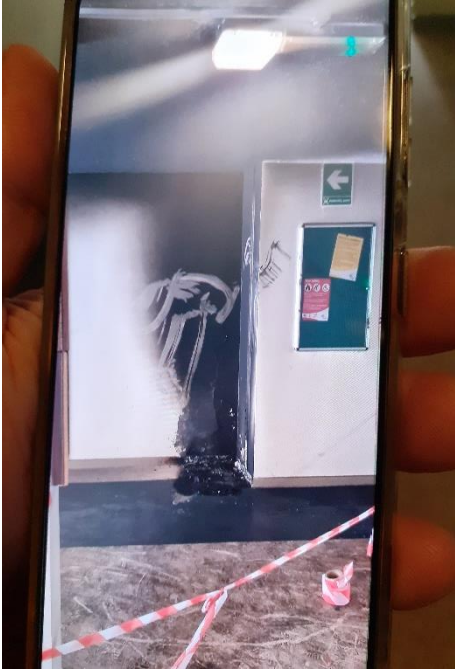
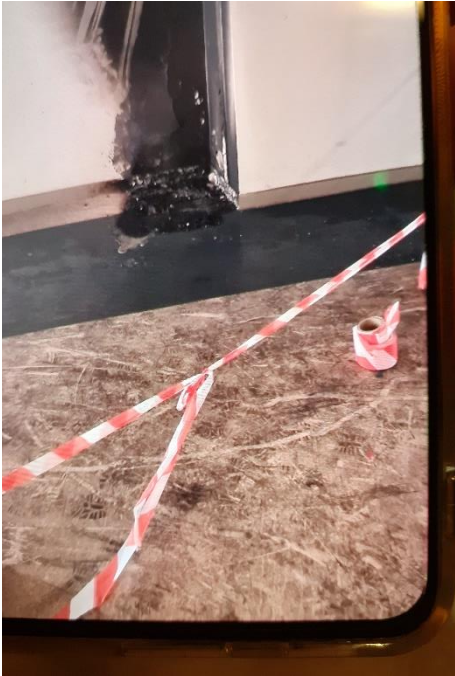
L 1.6 x W 2.6. Smoke damage to walls rear right hand side.	Smoke damage to walls front right-hand side. Fire doors to flats 1-12 leading to Lower Ground – 1A to 4A.	Closer view of wall damage.

Still taken from tenants' phone of damage pre-clean-up operation and prior to surveyors visit.	Still taken from tenants' phone of damage pre-clean-up operation and prior to surveyors visit.	Still taken from tenants' phone of damage pre-clean-up operation and prior to surveyors visit.
