Ref: **Subsidence Damage due to Tree Root Nuisance**  
Loss at: [REDACTED] Cambridge, [REDACTED]  
Insured: [REDACTED]

# Arboricultural Consultancy for Royal & Sun Alliance

# Update Following Completion of Site Investigations

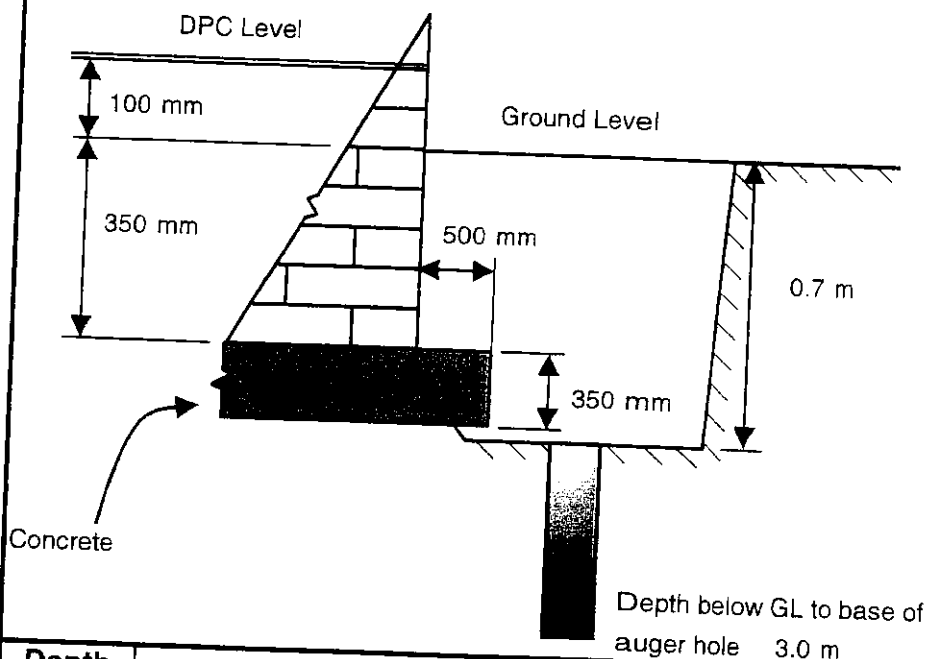
Roots Depth & Dia:  
Down to 3.0m,  
up to 2mm diameter

In summary all of the three trial pits to the house and conservatory revealed foundations bearing at depths of 700 to 800mm below ground level on firm to stiff clay soil. Stiff clay soil continued to a depth of 3 metres in all bore holes.

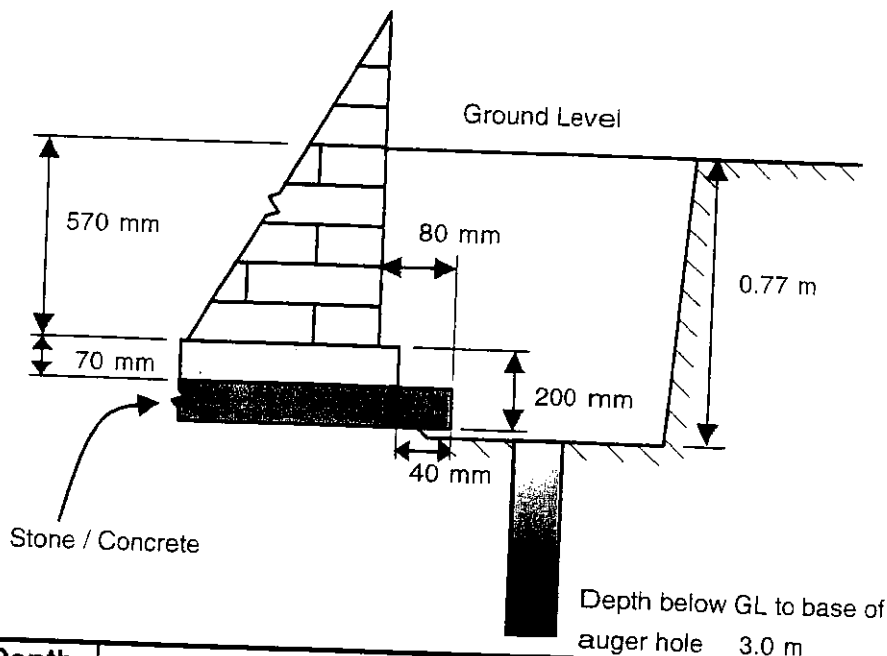
Roots Depth & Dia:

None observed on-site

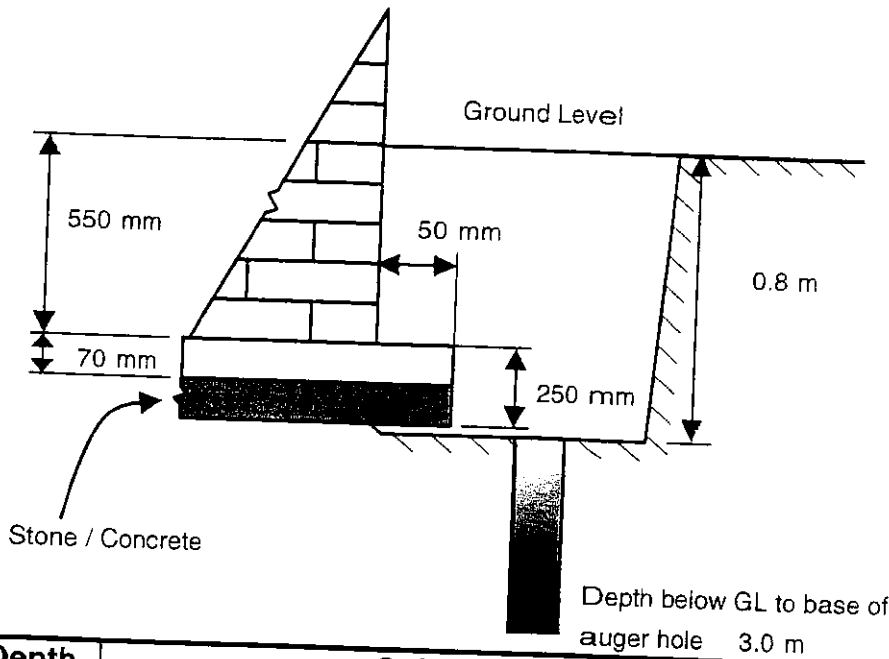
Roots Depth & Dia:  
Down to 3.0m,  
up to 2mm diameter

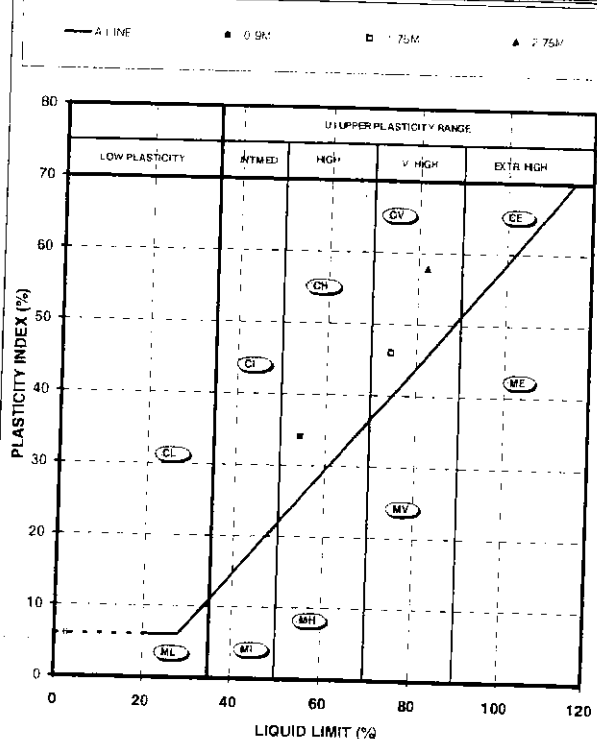
The interpretations below are outside of UKAS accreditation.  
A Heave Potential Analysis is not possible due to the low magnitude of the Suction values.

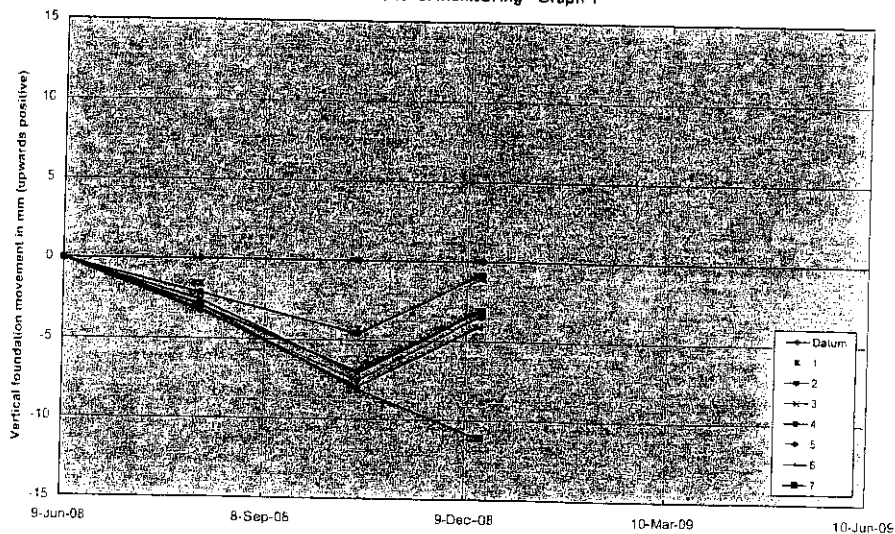
Precise level monitoring - Graph 1

The results of the level monitoring prove clearly that the property is experiencing seasonal movement that is exacerbated by the moisture demand of the adjacent vegetation. Downwards movement of over 10mm has been recorded, despite the last two years being regarded as "wet" periods. The site investigation has proven that roots from the Plane trees extend beneath the left hand side of the property and that the clay soil remains desiccated to the rear left hand corner, despite the soil samples not being recovered until December.
