**Principal Inspection
Report
Bridge No 1093**

**North Bridge, Station Road
Oundle**

**NORTHAMPTONSHIRE
COUNTY COUNCIL**

May 2018

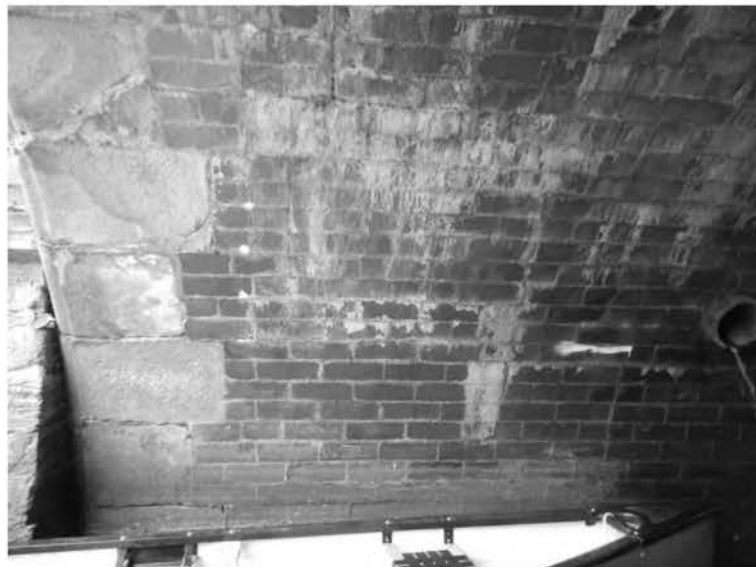
There are longitudinal cracks along the full width of the arch with transverse cracking at the south end of the arch. The cracks vary in width from hairline to approximately 3mm and generally show sign of water seepage with salt deposits. Localised areas of bulging generally associated with transverse cracking were noted but on the whole, the arch does not appear to be significantly out of shape.

Area of cracking at the south end of the arch

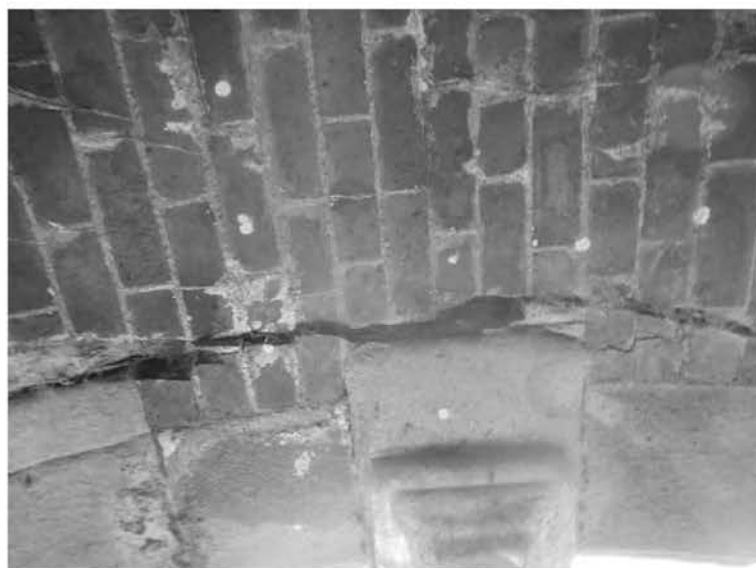
There is a large crack between the voussoirs and masonry arch. The crack measured approximately 20mm wide and 170mm deep at the apex of the arch.

Crack between South Voussoirs and the masonry arch

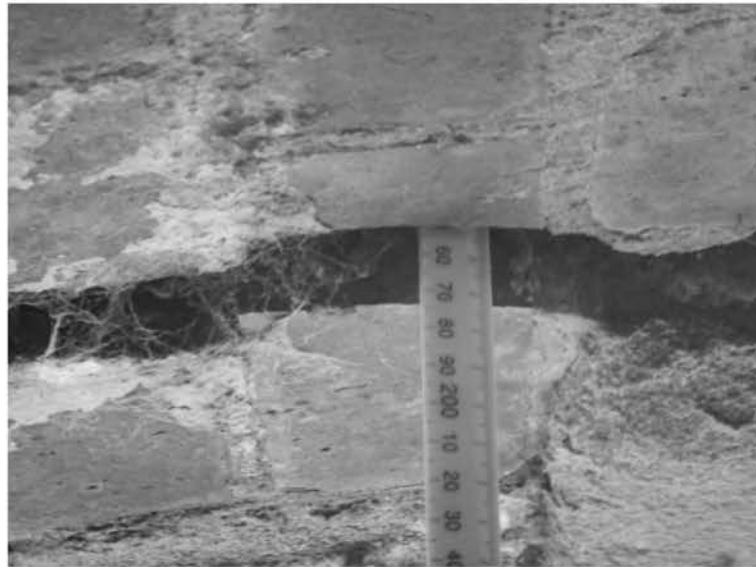
Close-up of crack showing depth

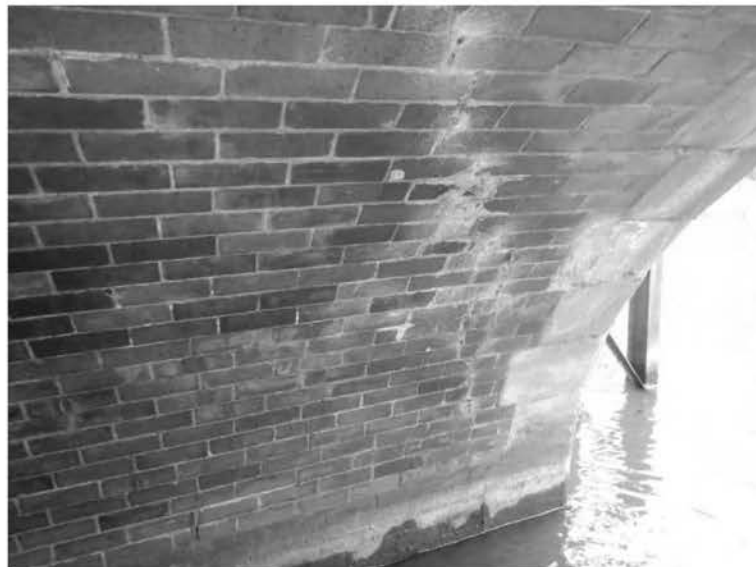
There is a diagonal crack in the north west corner. The crack measures a maximum of 15mm wide with a depth of 110mm.

Diagonal crack in the north west corner

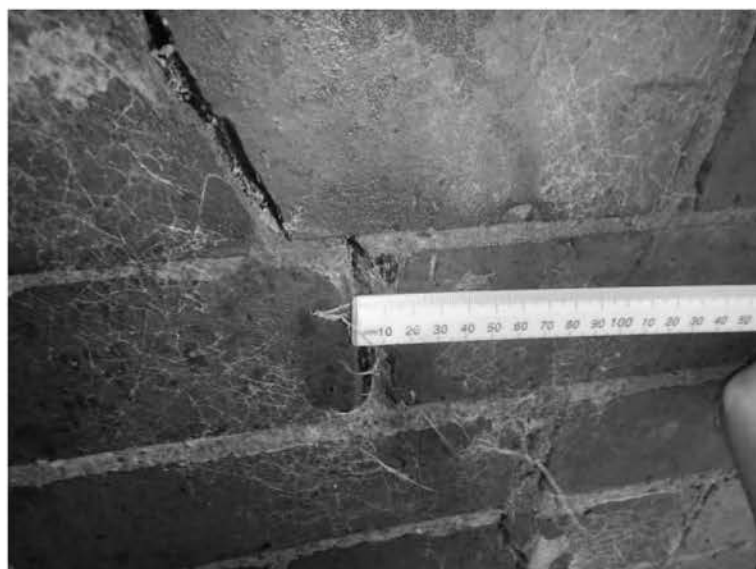
Close-up view of the diagonal crack

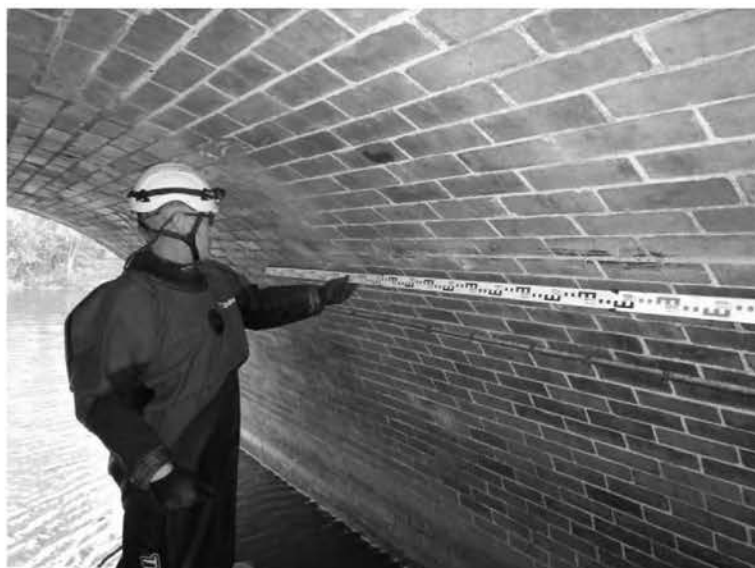
There is a large transverse crack located midway along the east side of the arch and approximately at the arch's third point. The crack is 3.8m long and is 6mm wide with a depth of 40mm. The lower course of brick have been displaced outwards by about 10mm.

Transverse crack in east side of the Arch

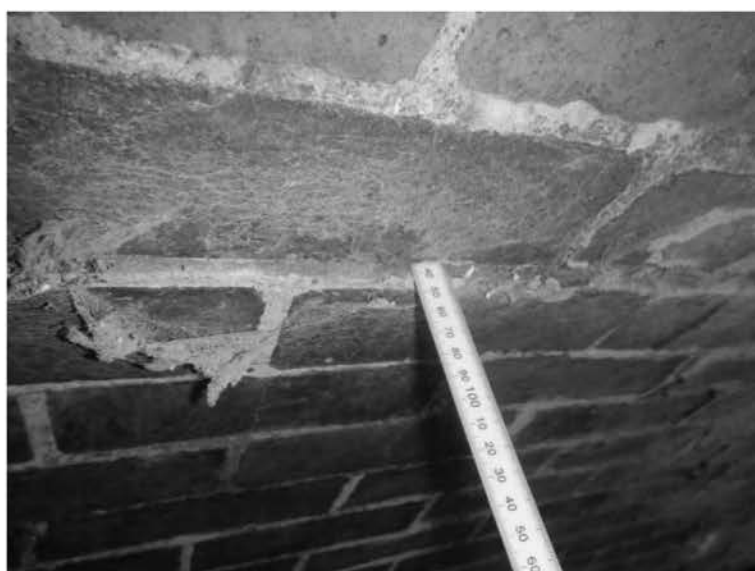
Close-up view of crack showing displaced bricks

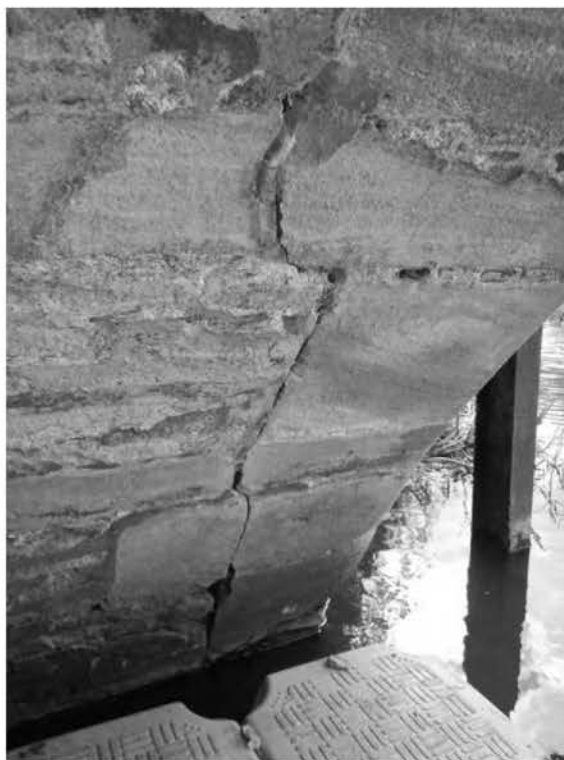
The northern stone masonry section appears to be in a reasonable condition. However, there is a longitudinal crack running along the edge of the voussiors.

Crack in northern section of the arch

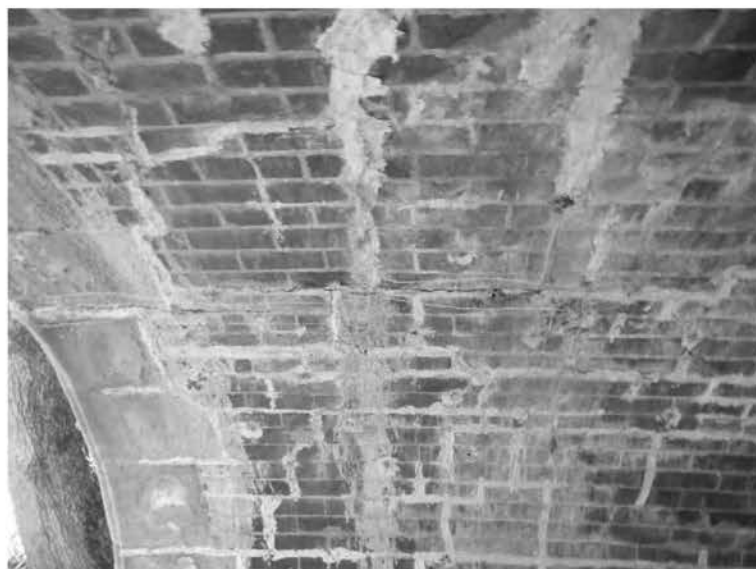
The southern brick masonry section is cracked both longitudinally and transversely. There has been an attempt to repair these cracks, however, a number of cracks have opened up since the repair was carried out. As the cracks appear to have been covered with a paint-like coating, it was not possible to determine the width or depth of the cracks.

Cracking in the southern section of the arch

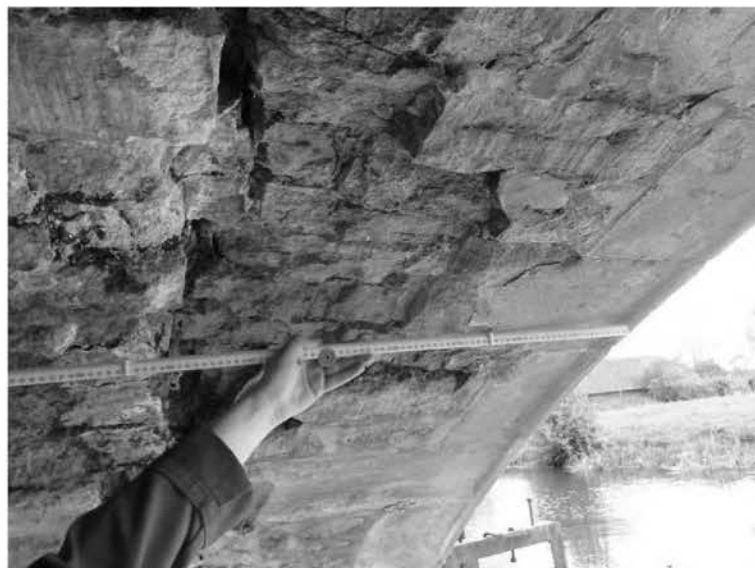
There are large areas where the stone appears to be weathering resulting in significant loss of stone. The stone in these areas is very soft and crumbly. This weathering coincided with a longitudinal crack along the edge of the voussiors. This weathering is likely due to water percolating through the arch.

Weather stone and crack along the edge of the Voussiors

The condition of the stone masonry section in Arch 4 is very poor with large areas where the stone has crumbled away. It is recommended that a further intrusive investigation is undertaken to determine the extent of the damage and suitable remedial work.

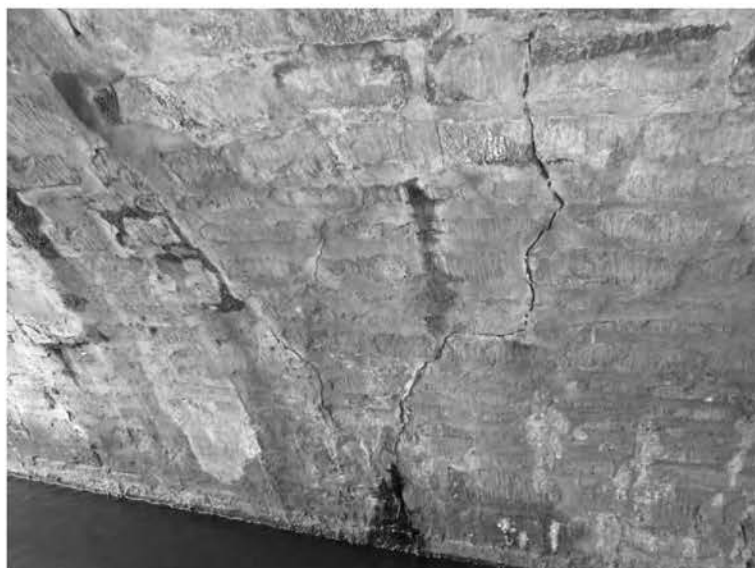
There are longitudinal cracks along the length of the section, one of which runs full span of the arch.

Longitudinal cracking in arch

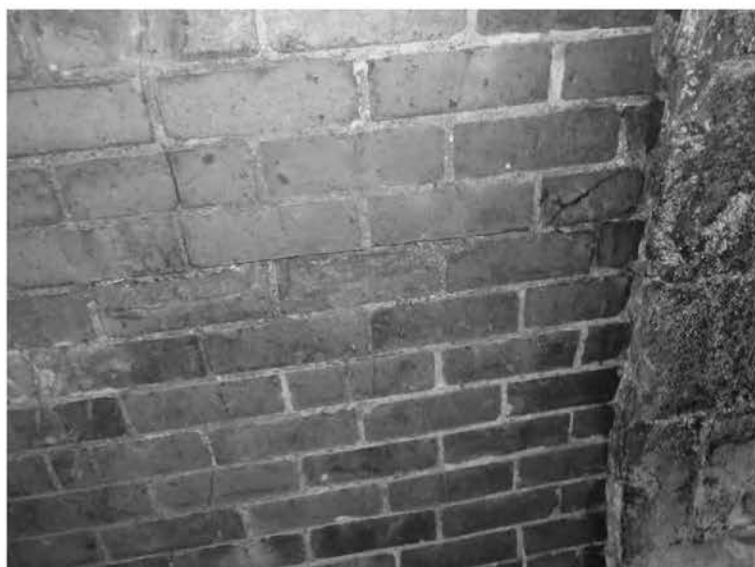
There are a number of longitudinal cracks, most of which show sign of seepage. There is also a transverse crack adjacent to the construction joint between the two materials with some spalled bricks. The crack is approximately 40mm deep.

Transverse crack adjacent to construction joint

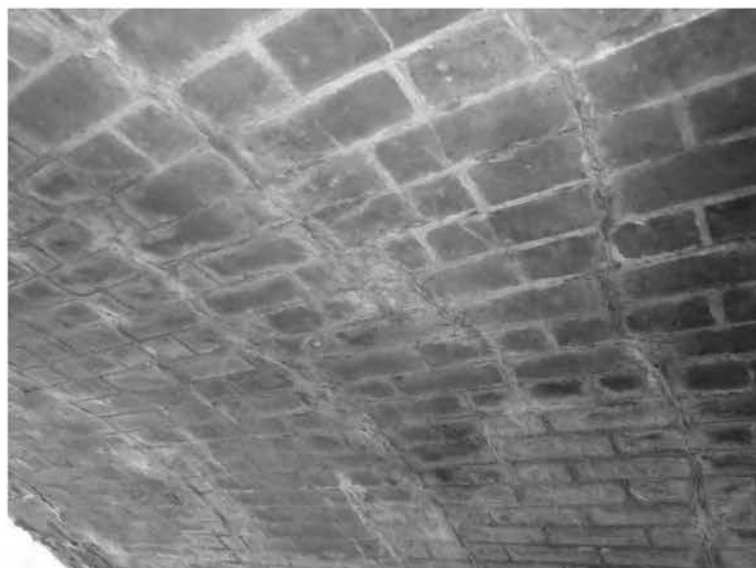
Cracking in barrel of the arch

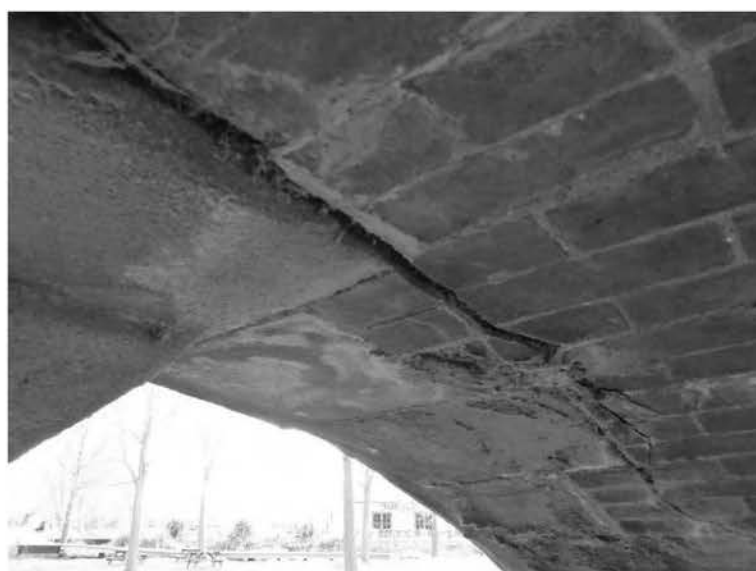
There is a large crack between the stone voussoirs and the brick arch.

Crack between Stone Voussoirs and brick arch

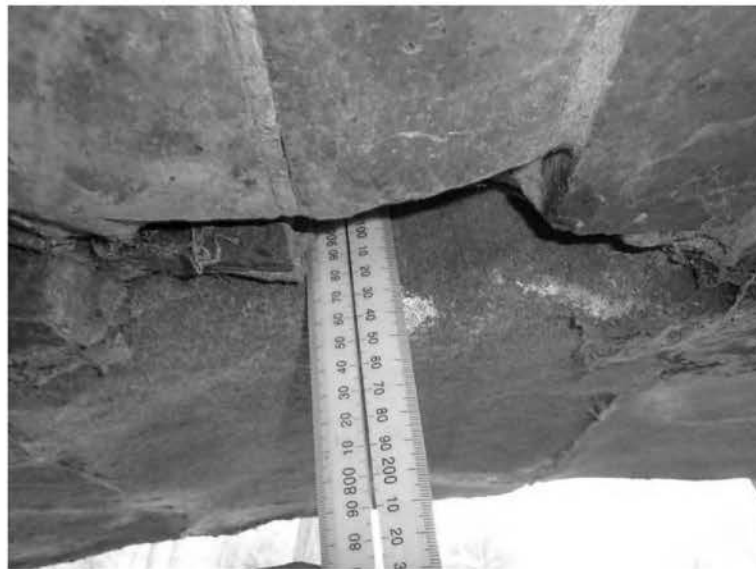
View showing depth of crack

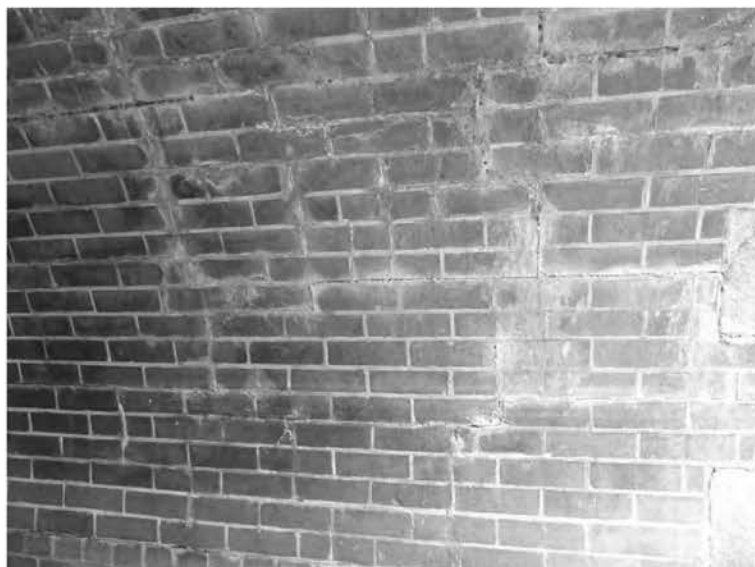
There are a number of circumferential hairline cracks along the northern half and larger cracks towards the southern end of the arch, both transverse and longitudinal cracking at the south east end of the arch. The cracks vary in width from hairline to approximately 3mm and generally show sign of water seepage with salt deposits.

Vertical & Horizontal Cracks near the south end of arch

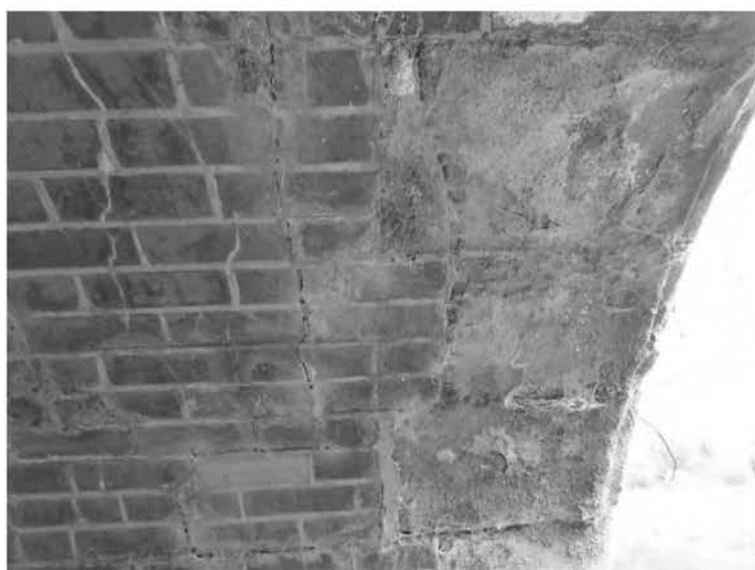
There are longitudinal cracks between the southern voussoirs and masonry arch.

Longitudinal cracks between the south voussoirs and masonry arch

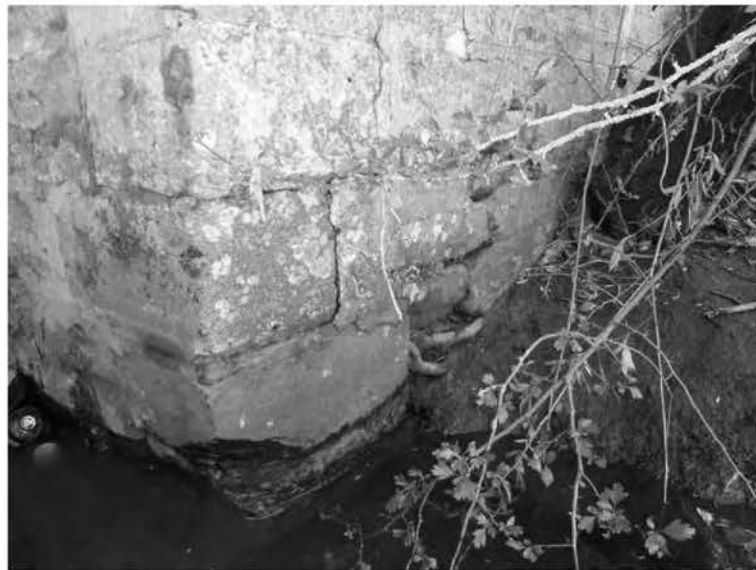
Cracking and vegetation in northwest corner

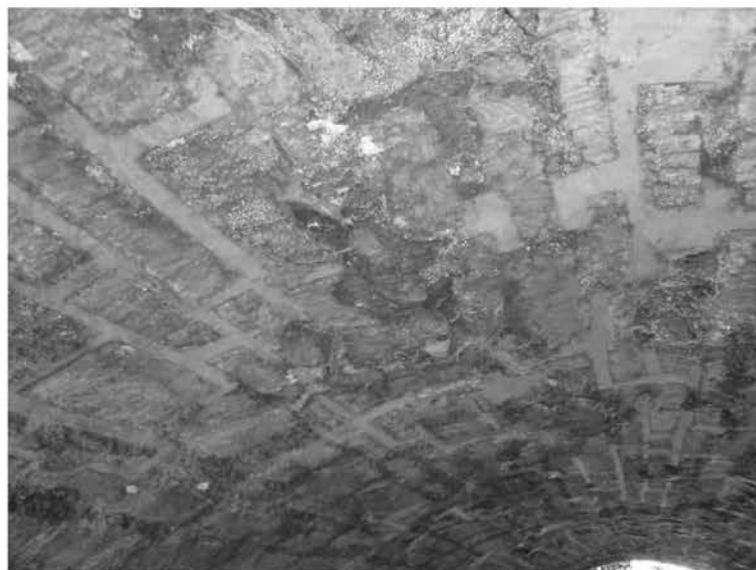
Areas of re-pointing

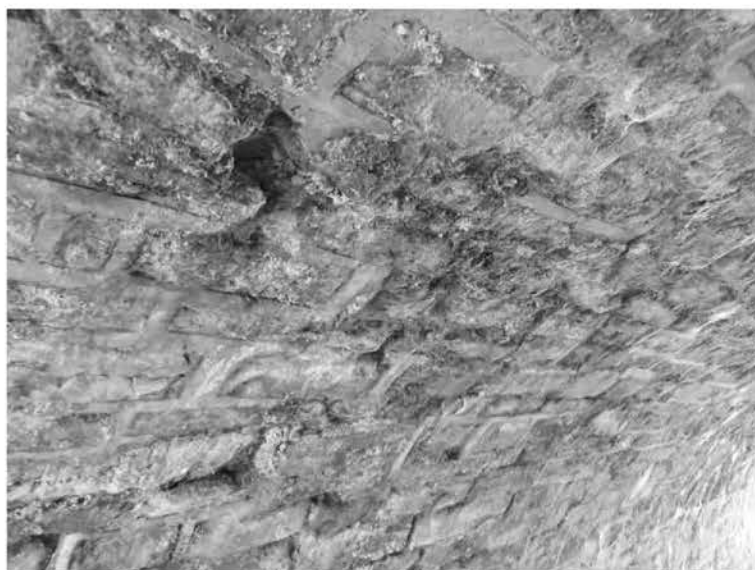
Generally in reasonable condition. There are areas of previous repairs to the arch ring with some minor spalling

Areas of repairs and minor spalling

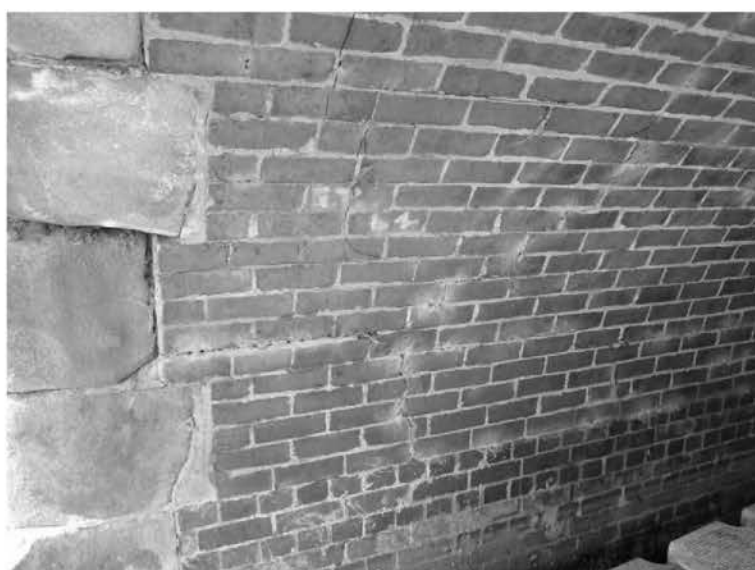
There is extensive cracking towards the southern end of the arch, both circumferential and transverse. The cracks vary in width from hairline to approximately 3mm and generally show sign of water seepage with salt deposits.

Extensive cracking near southern end of arch

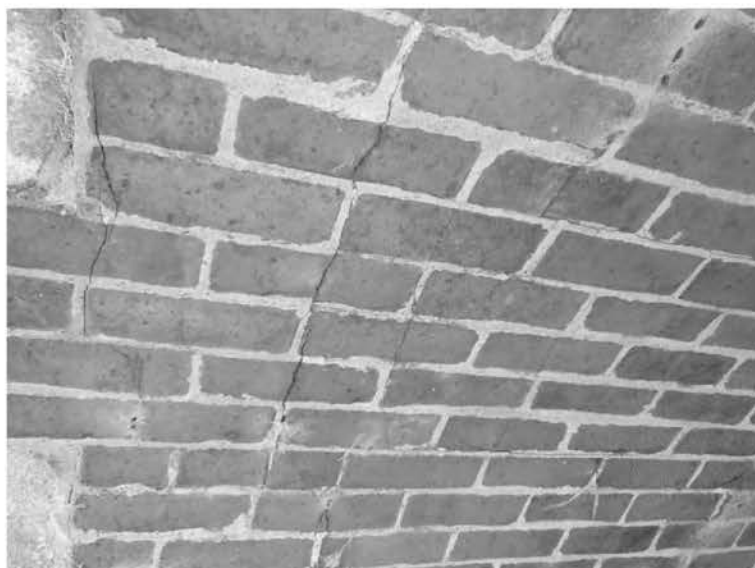
Close-up view of cracks

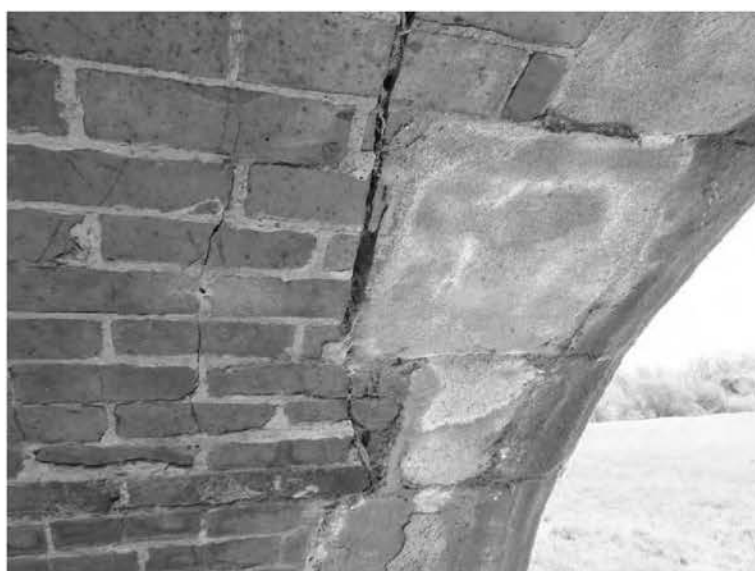
There are longitudinal cracks between the southern voussoirs and masonry arch.

Crack between southern stone voussoirs and masonry arch

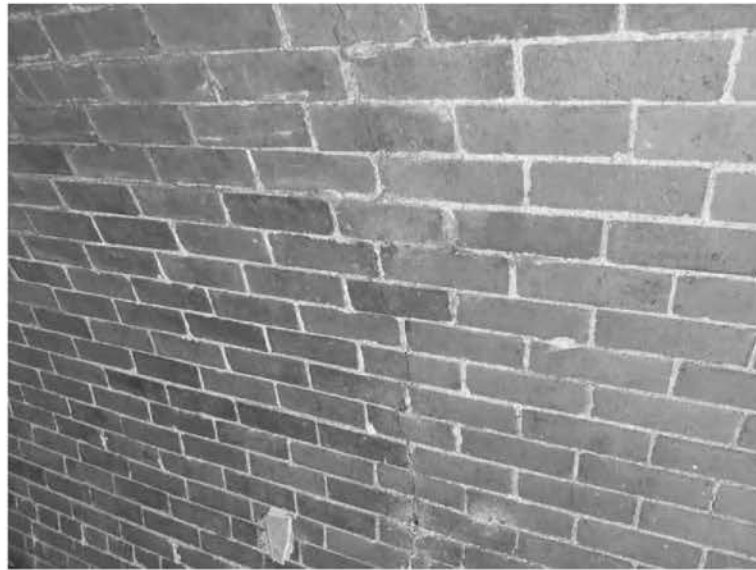
There are a number of circumferential cracks throughout the arch. The cracks vary in width from hairline to approximately 2mm but get worse towards the southern end. There is a large circumferential crack between masonry arch and stone voussoirs. The crack increases in width towards the apex of the arch possibly indicating that the spandrel wall is being displaced

Circumferential crack near southern end of arch

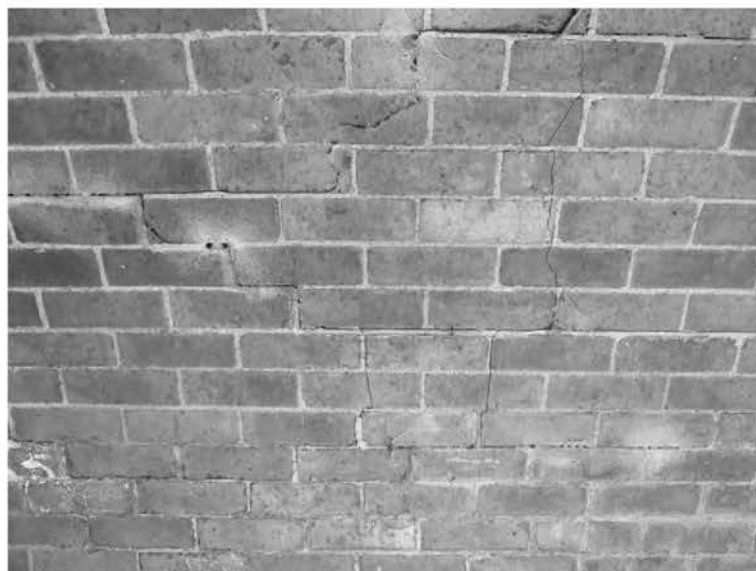
Cracking with displaced bricks near southern voussoirs

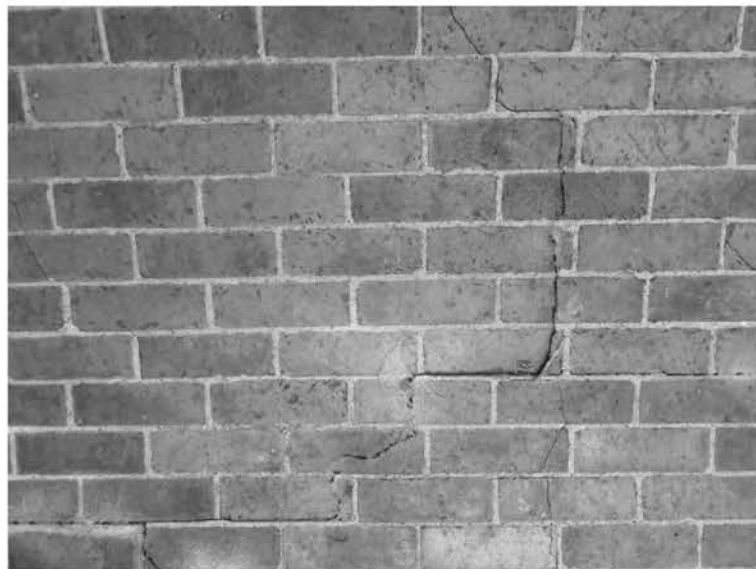
View of crack showing displacement of the bricks

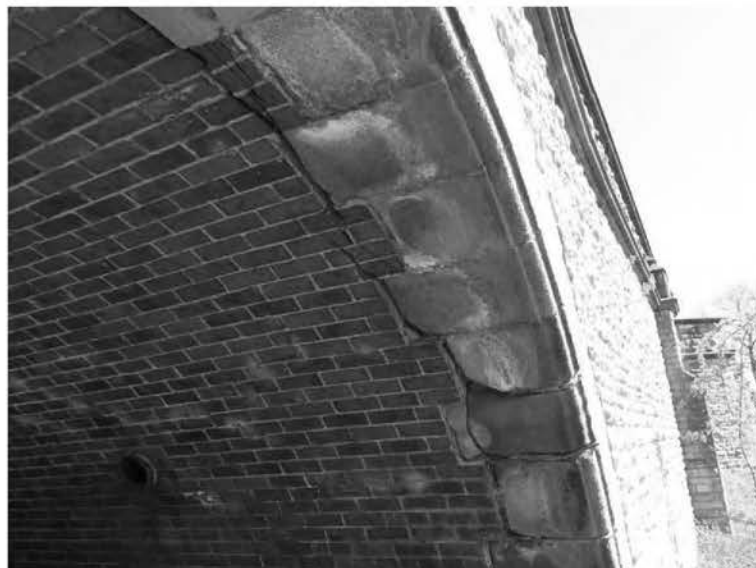
Crack between the masonry arch and the southern voussoirs

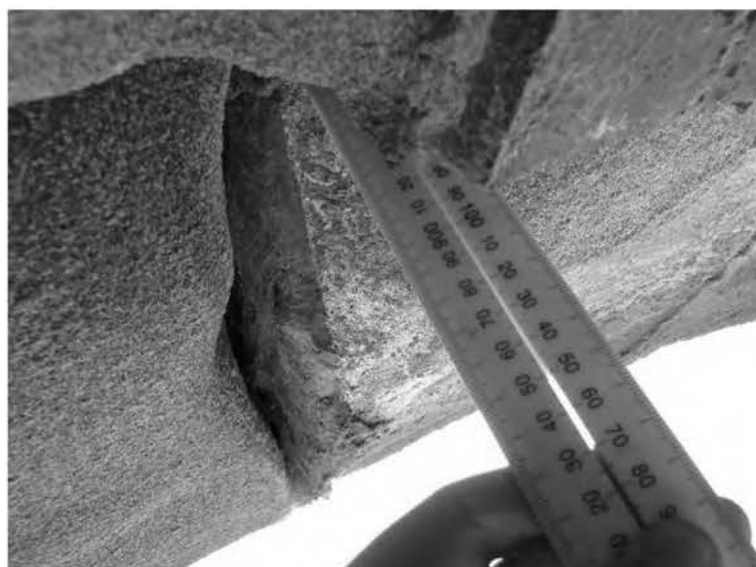
Depth of crack between the arch and the voussoirs

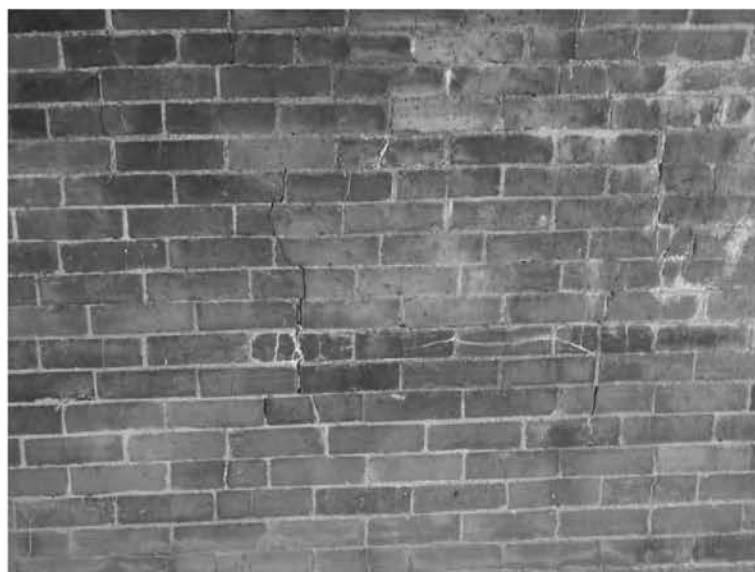
There are circumferential cracks both near the middle of the arch and towards the southern end. The cracks vary in width from hairline to approximately 2mm. There is a large crack between the masonry arch section and the southern voussiors extending from waterline to waterline.

Circumferential cracking near mid-span

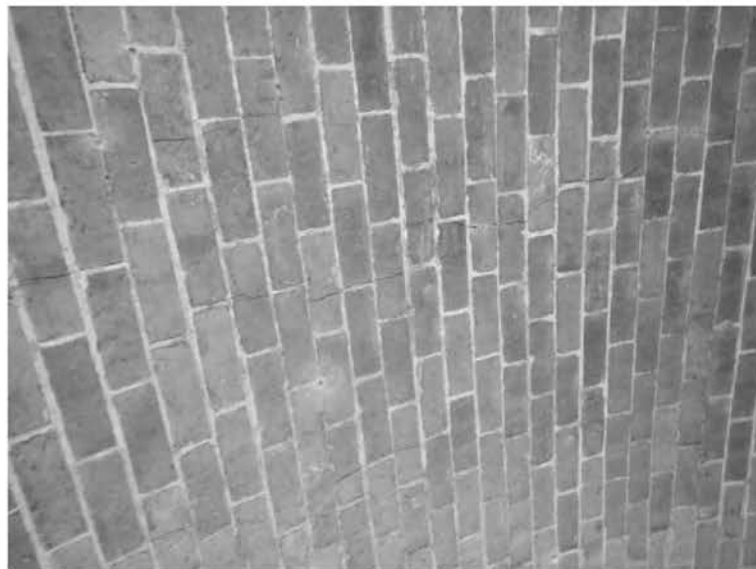
Crack extended across the apex of the arch

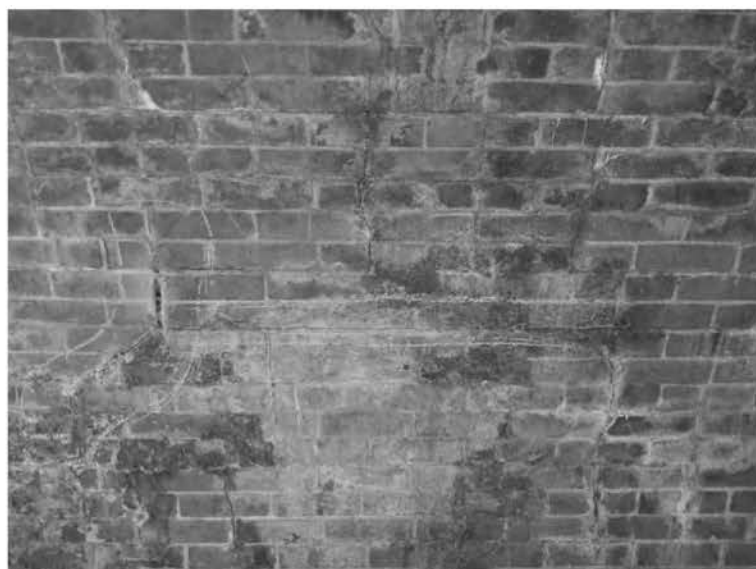
Cracking with some displacement of brickwork near the north west corner

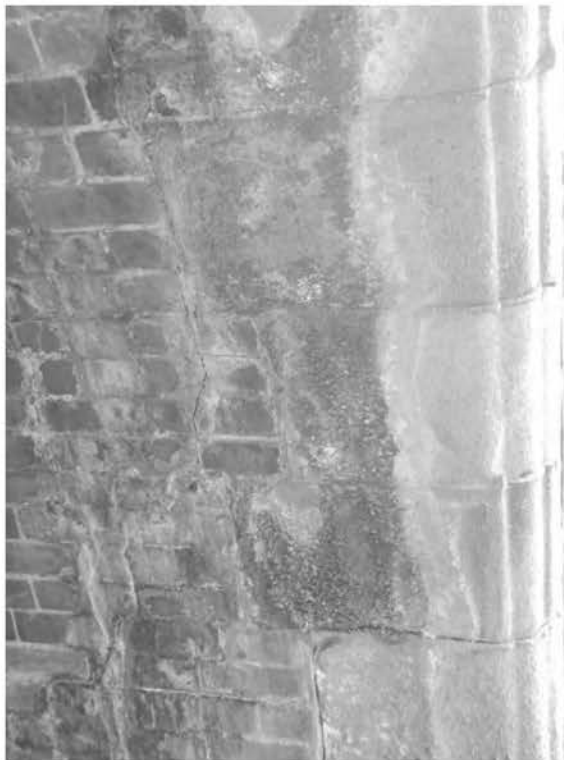
Cracking between the masonry arch and the southern Voussoirs

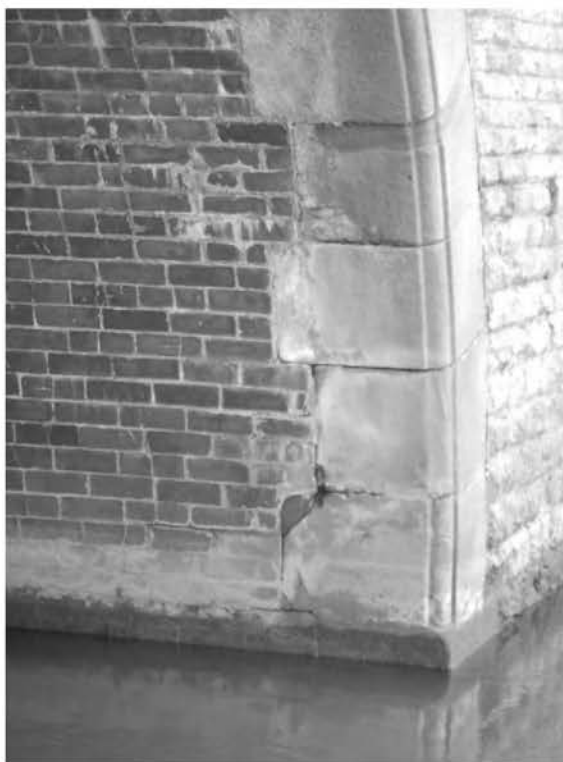
The arch appears to be in a reasonable condition. There are longitudinal cracks between the voussiors and the masonry arch at both ends.

Cracking between the masonry arch and the northern voussiors

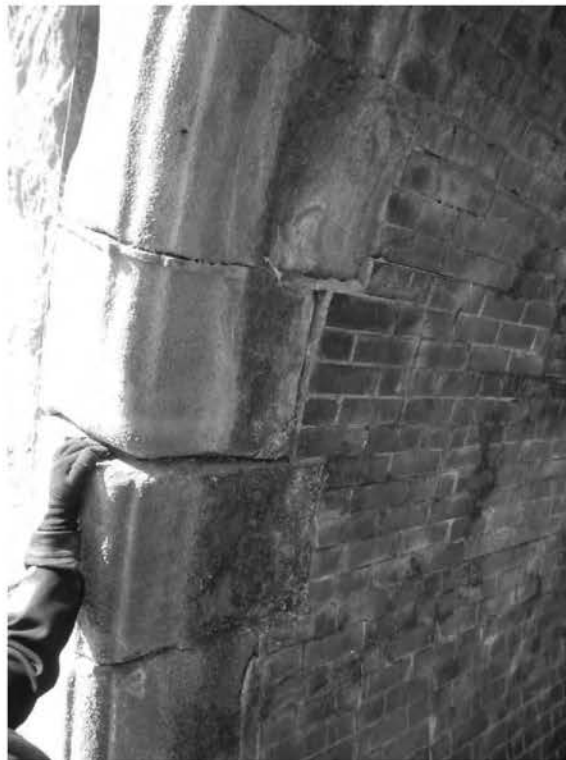
Cracking between the masonry arch and the southern voussoirs

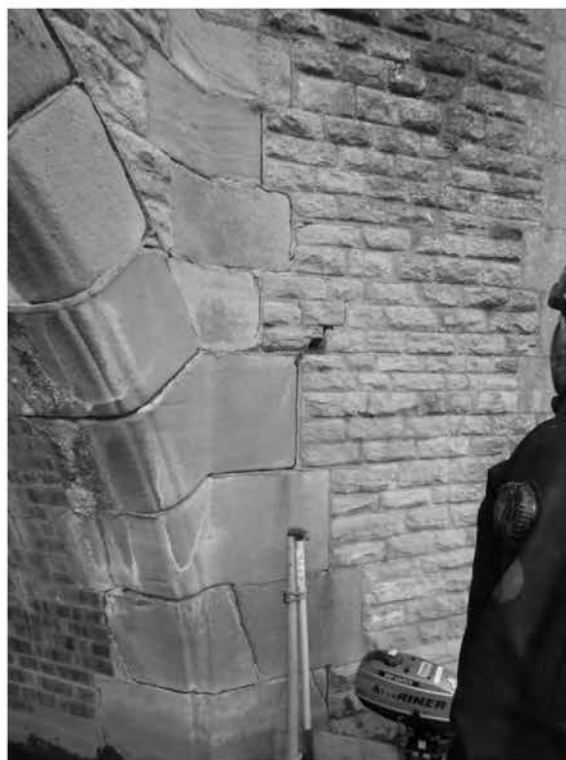
There is also a crack between the stone voussiors and the spandrel wall at the south east corner of the arch. This crack extends up the spandrel wall/cutwater to the parapet and is likely due to vehicular impact.

Cracking between the voussoirs and spandrel wall
at the south east corner

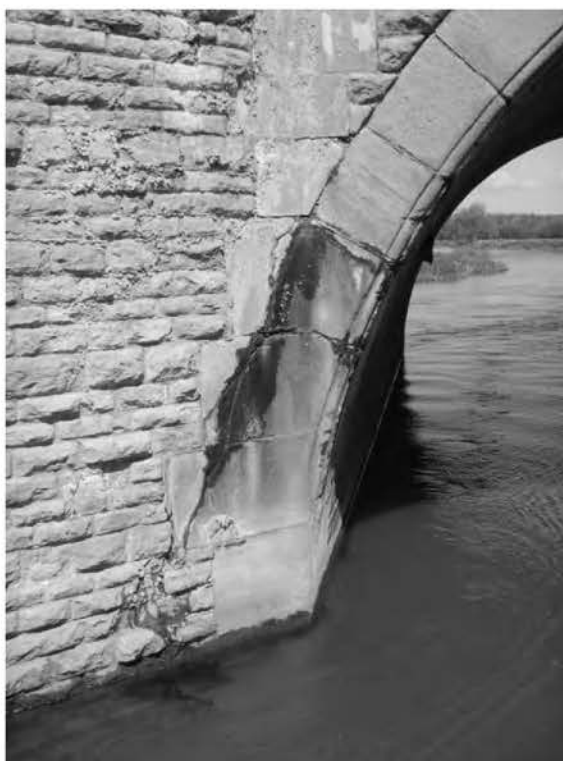
There is also a crack between the stone voussiors and the spandrel wall at both ends of the arch.

Crack between the northern voussiors and the spandrel wall
with evidence of water seepage

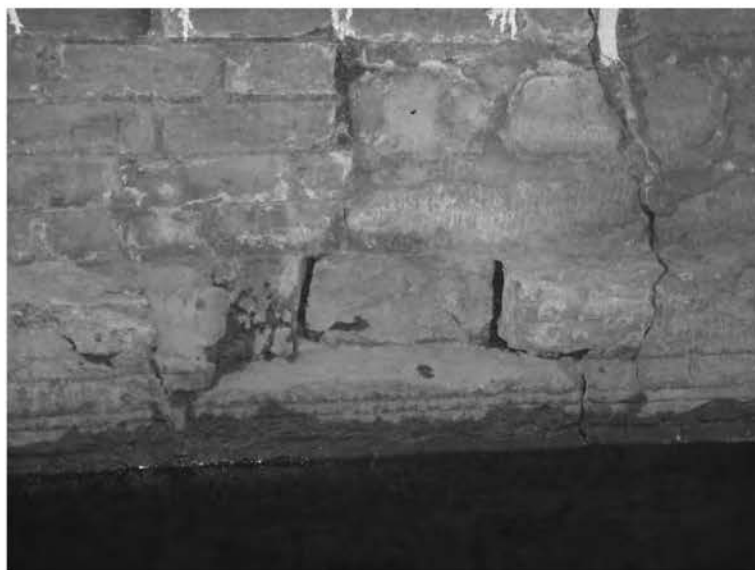
Junction between the stone and 'red' brick masonry sections.

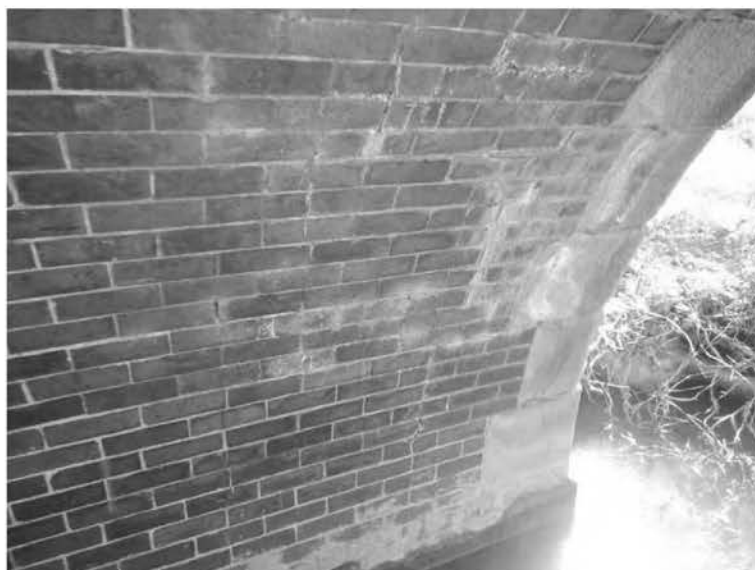
All the sections appear to be in a reasonable condition with no visible signs of structural distress. Some hairline cracks towards the southern end of the arch.

Hairline cracking to face of arch near the south east corner

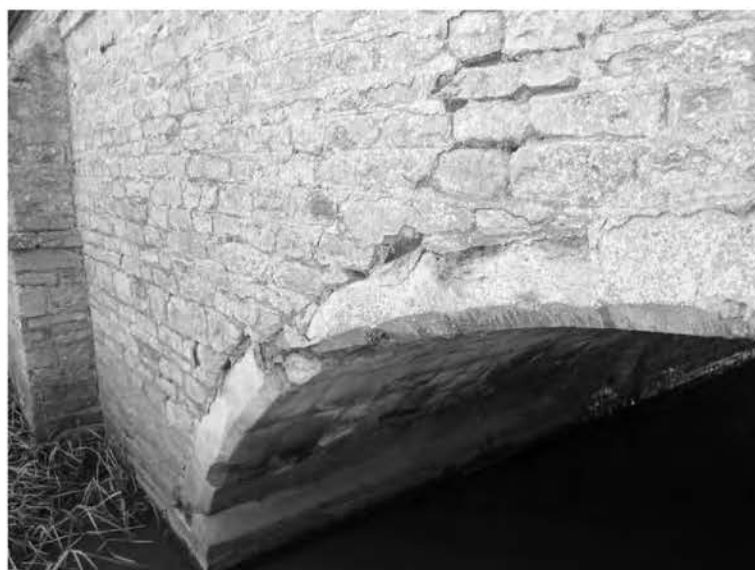
There is some cracking and damaged stonework along the joint between northern voussiors and the spandrel wall.

Cracking and damaged stonework along northern Voussiors

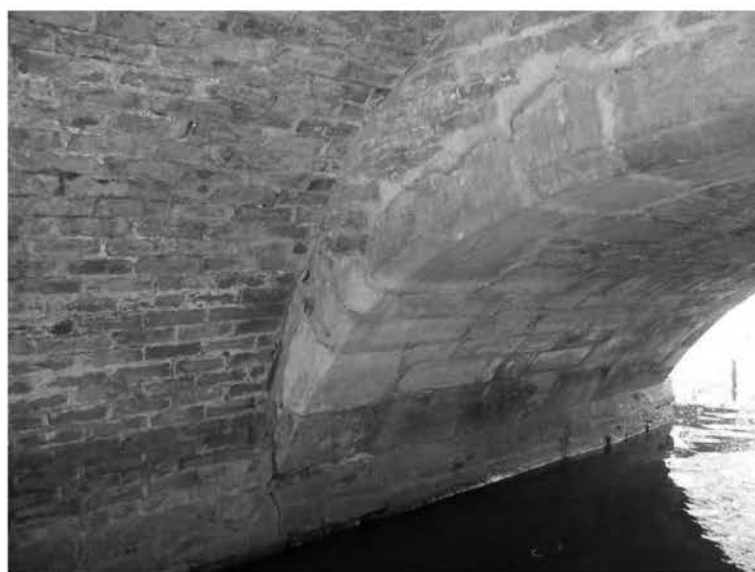
View showing junction between the north stone and the central 'red' brick sections

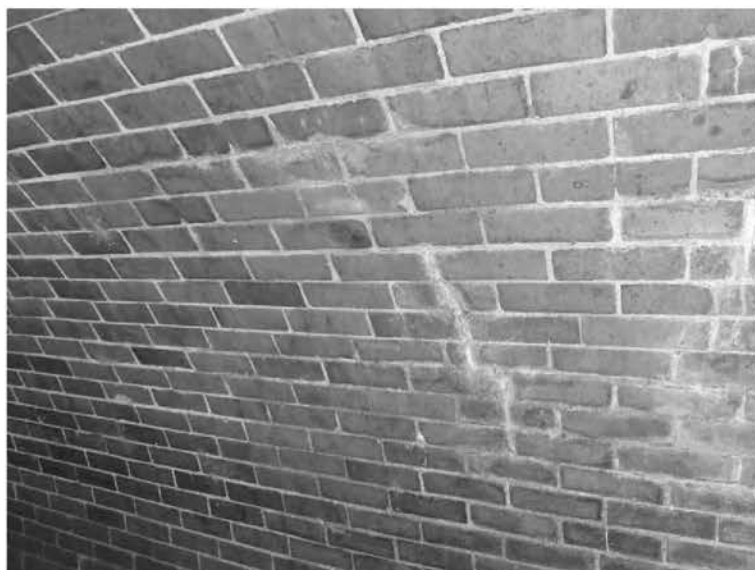
The central section of the arch appears to be in a reasonable condition with some hairline cracking to the arch. There is a crack between the north voussiors and the masonry arch which the full circumference of the arch.

Hairline cracking to arch barrel

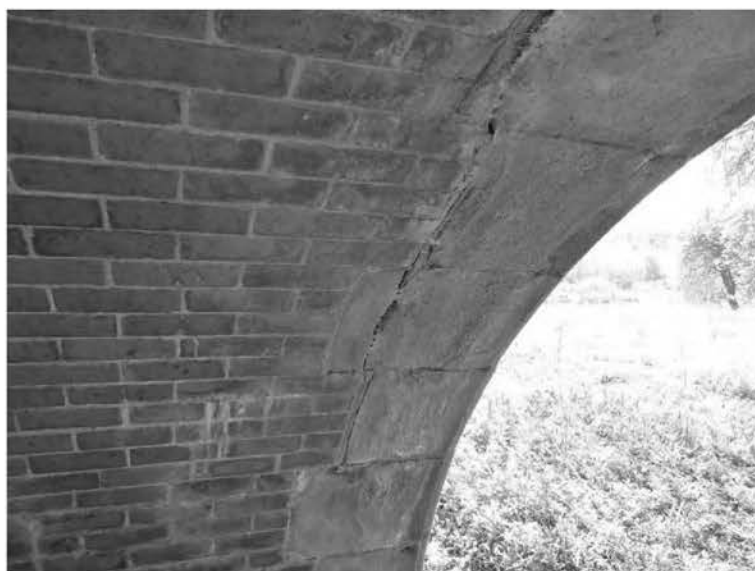
Cracking along the joint between the voussiors and masonry arch

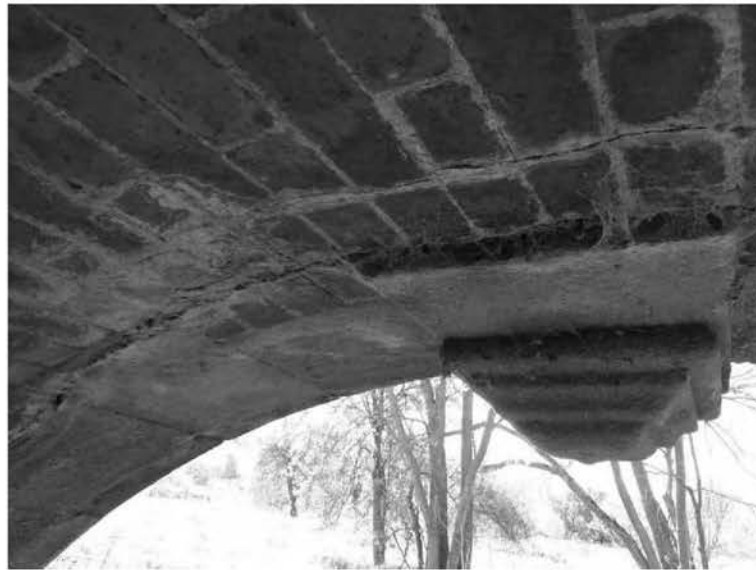
Cracking along the joint between the voussoirs and masonry arch

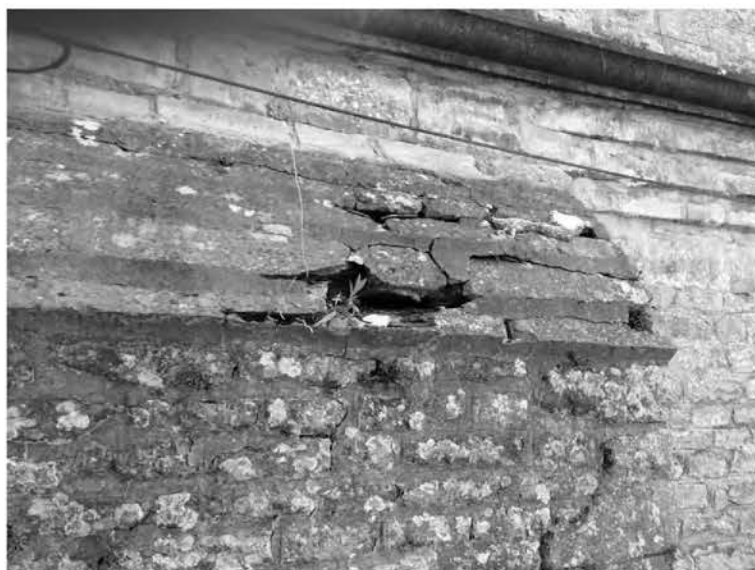
- 5.14.1 There is extensive damage and loss of pointing to the north east retaining wall (before Arch 13). The damage is likely due to vegetation growth which at some point has been removed.

Damage to eastern retaining wall due to vegetation growth

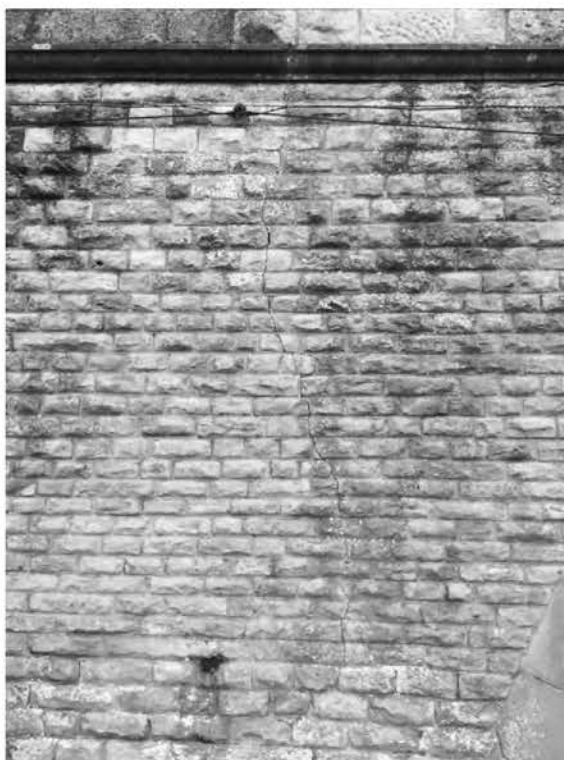
- 5.14.2 There are vertical cracks running up the spandrel wall between the arches. The cracks vary in width from hairline to approximately 3mm and typically extend up to the string course below the stone parapet.

Vertical crack in spandrel wall between Arches 11 & 12

There are a number of significant cracks in the spandrel wall. These appear to be more prevalent on the south (upstream elevation), in particular, the cutwaters. It is likely that these cracks are as a result of vehicular impact on the parapets. It is recommended that the cracks are repaired using a suitable stainless steel crack stitching system and the crack sealed using resin injection and re-pointed.

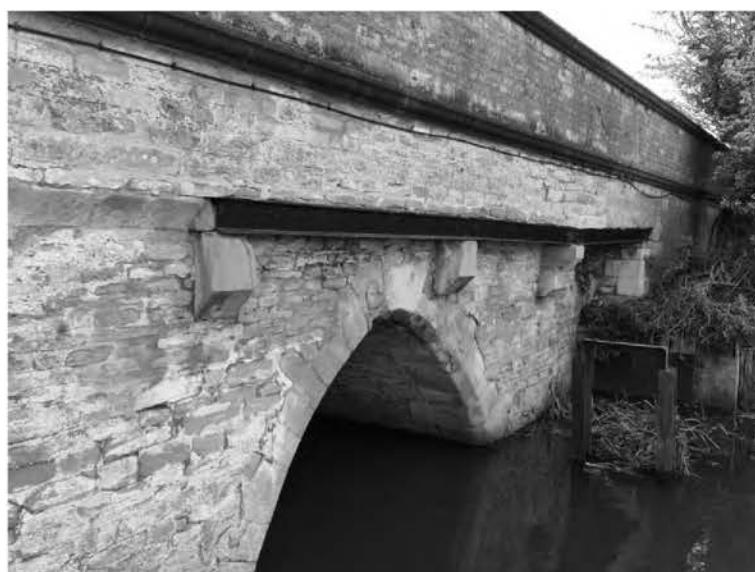
- 5.14.3 The string course over Arch 3 have been replaced with a steel joist supported on stone corbels. The spandrel wall and parapet are supported off the beam. There is a substantial void behind the beam/spandrel wall which is approximately 760mm deep in places. The date of the repair is not known but could have been carried out in 1946. Both the end corbels are cracked and eroded.

General view of steel joist and stone corbels

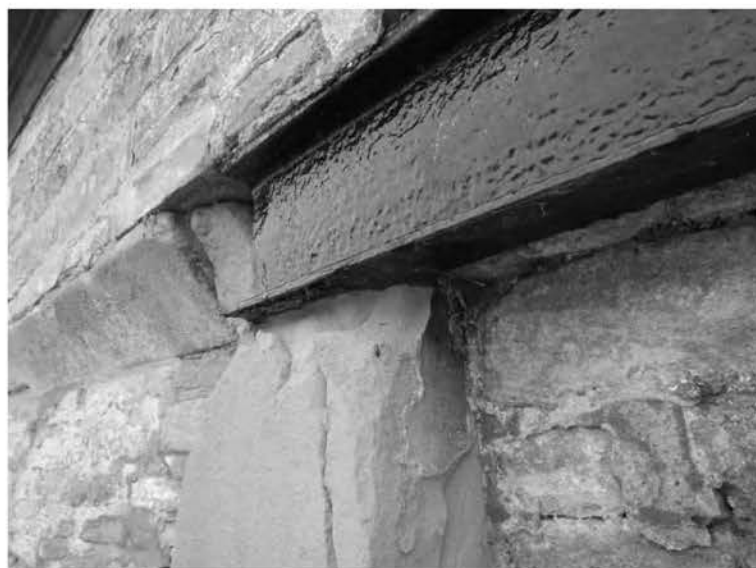
Damage to east end corbel

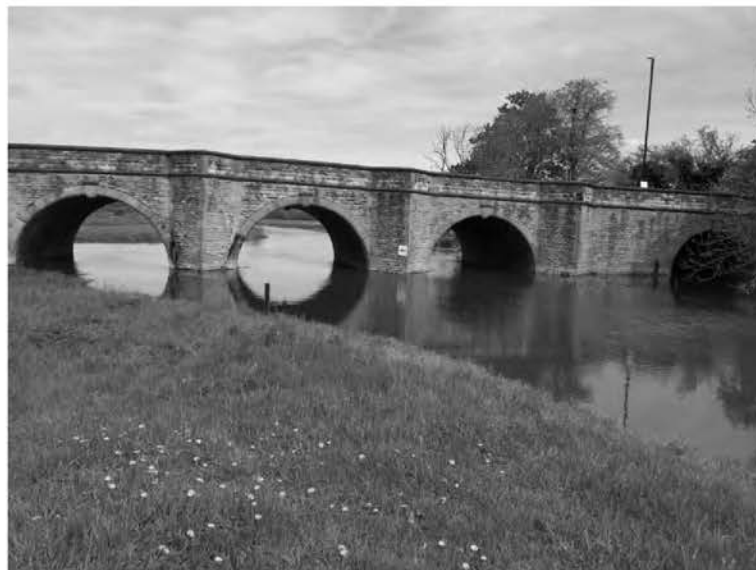
View of South Elevation showing cutwaters (Arches 10, 11, 12 & 13)
