**Principal Inspection
Report
Bridge No 1093**

**North Bridge, Station Road
Oundle**

**NORTHAMPTONSHIRE
COUNTY COUNCIL**

May 2018

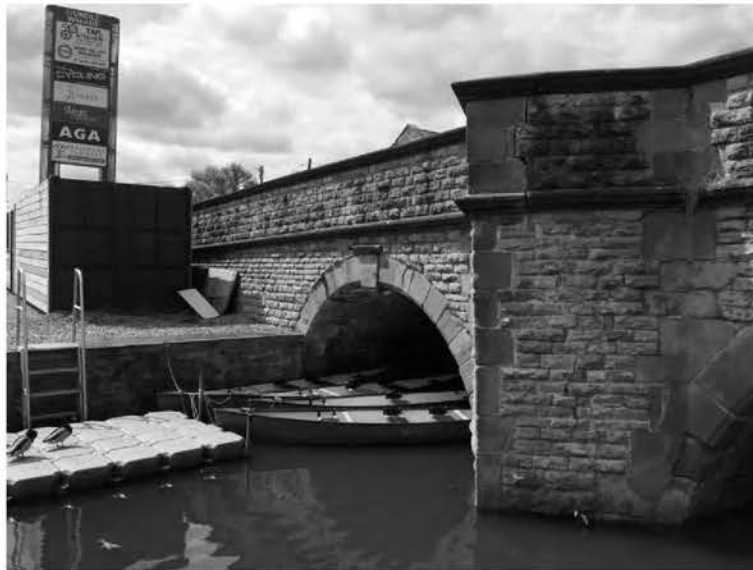
- 5.15.1 There are vertical cracks running up the face of the cutwaters, adjacent to the stone edging. The cracks vary in width from relatively small to approximately 10mm and typically occur at every cutwater. The cracks tend to increase in width towards the top and extend above the stone string course with significant displacement occurring in the parapets. Tell-tale crack gauges have previously been fixing across the cracks to try and monitor any movement that could be taking place. It is possible that these cracks are due to vehicular impact

View of cutwater between Arches 1 and 2

There are a number of significant cracks in the spandrel wall. These appear to be more prevalent on the south (upstream elevation), in particular, the cutwaters. It is likely that these cracks are as a result of vehicular impact on the parapets. It is recommended that the cracks are repaired using a suitable stainless steel crack stitching system and the crack sealed using resin injection and re-pointed.

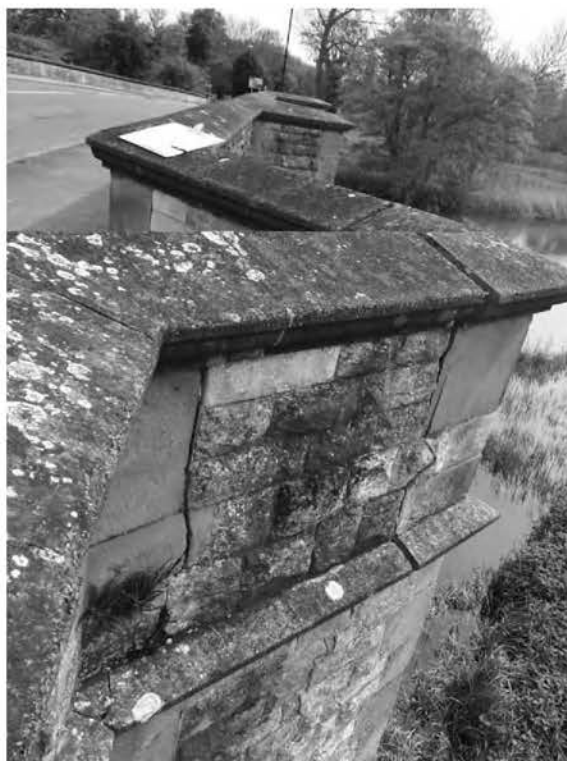
View of crack in cutwater

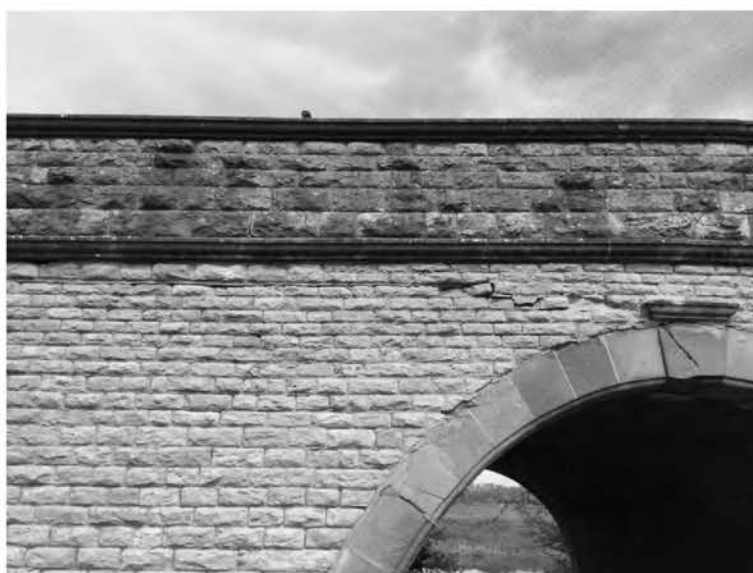
There is a significant horizontal crack which extends from the crown of Arch 7 towards Arch 6 with some displacement of the masonry. The crack appears to extend into the keystone of Arch 7. It is possible that the damage is due to vehicular impact.

View of crack

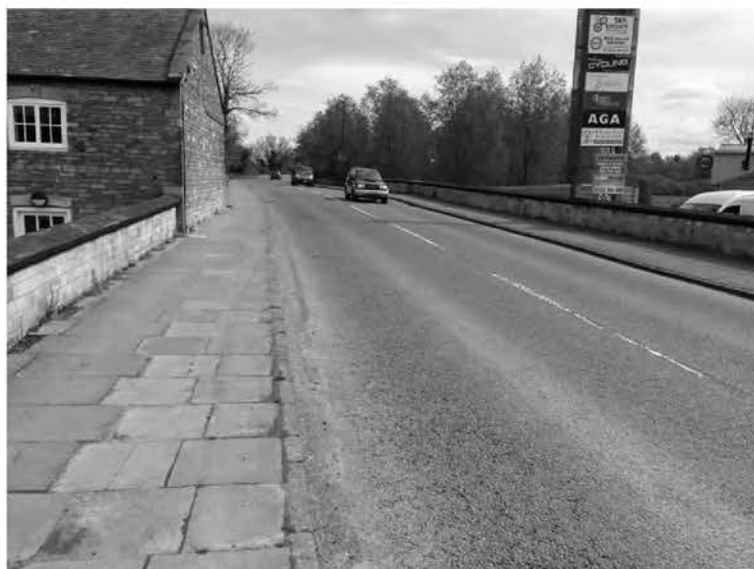
The carriageway surfacing is in a poor condition with numerous previous patch repairs starting to break up. There is ponding around the surface water gulley inlets due to the drains not working. This ponding is also likely to be contributing to the damage around the gulley inlets.

View looking east from Oundle end of bridge

The carriageway surfacing is in a poor condition with damage around the surface water gully inlets and areas of cracking and potholes. It is recommended that the drainage is jetted clear and the bridge is re-surfaced.

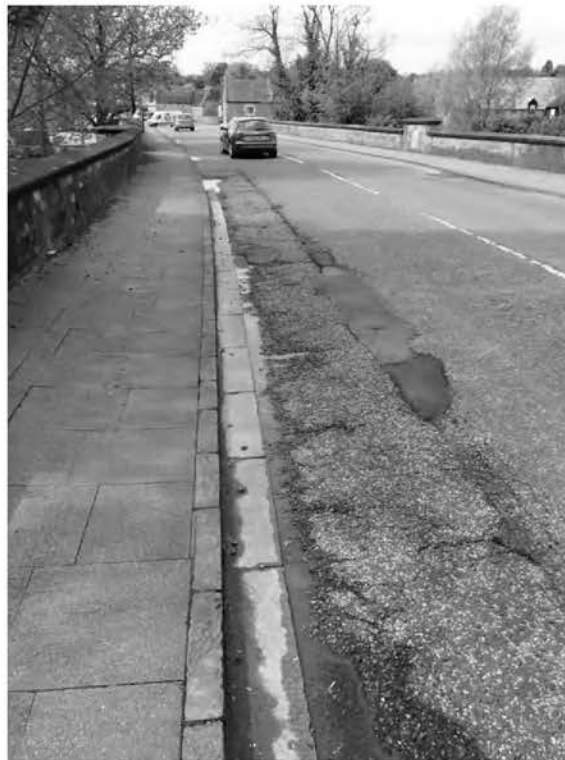
Area of patch repairs

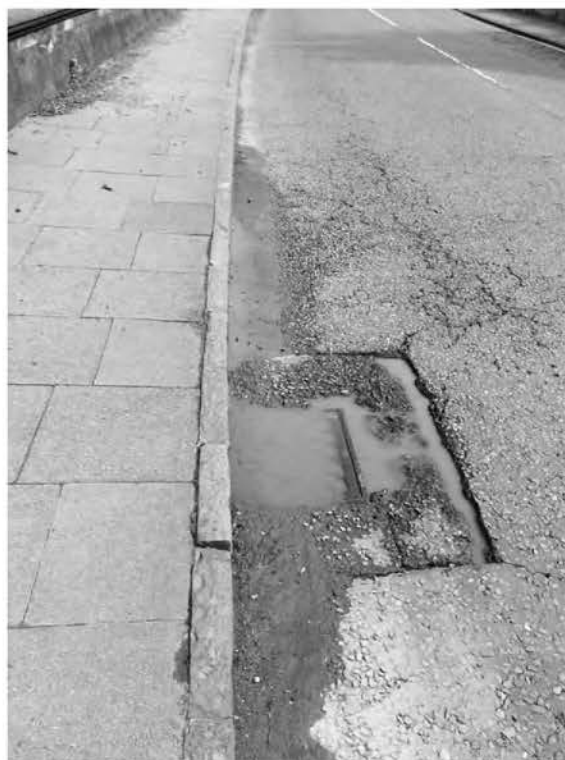
Ponding and damage around gully inlets

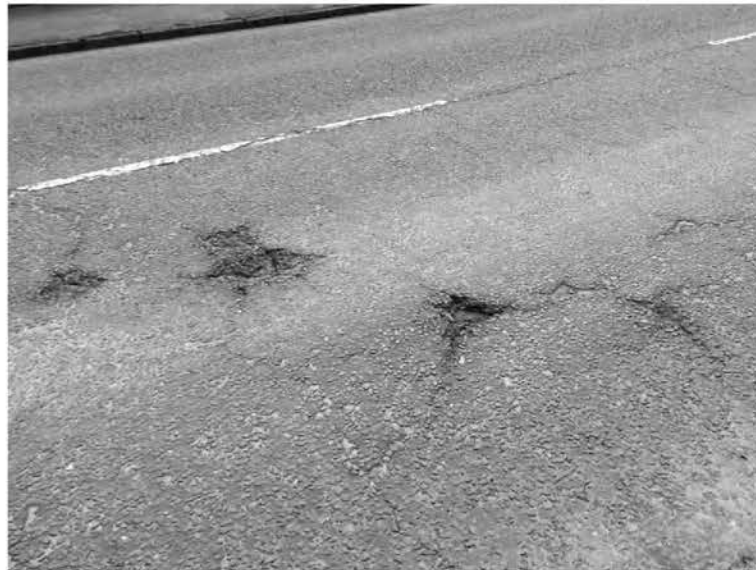
Cracking and potholes in the carriageway surfacing.

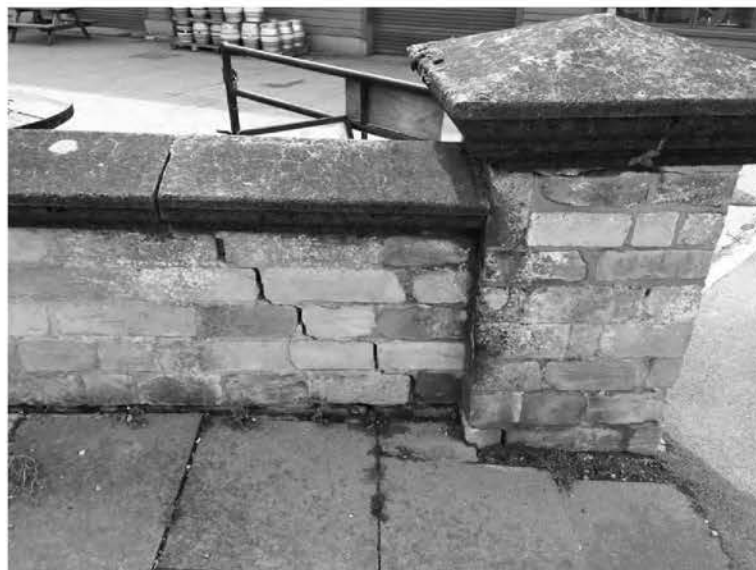
The parapets generally appeared to be in a reasonable condition, there are some significant defects, in particular, cracks in the parapets above the cutwaters in the southern parapet. These cracks vary in width, with some showing signs of displacement having occurred. There are also a number of diagonal cracks in the parapet. It is likely that a number of these defects were caused by vehicular impact.

Diagonal crack in parapet at the northwest corner

The cracks in the cutwaters are reflected in the parapets and there are a number of diagonal cracks in the parapets. It is recommended that the cracks are repaired using the same stainless steel crack stitching system as the walls.

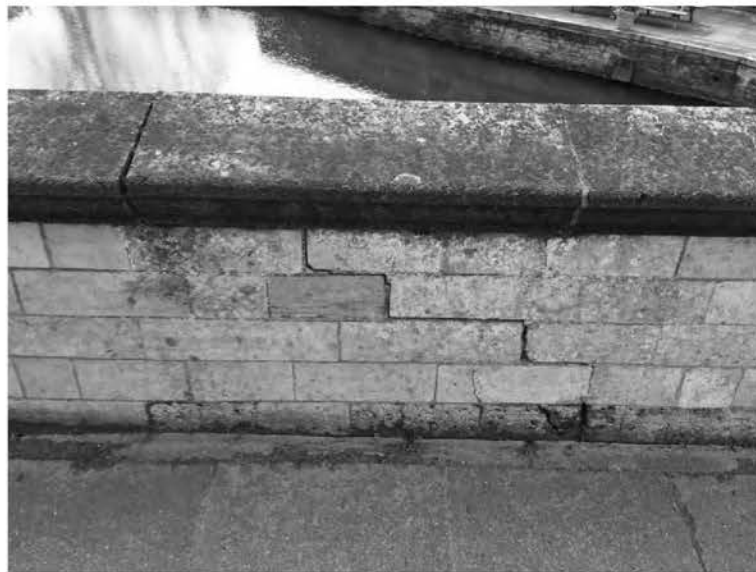
Typical diagonal cracking in the south parapet

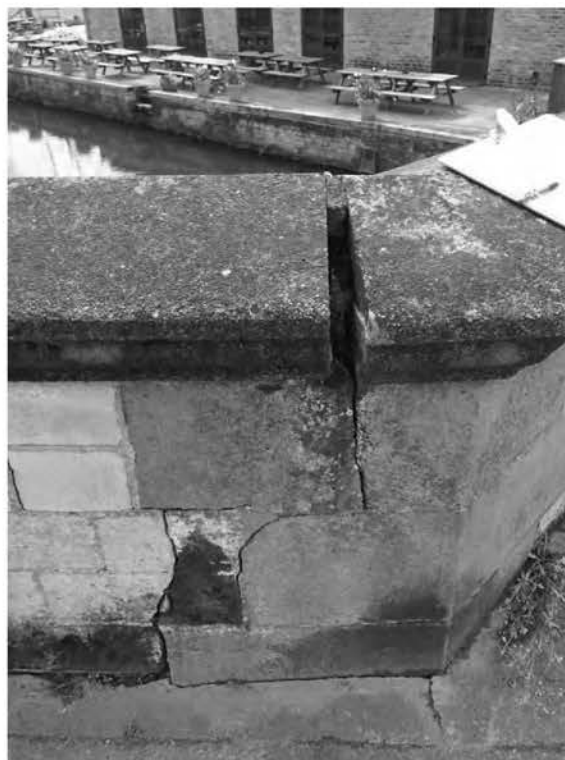
Crack in parapet over the cutwater between Arches 1 & 2

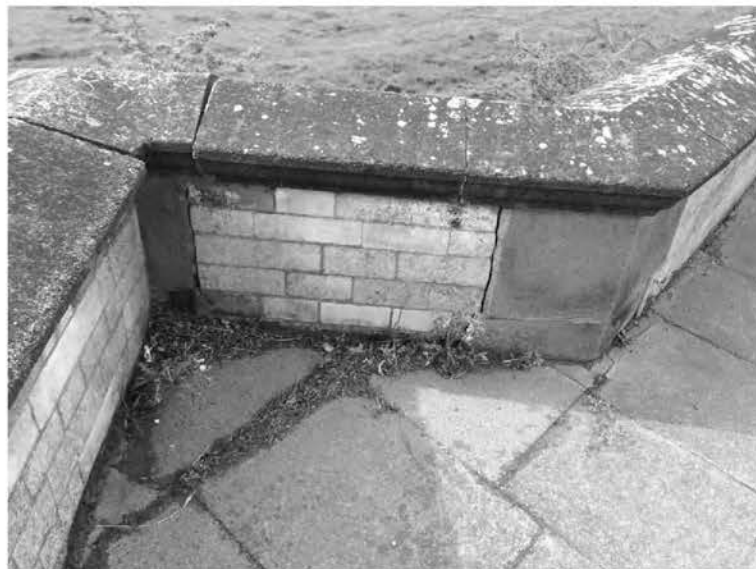
Crack in parapet over the cutwater adjacent to Arch 8

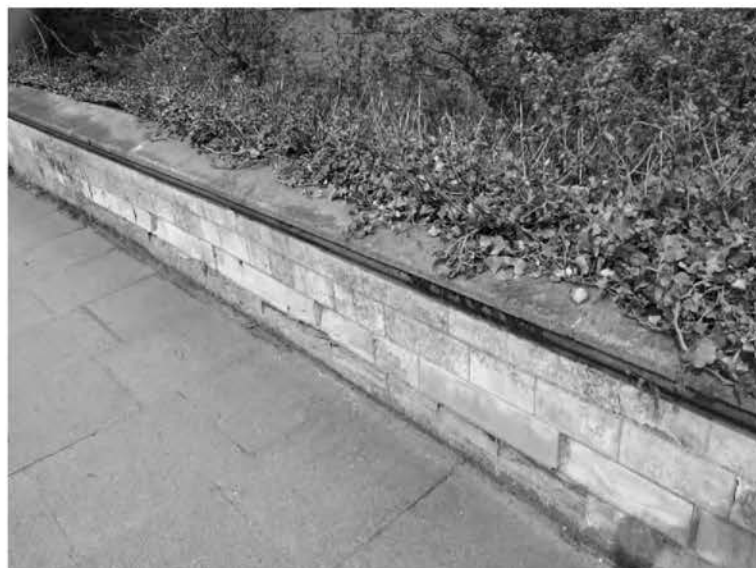
Area of minor water damage to bottom coarse of stone
