Defect Inspection Photographs

Hazard Assessment Sheet

Environment Awareness Sheet

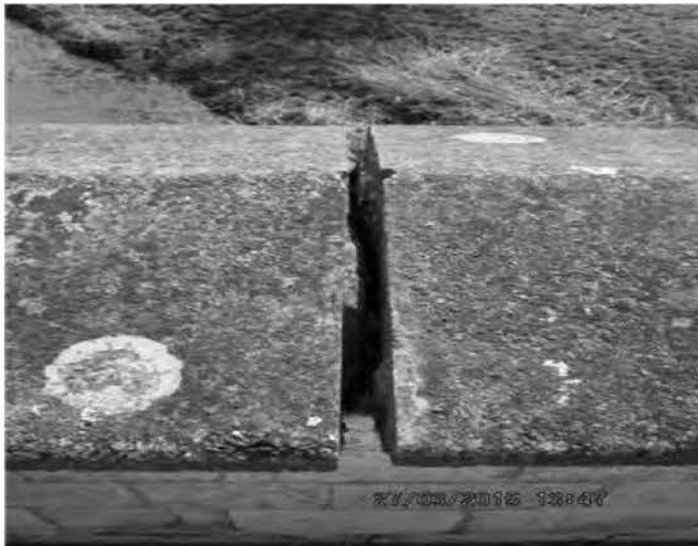
Loss of pointing to parapet copings

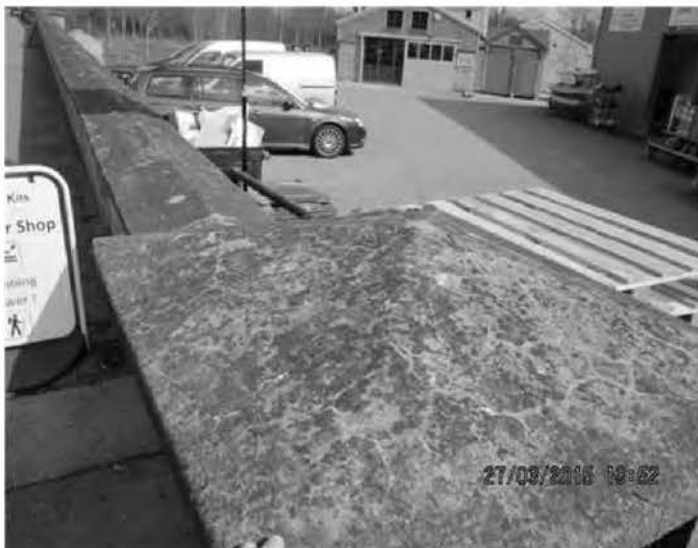
Map cracking on

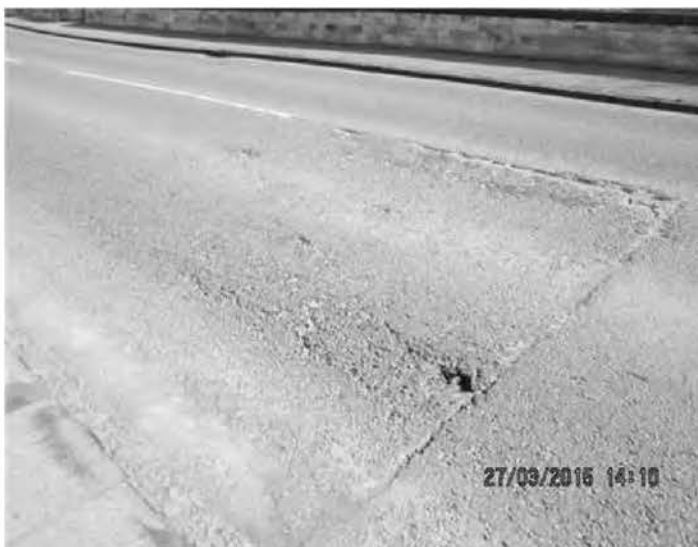
Some spalling on road surface
