Report No.: J054862

Nature of Work: Management Survey

Brownhills West Primary School
Shannon Drive
Brownhills
Walsall
WS8 7LA

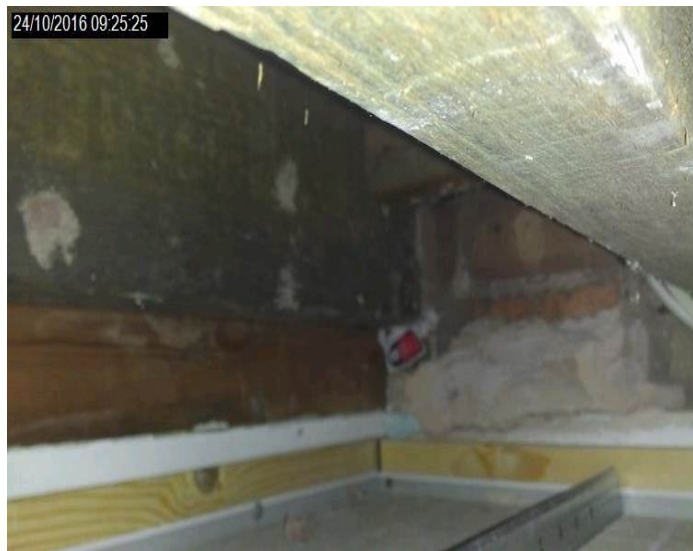
Location:	04 - Office	Block:	Brownhills West primary school	Floor Level: Ground Floor
Item No.:	1	Sample No.:	BF003561

Item:	Asbestos Insulating board packers			
Asbestos Content:	Result Based on:			
Chrysotile	Analysis of sample using PLM			
Sample Analysed By:	Miss H Sievwright	Extent:	<1 sq m	
Comments: Item identified to 1 beam but is presumed to be present throughout ceiling void.

Material Assessment Total Score: 5		Likelihood of Disturbance Assessment Total Score: 4		Management Assessment Licensable: Yes Recommendations: Monitor condition Reinspection Interval: 12 Months Overall Risk Category: C9
Product Type:	2 (Asbestos insulating board)	Location:	2 (Rooms up to 100 sq m)	
Condition:	1 (Minor scratches)	Accessibility:	1 (Occasionally likely to be disturbed)	
Surface Treatment:	1 (Encapsulated asbestos insulating board)			
Asbestos Type:	1 (Chrysotile)	Extent Score:	1 (<10 sq m or 10m pipe run)

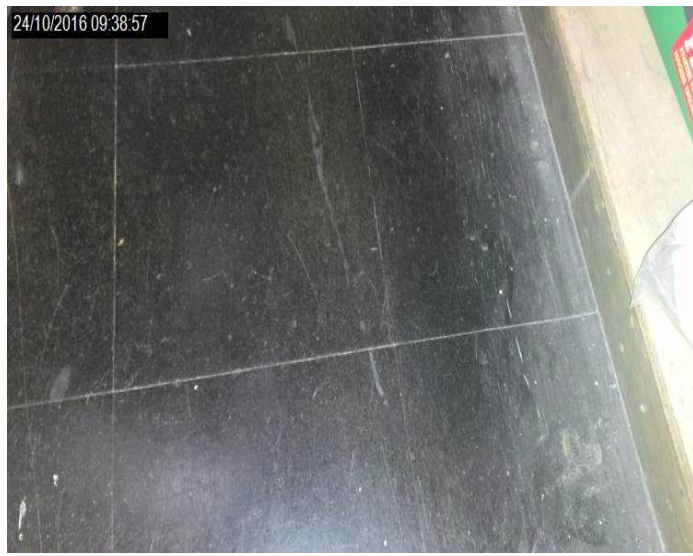
Location:	07 - First aid	Block:	Brownhills West primary school	Floor Level: Ground Floor
Item No.:	2	Sample No.:	BF003562

Item:	Asbestos Thermoplastic floor tiles			
Asbestos Content:		Result Based on:		
Chrysotile in tile and adhesive		Analysis of sample using PLM		
Sample Analysed By:	Miss H Sievwright	Extent:	8 sq m	
Comments:

Material Assessment Total Score: 3		Likelihood of Disturbance Assessment Total Score: 6		Management Assessment Licensable: No Recommendations: Monitor condition Reinspection Interval: 12 Months Overall Risk Category: C9
Product Type:	1 (Asbestos thermoplastic)	Location:	2 (Rooms up to 100 sq m)	
Condition:	1 (Minor scratches)	Accessibility:	3 (Routinely disturbed)	
Surface Treatment:	0 (Composite material)			
Asbestos Type:	1 (Chrysotile)	Extent Score:	1 (<10 sq m or 10m pipe run)

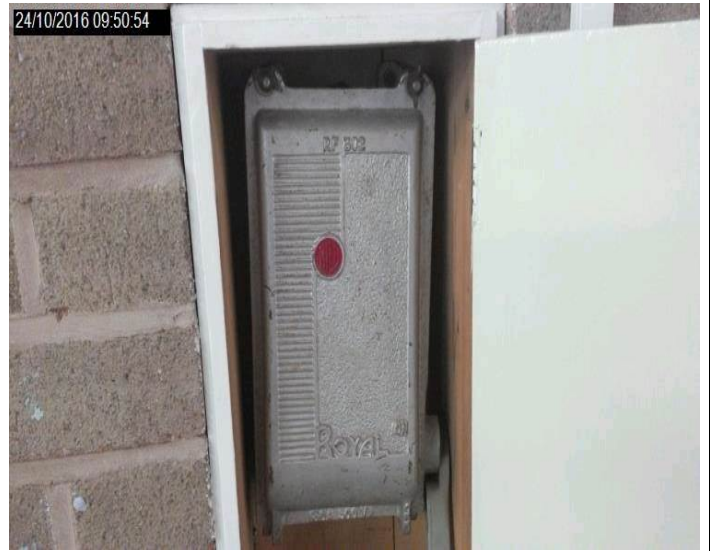
Location:	09 - Main hall	Block:	Brownhills West primary school		Floor Level:	Ground Floor
Item No.:	3	Sample No.:	No sample - presumed		<div>24/10/2016 09:50:54</div>

Item:	Asbestos Textile fuse tapes					
Asbestos Content:		Result Based on:				
Chrysotile		Presumed				
Sample Analysed By:	Not applicable	Extent:	<1 sq m			
Comments: Present within timber boxing, no sample taken as item is live and connected, asbestos content presumed.

Material Assessment Total Score: 6		Likelihood of Disturbance Assessment Total Score: 4		Management Assessment Licensable: No Recommendations: Monitor condition Reinspection Interval: 12 Months Overall Risk Category: C10
Product Type:	2 (Asbestos Textiles/Paper)	Location:	2 (Rooms up to 100 sq m)	
Condition:	1 (Minor scratches)	Accessibility:	1 (Occasionally likely to be disturbed)	
Surface Treatment:	2 (Unencapsulated textile/paper)			
Asbestos Type:	1 (Chrysotile)	Extent Score:	1 (<10 sq m or 10m pipe run)

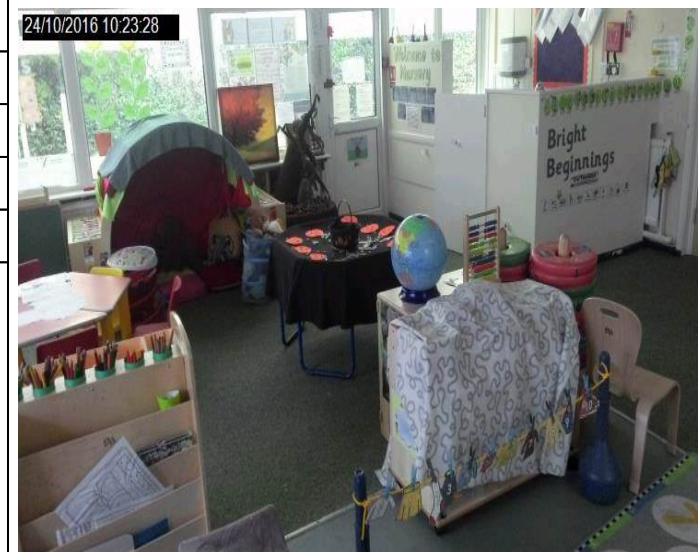
Location:	12 - Classroom	Block:	Brownhills West primary school	Floor Level: Ground Floor
Item No.:	4	Sample No.:	BF003563	24/10/2016 10:23:28
Item:	Asbestos Thermoplastic floor tiles			
Asbestos Content:			Result Based on:	
Chrysotile in tile and adhesive		Analysis of sample using PLM		
Sample Analysed By:	Miss H Sievwright	Extent:	50 sq m	
Comments: Cream and blue floor tiles present beneath carpet.

Material Assessment Total Score: 3		Likelihood of Disturbance Assessment Total Score: 5		Management Assessment Licensable: No Recommendations: Monitor condition Reinspection Interval: 12 Months Overall Risk Category: C8
Product Type:	1 (Asbestos thermoplastic)	Location:	2 (Rooms up to 100 sq m)	
Condition:	1 (Minor scratches)	Accessibility:	1 (Occasionally likely to be disturbed)	
Surface Treatment:	0 (Composite material)			
Asbestos Type:	1 (Chrysotile)	Extent Score:	2 (>10 - <50 sq m or >10m - <50m pipe run)

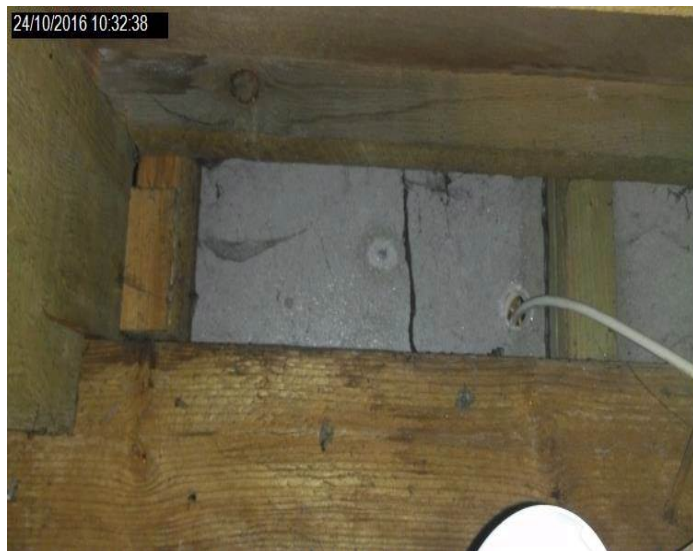
Location:	12 - Classroom	Block:	Brownhills West primary school	Floor Level: Ground Floor
Item No.:	5	Sample No.:	BF003564

Item:	Insulating board panels			
Asbestos Content:		Result Based on:		
No Asbestos Detected		Analysis of sample using PLM		
Sample Analysed By:	Miss H Sievwright	Extent:	32 sq m	
Comments: Present to wall above windows.

Material Assessment Total Score: 0		Likelihood of Disturbance Assessment Total Score: 0		Management Assessment Licensable: Not applicable Recommendations: Not Applicable Reinspection Interval: Not Applicable Overall Risk Category: E0
Product Type:	0 Not Applicable	Location:	0 Not Applicable	
Condition:	0 Not Applicable	Accessibility:	0 Not Applicable	
Surface Treatment:	0 Not Applicable			
Asbestos Type:	0 Not Applicable	Extent Score:	0 Not Applicable

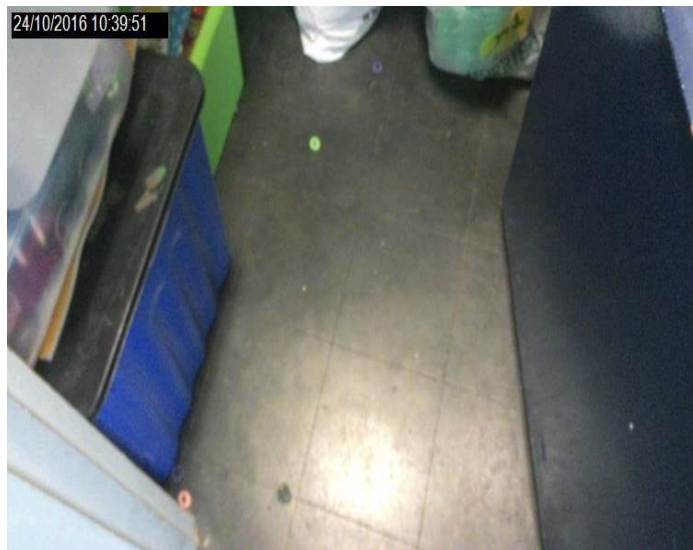
Location:	13 - Cupboard	Block:	Brownhills West primary school	Floor Level: Ground Floor
Item No.:	6	Sample No.:	As BF003563

Item:	Asbestos Thermoplastic floor tiles			
Asbestos Content:		Result Based on:		
Chrysotile in tile and adhesive		Strongly presumed		
Sample Analysed By:	Not applicable	Extent:	4 sq m	
Comments:

Material Assessment Total Score: 3		Likelihood of Disturbance Assessment Total Score: 6		Management Assessment Licensable: No Recommendations: Monitor condition Reinspection Interval: 12 Months Overall Risk Category: C9
Product Type:	1 (Asbestos thermoplastic)	Location:	2 (Rooms up to 100 sq m)	
Condition:	1 (Minor scratches)	Accessibility:	3 (Routinely disturbed)	
Surface Treatment:	0 (Composite material)			
Asbestos Type:	1 (Chrysotile)	Extent Score:	1 (<10 sq m or 10m pipe run)

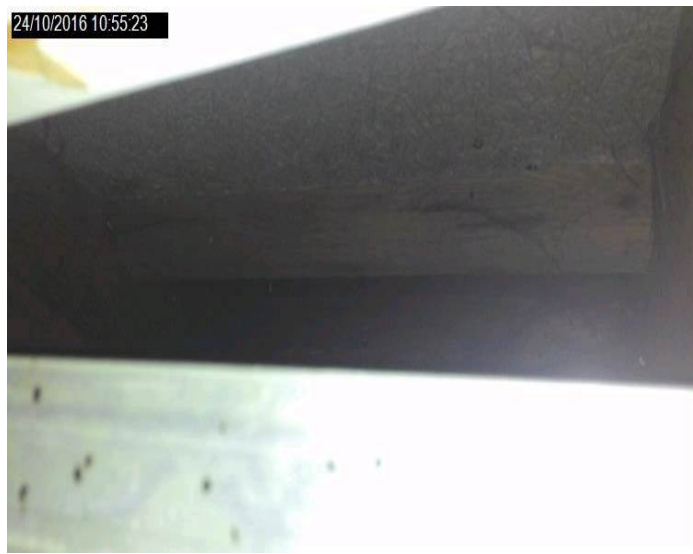
Location:	15 - Classroom	Block:	Brownhills West primary school	Floor Level: Ground Floor
Item No.:	7	Sample No.:	As BF003564

Item:	Insulating board panels			
Asbestos Content:		Result Based on:		
No Asbestos Detected		Strongly presumed		
Sample Analysed By:	Not applicable	Extent:	6 sq m	
Comments: Present to wall above windows.

Material Assessment Total Score: 0		Likelihood of Disturbance Assessment Total Score: 0		Management Assessment Licensable: Not applicable Recommendations: Not Applicable Reinspection Interval: Not Applicable Overall Risk Category: E0
Product Type:	0 Not Applicable	Location:	0 Not Applicable	
Condition:	0 Not Applicable	Accessibility:	0 Not Applicable	
Surface Treatment:	0 Not Applicable			
Asbestos Type:	0 Not Applicable	Extent Score:	0 Not Applicable

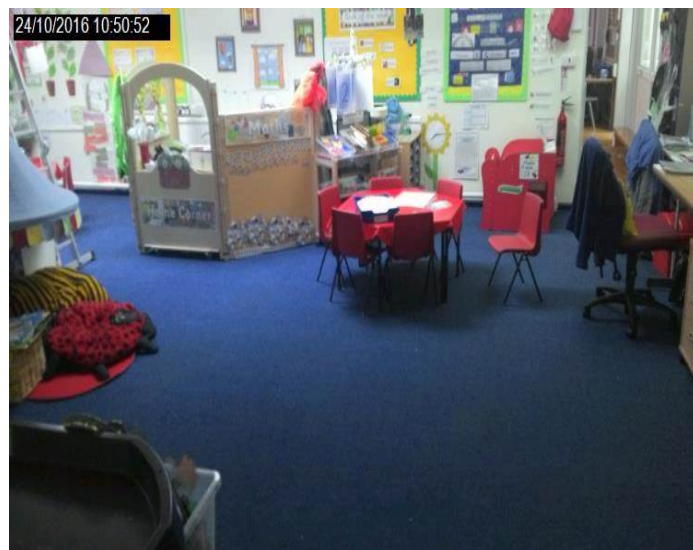
Location:	15 - Classroom	Block:	Brownhills West primary school	Floor Level:	Ground Floor
Item No.:	8	Sample No.:	BF003565	<div>24/10/2016 10:50:52</div>

Item:	Asbestos Bitumen adhesive				
Asbestos Content:		Result Based on:			
Chrysotile		Analysis of sample using PLM			
Sample Analysed By:	Miss H Sievwright	Extent:	45 sq m		
Comments: Present beneath carpet.

Material Assessment Total Score: 3		Likelihood of Disturbance Assessment Total Score: 5		Management Assessment Licensable: No Recommendations: Monitor condition Reinspection Interval: 12 Months Overall Risk Category: C8
Product Type:	1 (Asbestos bitumen)	Location:	2 (Rooms up to 100 sq m)	
Condition:	1 (Minor scratches)	Accessibility:	1 (Occasionally likely to be disturbed)	
Surface Treatment:	0 (Composite material)			
Asbestos Type:	1 (Chrysotile)	Extent Score:	2 (>10 - <50 sq m or >10m - <50m pipe run)

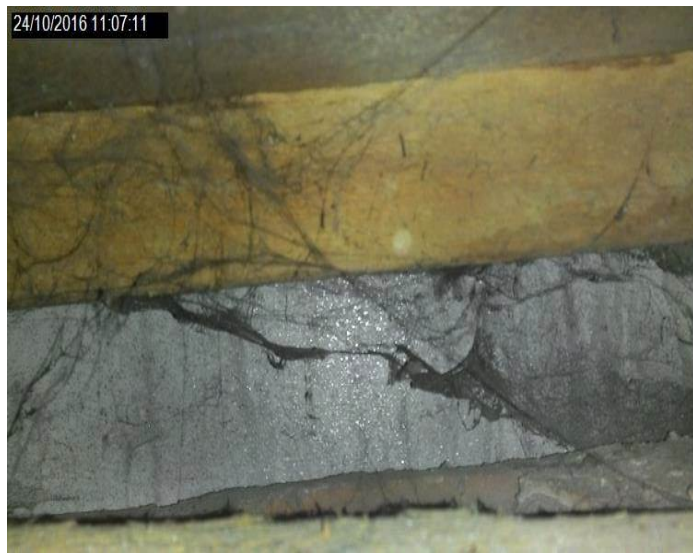
Item:	Insulating board panels			
Asbestos Content:		Result Based on:		
No Asbestos Detected		Strongly presumed		
Sample Analysed By:	Not applicable	Extent:	9 sq m	
Comments: Present to wall above windows.

Material Assessment Total Score: 0		Likelihood of Disturbance Assessment Total Score: 0		Management Assessment Licensable: Not applicable Recommendations: Not Applicable Reinspection Interval: Not Applicable Overall Risk Category: E0
Product Type:	0 Not Applicable	Location:	0 Not Applicable	
Condition:	0 Not Applicable	Accessibility:	0 Not Applicable	
Surface Treatment:	0 Not Applicable			
Asbestos Type:	0 Not Applicable	Extent Score:	0 Not Applicable

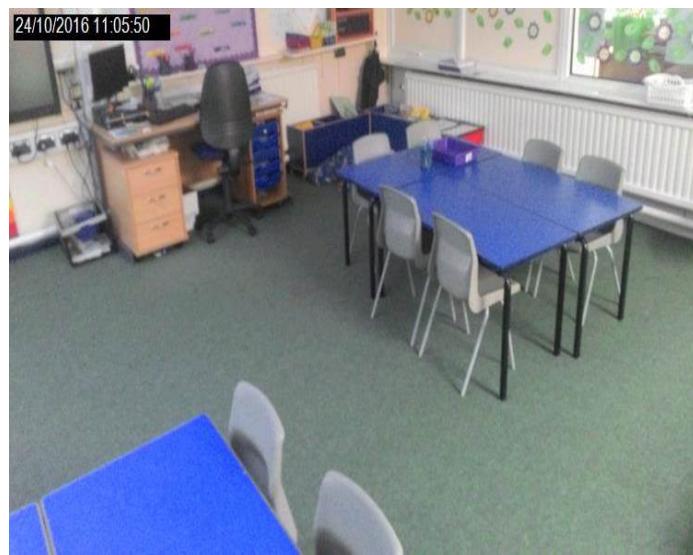
Item:	Asbestos Bitumen adhesive				
Asbestos Content:		Result Based on:			
Chrysotile		Strongly presumed			
Sample Analysed By:	Not applicable	Extent:	55 sq m		
Comments: Present beneath carpet.

Material Assessment Total Score: 3		Likelihood of Disturbance Assessment Total Score: 6		Management Assessment Licensable: No Recommendations: Monitor condition Reinspection Interval: 12 Months Overall Risk Category: C9
Product Type:	1 (Asbestos bitumen)	Location:	2 (Rooms up to 100 sq m)	
Condition:	1 (Minor scratches)	Accessibility:	1 (Occasionally likely to be disturbed)	
Surface Treatment:	0 (Composite material)			
Asbestos Type:	1 (Chrysotile)	Extent Score:	3 (>50 sq m or >50m pipe run)

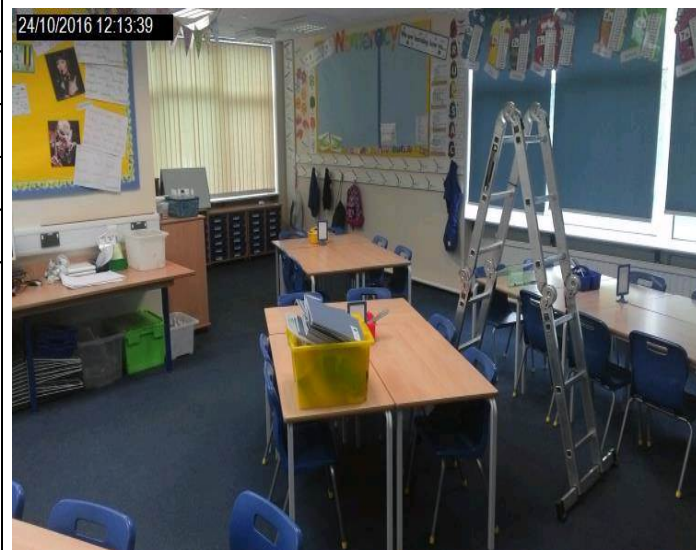
Item:	Asbestos Thermoplastic floor tiles				
Asbestos Content:		Result Based on:			
Chrysotile in tile and adhesive		Analysis of sample using PLM			
Sample Analysed By:	Miss H Sievwright	Extent:	40 sq m		
Comments: Present beneath carpet.

Material Assessment Total Score: 3		Likelihood of Disturbance Assessment Total Score: 5		Management Assessment Licensable: No Recommendations: Monitor condition Reinspection Interval: 12 Months Overall Risk Category: C8
Product Type:	1 (Asbestos thermoplastic)	Location:	2 (Rooms up to 100 sq m)	
Condition:	1 (Minor scratches)	Accessibility:	1 (Occasionally likely to be disturbed)	
Surface Treatment:	0 (Composite material)			
Asbestos Type:	1 (Chrysotile)	Extent Score:	2 (>10 - <50 sq m or >10m - <50m pipe run)

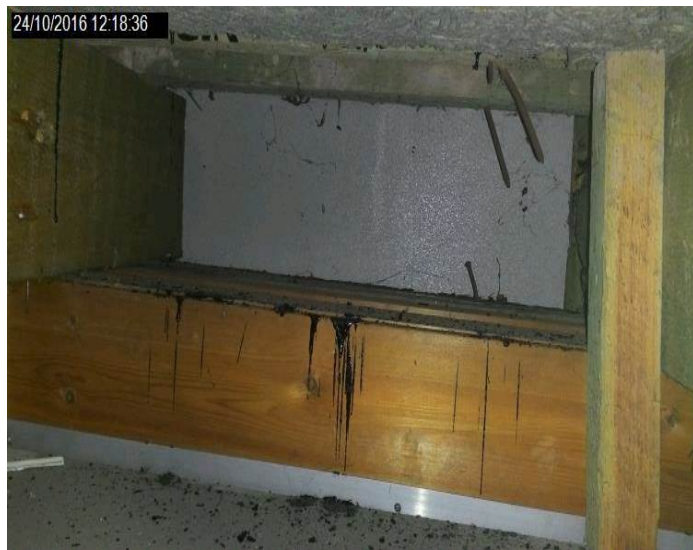
Item:	Insulating board panels			
Asbestos Content:		Result Based on:		
No Asbestos Detected		Analysis of sample using PLM		
Sample Analysed By:	Miss H Sievwright	Extent:	36 sq m	
Comments: Present to wall above windows.

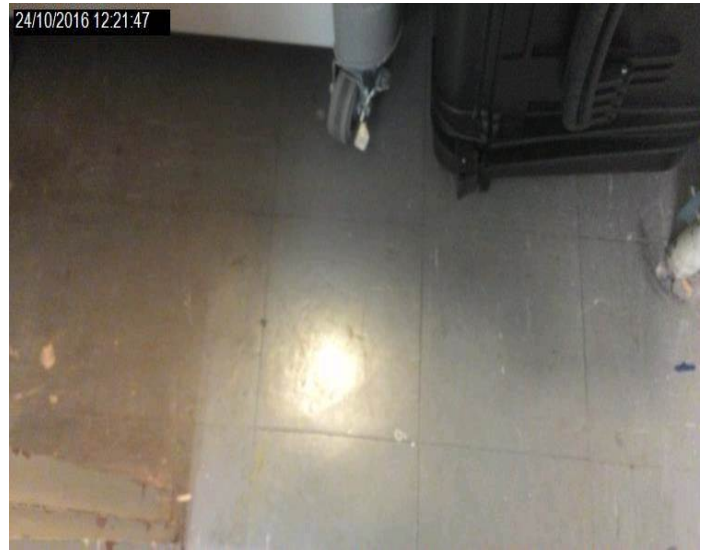
Item:	Asbestos Thermoplastic floor tiles				
Asbestos Content:		Result Based on:			
Chrysotile in tile and adhesive		Strongly presumed			
Sample Analysed By:	Not applicable	Extent:	4 sq m		
Comments:

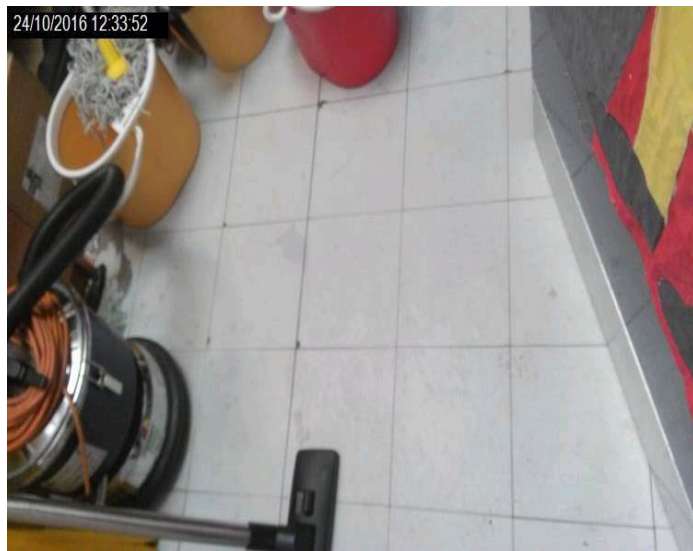
Item:	Asbestos Thermoplastic floor tiles			
Asbestos Content:		Result Based on:		
Chrysotile in tile and adhesive		Analysis of sample using PLM		
Sample Analysed By:	Miss H Sievwright	Extent:	4 sq m	
Comments:

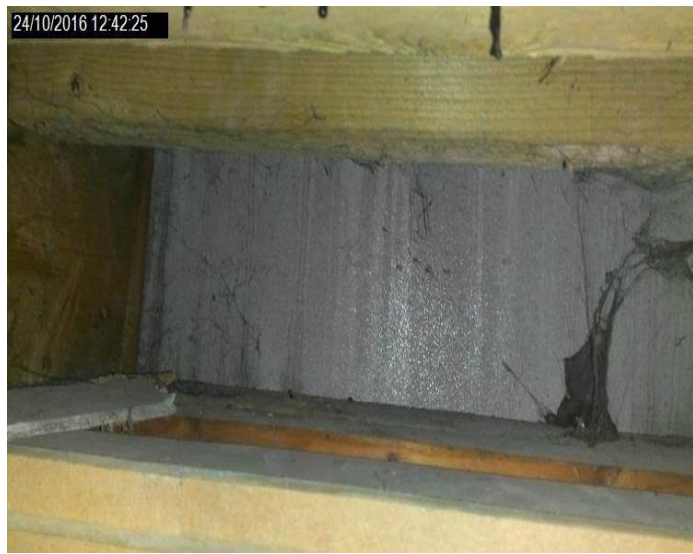
Item:	Insulating board panels			
Asbestos Content:		Result Based on:		
No Asbestos Detected		Strongly presumed		
Sample Analysed By:	Not applicable	Extent:	9 sq m	
Comments: Present above windows within ceilig void

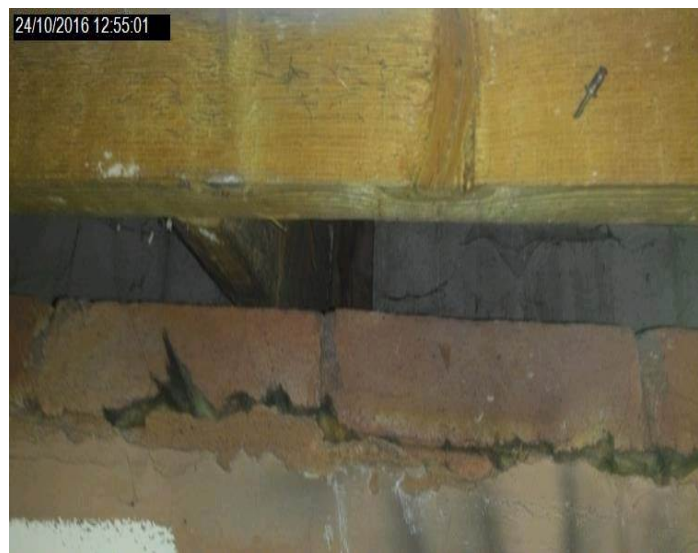
Item:	Insulating board panels				
Asbestos Content:		Result Based on:			
No Asbestos Detected		Strongly presumed			
Sample Analysed By:	Not applicable	Extent:	32 sq m		
Comments: Present above windows within ceiling void

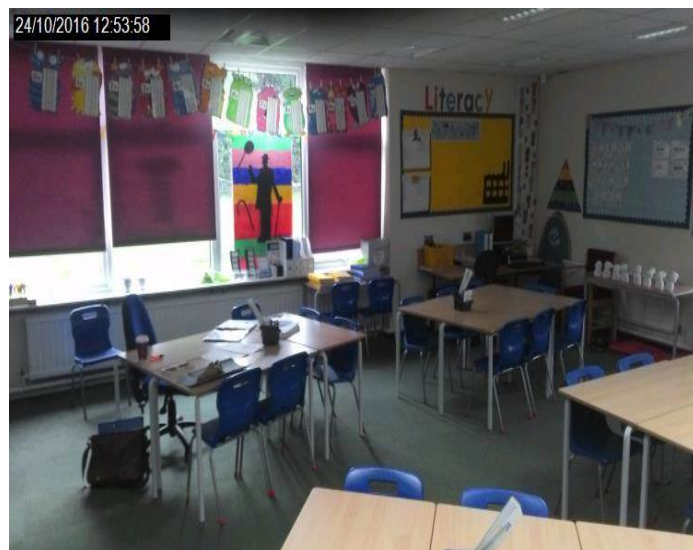
Item:	Asbestos Bitumen adhesive				
Asbestos Content:		Result Based on:			
Chrysotile		Analysis of sample using PLM			
Sample Analysed By:	Miss H Sievwright	Extent:	64 sq m		
Comments: Present beneath carpet.

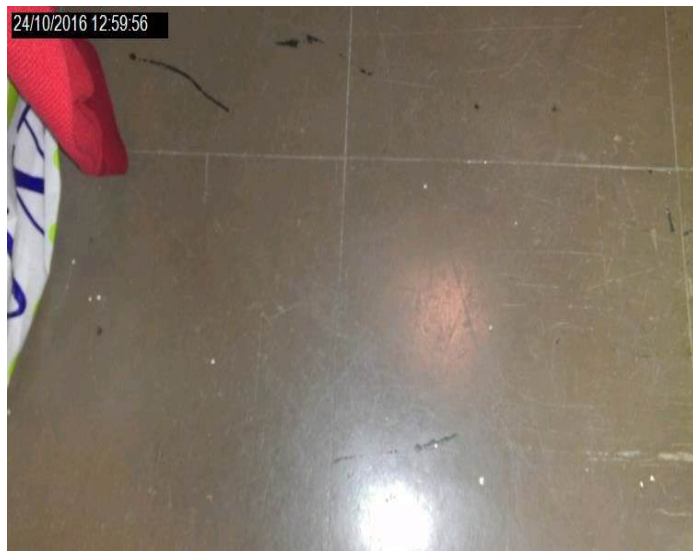
Item:	Asbestos Thermoplastic floor tiles			
Asbestos Content:		Result Based on:		
Chrysotile in tile and adhesive		Analysis of sample using PLM		
Sample Analysed By:	Miss H Sievwright	Extent:	4 sq m	
Comments:

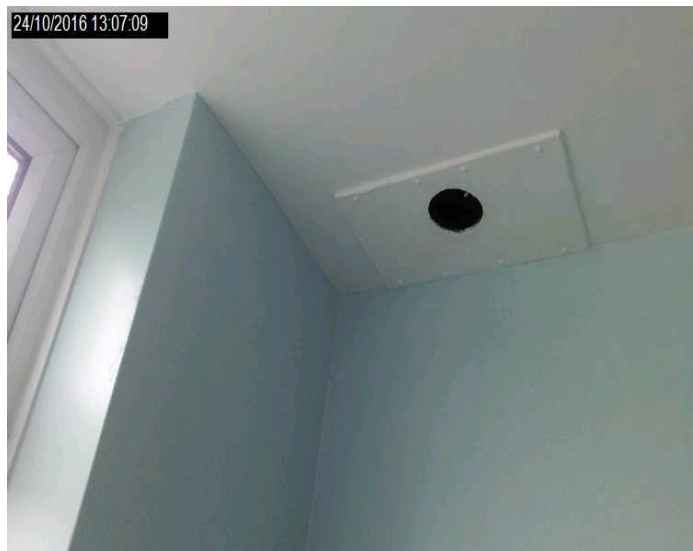
Item:	Asbestos Insulating board panel			
Asbestos Content:	Result Based on:			
Amosite	Analysis of sample using PLM			
Sample Analysed By:	Miss H Sievwright	Extent:	<1 sq m	
Comments:

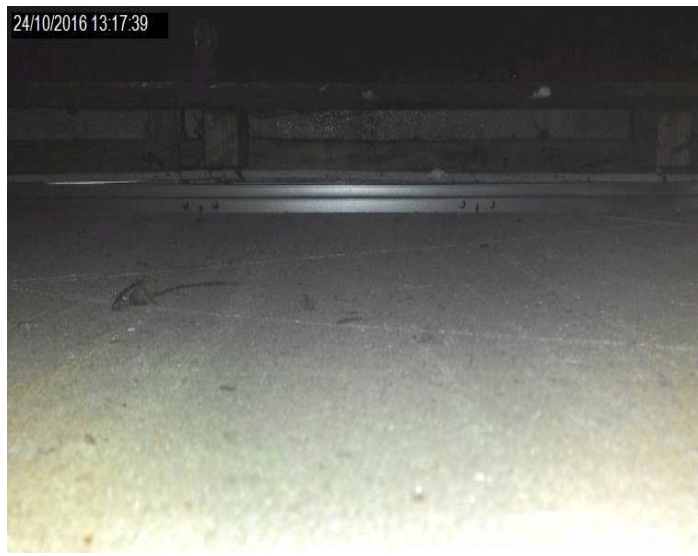
Item:	Insulating board panels			
Asbestos Content:		Result Based on:		
No Asbestos Detected		Strongly presumed		
Sample Analysed By:	Not applicable	Extent:	10 sq m	
Comments: Present above windows within ceiling void

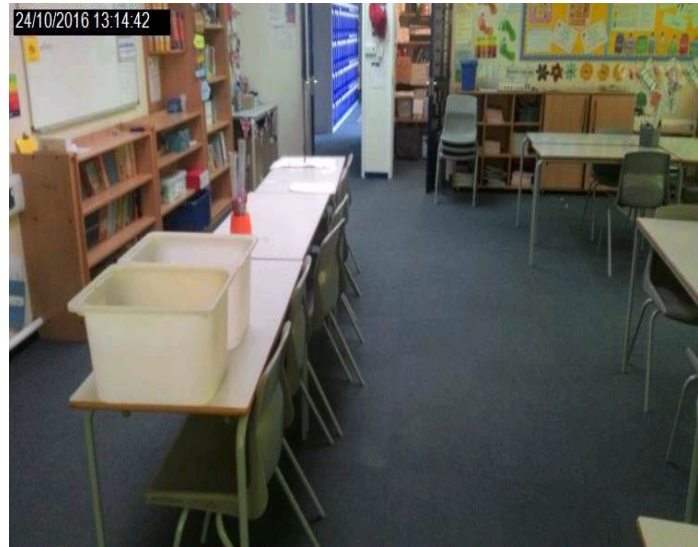
Item:	Asbestos Bitumen adhesive				
Asbestos Content:		Result Based on:			
Chrysotile		Strongly presumed			
Sample Analysed By:	Not applicable	Extent:	80 sq m		
Comments: Present beneath carpet.

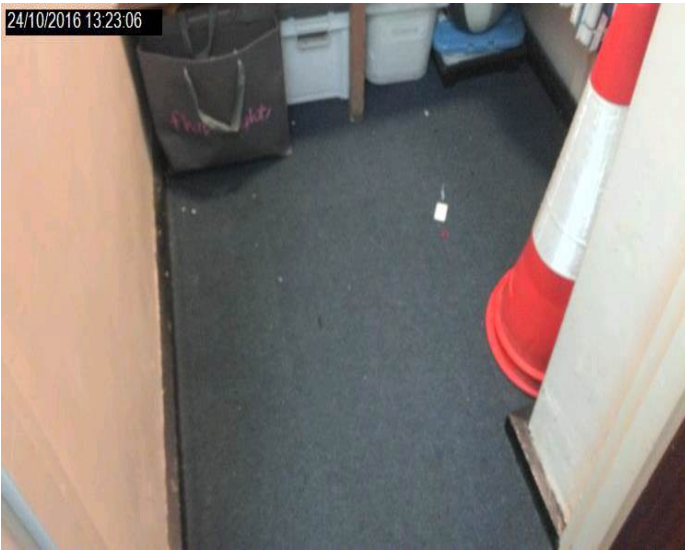
Item:	Asbestos Bitumen adhesive				
Asbestos Content:		Result Based on:			
Chrysotile		Strongly presumed			
Sample Analysed By:	Not applicable	Extent:	4 sq m		
Comments: Present beneath carpet.

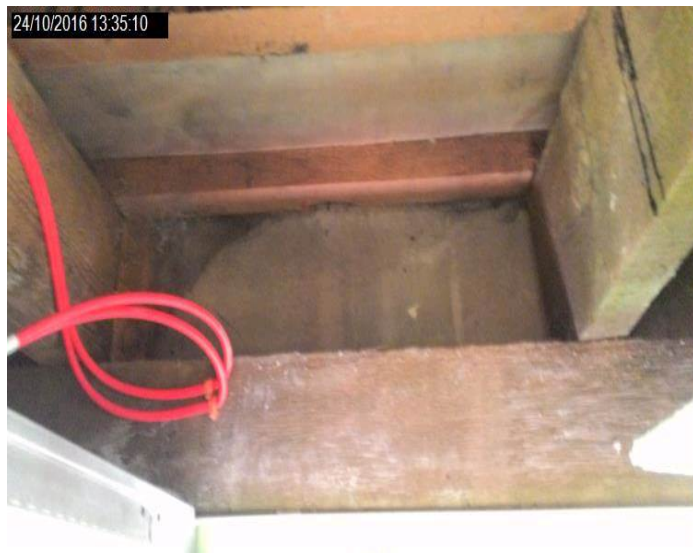
Item:	Insulating board panels			
Asbestos Content:		Result Based on:		
No Asbestos Detected		Analysis of sample using PLM		
Sample Analysed By:	Miss H Sievwright	Extent:	8 sq m	
Comments: Present above windows within ceiling void

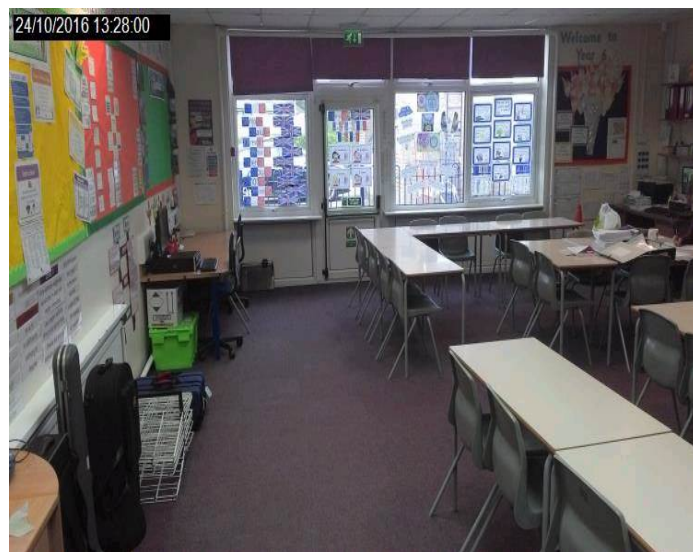
Item:	Asbestos Bitumen adhesive				
Asbestos Content:	Result Based on:				
Chrysotile	Strongly presumed				
Sample Analysed By:	Not applicable	Extent:	81 sq m		
Comments: Present beneath carpet.

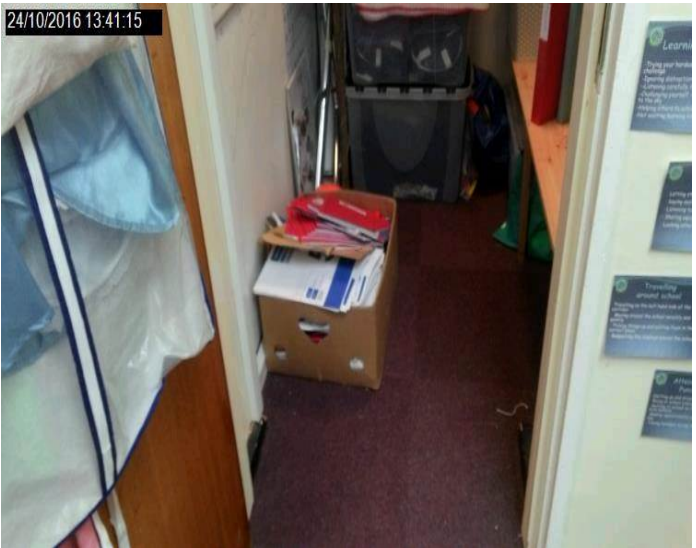
Item:	Asbestos Bitumen adhesive to floor				
Asbestos Content:		Result Based on:			
Chrysotile		Strongly presumed			
Sample Analysed By:	Not applicable	Extent:	4 sq m		
Comments: Present beneath carpet.

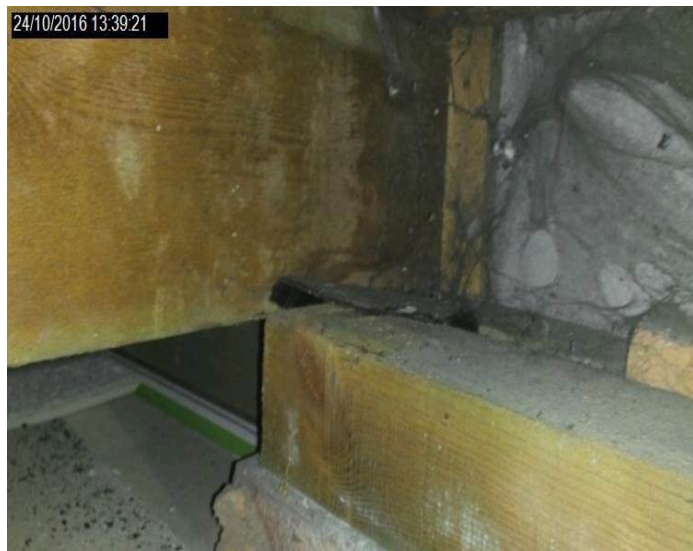
Item:	Asbestos Bitumen packer to timber beam			
Asbestos Content:		Result Based on:		
Chrysotile		Analysis of sample using PLM		
Sample Analysed By:	Miss H Sievwright	Extent:	<1 sq m	
Comments: Item present within ceiling void.

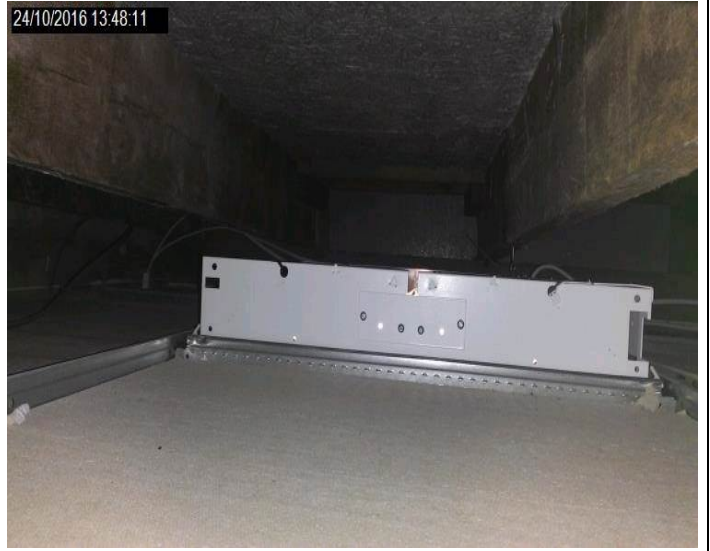
Item:	Insulating board panels			
Asbestos Content:		Result Based on:		
No Asbestos Detected		Strongly presumed		
Sample Analysed By:	Not applicable	Extent:	3 sq m	
Comments: Present above windows within ceiling void

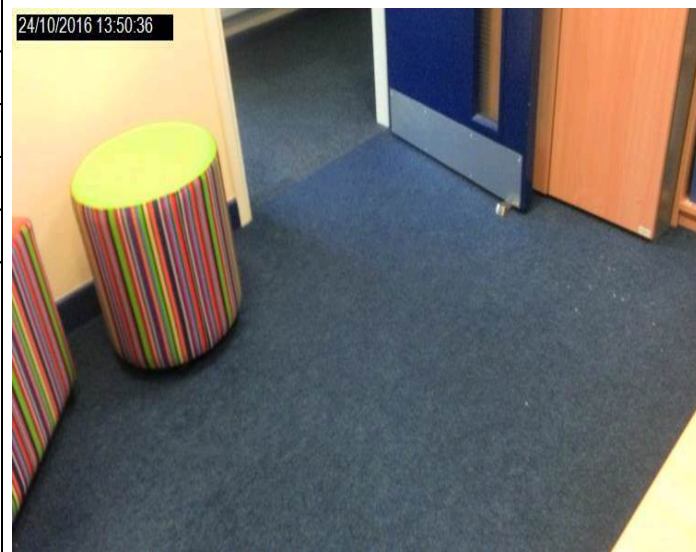
Item:	Asbestos Bitumen adhesive to floor				
Asbestos Content:		Result Based on:			
Chrysotile		Strongly presumed			
Sample Analysed By:	Not applicable	Extent:	8 sq m		
Comments: Present beneath carpet.

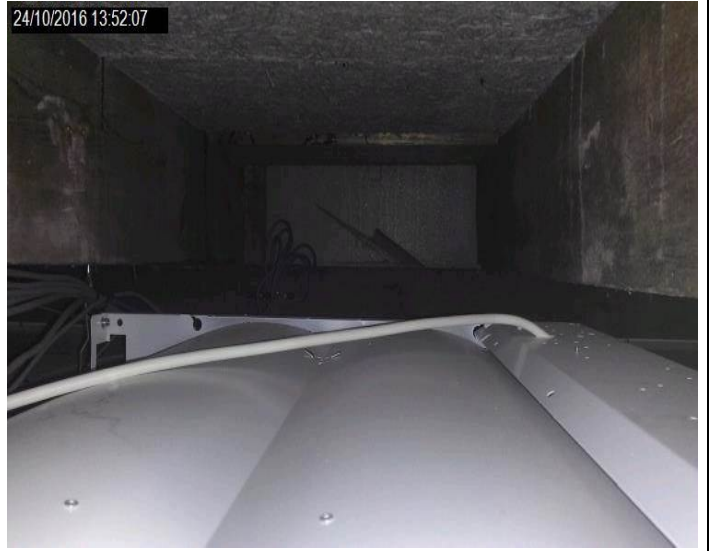
Item:	Insulating board panels			
Asbestos Content:		Result Based on:		
No Asbestos Detected		Strongly presumed		
Sample Analysed By:	Not applicable	Extent:	5 sq m	
Comments: Present above windows within ceiling void

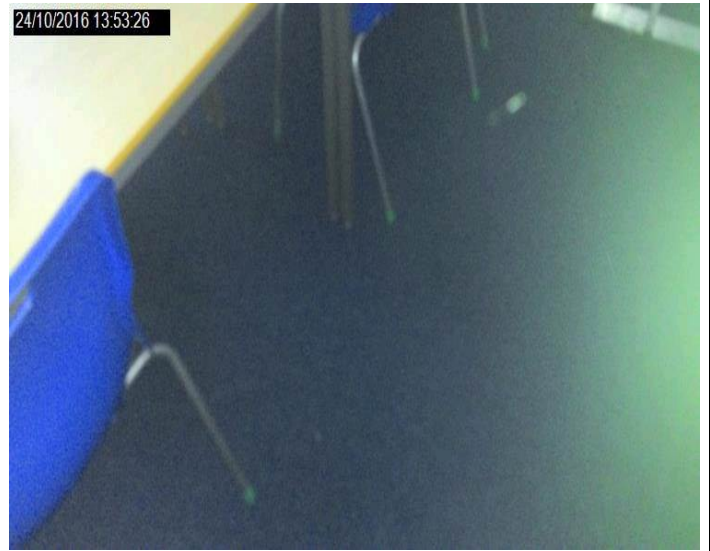
Item:	Asbestos Bitumen adhesive to floor				
Asbestos Content:		Result Based on:			
Chrysotile		Strongly presumed			
Sample Analysed By:	Not applicable	Extent:	12 sq m		
Comments: Present beneath carpet.

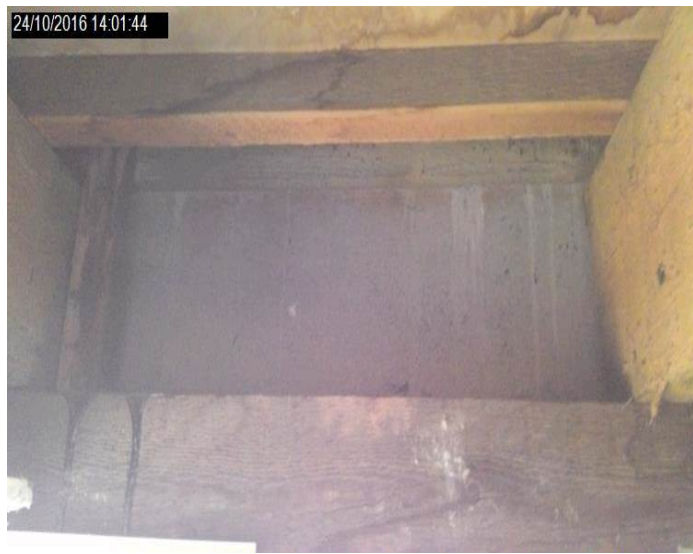
Item:	Insulating board panels			
Asbestos Content:		Result Based on:		
No Asbestos Detected		Analysis of sample using PLM		
Sample Analysed By:	Miss H Sievwright	Extent:	12 sq m	
Comments: Present above windows within ceiling void

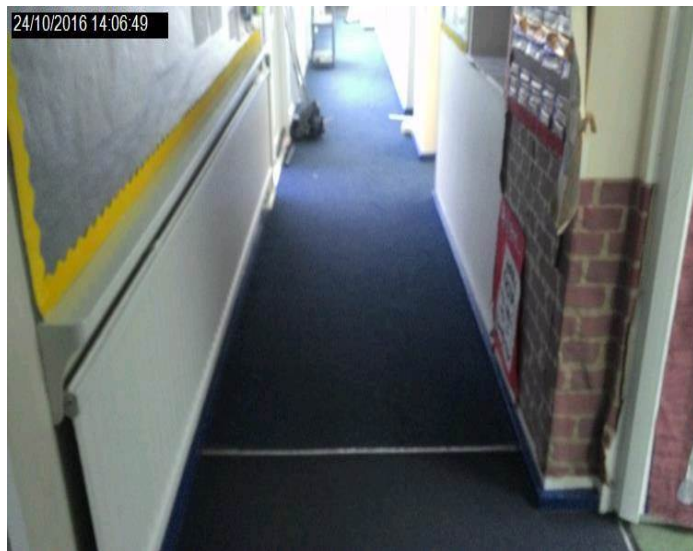
Item:	Asbestos Thermoplastic floor tiles			
Asbestos Content:		Result Based on:		
Chrysotile in tile and adhesive		Analysis of sample using PLM		
Sample Analysed By:	Miss H Sievwright	Extent:	70 sq m	
Comments: Present beneath carpet.

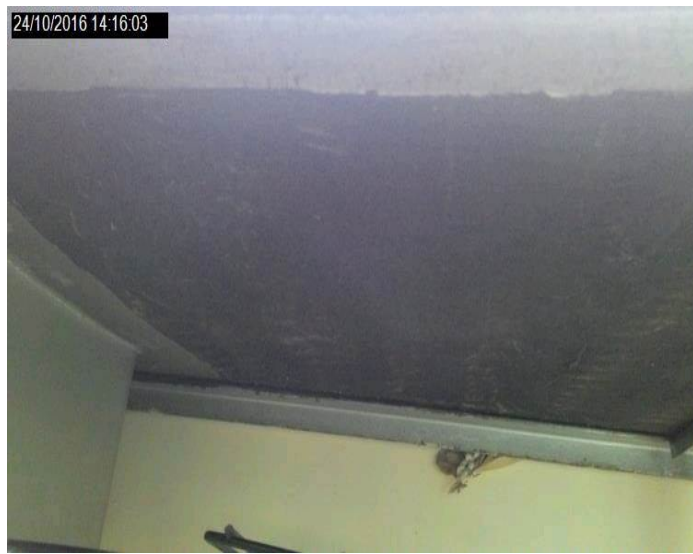
Item:	Bitumen paint to underside of sink unit			
Asbestos Content:		Result Based on:		
No Asbestos Detected		Analysis of sample using PLM		
Sample Analysed By:	Miss H Sievwright	Extent:	3 units	
Comments: Item present to three sinks.

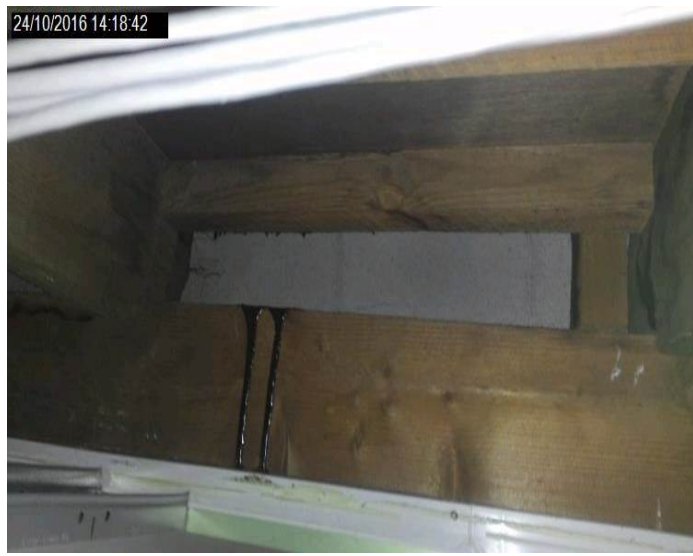
Item:	Insulating board panel			
Asbestos Content:		Result Based on:		
No Asbestos Detected		Strongly presumed		
Sample Analysed By:	Not applicable	Extent:	5 sq m	
Comments: Present above windows within ceiling void

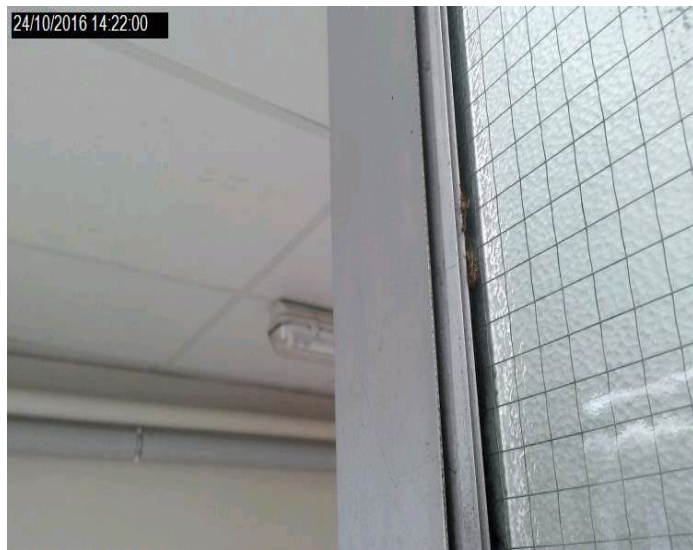
Item:	Textile rope seal to frame of windows			
Asbestos Content:		Result Based on:		
No Asbestos Detected		Analysis of sample using PLM		
Sample Analysed By:	Miss H Sievwright	Extent:	14 linear metres	
Comments: Present to glass upstands.

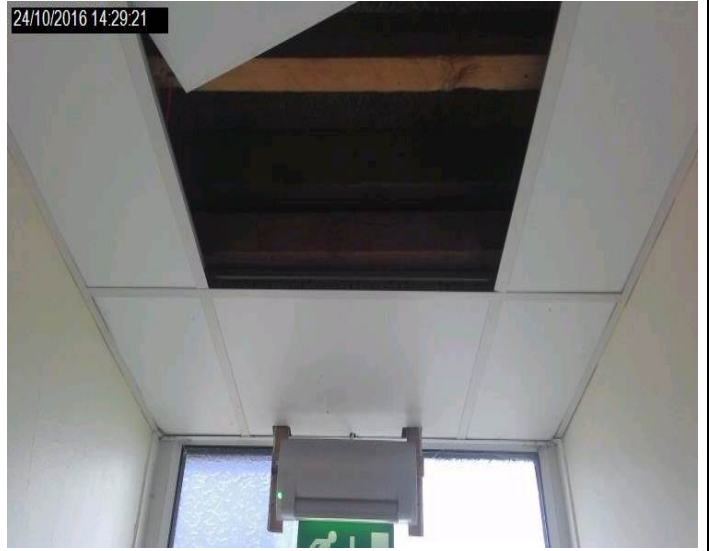
Item:	Insulating board panel			
Asbestos Content:		Result Based on:		
No Asbestos Detected		Strongly presumed		
Sample Analysed By:	Not applicable	Extent:	1 sq m	
Comments: Present above windows within ceiling void

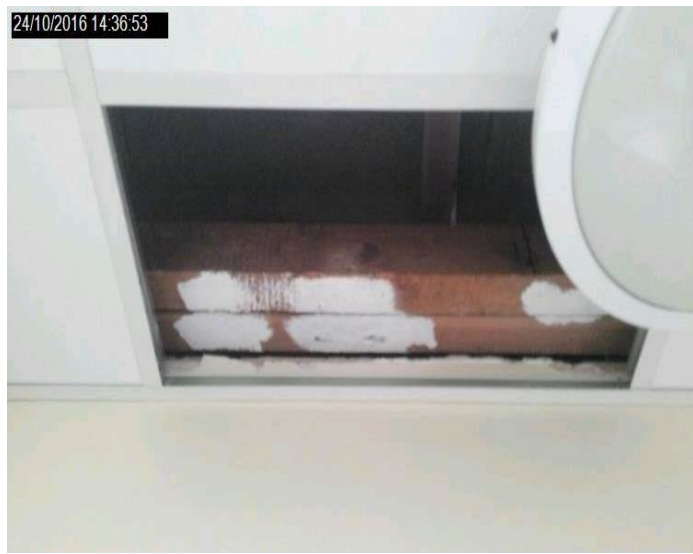
Item:	Insulating board residue to beams			
Asbestos Content:		Result Based on:		
No Asbestos Detected		Analysis of sample using PLM		
Sample Analysed By:	Miss H Sievwright	Extent:	<1 sq m	
Comments: Small amounts where the nails affixed the boarding to the beams was identified, item has been encapsulated with ET 150.

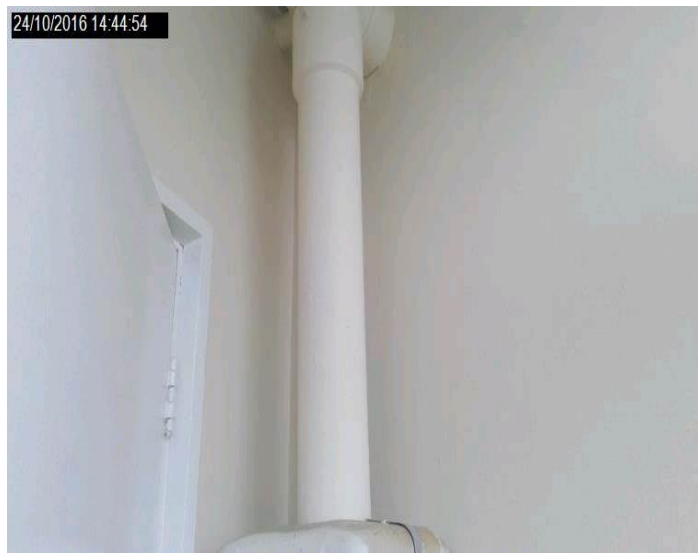
Item:	Asbestos Cement pipe to burner			
Asbestos Content:		Result Based on:		
Chrysotile		Analysis of sample using PLM		
Sample Analysed By:	Miss H Sievwright	Extent:	1 linear metres	
Comments:

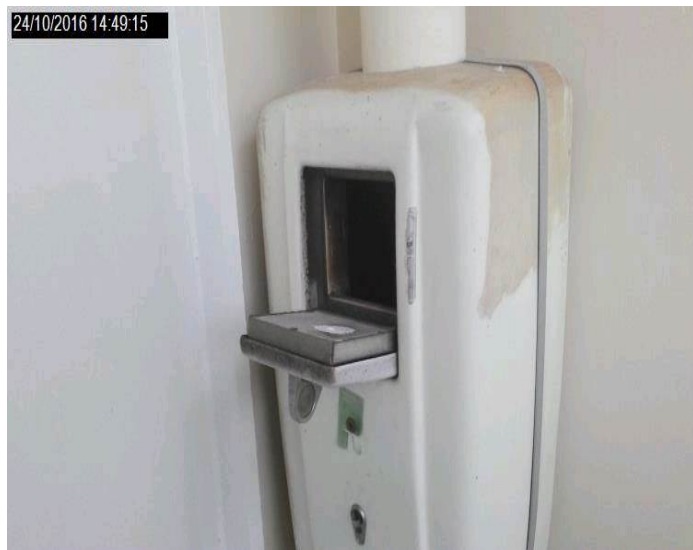
Item:	Asbestos Insulating board to access hatch to burner			
Asbestos Content:		Result Based on:		
Chrysotile		Analysis of sample using PLM		
Sample Analysed By:	Miss H Sievwright	Extent:	<1 sq m	
Comments:

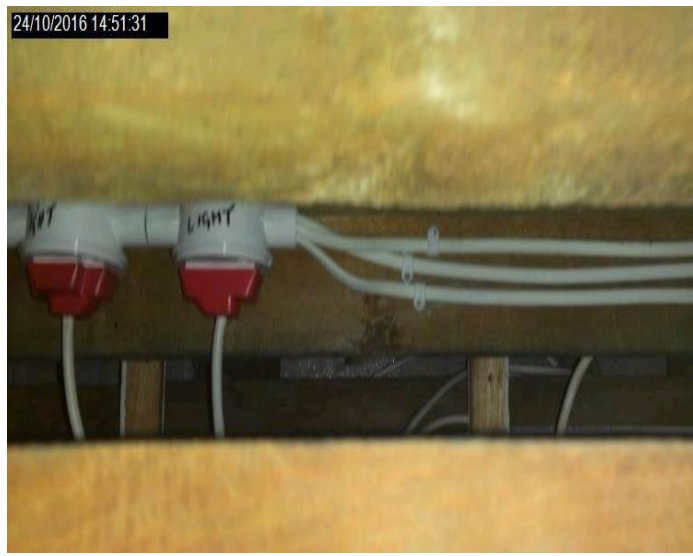
Item:	Insulating board panel			
Asbestos Content:		Result Based on:		
No Asbestos Detected		Strongly presumed		
Sample Analysed By:	Not applicable	Extent:	2 sq m	
Comments: Present above windows within ceiling void

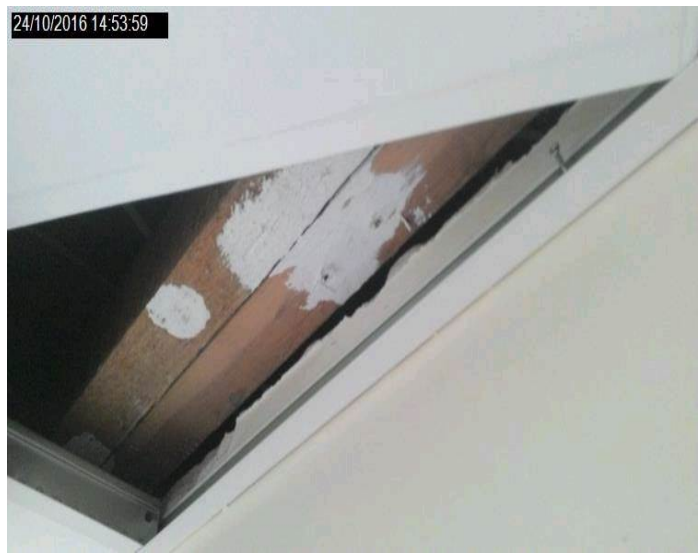
Item:	Insulating board residue to beam			
Asbestos Content:		Result Based on:		
No Asbestos Detected		Strongly presumed		
Sample Analysed By:	Not applicable	Extent:	<1 sq m	
Comments: Small amounts where the nails affixed the boarding to the beams was identified, item has been encapsulated with ET 150.

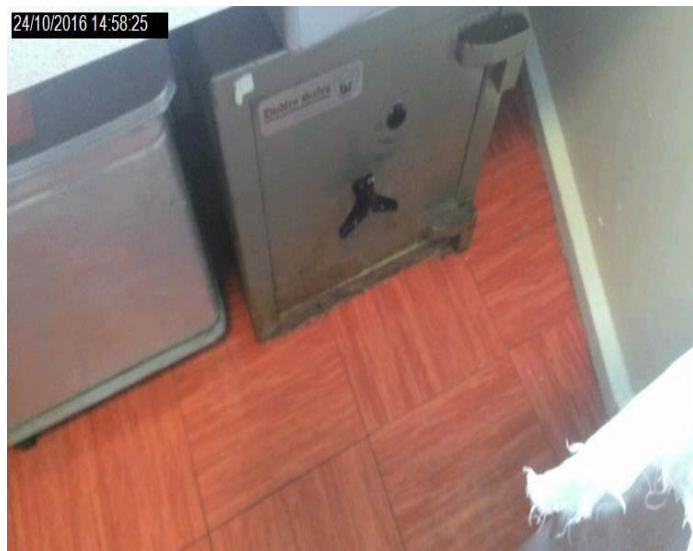
Item:	Asbestos Insulation within safe				
Asbestos Content:		Result Based on:			
Crocidolite		Presumed			
Sample Analysed By:	Not applicable	Extent:	2 sq m		
Comments: Item presumed as there were no keys available to access the safe and sample the material.

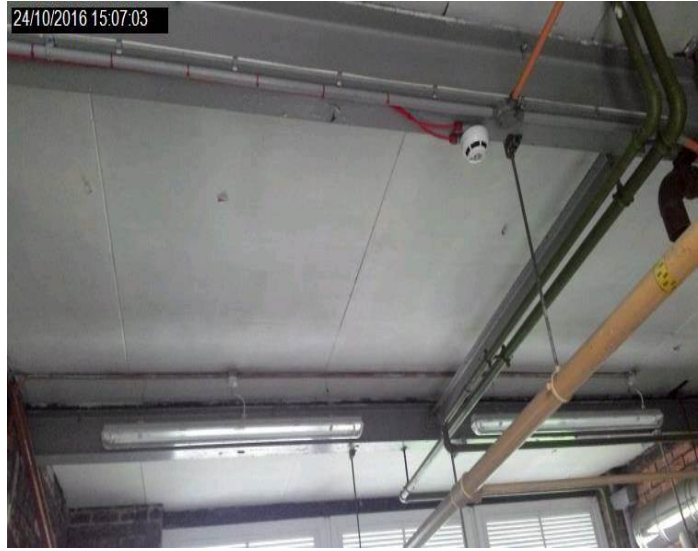
Item:	Asbestos Insulating board to ceiling			
Asbestos Content:	Result Based on:			
Amosite	Analysis of sample using PLM			
Sample Analysed By:	Miss H Sievwright	Extent:	36 sq m	
Comments:

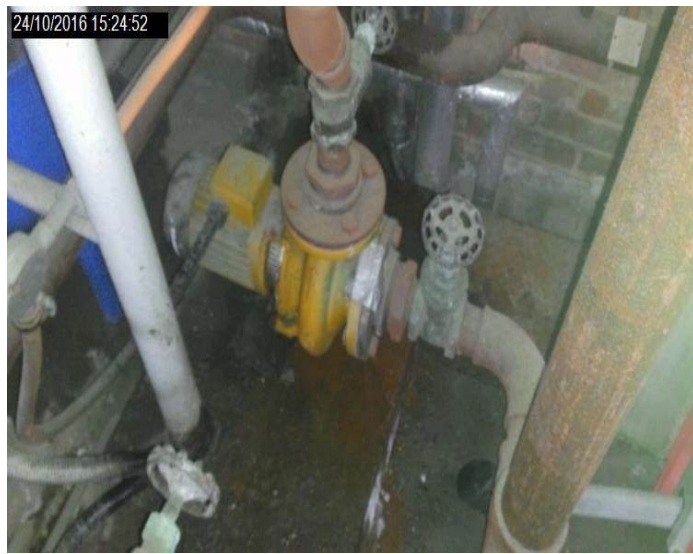
Item:	Asbestos Gaskets to pipe flanges of low level pipework			
Asbestos Content:		Result Based on:		
Chrysotile		Analysis of sample using PLM		
Sample Analysed By:	Miss H Sievwright	Extent:	4 units	
Comments:

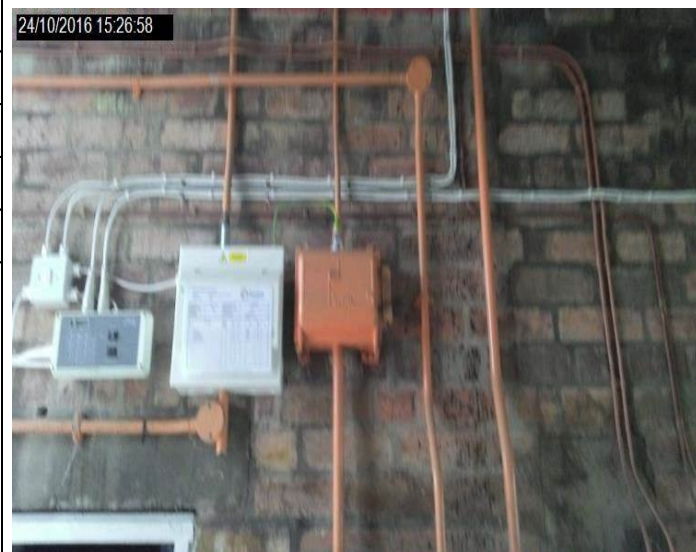
Item:	Asbestos textile fuse tapes to fuse box				
Asbestos Content:		Result Based on:			
Chrysotile		Presumed			
Sample Analysed By:	Not applicable	Extent:	<1 sq m		
Comments: No sample taken as item was live and connected. Asbestos content presumed.

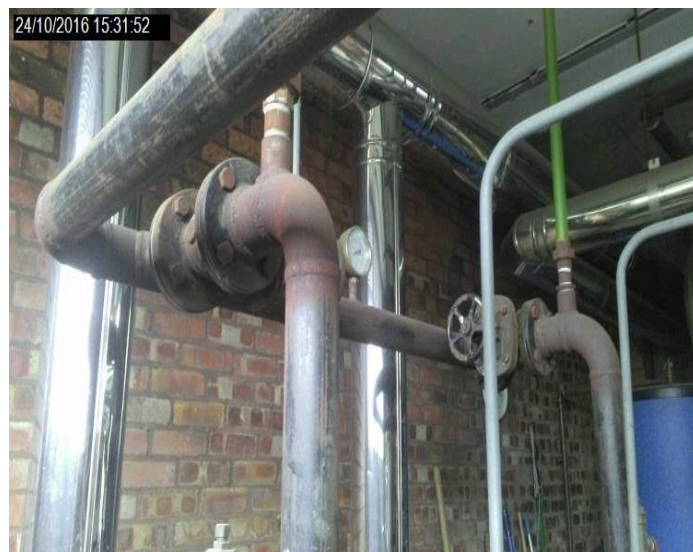
Item:	Asbestos Gaskets to pipe flanges of high and low level pipework				
Asbestos Content:		Result Based on:			
Chrysotile		Analysis of sample using PLM			
Sample Analysed By:	Miss H Sievwright	Extent:	19 units		
Comments: Item is present to pipework connected to boiler.
