Report No.: J054862

Nature of Work: Management Survey

Brownhills West Primary School
Shannon Drive
Brownhills
Walsall
WS8 7LA

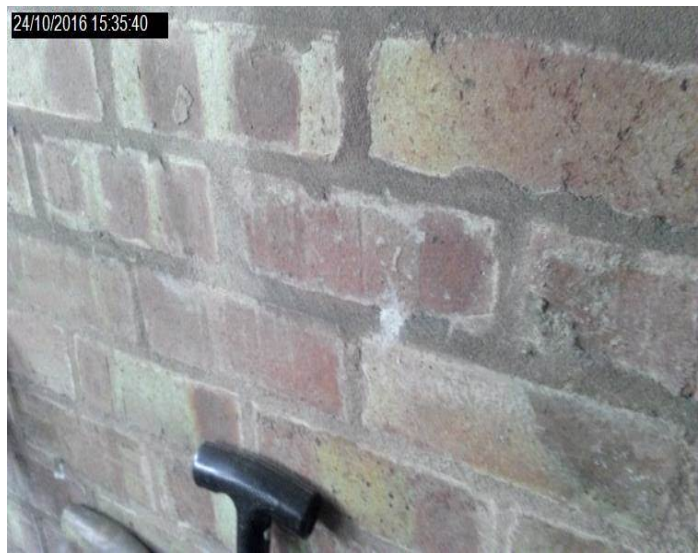
Material Assessment Total Score: 11		Likelihood of Disturbance Assessment Total Score: 5		Management Assessment Licensable: Yes Recommendations: Program removal Reinspection Interval: Not Applicable Overall Risk Category: A16
Product Type:	3 (Asbestos insulation)	Location:	2 (Rooms up to 100 sq m)	
Condition:	3 (Significant damage)	Accessibility:	2 (Easily disturbed)	
Surface Treatment:	3 (Unencapsulated insulation)			
Asbestos Type:	2 (Chrysotile Amosite)	Extent Score:	1 (<10 sq m or 10m pipe run)

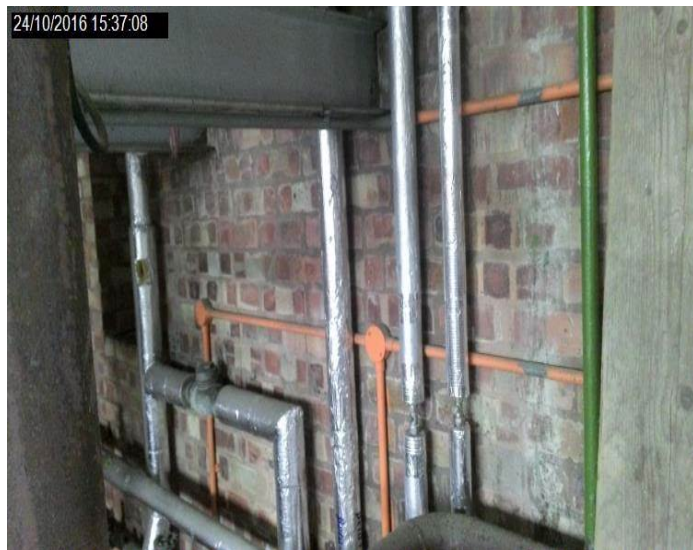
Item:	Asbestos Insulation debris to wall			
Asbestos Content:	Result Based on:			
Chrysotile Amosite	Analysis of sample using PLM			
Sample Analysed By:	Miss H Sievwright	Extent:	<1 sq m	
Comments: It is recommended following the analysis of this sample proved to contain asbestos that access should continue to be restricted until remedial works are carried out by a licensed removal contractor. Caretaker on site is aware.

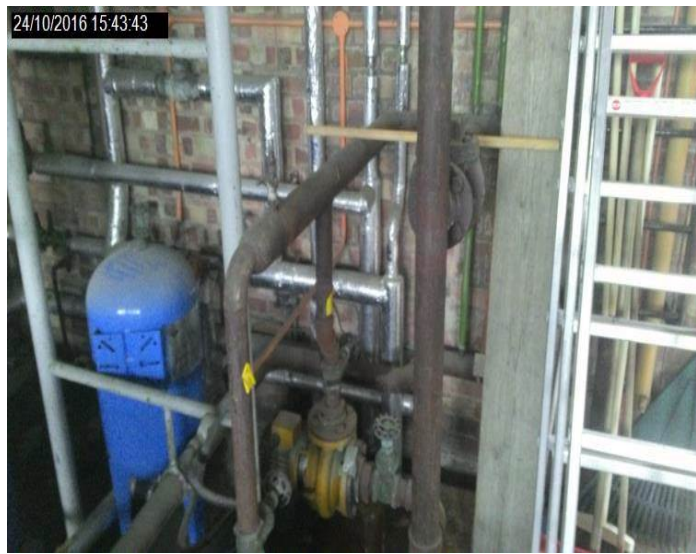
Material Assessment Total Score: 11		Likelihood of Disturbance Assessment Total Score: 5		Management Assessment Licensable: Yes Recommendations: Program removal Reinspection Interval: Not Applicable Overall Risk Category: A16
Product Type:	3 (Asbestos insulation)	Location:	2 (Rooms up to 100 sq m)	
Condition:	3 (Significant damage)	Accessibility:	2 (Easily disturbed)	
Surface Treatment:	3 (Unencapsulated insulation)			
Asbestos Type:	2 (Chrysotile Amosite)	Extent Score:	1 (<10 sq m or 10m pipe run)

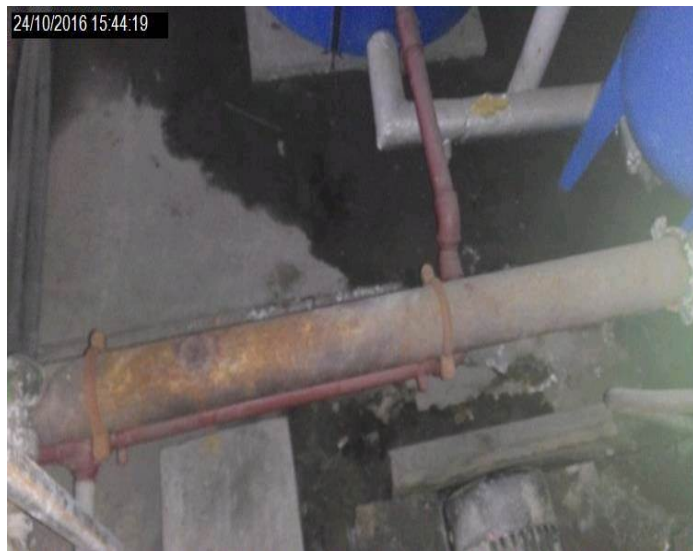
Item:	Asbestos Residue to pipework				
Asbestos Content:		Result Based on:			
Chrysotile Amosite		Analysis of sample using PLM			
Sample Analysed By:	Miss H Sievwright	Extent:	14 linear metres		
Comments: It is recommended following the analysis of this sample proved to contain asbestos that access should continue to be restricted until remedial works are carried out by a licensed removal contractor. Caretaker on site is aware.

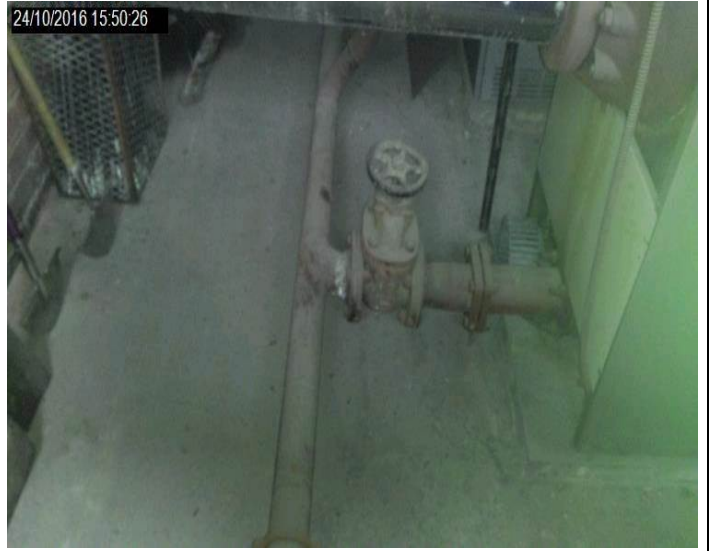
Item:	Residue to pipework			
Asbestos Content:		Result Based on:		
No Asbestos Detected		Analysis of sample using PLM		
Sample Analysed By:	Miss H Sievwright	Extent:	10 linear metres	
Comments:

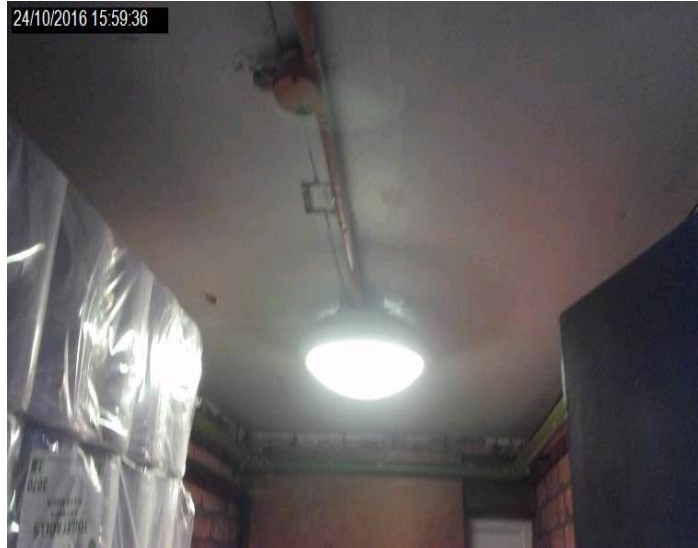
Item:	Asbestos Insulating board to ceiling			
Asbestos Content:		Result Based on:		
Amosite		Strongly presumed		
Sample Analysed By:	Not applicable	Extent:	6 sq m	
Comments:
