Freedom of Information Request – Detailed Examination Reports for HRE Tunnels

Detailed Examination Report for

Balfour Beatty Rail, Manchester**Monks Ferry Tunnel****ELR:CCS3/01****Examined:03/10/2019**

Balfour Beatty Rail, Manchester**Law Tunnel****ELR:DDN/12A****Examined:07/10/2019**

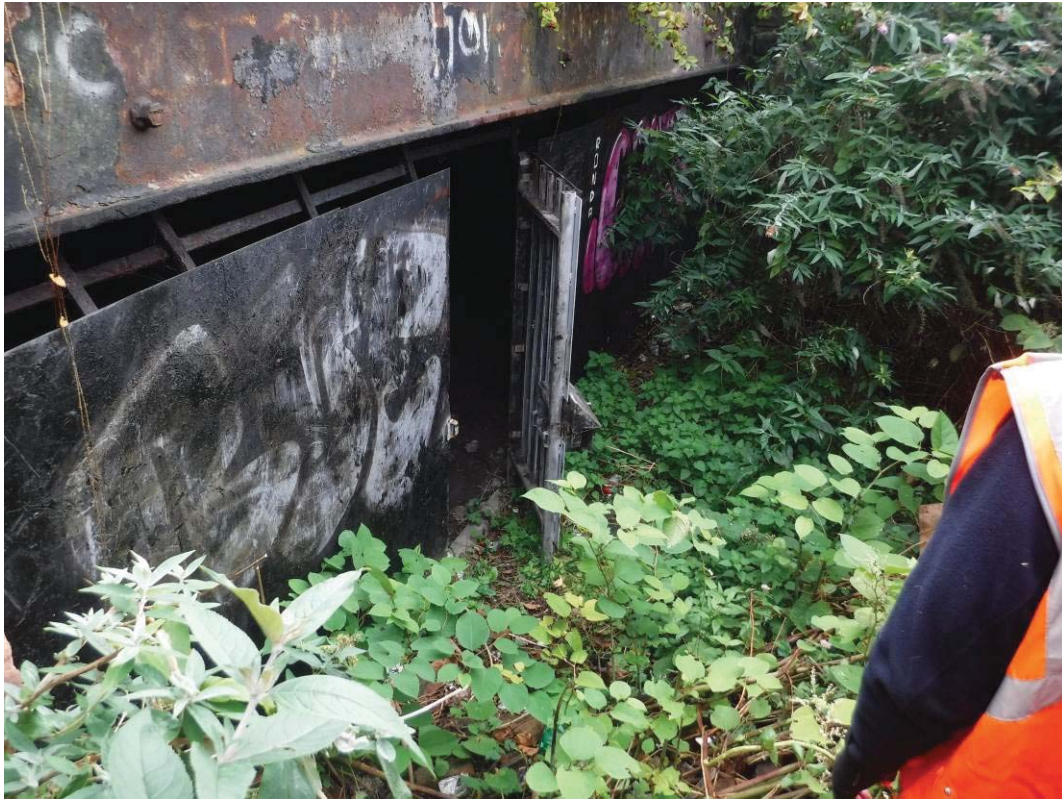
| Location | Defect | | Action |
|---|---|---|--|
| 000+00 Portal Up & Down | Rock Ferry Portal, view of solum approach overgrown with a forest of Japanese Knotweed. Access to tunnel difficult. | 1 | Recommend clear solum approach adjacent to portal, Priority 1, work to be completed 03/10/2020. |

**Photo No.1: Rock Ferry Portal, view of solum approach overgrown with a forest of Japanese Knotweed.
Access to tunnel difficult.**

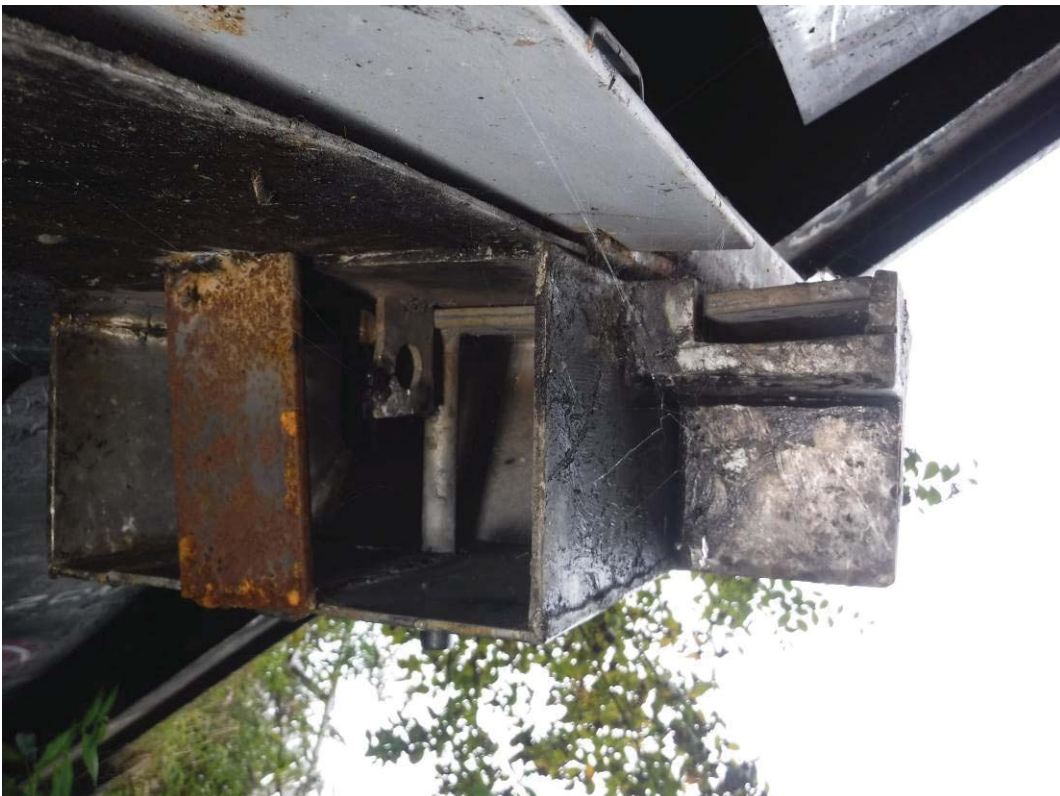
| Location | Defect | | Action |
|---|---|---|--|
| 000+00 Portal Up & Down | Rock Ferry Portal, tunnel gate found open and padlock missing. | 2 | |

Photo No.2: Rock Ferry Portal, tunnel gate found open and padlock missing.

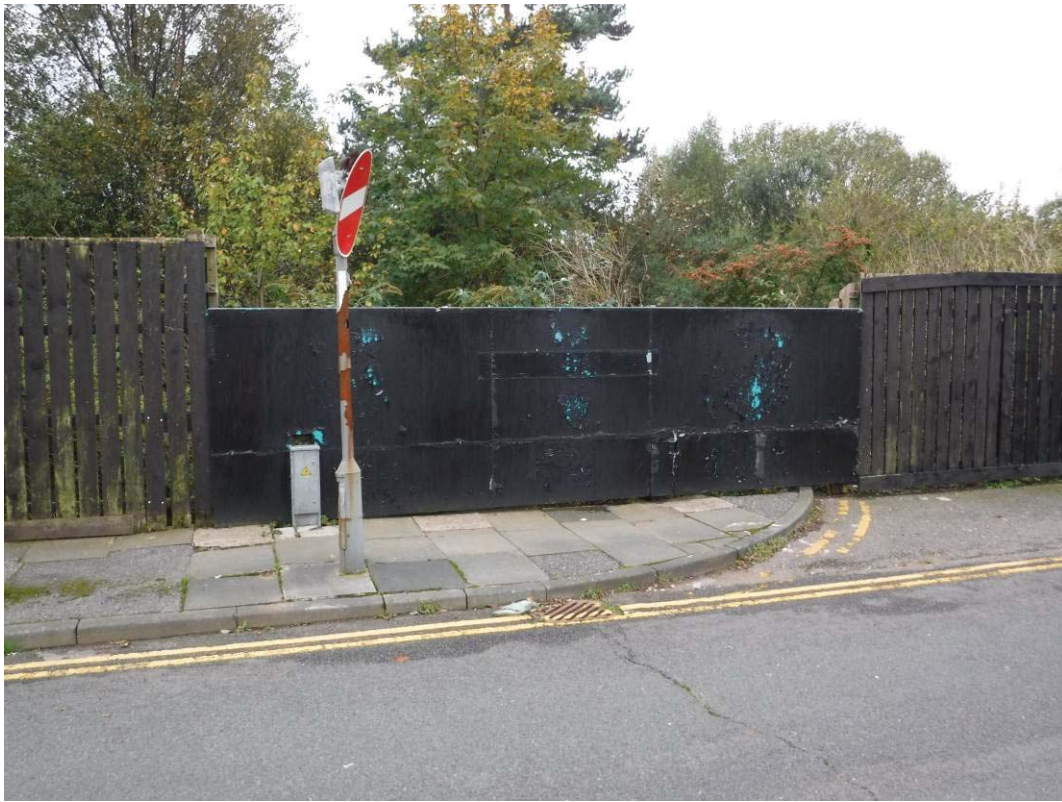
| Location | Defect | | Action |
|---|---|---|--|
| 000+00 Portal Down | Rock Ferry Portal, probable easy access route for trespassers / vandals found at low level fence. | 3 & 4 | Recommend replace fence with higher level security, Priority 1, work to be completed 03/10/2020. |

Photo No.3: 000+00 Portal Down, Rock Ferry Portal, probable easy access route for trespassers / vandals found at low level fence.

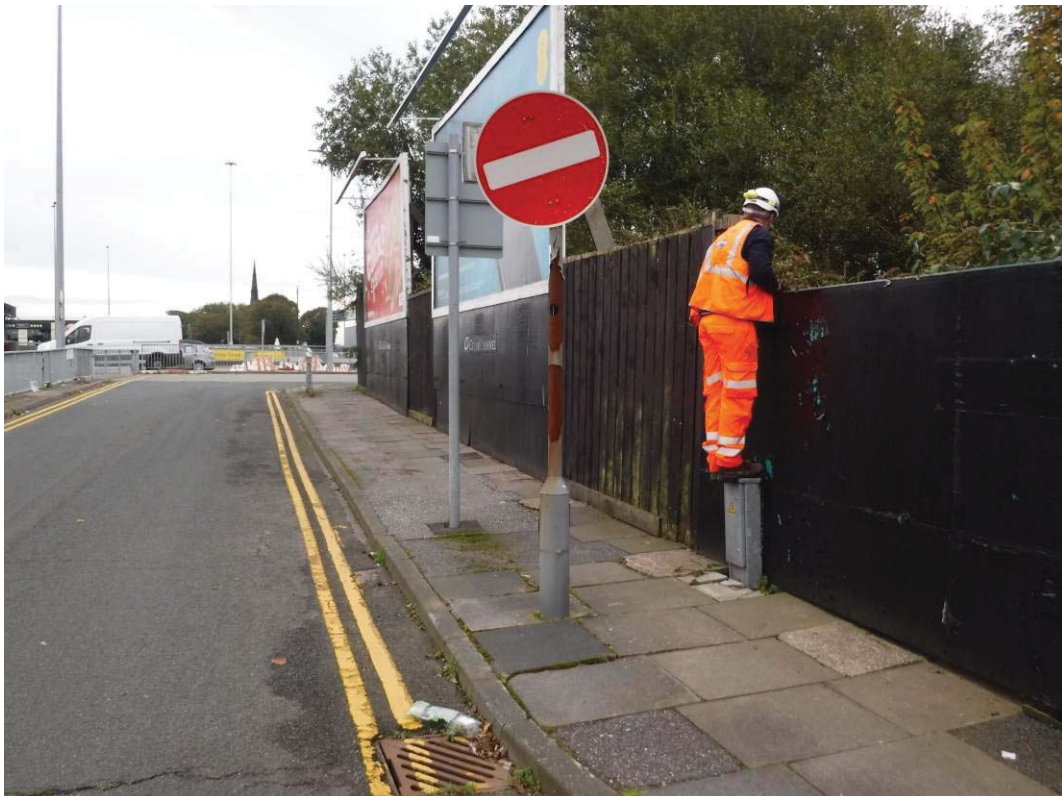
Photo No.4: 000+00 Portal Down, Rock Ferry Portal, probable easy access route for trespassers / vandals found at low level fence.

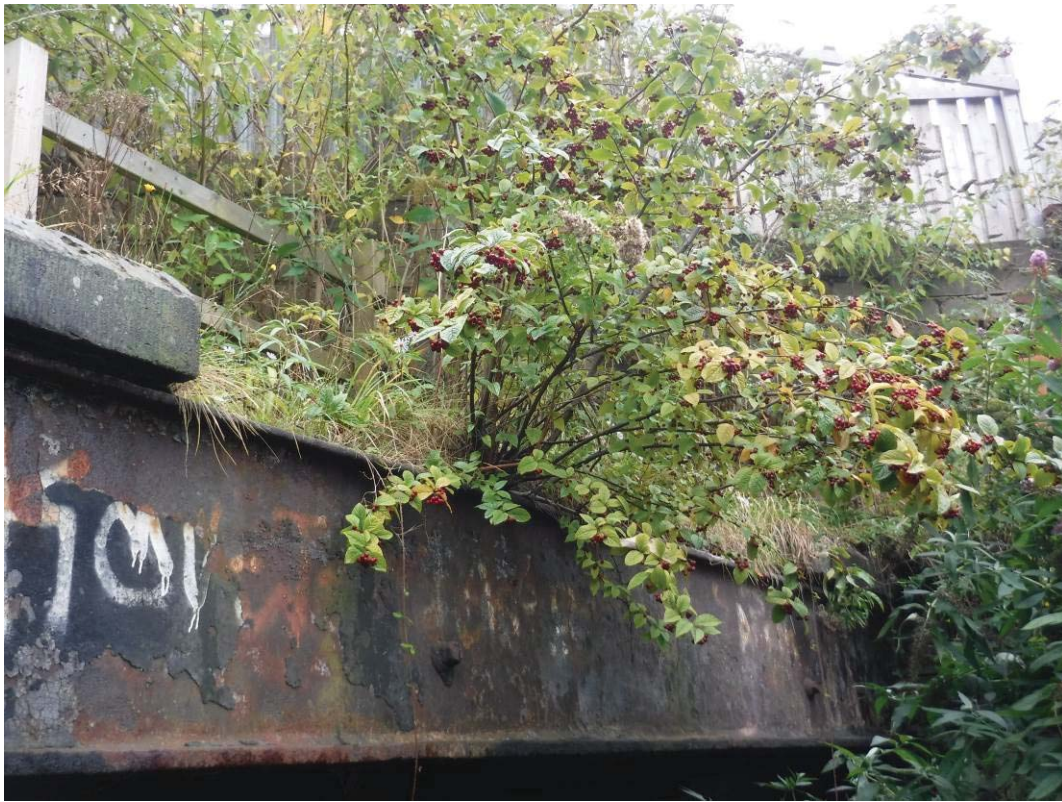
| Location | Defect | | Action |
|---|---|---|--|
| 000+00 Portal Up | Rock Ferry Portal, 3No. copings missing. | 5 | Recommend replace coping stones, Priority 1, work to be completed 03/10/2020. |

Photo No.5: 000+00 Portal Up, Rock Ferry Portal, 3No. copings missing.

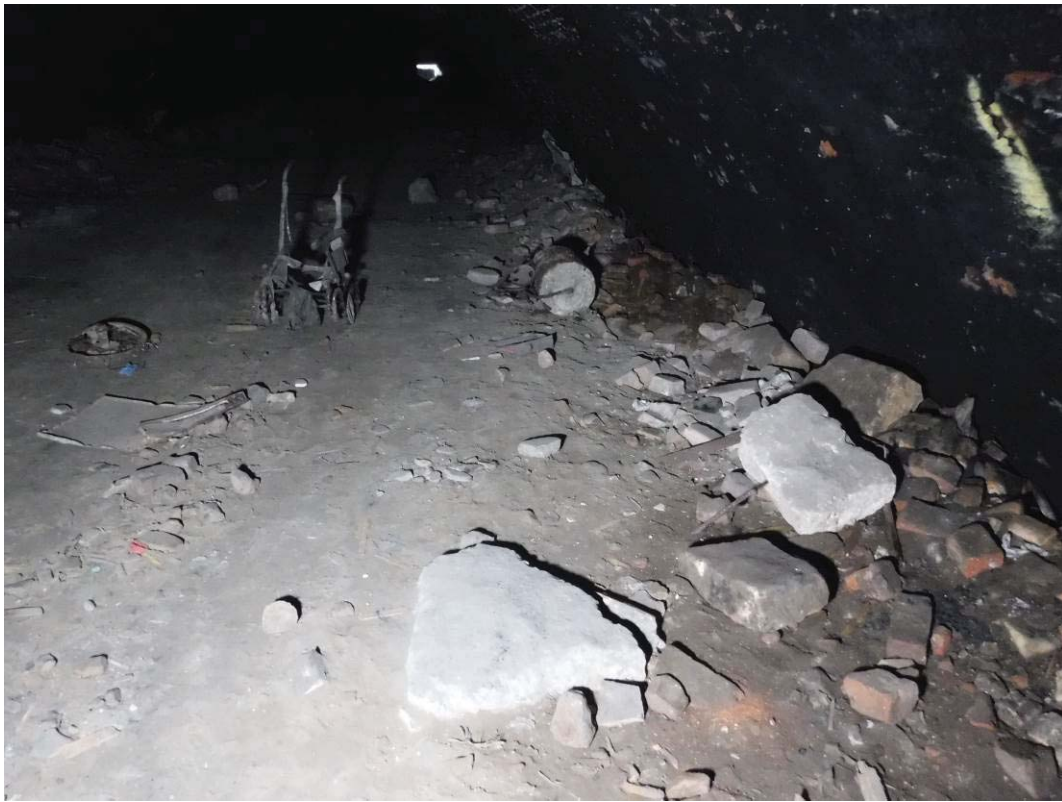
| Location | Defect | | Action |
|---|---|---|--|
| 000+00 to 012+15 Solum Up & Down | Debris, fly-tipping & fires throughout. | 9, 10 & 11 | Recommend remove all debris, Priority 1, work to be completed by 03/10/2020. |

Photo No.9: 000+00 to 012+15 Solum Up & Down, Debris, fly-tipping & fires throughout.

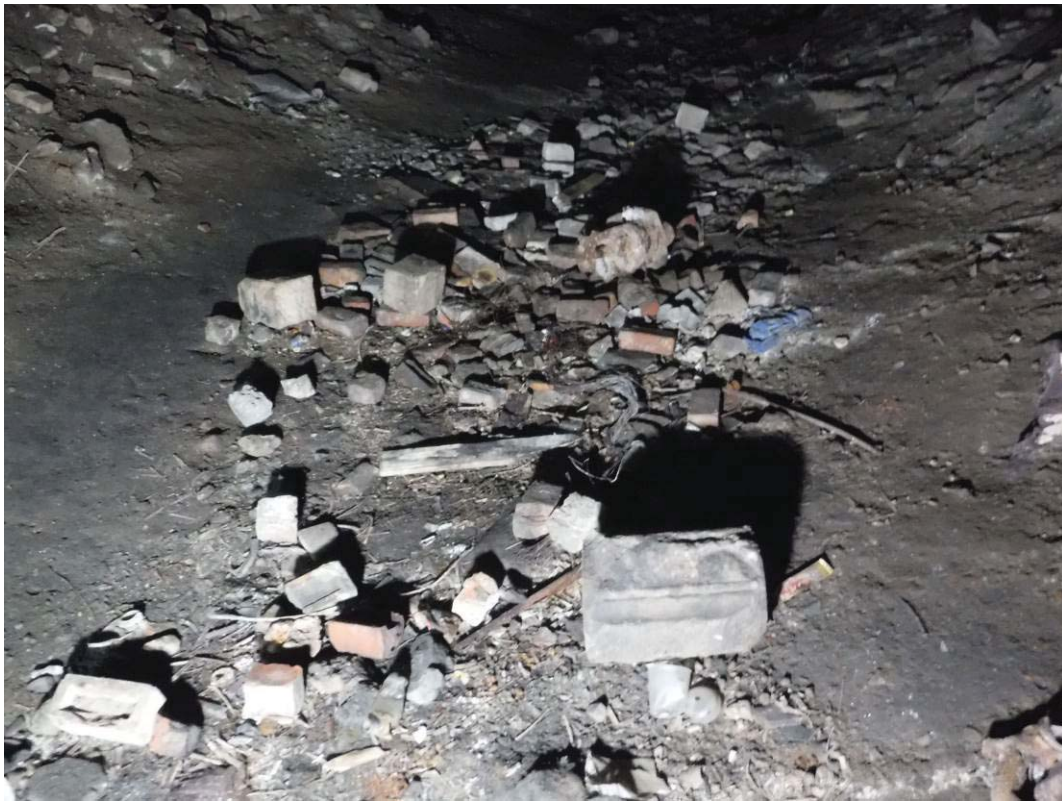
Photo No.11: 000+00 to 012+15 Solum Up & Down, Debris, fly-tipping & fires throughout.

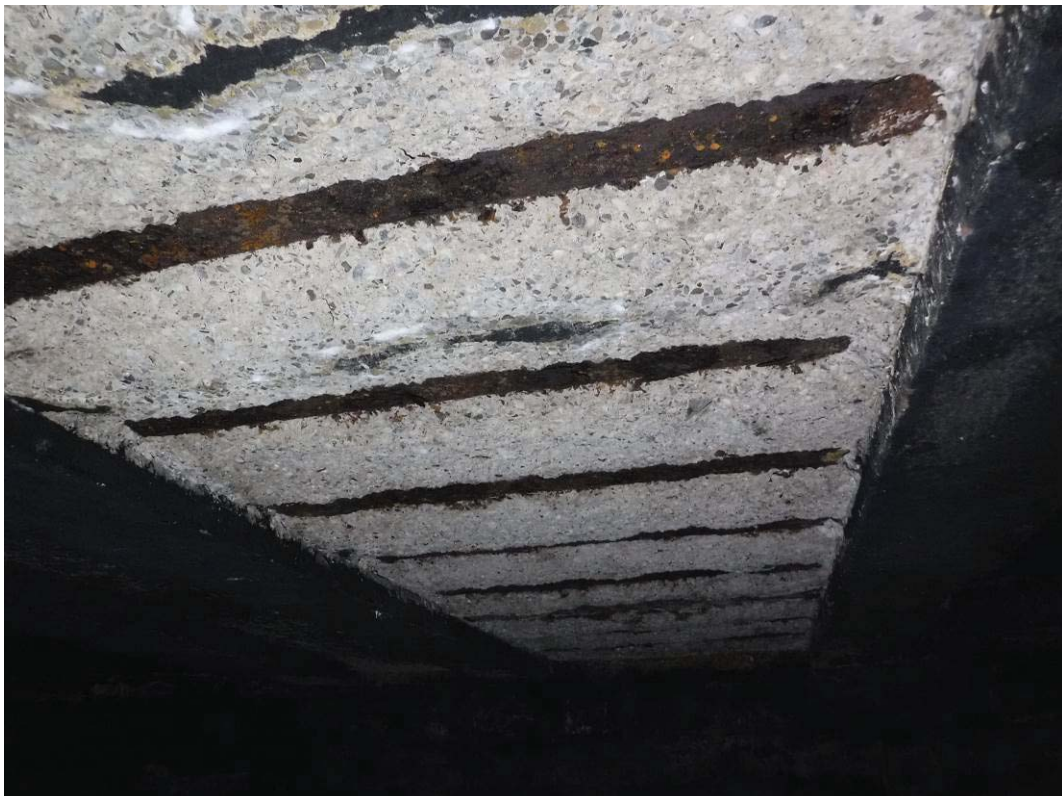
| Location | Defect | | Action |
|---|---|---|--|
| 001+03 Deck Up & Down | Cable trough running across the deck of the tunnel between concrete beams. Concrete spalled, ties exposed. | 12 | Recommend repair concrete, Priority 1, work to be completed 03/10/2020. |

Photo No.12: 001+03 Deck Up & Down, Cable trough running across the deck of the tunnel between concrete beams. Concrete spalled, ties exposed.

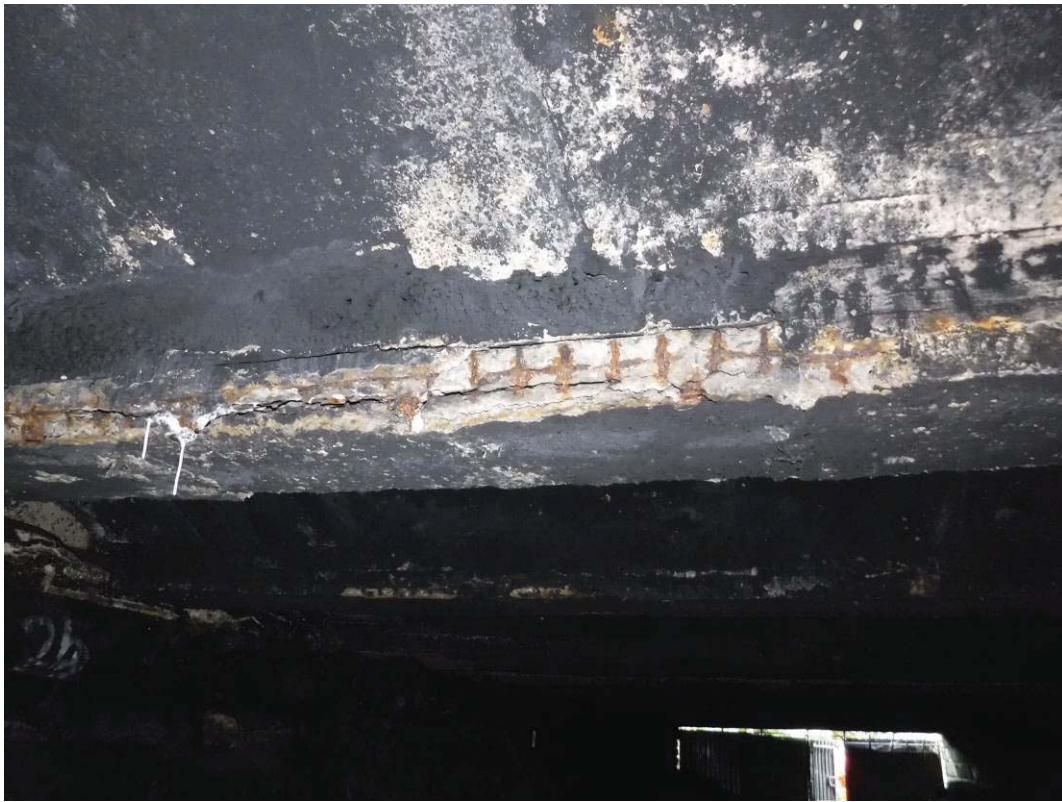
| Location | Defect | | Action |
|---|---|---|--|
| 001+09 Deck Up & Down | Concrete beam burst to both sides, hollow, area 6sq.m., medium. | 13 | Recommend repair concrete beam, Priority 1, work to be completed 03/10/2020. |

Photo No.13: 001+09 Deck Up & Down, Concrete beam burst to both sides, hollow, area 6sq.m., medium.

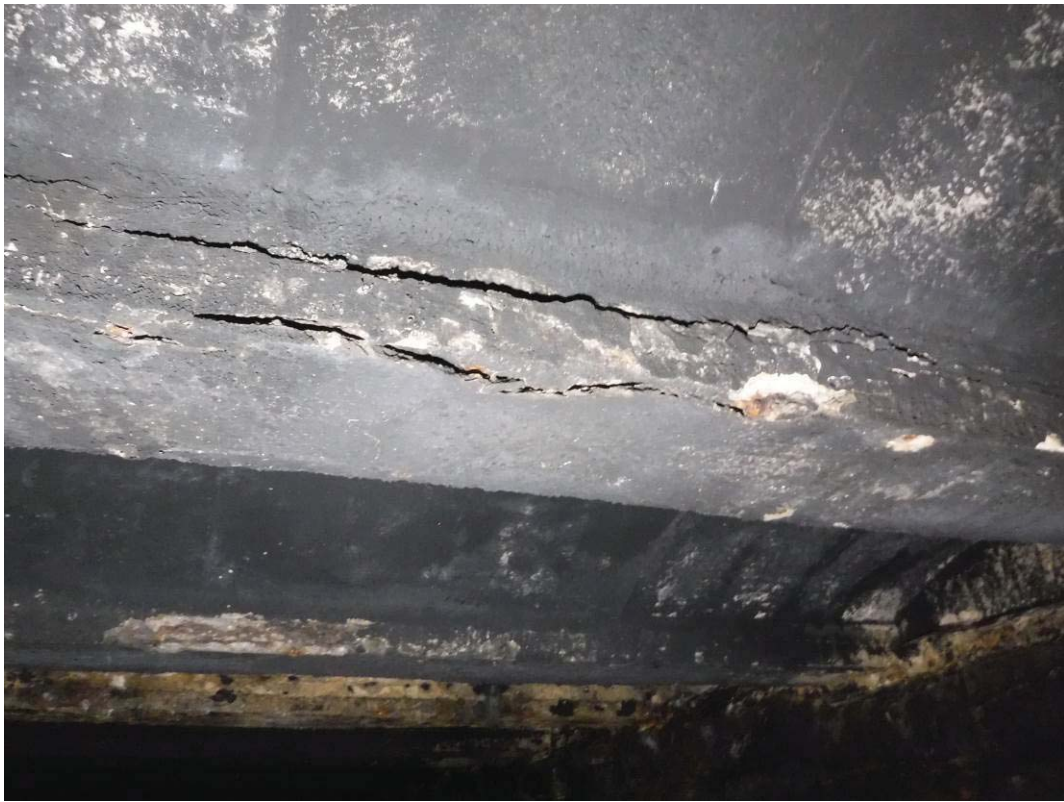
| Location | Defect | | Action |
|---|---|---|---|
| 002+02 Deck Up & Down | Bottom flange of concrete beam, spalling and hollow, depth 75mm, area 1sq.m., medium. | 15 | Recommend repair concrete beam, Priority 1, work to be completed 03/10/2020. |

Photo No.15: 002+02 Deck Up & Down, Bottom flange of concrete beam, spalling and hollow, depth 75mm, area 1sq.m., medium.

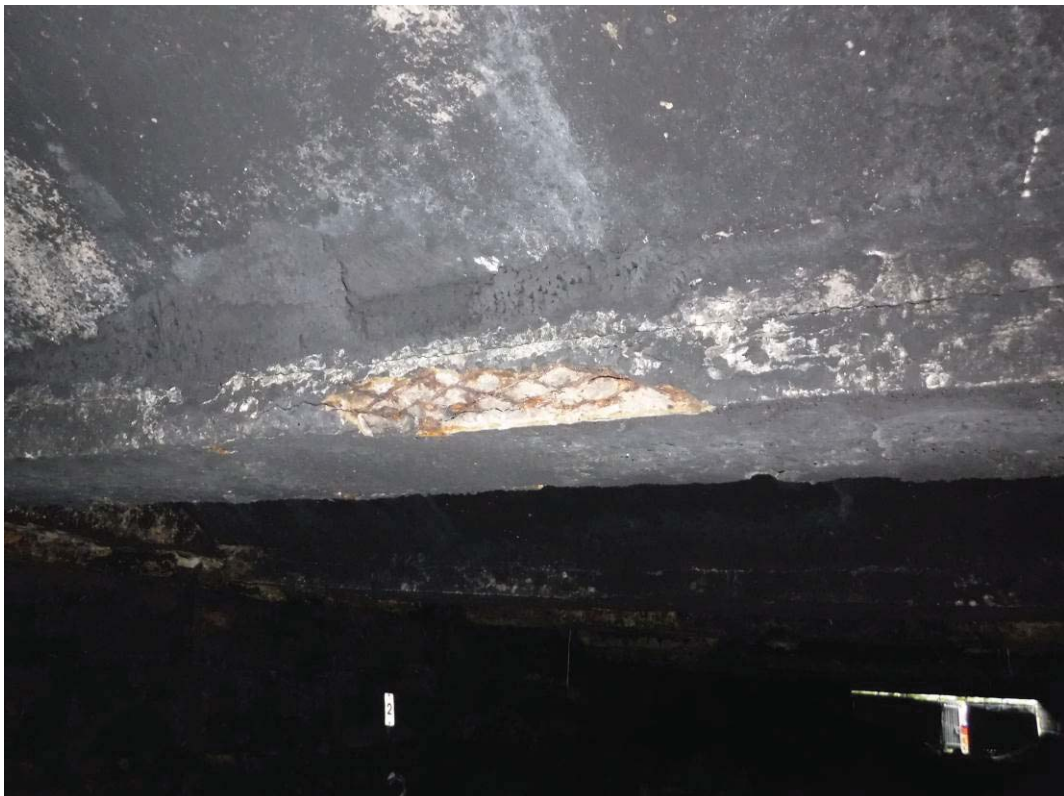
| Location | Defect | | Action |
|---|---|---|---|
| 002+04 Deck Up & Down | Concrete beam, hollow, new cracking to bottom of beam, longitudinal, width 4mm, length 6m. | 16 | Recommend repair concrete beam, Priority 1, work to be completed 03/10/2020. |

Photo No.16: 002+04 Deck Up & Down, Concrete beam, hollow, new cracking to bottom of beam, longitudinal, width 4mm, length 6m.

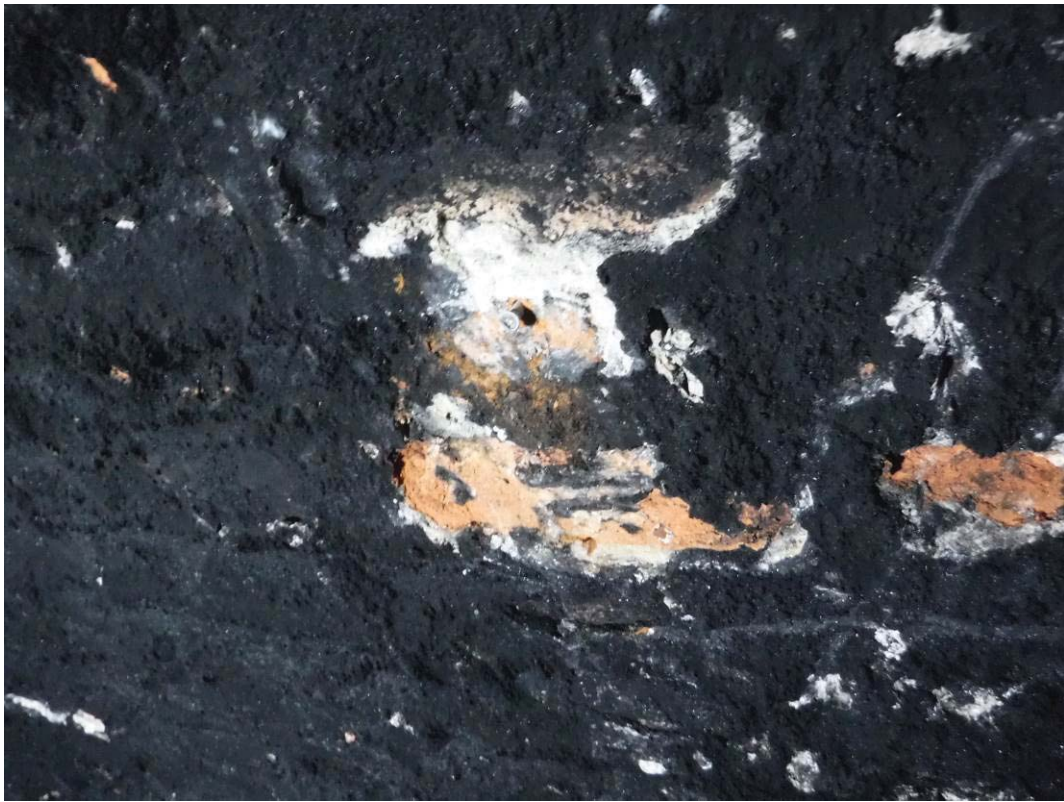
| Location | Defect | | Action |
|---|---|---|---|
| 005+00 Sidewall Up | Evidence of new tablet number broken off sidewall and cannot be found nearby along the solum. | 17 | Recommend replace tablet number, Priority 1, work to be completed 03/10/2020. |

Photo No.17: 005+00 Sidewall Up, Evidence of new tablet number broken off sidewall and cannot be found nearby along the solum.

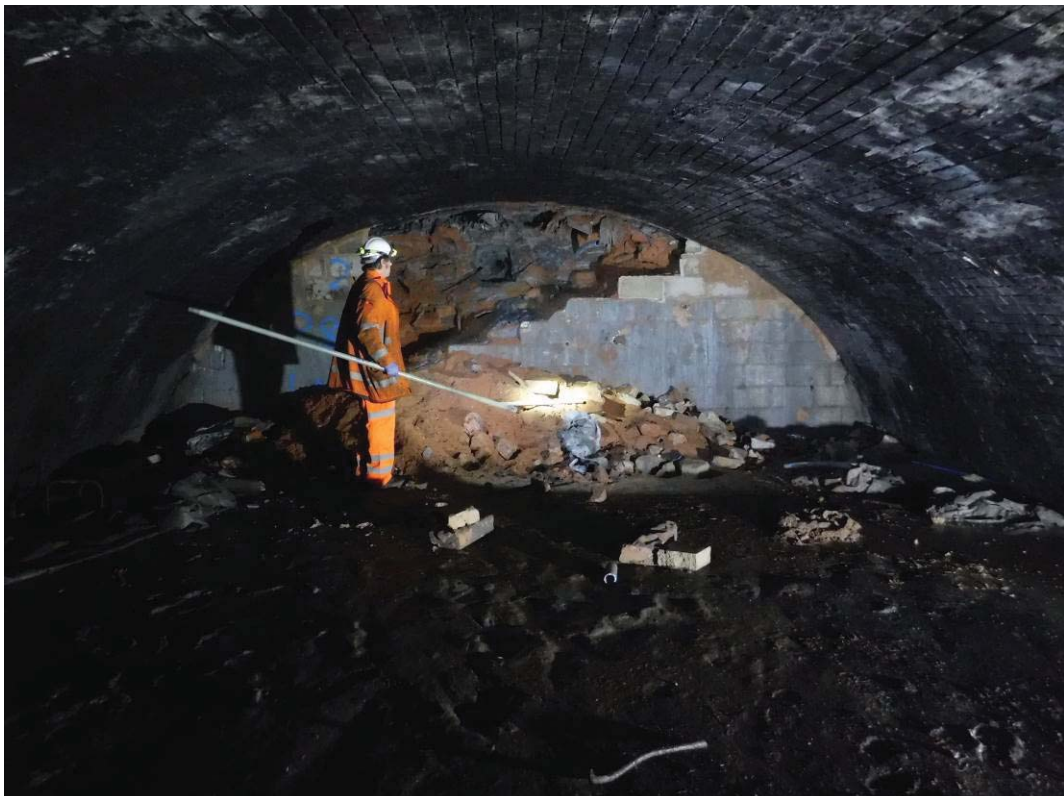
Photo No.18: 012+16 Full Profile Up & Down, Blockwork wall built across tunnel. Trespassers and/or 3rd parties repeatedly excavating a hole to wall at high level, now approx. 11ft. x 5ft. x 5ft. deep.

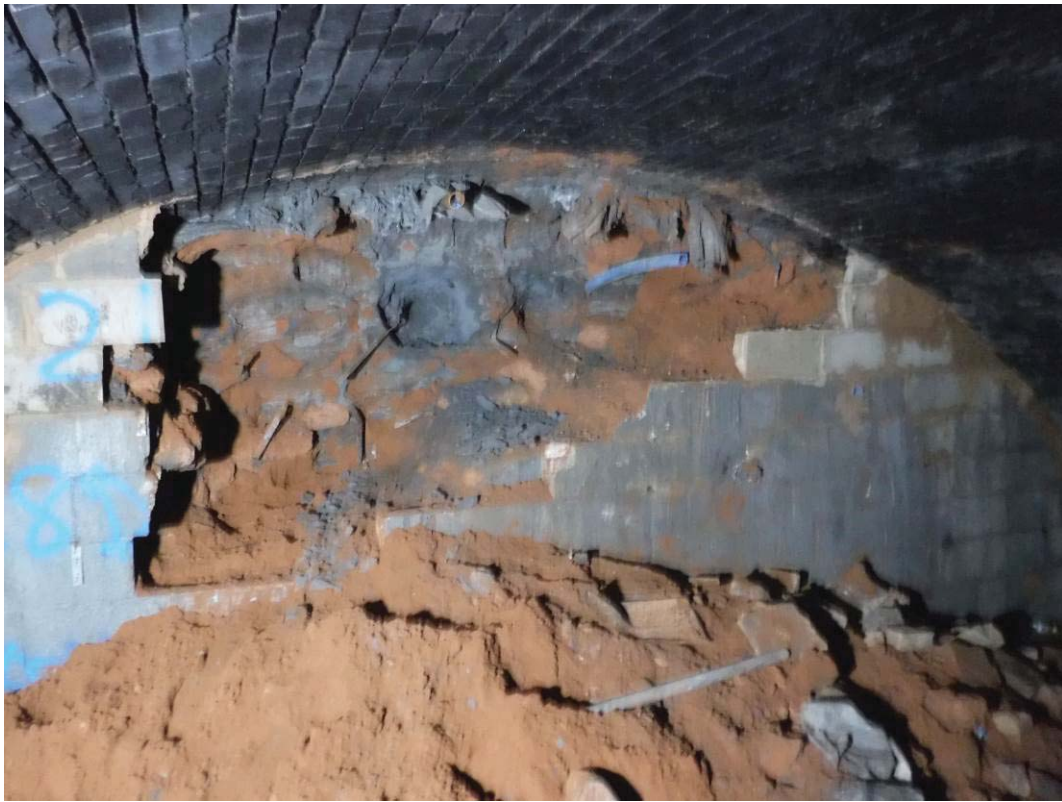
Photo No.19: 012+16 Full Profile Up & Down, Blockwork wall built across tunnel. Trespassers and/or 3rd parties repeatedly excavating a hole to wall at high level, now approx. 11ft. x 5ft. x 5ft. deep.

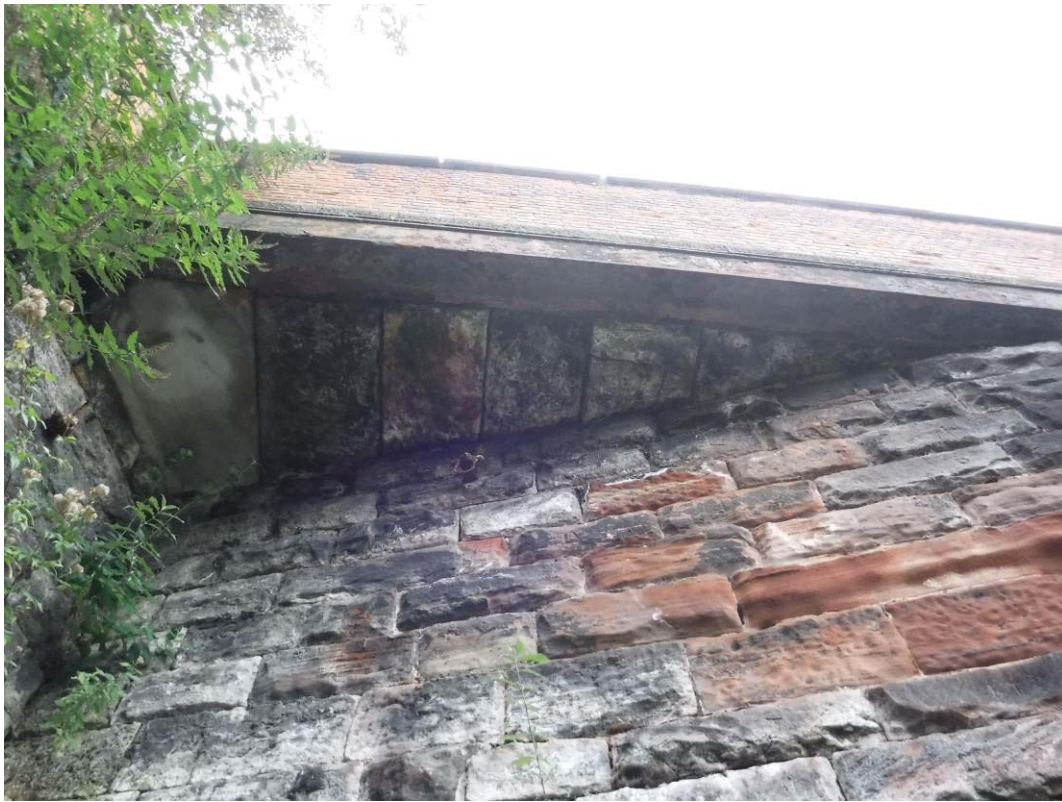
| Location | Defect | Action | |
|---|--|---|--|
| 025+06 Portal Down | Woodside Portal, side bridge supporting 8m length of footpath above. | 21 & 22 | Recommend add bridge to examinations programme (label CSS1/61A), Priority 1, work to be completed by 03/10/2020. |

Photo No.21: 025+06 Portal Down, Woodside Portal, side bridge supporting 8m length of footpath above.

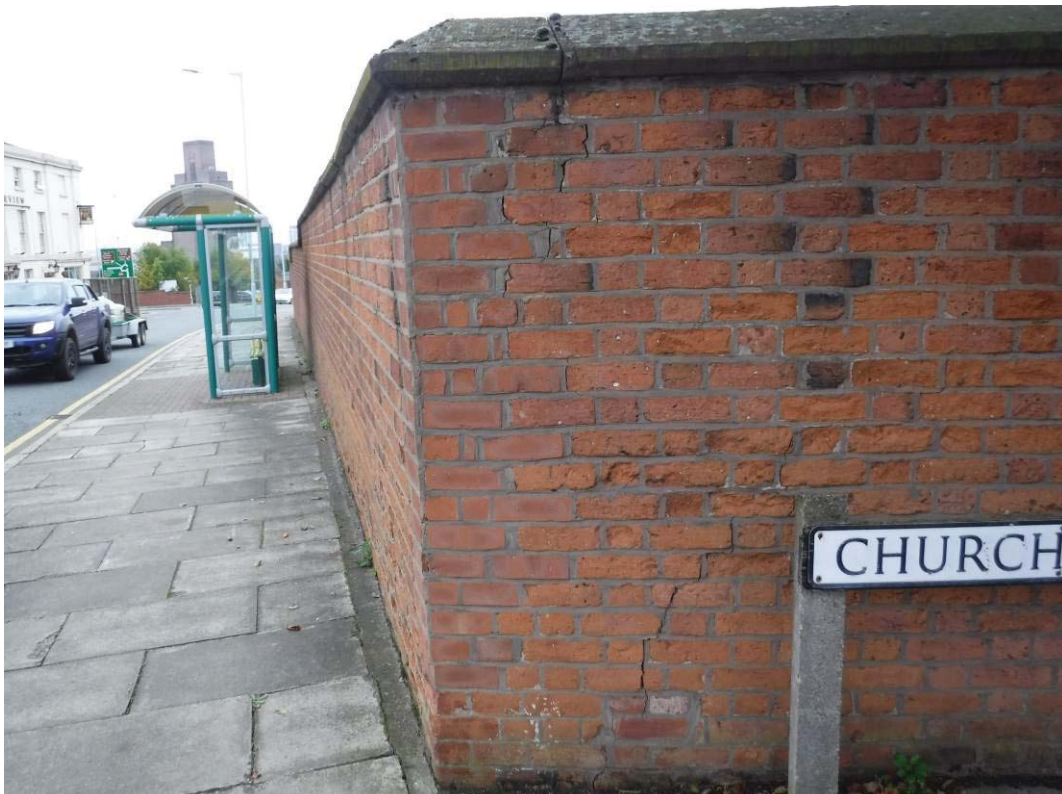
| Location | Defect | Action | |
|---|--|---|--|
| 025+06 Portal Down | Woodside Portal, Brickwork, roadside parapet, near return, vertical crack up from footpath, forks 2ft. up, full height 2m, max. width 4mm at top. | 24 | Recommend repoint and monitor annually, Priority 1, work to be completed by 03/10/2020. |

Photo No.24: 025+06 Portal Down, Woodside Portal, Brickwork, roadside parapet, near return, vertical crack up from footpath, forks 2ft. up, full height 2m, max. width 4mm at top.

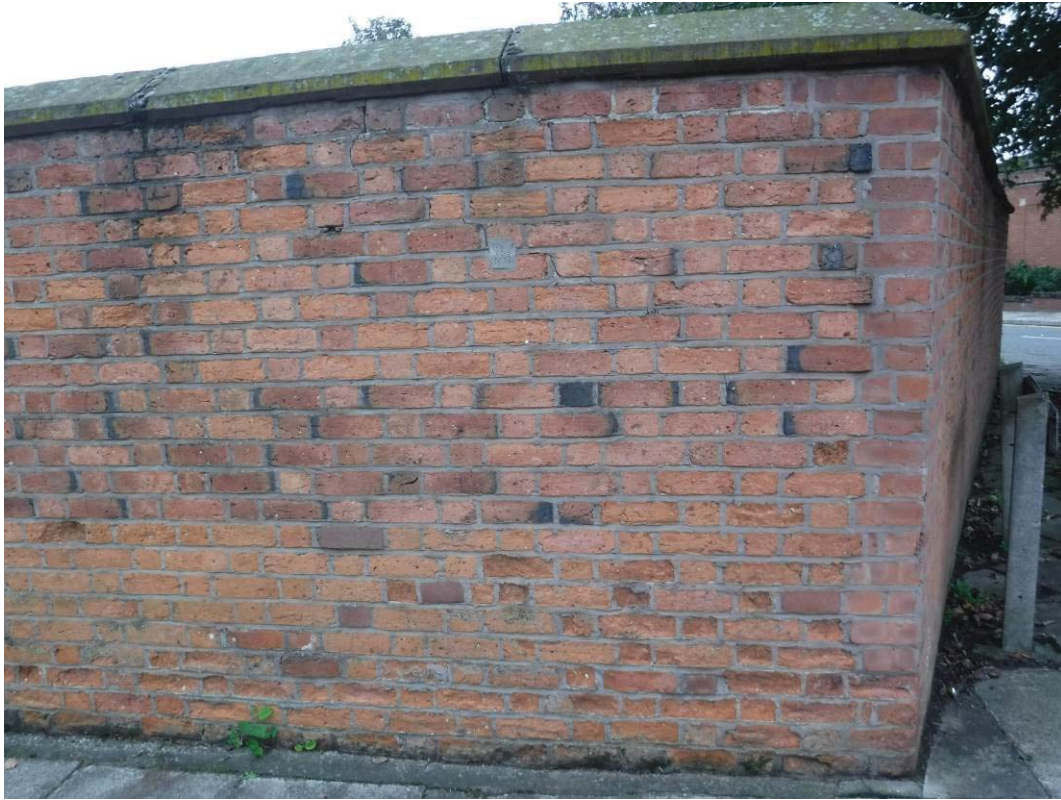
| Location | Defect | Action | |
|---|--|---|--|
| 025+06 Portal Down | Woodside Portal, Brickwork, roadside parapet, near portal parapet return, diagonal stepped crack, full height 2m, max. width 4mm at top. Hairline crack through datal. | 25 & 26 | Recommend repoint and monitor annually, Priority 1, work to be completed by 03/10/2020. |

Photo No.25: 025+06 Portal Down, Woodside Portal, Brickwork, roadside parapet, near portal parapet return, diagonal stepped crack, full height 2m, max. width 4mm at top. Hairline crack through datal.

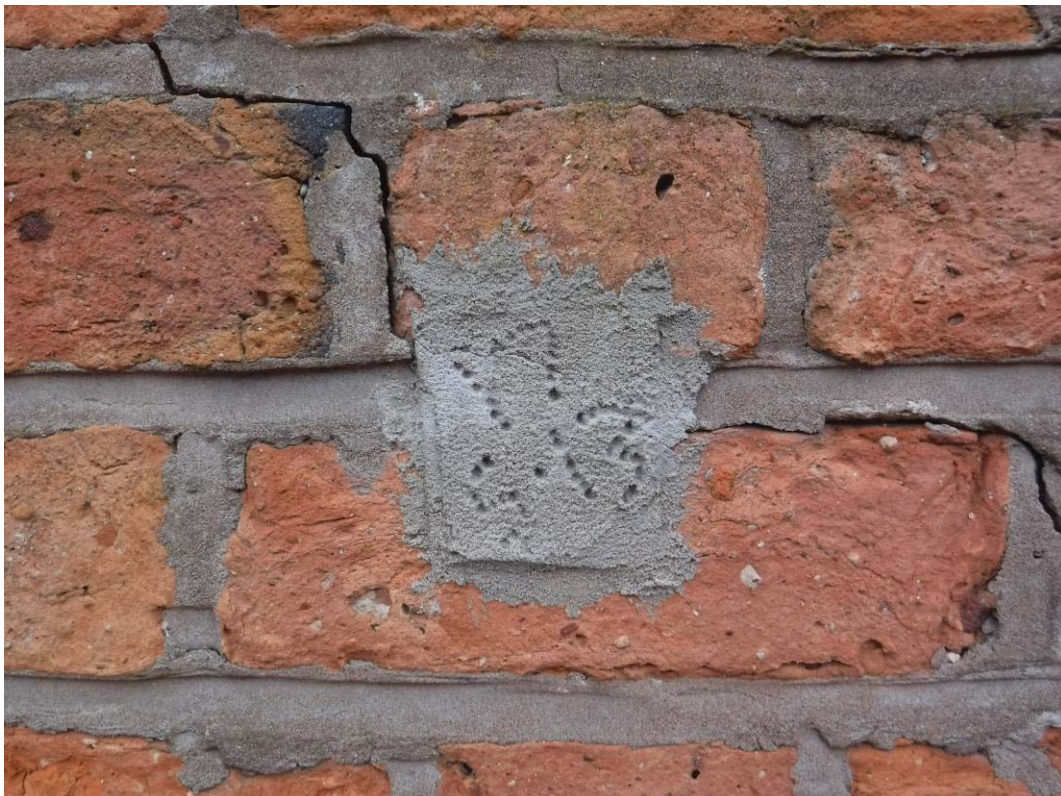
Photo No.26: 025+06 Portal Down, Woodside Portal, Brickwork, roadside parapet, near portal parapet return, diagonal stepped crack, full height 2m, max. width 4mm at top. Hairline crack through datal.

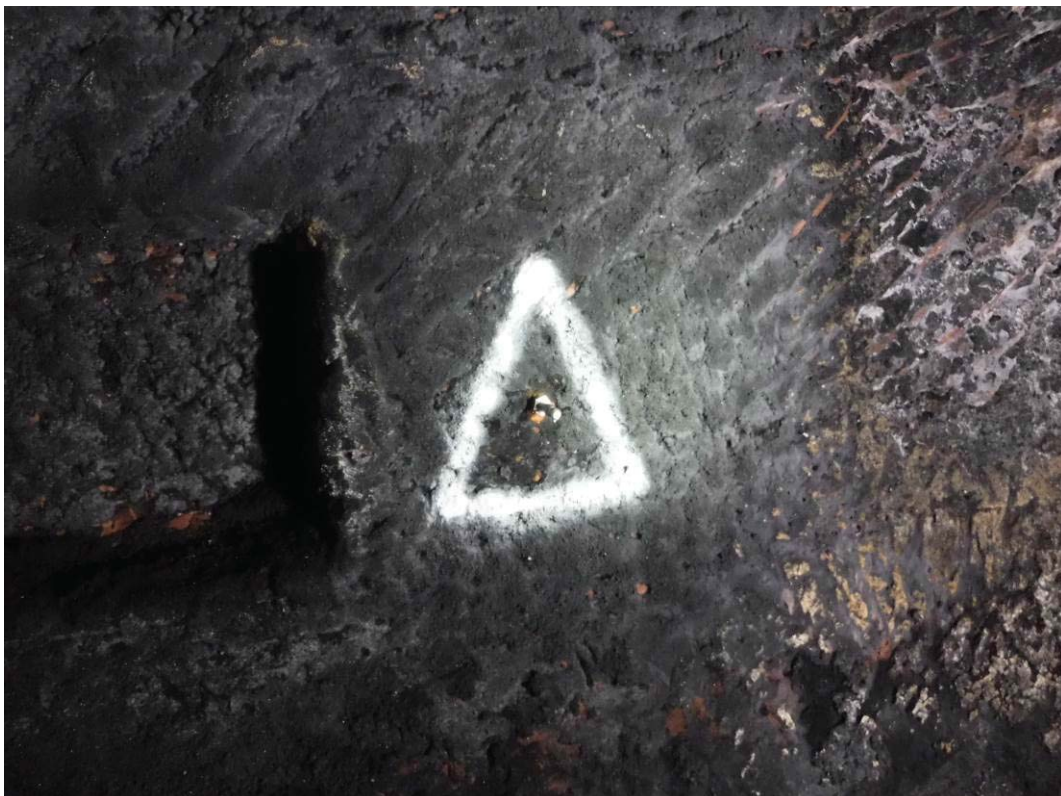
| Location | Defect | | Action |
|--|---|---|--|
| 000+00 to 015+15 Crown & Haunch Up & Down | New metal pins found along the tunnel at this examination. | 2 | Recommend investigate ownership and remove from tunnel, Priority 1; work to be completed by 03/10/2020. |

Photo No.2: 000+00 to 015+15 Crown & Haunch Up & Down, New metal pins found along the tunnel at this examination.

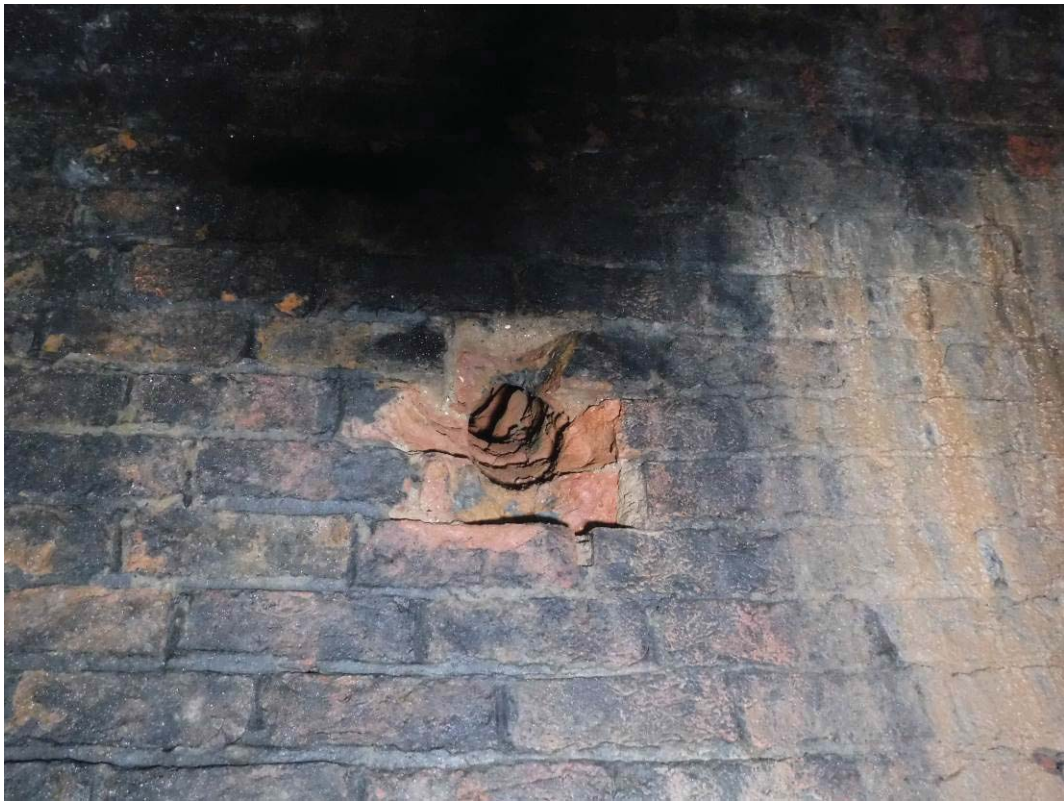
| Location | Defect | | Action |
|--|---|---|--|
| 003+06 High Haunch Down | Brickwork, new 3rd party borehole, 4" dia. | 5 | Recommend investigate and obtain remedial works proposal from 3rd party, Priority 1; work to be completed by 03/10/2020. |

Photo No.5: 003+06 High Haunch Down, Brickwork, new 3rd party borehole, 4" dia.

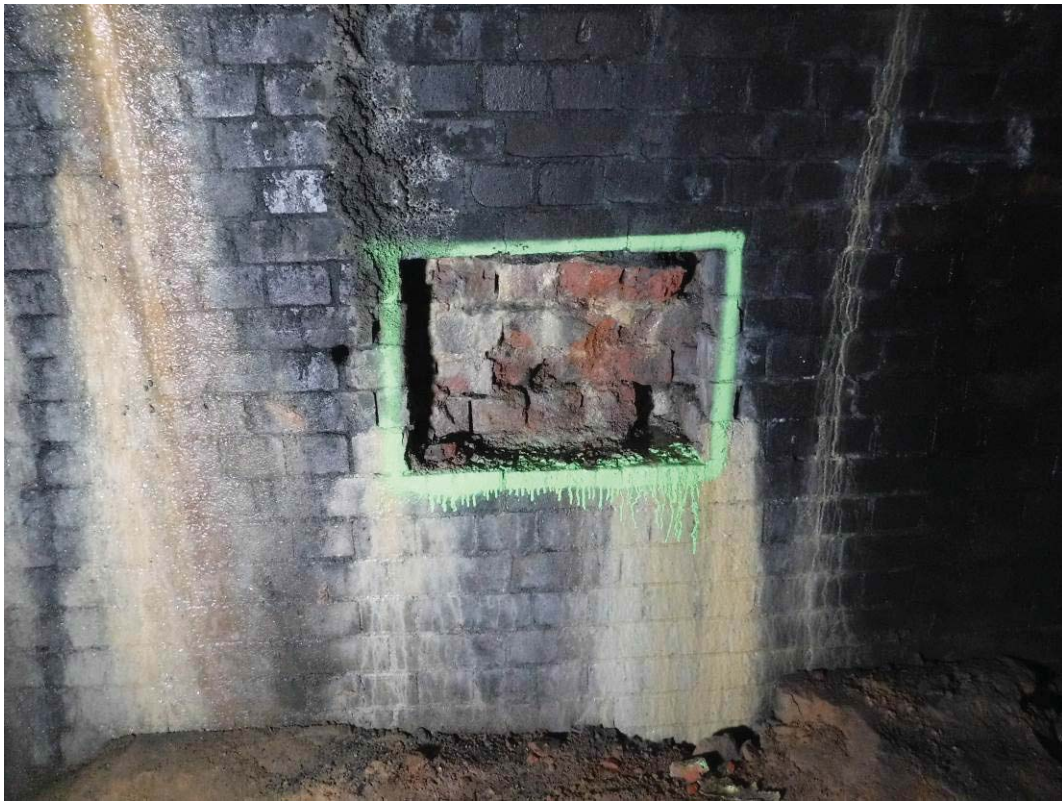
| Location | Defect | | Action |
|--|---|---|--|
| 005+15 Sidewall Up | Brickwork, missing bricks, 0.5sq.m. 100mm deep. | 7 | Recommend replace brickwork, Priority 1; work to be completed by 03/10/2020. |

Photo No.7: 005+15 Sidewall Up, Brickwork, missing bricks, 0.5sq.m. 100mm deep.

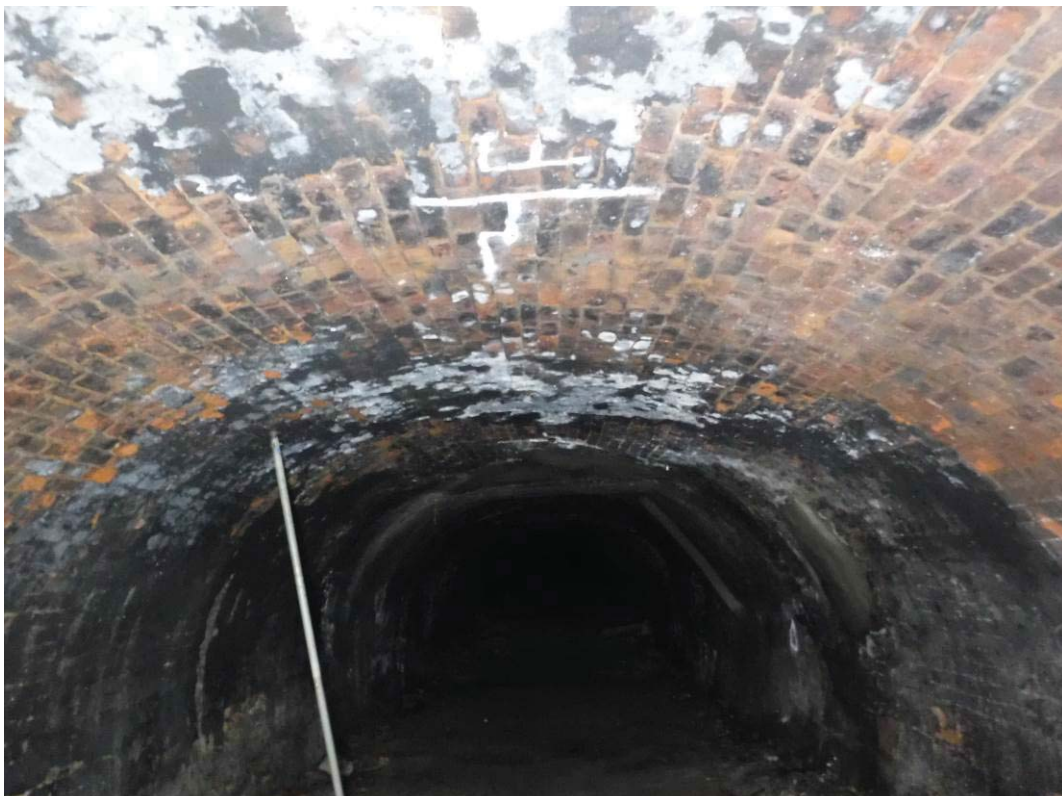
| Location | Defect | | Action |
|---|---|---|---|
| 007+07 Crown Down | Brickwork, bulging 100mm, length 2m, missing brick, hollow. | 8 | Recommend add section of lining to the 6monthly monitoring examination, Priority 1; work to be completed by 03/10/2020. |

Photo No.8: 007+07 Crown Down, Brickwork, bulging 100mm, length 2m, missing brick, hollow.

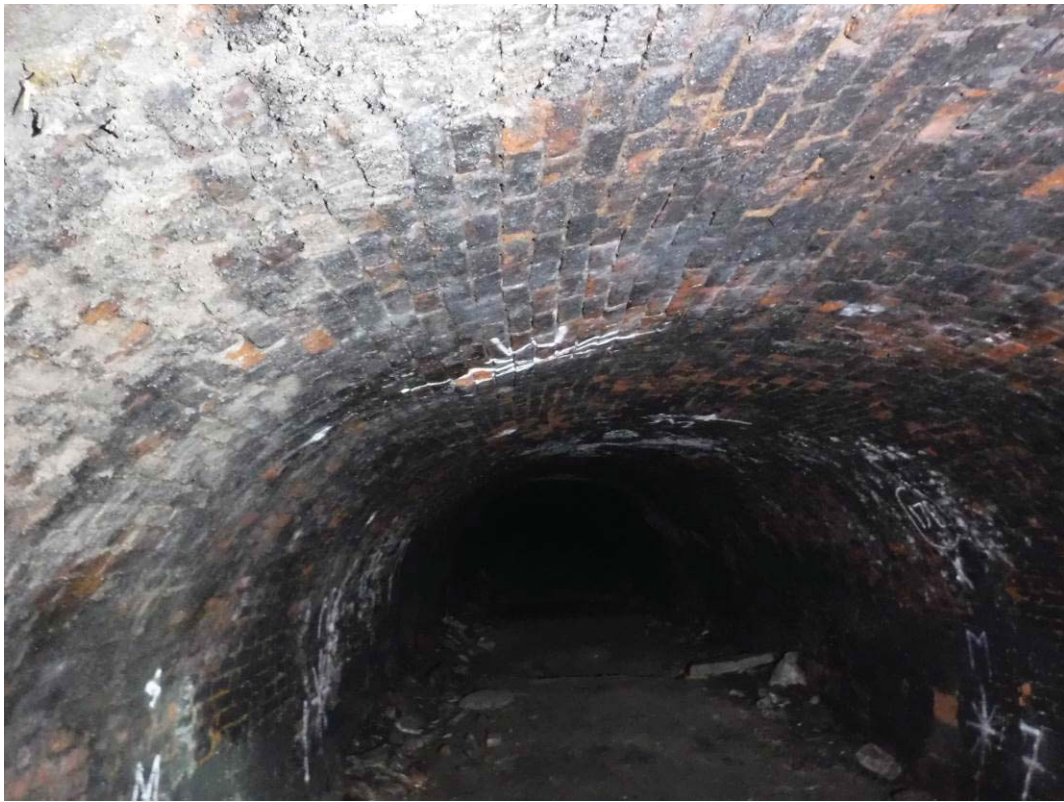
| Location | Defect | | Action |
|---|---|---|---|
| 007+16 Crown Up | Brickwork, flat, damp, hollow, area 6sq.m., medium. | 9 | Recommend this defect continues to be monitored at 6monthly intervals. |

Photo No.9: 007+16 Crown Up, Brickwork, flat, damp, hollow, area 6sq.m., medium.

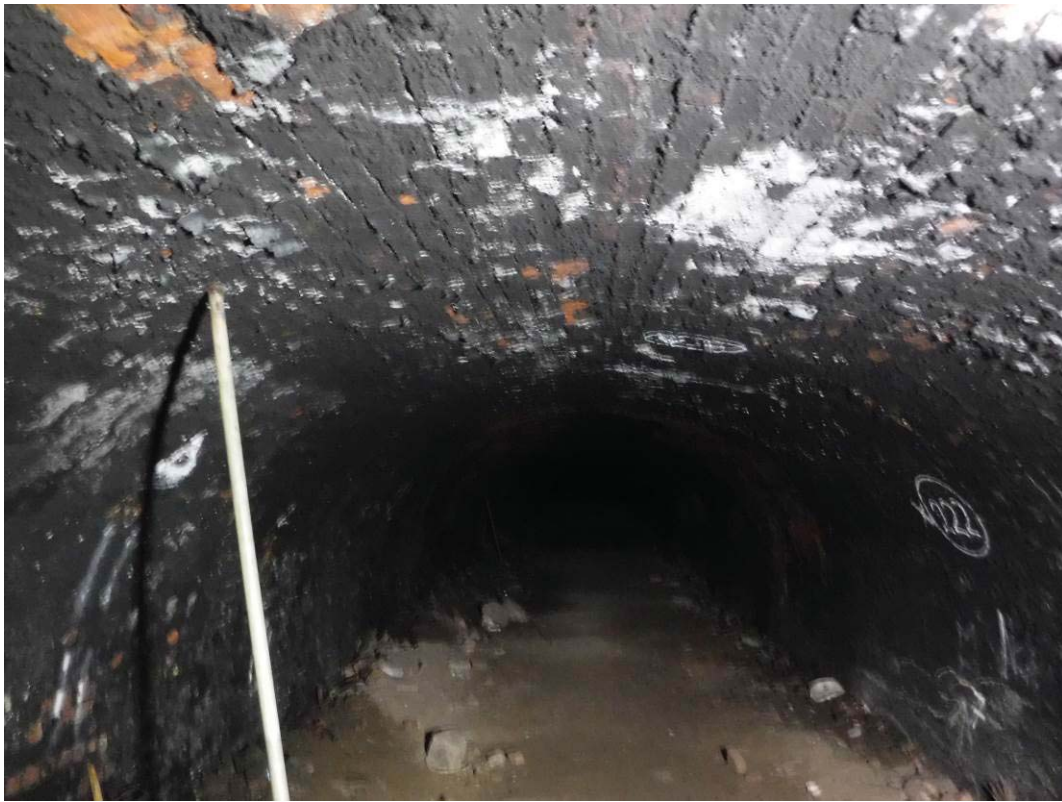
| Location | Defect | | Action |
|---|---|---|---|
| 010+03 Crown Down | Brickwork, flat, length 4m. | 11 | Recommend this defect continues to be monitored at 6monthly intervals. |

Photo No.11: 010+03 Crown Down, Brickwork, flat, length 4m.
