Freedom of Information Request – Detailed Examination Reports for HRE Tunnels

Detailed Examination Report for

Balfour Beatty Rail, Manchester**Monks Ferry Tunnel****ELR:CCS3/01****Examined:03/10/2019**

Balfour Beatty Rail, Manchester**Law Tunnel****ELR:DDN/12A****Examined:07/10/2019**

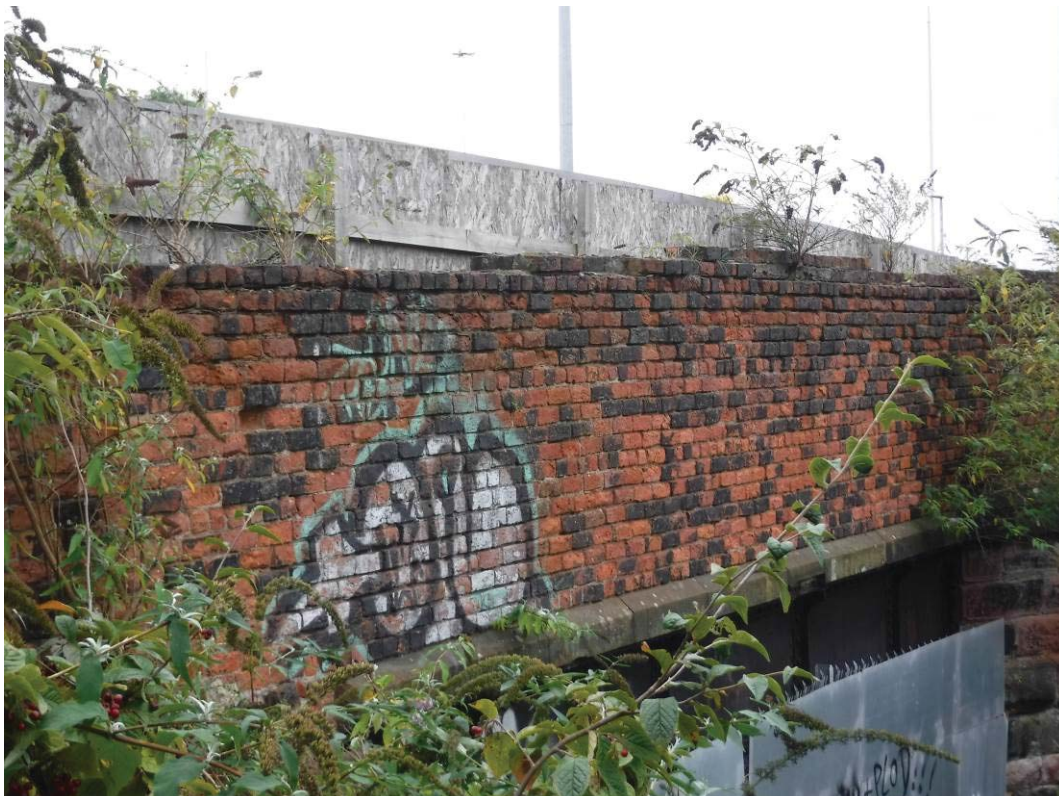
| Location | Defect | | Action |
|---|---|---|---|
| 015+15 to 016+03 Crown Up & Down | Bridge deck in front of portal, Parapet, brickwork, spalling and open joints to both faces. Loose bricks to top of parapet. Capping missing throughout. | 16 | Recommend repair brickwork, Priority 1; work to be completed by 03/10/2020. |

Photo No.16: 015+15 to 016+03 Crown Up & Down, Bridge deck in front of portal, Parapet, brickwork, spalling and open joints to both faces. Loose bricks to top of parapet. Capping missing throughout.

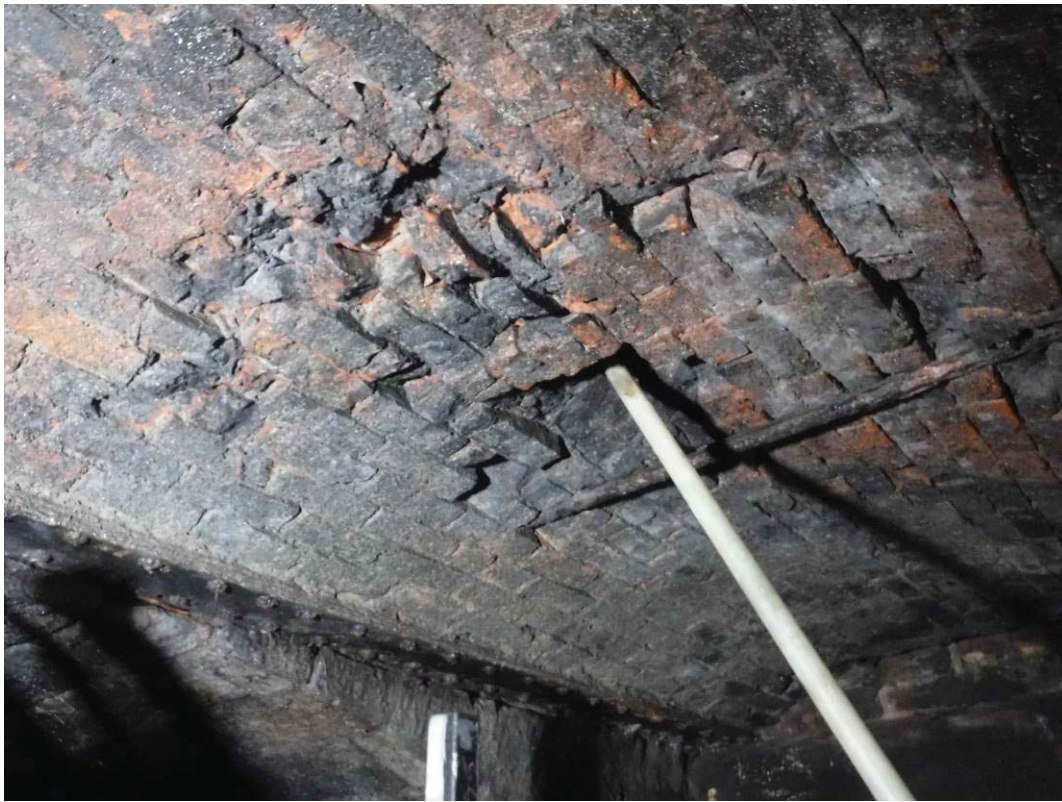
Photo No.17: 015+16 Crown Up & Down, Bridge deck in front of portal, Jack Arch adjacent to tunnel, brickwork, spalling, depth 100mm, loose, damp, area 1sq.m., medium. Tie bars corroded at interface with brickwork.

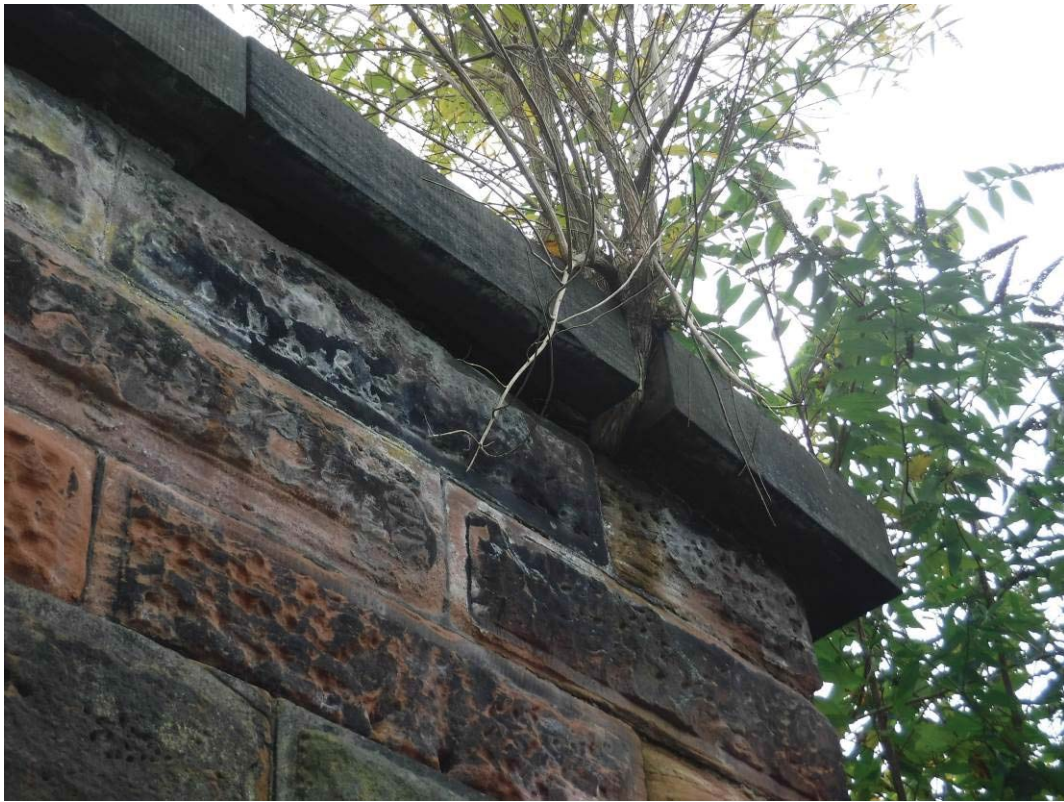
Photo No.21: 016+03 Wingwall Up, Bridge deck in front of portal, Wingwall to buttress - Trees/shrubs growing, displaced blocks & copings.

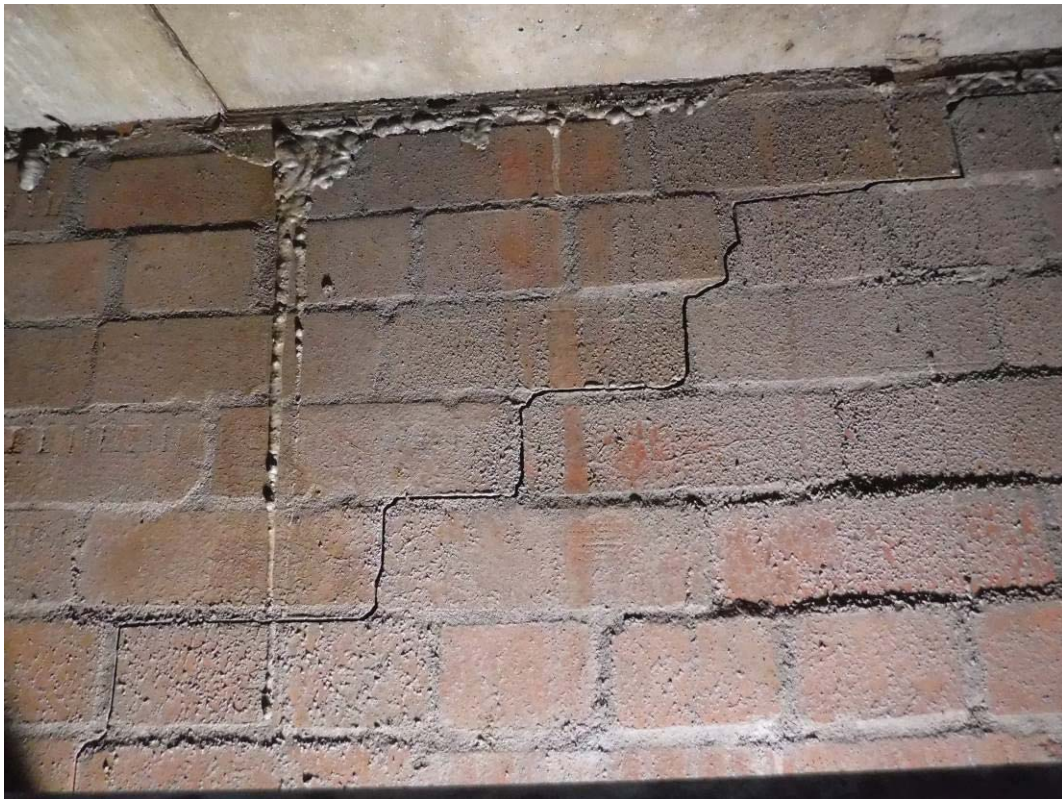
Photo No.5: Manhole Shaft, top of base section, brickwork, step fracture, length 207cm, max. width 3mm, new house foundations above.

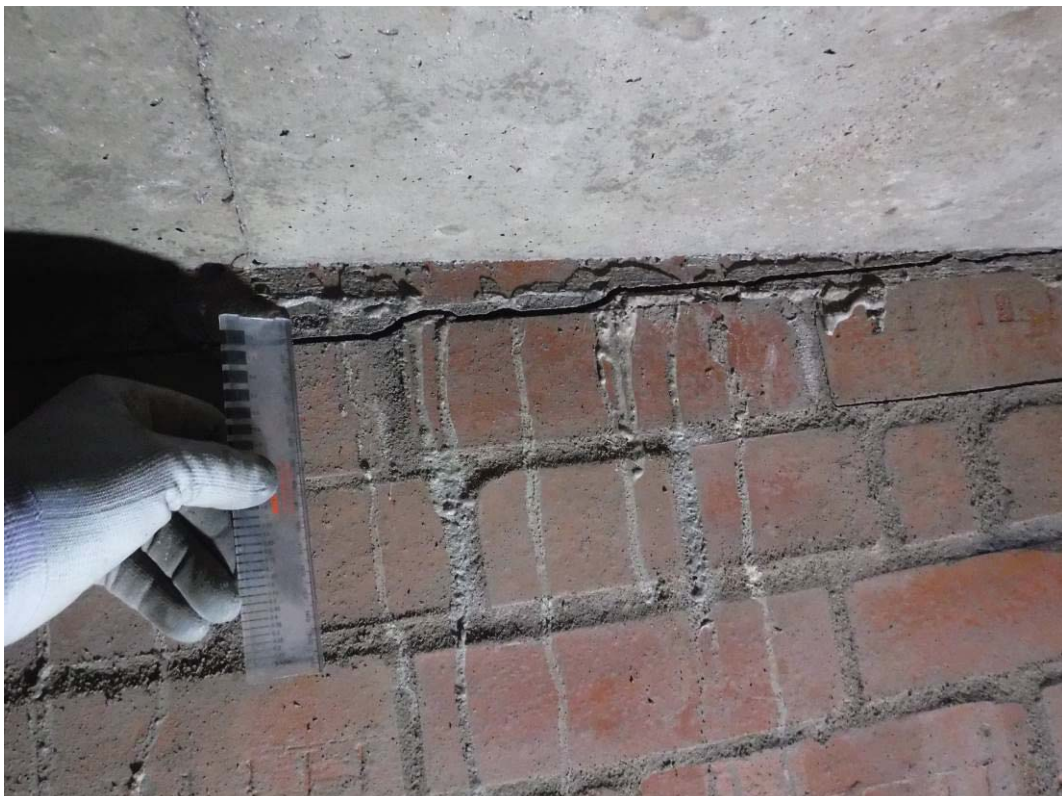
Photo No.6: Manhole Shaft, top of base section, brickwork, step fracture, length 207cm, max. width 3mm, new house foundations above.

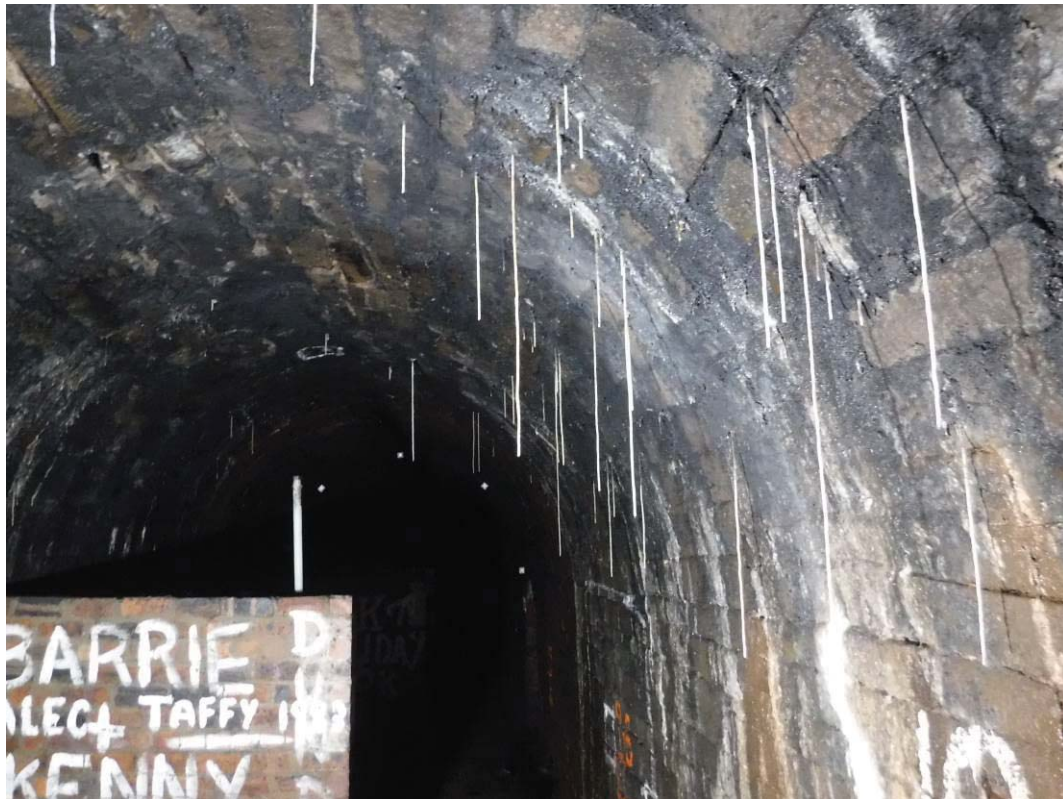
Photo No.9: Stonework, damp and wet throughout with stalactites, area 80sq.m.

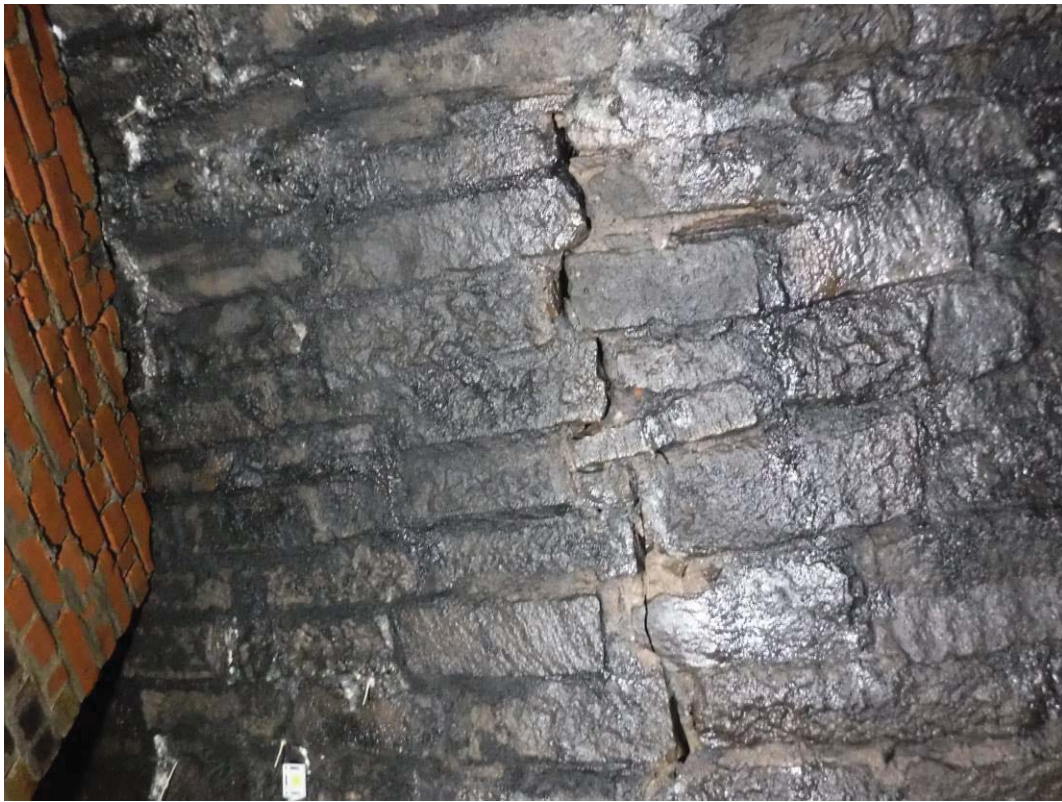
Photo No.11: Stonework, construction joint, mortar missing, 100mm x 50mm x 50mm deep, with a circumferential fracture, length 5m, sealed with calcite to the upside and open to the downside, max. width 5mm, wet.

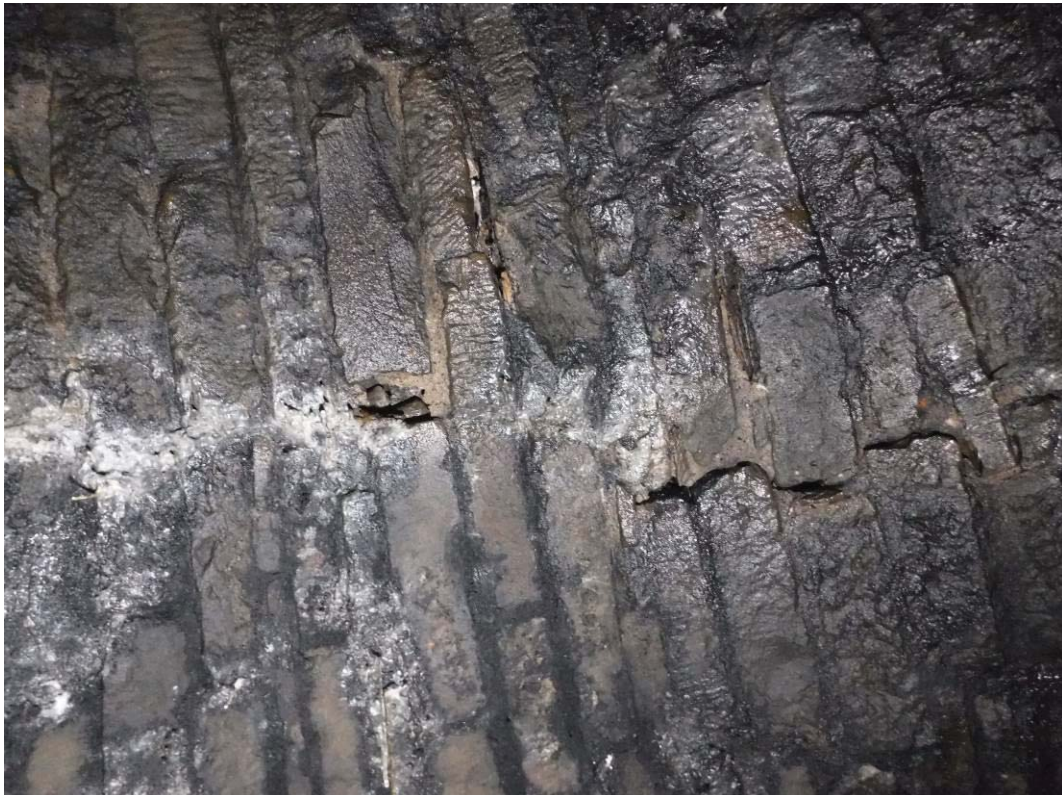
Photo No.12: Stonework, construction joint, mortar missing, 100mm x 50mm x 50mm deep, with a circumferential fracture, length 5m, sealed with calcite to the upside and open to the downside, max. width 5mm, wet.

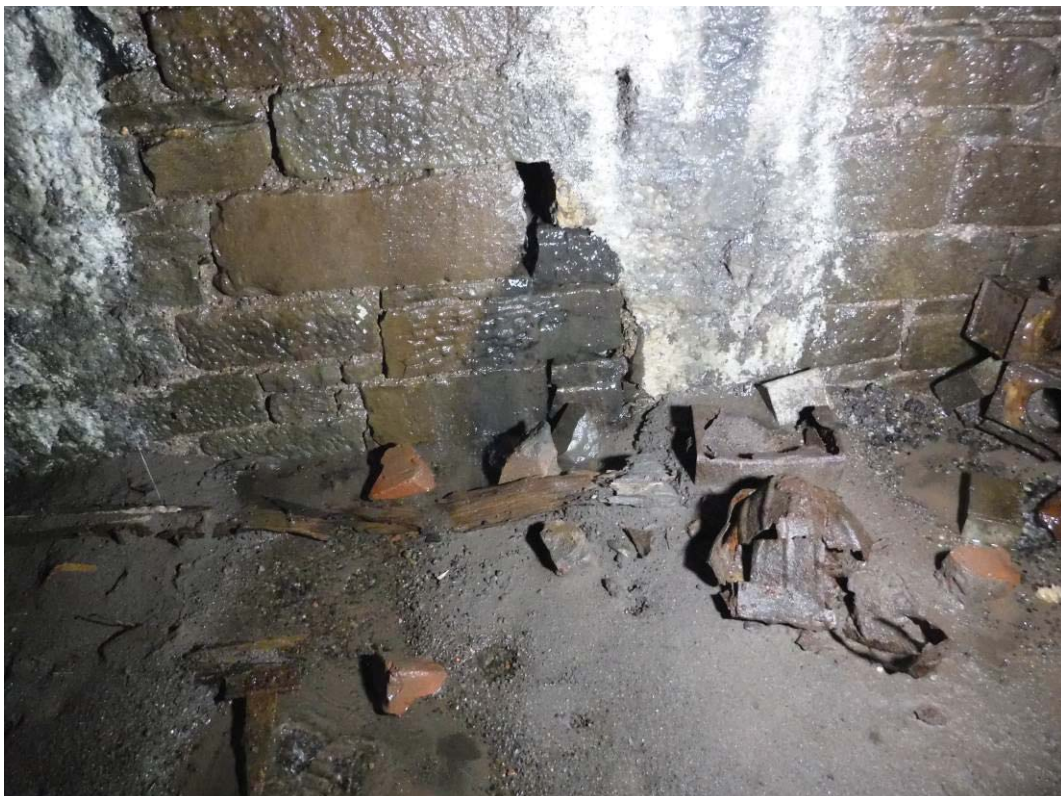
Photo No.14: Water and sewage leaking into tunnel at base of sidewall, only a slight smell of sewage at this examination.

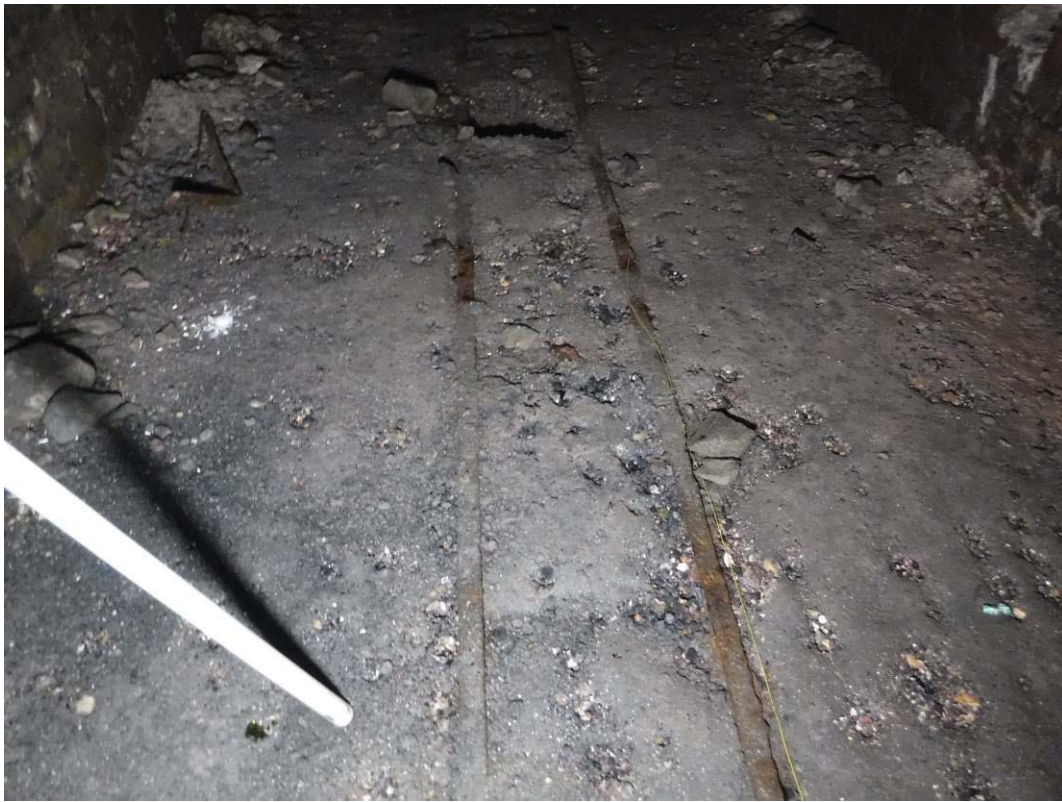
Photo No.15: Old corroded rails run intermittently throughout the tunnel along the middle of the solum. These were fixed to support timber which have now rotted away.

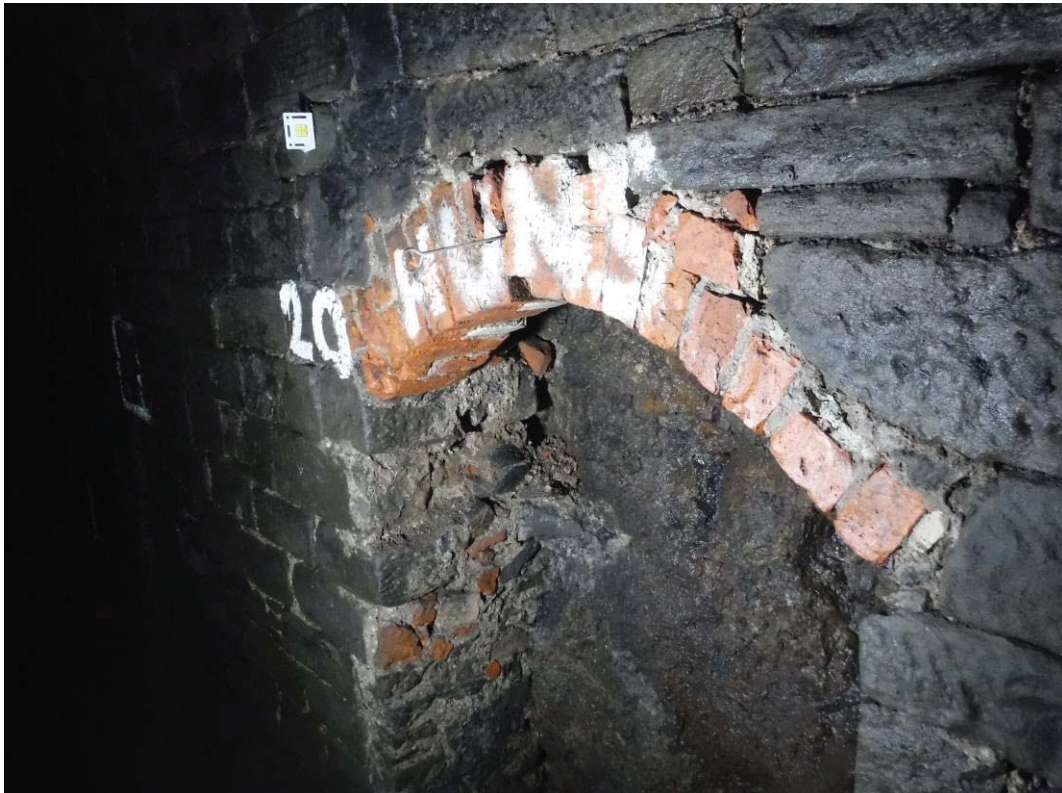
Photo No.16: Brickwork, Arch, spalled, depth 75mm, open joints, depth 125mm, area 0.25sq.m. Rear of refuge is natural rock with stonework quoins.

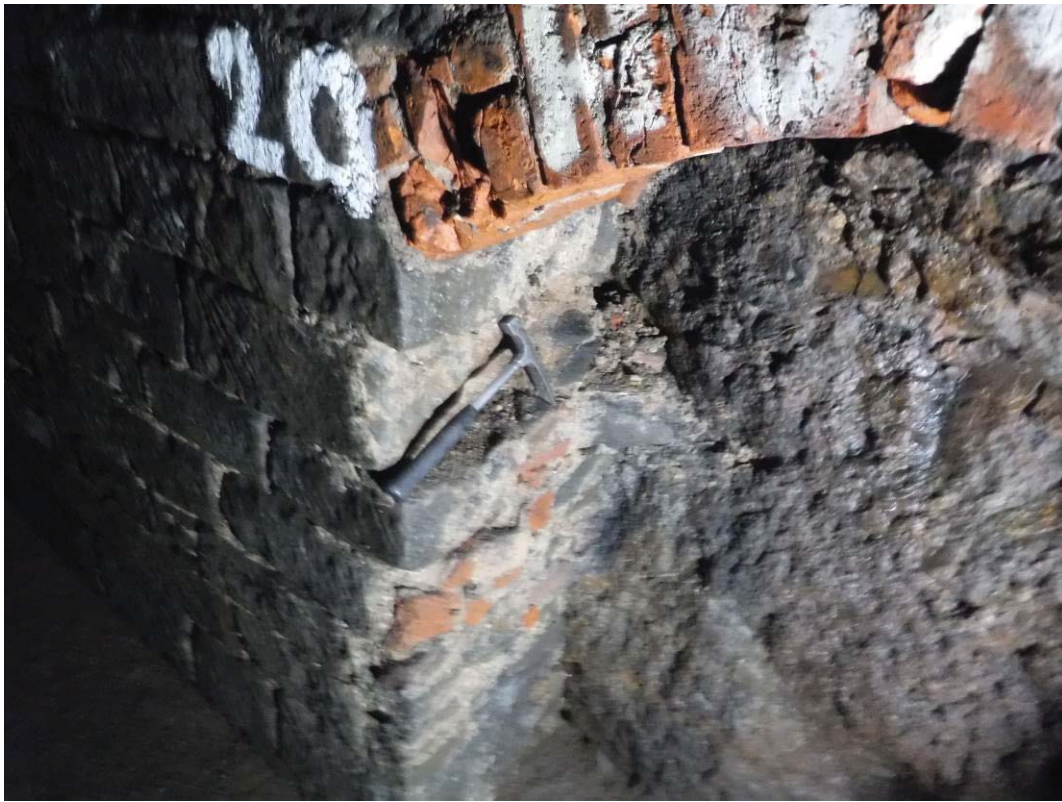
Photo No.17: Stonework, North Quoin, spalled, depth 100mm, area 0.5sq.m.

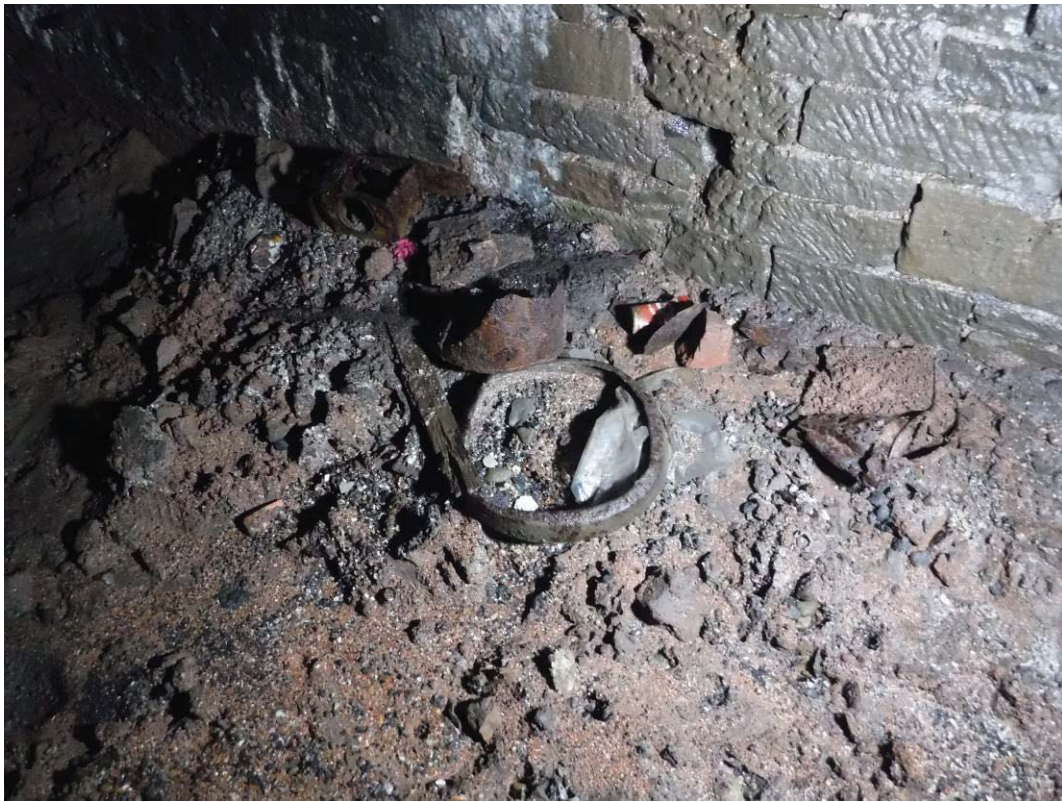
Photo No.19: Rubbish and debris laid to Solum.

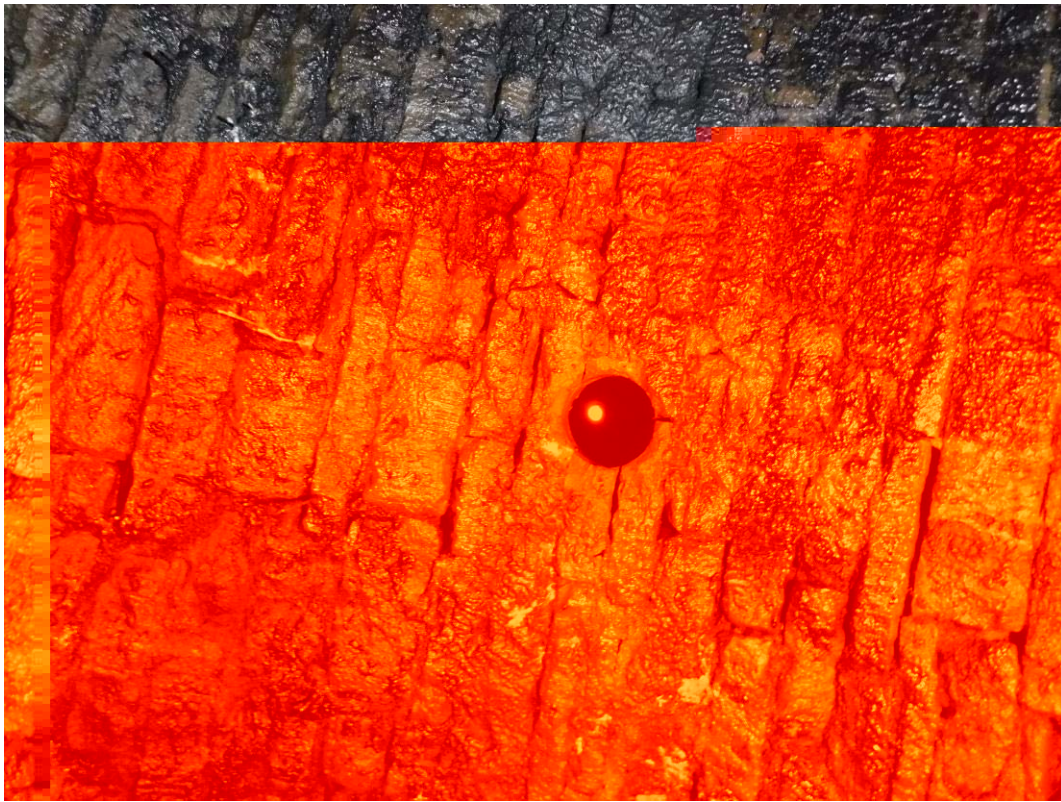
Photo No.27: New 150mm dia. borehole from surface through tunnel crown.

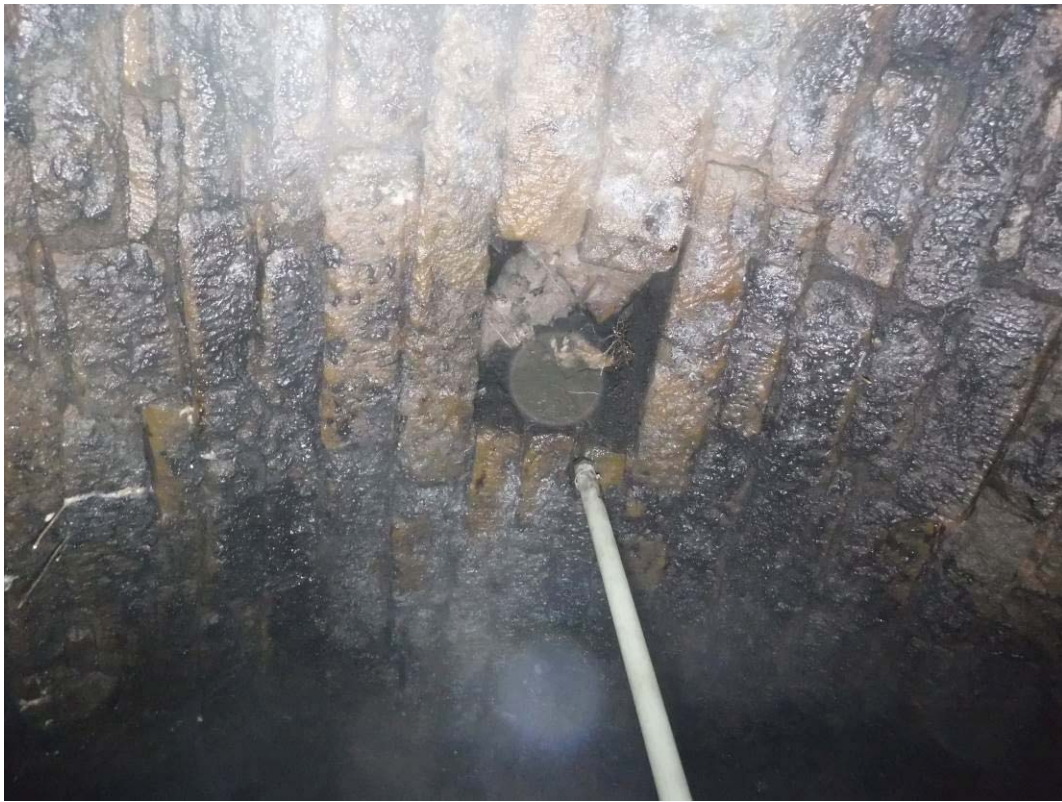
Photo No.29: Stonework, windows cut out, 450mm x 450mm x 300mm deep.

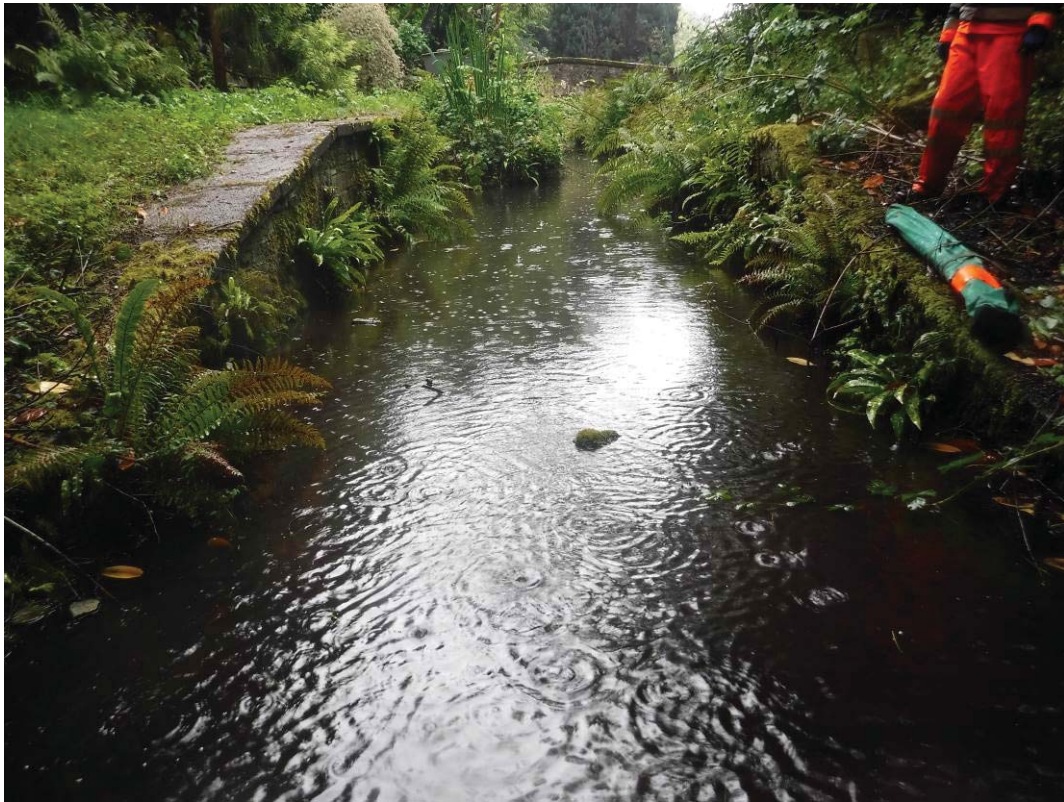
Photo No.1: East Portal, Solum on approach to the portal is flooded, maximum depth 200mm.

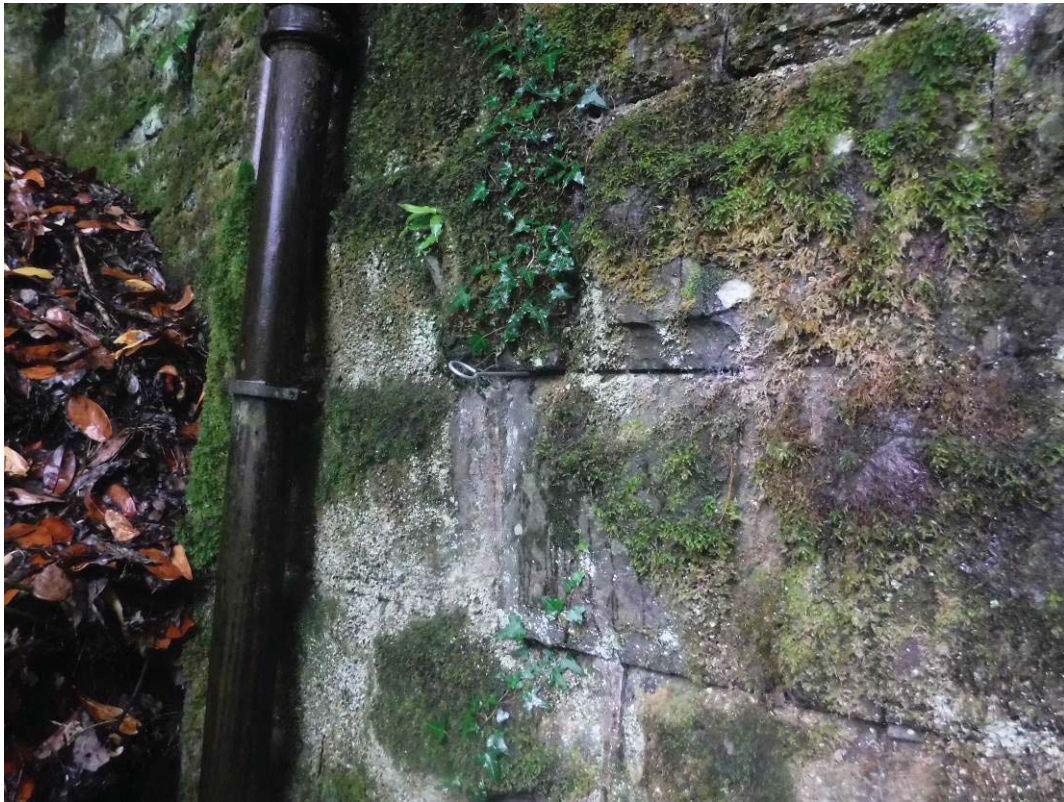
Photo No.3: East Portal, Stonework, open joints, depth 300mm, area 20sq.m., medium, one block displaced.

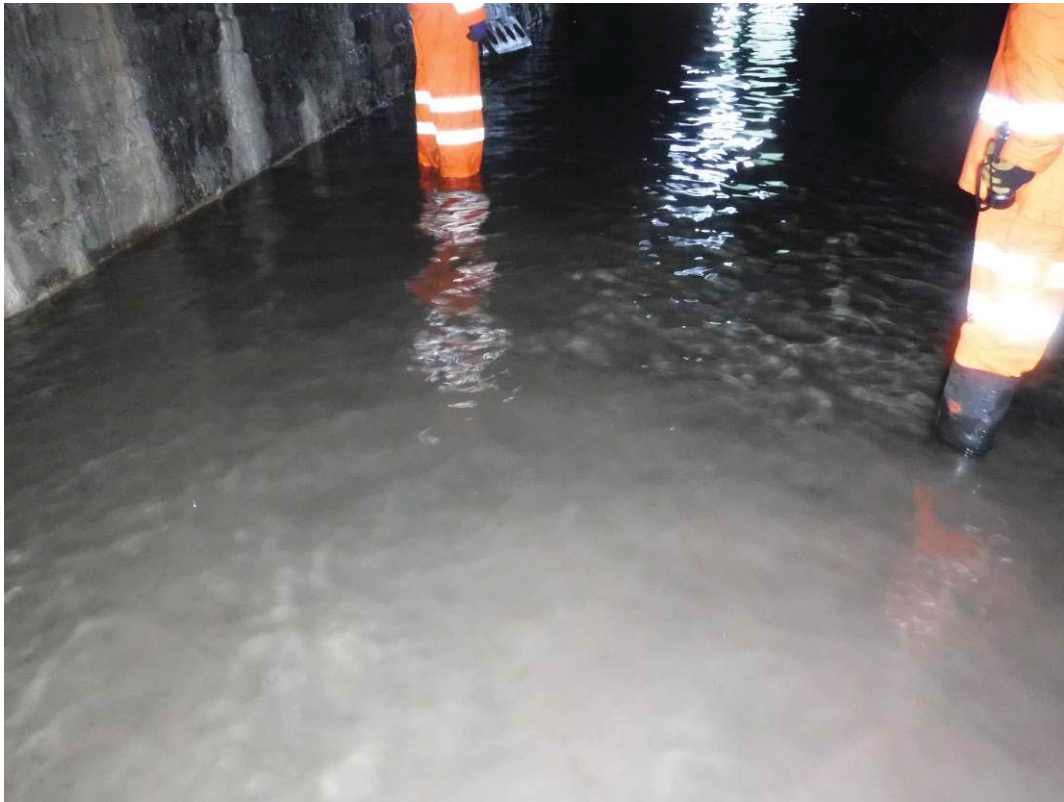
Photo No.7: 000+00 to 007+00 Solum Up & Down, Solum flooded maximum depth 200mm.

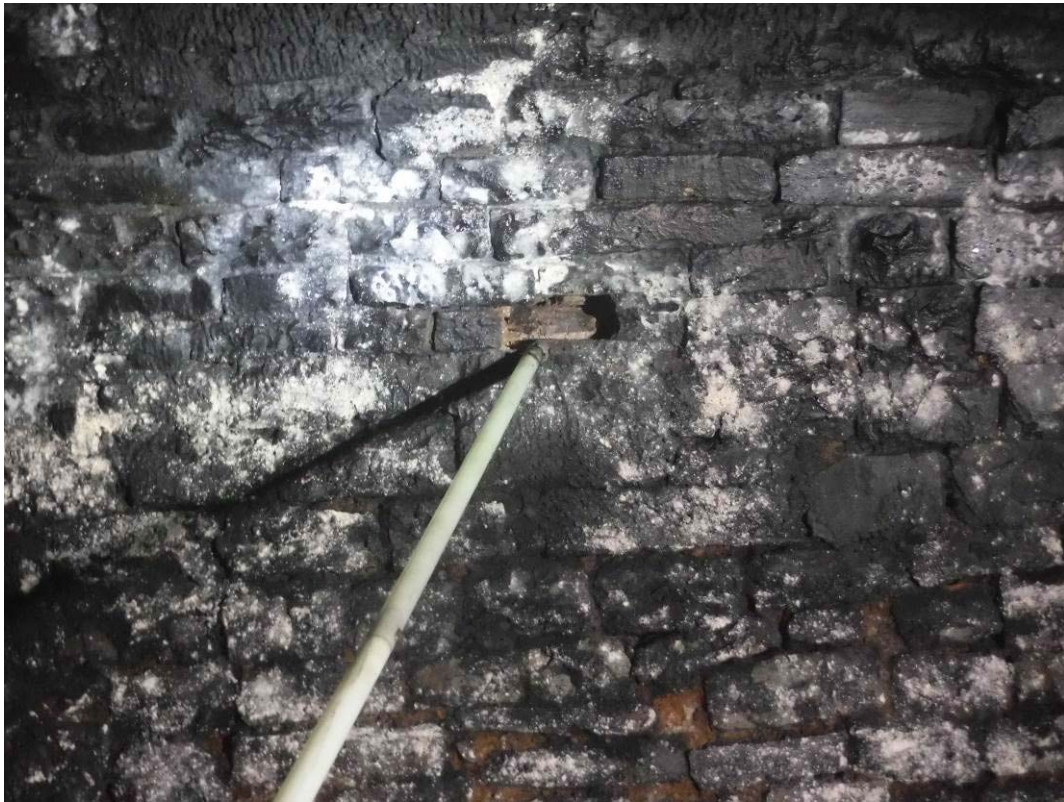
Photo No.9: 024+11 Crown Up & Down, Stonework, missing block.

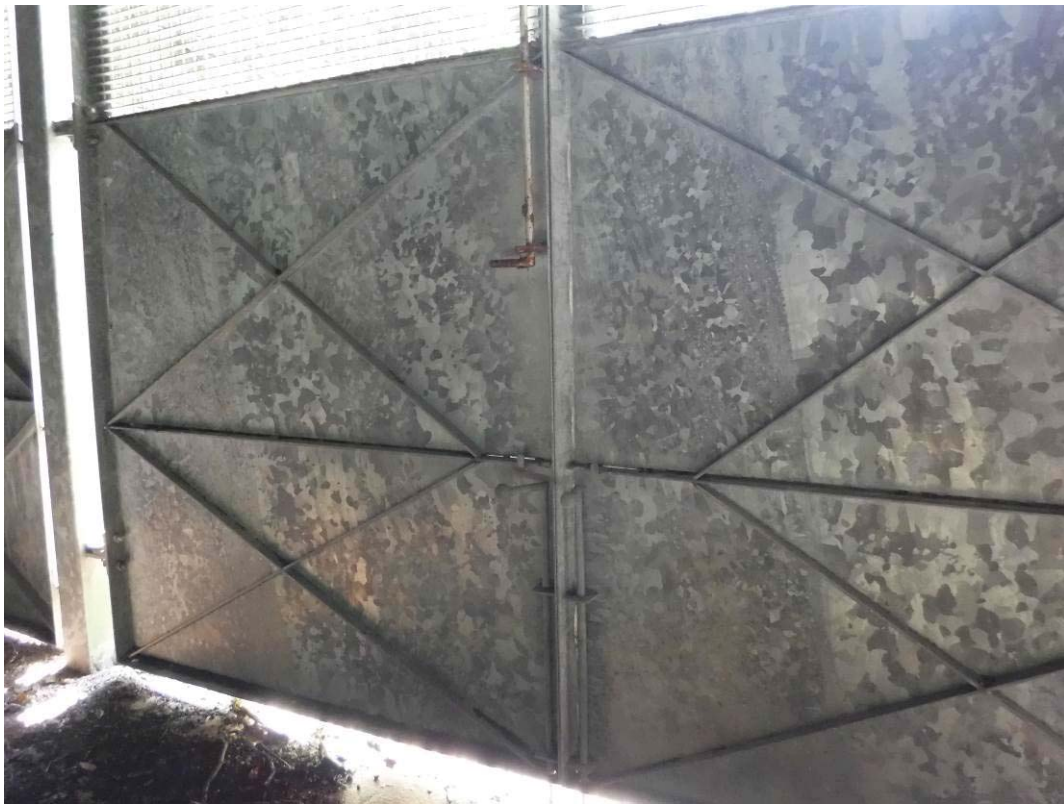
Photo No.1: Northwest Portal, Gates cannot be opened from inside tunnel to allow access to the external face of the portal for examination purposes.

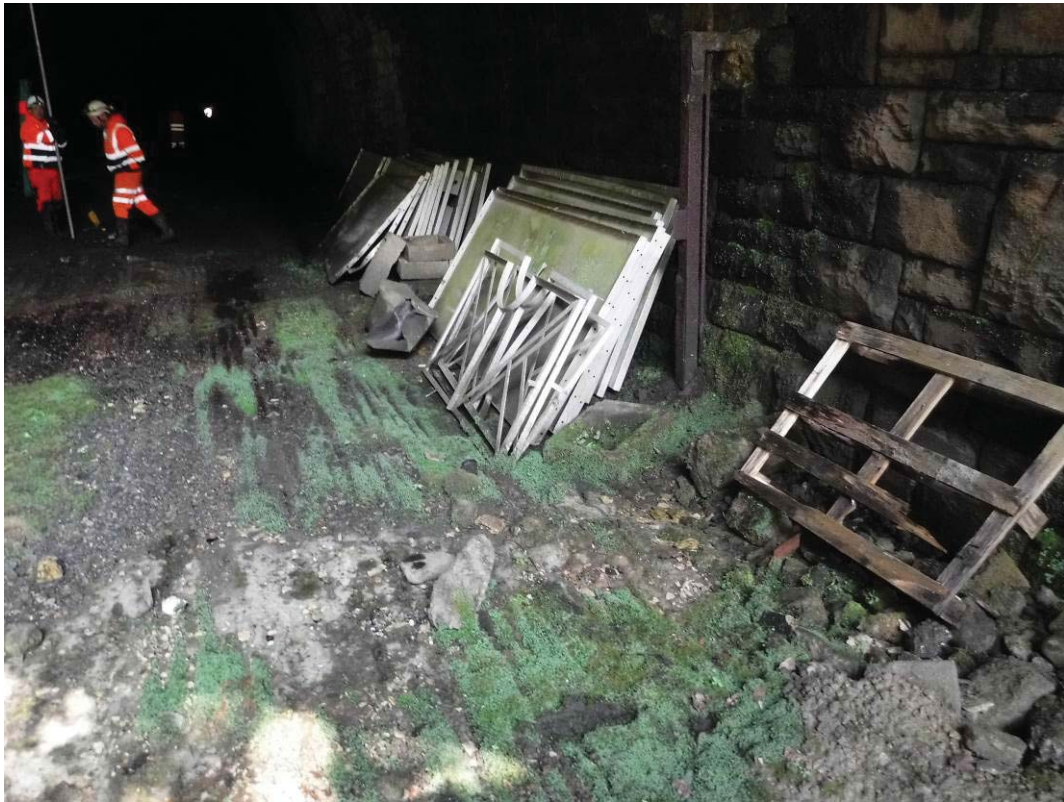
Photo No.3: 000+00 to 005+33 Solum Up & Down, Dumped debris.

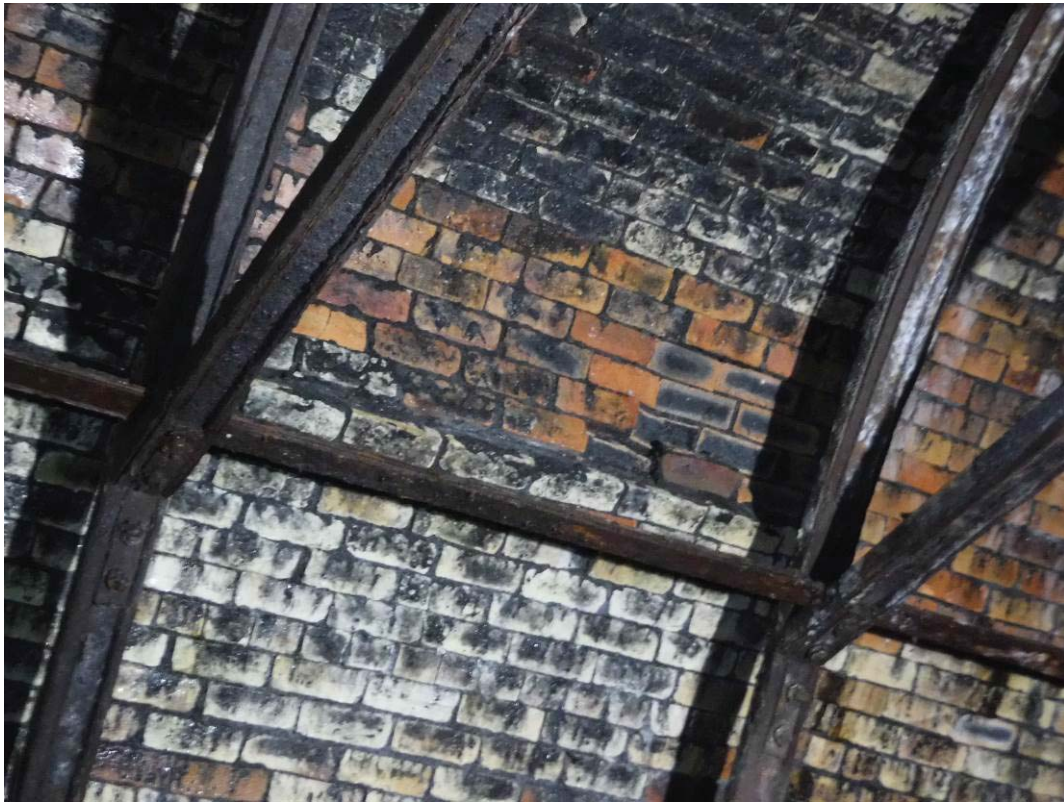
Photo No.5: 002+06 to 002+30 Haunch Down, Brickwork, haunch failed with missing bricks, hanging bricks, distorted profile, hollow, area 8sq.m.

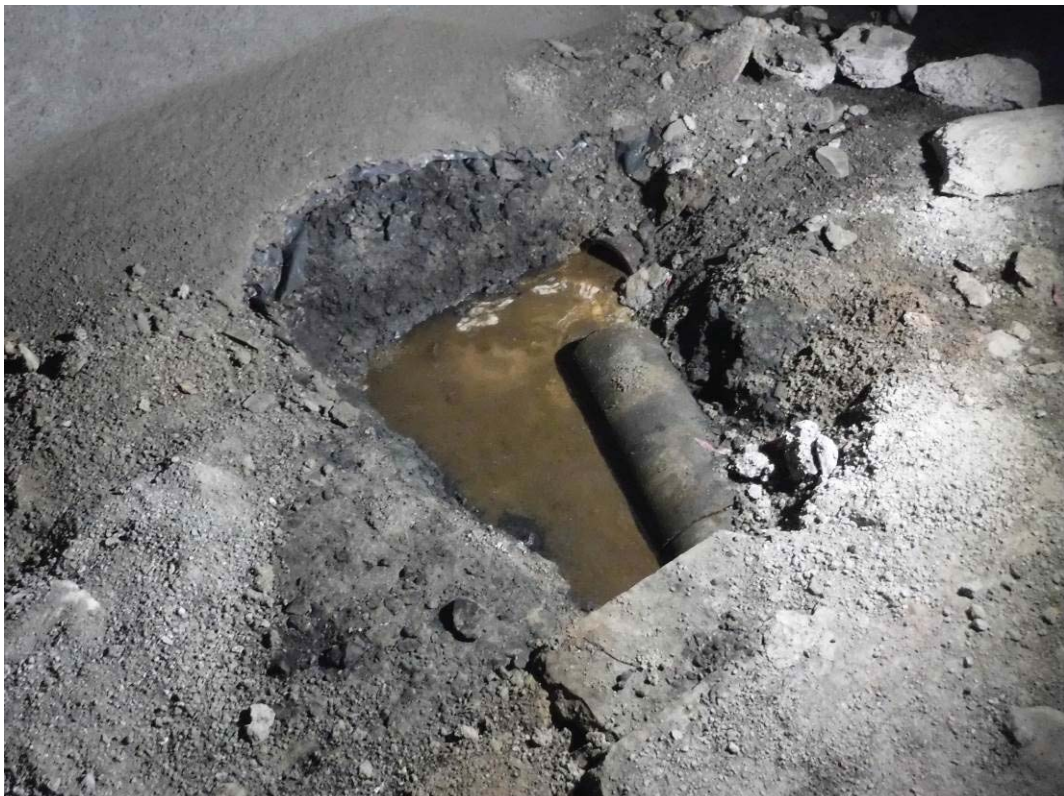
Photo No.6: 007+55 Solum Down, Open pit to six-foot area of solum.
