**TUNNEL EXAMINATION REPORT  
PHOTOGRAPHS OF STRUCTURE**

ELR : PTP Br. No. : 00

Mileage : 05 M 08 Ch Sheet 1 of 15

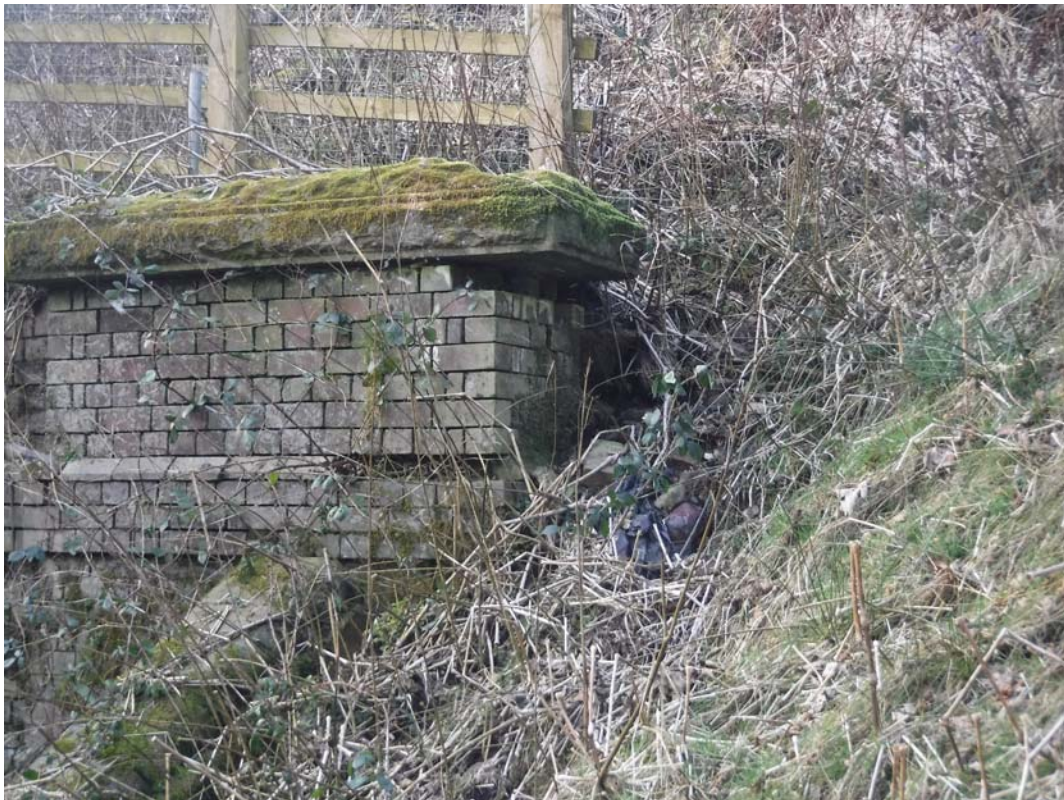
**Photo No. 1:** Southeast Portal, brickwork, 5 brick arch ring to voussoirs area has open joints and running water, depth 200mm, area 4sq.m.

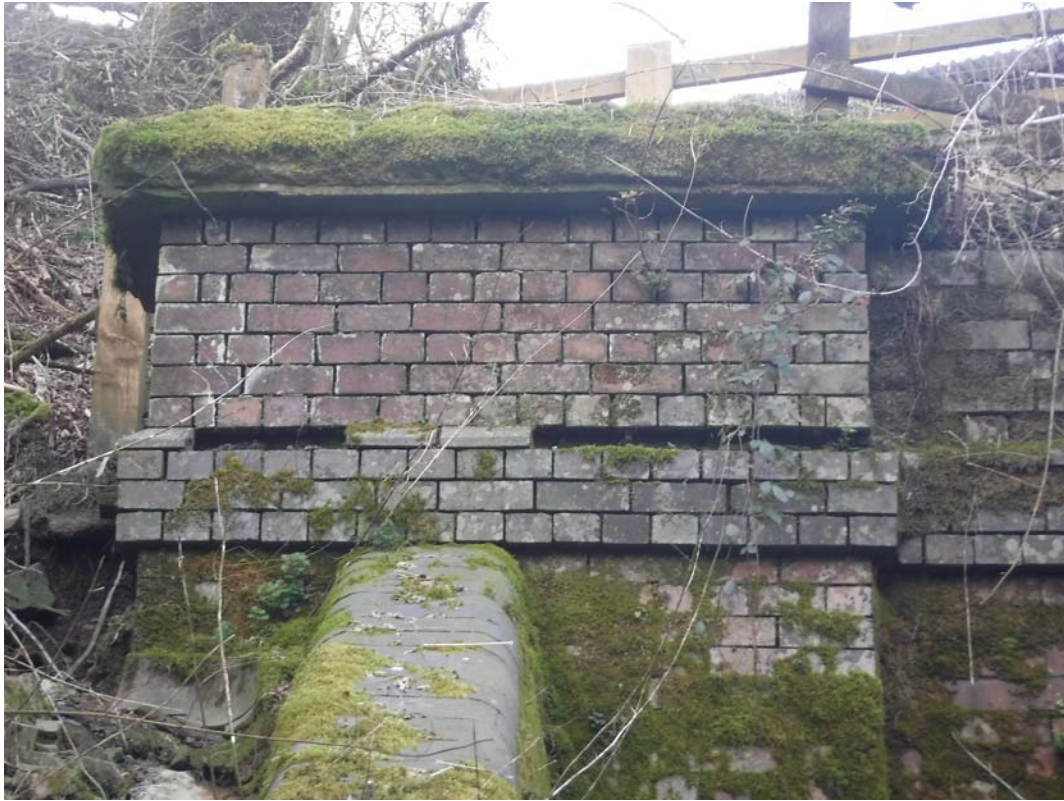
**Photo No. 3:** Southeast Portal, Wingwall, Pilaster, missing and loose bricks, area 2sq.m

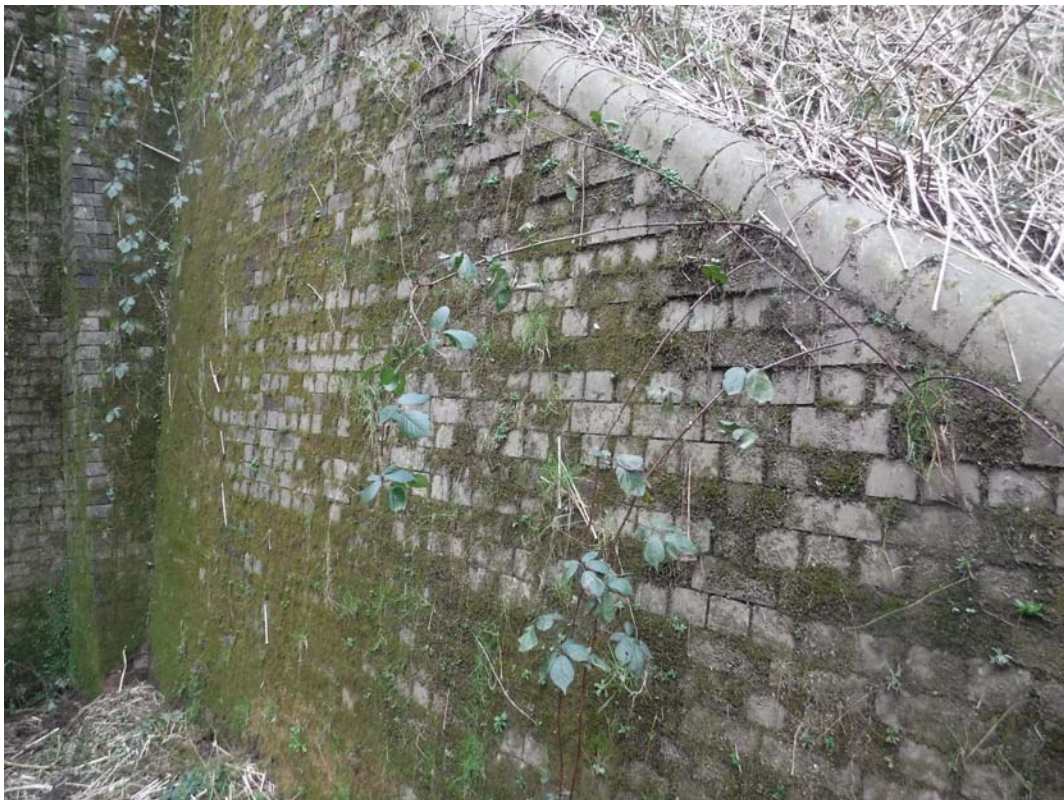
**Photo No. 4:** Southeast Portal, Wingwall, brickwork, open joints, depth 75mm, area 6sq.m., medium, with loose copings and bricks below for 8 metres in length.

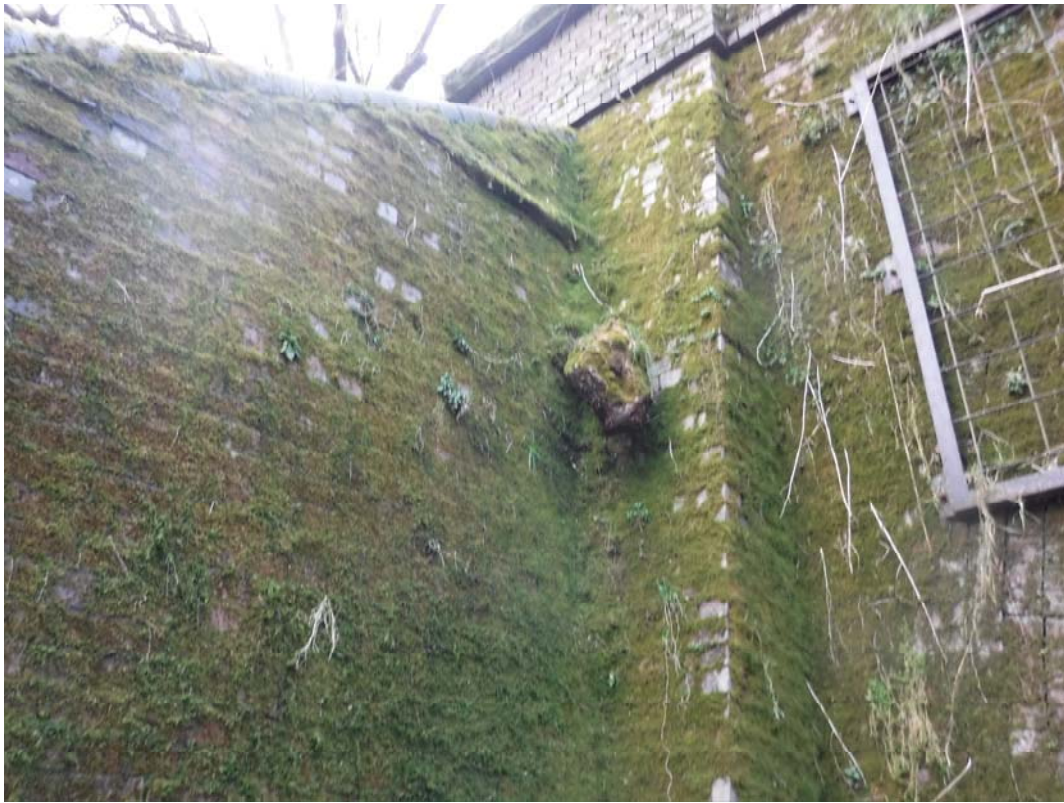
**Photo No. 5:** Southeast Portal, Buttress, tree growing girth 150mm.

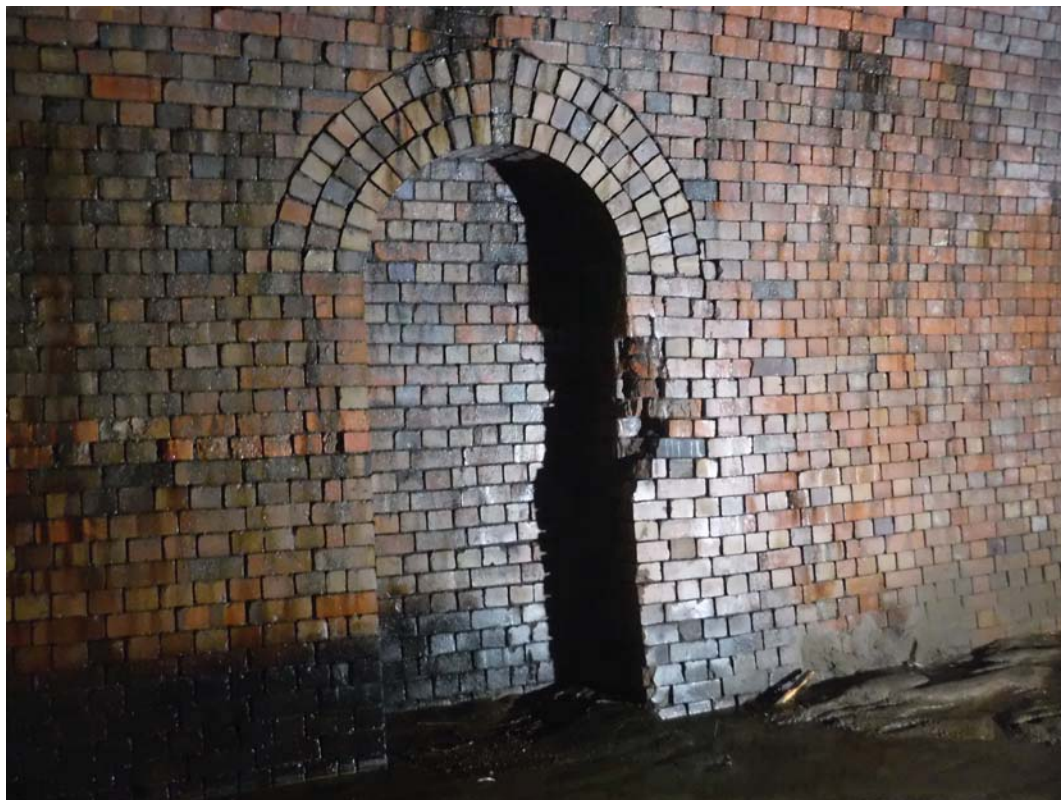
**Photo No. 9:** 001+30 Refuge Up, Brickwork, NW quoin, spalling, depth 200mm, area 0.5sq.m.

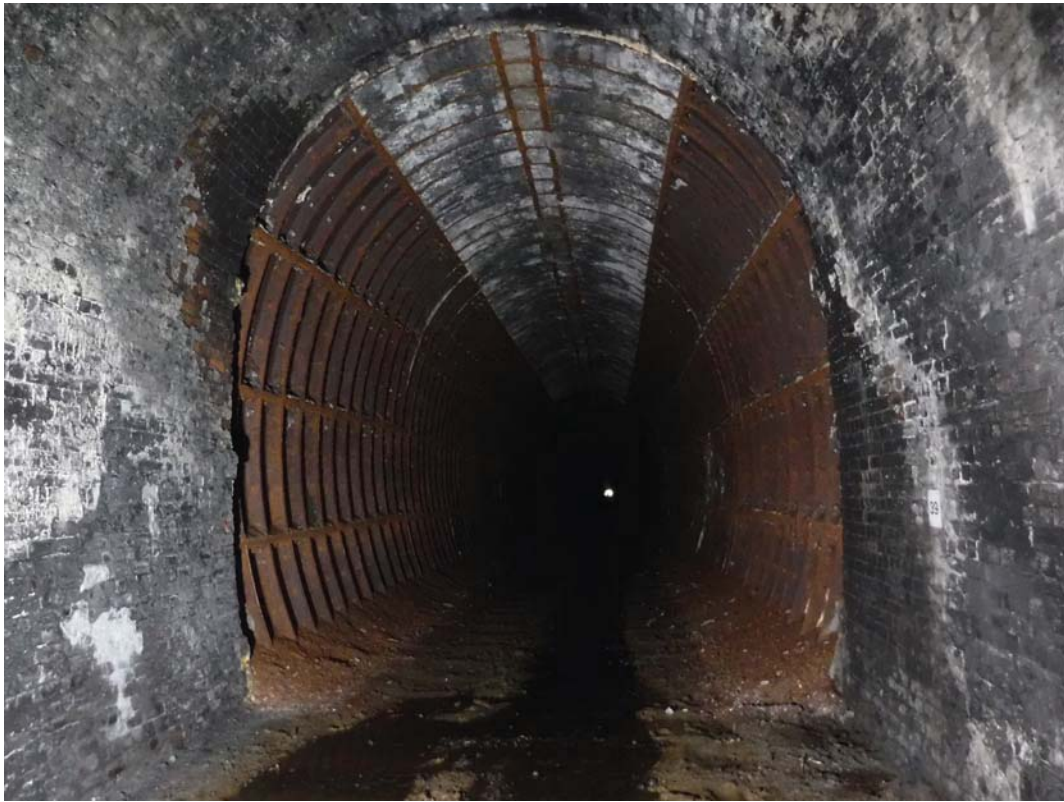
**Photo No. 11:** 035+16 to 038+45 Full Profile Up & Down, Steel segmental lining to tunnel, this is heavily corroded with missing and corroded bolts with large amounts of detritus to solum.

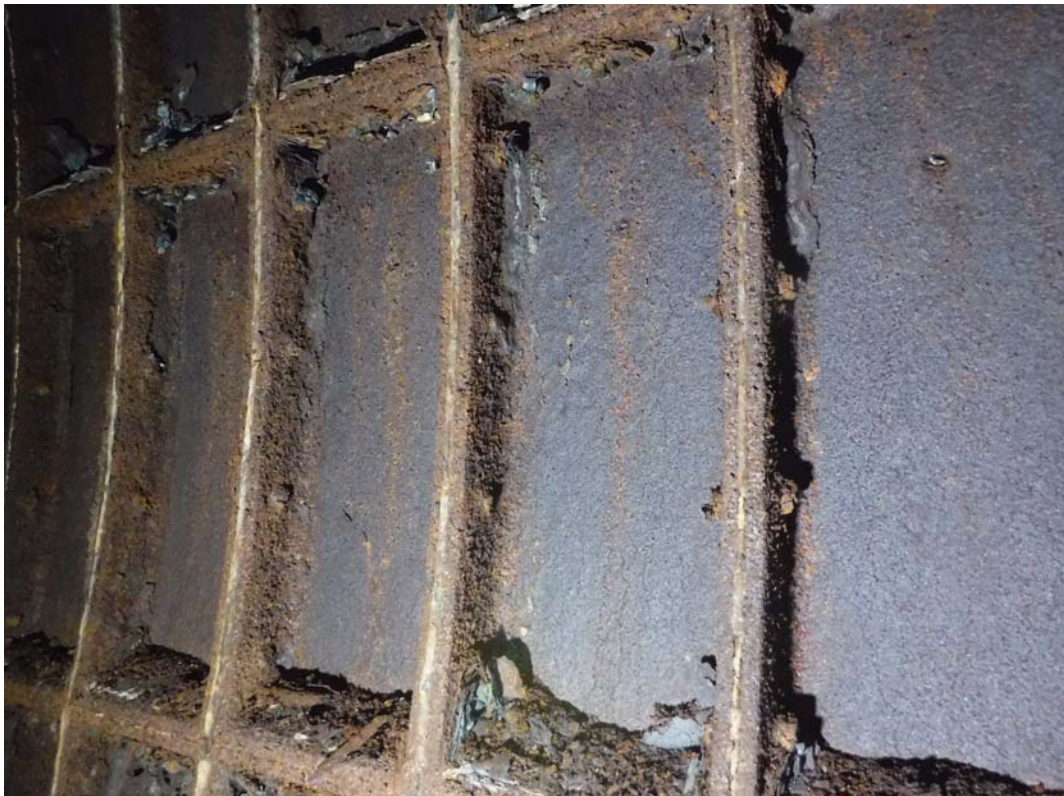
**Photo No. 12:** 035+16 to 038+45 Full Profile Up & Down, Steel segmental lining to tunnel, this is heavily corroded with missing and corroded bolts with large amounts of detritus to solum.

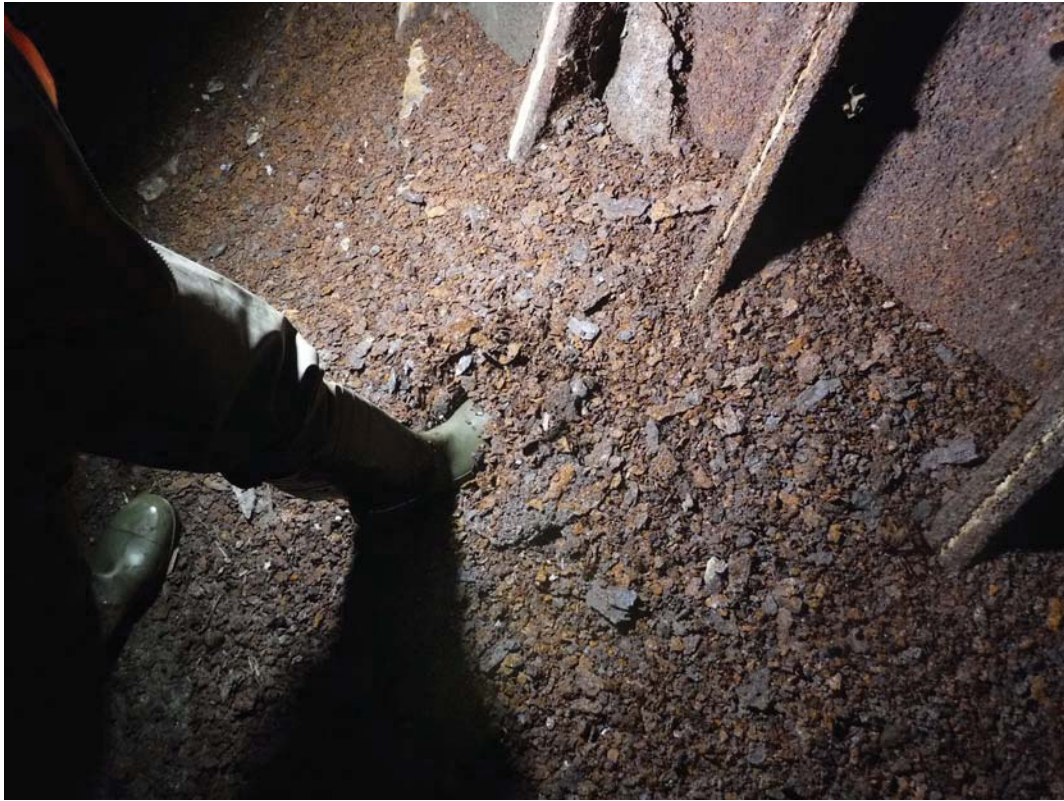
**Photo No. 13:** 035+16 to 038+45 Full Profile Up & Down, Steel segmental lining to tunnel, this is heavily corroded with missing and corroded bolts with large amounts of detritus to solum.

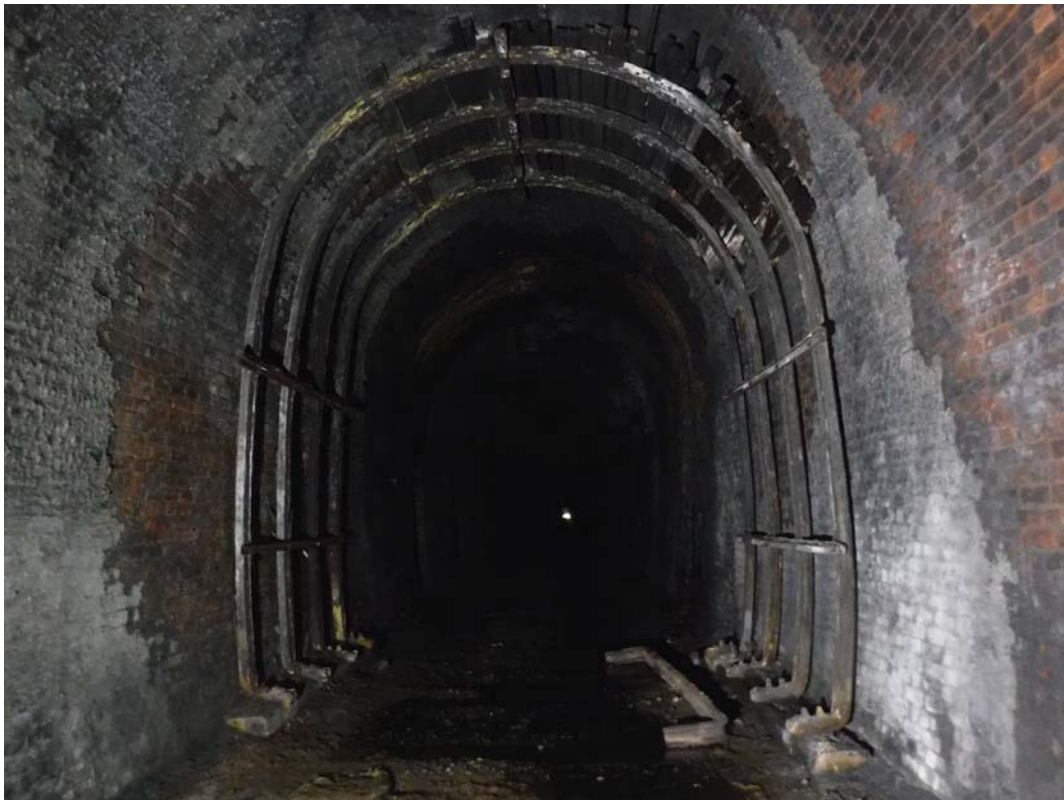
**Photo No. 14:** 041+10 to 041+23 Full Profile Up & Down, 4No. Bullhead rail arch supports with timber laggings fitted to lining these are heavily corroded and leaning. They appear to be supporting a calcite covered bulge, max. depth 50mm.

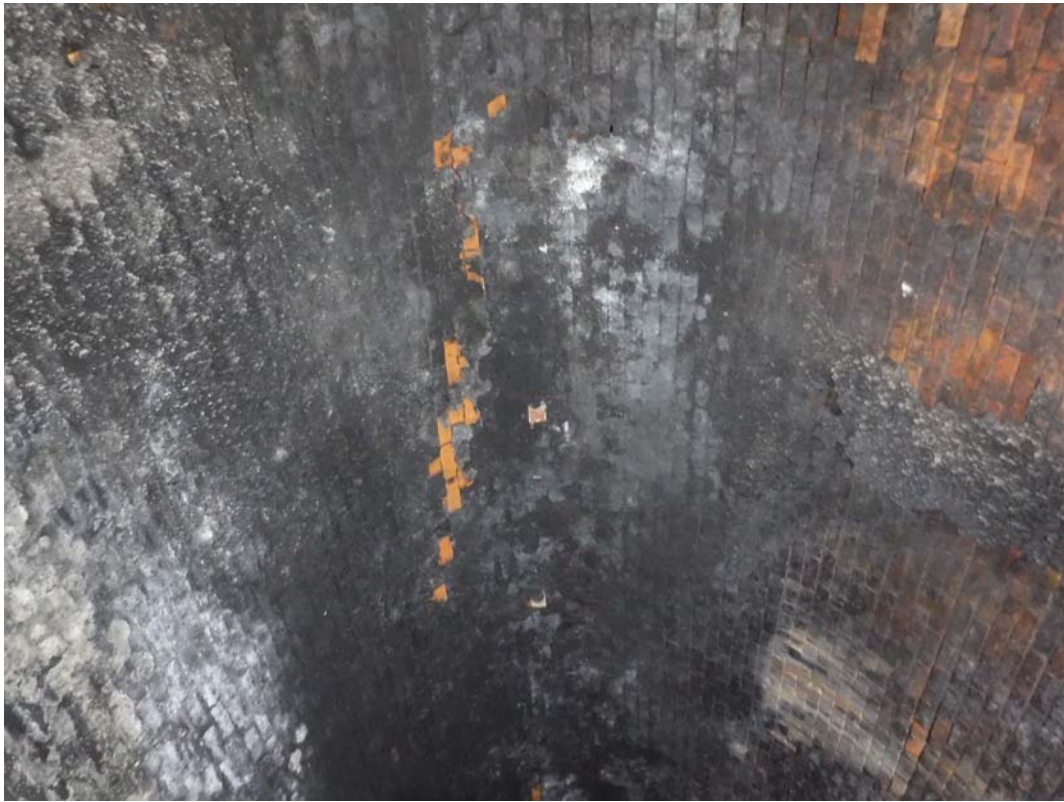
**Photo No. 15:** 042+00 to 043+40 Crown & Haunches Up & Down, Brickwork, Bulging to haunches, hollow and pinching to the crown with spalling, depth 25mm, area 10sq.m., sparse. New longitudinal cracking along the crown, length 5m, width hairline (042+30 to 042+45).

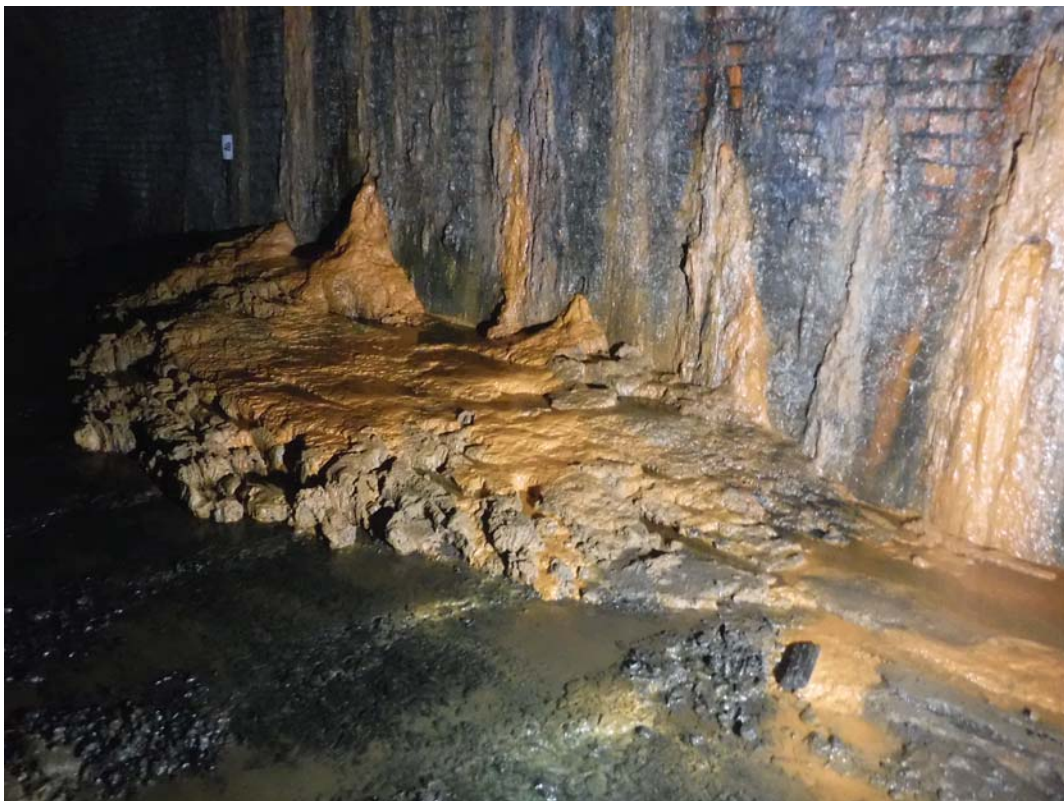
**Photo No. 16:** 048+00 to 048+15 Sidewall & Solum Up, Ochre deposits to solum, depth 700mm, area 14sq.m.

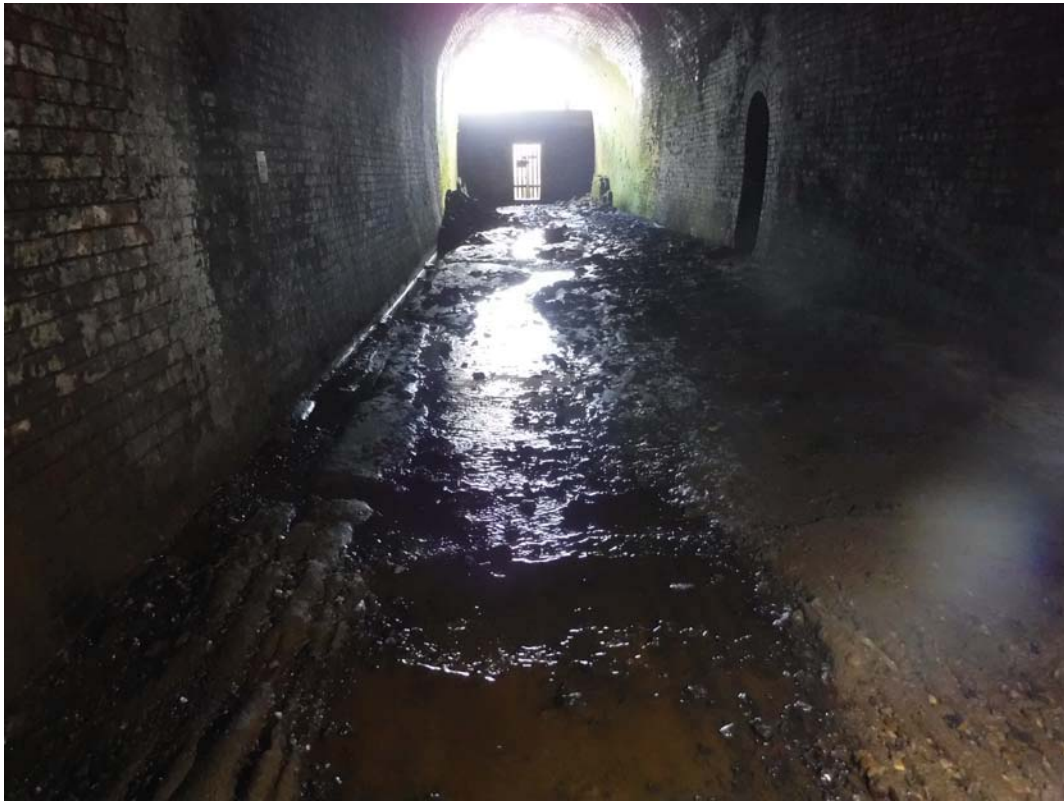
**Photo No. 17:** 055+06 to 060+36 Full Profile Up & Down, Solum, stream and mud, depth 300mm. Both inside and on approach to tunnel.

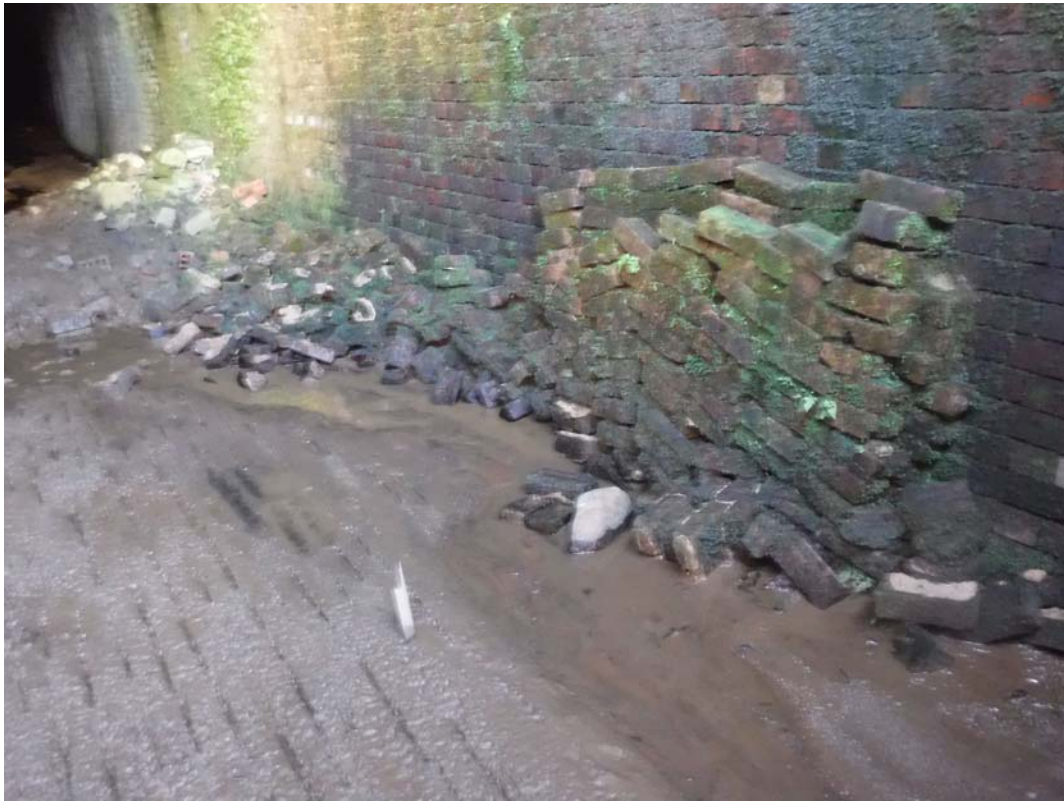
**Photo No. 19:** 059+35 to 60+36 Solum Up & Down, Rubble and debris piled to solum.

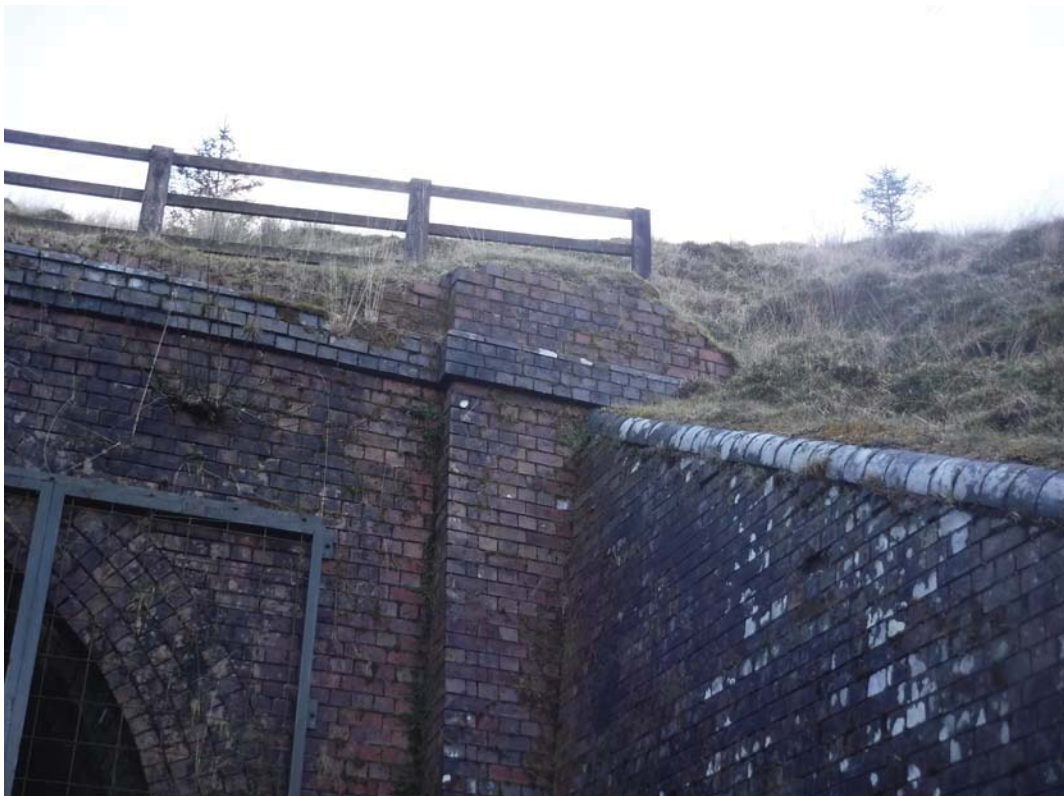
**Photo No. 22:** 060+36 Portal Up, Northwest Portal, Brickwork, Pilaster, capstone and brickwork missing

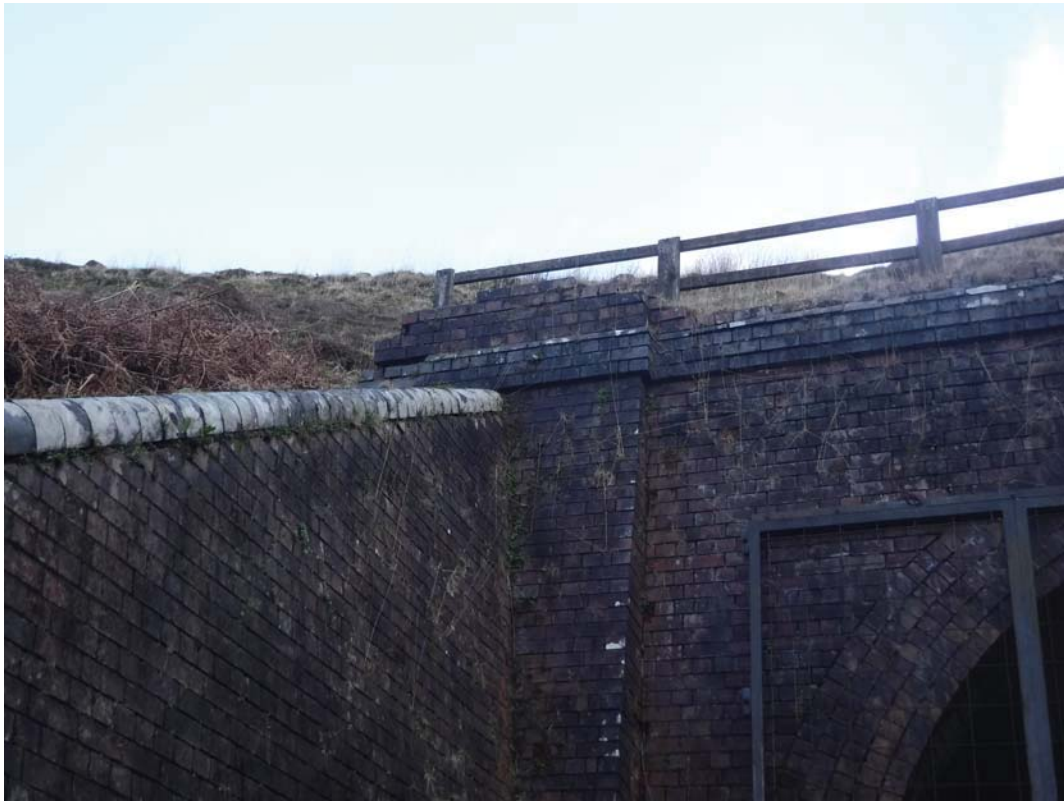
**Photo No. 23:** 060+36 Portal Down, Northwest Portal, Brickwork, Pilaster, capstone and brickwork missing.

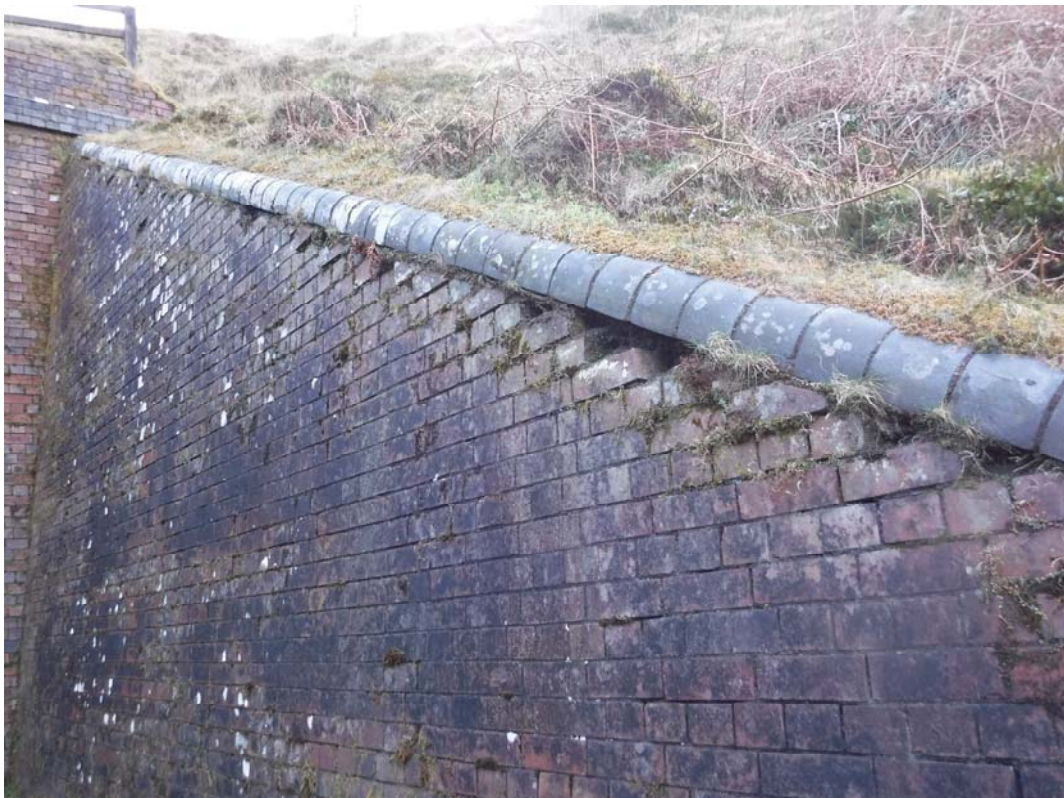
**Photo No. 24:** 060+36 Portal Up, Northwest Portal, Wingwall, Brickwork, loose copings and loose & missing bricks below, area 8sq.m.

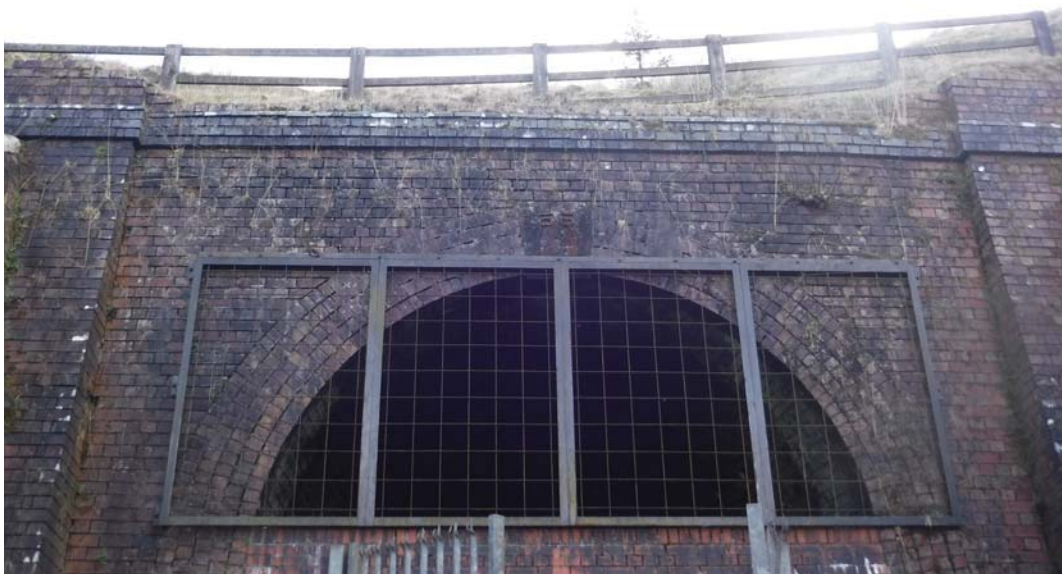
**Photo No. 26:** 060+36 Portal Up & Down, Northwest Portal, brickwork, 8 courses of parapet missing and loose bricks, area 2sq.m.

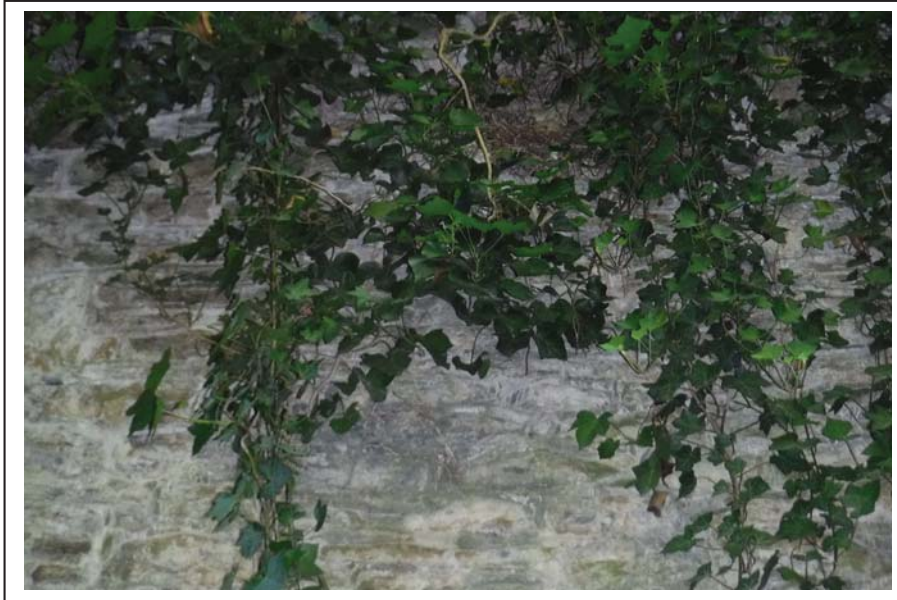
Photograph no 1: DL wingwall

Previously noted area of missing masonry 15m from the portal, and 4.5m above existing ground level, approximately 300mm deep with 1m<sup>2</sup> loose area of masonry surrounding

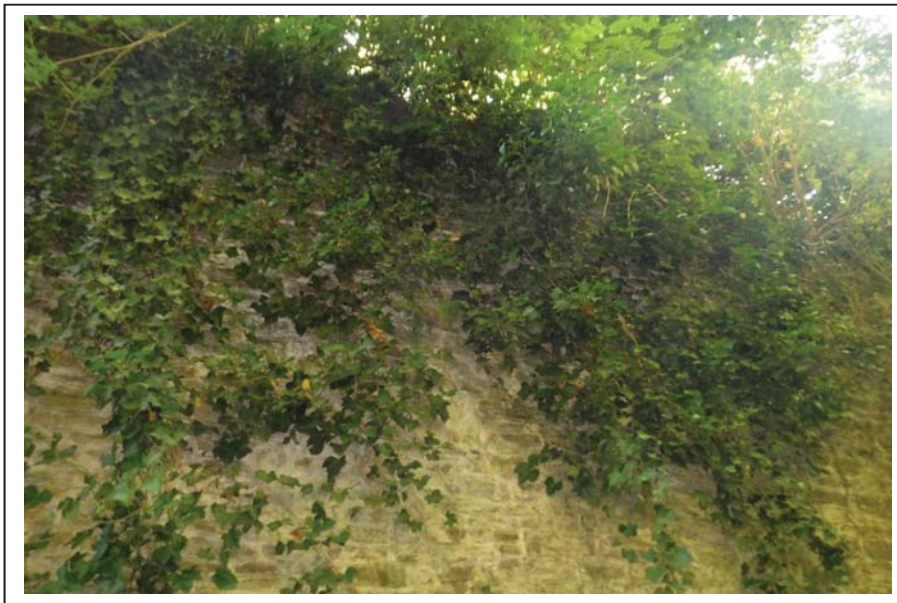
Photograph no 2: DL wingwall

Ivy growth now largely obscures long standing defects to top of wingwall

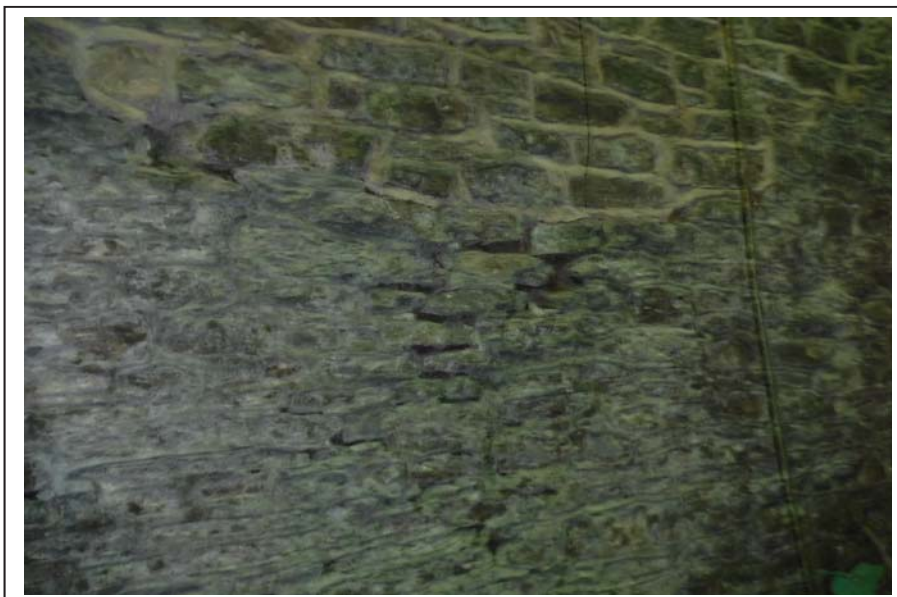
Photograph no 3: DL wingwall  
Section of loose masonry 10m from portal noted at 1.6m above G/L

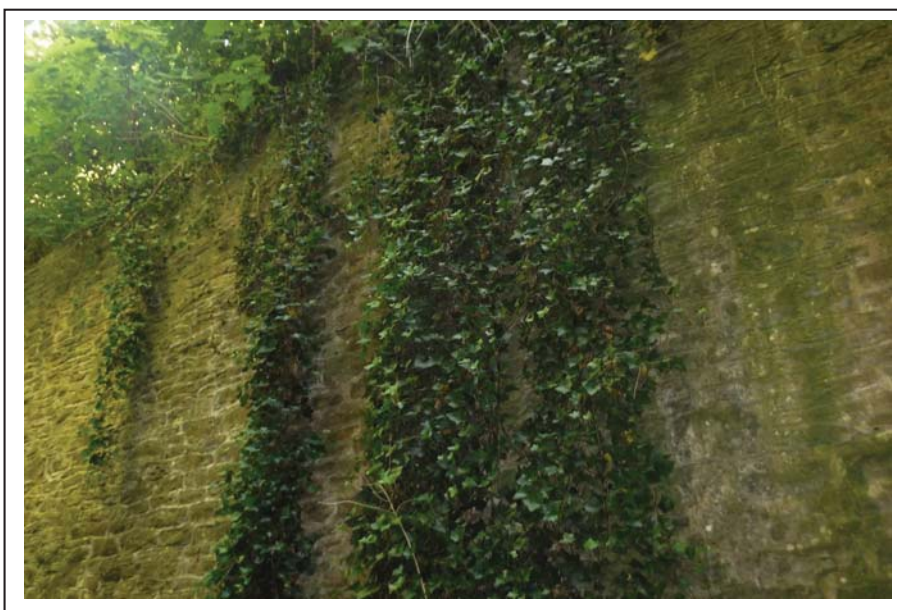
Photograph no 4: DL wingwall  
The C/End of wingwall (near portal) is heavily overgrown with ivy

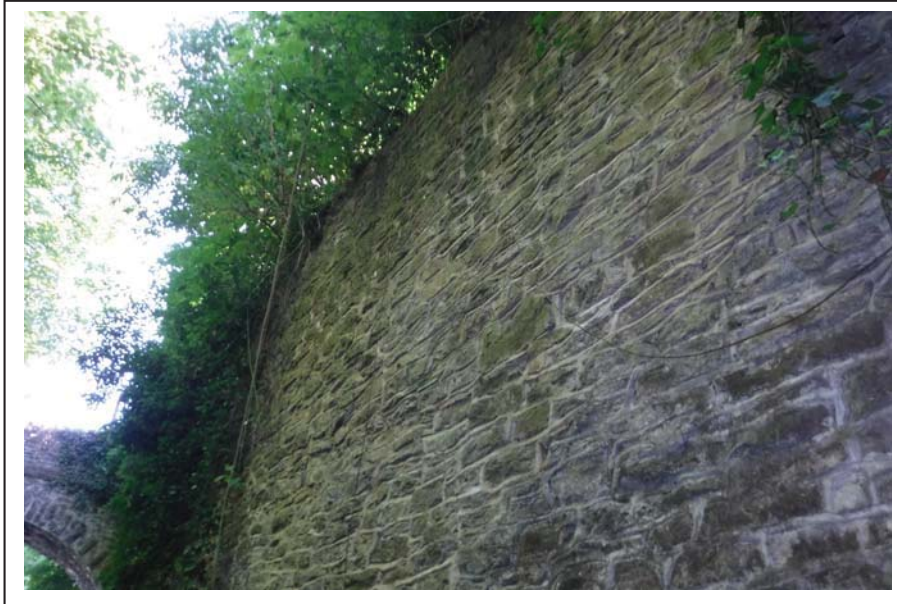
Photograph no 5: DL wingwall  
Area above has long-standing bulging which has been pointed in  
Found generally good but with odd sections slightly loose

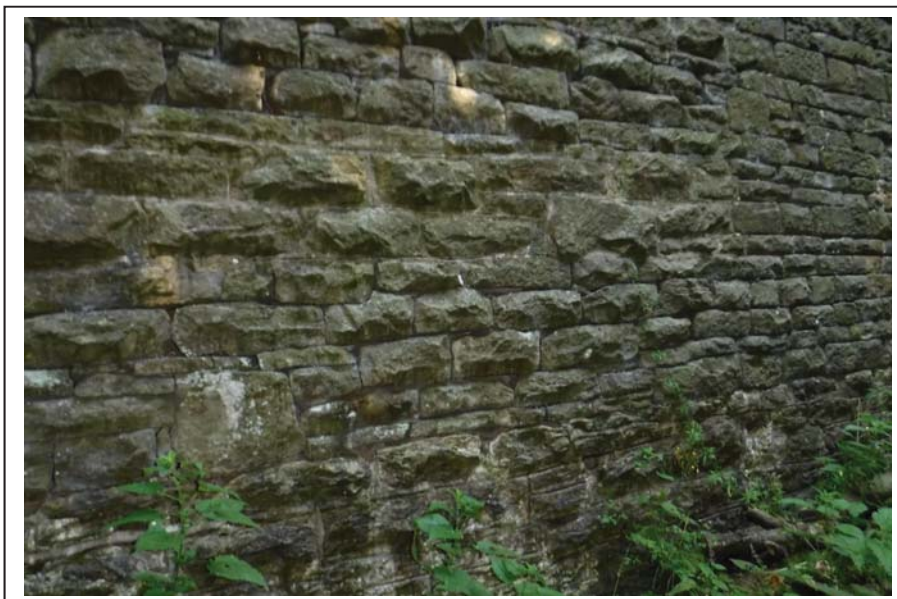
<b>Upside Wingwall</b> Widespread deep open joints, generally 100mm, but up to 280mm locally, total area approximately 50m <sup>2</sup> . Individual stones move to hammer (P.6). 1.5m from portal, long-standing area of masonry loss approximately 0.2m <sup>2</sup> up to 400mm deep with adjacent stones below loose to hammer (P.7) Isolated spalling of individual stones to depth of 50mm

Photograph no 6: UL wingwall  
Individual stones move to hammer

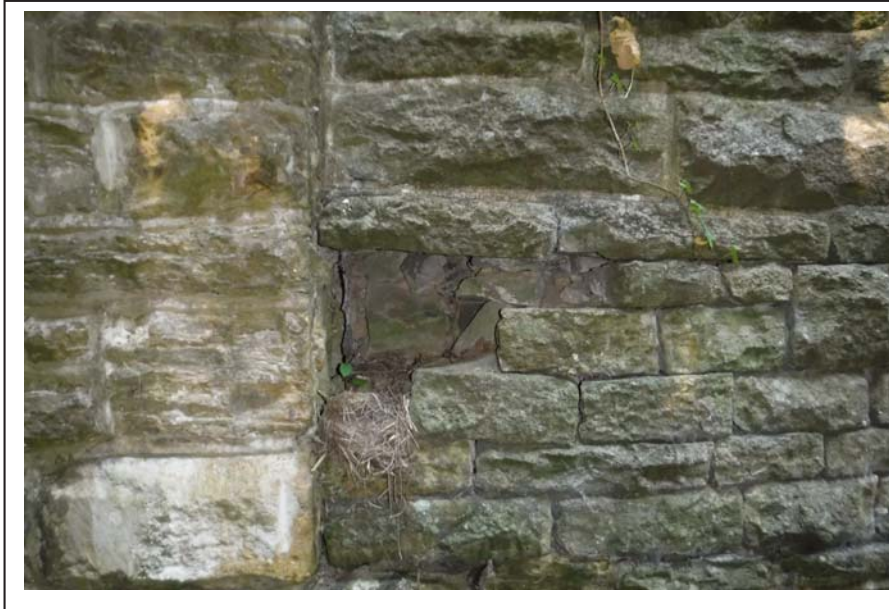
Photograph no 7: UL wingwall  
1.5m from portal, long-standing area of masonry loss approximately 0.2m<sup>2</sup> up to 400mm deep  
with adjacent stones below loose to hammer

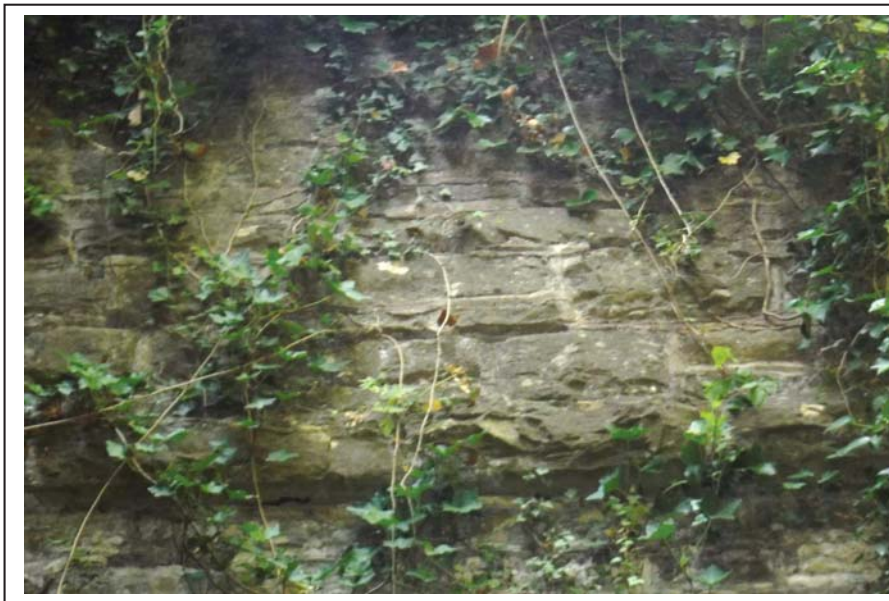
Photograph no 8: LE headwall  
Isolated open joints present throughout the headwall up to 100mm deep in places over a total area of  
approximately 0.75m<sup>2</sup>

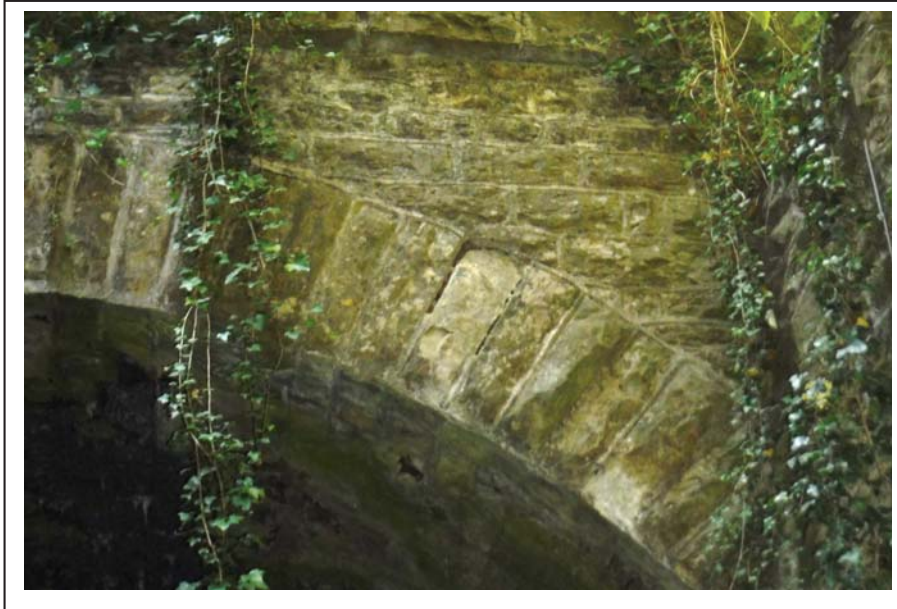
Photograph no 11: LE headwall  
Single voussoir to UL spalled to 50mm locally

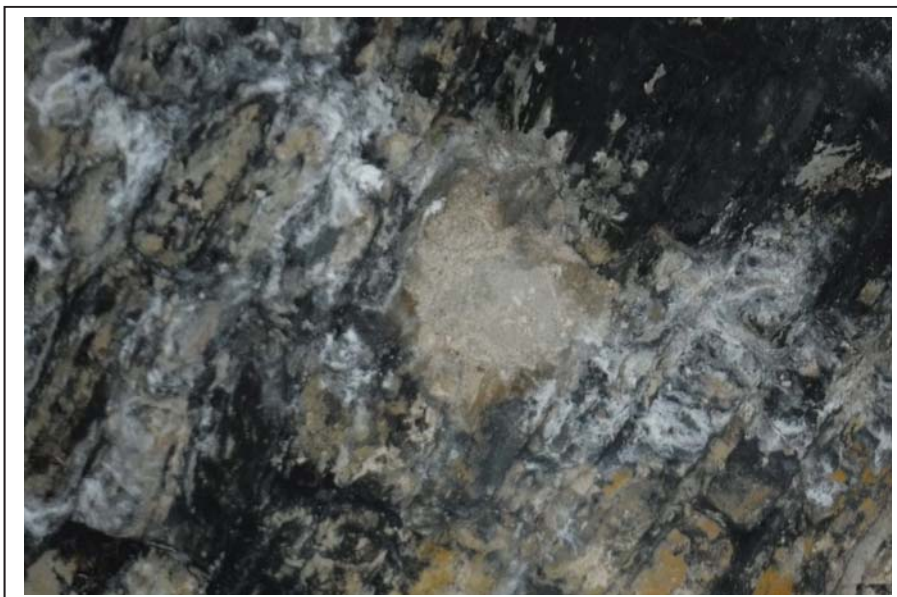
Photograph no 13: LE crown at 0.5ch  
Isolated spalling to 120mm

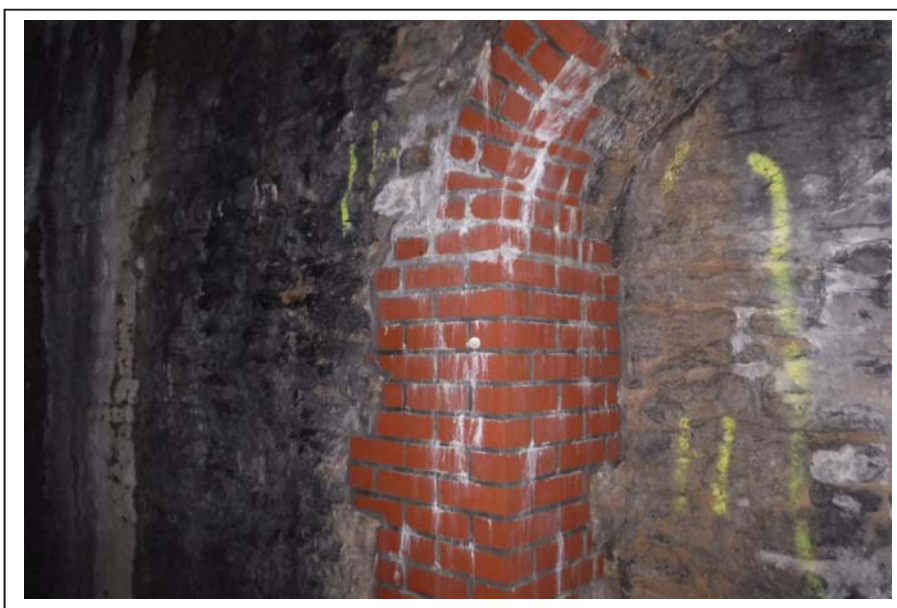
Photograph no 14: DL quoin refuge now repaired in brickwork to good standard

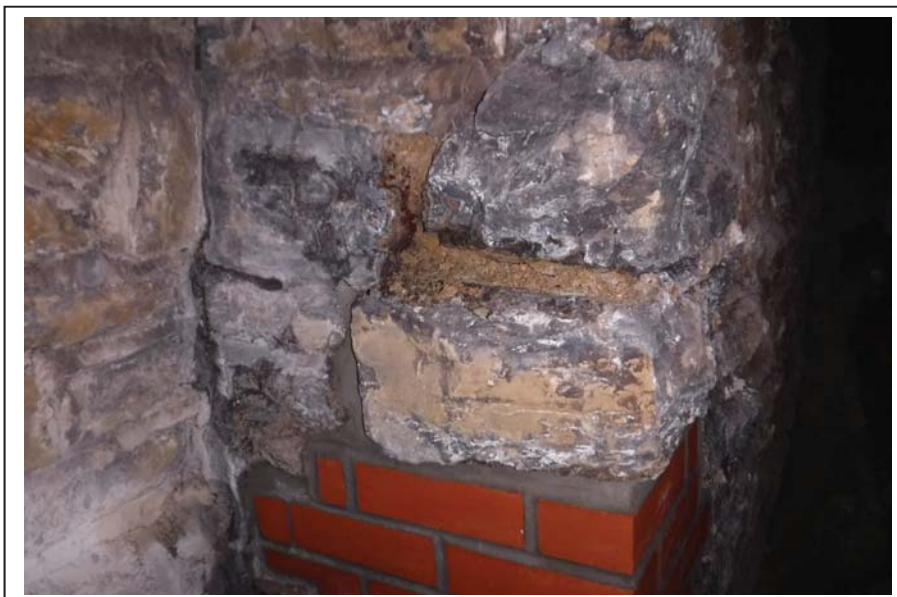
DC quoin now  
repaired to good  
standard (P20) but  
open joint remains  
above repair (P16)

Photograph no 16: DC quoin now repaired to good standard but open joint remains above repair

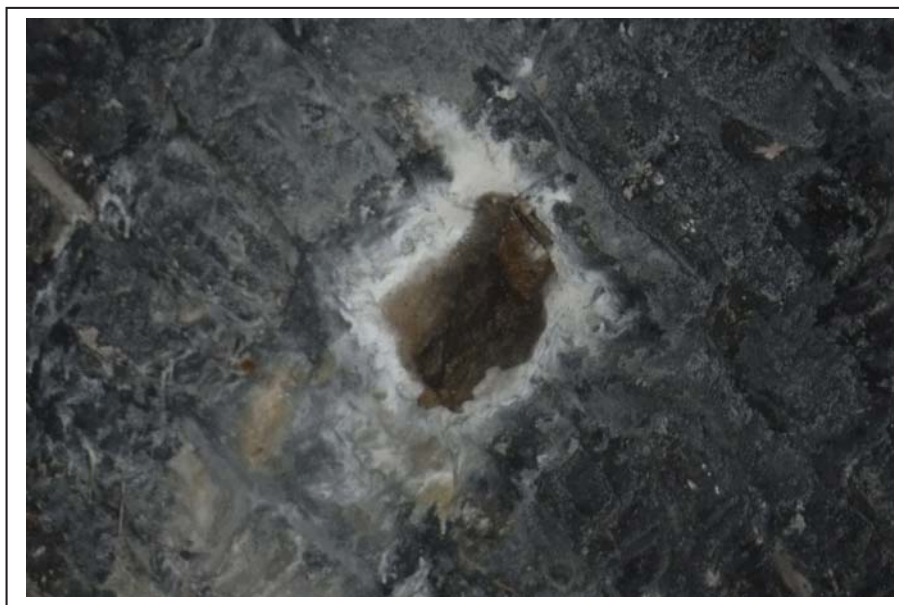
Photograph no 19: Loose stone to UL haunch at 1.75ch

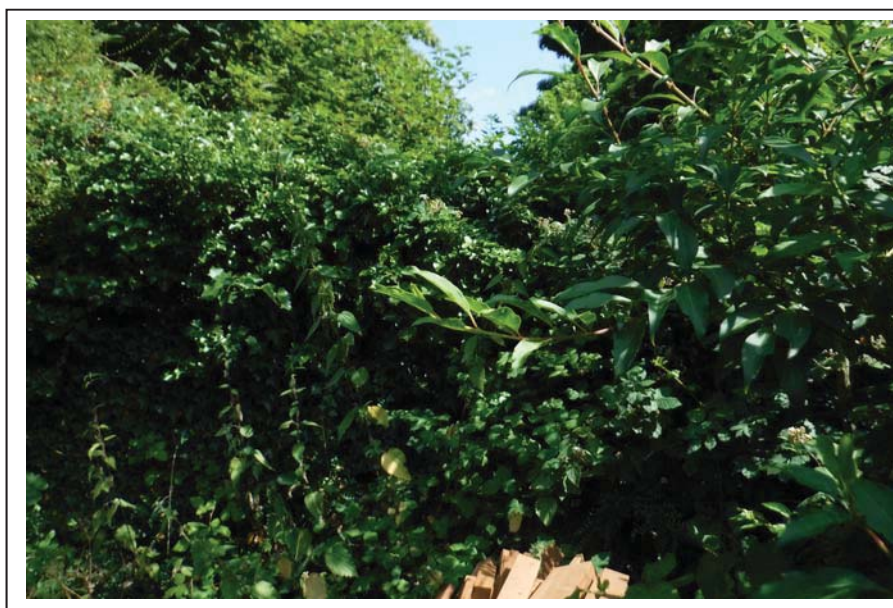
The area above the tunnel is generally in private gardens and inaccessible. However, the rear of the LE headwall could previously be viewed over a high wooden fence but is found fully covered with ivy growth (P.22). The road over the tunnel (B4040) is found in good condition over the tunnel line (P.23).

Photograph no 22: Rear of the LE headwall could previously be viewed over a high wooden fence but is found fully covered with ivy growth
