**TUNNEL EXAMINATION REPORT  
PHOTOGRAPHS OF STRUCTURE**

ELR : PTP Br. No. : 00

Mileage : 05 M 08 Ch Sheet 1 of 15

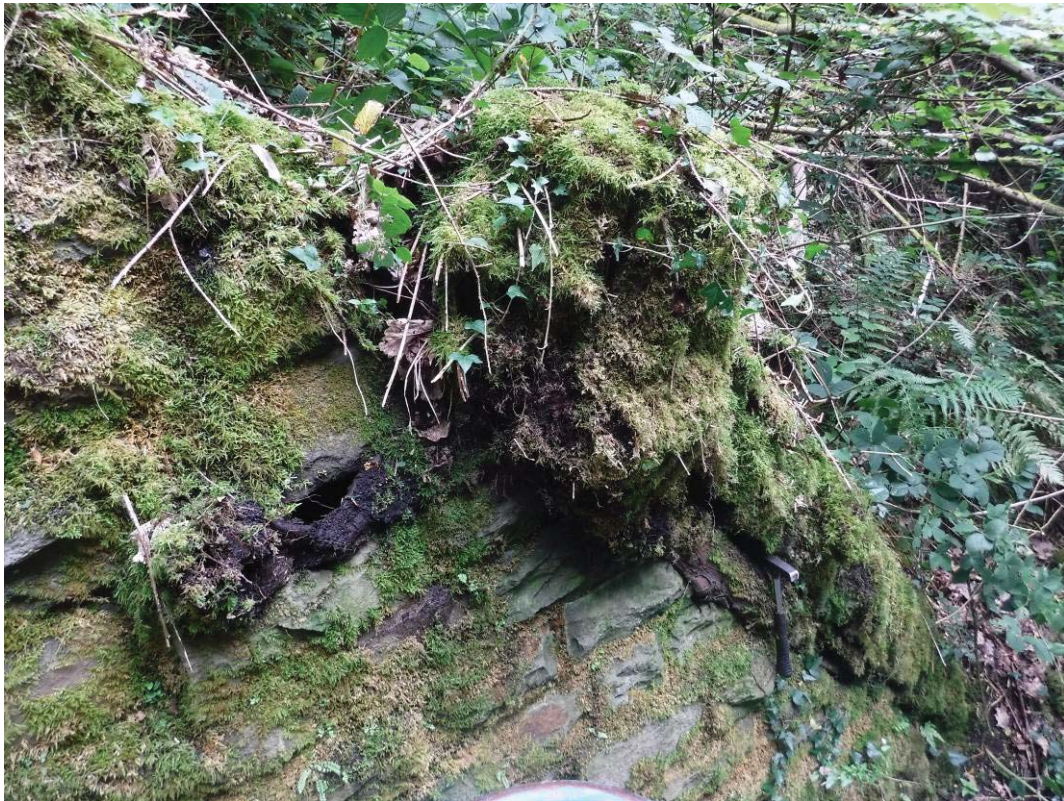
**Photo No.17:** Southwest Portal, Wingwall, trees were removed before 2015 leaving saplings, stumps, tree roots and displaced copings. Loose blocks and open joints, depth 100m.

000+00 Portal Down	Southwest Portal, Wingwall, trees were removed before 2015 leaving saplings, stumps, tree roots and displaced copings. Loose blocks and open joints, depth 100mm, area 10sq.m., light. 8" high half-round copings are missing in upper half of wingwall, length 8yds. Remaining copings in lower half of wingwall lifted 75mm by roots. Evidence of a chute behind top of wingwall not visible due to dense vegetation.	<b>17 to 21</b>	Recommend tree stumps & roots be removed, top of wingwall cleared of vegetation (and unblock chute if found), missing copings replaced and loose blocks repaired, Priority 1; work to be completed by 24/08/2019.
000+00 Portal Up	Southwest Portal, Wingwall, trees were removed before 2015 leaving saplings, stumps, tree roots and displaced copings. Loose blocks and open joints, depth 75mm, area 10sq.m., light. 8" high half-round copings are missing in upper half of wingwall, length 9yds. Large stump near top of wingwall sprouting saplings. Large tree fallen within 4ft. of top of wingwall. Tree growing behind top of wingwall approx. at mid-point, girth 12". Evidence of a chute behind top of wingwall not visible due to dense vegetation.	<b>22, 23 &amp; 24</b>	Recommend trees, tree stumps & roots be removed, top of wingwall cleared of vegetation (and unblock chute if found), missing copings replaced and loose blocks repaired, Priority 1; work to be completed by 24/08/2019.

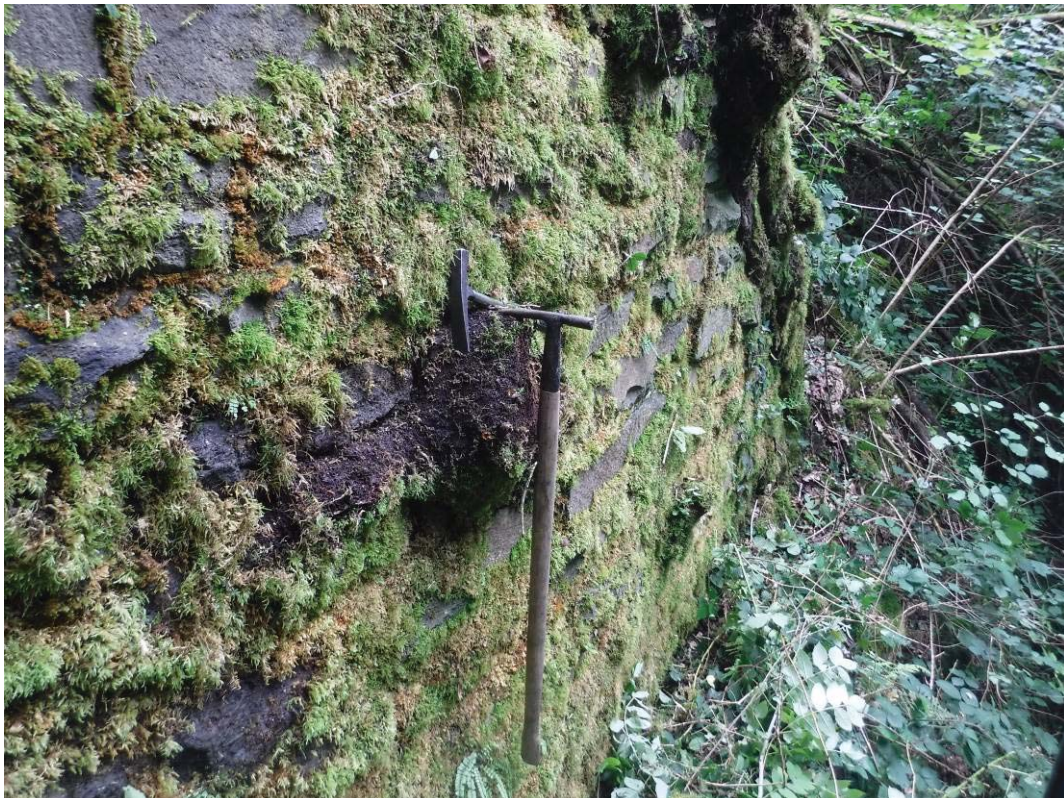
**Photo No.18:** Southwest Portal, Wingwall, trees were removed before 2015 leaving saplings, stumps, tree roots and displaced copings. Loose blocks and open joints, depth 100m.

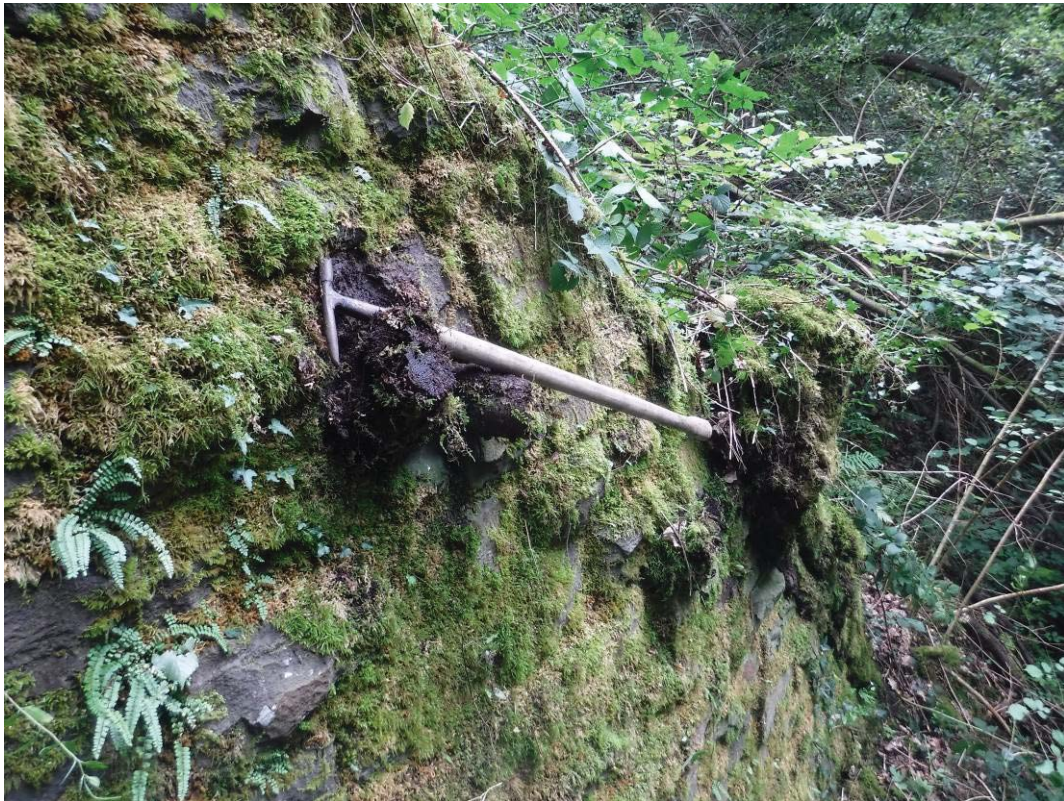
**Photo No.19:** Southwest Portal, Wingwall, trees were removed before 2015 leaving saplings, stumps, tree roots and displaced copings. Loose blocks and open joints, depth 100m.

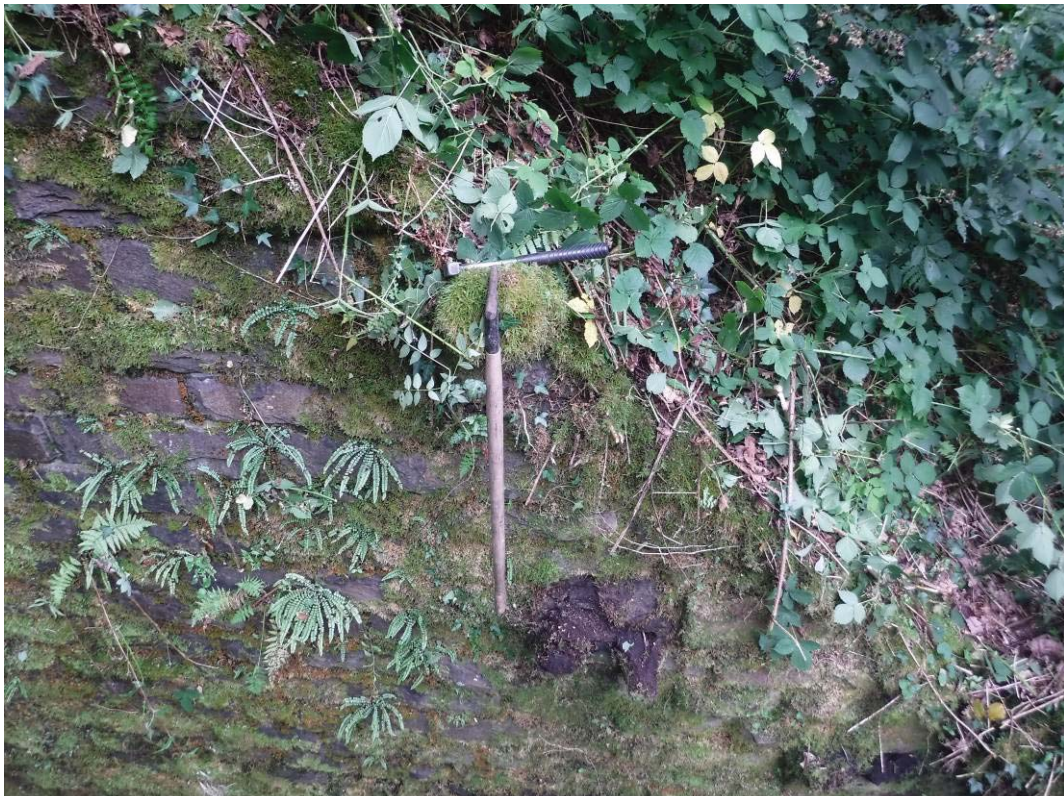
**Photo No.20:** Southwest Portal, Wingwall, trees were removed before 2015 leaving saplings, stumps, tree roots and displaced copings. Loose blocks and open joints, depth 100m.

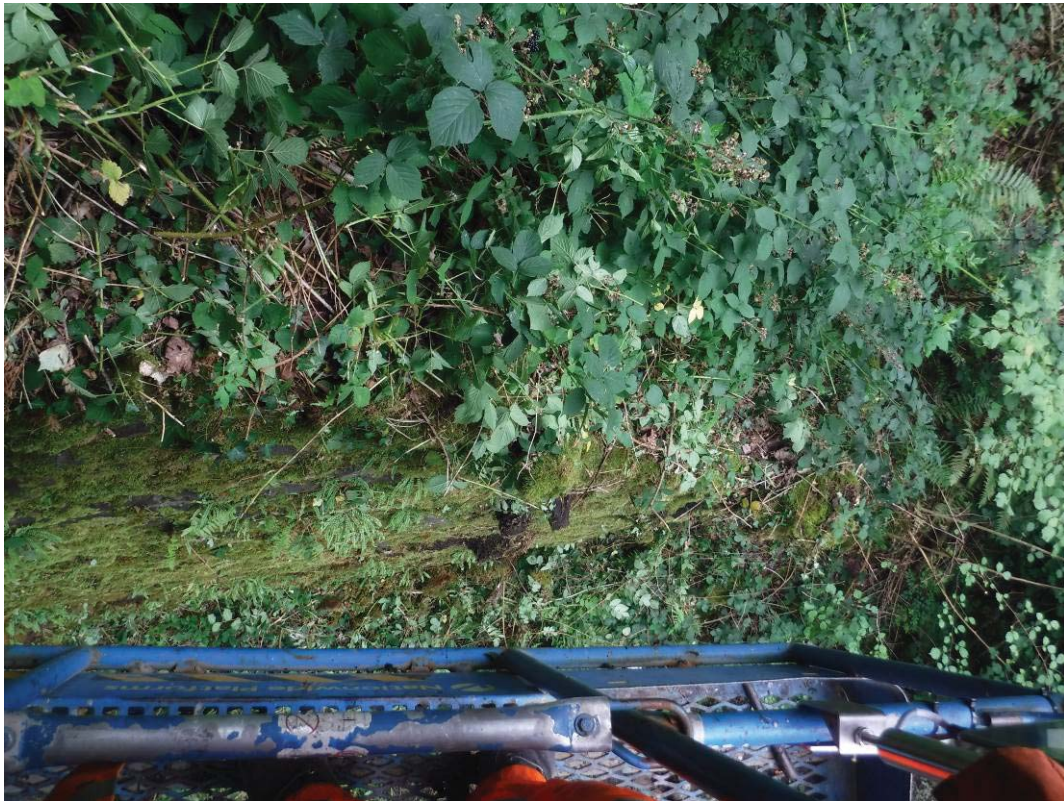
**Photo No.21:** Southwest Portal, Wingwall, trees were removed before 2015 leaving saplings, stumps, tree roots and displaced copings. Loose blocks and open joints, depth 100m.

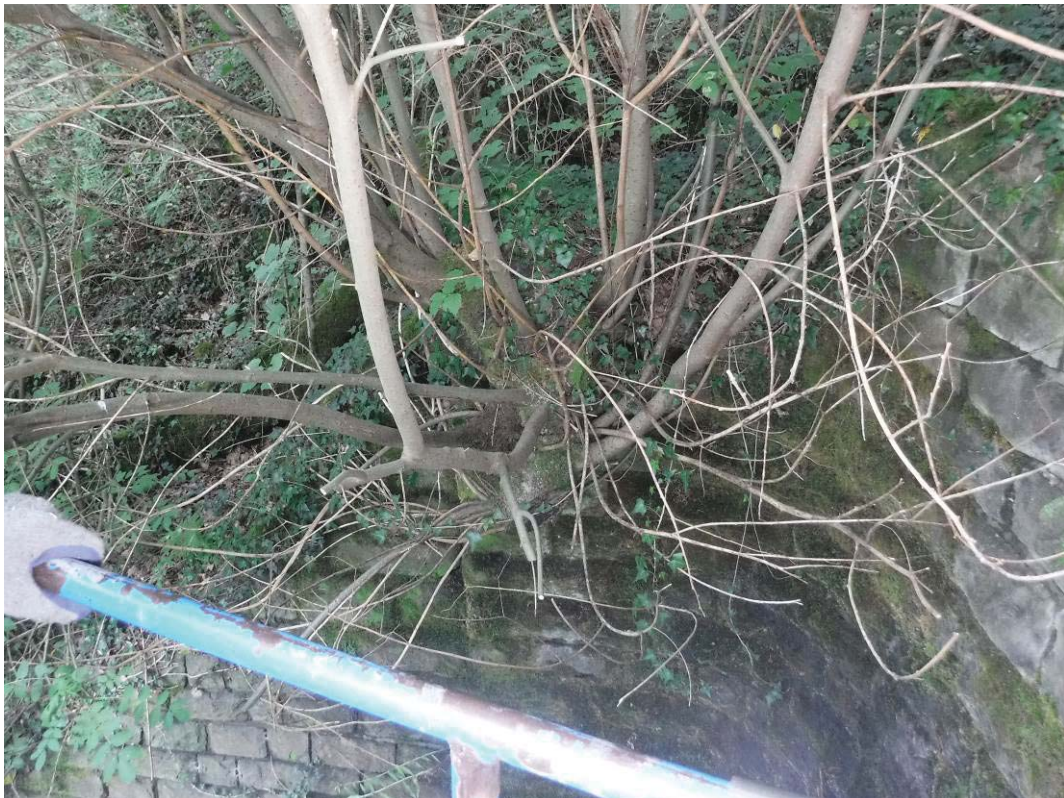
**Photo No.22:** Southwest Portal, Wingwall, trees were removed before 2015 leaving saplings, stumps, tree roots and displaced copings. Loose blocks and open joints, depth 75mm, area 10sq.m.

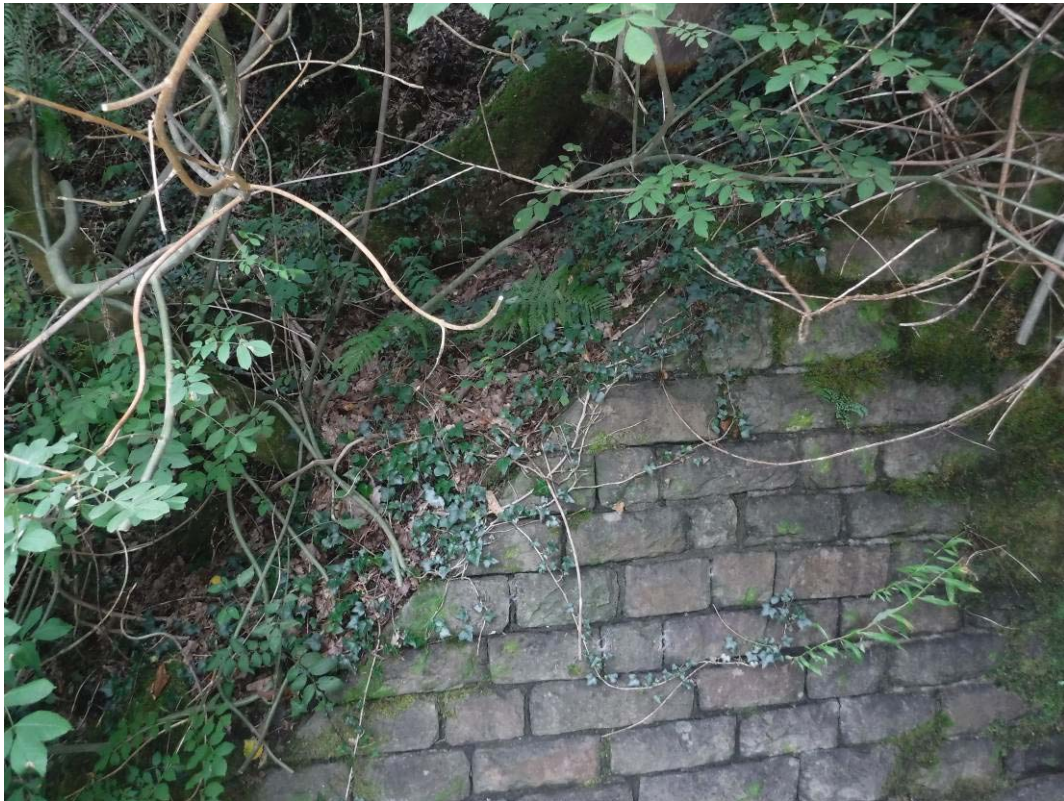
**Photo No.23:** Southwest Portal, Wingwall, trees were removed before 2015 leaving saplings, stumps, tree roots and displaced copings. Loose blocks and open joints, depth 75mm, area 10sq.m.

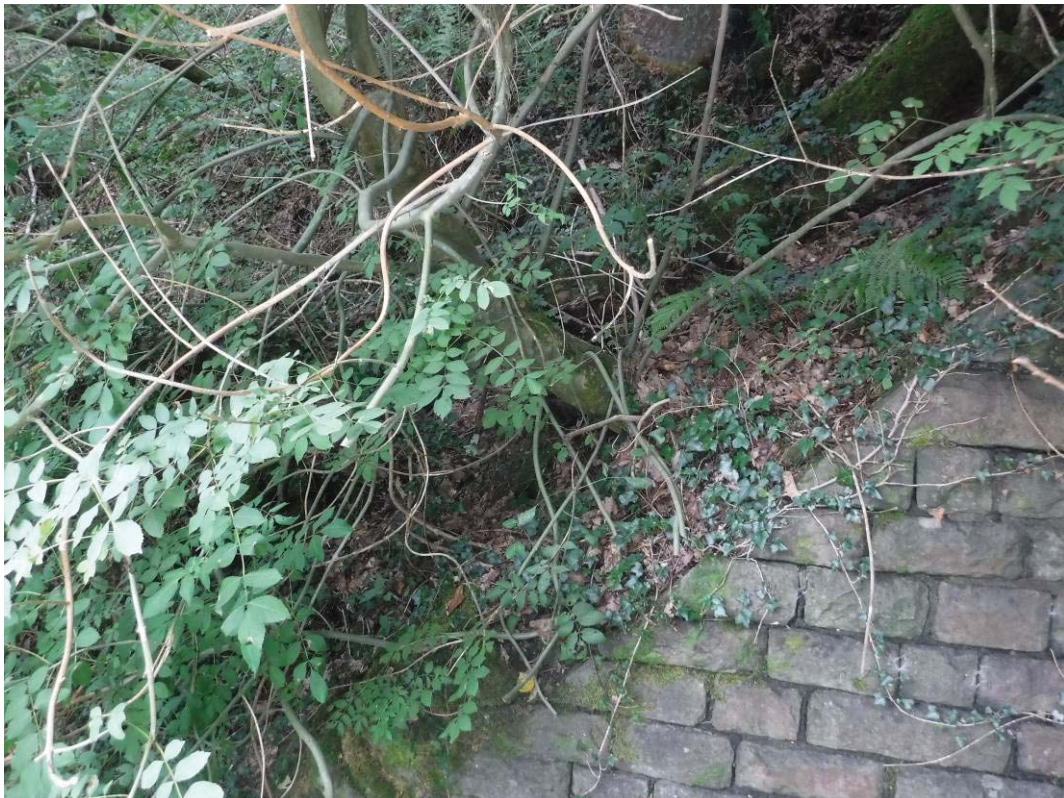
**Photo No.24:** Southwest Portal, Wingwall, trees were removed before 2015 leaving saplings, stumps, tree roots and displaced copings. Loose blocks and open joints, depth 75mm, area 10sq.m.

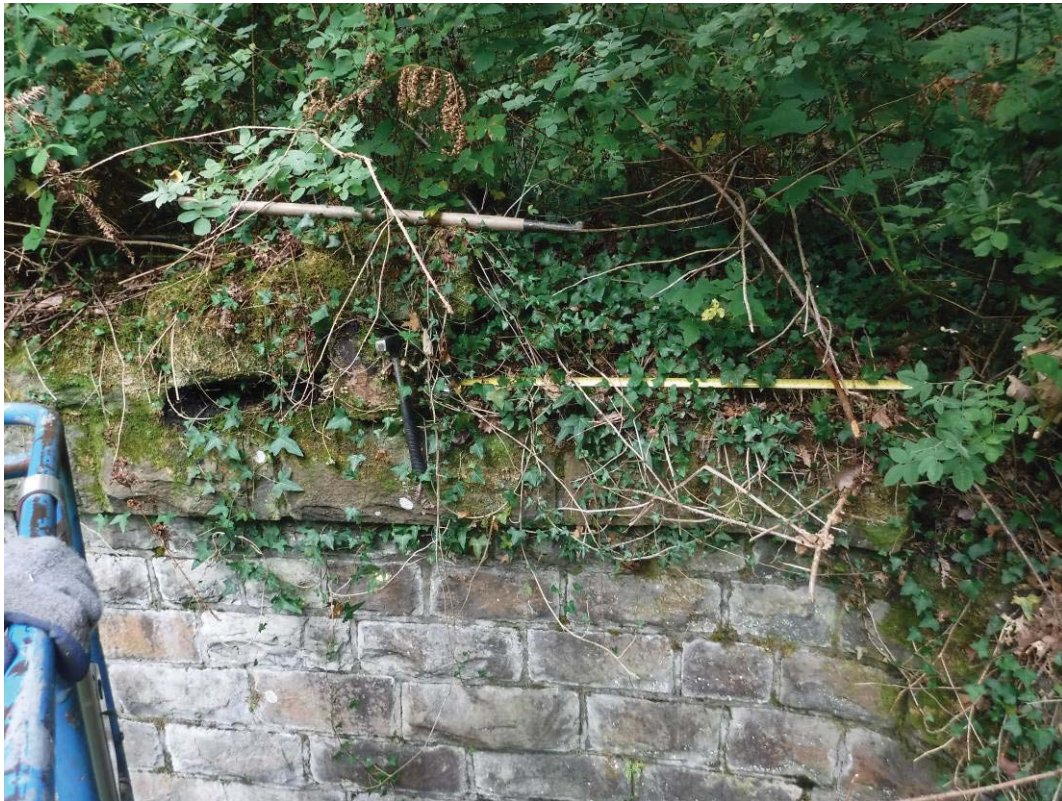
**Photo No.25:** Southwest Portal, Stonework, 8" high half-round copings are missing at end of spandrel, length 3ft and copings displaced by tree roots.

000+00 Portal Down	Southwest Portal, Stonework, 8" high half-round copings are missing at end of spandrel, length 3ft and copings displaced by tree roots.	<b>25</b>	Recommend remove stumps & roots, rebed copings and replace missing copings, Priority 1; work to be completed by 24/08/2019.
000+00 Portal Up & Down	Southwest Portal, Stonework, 8" high half-round copings are missing above the arch, length 6yds.	<b>26</b>	Recommend replace missing copings, Priority 1; work to be completed by 24/08/2019.

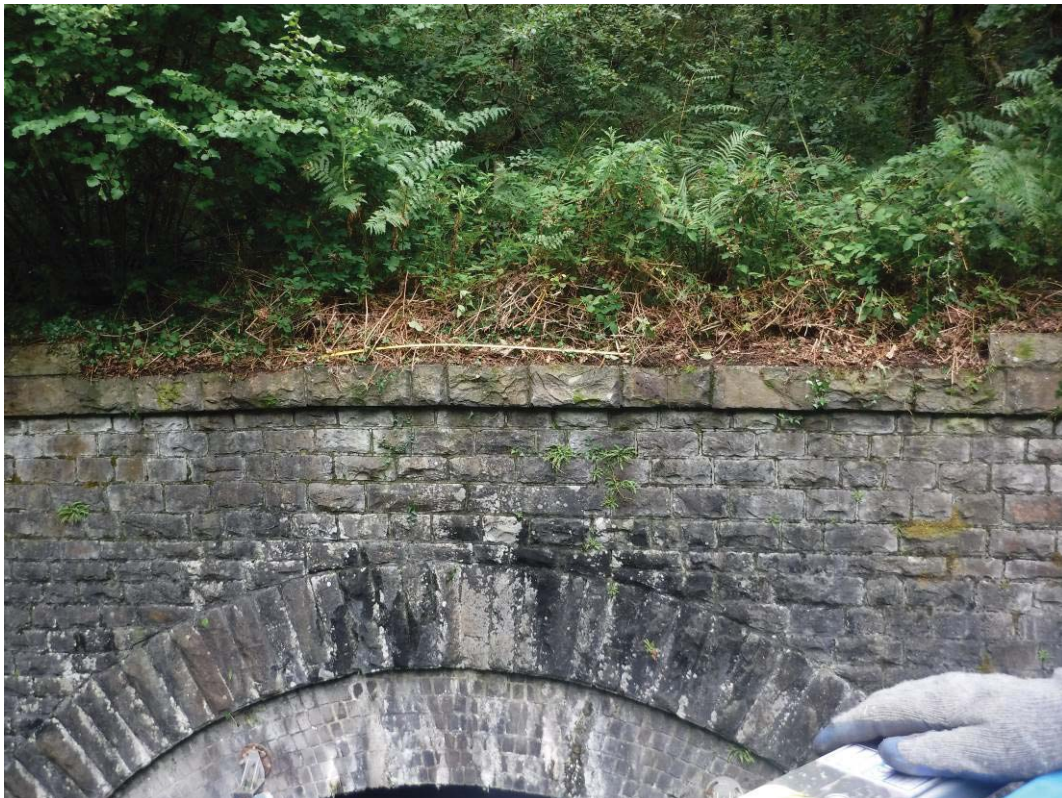
**Photo No.26:** Southwest Portal, Stonework, 8" high half-round copings are missing above the arch, length 6yds.

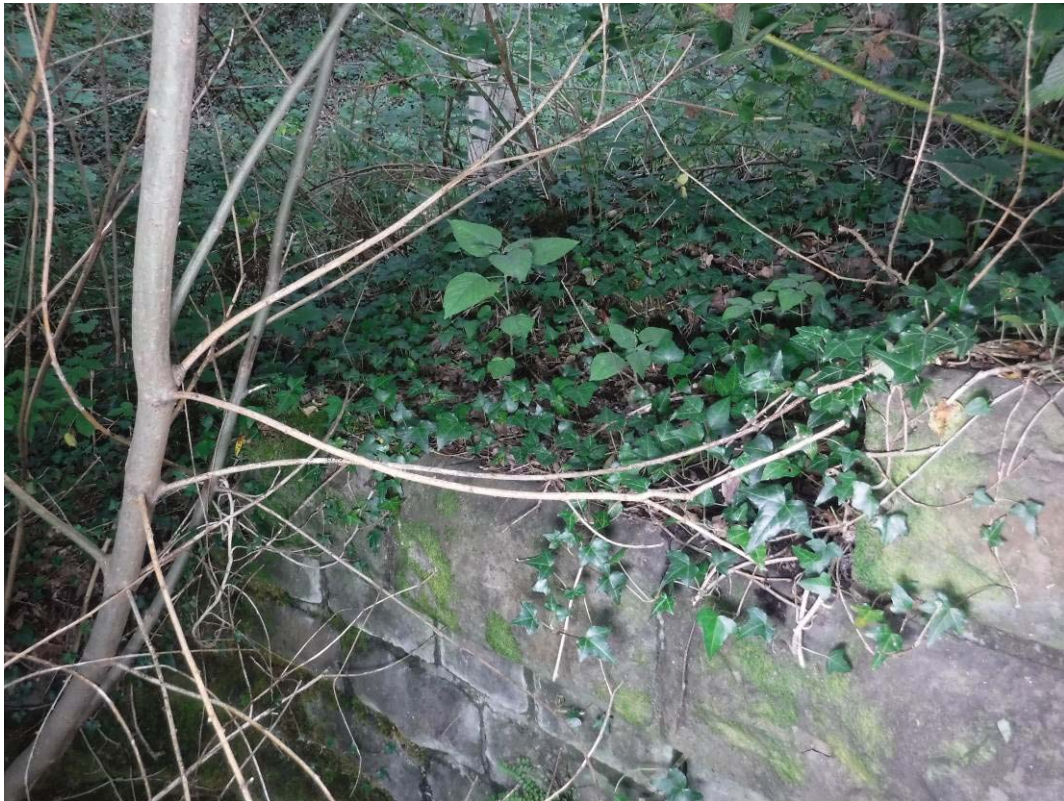
**Photo No.27:** Southwest Portal, Stonework, 8" high half-round copings are missing at end of spandrel, length 4ft.

Location	Defect		Action
000+00 Portal Up	Southwest Portal, Stonework, 8" high half-round copings are missing at end of spandrel, length 4ft.	<b>27</b>	Recommend replace missing copings, Priority 1; work to be completed by 24/08/2019.
000+00 Portal Up	Southwest Portal, Stonework, circumferential open joint to rear of voussoirs, length 1m, max. depth 75mm.	<b>28</b>	Recommend hand point, Priority 3; work to be completed by 24/08/2021.
000+00 Portal Up & Down	Southwest Portal, Stonework, build up of rotting vegetation detritus adding load to the rear of the spandrel and hiding the buried drainage channel (if built).	<b>29</b>	Recommend remove load (and unblock drainage channel if found), Priority 1; work to be completed by 24/08/2019.
000+00 Portal Up & Down	Southwest Portal, Post & wire fence set back approx. 7ft. from top of portal. Top wire missing.	<b>30 &amp; 31</b>	Recommend repair fence, Priority 1; work to be completed by 24/08/2019.

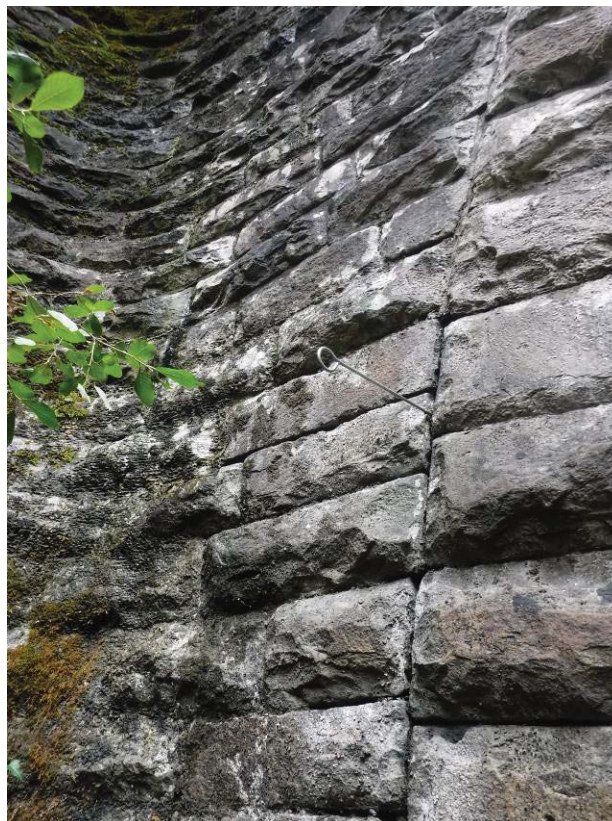
**Photo No.28:** Southwest Portal, Stonework, circumferential open joint to rear of voussoirs, length 1m, max. depth 75mm.

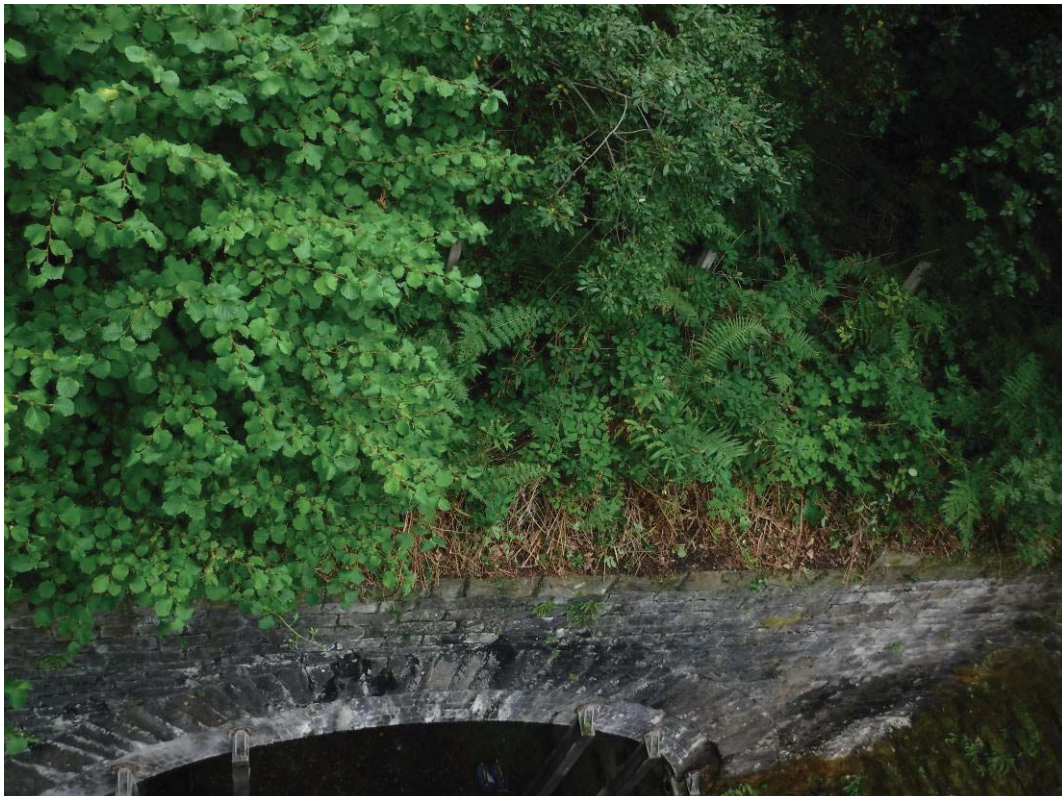
**Photo No.30:** Southwest Portal, Post & wire fence set back approx. 7ft. from top of portal. Top wire missing.

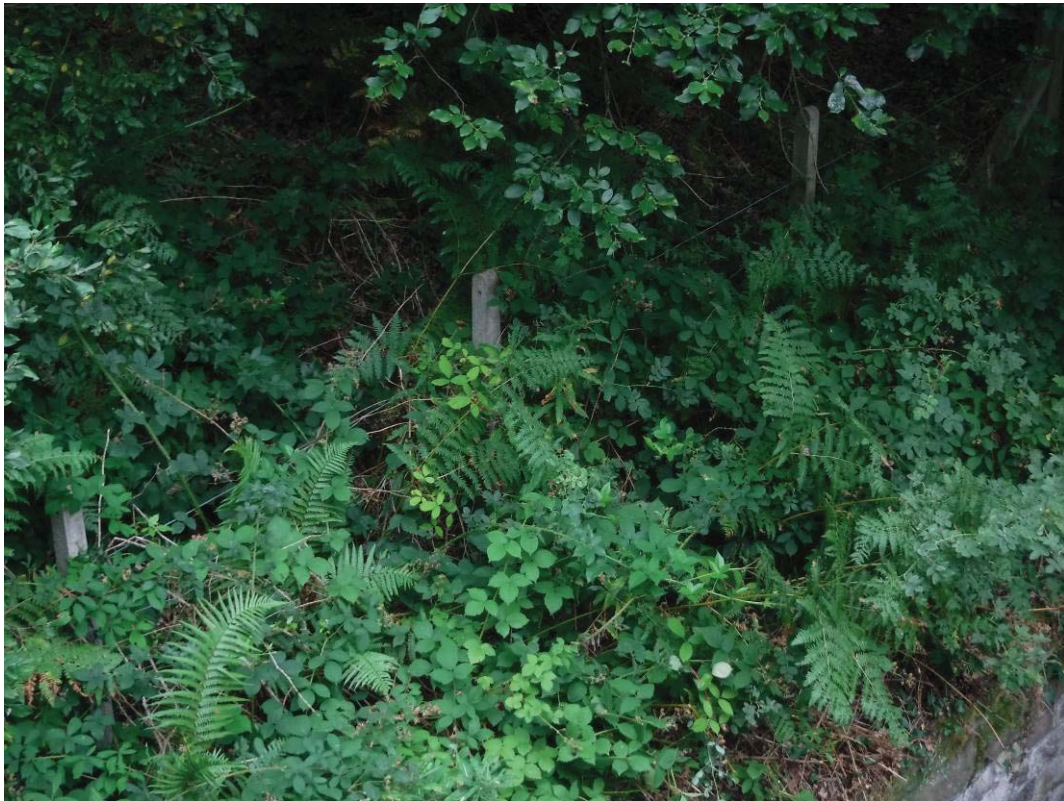
**Photo No.31:** Southwest Portal, Post & wire fence set back approx. 7ft. from top of portal. Top wire missing.

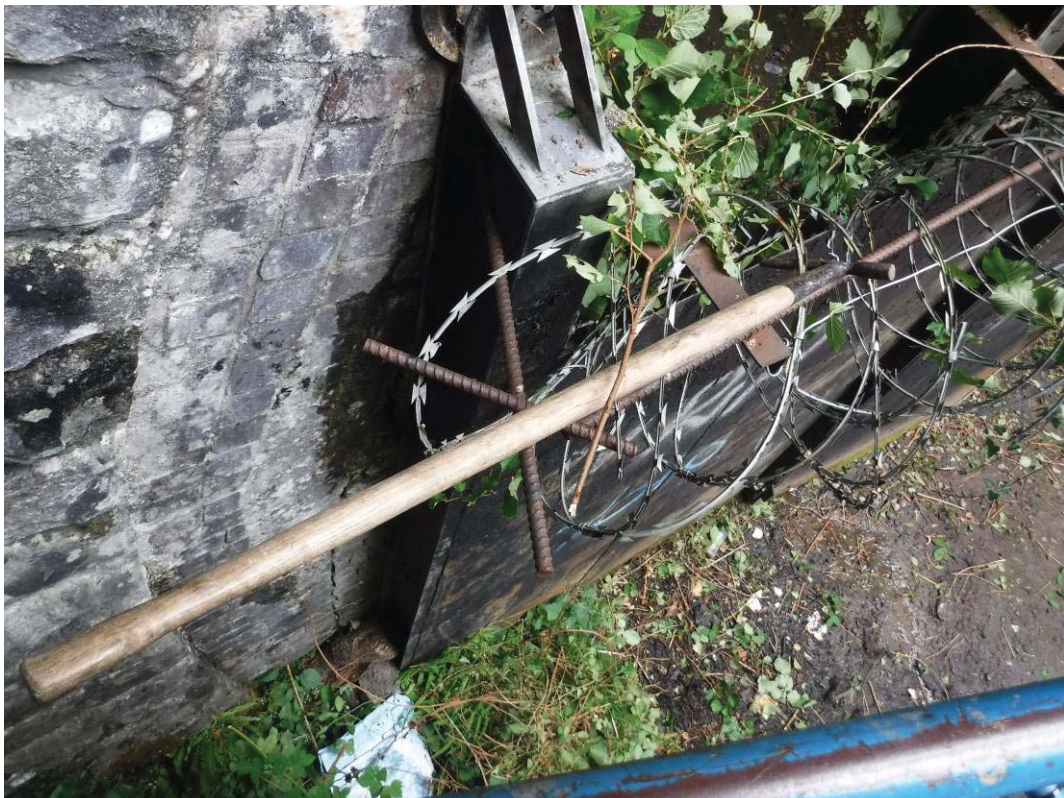
**Photo No.32:** Southwest Portal, Security, again found vandalised at this examination.

000+00 Portal Up	Southwest Portal, Security, again found vandalised at this examination with razor-wire moved aside to aid trespass over the top of the fence. Razor-wire was pushed back across gap during this examination.	<b>32</b>	Recommend re-secure razor-wire and fortify top of fence, Priority 1; work to be completed by 24/08/2019.
000+00 Portal Up & Down	Southwest Portal, oiling hinges.	<b>33</b>	
000+00 Portal Up & Down	Southwest Portal, oiling padlock.	<b>34</b>	
000+00 to 113+20 Full Profile Up & Down	Needle/boyot holes are visible throughout the tunnel.		
000+00 to 113+20 Full Profile Up & Down	General views of detailed examination operations.	<b>35 to 38</b>	
000+00 to 001+12 Crown & Haunch Up & Down	Arch relined in brickwork (archaic) and then recently strengthened with sprayed concrete sometime during the period Jun.2012 and Jul.2013.	<b>39 &amp; 40</b>	
000+00 to 001+12 Crown & Haunch Up & Down	Shotcrete, random multi-directional hairline cracks.

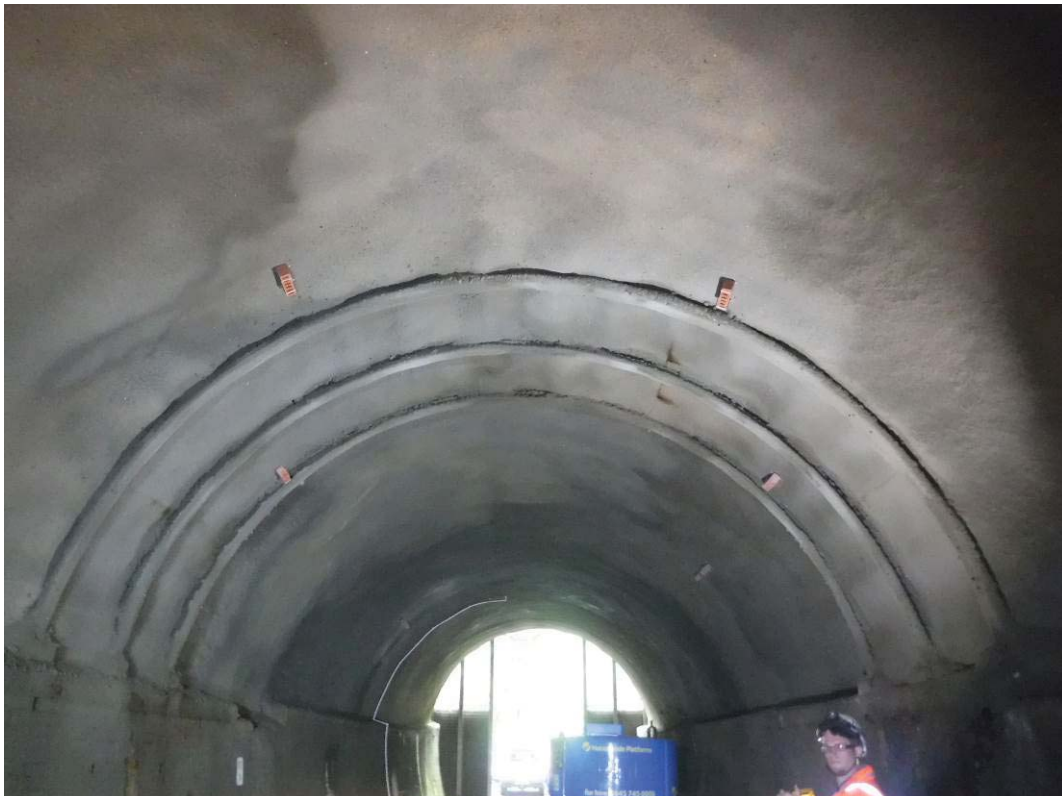
**Photo No.42:** 001+00 to 001+05 Crown & Haunch Up & Down, Railway irons, 3No. old ribs bearing on top of sidewalls still visible under shotcrete, circumferential fractures in shotcrete on bottom flanges, hollow.

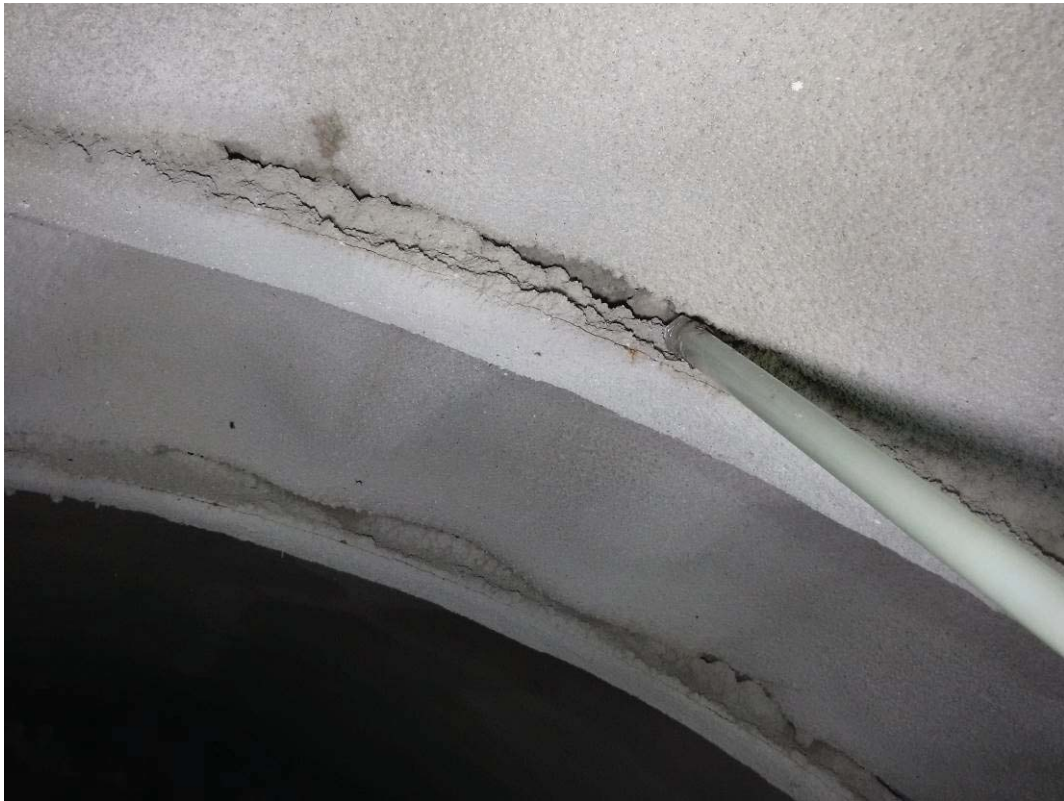
**Photo No.43:** 001+00 to 001+05 Crown & Haunch Up & Down, Railway irons, 3No. old ribs bearing on top of sidewalls still visible under shotcrete, circumferential fractures in shotcrete on bottom flanges, hollow.

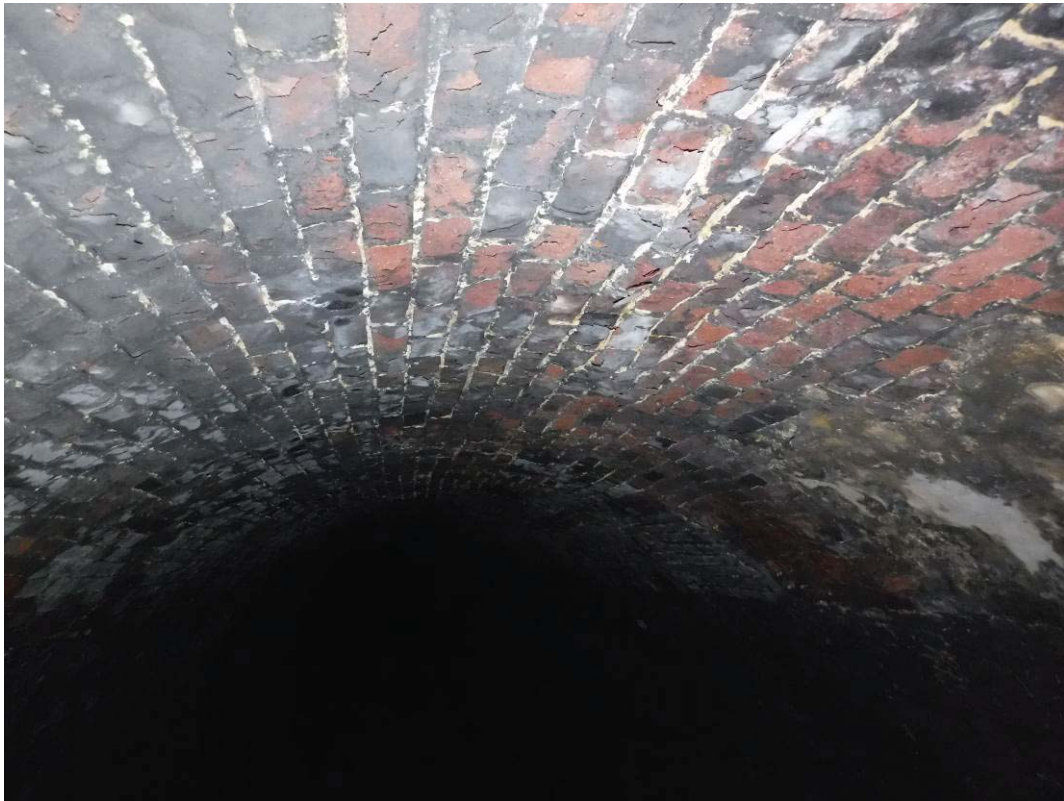
**Photo No.45:** 001+12 to 021+02 Crown & Haunches Up & Down, Brickwork, shelling, loose/hanging, area 2000sq.m., medium (photo taken at ch.11 shows a typical view of condition).

001+12 to 021+02 Crown & Haunches Up & Down	Brickwork, shelling, loose/hanging, area 2000sq.m., medium (photo taken at ch.11 shows a typical view of condition).	<b>45</b> Recommend remove shelling down to firm brickwork and patch repair where necessary, Priority 1; work to be completed by 24/08/2019.
001+13 to 004+13 Haunch Down	Brickwork, Multiple Longitudinal, Circumferential and step fractures, width 10mm. Old standing. Repaired / pointed recently pre-2015. Intact.	
001+18 to 002+20 Sidewalls Up & Down	Timber baulk framework is rotten with some laid to solum and appears to be offering no support to the lining behind.	<b>46</b> Recommend Timbers be removed with a view to checking stability of sidewalls and carry out repairs, Priority 1; work to be completed by 24/08/2019.
002+12 High Haunch Up	Brickwork, 1No. brick missing.	Recommend repair brickwork, Priority 3; work to be completed by 24/08/2021.

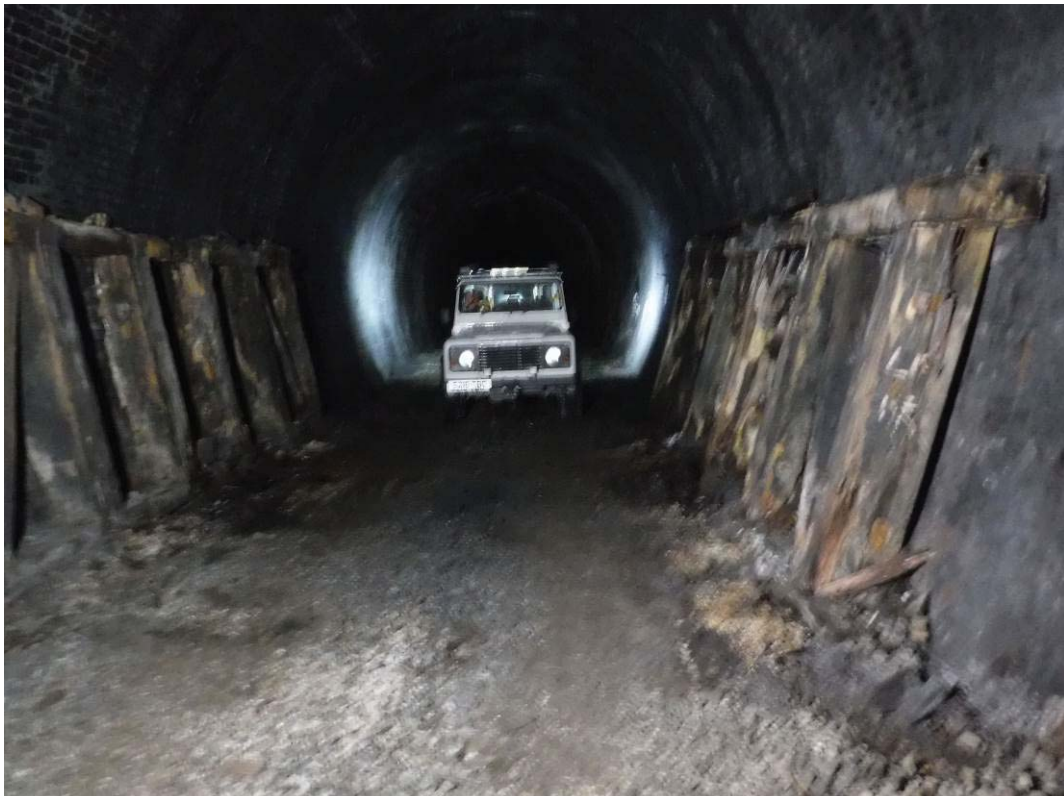
**Photo No.46:** 001+18 to 002+20 Sidewalls Up & Down, Timber baulk framework is rotten with some laid to solum and appears to be offering no support to the lining behind.

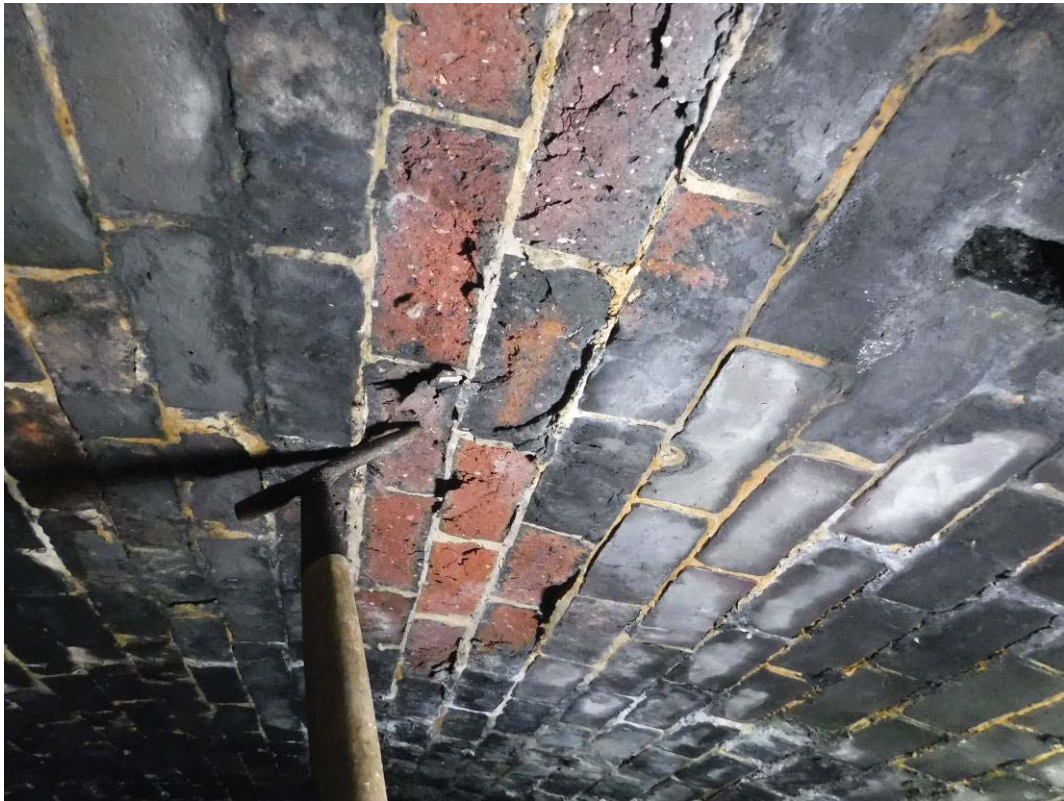
**Photo No.47:** 003+08 Crown Down, Brickwork, spalling, depth 25mm, area 1sq.m., shelling removed during the examination.

003+08 Crown Down	Brickwork, spalling, depth 25mm, area 1sq.m., shelling removed during the examination.	<b>47</b> Recommend repair brickwork, Priority 3; work to be completed by 24/08/2021.
004+16 Crown Up & Down	Brickwork, spalling, depth 50-75mm, area 1sq.m., medium, shelling removed during the examination.	<b>48</b> Recommend repair brickwork, Priority 1; work to be completed by 24/08/2019.
004+17 to 006+00 Full Profile Up & Down	Brickwork, multiple random fractures, max. width 10mm, old standing.	Some defects have been repaired / pointed pre-2015. Intact.
005+06 Full Profile Up	Brickwork, circumferential fracture, max. width 3mm, length 7m, wet, old standing.

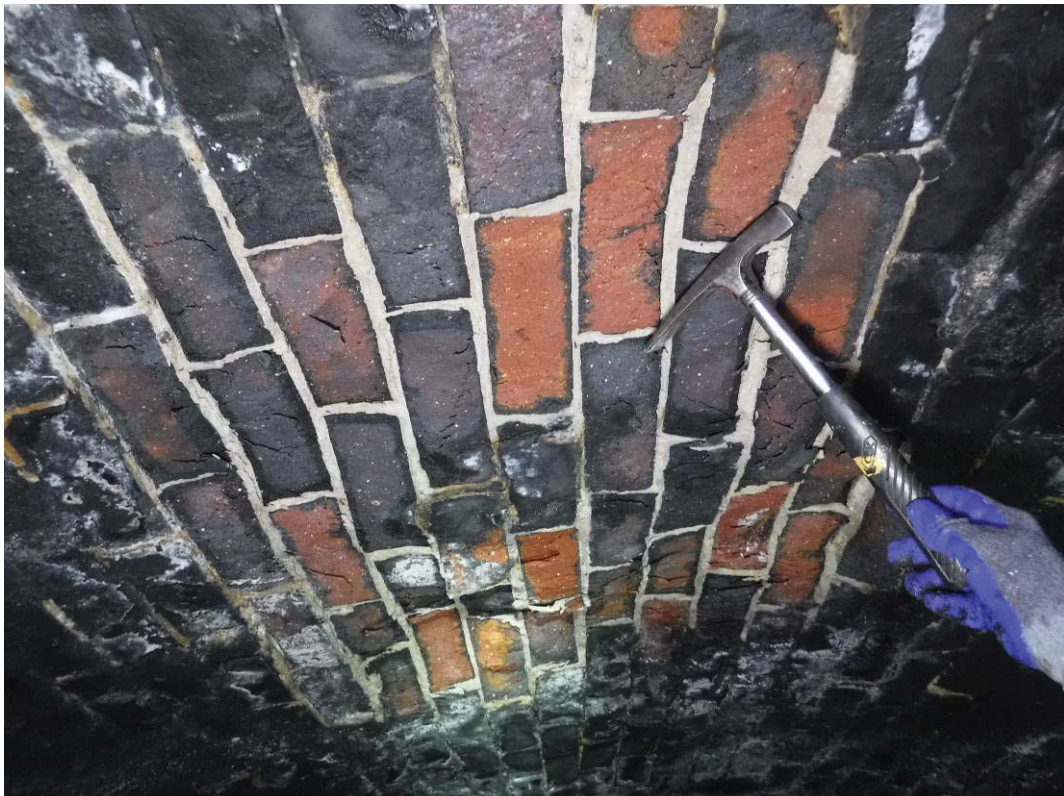
**Photo No.48:** 004+16 Crown Up & Down, Brickwork, spalling, depth 50-75mm, area 1sq.m., medium, shelling removed during the examination.

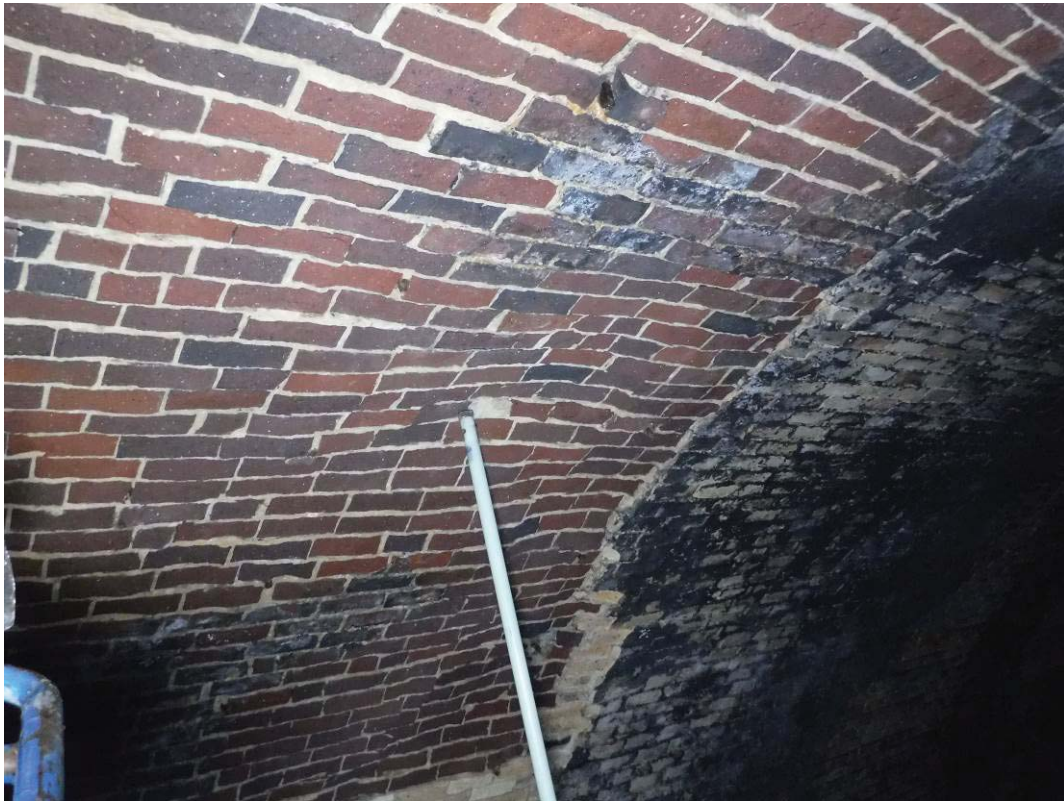
**Photo No.53:** 009+11 to 009+18 Crown & Haunch Down, Brickwork, spalling, depth 50-75mm, area 30sq.m., shelling removed during the examination.

009+11 to 009+18 Crown & Haunch Down	Brickwork, spalling, depth 50-75mm, area 30sq.m., shelling removed during the examination.	<b>53</b>	Recommend brickwork be replaced, Priority 1; work to be completed by 24/08/2019.
009+13 Sidewall Down	Brickwork, hollow, area 16sq.m.		
009+19 Sidewall Up	Brickwork, hollow, shelling/spalling, depth 50mm, area 9sq.m.		
010+00 Crown Up & Down	Brickwork, spalling, depth 50mm, area 1sq.m., spalling removed during the examination.		
010+02 Refuge Down	Brickwork, circumferential fractures inside quoins & arch returns, width 2mm, length 8m, hollow, area 2sq.m.		Recommend repair brickwork, Priority 2; work to be completed by 24/08/2020.
010+02 Sidewall Up	Old brick works cabin.	<b>54</b>	
010+04 Crown Down	Brickwork, spalling, depth 50mm, area 0.5sq.m., large section of hanging spalling removed during the examination.	<b>55 &amp; 56</b>	Recommend brickwork be replaced, Priority 1; work to be completed by 24/08/2019.

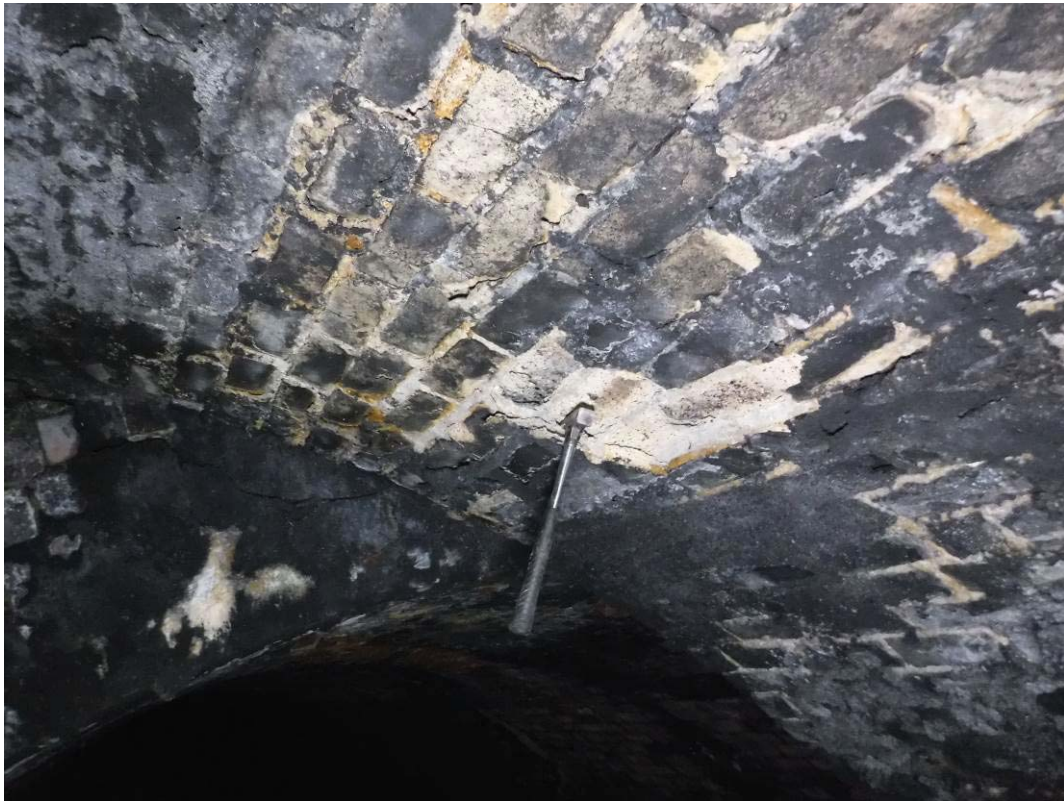
**Photo No.55:** 010+04 Crown Down, Brickwork, spalling, depth 50mm, area 0.5sq.m., large section of hanging spalling removed during the examination.

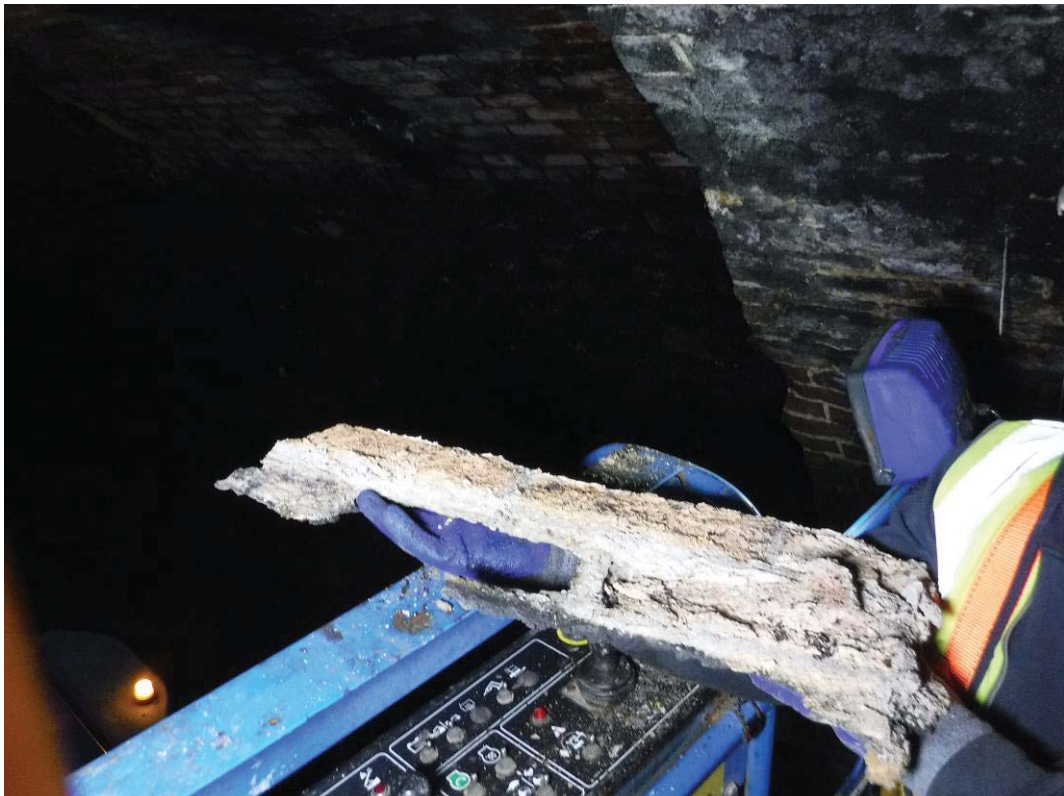
**Photo No.56:** 010+04 Crown Down, Brickwork, spalling, depth 50mm, area 0.5sq.m., large section of hanging spalling removed during the examination.
