**TUNNEL EXAMINATION REPORT  
PHOTOGRAPHS OF STRUCTURE**

ELR : PTP Br. No. : 00

Mileage : 05 M 08 Ch Sheet 1 of 15

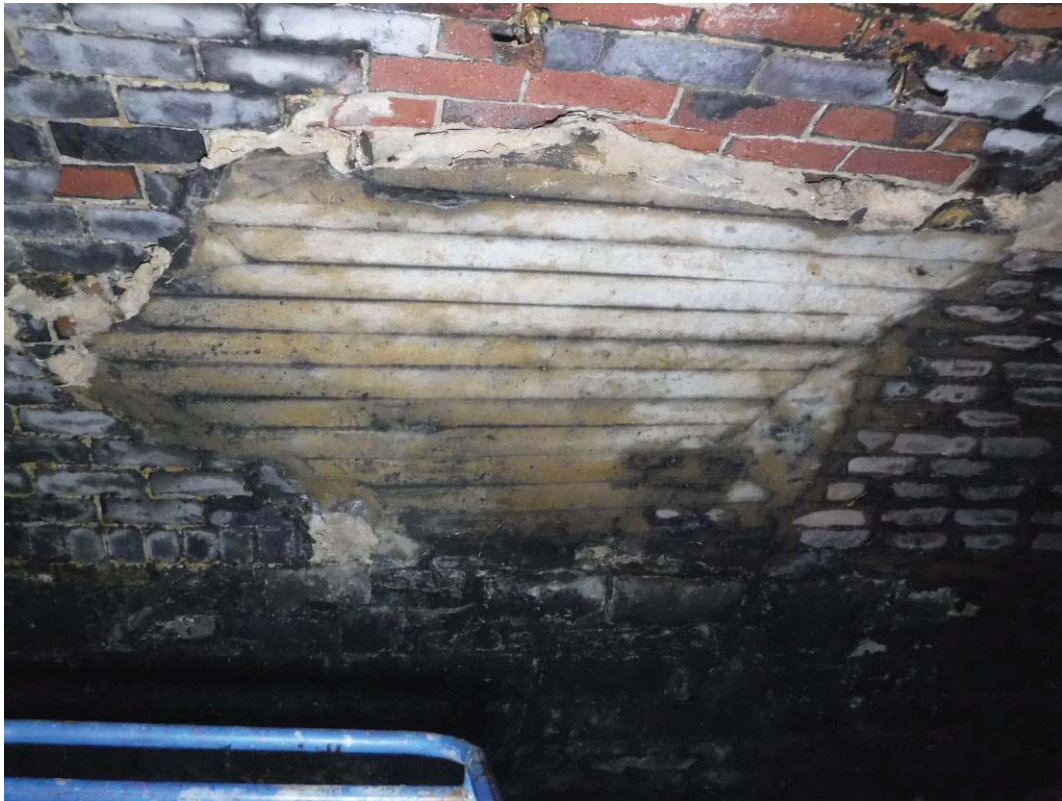
**Photo No.59:** 010+12 High Haunch Down, Old concrete patch repair, hollow / potentially loose, area 2sq.m.

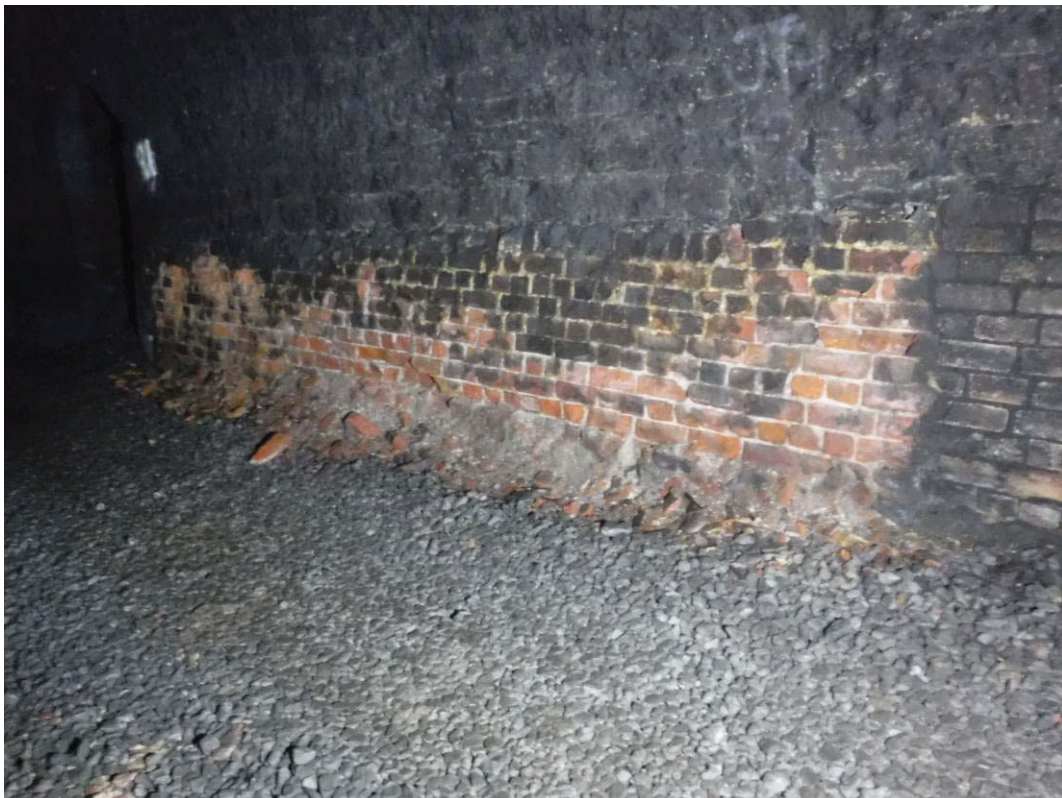
**Photo No.60:** 010+14 Sidewall Up, Brickwork, spalling, depth 75mm, area 5sq.m.

010+14 Sidewall Up	Brickwork, spalling, depth 75mm, area 5sq.m.	60 Recommend brickwork be replaced, Priority 1; work to be completed by 24/08/2019.
010+16 to 012+09 Sidewalls Up & Down	Stonework.	
010+17 Crown Up & Down	Brickwork, window, 750mm x 350mm x depth 1.7m. Old standing. 5course brickwork supporting random stones, rotten timbers and natural rock.	
010+17 Sidewall Up	Stonework, window.	
011+05 Crown Up & Down	Brickwork, shelling, depth 25mm, area 4sq.m.	
011+17 Crown Up & Down	Brickwork, window, 400mm x 700mm x depth 800mm. Old standing. 6course brickwork supporting natural rock.	
012+08 Sidewall Down	Stonework, vertical fracture, length 3m, width max. 4mm, old standing.	
012+09 to 016+08 Full Profile Up & Down	Various sections repaired with brickwork. Some sections of natural rock faces.	61
012+10 Sidewall Down	Brickwork, vertical fracture, length 3m, width 3mm, old standing.	
012+11 to 013+02 Sidewalls Up & Down	Brickwork, numerous vertical fractures, height 3m, max. width 3mm. Some pointed pre-2015, intact.

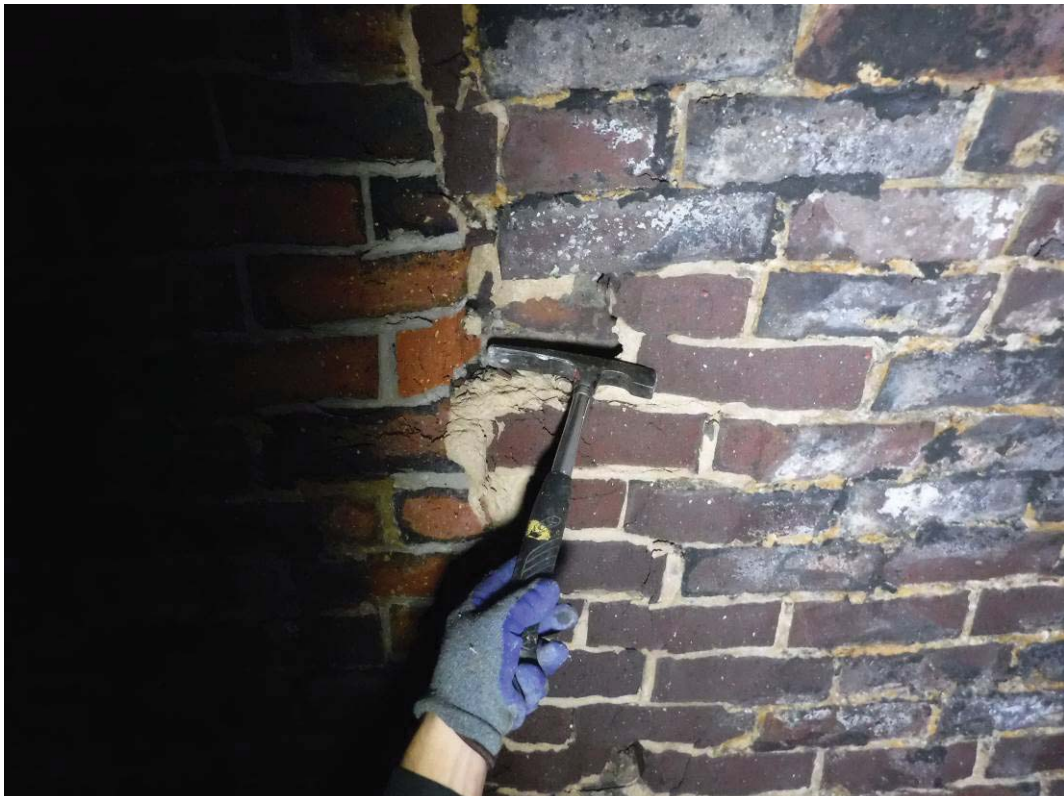
**Photo No.62:** 013+03 Crown & Haunch Down, Brickwork, spalling, depth 75-100mm, area 2sq.m.

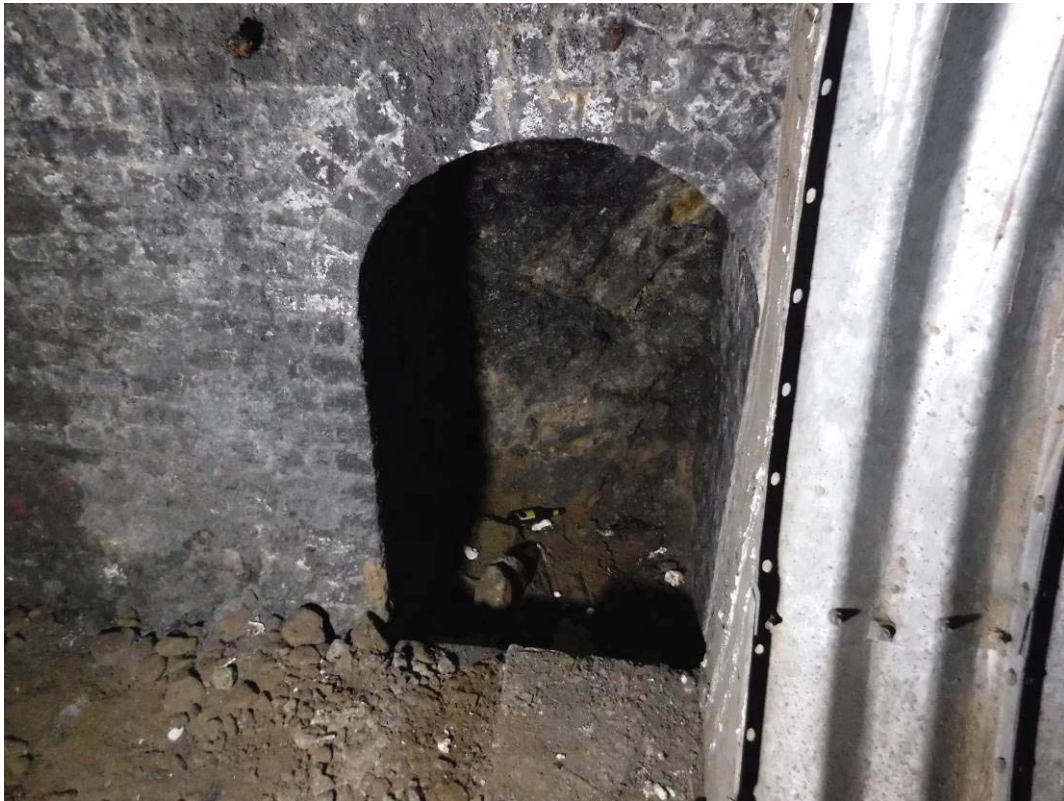
**Photo No.77:** 026+06 Refuge Down, Fall hazard due to ramp sloped up to invert of new tube.

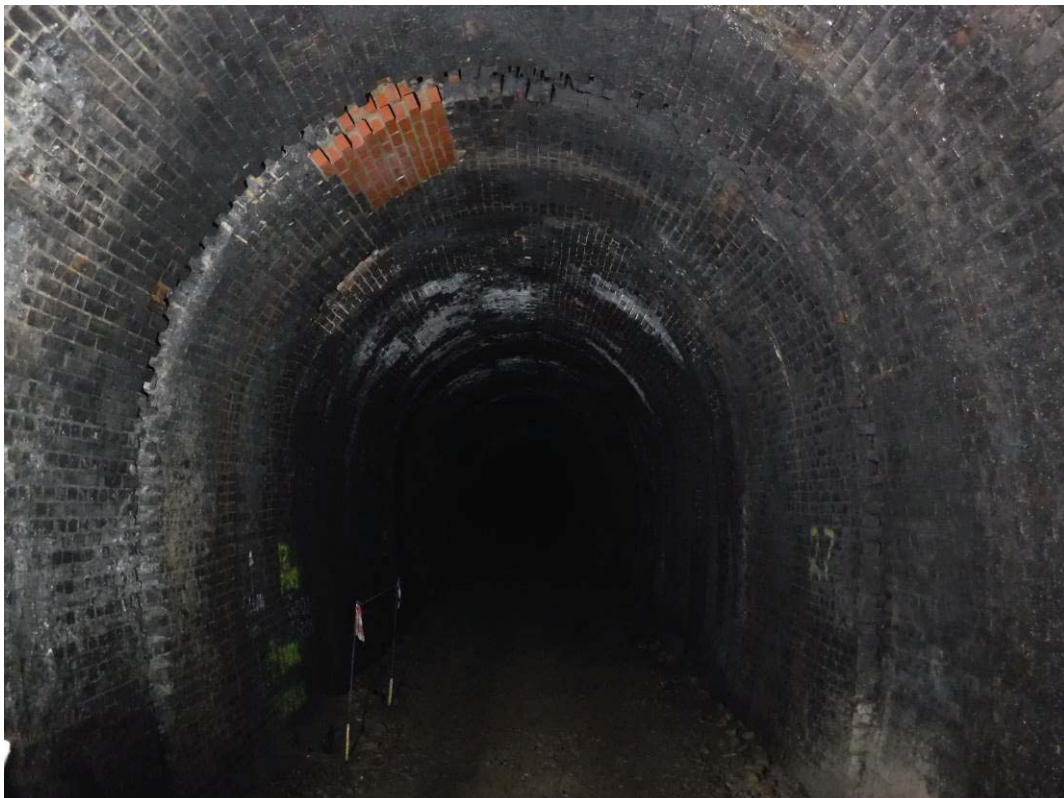
**Photo No.78:** 026+11 Full Profile Up & Down, Arch steps in 100mm, bore narrows towards NE, open construction joint. 026+15 Cess Up, Open catch-pit.

026+15 Cess Up	Open catch-pit (see photo 78).	<b>78</b>	Recommend catch-pit cover be replaced, Priority 1; work to be completed by 24/08/2019.
