**TUNNEL EXAMINATION REPORT  
PHOTOGRAPHS OF STRUCTURE**

ELR : MER Br. No. : 00

Mileage : 03 M 37 ch Sheet 41 of 79

<b>ELR:</b>	BLE	<b>Structure No:</b>		<b>Mileage:</b>	187m 64ch	<b>Examination date:</b>	14/11/17
<b>Route:</b>	Barnstaple Branch Line					<b>OS ref:</b>	SS 871 261
<b>Name:</b>	East Anstey Tunnel					<b>Type:</b>	Tunnel

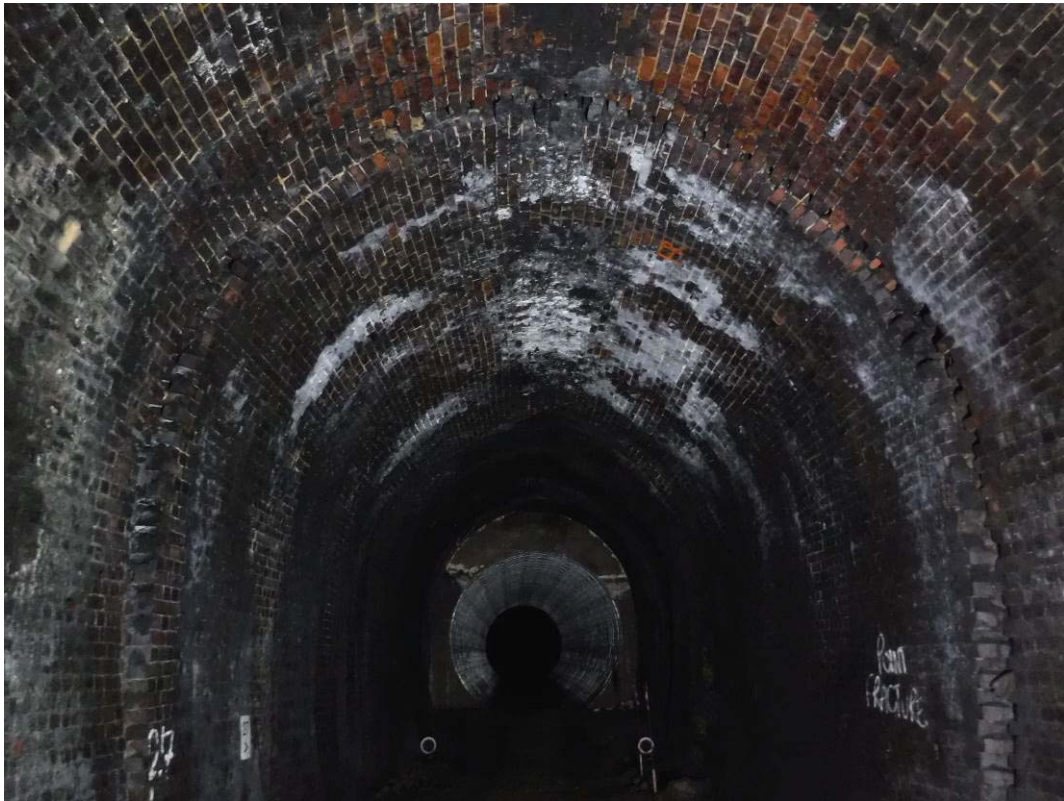
**Photo No.79:** 027+02 Full Profile Up & Down, Arch steps out 100mm, bore increases towards NE, open construction joint.

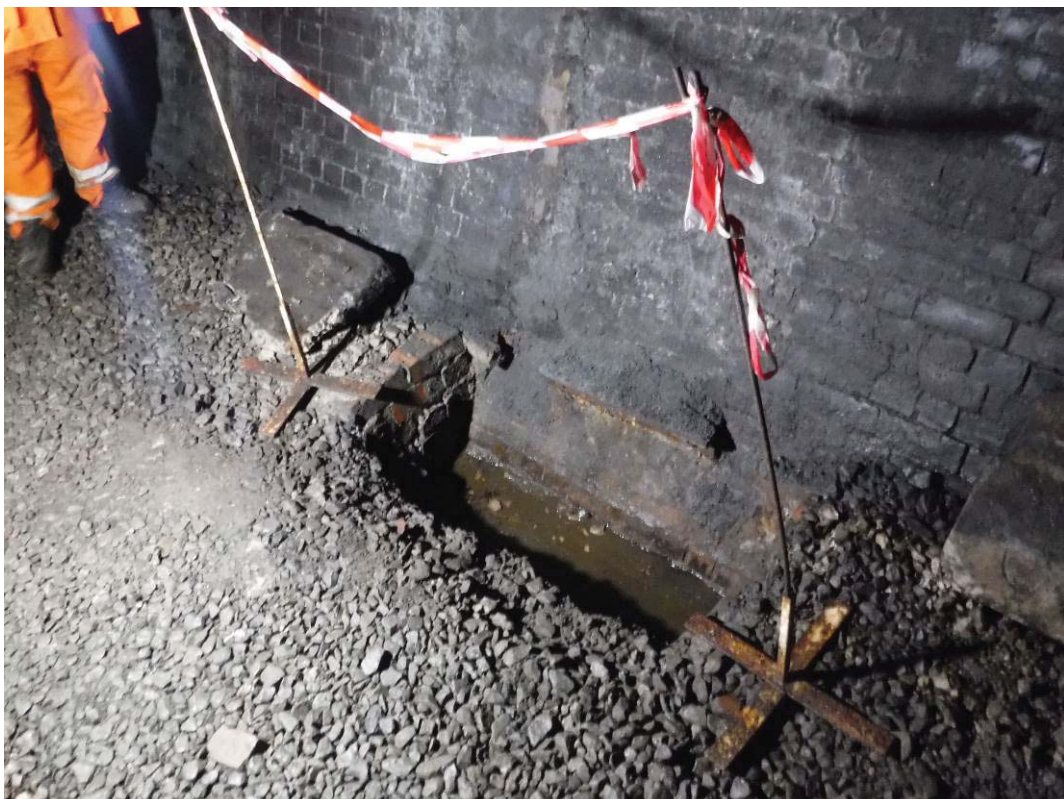
**Photo No.80:** 027+16 Cess Up, Open catch-pit.

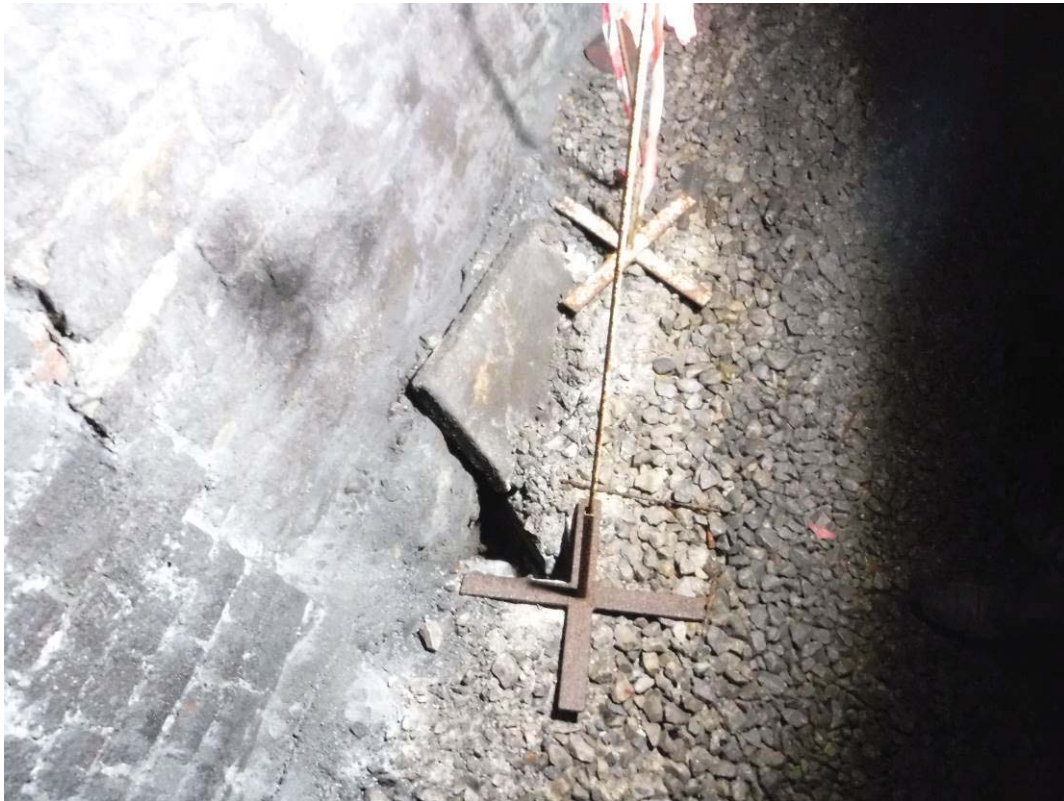
**Photo No.81:** 028+21 Cess Up, Open catch-pit.

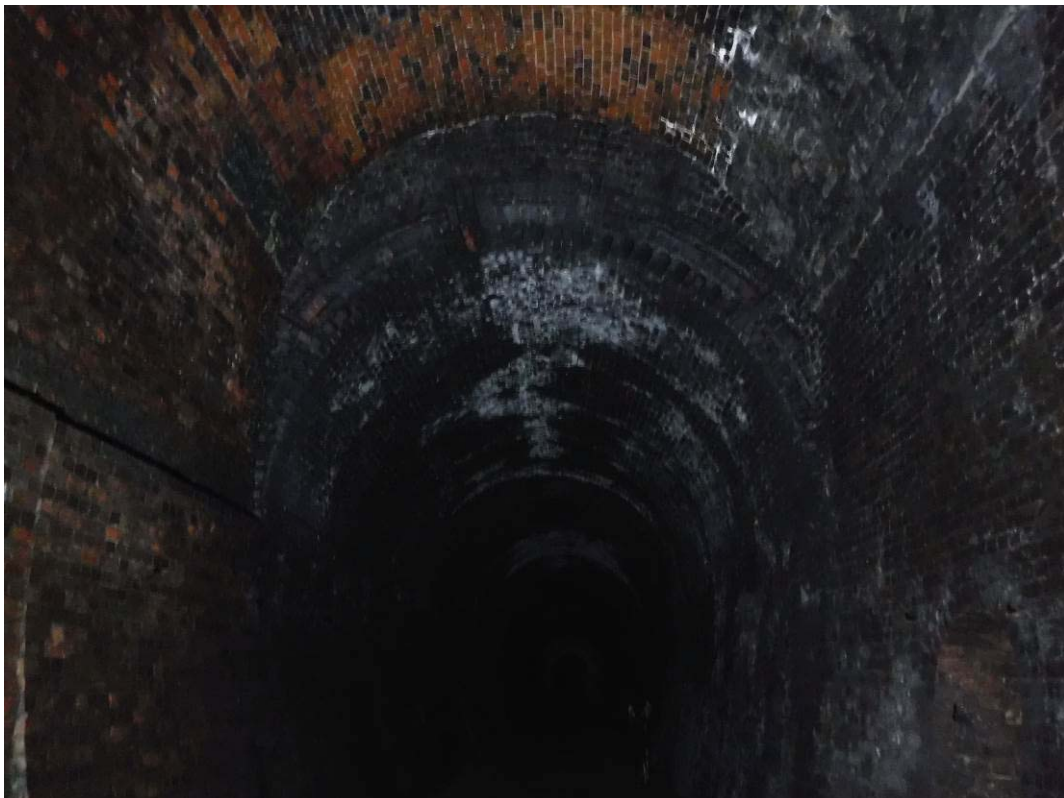
**Photo No.82:** 029+09 Crown & Haunch Up & Down, Arch steps up 2m, bore increases towards NE.

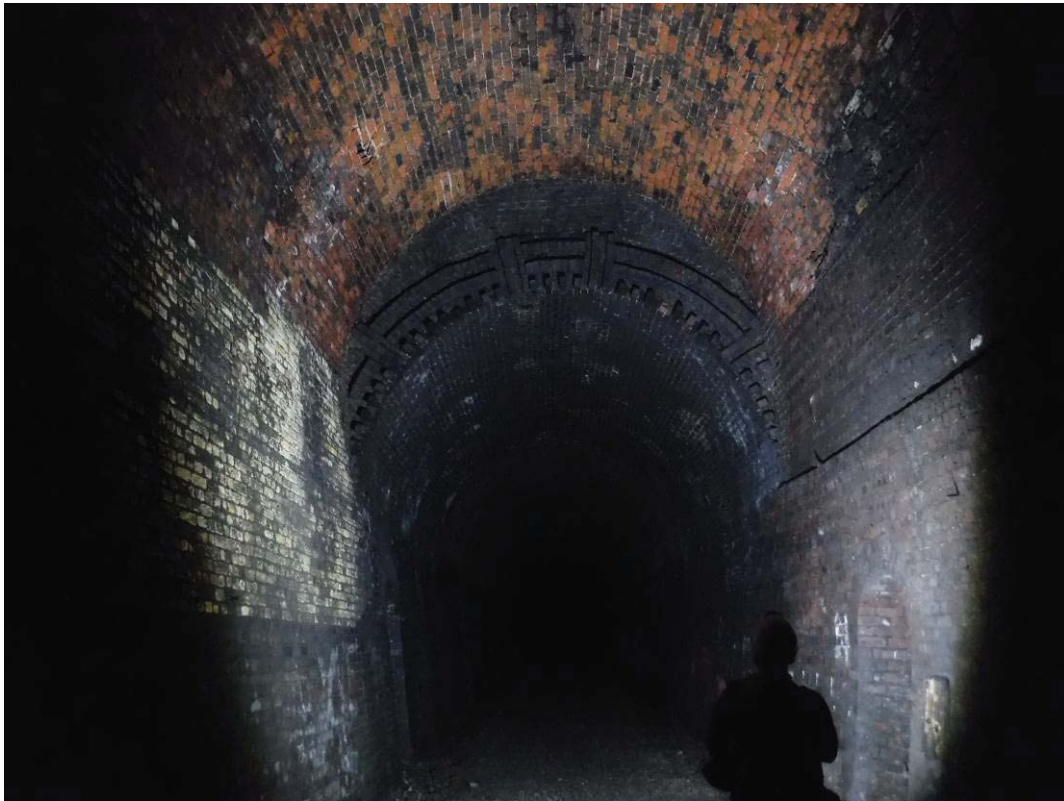
**Photo No.83:** 030+15 Crown & Haunch Up & Down, Arch steps down 2m, bore decreases towards NE.

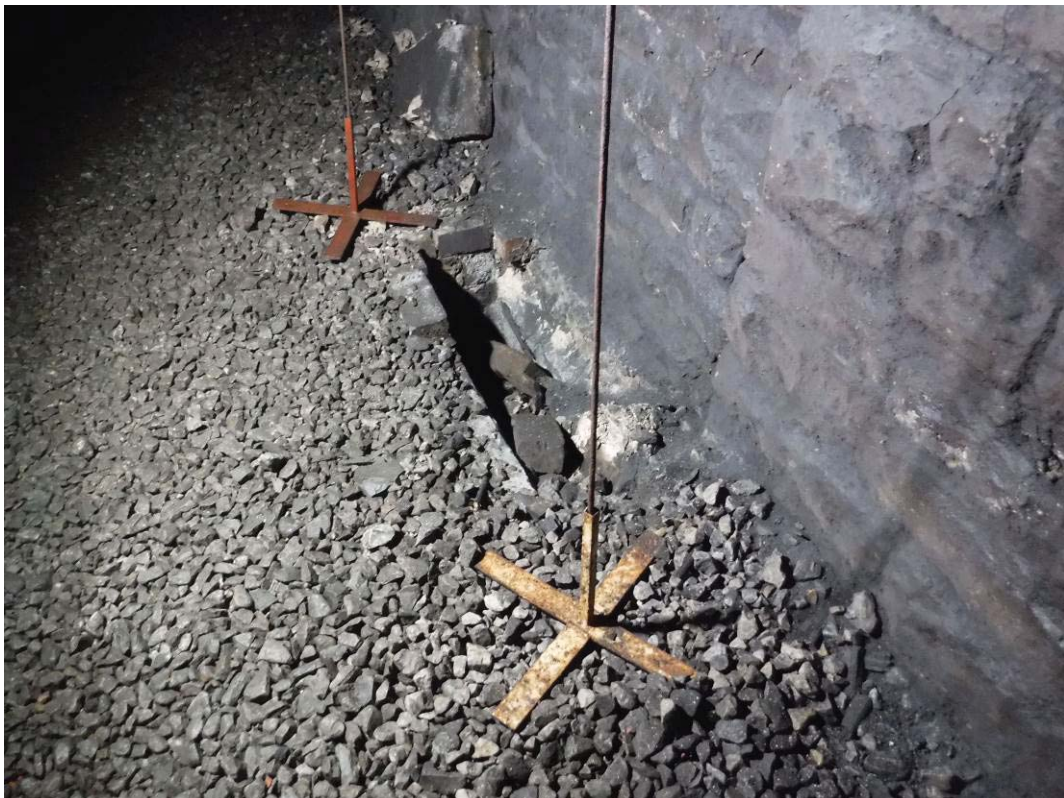
**Photo No.84:** 029+15 Cess Up, Open catch-pit.

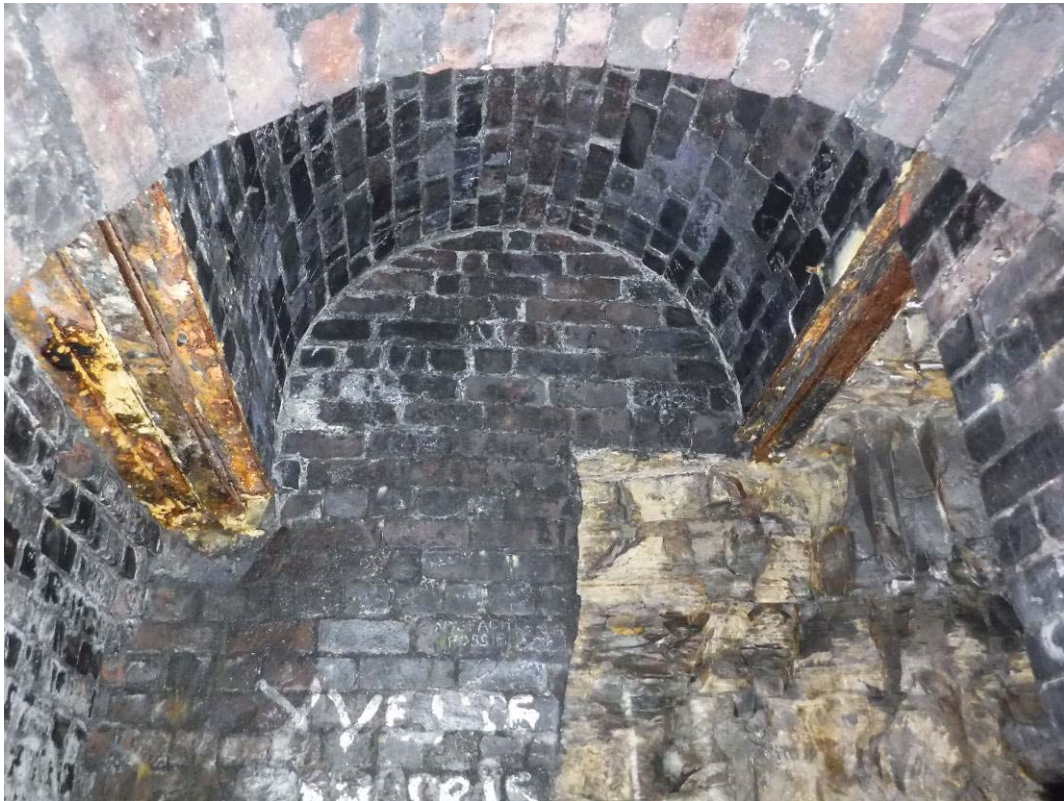
**Photo No.85:** 030+17 Sidewall Up, Old cabin built behind Refuge, old bullhead rail used as lintels for entrance are heavily corroded.

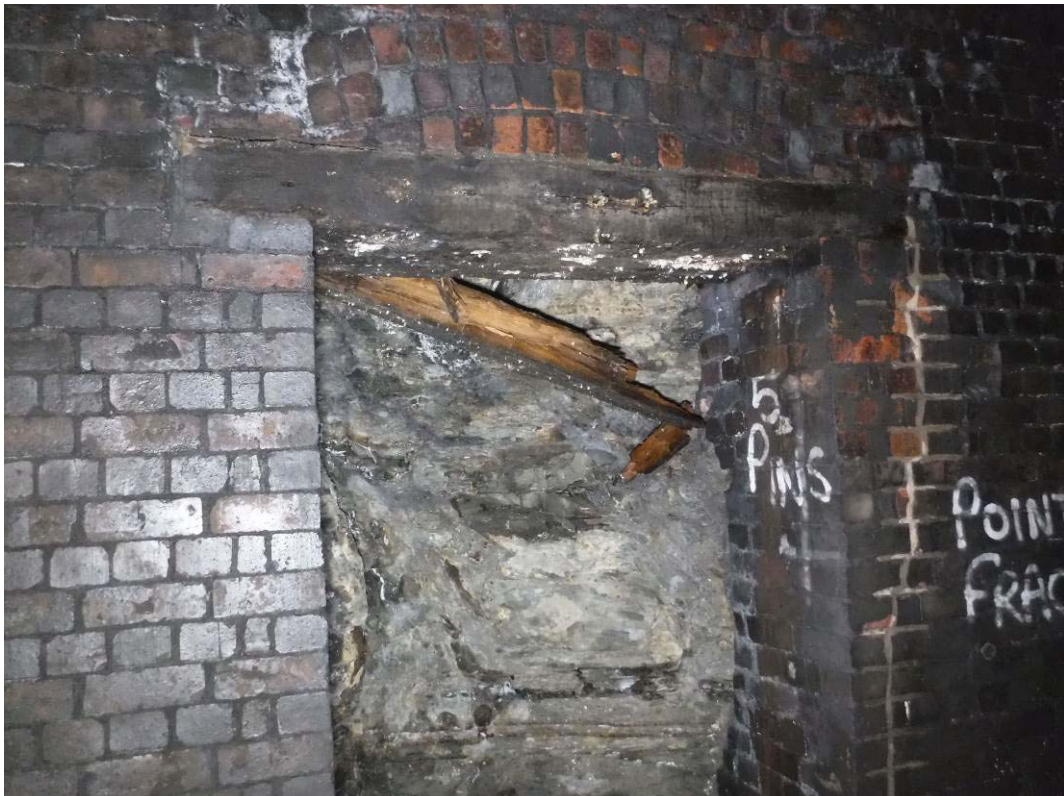
**Photo No.86:** 031+12 Refuge Up, Brickwork, rail sleeper lintel supports brick arch, timber section to rear rotten and hanging.

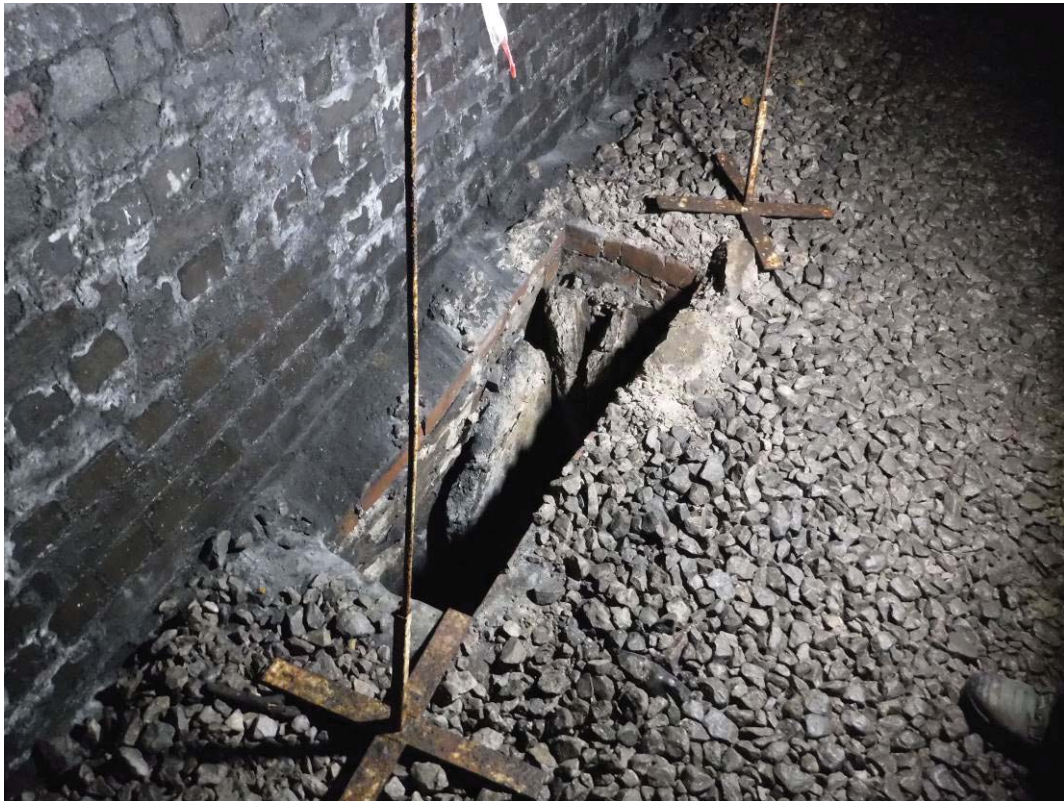
**Photo No.87:** 032+15 Cess Up, Open catch-pit.

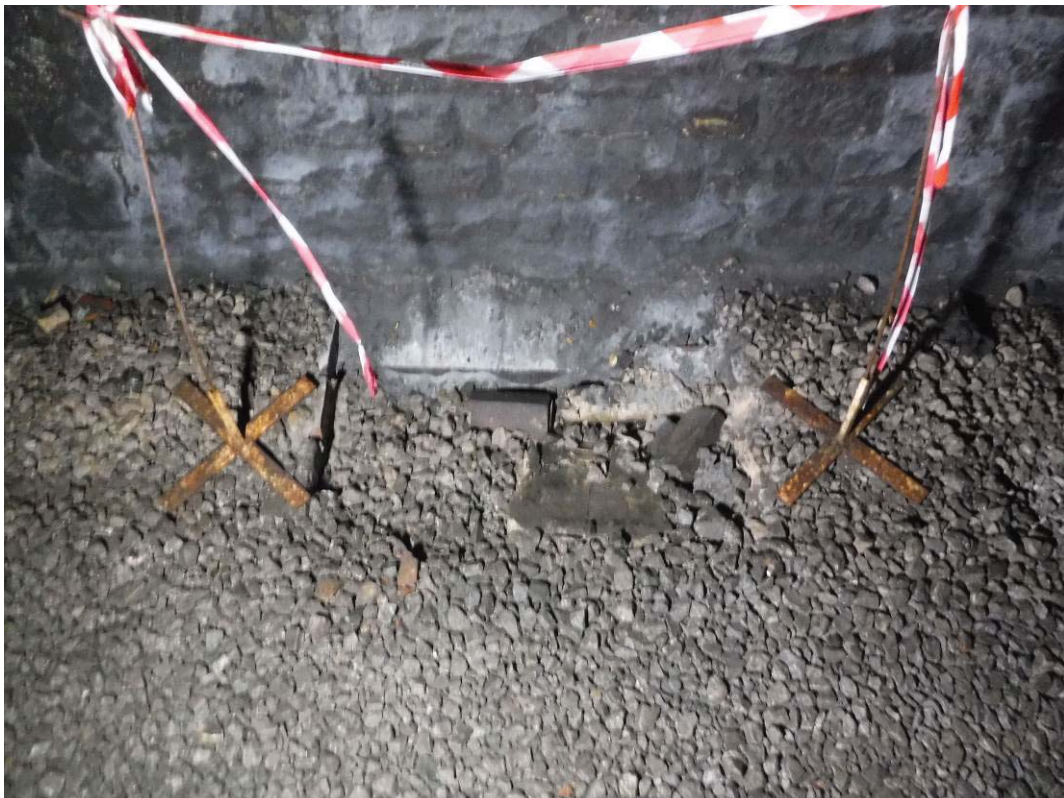
**Photo No.88:** 032+15 Cess Up, Open catch-pit.

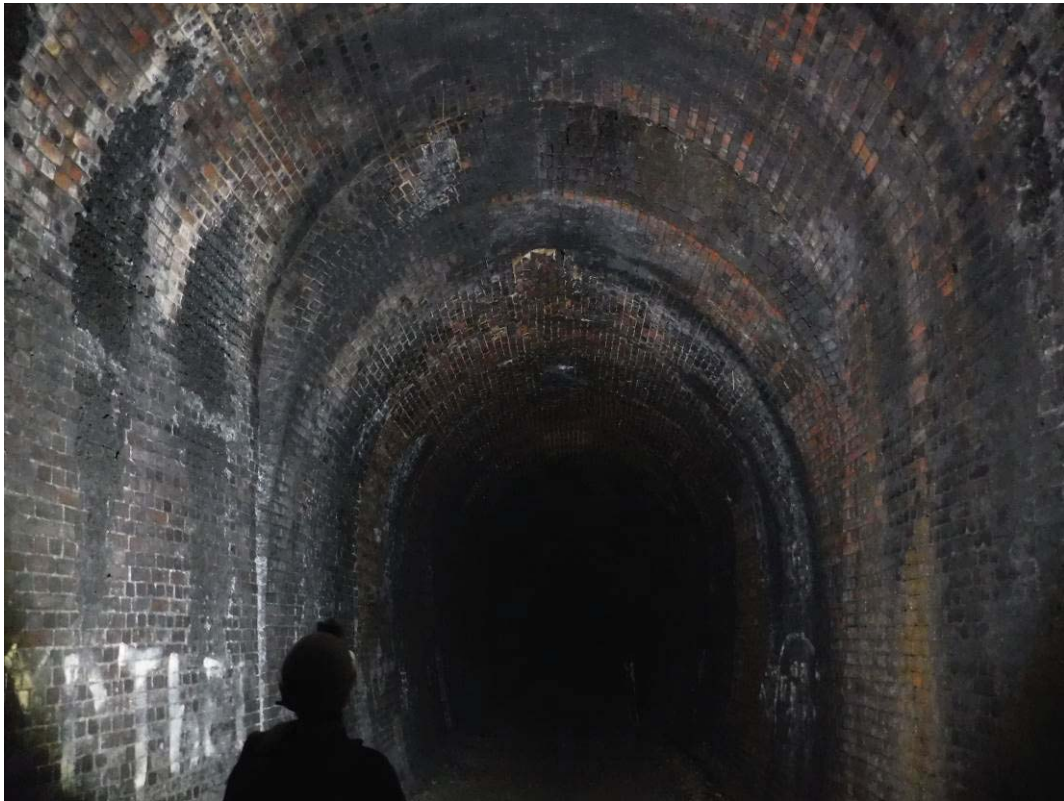
**Photo No.89:** 033+09 Crown & Haunch Up & Down, Brickwork, arch steps up 600mm, bore increases towards NE.

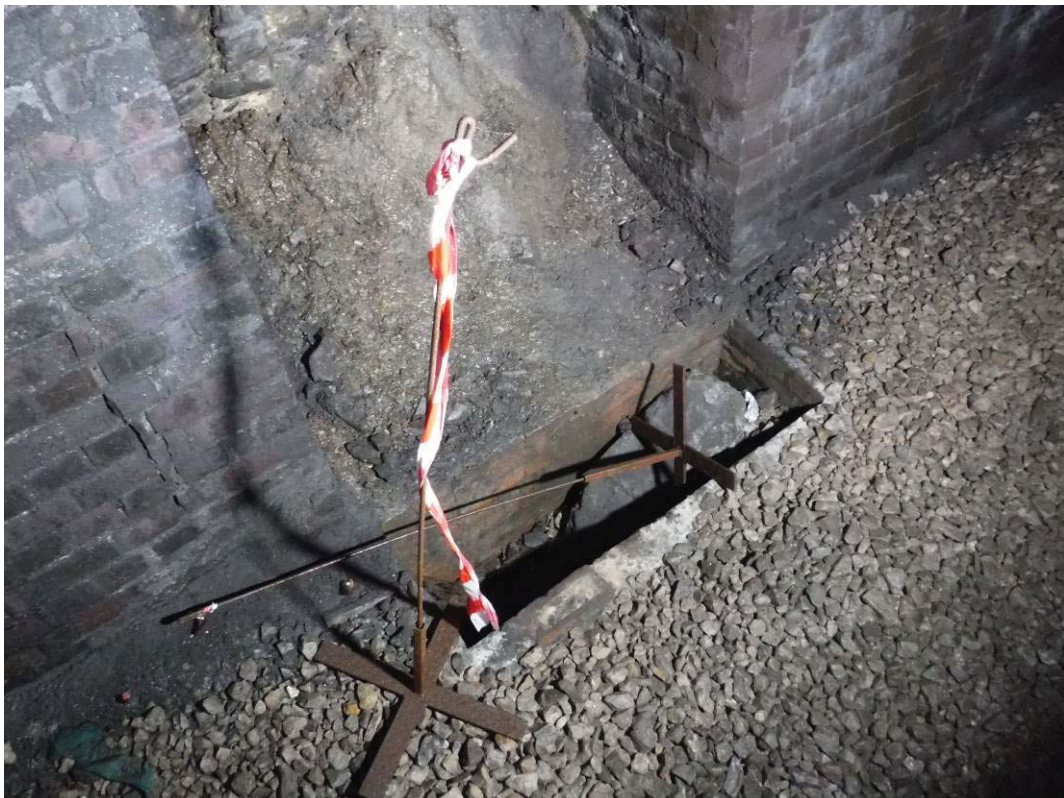
**Photo No.90:** 033+15 Cess Up, Open catch-pit.

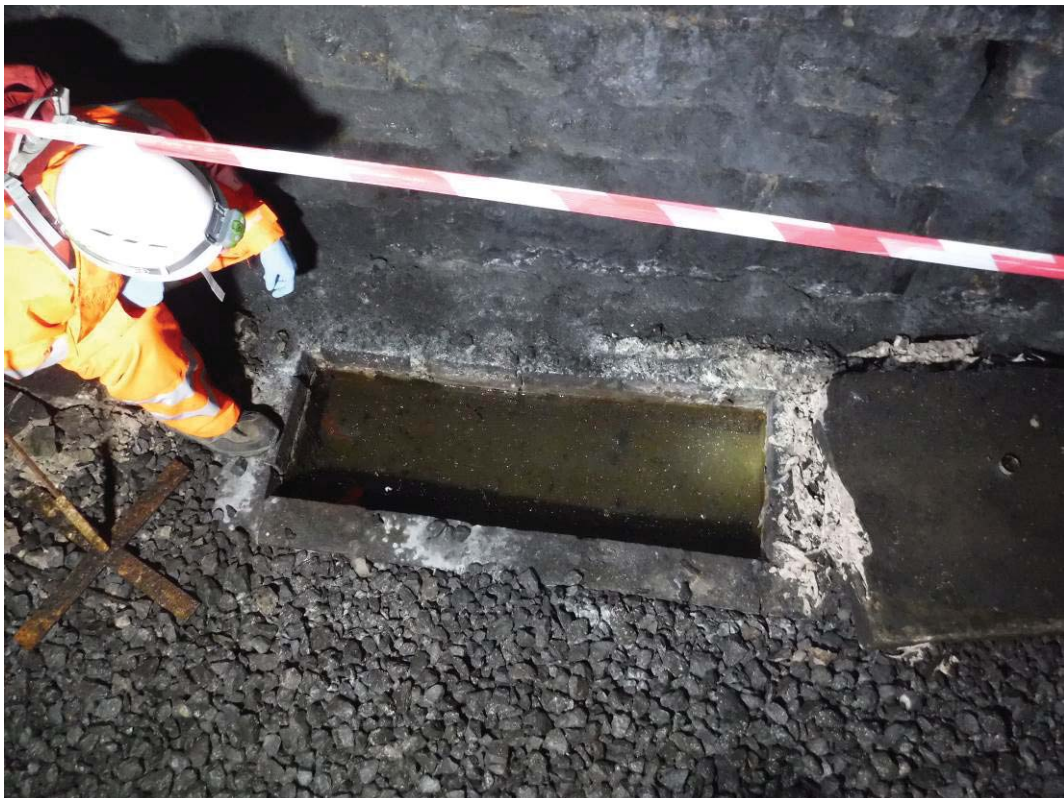
**Photo No.106:** 056+18 Cess Up, Open catch-pit and substantially blocked.

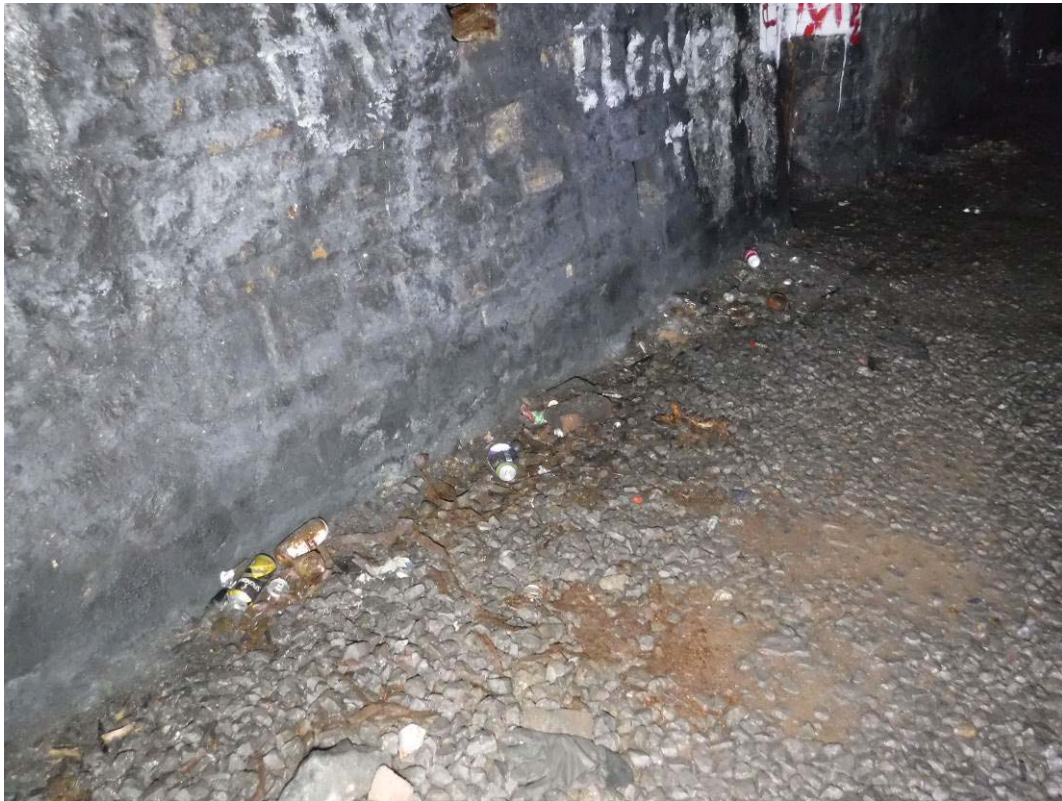
**Photo No.107:** 058+07 Solum Up, Rubbish and litter thrown/accumulated on solum.

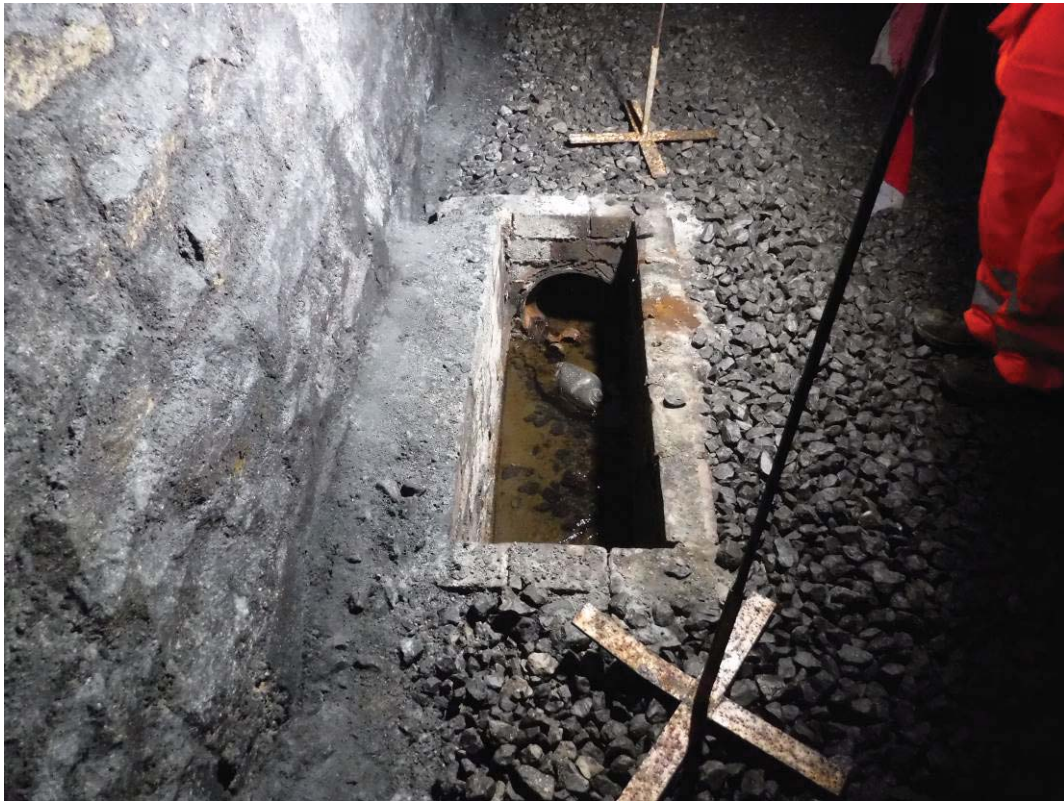
**Photo No.115:** 066+13 Cess Up, Open catch-pit.

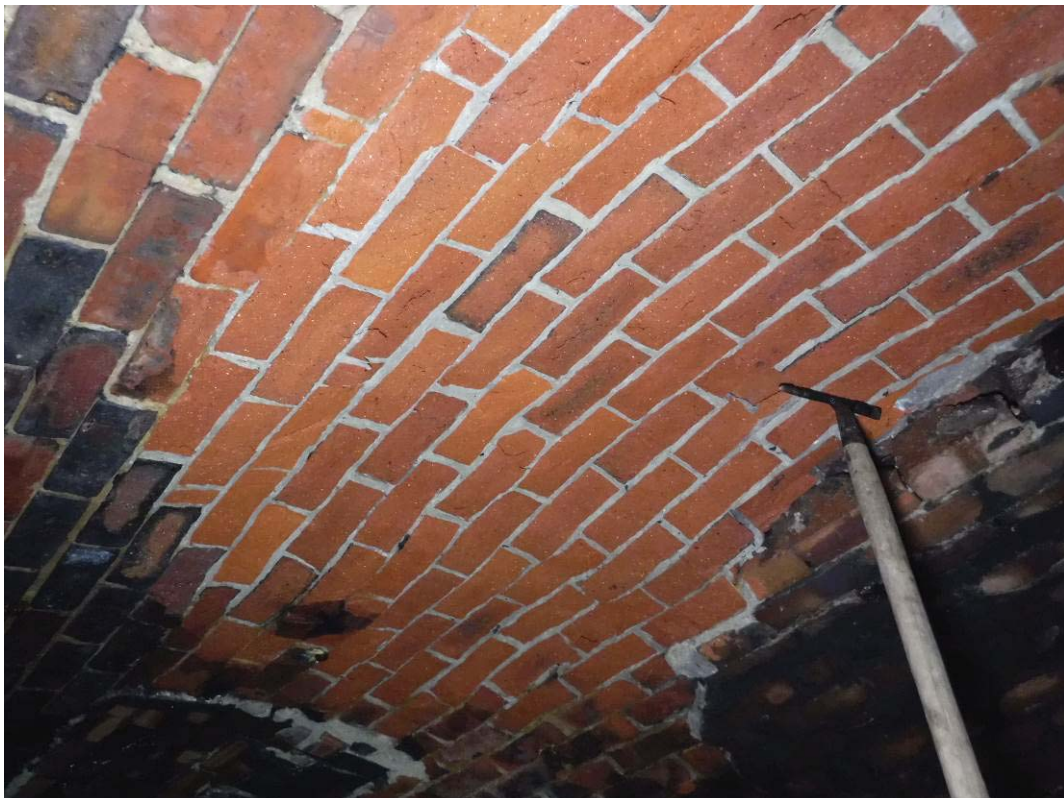
**Photo No.122:** 080+07 to 080+19 Crown Up & Down, Brickwork, spalling, depth 75mm, area 60sq.m., light.

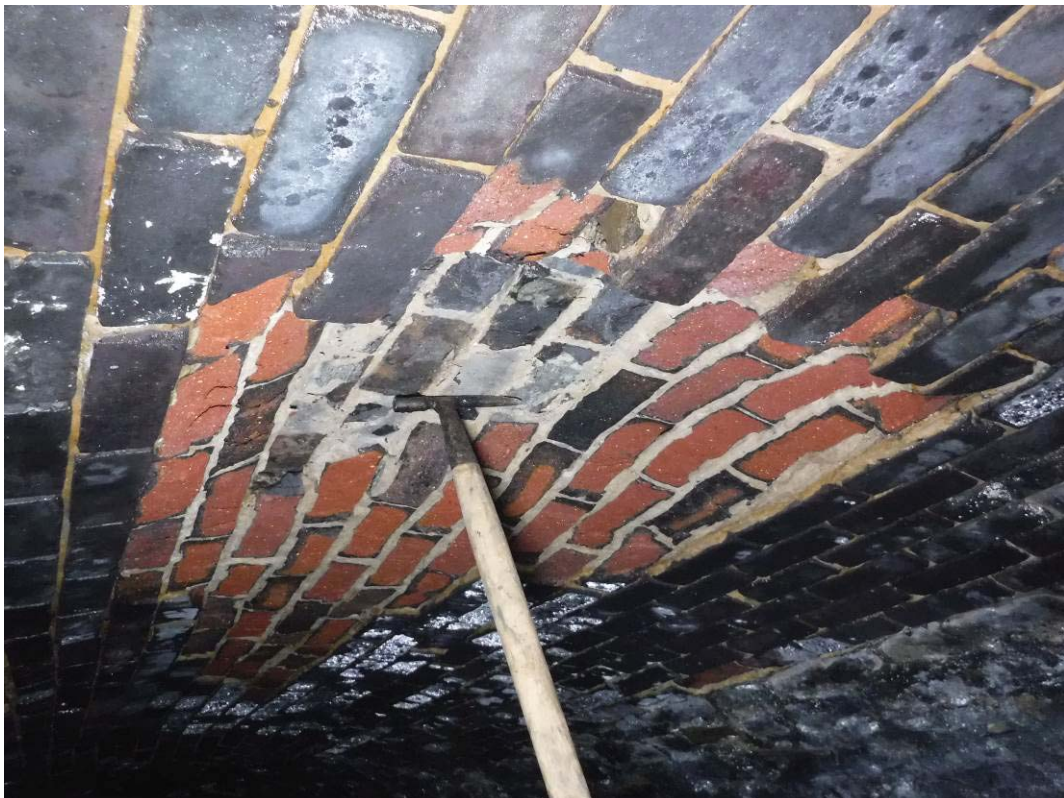
**Photo No.124:** 084+17 to 085+11 Crown Up & Down, Brickwork, spalling and hollow, depth 100mm, area 34sq.m., sparse.

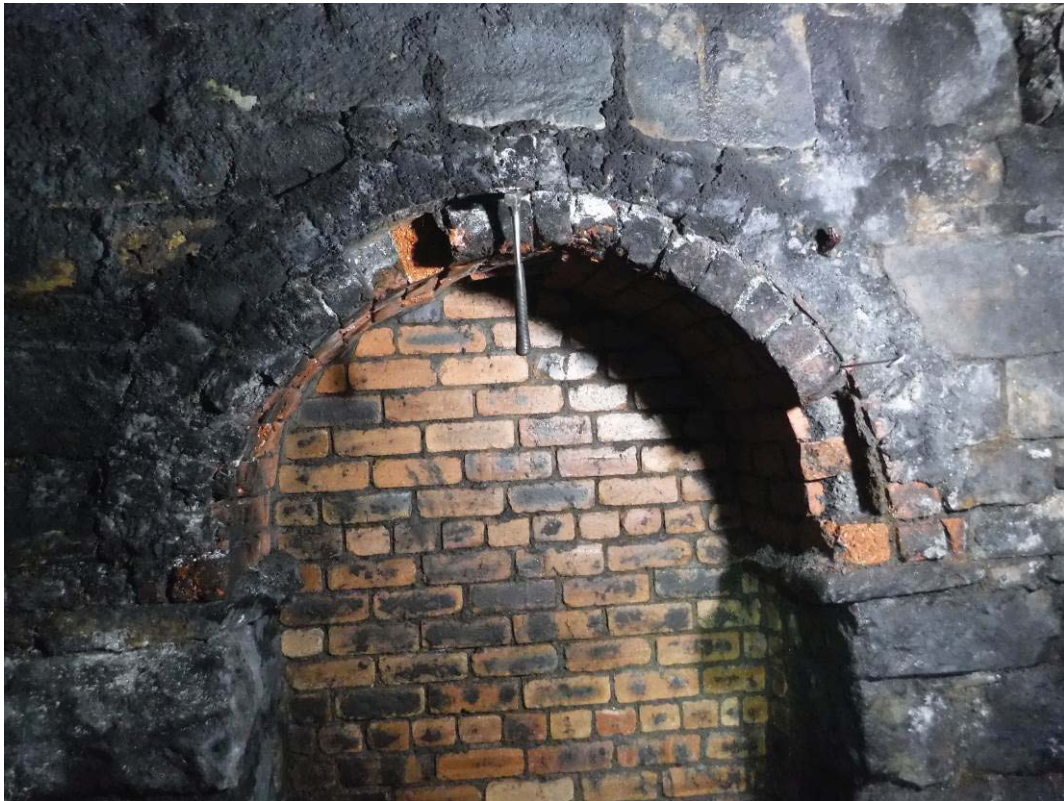
**Photo No.125:** 084+19 Refuge Up, Brickwork, arch, hollow with 5No. half bricks missing and some loose bricks, perished mortar, depth 75mm, area 1sq.m.

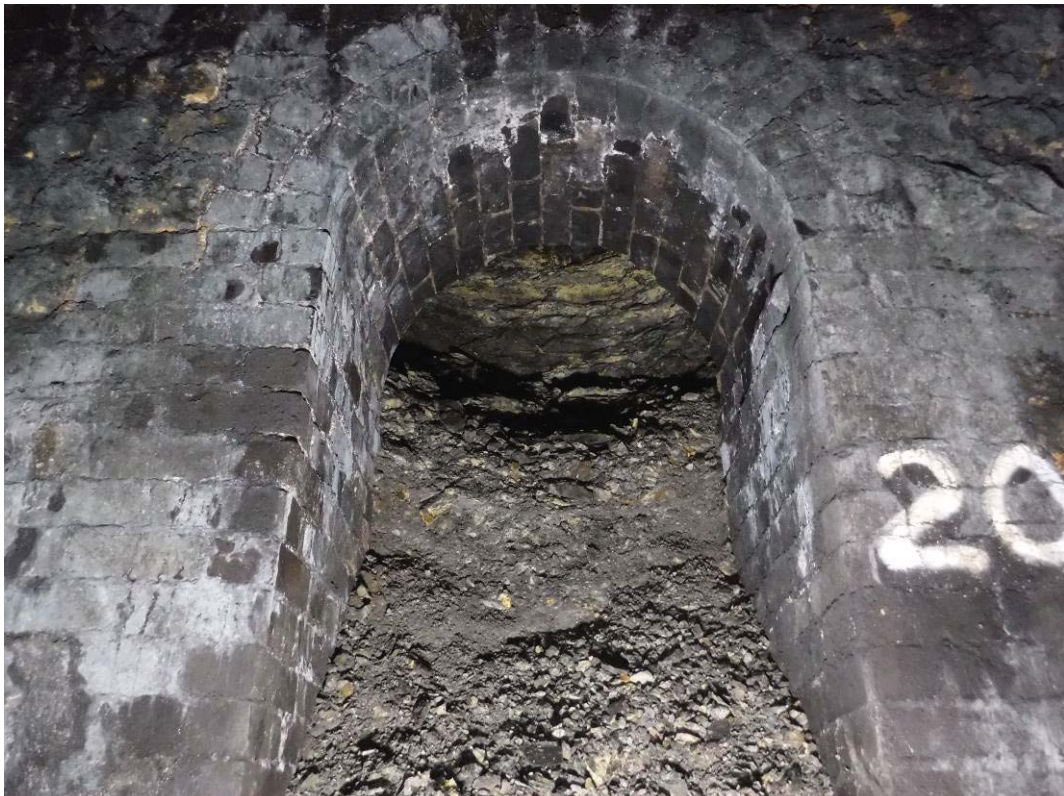
**Photo No.126:** 089+06 Refuge Down, Natural rock to rear has collapsed and run through to cess.

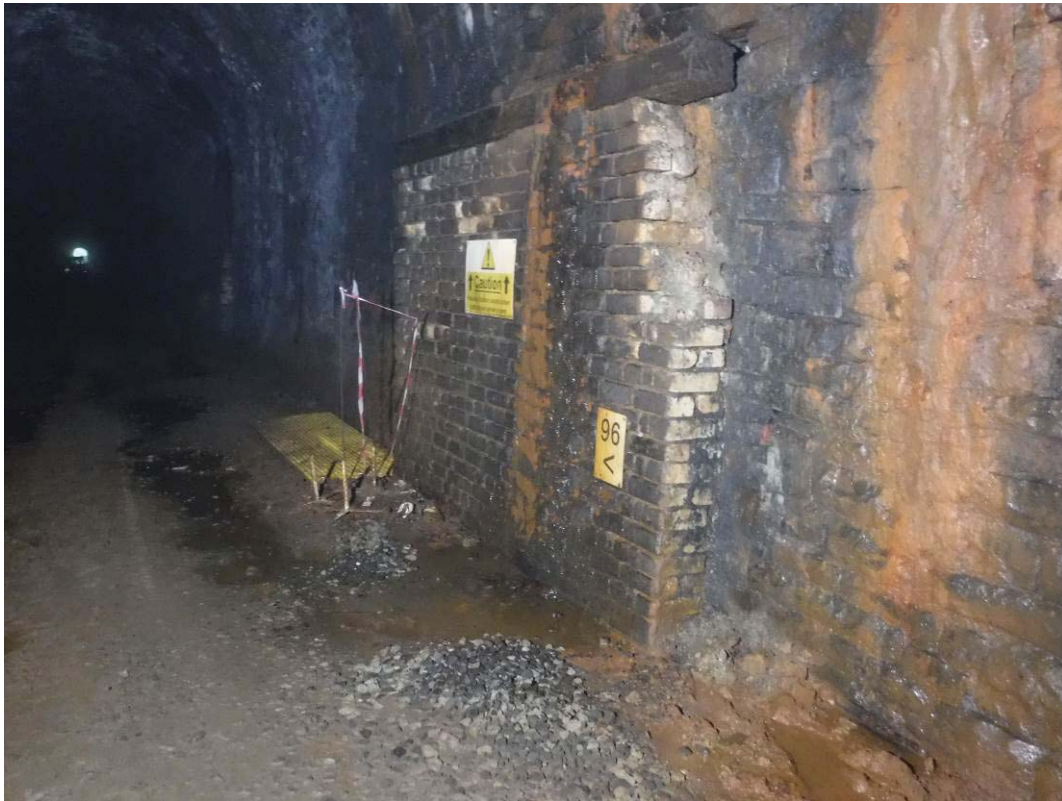
**Photo No.127:** 096+00 Sidewalls Up & Down, Brickwork, buttresses collapsing with rotten timber bearers on top and numerous loose bricks, area 10sq.m.

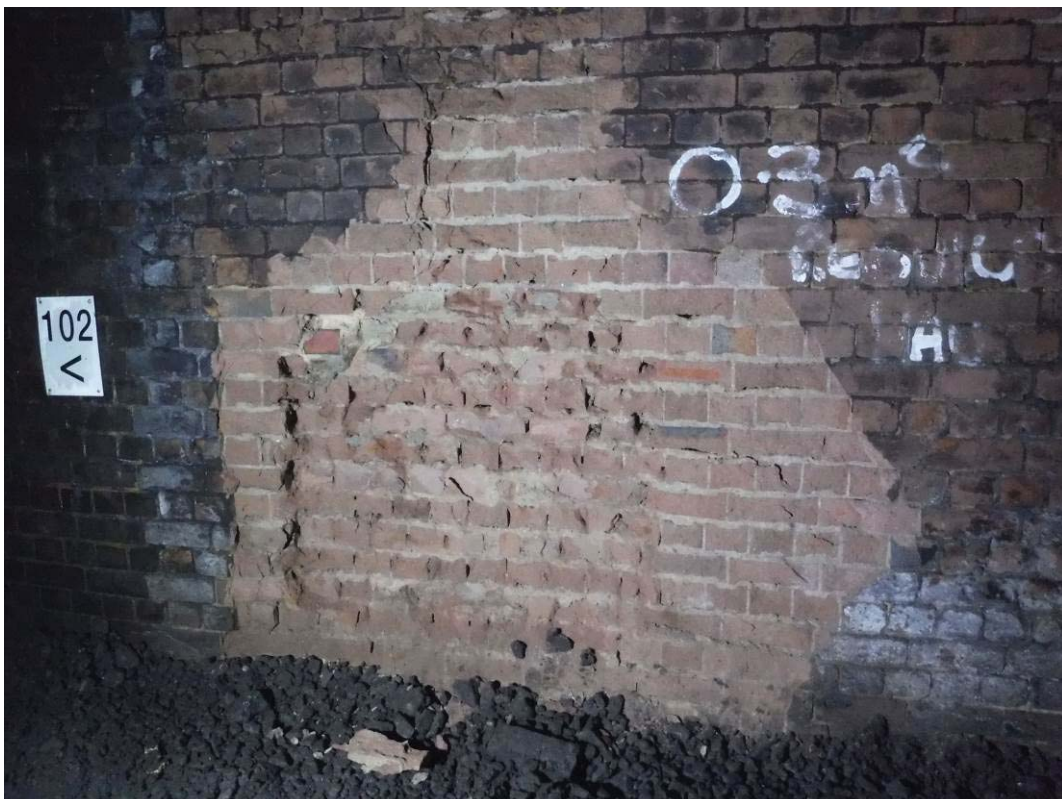
**Photo No.128:** 101+21 Sidewall Down, Brickwork, spalling, depth 100mm, area 4sq.m.

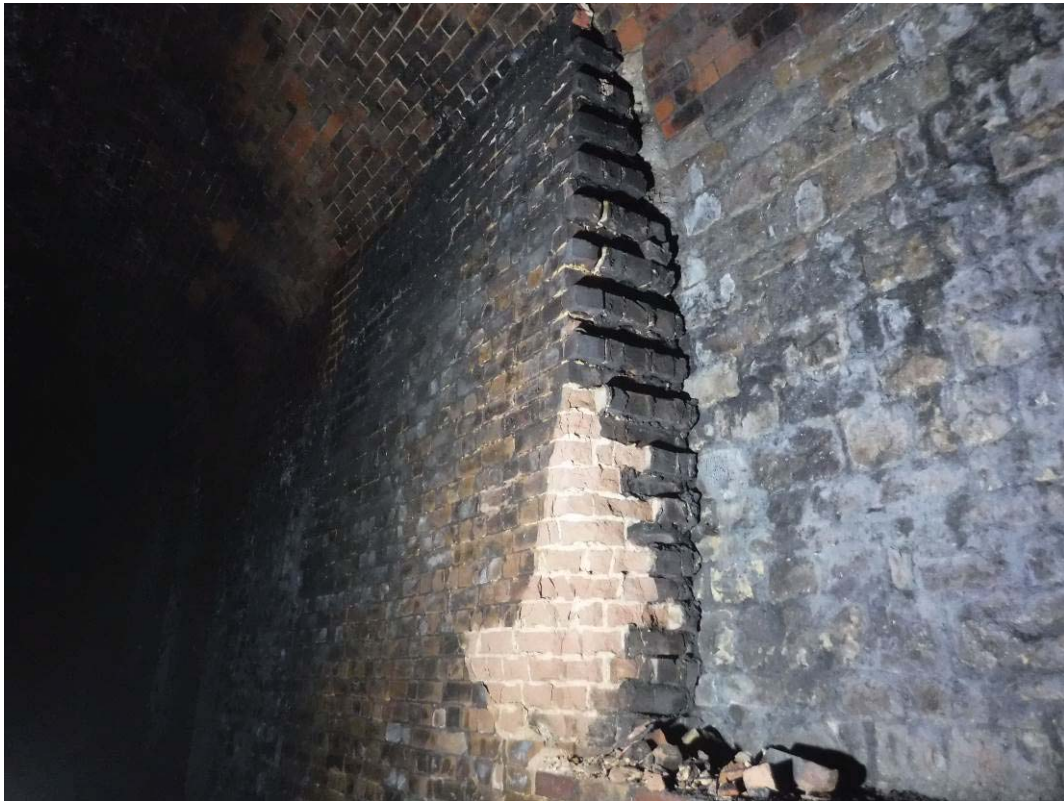
**Photo No.129:** 102+01 Sidewall Down, Brickwork, spalling to corner of support brickwork, depth 200mm, area 1sq.m. with a 5m long diagonal fracture, width 3mm.

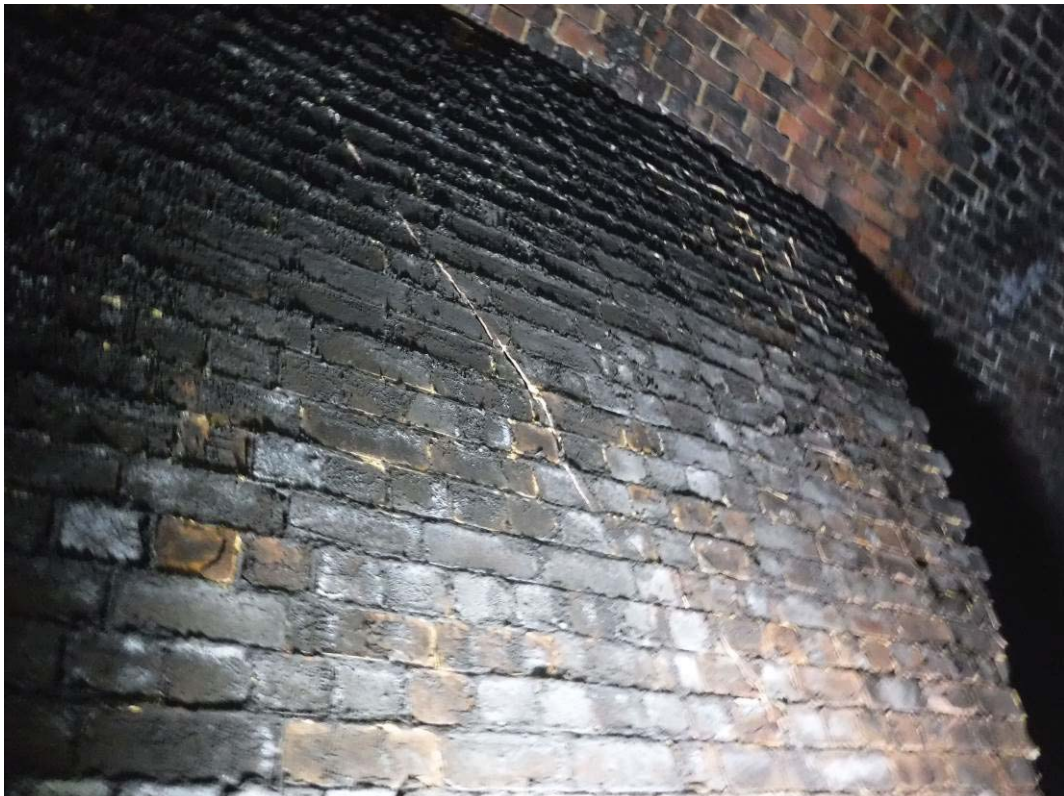
**Photo No.130:** 102+01 Sidewall Down, Brickwork, spalling to corner of support brickwork, depth 200mm, area 1sq.m. with a 5m long diagonal fracture, width 3mm.

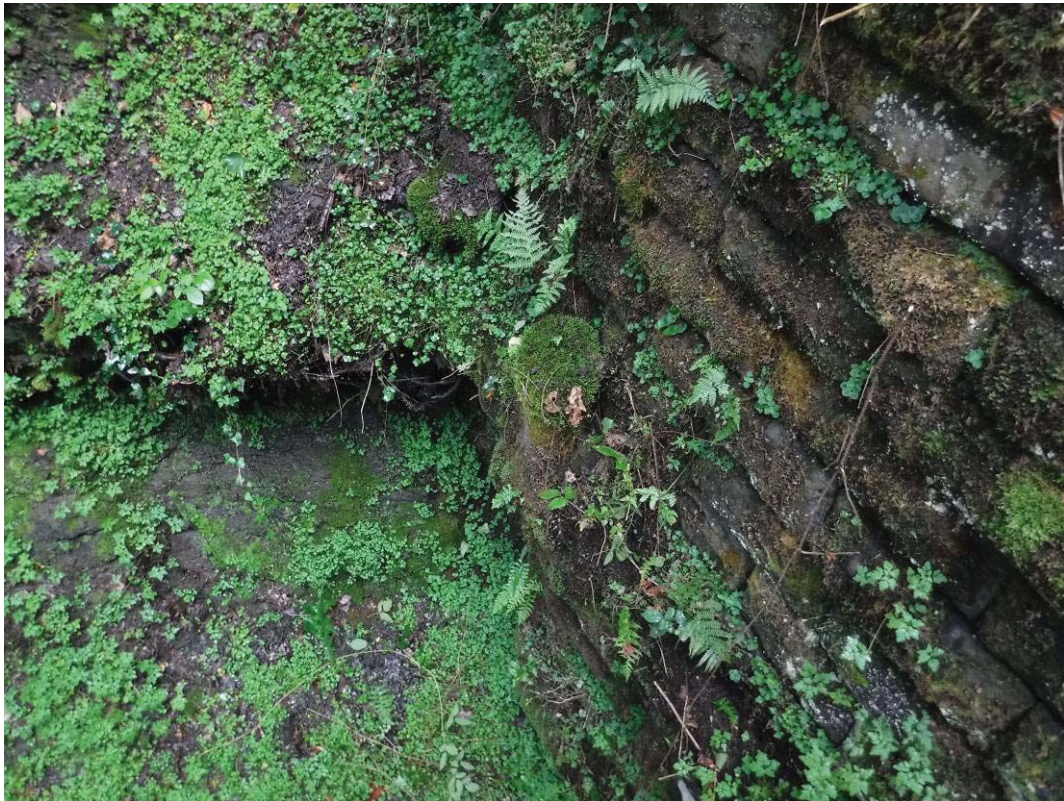
**Photo No.133:** Northeast Portal, Stonework, parapet stringcourse, tree stump growing, girth 500mm.

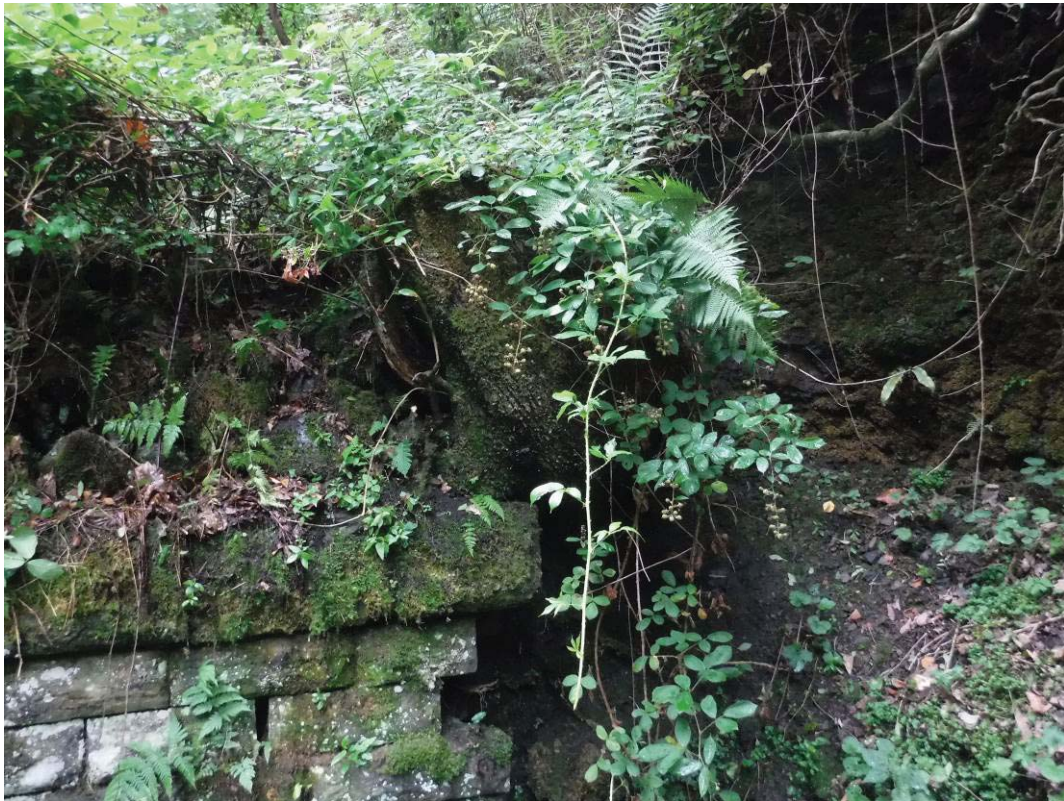
**Photo No.135:** Northeast Portal, Stonework, end of parapet, tree stump growing, girth 1.5m.

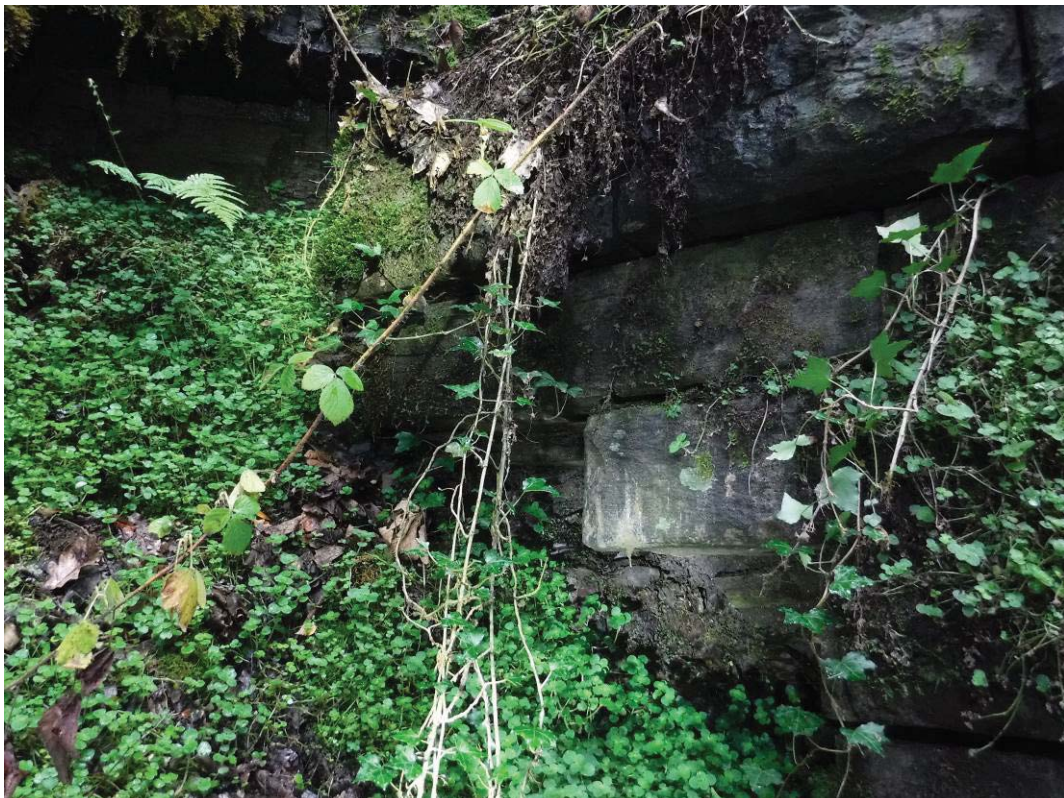
**Photo No.136:** Northeast Portal, Stonework, end of parapet, c.3No. blocks missing.
