**TUNNEL EXAMINATION REPORT  
PHOTOGRAPHS OF STRUCTURE**

ELR : MER Br. No. : 00

Mileage : 03 M 37 ch Sheet 41 of 79

<b>ELR:</b>	BLE	<b>Structure No:</b>		<b>Mileage:</b>	187m 64ch	<b>Examination date:</b>	14/11/17
<b>Route:</b>	Barnstaple Branch Line					<b>OS ref:</b>	SS 871 261
<b>Name:</b>	East Anstey Tunnel					<b>Type:</b>	Tunnel

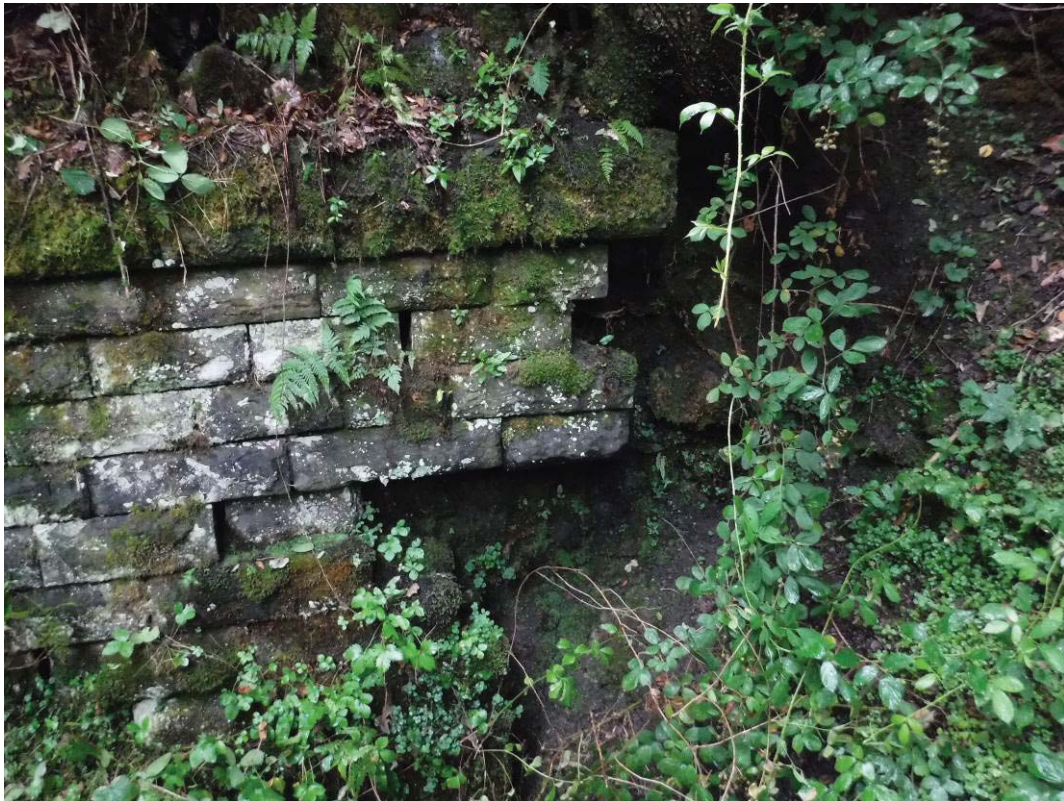
**Photo No.137:** Northeast Portal, Stonework, end of parapet, c.5No. blocks missing.

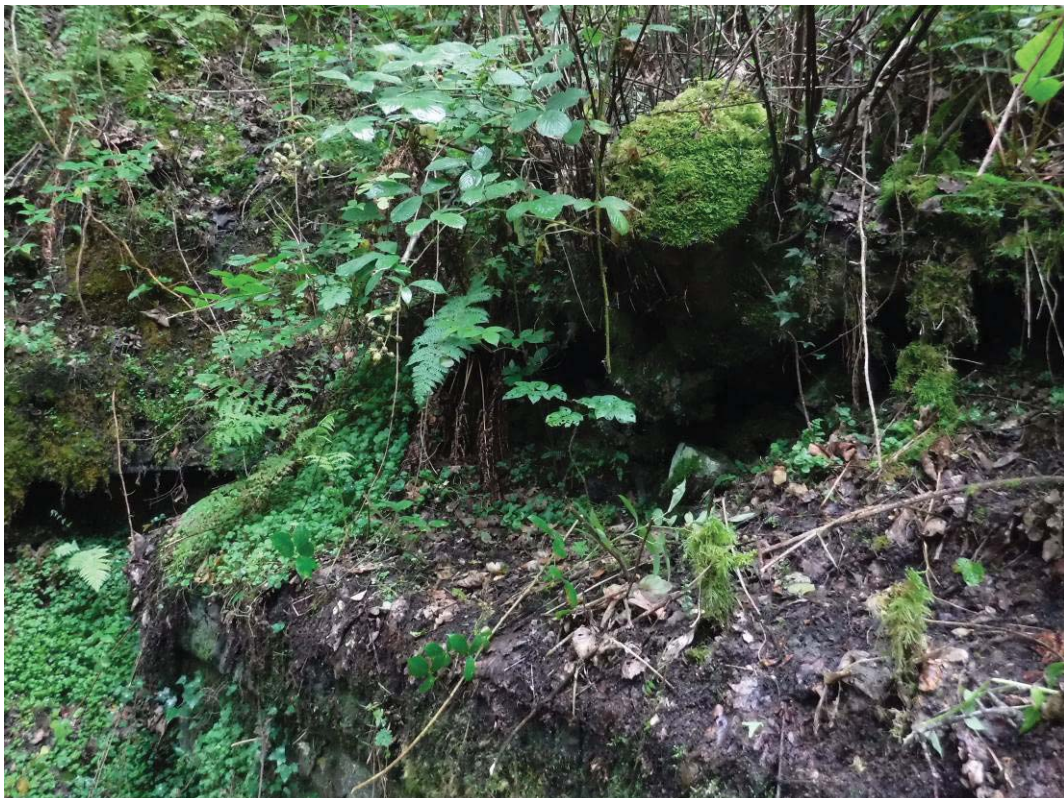
**Photo No.138:** Northeast Portal, Stonework, parapet, tree stump behind coping.

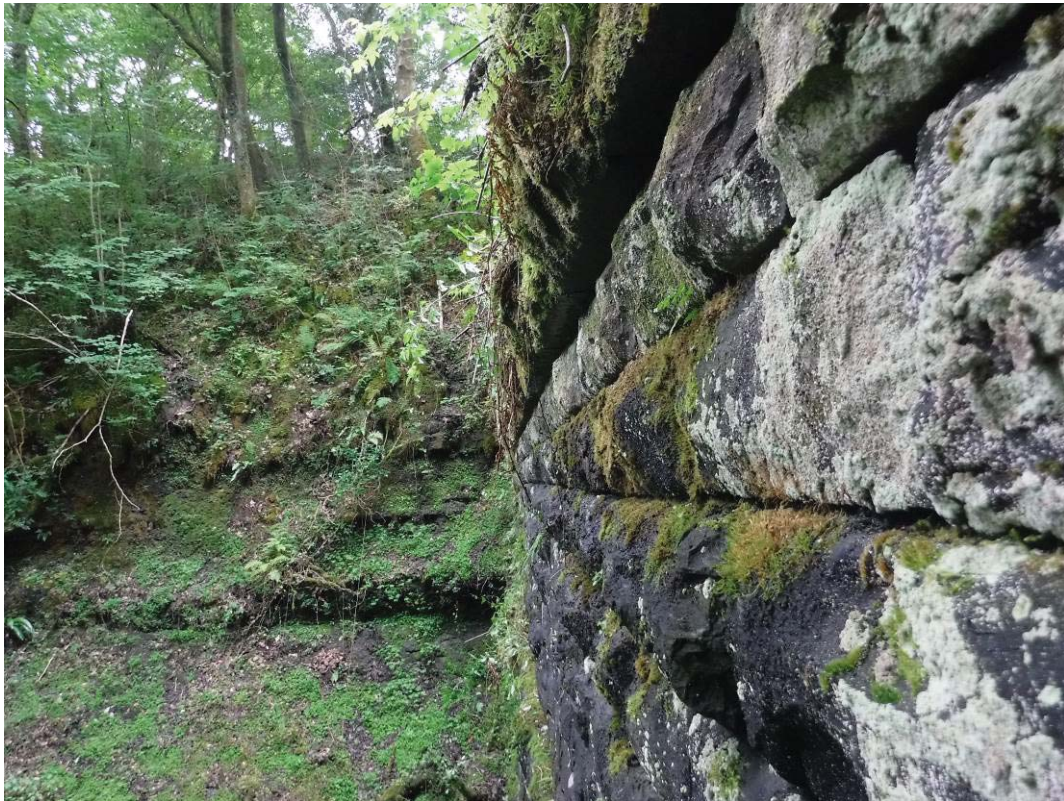
**Photo No.139:** Northeast Portal, Stonework, parapet coping pushing forward c.6". Tree stumps behind coping.

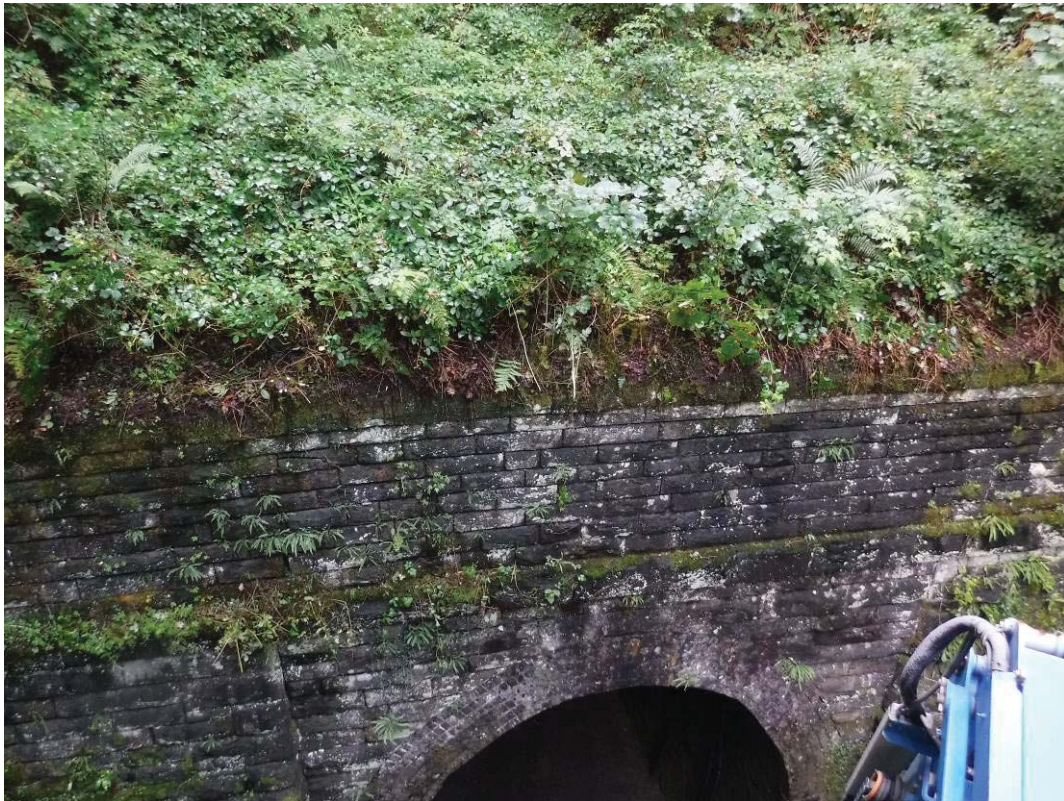
**Photo No.141:** Northeast Portal, Stonework, parapet coping pushing forward c.6". Tree stumps behind coping.

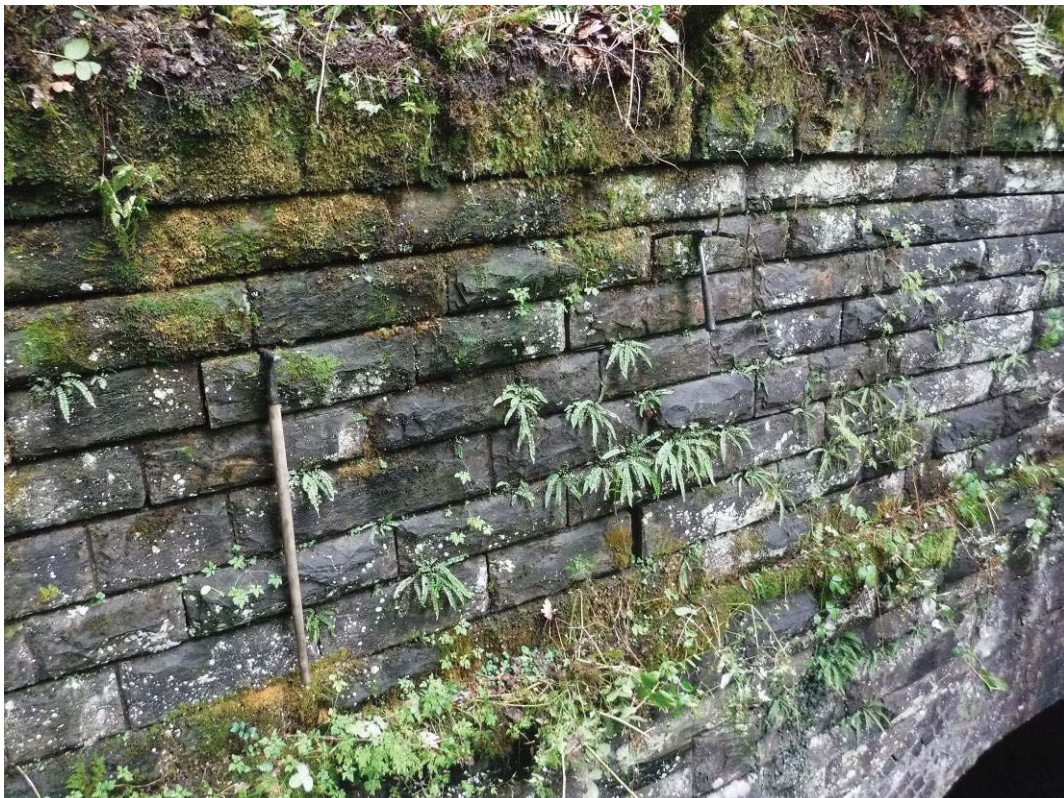
**Photo No.142:** Northeast Portal, Stonework, loose blocks and open joints, depth 3" to 12" where blocks not tight or pointed, area 40sq.m., light.

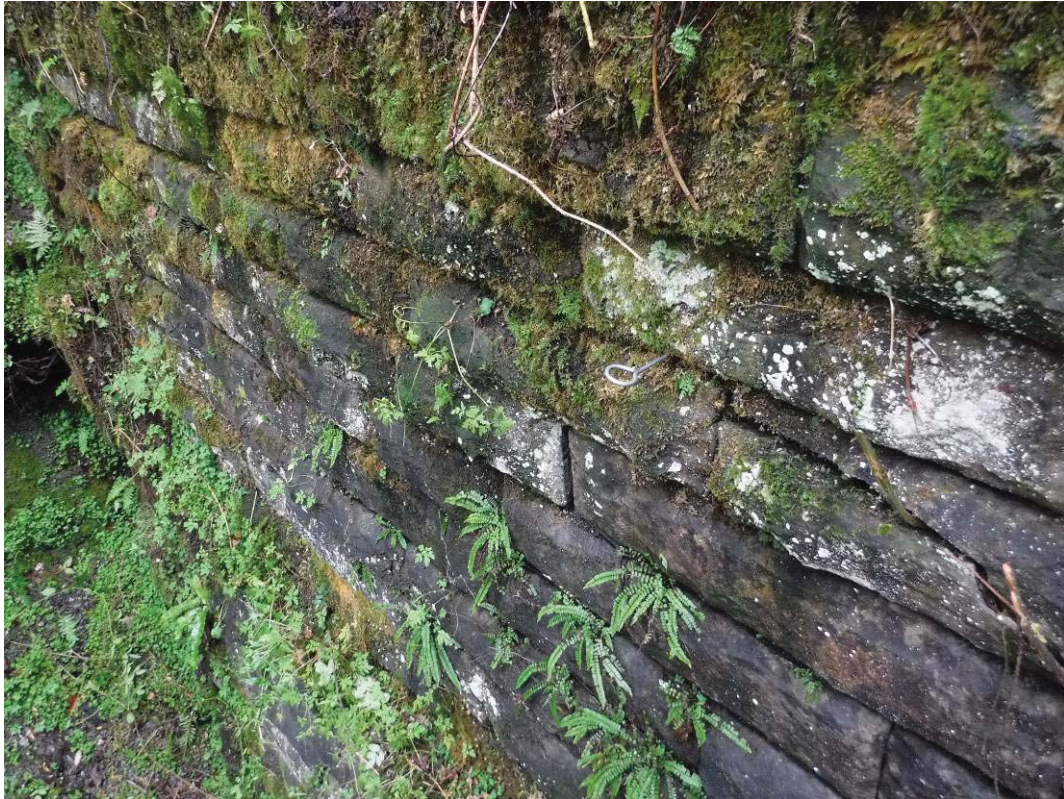
**Photo No.143:** Northeast Portal, Stonework, loose blocks and open joints, depth 3" to 12" where blocks not tight or pointed, area 40sq.m., light.

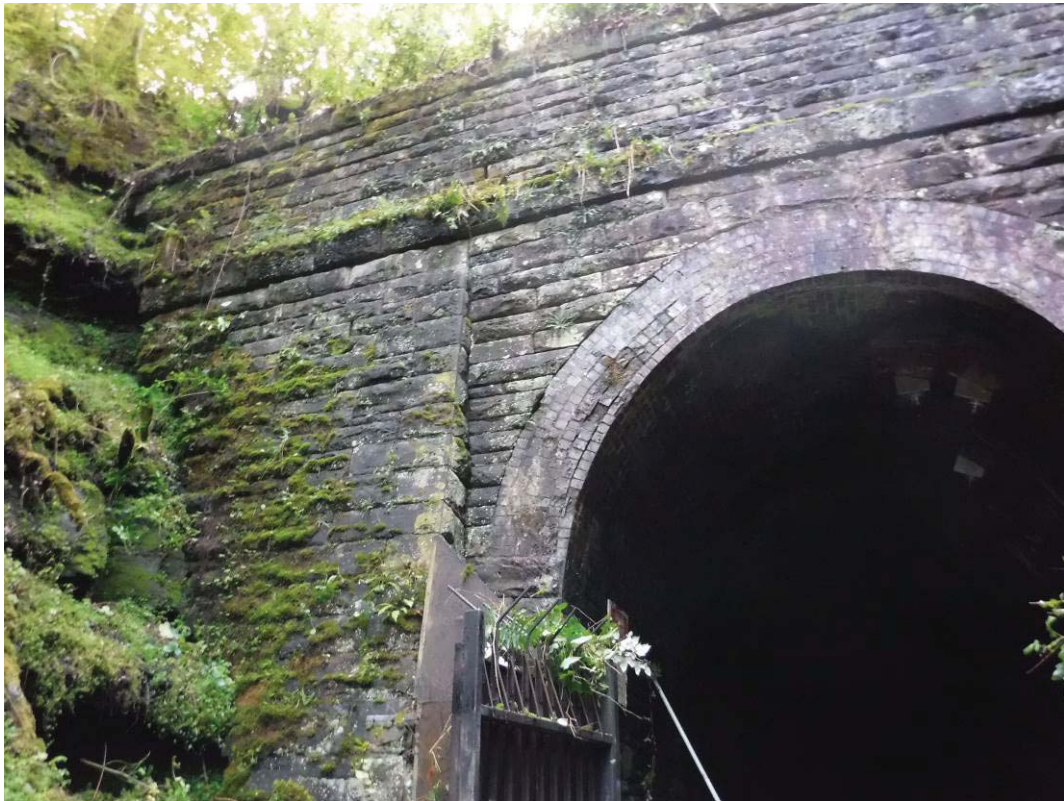
**Photo No.153:** Northeast Portal, Stonework, Vegetation. AFTER WORKS - only moss & lichens remain on stonework.

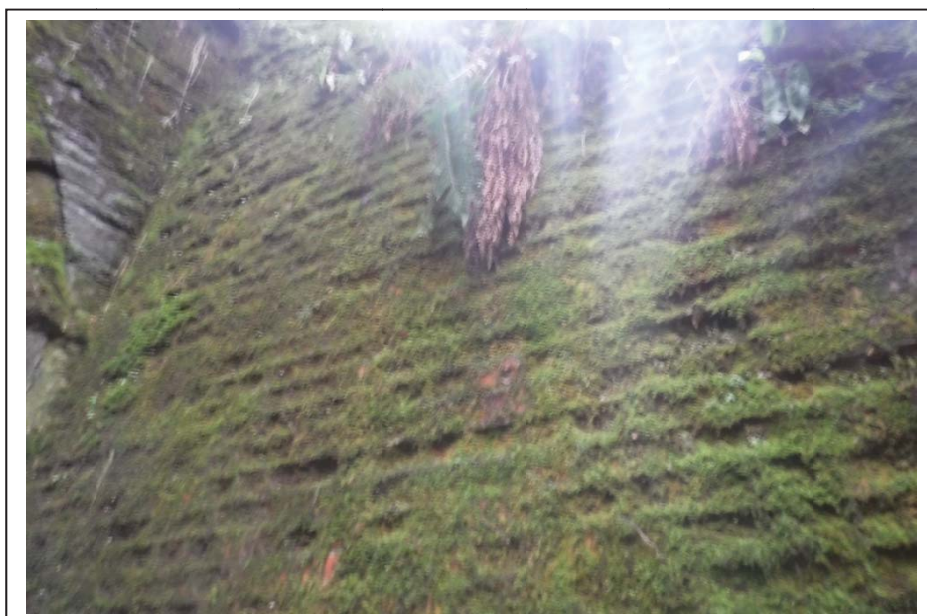
Photograph no 2: UC Wingwall: widespread long-standing spalling up to 30mm deep over 5m<sup>2</sup> in the upper half of the wingwall (mainly moss covered)

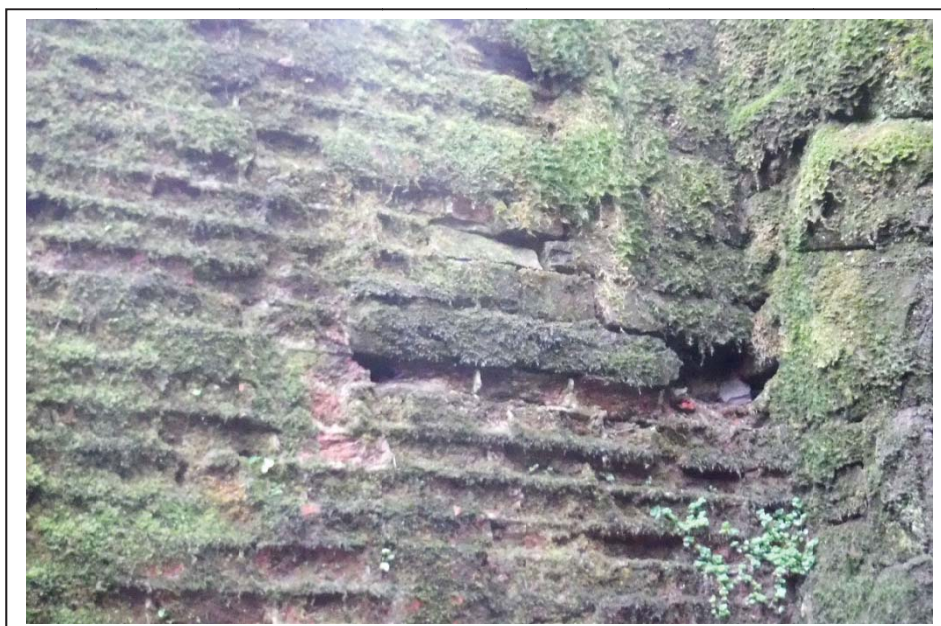
<p><b>Upside Wingwall (P3)</b> Widespread spalling up to 30mm throughout affecting <b>70%</b> of the wingwall. Minor increases noted to patches Localised areas of spalling up to 100mm adjacent to mitre; total area affected approximately 0.5m<sup>2</sup> (<b>P4</b>). Single unit removed (<b>P5</b>); remainder firm to hammer.</p>

Photograph no 4: UC wingwall  
Localised areas of spalling up to 100mm adjacent to mitre  
Total area affected approximately 0.5m<sup>2</sup>

Remove moss and rebuild upper section of UC wingwall adjacent to mitre - P2 £6k.

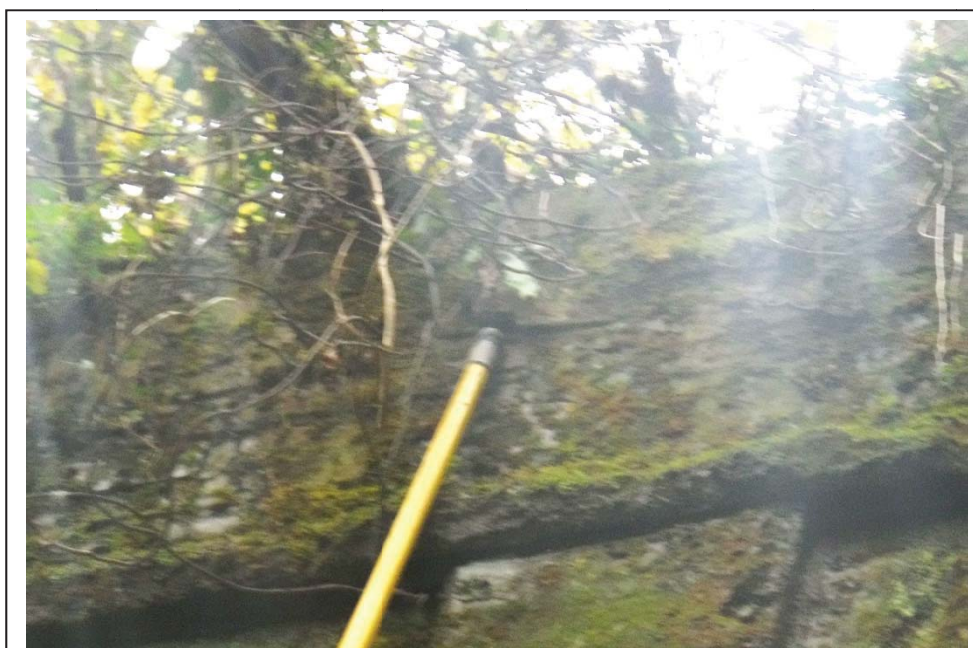
Photograph no 6: CE headwall  
Vertical fracture to headwall above crown open 2mm displaced 20mm

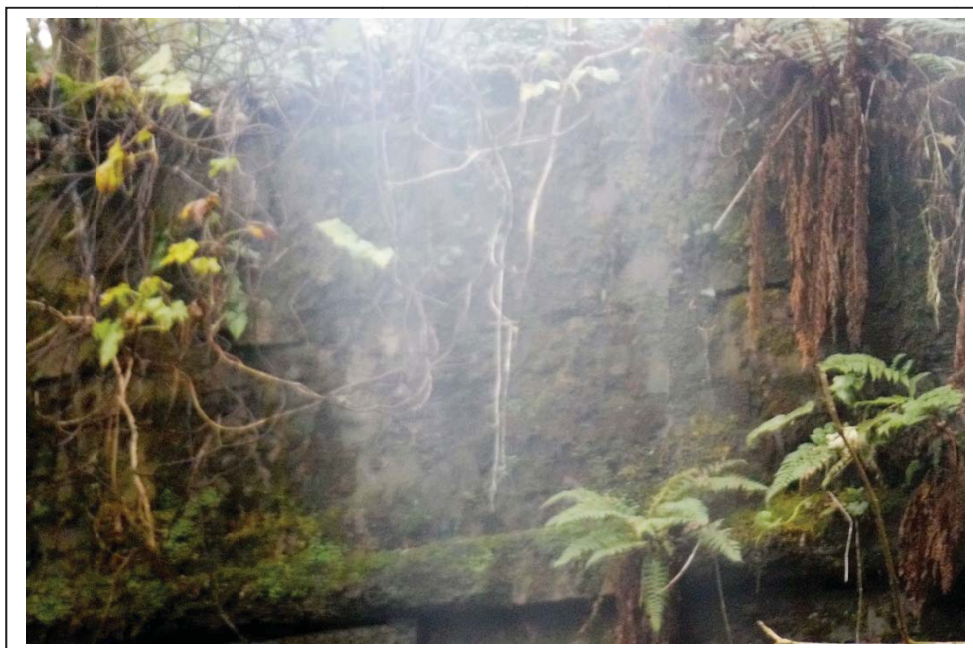
Photograph no 7: Previously noted F3 in bed joint 450mm below coping visible at DC headwall, now largely obscured by vegetation

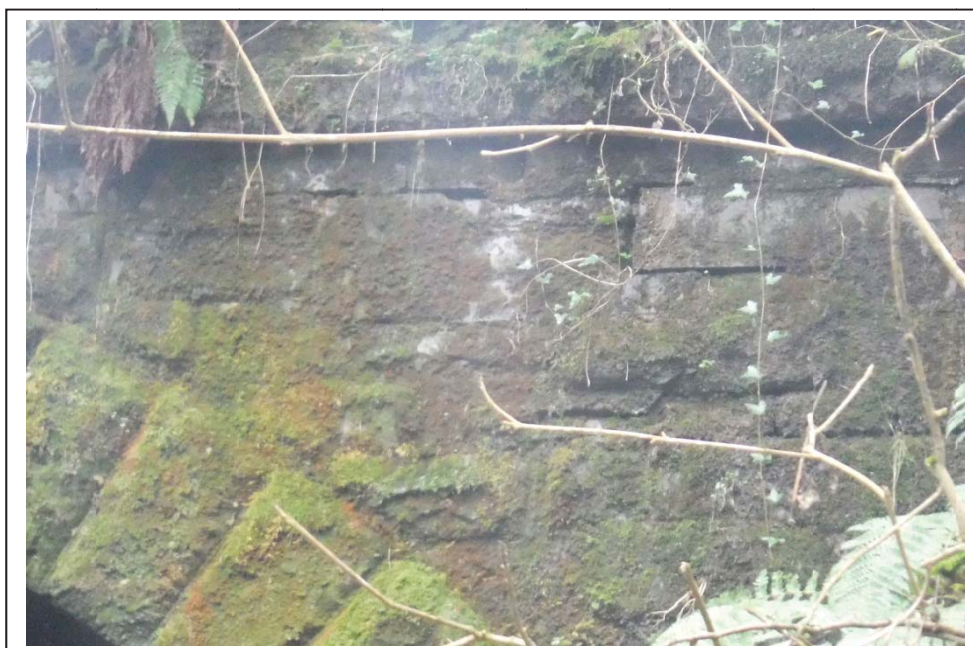
Photograph no 8: CE headwall  
Open joints to DS spandrel to 20mm

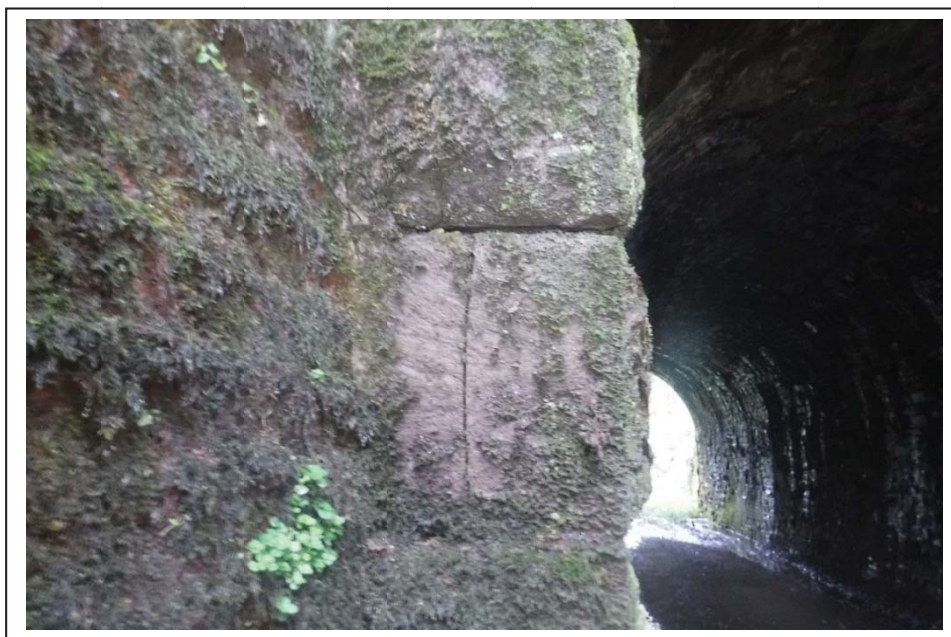
Photograph no 9: CE headwall  
5mm vertical fracture through masonry units in quoin of sidewall remains below U/S spandrel

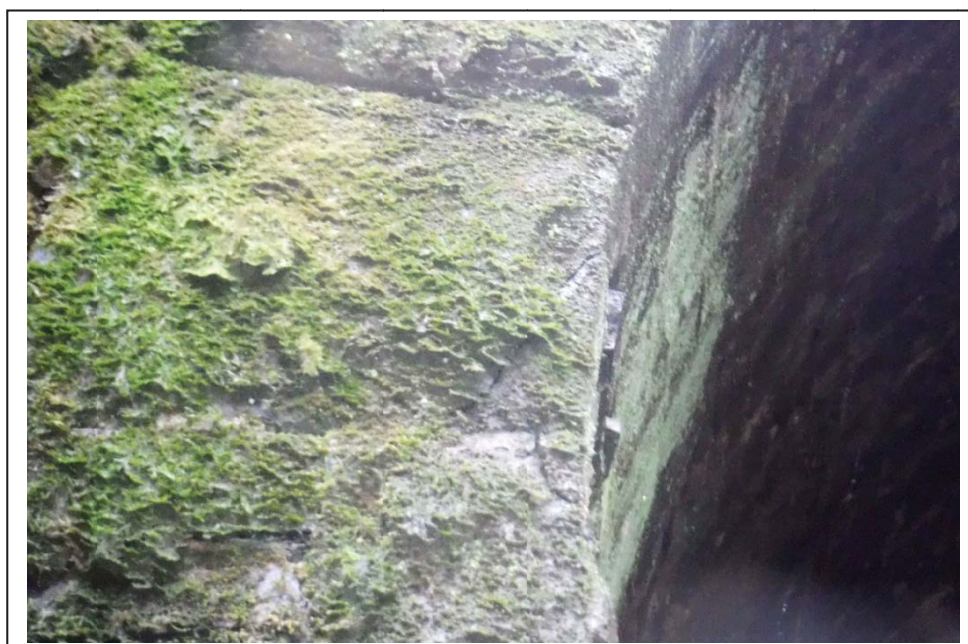
Photograph no 10: **F3mm** in first voussoir above US springing level extends into soffit of arch barrel
