ELR:	BLE	Structure No:	Mileage: 187m 64ch	Examination date: 14/11/17
Route:	Barnstaple Branch Line			OS ref: SS 871 261
Name:	East Anstey Tunnel			Type: Tunnel

ELR:	BOK1	Structure No:	283	Mileage:		Examination date:	26/03/19
Route:	Broad Street to Dalston West Junction					OS ref:	TQ 336 847
Name:	Dalston Lane					Type:	Tunnel

Balfour Beatty Rail, Manchester
Bridgnorth Tunnel
ELR:SVB/43
Examined:29/11/2018

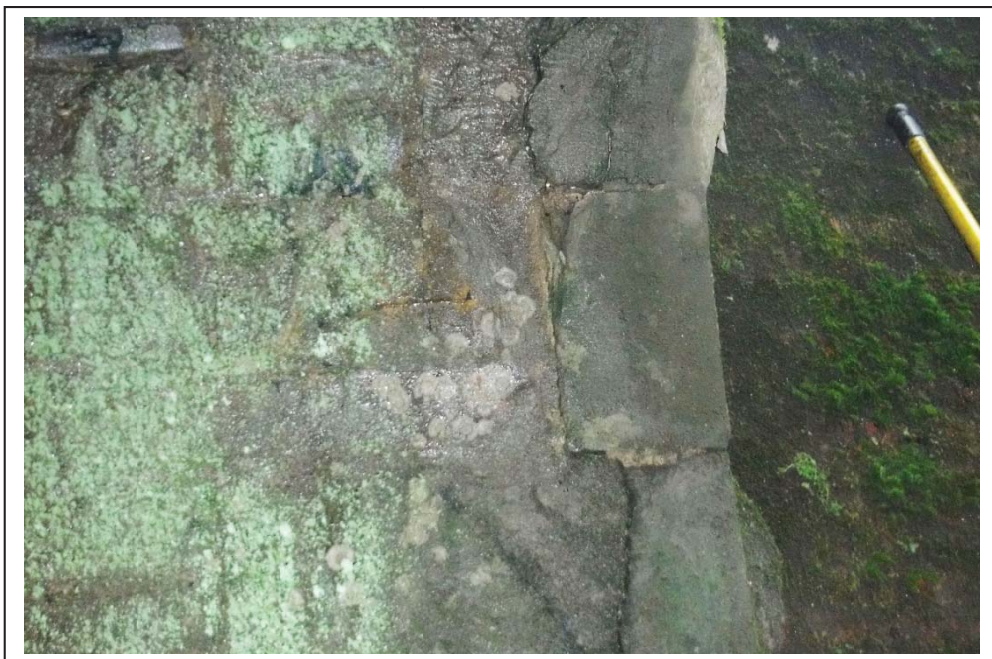
Photograph no 11: F6mm 2.5m long 150mm from Country end portal

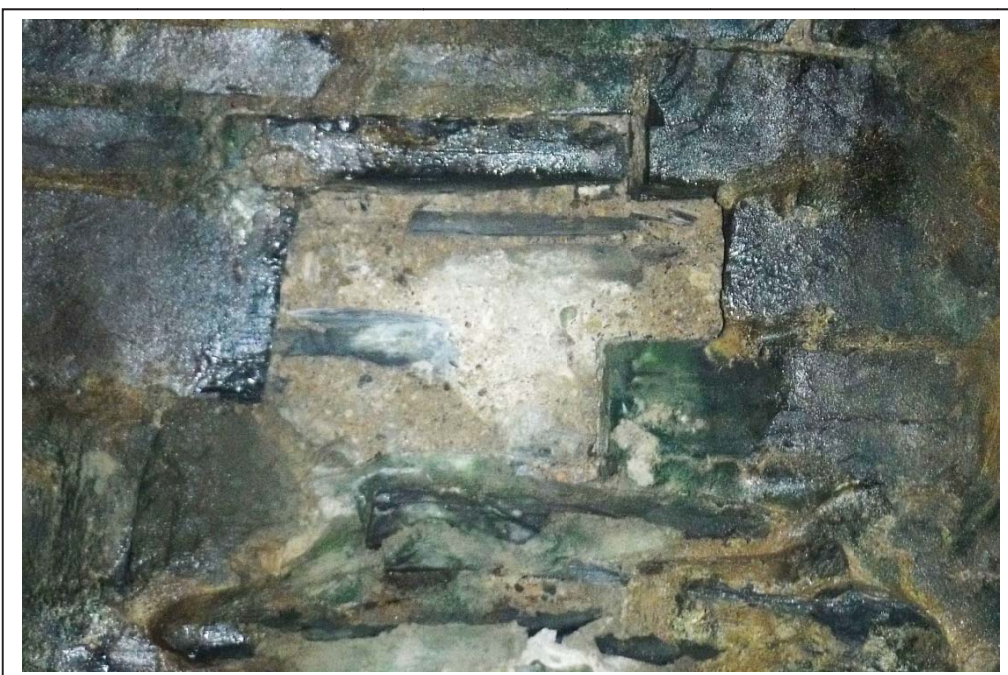
Photograph no 12: Spalling 450 x 300 x 125mm at DS haunch at 1.25ch

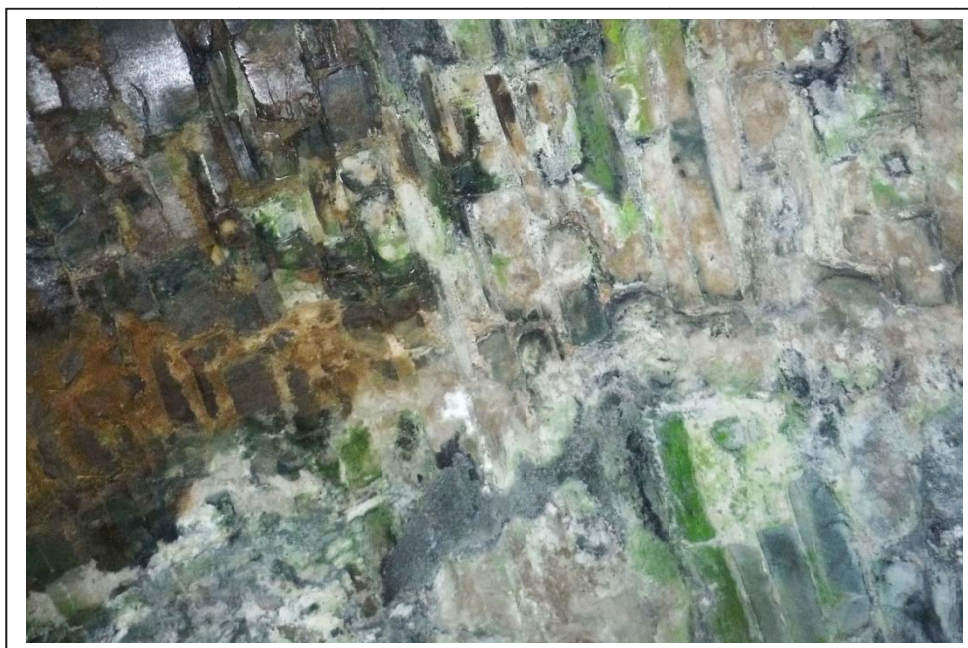
Photograph no 13: F2 at crown at 1.25ch

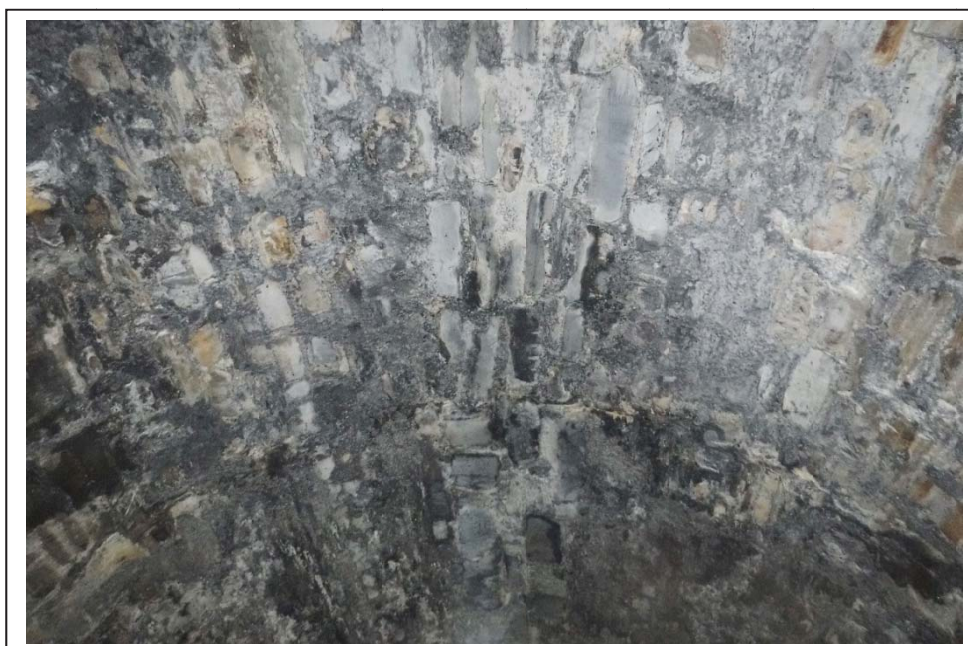
Photograph no 14: Crown at 0.5ch
Good

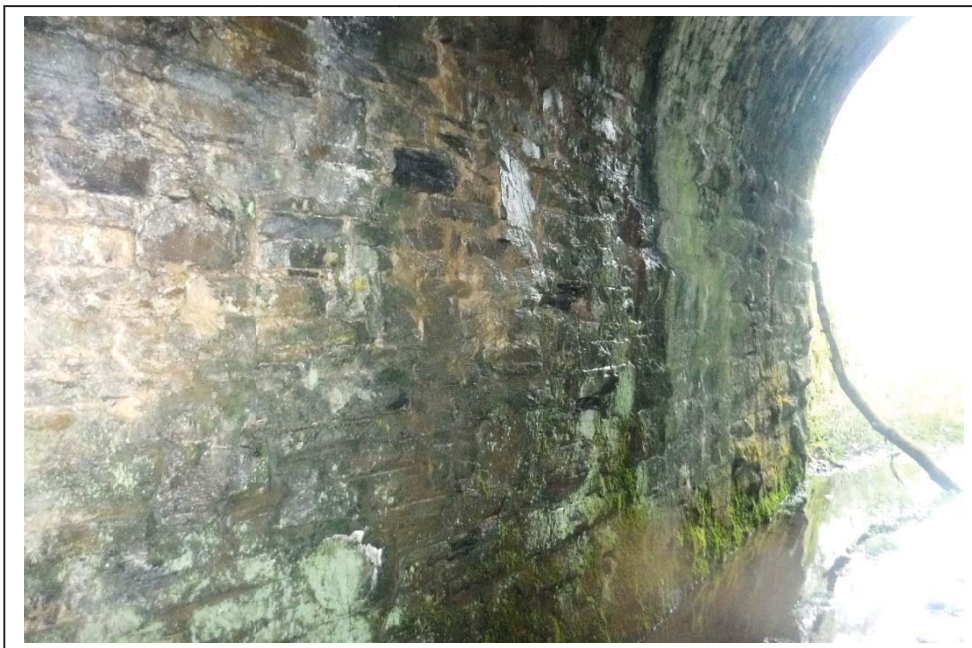
Photograph no 15: UL sidewall
Bulging 75 x 1.5m high 1.0m above G/L

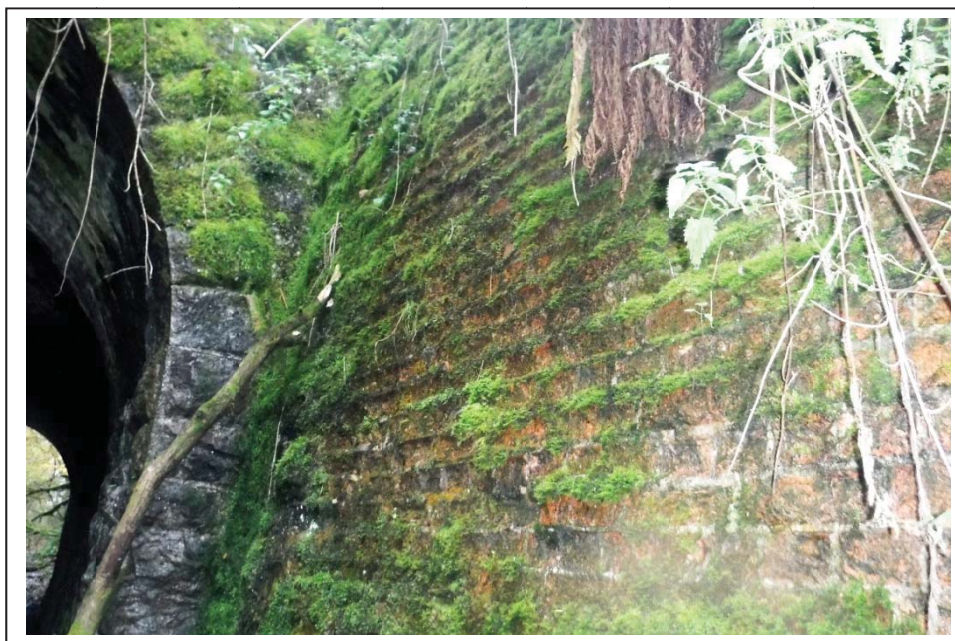
Photograph no 19: UL wingwall

Widespread and long-standing spalling throughout up to 50mm deep max
Total area affected approximately 10m²

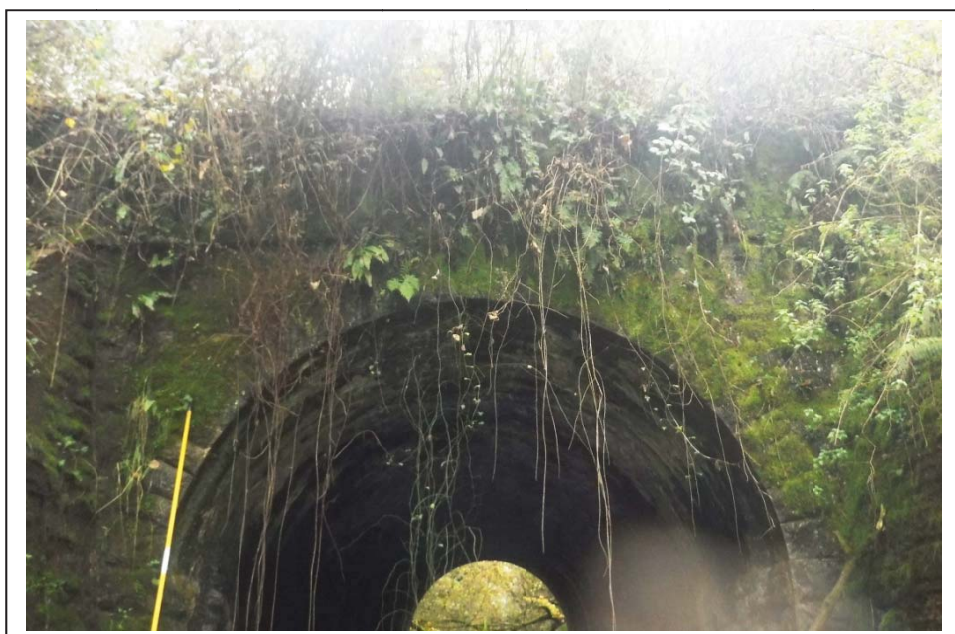
Photograph no 20: LE headwall

Moss growth and overhanging vegetation cover approximately 90% of the headwall

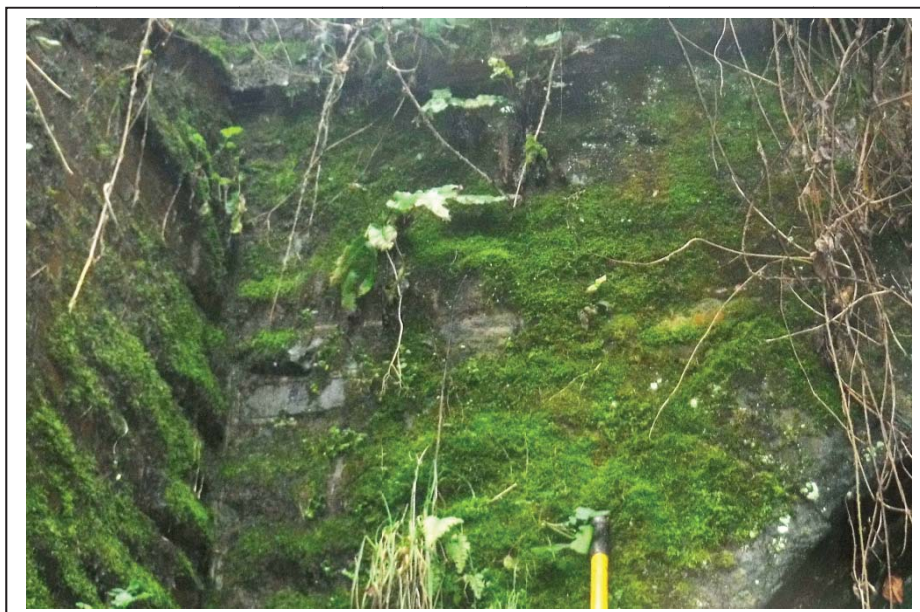
Photograph no 21: LE headwall
DS spandrel repaired in 2012 remains in good condition where seen

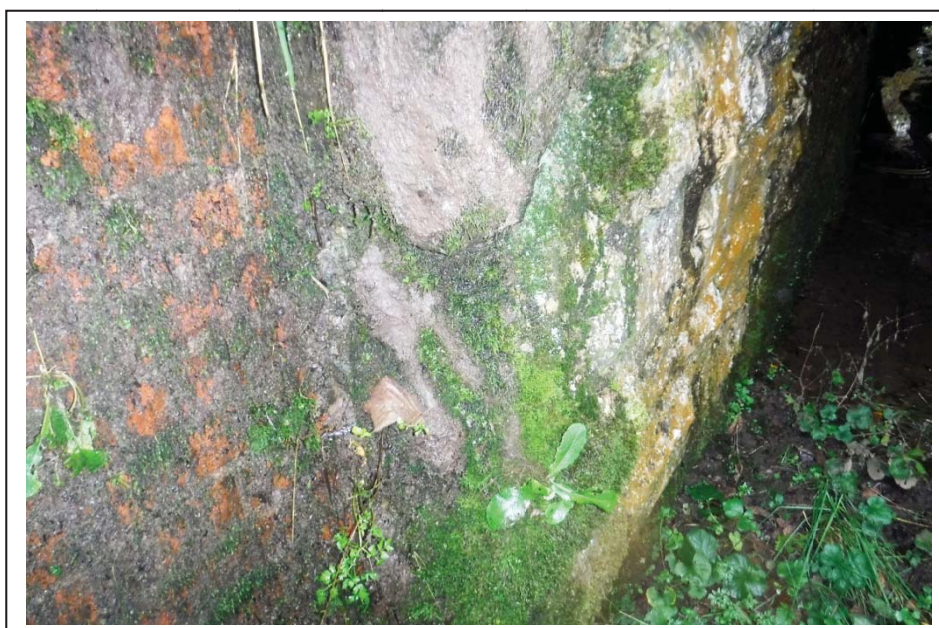
Photograph no 22: LE headwall
Long-standing spalling to 100mm at DL sidewall quoin 900mm above GL

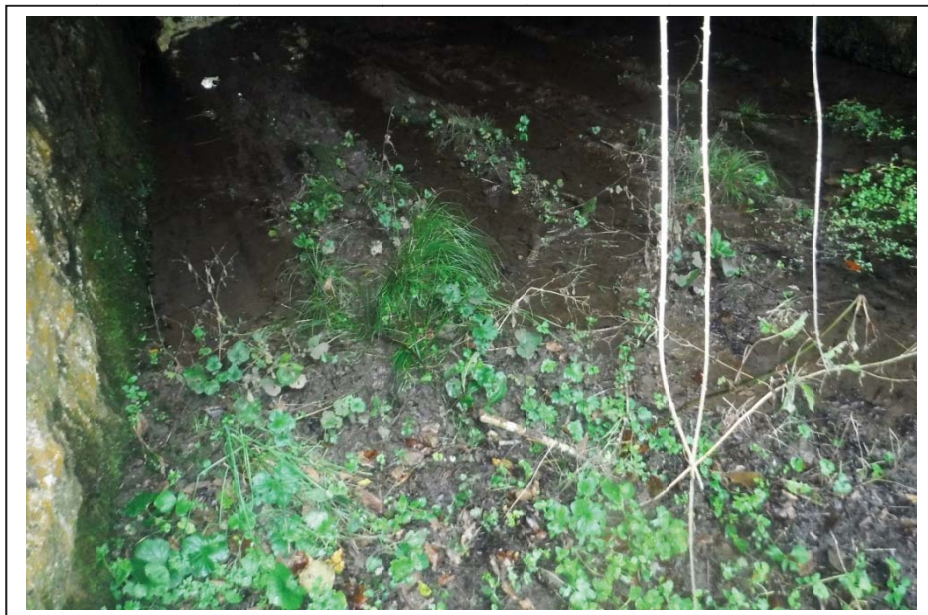
Photograph no 23: Formation is found very muddy with standing water to LE of barrel

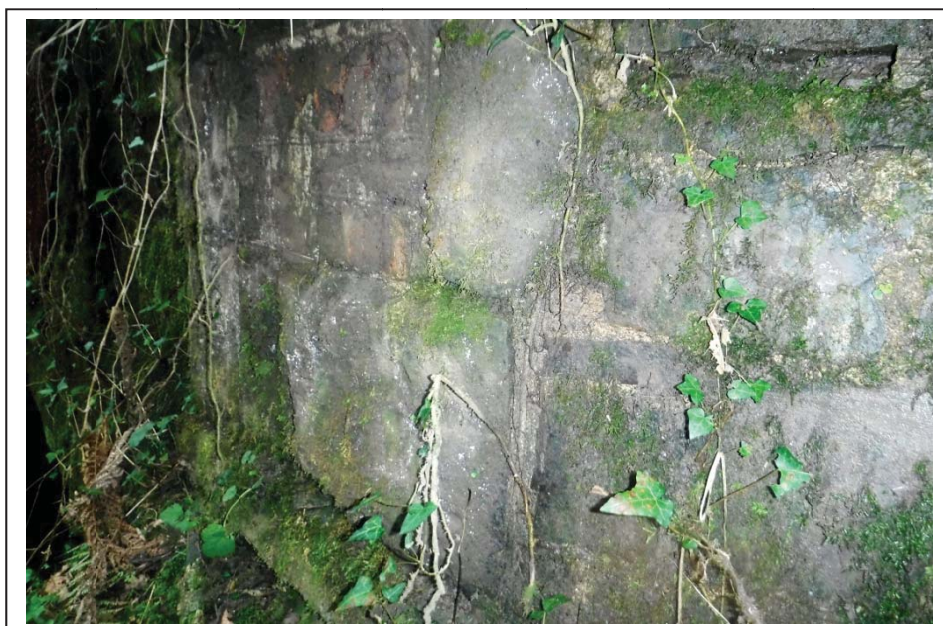
Photograph no 24: CE headwall
Horizontal fracture one course below DS stringer, 1.2m long, open 5mm and pushing 10mm

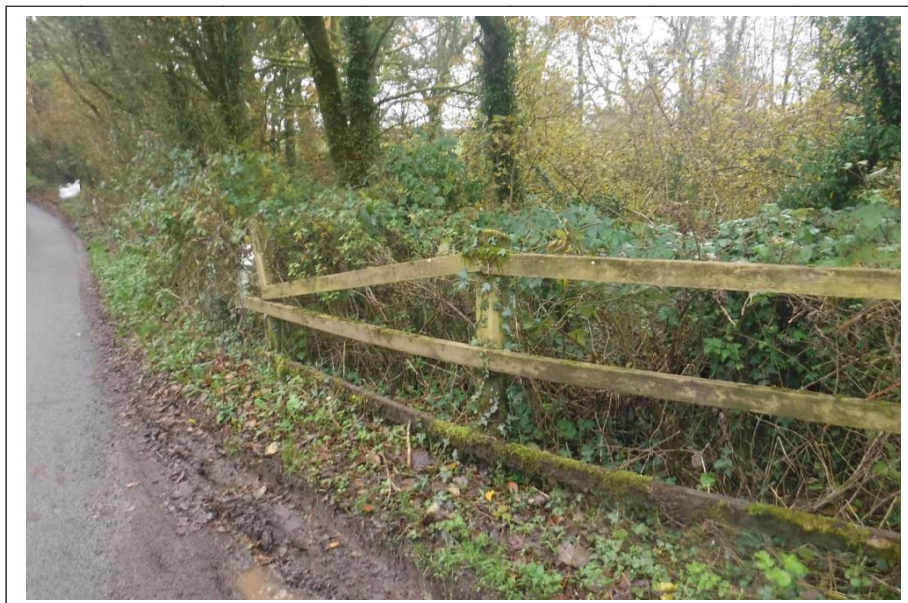
Photograph no 29: Single fence element displaced beyond UC embankment
(May not be HE (HRE) liability)

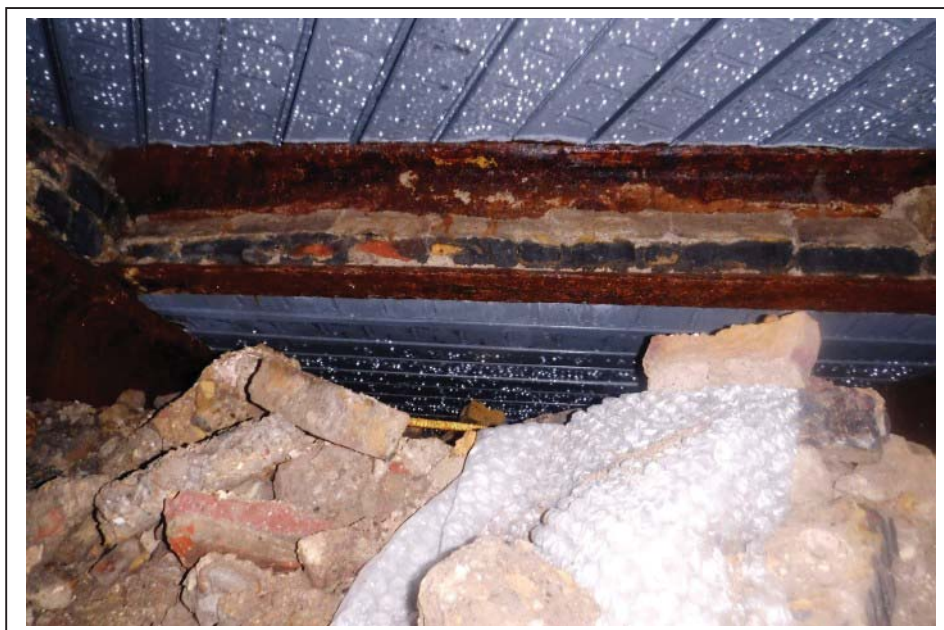
Photograph no 1: Cross girder and permanent formwork wet throughout (CG 5 shown)

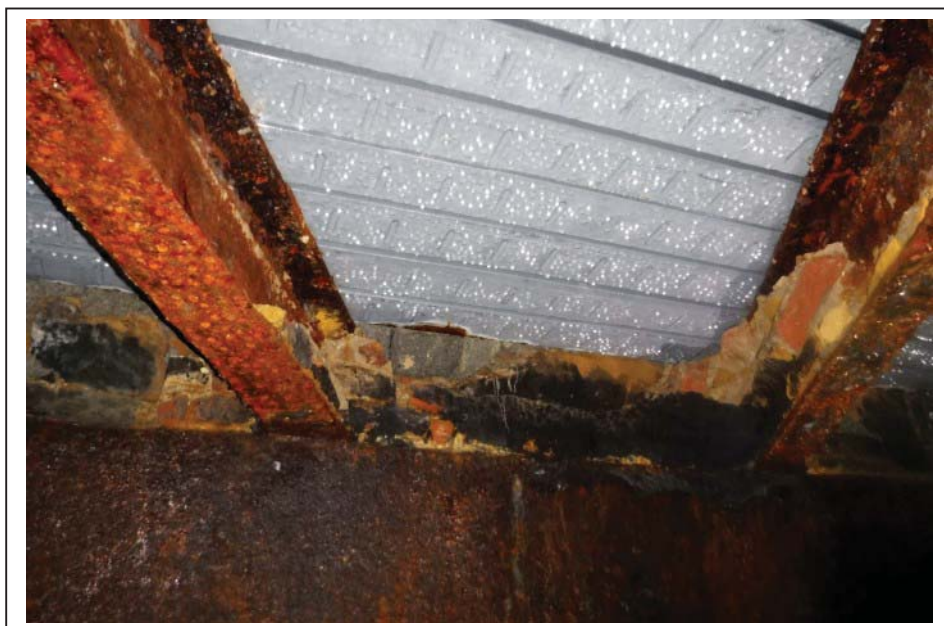
Photograph no 2: LE of cross girder 6 and main girder 2 wet throughout

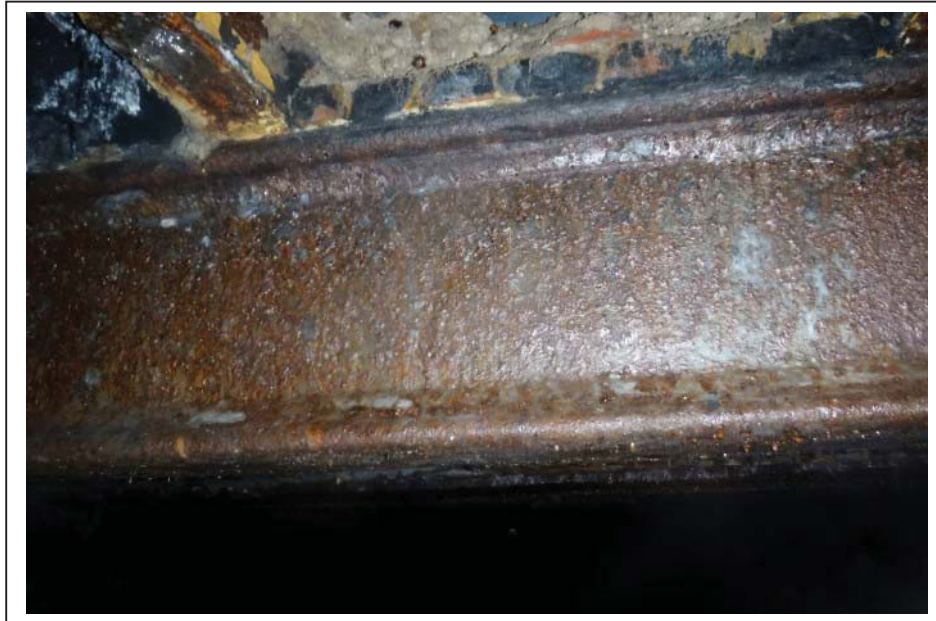
Girder No3: metal beam (510mm deep, 410wide). Moderate surface corrosion to all exposed faces. Girder found wet throughout (P5): surface corrosion removed in places for examination.

Photograph no 5: Main inner girder No3
Moderate surface corrosion to all exposed faces. Girder found wet throughout

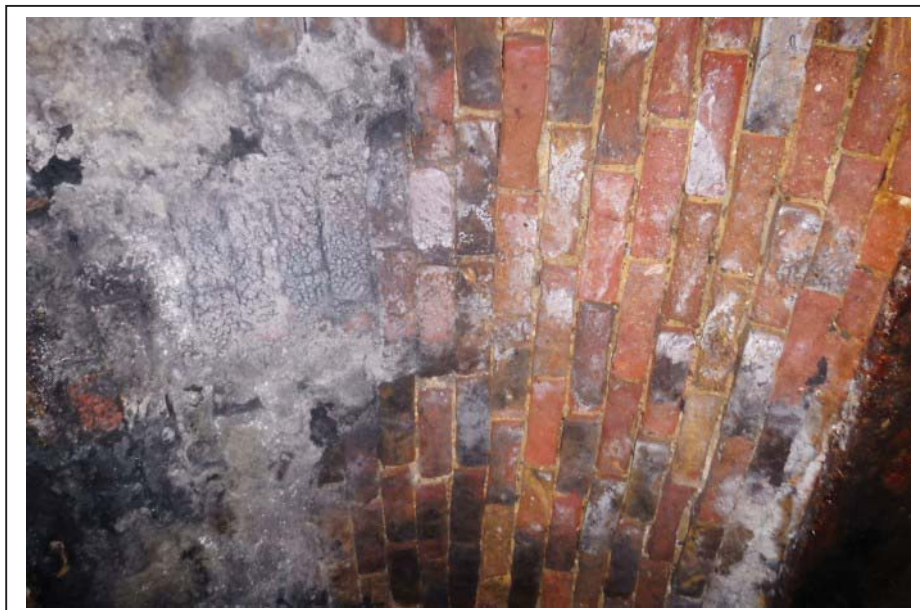
Jack arch No8: 3m² open joints to 70 mm max to DS (P6) and 50mm max to US (P7). DS area is found with spalled bricks to 50mm max (P8).

Photograph no 6: Jack arch No8
3m² open joints to 110 mm max to DS

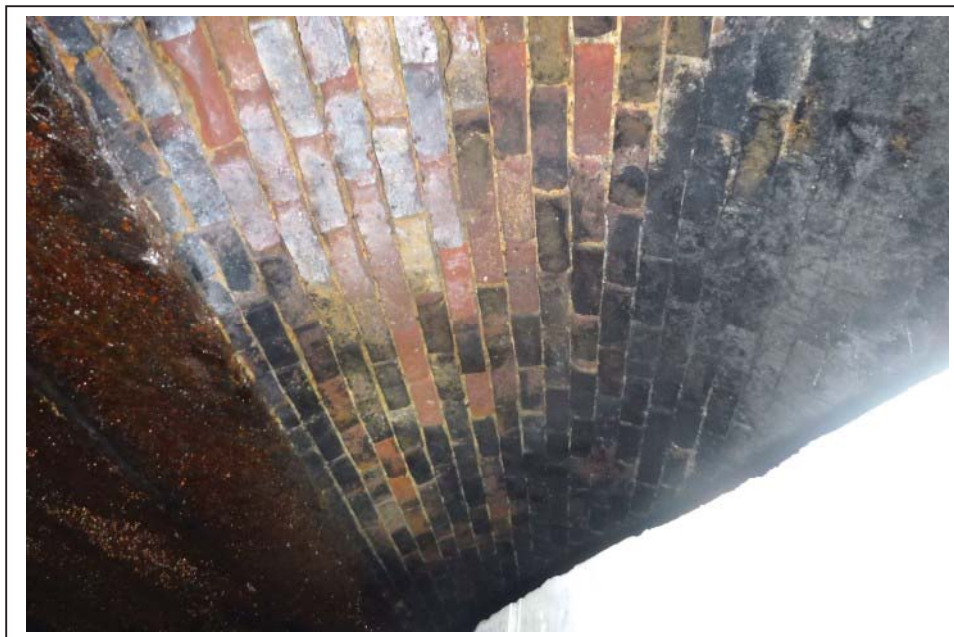
Photograph no 7: Jack arch No8
3m² open joints to 50mm max to US

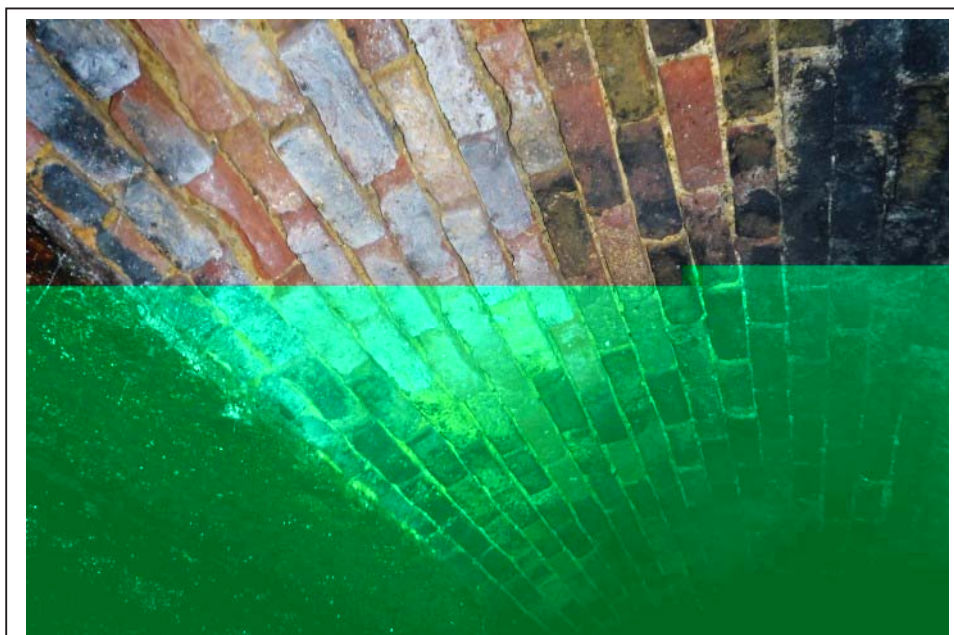
Photograph no 8: Jack arch No8
DS area is found with spalled bricks to 50mm max

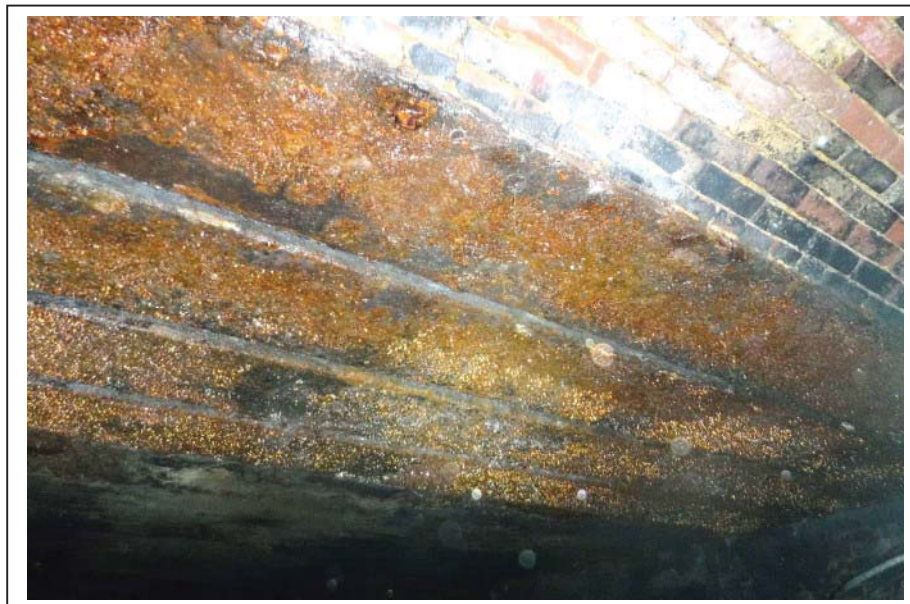
Girder No4: metal beam (460mm wide), wet, with water dripping throughout (P9) and lamination to 8mm and moderate corrosion. Significant areas of delamination, to 2-3mm, noted (P10).

Photograph no 9: Girders No4-7: metal beams (460mm wide), wet, with water dripping throughout

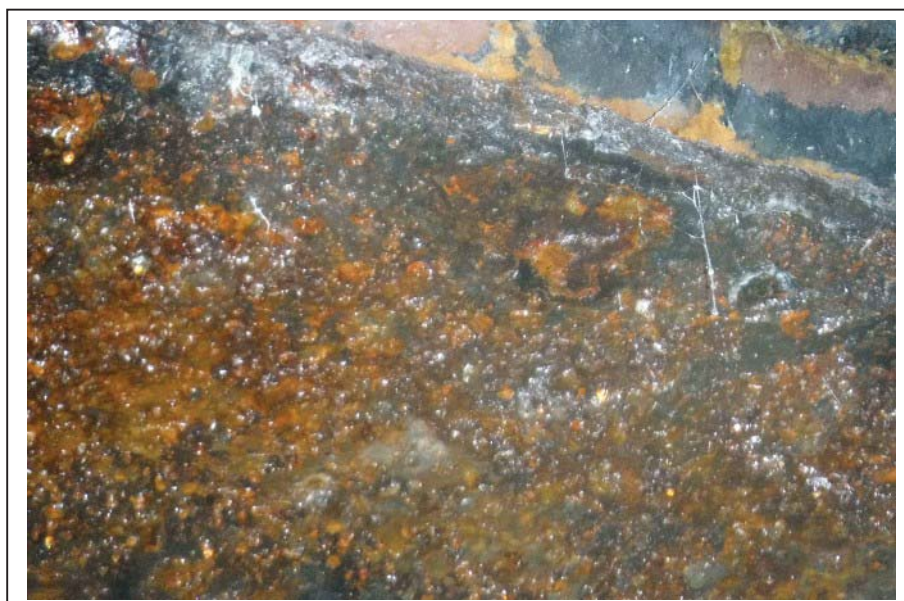
Photograph no 10: Girder No4: metal beam (460mm wide)
Lamination to 8mm and moderate corrosion. Significant areas of delamination, to 2-3mm, remain

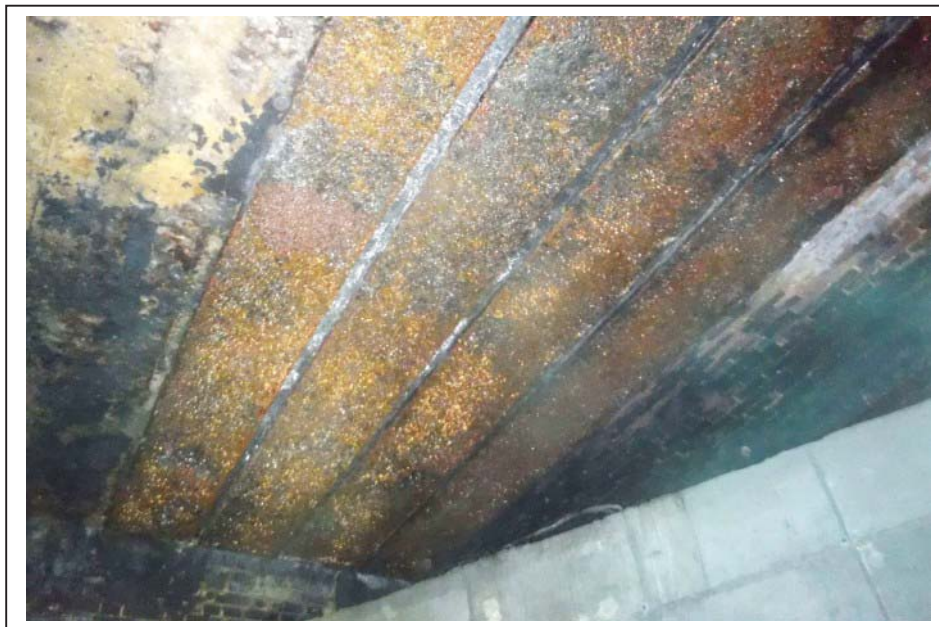
Girder No5 6 & 7: metal beams 460mm wide; moderate corrosion and saturated throughout the exposed bottom flanges (P11)

Photograph no 11: Girder No4-7: metal beams 460mm wide
Moderate corrosion and saturated throughout

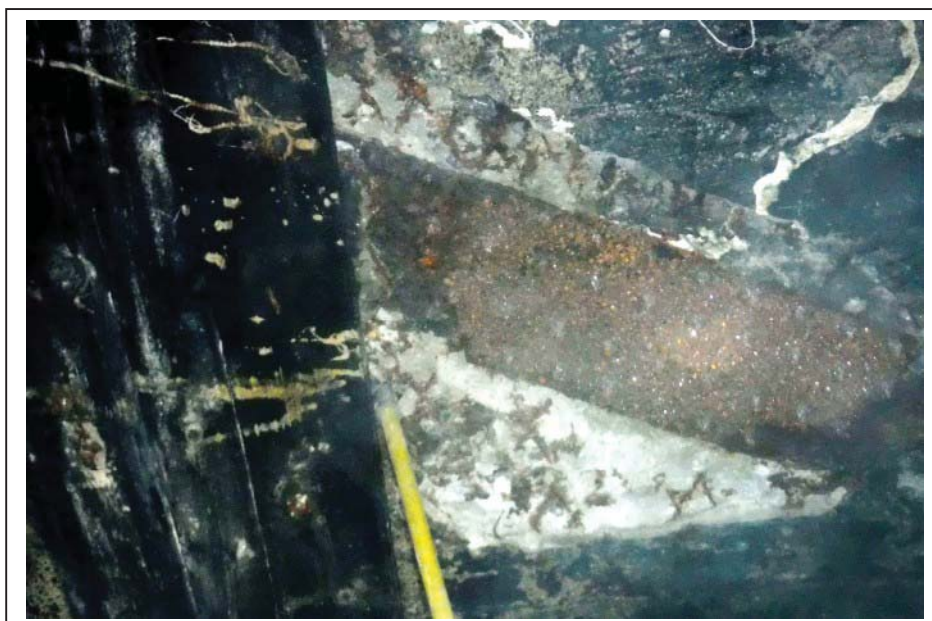
10m space between girders No7 & 8:- Original soffit of wrought iron girders protected with reinforced concrete render which has failed in isolated pockets, exposing pockets of original main girders (P13). Fresh loose material noted to DS bottom flange (P12). Strengthening timbers or old formwork runs parallel to sidewalls on DS (P14). Render generally in poor condition throughout and loose in places (P15).

Photograph no 12: 10m space between girders No7 & 8
Fresh loose material noted to DS bottom flange

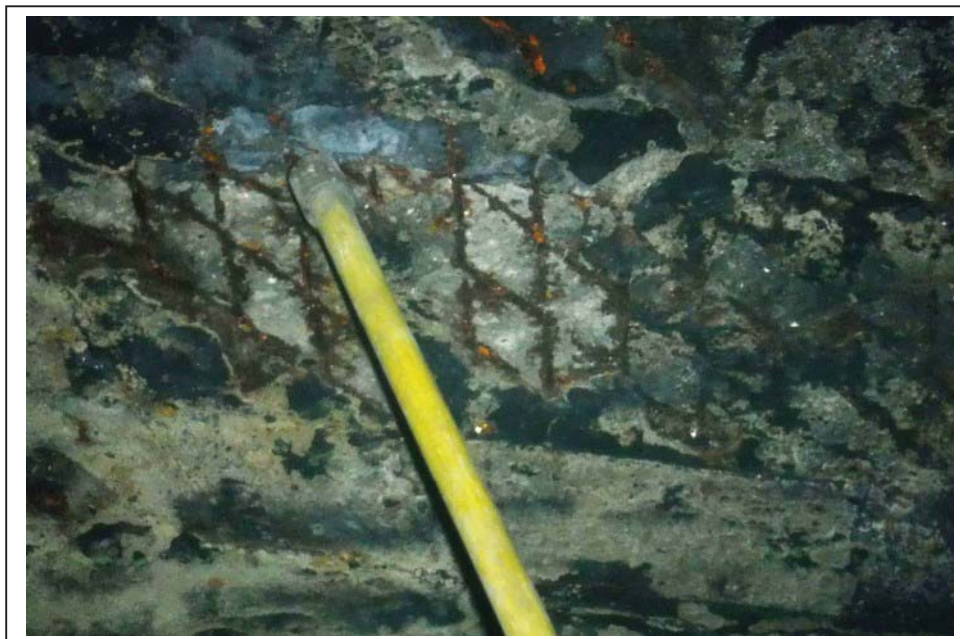
Photograph no 13: 10m space between girders No7 & 8
Original soffit of wrought iron girders protected with reinforced concrete render which has failed in isolated pockets, exposing pockets of original main girders

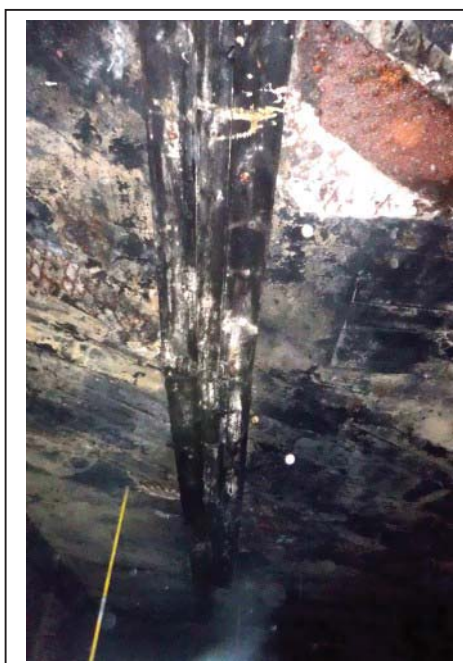
Photograph no 14: 10m space between girders No7 & 8
Heavily decayed strengthening timbers or old formwork runs parallel to sidewalls on DS

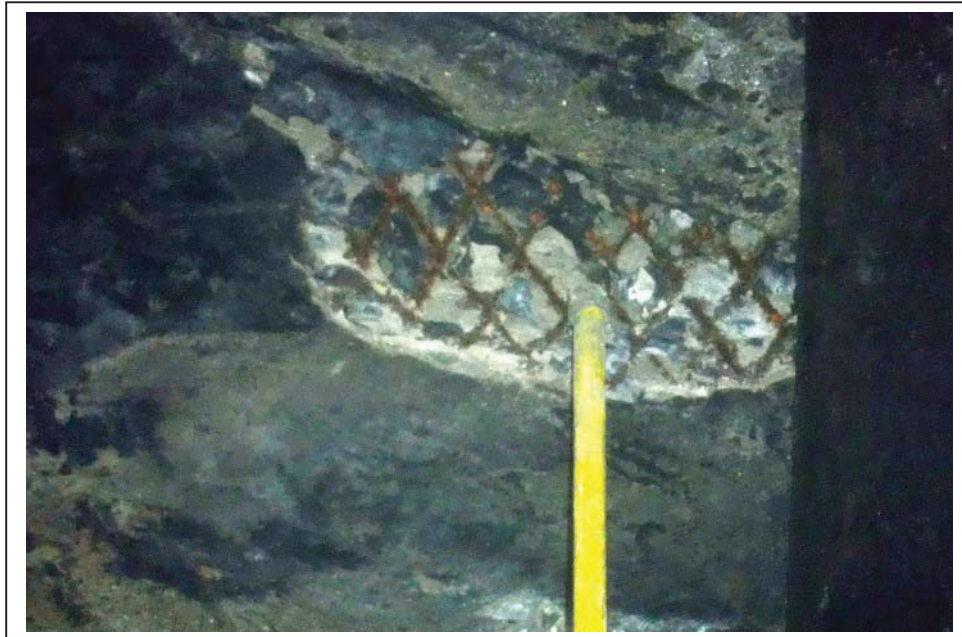
Photograph no 15: 10m space between girders No7 & 8
Render generally in poor condition throughout and loose in places with large quantities removed

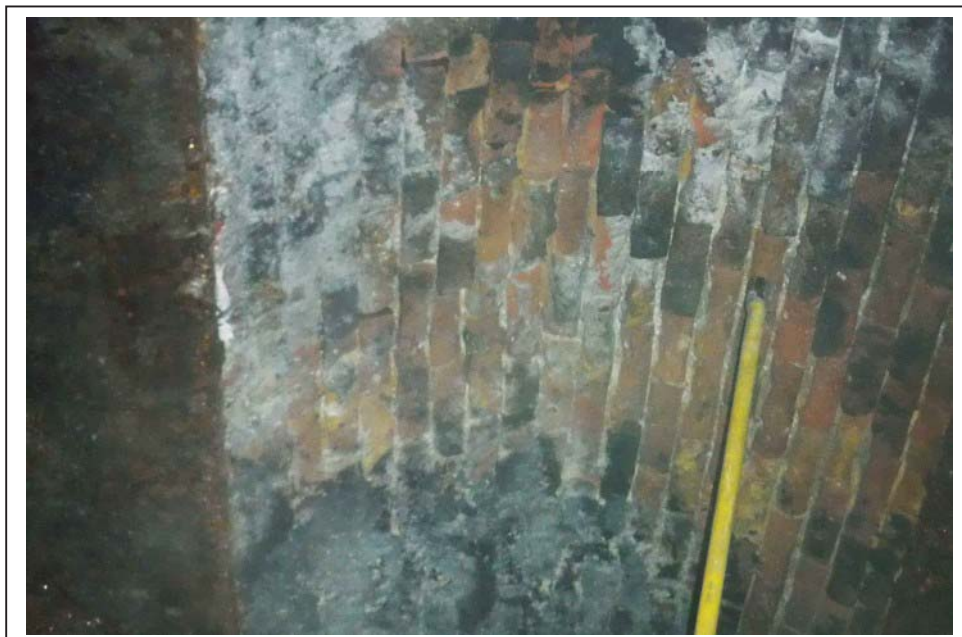
Jack Arch No9: spalling to 75mm 1m² on US (P20) spalling to 100mm over 7.5m² to DS (P16, P17)

Photograph no 16: Jack Arch No9: spalling to 100mm over 7.5m² to DS
with whole DS hollow

Cut out and replace spalled areas of jack arches 8(DS), 9(US), 9(DS), 15(DS) - P2 £2.5k.

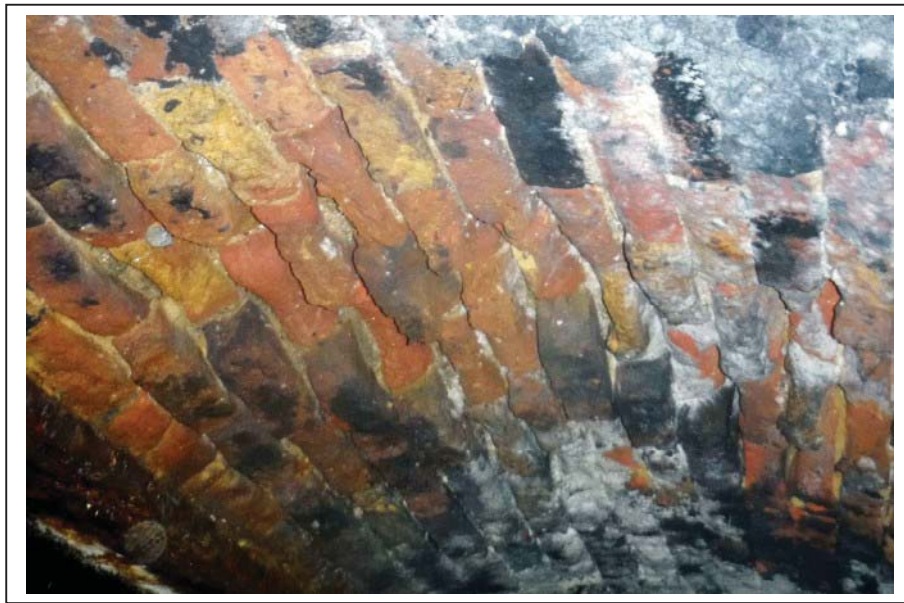
Photograph no 17: Jack Arch No9: spalling to 100mm over 7.5m² to DS

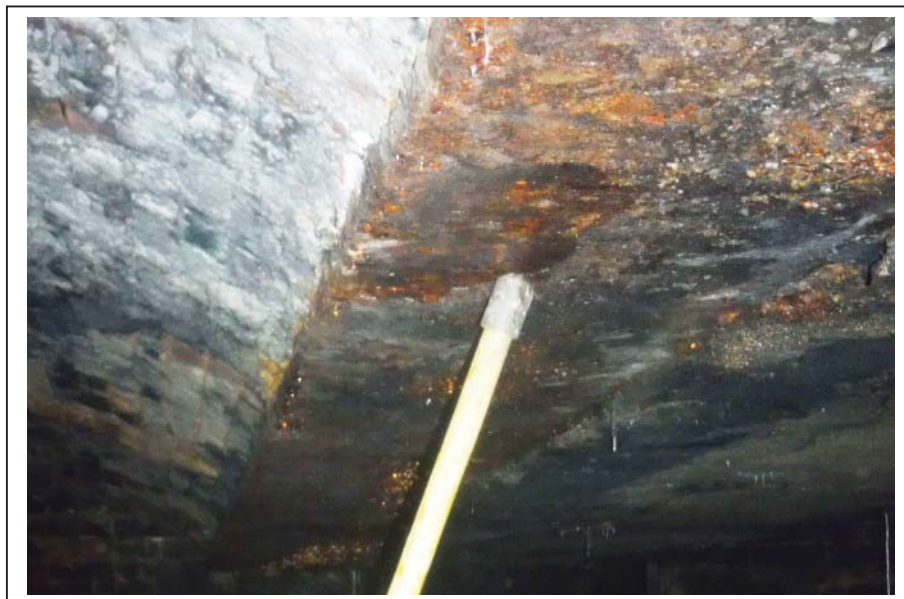
Girder No8: metal beam (510mm wide), generally in fair condition, saturated with moderate surface corrosion (P18). Small area of lamination removed to CE bottom flange (P19)

Photograph no 18: Girder No8: metal beam (510mm wide), generally in fair condition, saturated with moderate surface corrosion
Lamination approx 1mm removed over area of 0.25m²

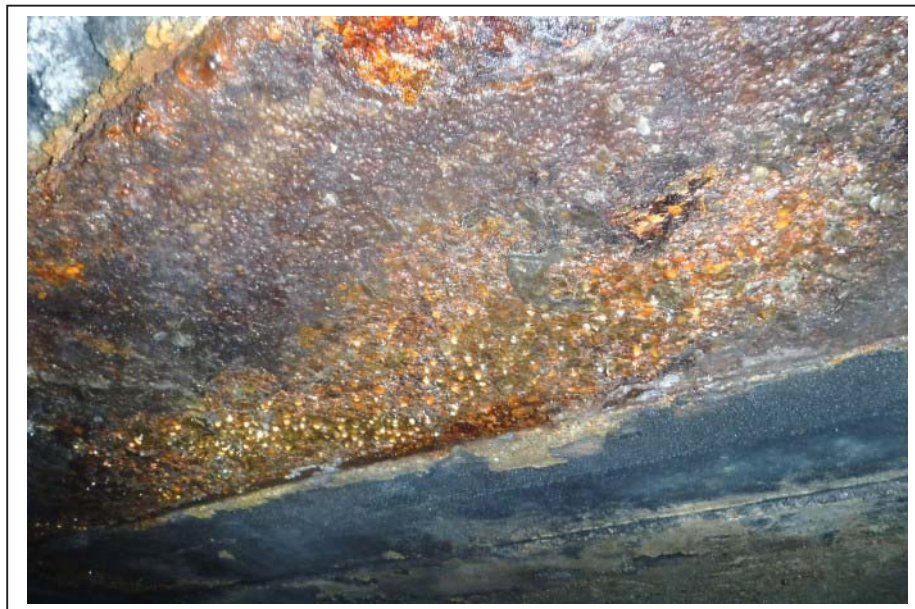
Photograph no 19: Girder No8: metal beam (510mm wide)
Small area of lamination removed to CE bottom flange

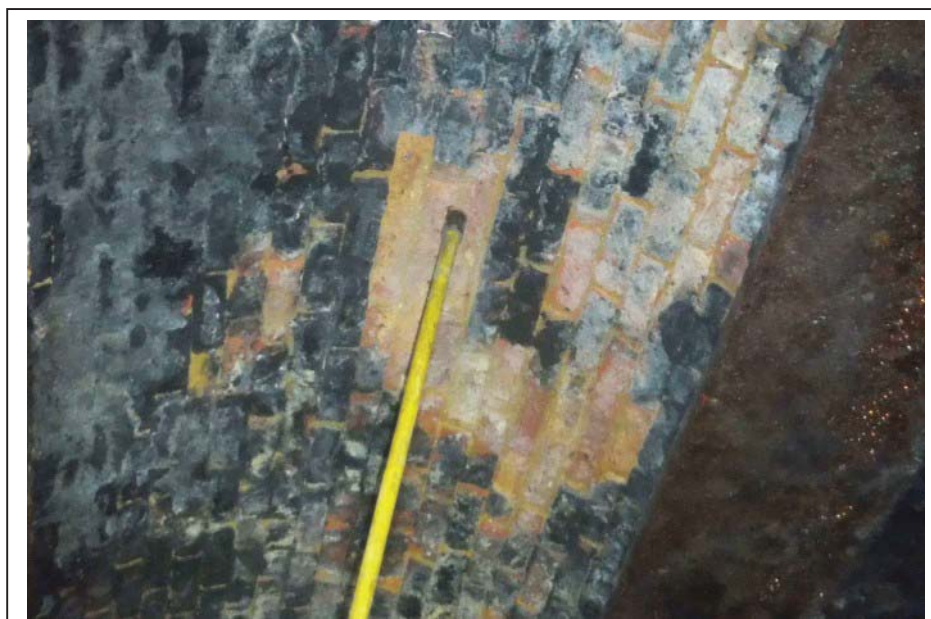
Photograph no 20: Jack Arch No9: spalling to 75mm 1m² on US

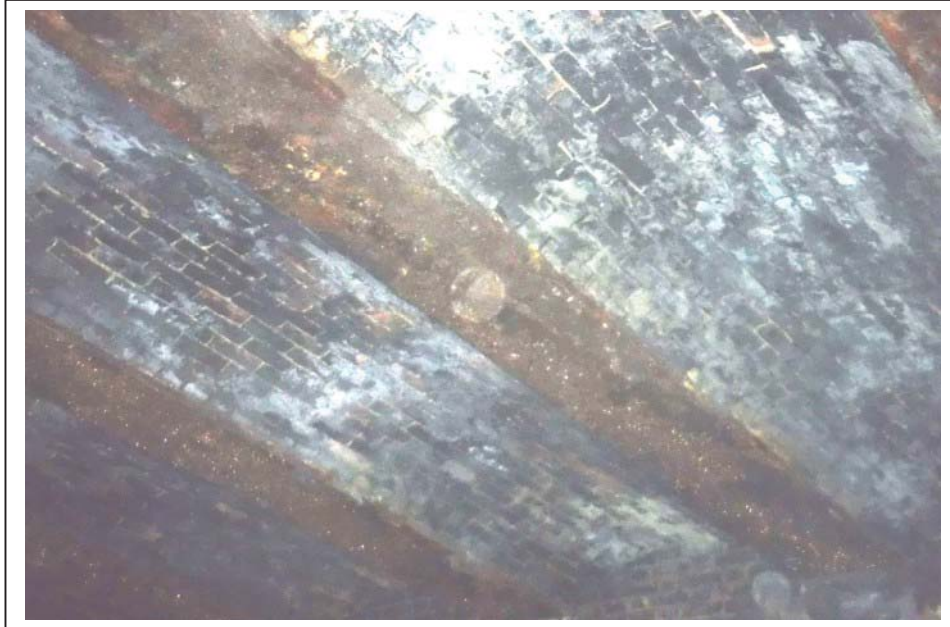
GirderNo9: metal beam (510mm wide) generally in fair condition. Wetness and surface corrosion with lamination to 5mm locally removed to DS (P21)

Photograph no 21: GirdersNo9-11: metal beams (510mm wide) generally in fair condition
Wetness and surface corrosion with lamination to 5mm locally removed to DS

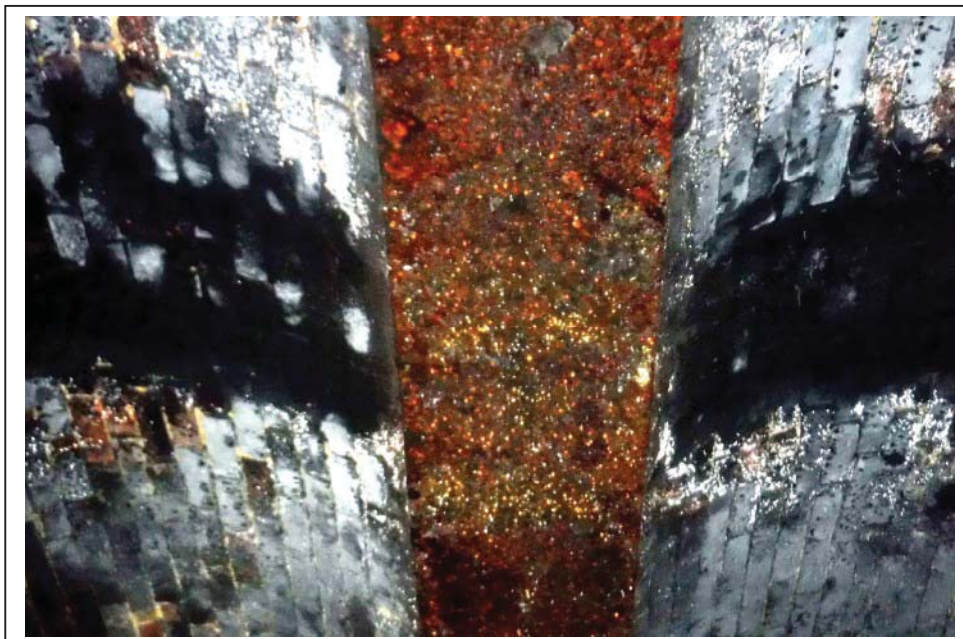
Girder No12: metal beam (510mm wide): generally in fair condition. Wet throughout with lamination to 2mm removed from US bearing area (P22)

Photograph no 22: Girder No12: metal beam (510mm wide): generally in fair condition
Wet throughout with lamination to 2mm removed from US bearing area

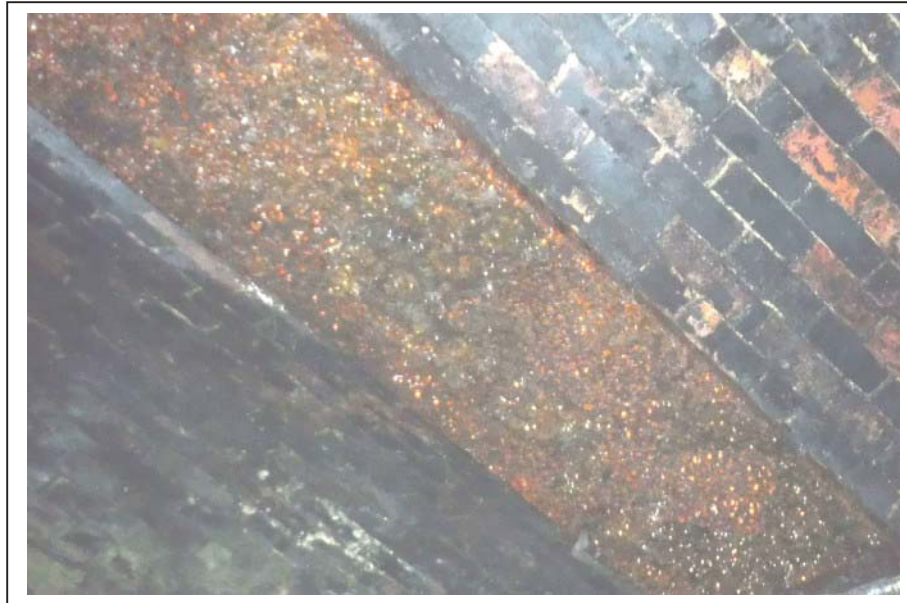
Girder No14: metal beam (510mm wide) generally in fair condition. Moderate surface corrosion and wet throughout with water dripping (P23). Small patches of corrosion removed. Delamination to 8mm to DS at bearing.

Photograph no 23: Girder No14 wet throughout

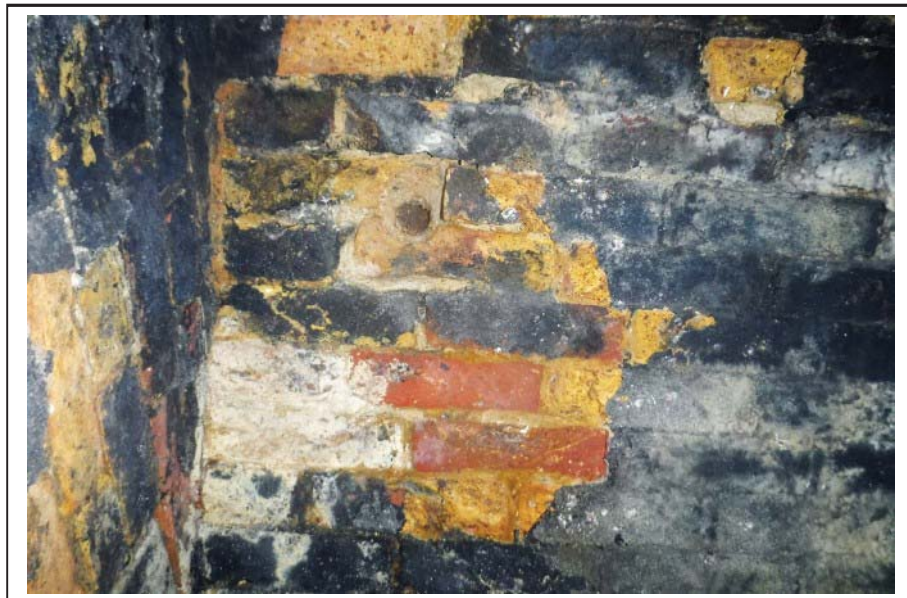
Jack Arch No15: Loss of section above D/Side sidewall: 4No bricks missing. Further fresh minor spalling noted adjacent with local area of brickwork drummy and very soft over 0.5m² area (P24)

Photograph no 24: Jack Arch No15: Loss of section above D/Side sidewall: 4No bricks missing
Further fresh minor spalling noted adjacent with local area of brickwork drummy
and very soft over 0.5m² area

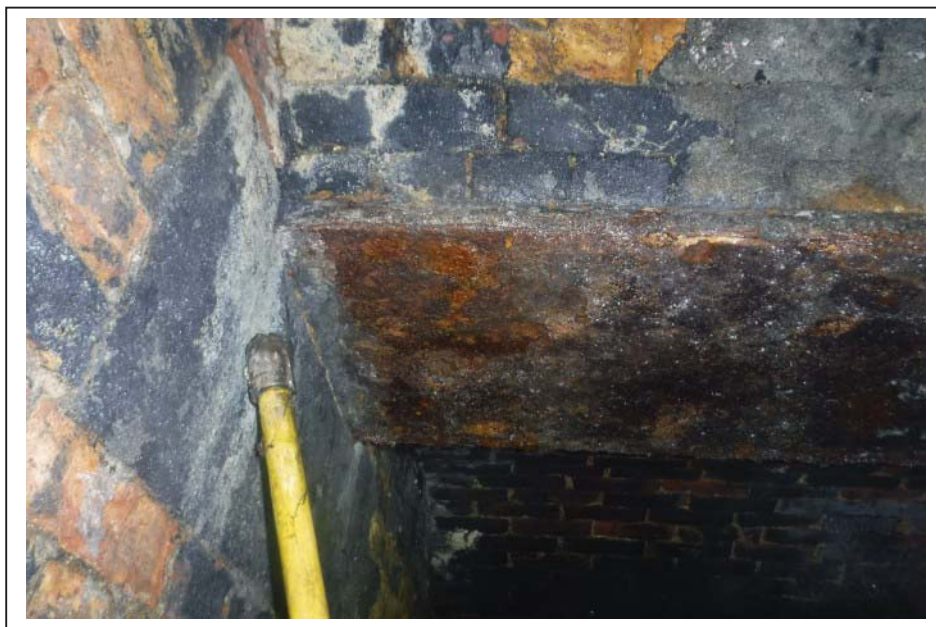
Photograph no 25: Girder No15: metal beam (510mm wide)
No further loss noted

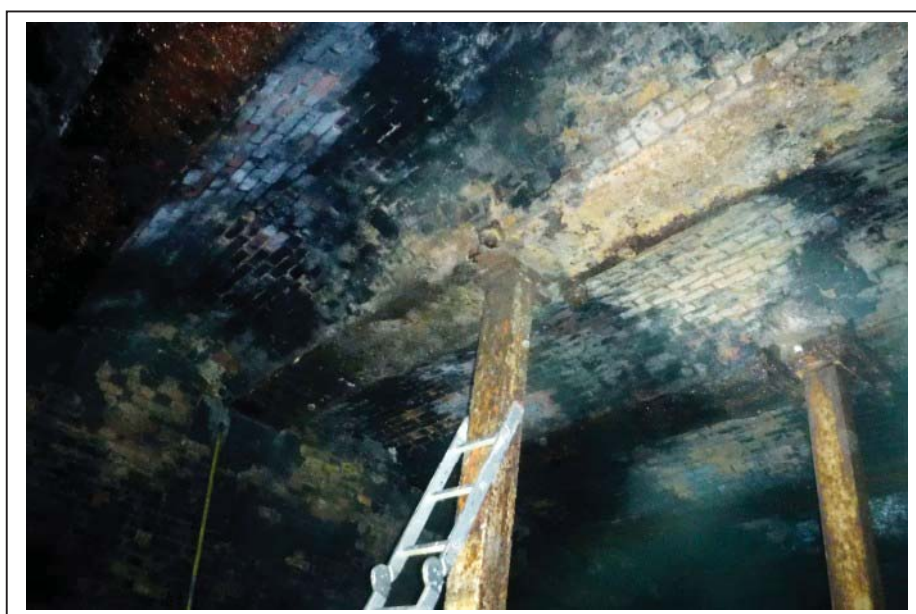
Photograph no 26: Girder No15: metal beam (510mm wide)
2.9m from DS wall, girder No15 is supported by a vertical column (column 1)

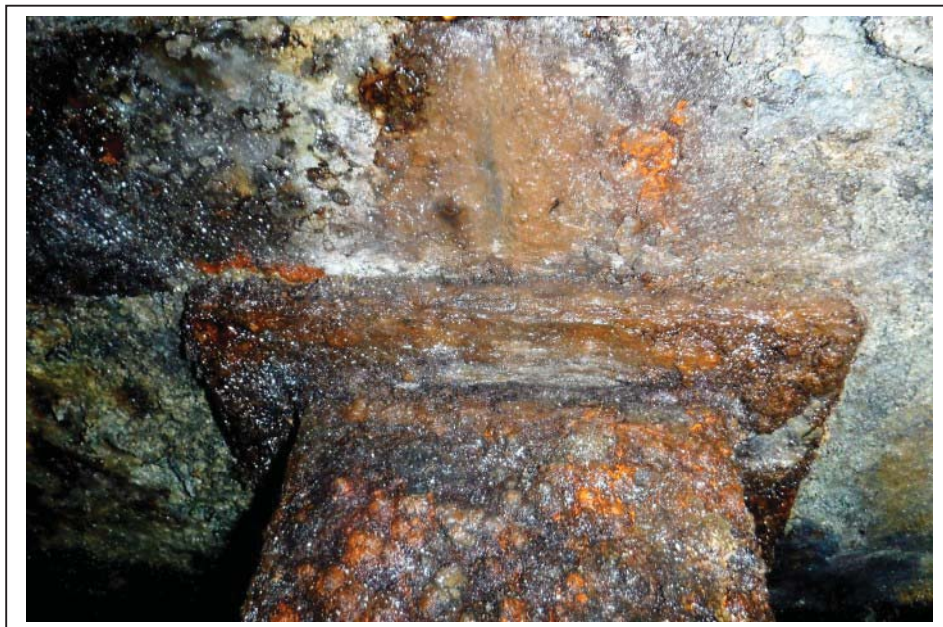
Photograph no 27: Girder No15: metal beam (510mm wide)
All bolt heads base plates and column are wet with water dripping from bolt heads
