ELR:	BLE	Structure No:	Mileage: 187m 64ch	Examination date: 14/11/17
Route:	Barnstaple Branch Line			OS ref: SS 871 261
Name:	East Anstey Tunnel			Type: Tunnel

ELR:	BOK1	Structure No:	283	Mileage:		Examination date:	26/03/19
Route:	Broad Street to Dalston West Junction					OS ref:	TQ 336 847
Name:	Dalston Lane					Type:	Tunnel

Balfour Beatty Rail, Manchester
Bridgnorth Tunnel
ELR:SVB/43
Examined:29/11/2018

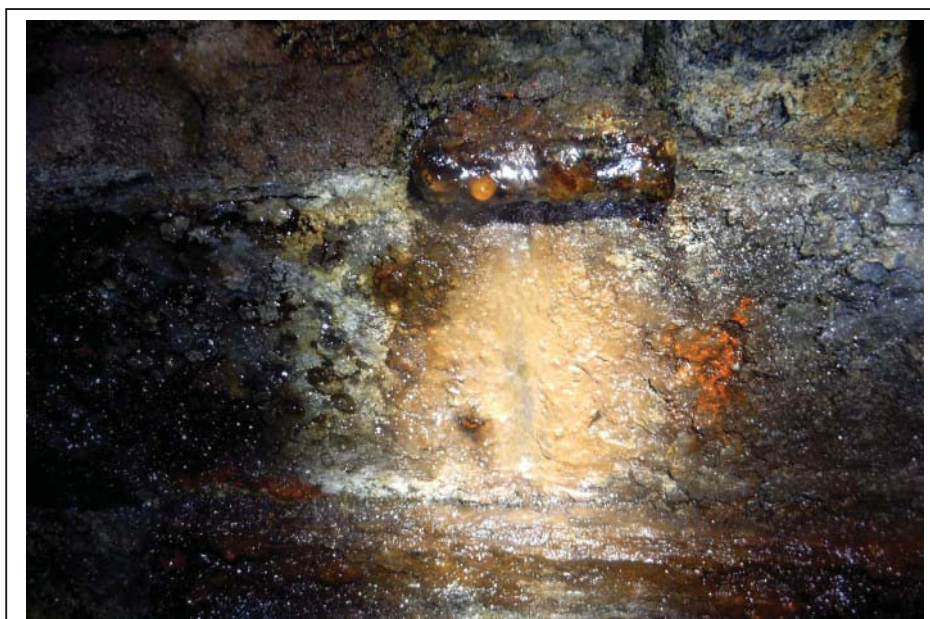
Photograph no 28: Girder No15: metal beam (510mm wide)
Fracture/ depression to bottom flange is visible to L/End

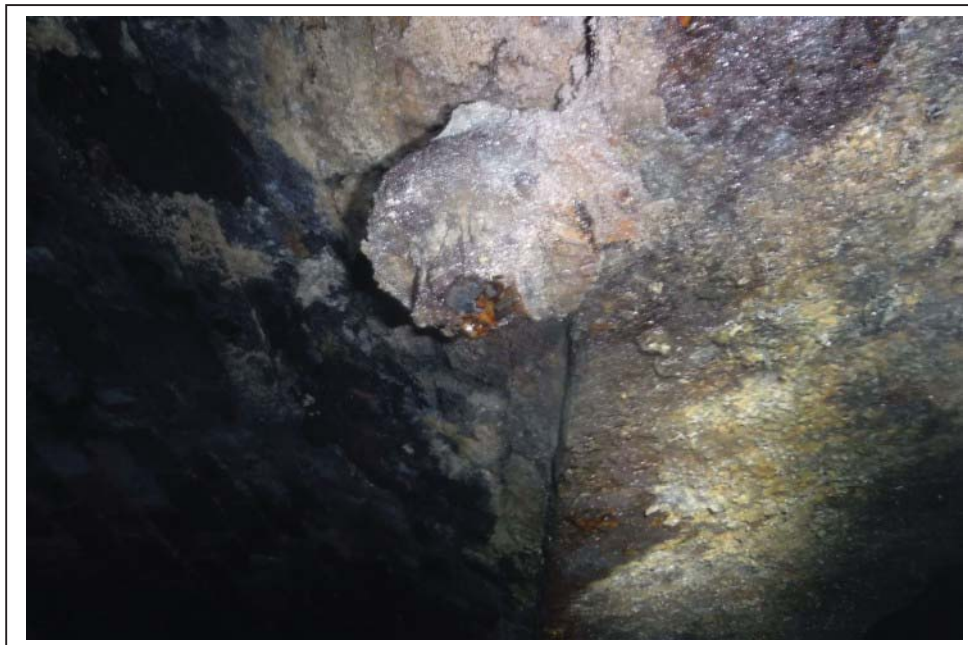
Photograph no 29: Girder No15: Bolt shanks are exposed at LE and moderately corroded by 2-5mm

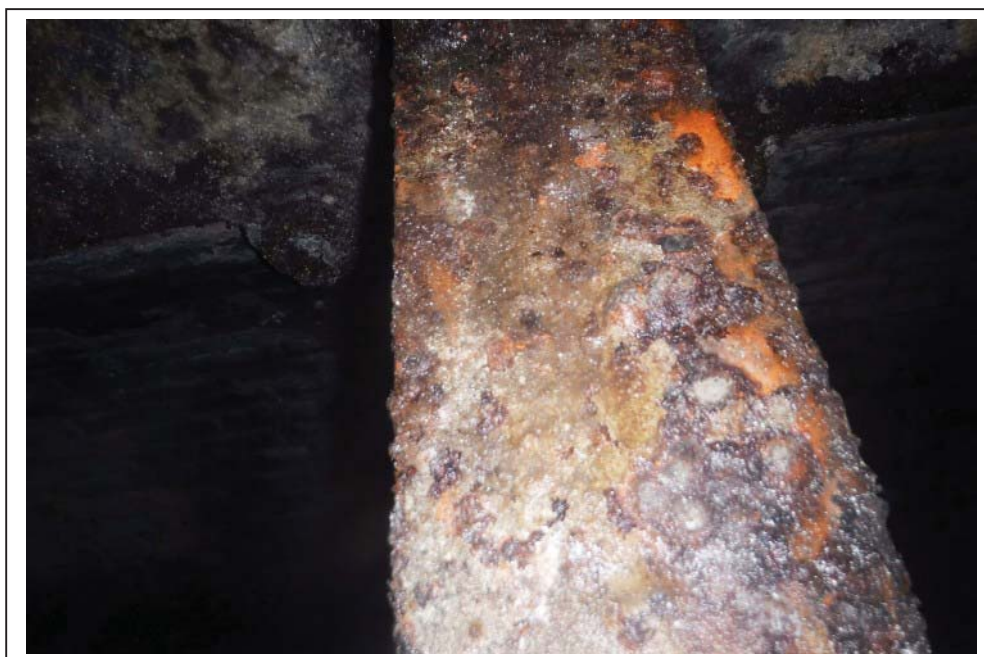
Photograph no 30: Girder No15: metal beam (510mm wide)
Support shows surface corrosion

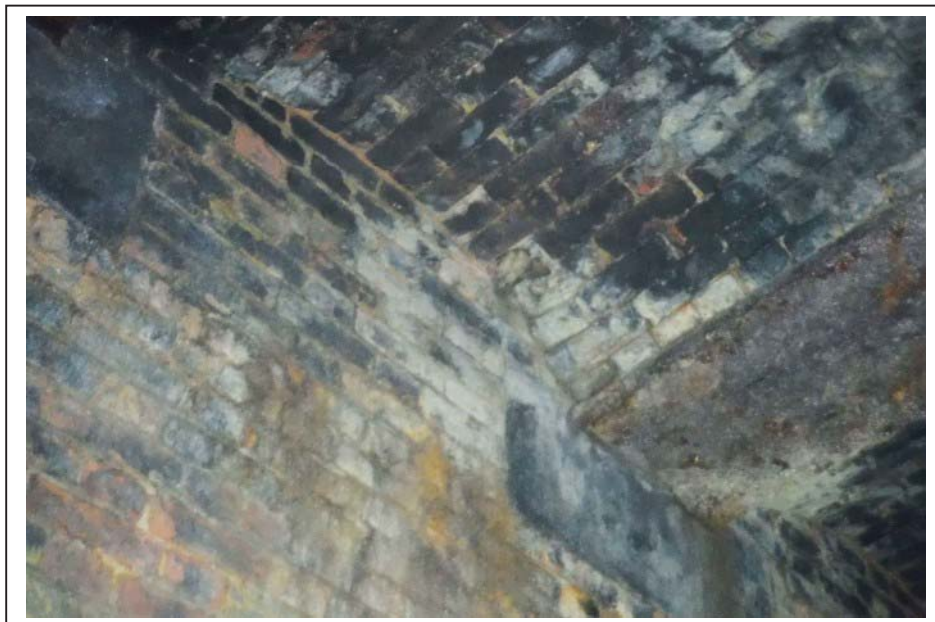
Jack Arch No16: 1No missing brick to UL above sidewall but firm to hammer (**P31**). 2m² open joints to 25mm. Area adjacent to column supports also wet

Photograph no 31: Jack Arch No16: 1No missing brick to UL above sidewall but firm to hammer

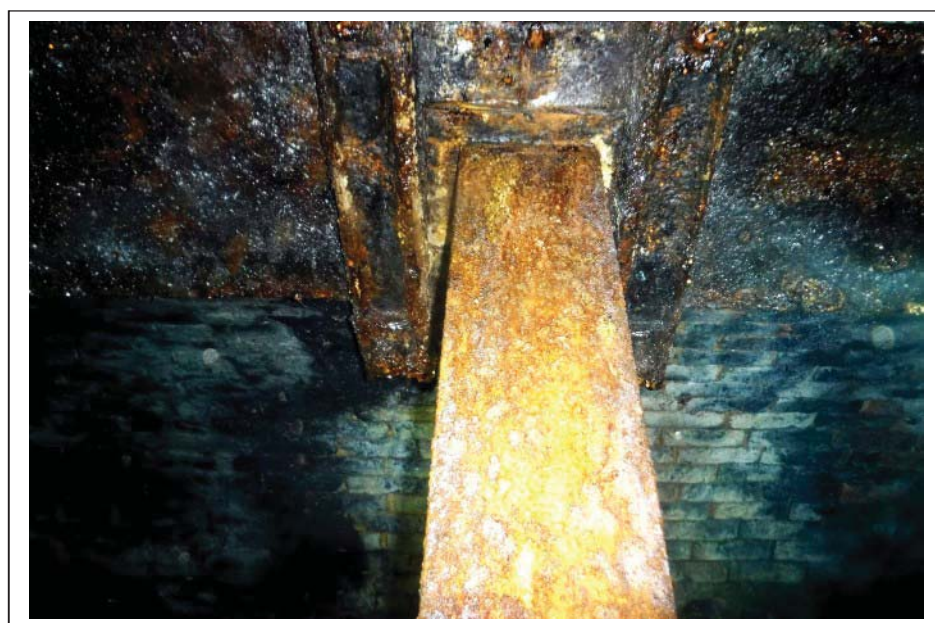
Girder No16: metal beam (510mm wide) wet with water dripping especially around support. 3.7m from D/Side wall, the girder is supported by a vertical column (column 2 – **P32**) total size 150mm x 200mm fabricated from welded steel channel sections. Top of column connects to girder with top plate 260mm x 320mm x 20mm. 2No bullhead sections also support the flanges of the girder (**P33**). The girder is found wet with water dripping. Bullhead supports show moderate corrosion and lamination to 5mm particularly to outer edges. The column is vertical and in good condition (**P36**). Gap (between plates) noted at support shows no change (**P34, P35**). Lamination to girder on DS to 2mm.

Photograph no 32: 3.7m from D/Side wall
The girder is supported by a vertical column (column 2)

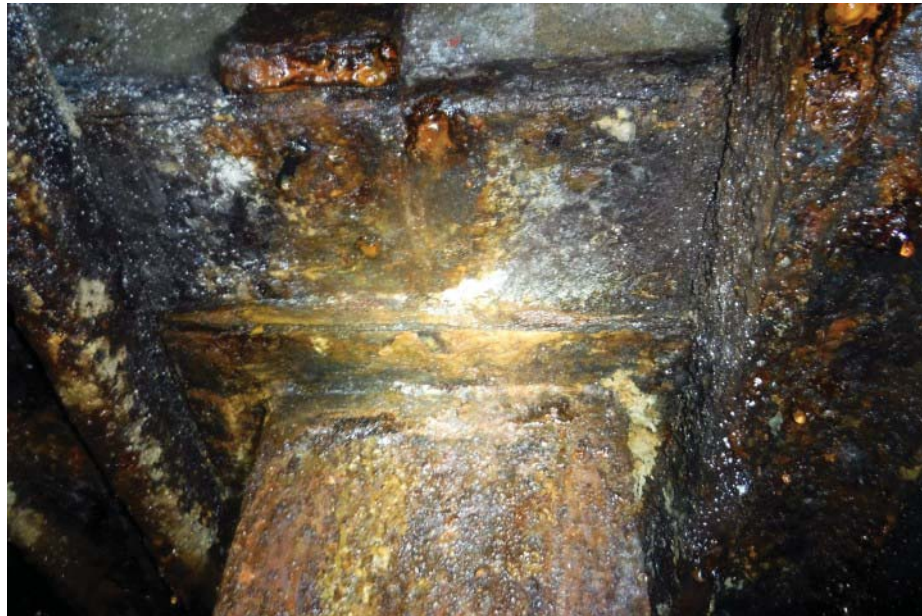
Photograph no 33: Jack Arch No16: 2No bullhead sections also support the flanges of the girder

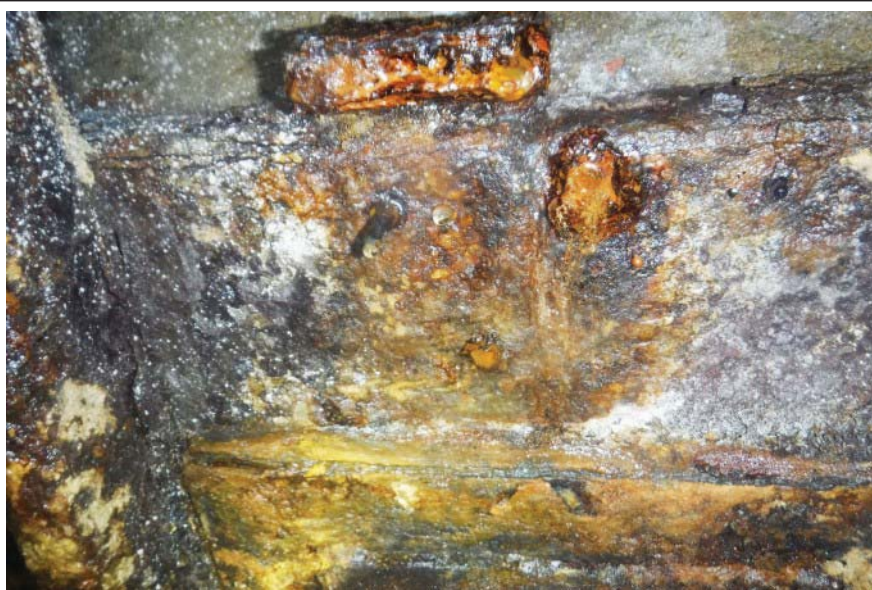
Photograph no 34: Jack Arch No16: Gap (between plates) noted at support shows no change

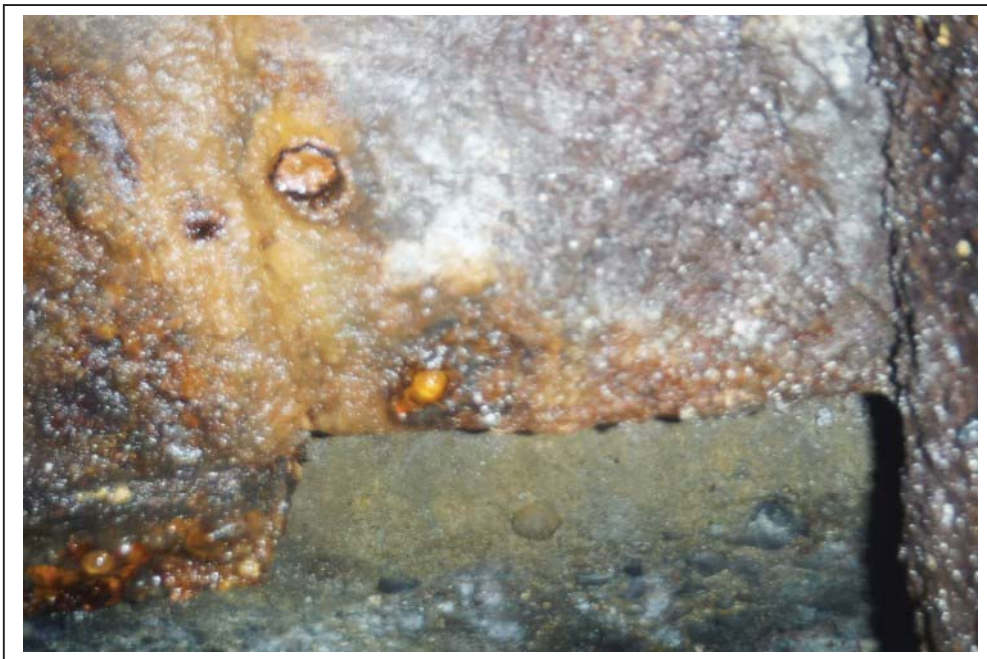
Photograph no 35: Jack Arch No16: Gap (between plates) noted at support shows no change

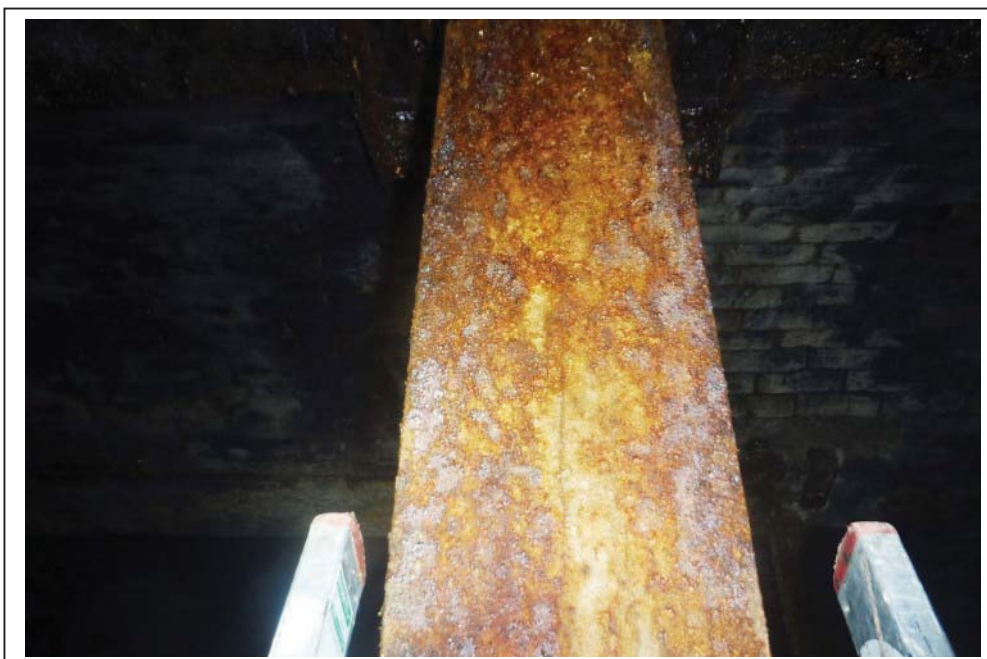
Photograph no 36: Jack Arch No16: The column is vertical and in good condition

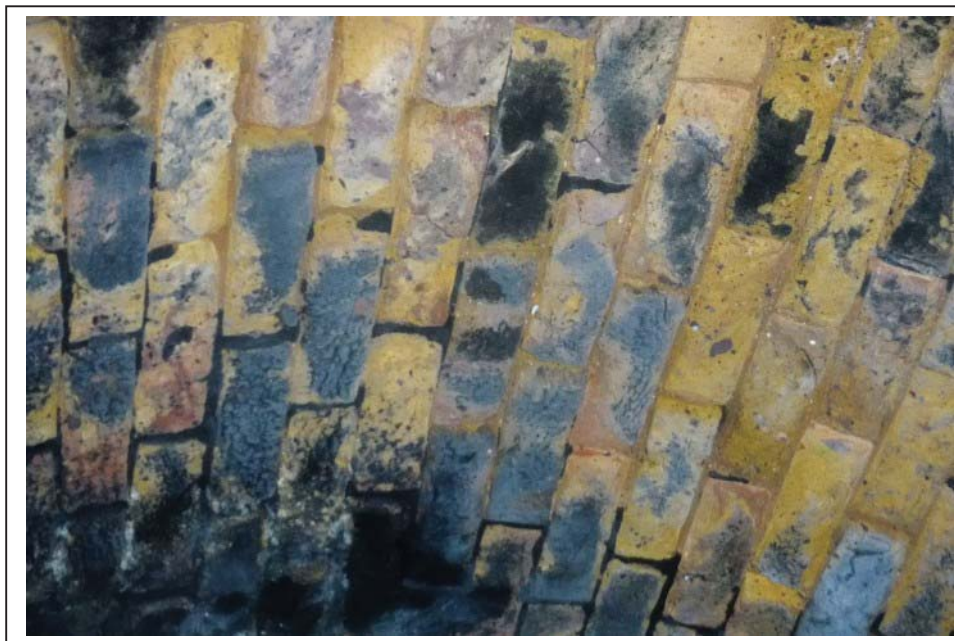
Jack Arch No17: generally in fair condition. Patch of open joints 0.5m² to 25mm and isolated spalling to 20mm, both to D/Side (**P37**)

Photograph no 37: Jack Arch No17: Patch of open joints 0.5m² to 25mm and isolated spalling to 20mm, both to D/Side

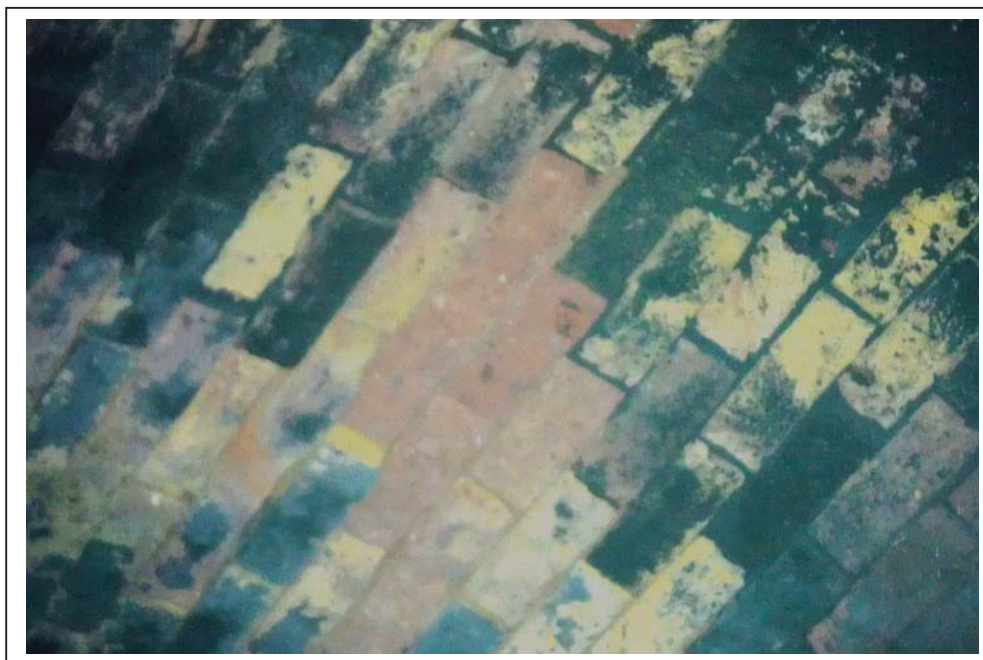
Jack Arch No20: generally found in good condition with small patches of soft brickwork especially at US and water dripping at centre (**P38**).

Photograph no 38: Jack Arch No20: small patches of soft brickwork especially at US and water dripping at centre

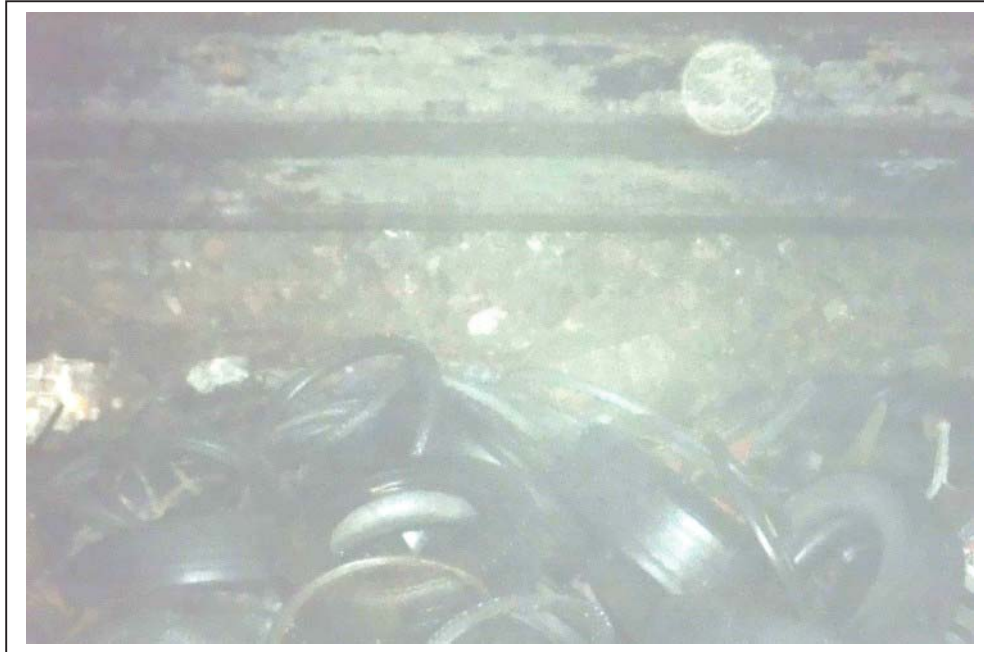
Photograph no 39: In-fill at C/End to full height prevents tactile inspection past girder No22

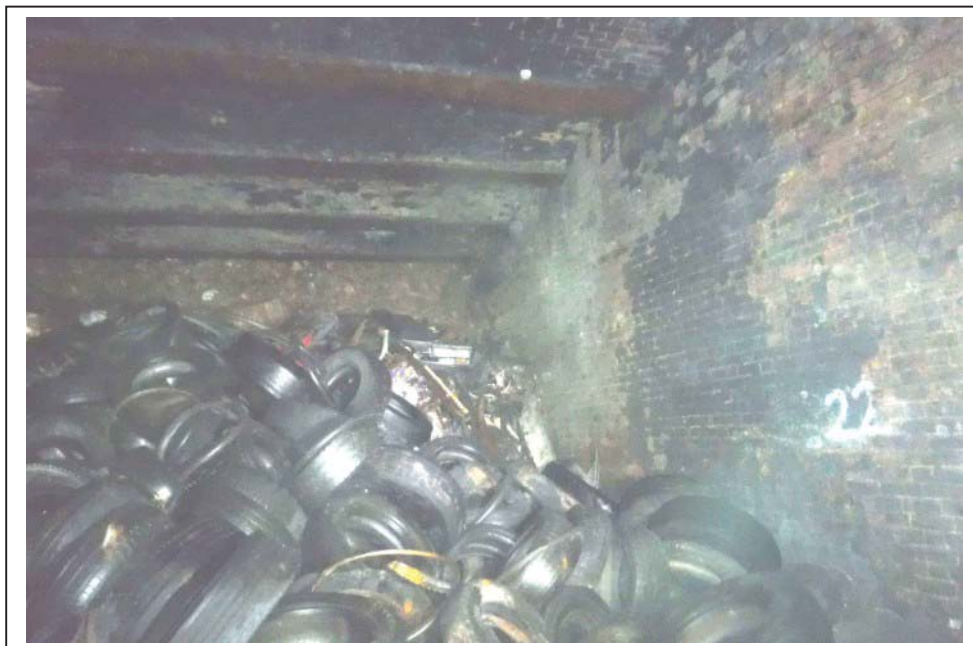
Photograph no 40: The CE portal remains infilled
Rough brickwork installed to rear shows no visible change

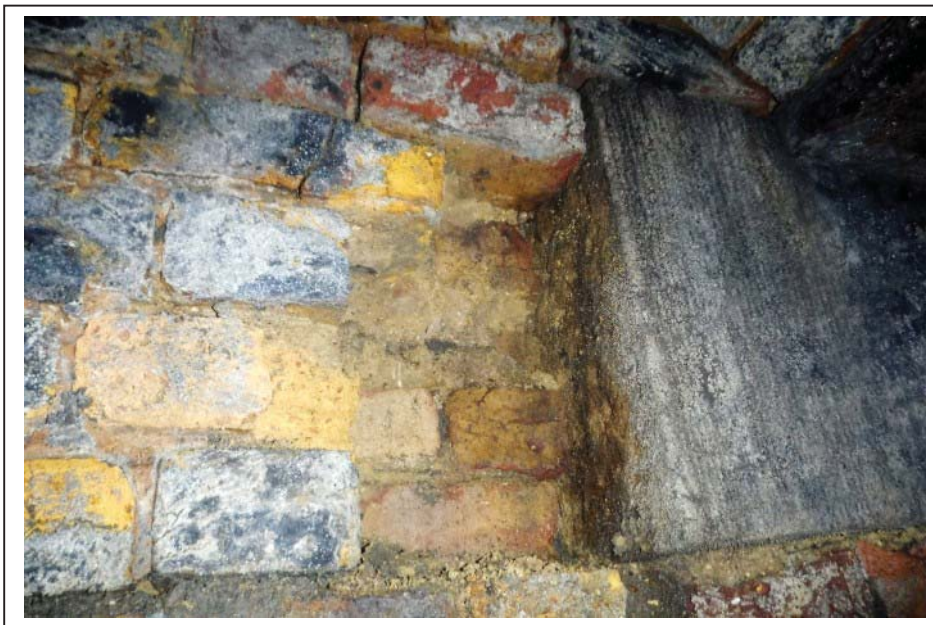
Below Jack Arch No20: (to UC of Girder 19) area of loss of section and loose brickwork to 140mm deep x 600mm high x 250mm wide (**P41**) with local area around padstone wet with water dripping (**P42**)

Photograph no 41: Sidewall U/side below Jack Arch No20 (to UC of Girder 19)
area of loss of section and loose brickwork to 140mm deep x 600mm high x 250mm wide

Replace missing brickwork to US sidewall below jack arch 20 - P2 £750.

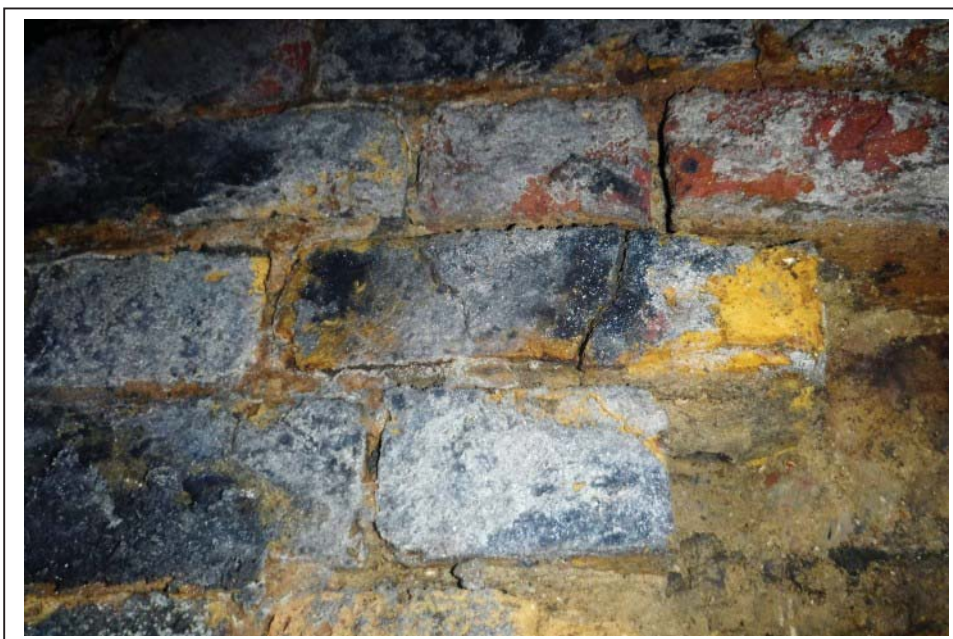
Photograph no 42: Sidewall U/side below Jack Arch No20: (to UC of Girder 19)
local area around padstone wet with water dripping

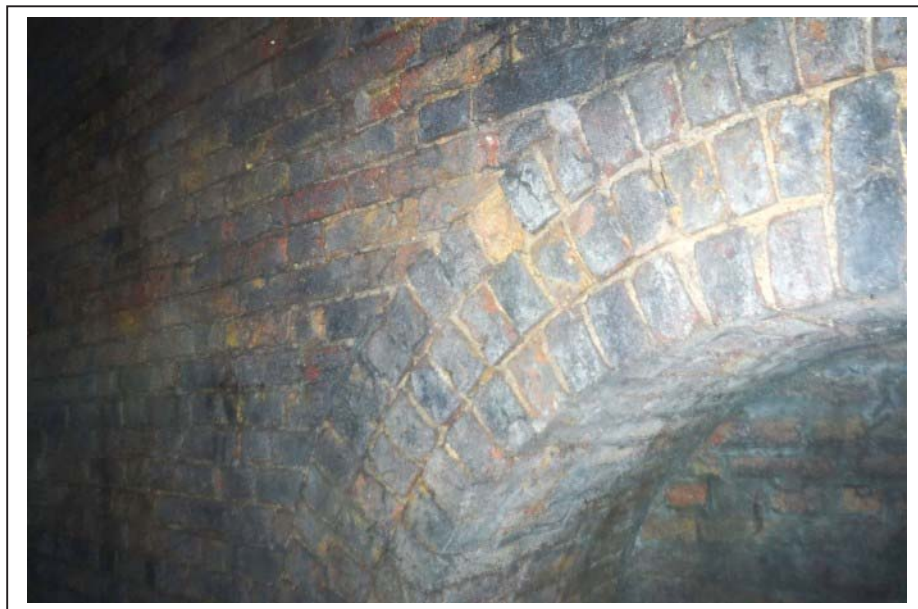
3No refuges found throughout tunnel. Joint loss to face ring on Refuge No3 (below US girder 18) to 0.5m² to 20mm (**P43**)

Photograph no 43: Joint loss to face ring on Refuge No3 (below US girder 18) to 0.5m² to 20mm

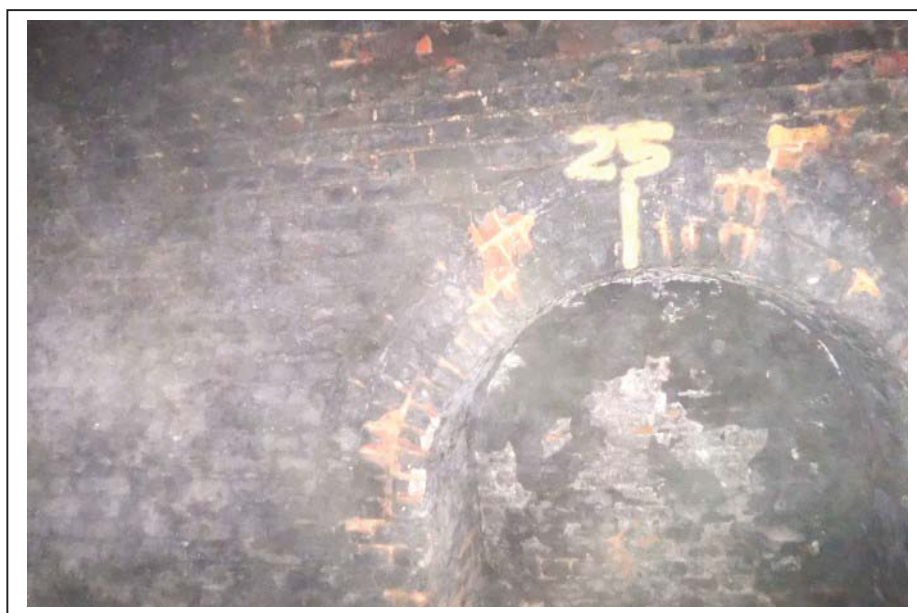
Refuge 2 (below DS girder 10): good condition (**P44**)

Photograph no 44: Refuge 2 (below DS girder 10): good condition

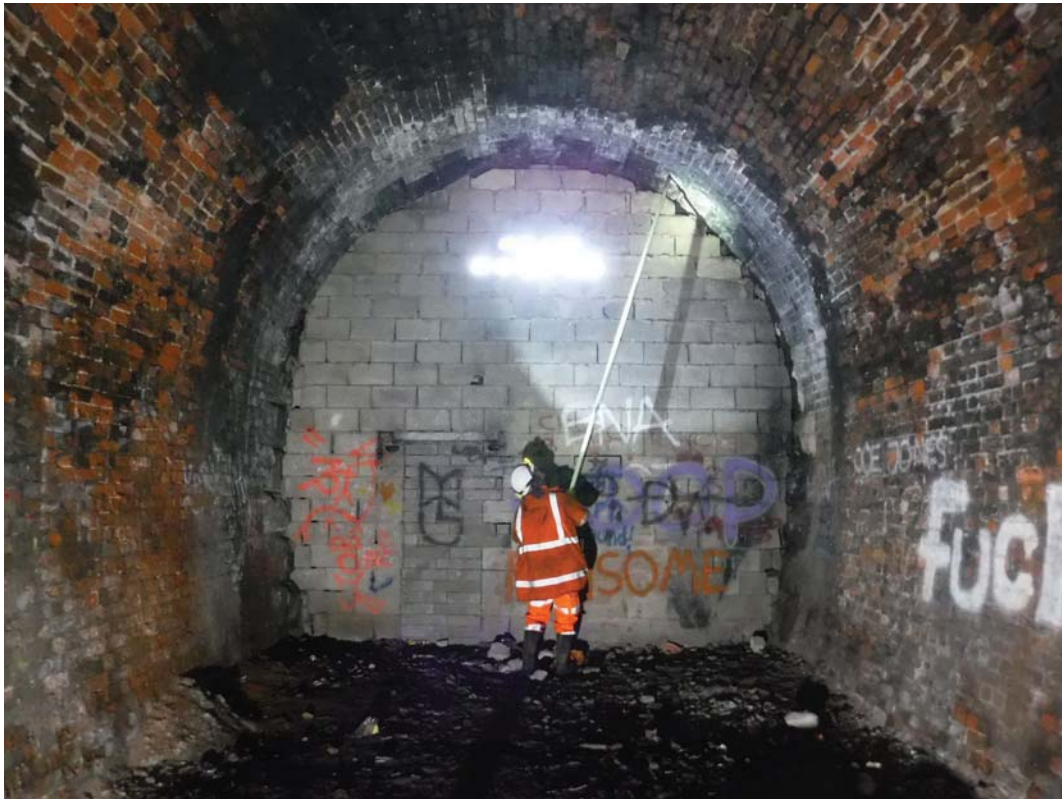
Photo No. 1 : 000+00 Portal Full Profile Up & Down, Bridgnorth Portal, View to the inside of the sealed portal.

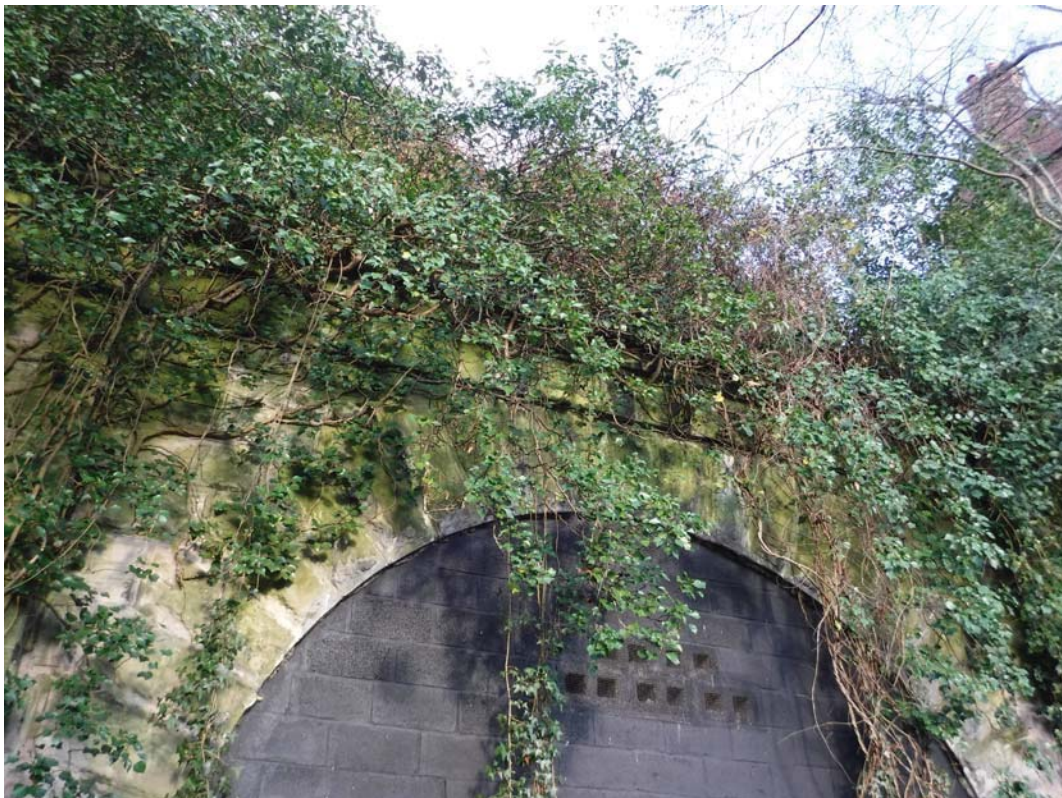
Photo No. 2 : 000+00 Portal Full Profile Up & Down, Bridgnorth Portal, Stonework, overgrown with vegetation and saplings, area 50sq.m.
