**TUNNEL EXAMINATION REPORT
PHOTOGRAPHS OF STRUCTURE**

Balfour Beatty Rail, Manchester**Caerau (Cymmer) Tunnel****ELR: BAL/10m17ch****Examined: 05/02/2019**

Balfour Beatty Rail, Manchester**Pen-Cae-Drain Tunnel****ELR: VON/28m 65ch****Examined: 30/07/2019**

Balfour Beatty Rail, Manchester
Penar Tunnel
ELR:HRD2/4m 42ch Examined:14/10/2019

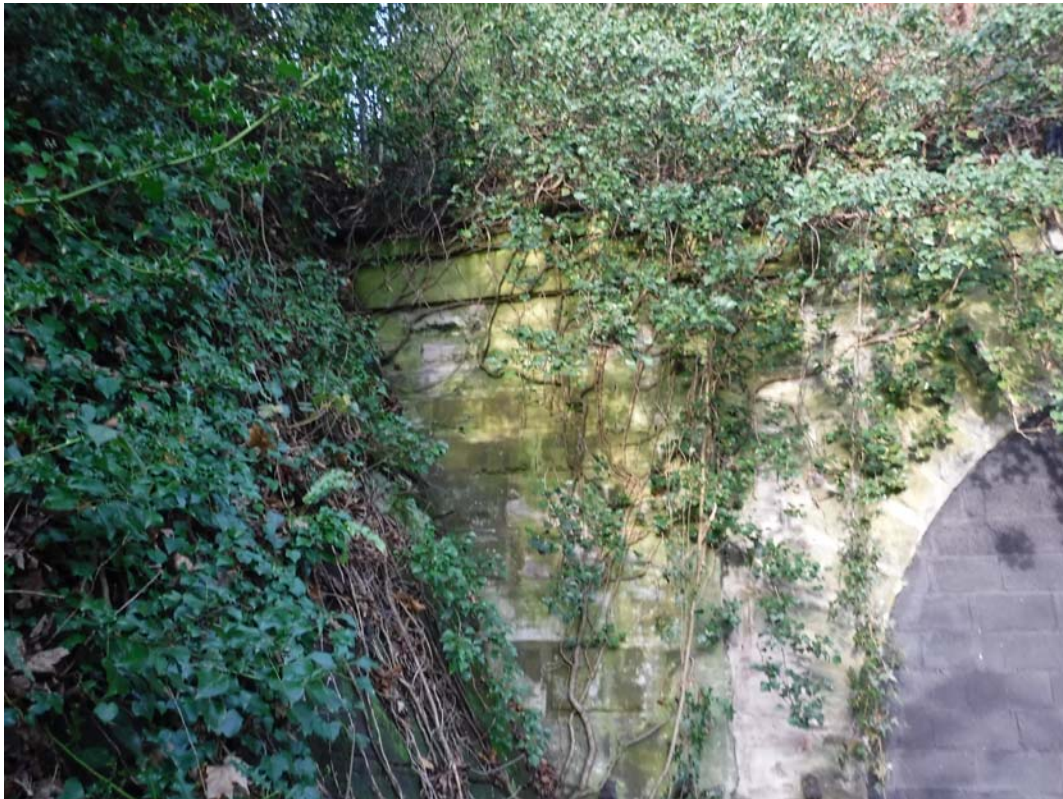
Photo No. 3 : 000+00 Portal Full Profile Up & Down, Bridgnorth Portal, Stonework, overgrown with vegetation and saplings, area 50sq.m.

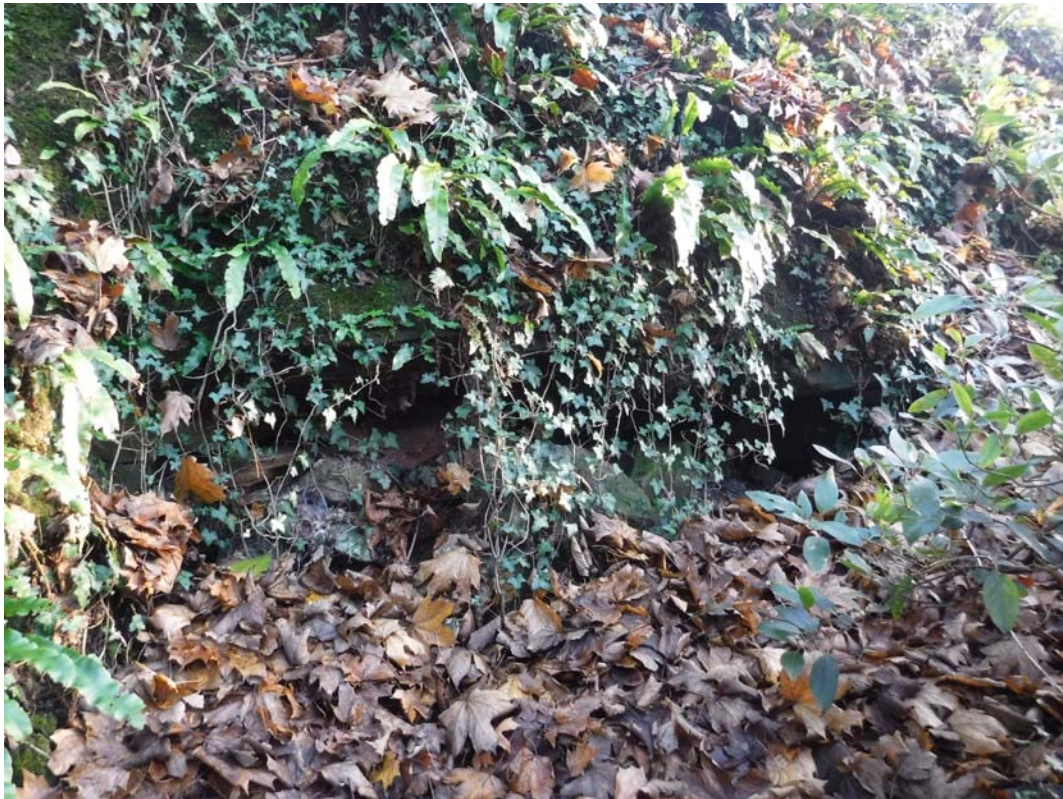
Photo No. 5 : 000+00 Portal Up, Bridgnorth Portal, Wingwall/Retaining Wall, stonework, undermining with loose blocks, area 3sq.m.

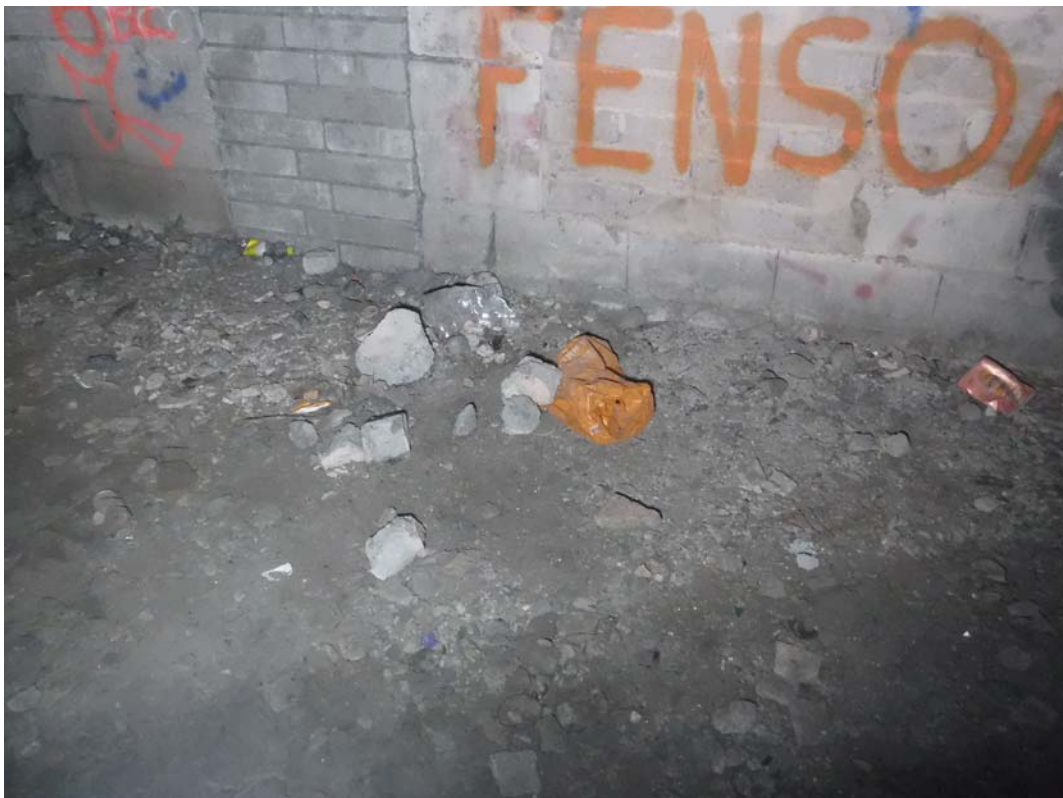
Photo No. 6 : 000+00 to 000+05 Solum Up & Down, Rubble from blockwork portal seal repairs and litter on solum.

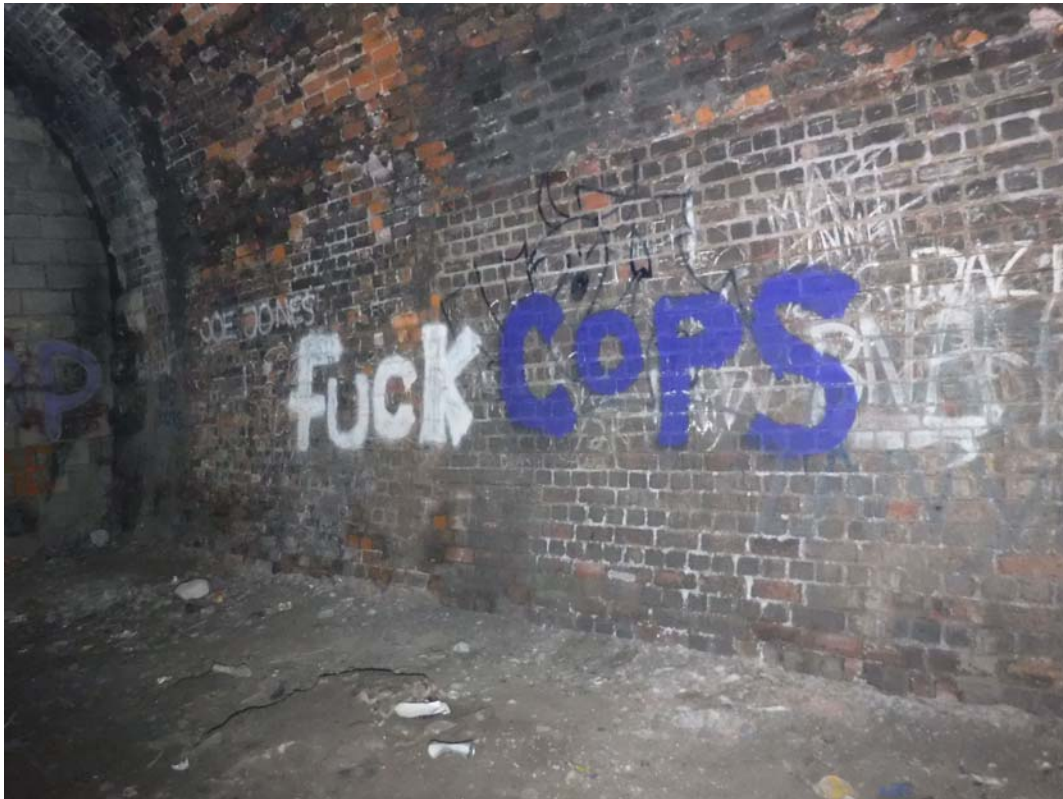
Photo No. 7 : 000+00 to 000+10 Sidewall Down, Brickwork, offensive graffiti.

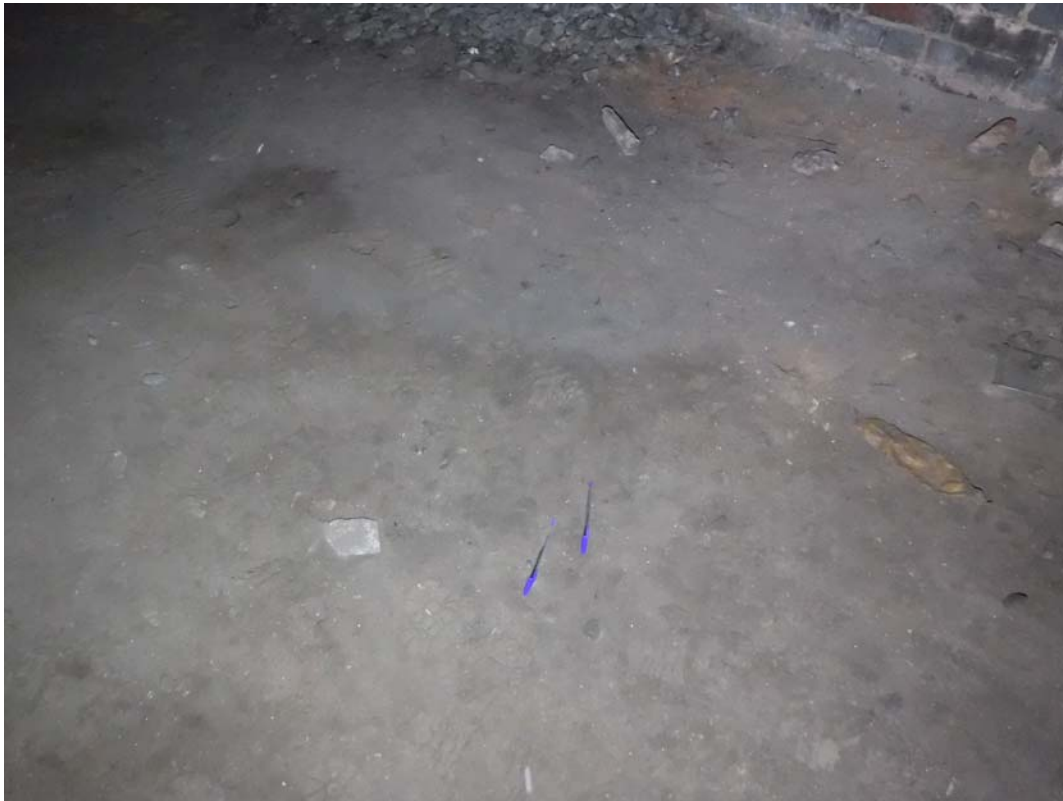
Photo No. 9 : 000+00 to 025+11 Solum Up & Down, Typical views showing recent example of paint cans, pens and litter left in the tunnel.

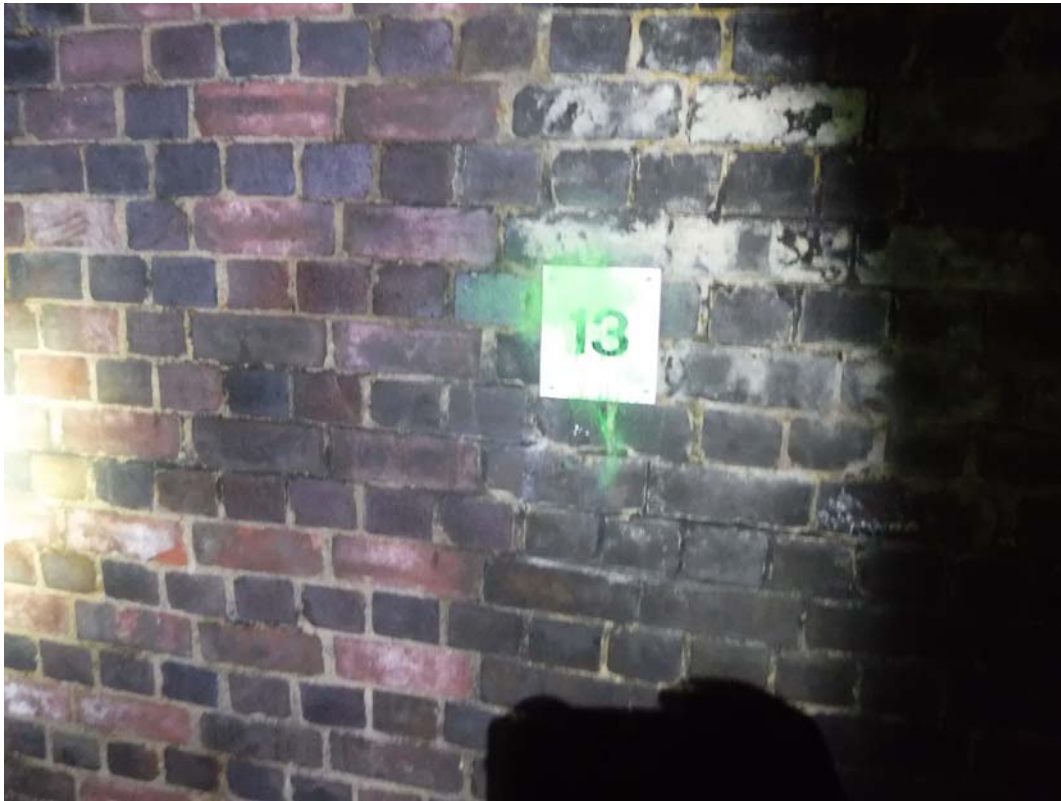
Photo No. 11 : 013+00 to 021+00 Sidewall Up, Typical views showing more tablet markers recently defaced by trespassers.

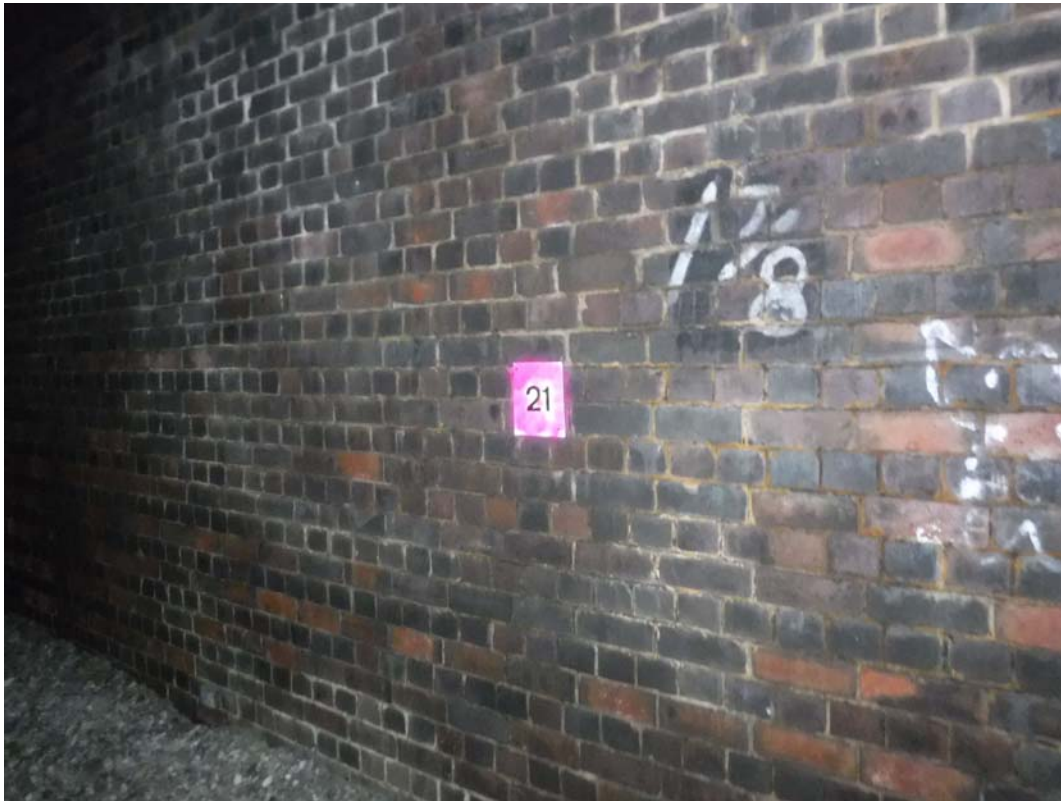
Photo No. 13 : 013+00 to 021+00 Sidewall Up, Typical views showing more tablet markers recently defaced by trespassers.

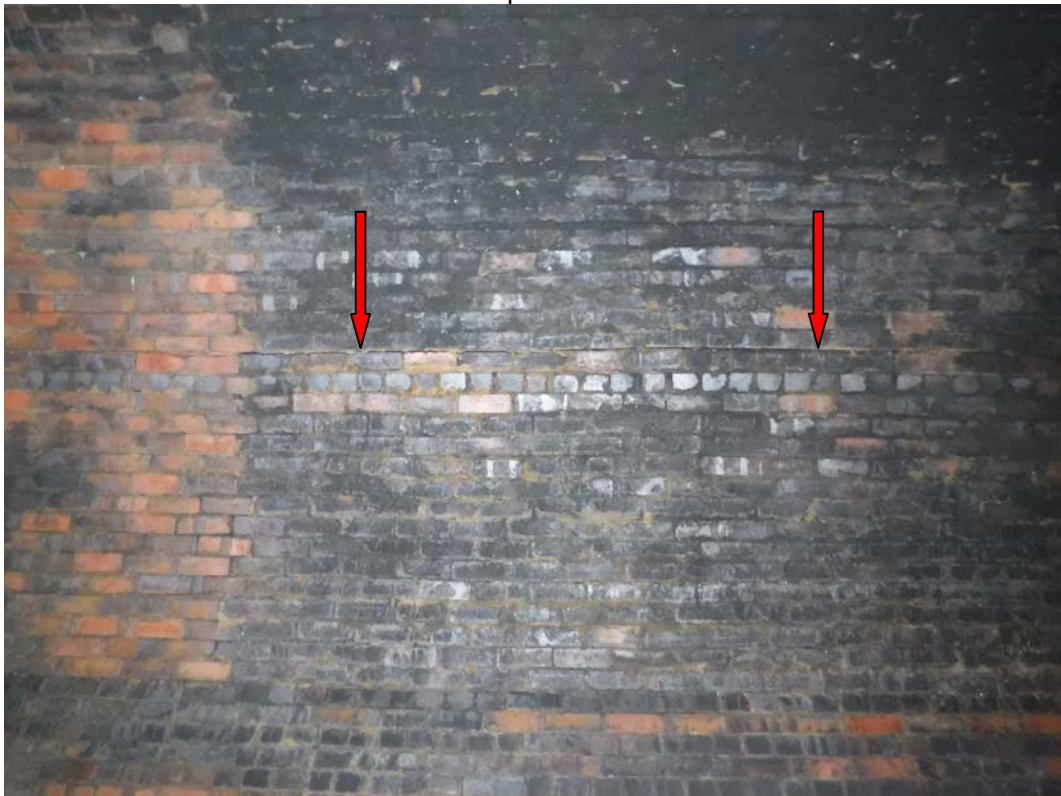
Photo No. 14 : 021+11 to 022+11 Haunch Up & Down, Brickwork, multiple longitudinal bedding fractures, max. width 3mm.

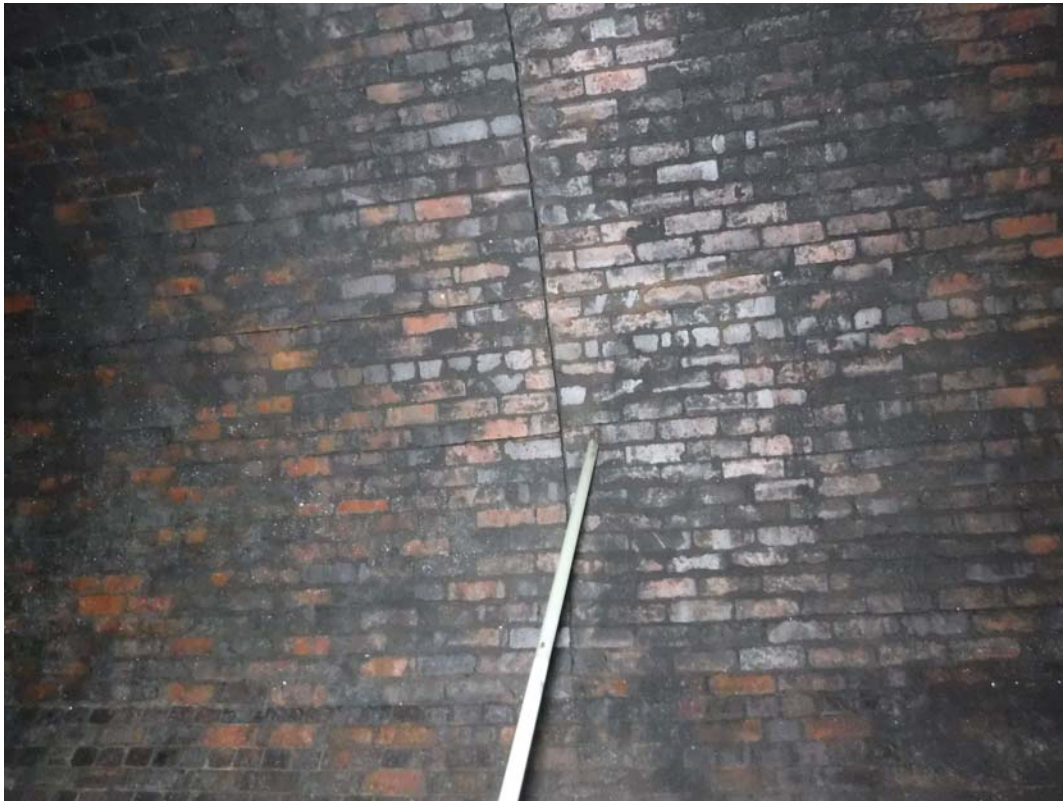
Photo No. 15 : 022+14 to 023+19 Haunch Up, Brickwork, multiple longitudinal bedding fractures, max. width 3mm.

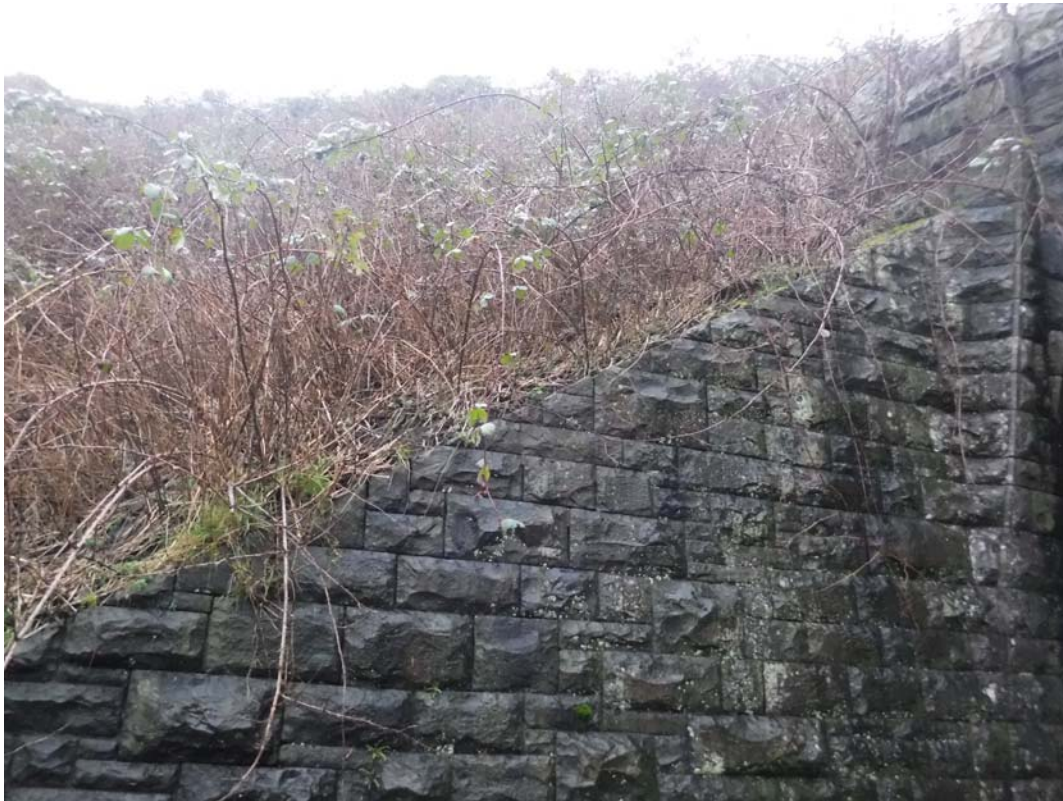
Photo No.1 : 000+00 Portal Down, South Portal, Wingwall, stonework, copings missing, full length, with loose blocks below, area 8sq.m.

Location	Defect	Action	
000+00 Portal Down	South Portal, Wingwall, stonework, copings missing, full length, with loose blocks below, area 8sq.m.	1	Recommend that copings and loose blocks be replaced, Priority 1; work to be completed by 05/02/2020.
000+00 Portal Up	South Portal, Wingwall, stonework, copings missing, full length, with loose blocks below, area 8sq.m.	2	Recommend that copings and loose blocks be replaced, Priority 1; work to be completed by 05/02/2020.
000+00 Portal Up & Down	South Portal, stonework, vegetation, area 15sq.m.	3	Recommend that vegetation be removed, Priority 1; work to be completed by 05/02/2020.
000+00 Portal Up & Down	South Portal, Steel door is becoming heavily corroded and holed to base.	4	New door fitted, but old door left inside tunnel at 000+15. Recommend door be removed from tunnel and recycled off-site, Priority 1; work to be completed by 05/02/2020.
000+00 to 073+05 Refuge Up & Down	Several refuges have windows to the rear walls throughout the tunnel.

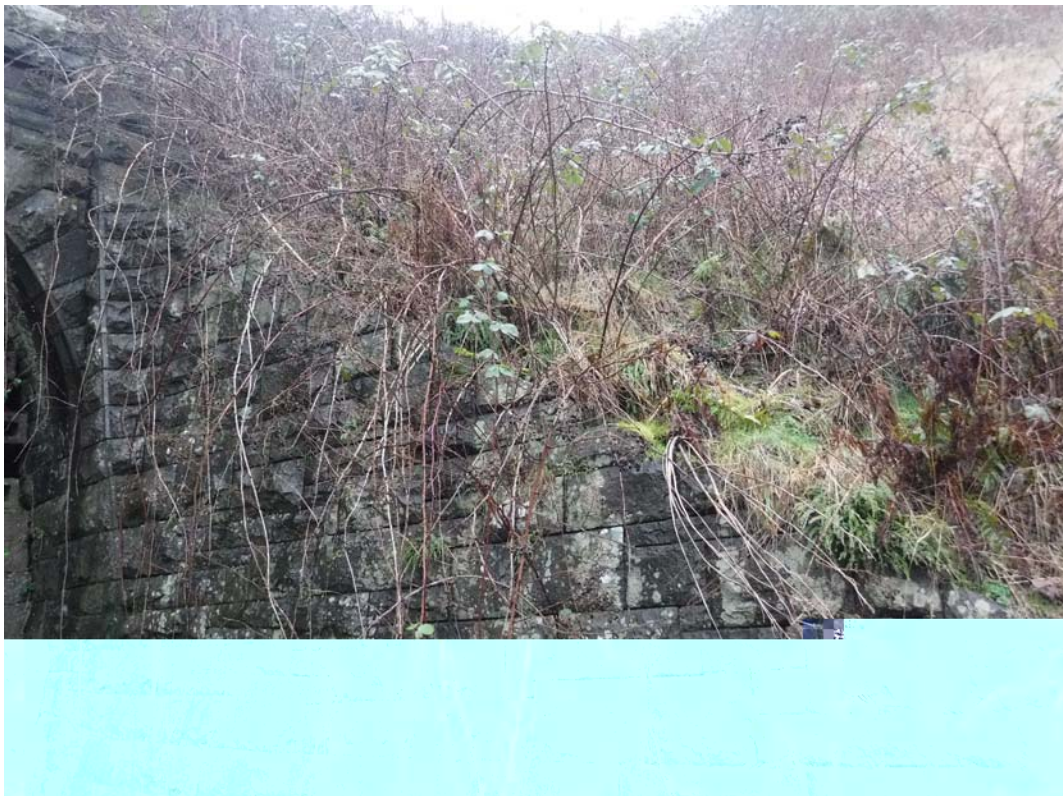
Photo No.2 : 000+00 Portal Up, South Portal, Wingwall, stonework, copings missing, full length, with loose blocks below, area 8sq.m.

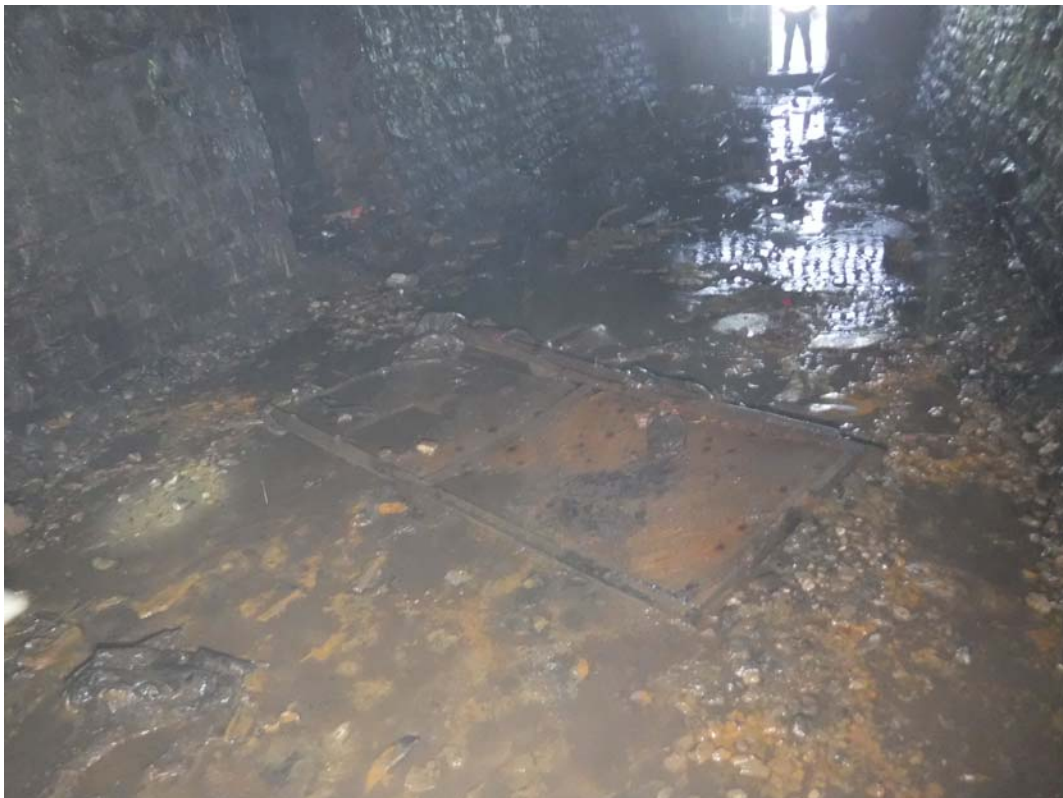
Photo No.4 : 000+00 Portal Up & Down, South Portal, Steel door is becoming heavily corroded and holed to base.

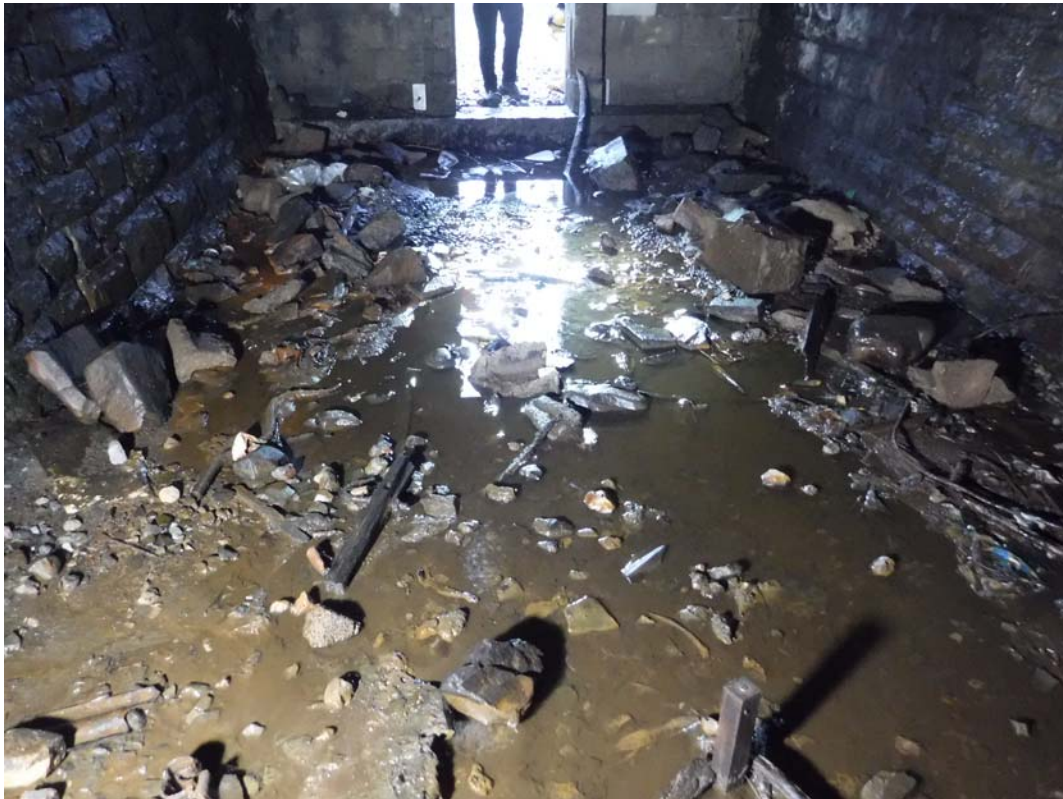
Photo No.5 : 000+00 to 03+00 Solum Up & Down, Boulders and debris underfoot making access difficult.

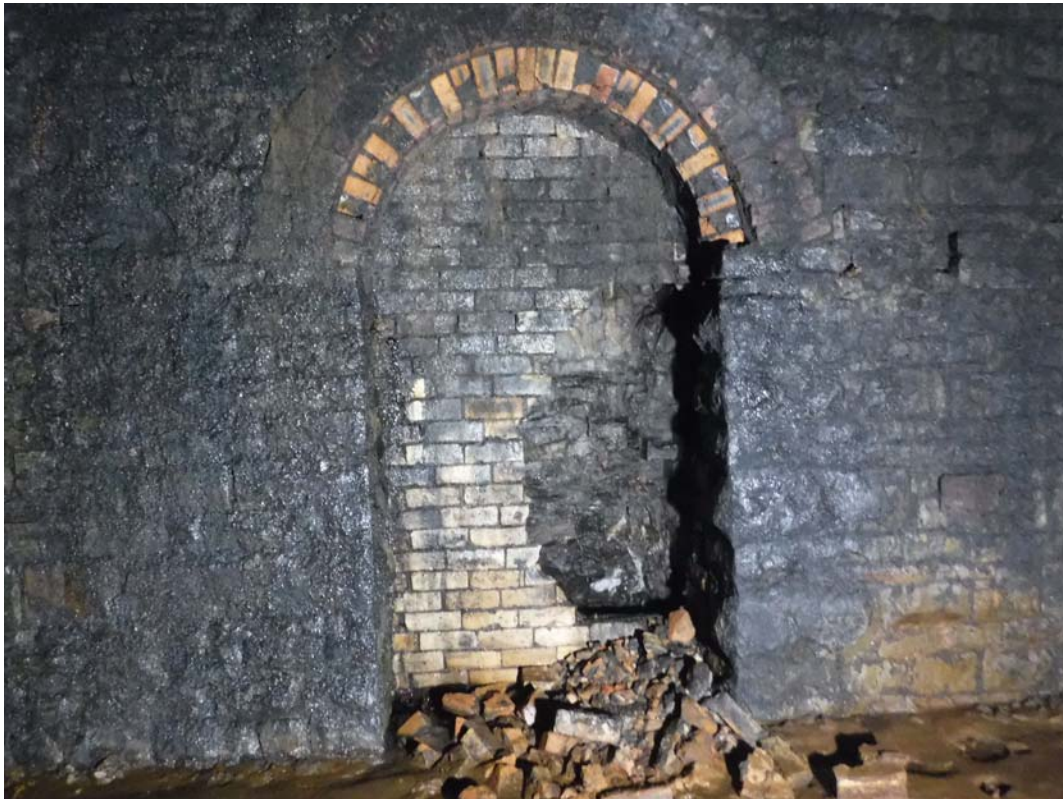
Photo No.7 : 010+02 Refuge Up, Brickwork, Arch, spalled and missing bricks, depth 100mm, area 1.5sq.m.

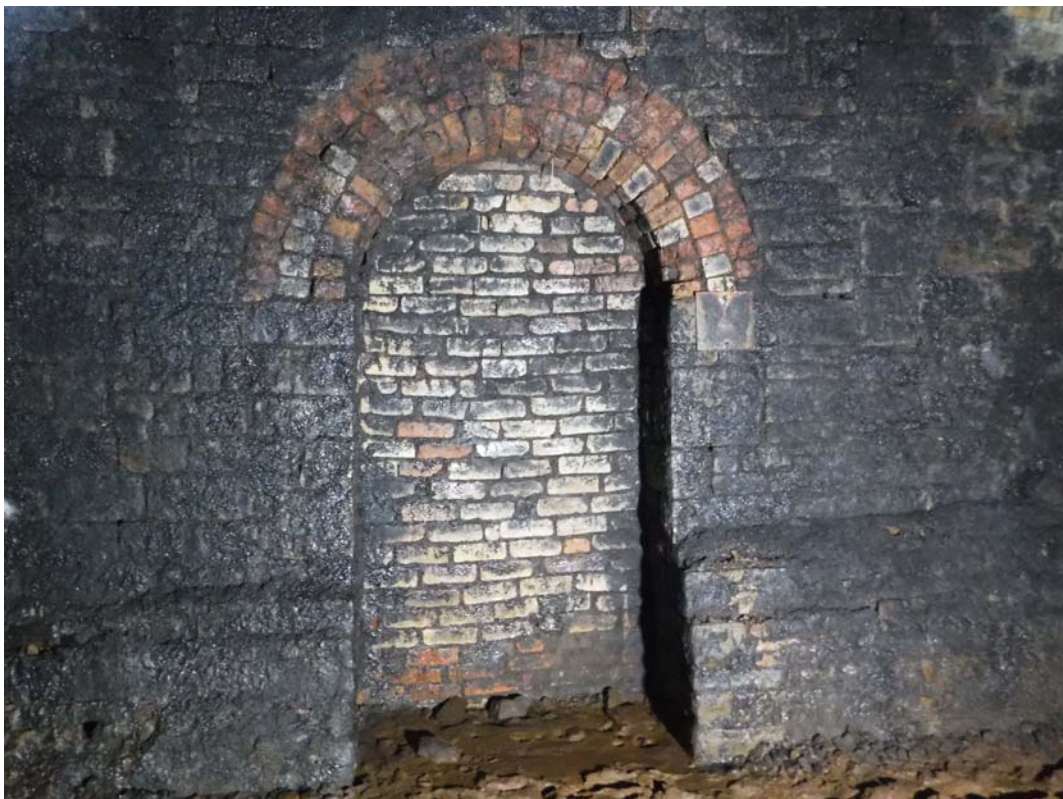
Photo No.8 : 011+16 Refuge Up, Brickwork, Arch, spalling, depth 75mm, area 1sq.m., damp, light.

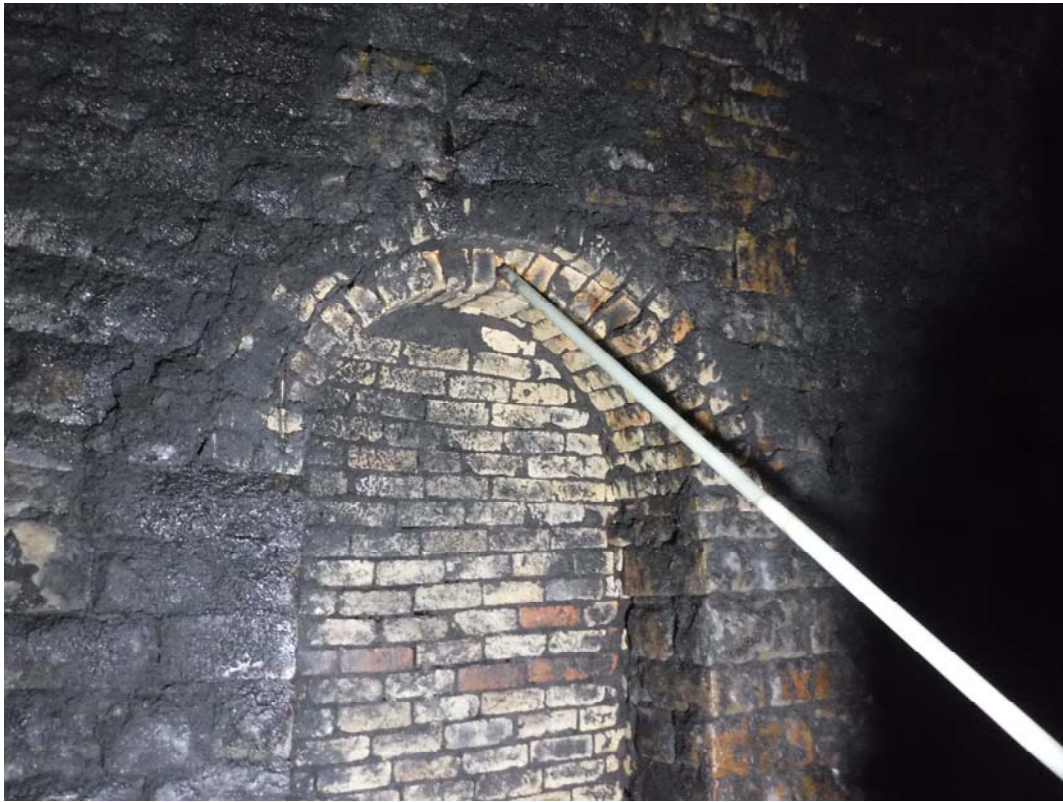
Photo No.9 : 016+07 Refuge Up, Brickwork, Arch, hollow, area 1m.sq, with missing bricks, depth 100mm, area 0.25sq.m., medium.

016+07 Refuge Up	Brickwork, Arch, hollow, area 1m.sq, with missing bricks, depth 100mm, area 0.25sq.m., medium.	9 Recommend brickwork be replaced, Priority 1; work be completed by 05/02/2020.
016+18 Haunch Up	Stonework, running water and ochre deposits, area 1sq.m.	
016+18 Sidewall & Haunch Down	Stonework, 2No. downpipes fitted to Haunch with running water. Possible Hidden Shaft.	10 Recommend investigate location for the presence of a hidden shaft, Priority 1; work to be completed by 05/02/2020.
016+00 to 017+12 Crown Up & Down	Stonework, wet/damp, area 120sq.m.	
019+13 to 022+02 Full Profile Up & Down	Stonework/brickwork, wet/damp, area 700sq.m.	
020+00 to 048+13 Full Profile Up & Down	Construction Brickwork.

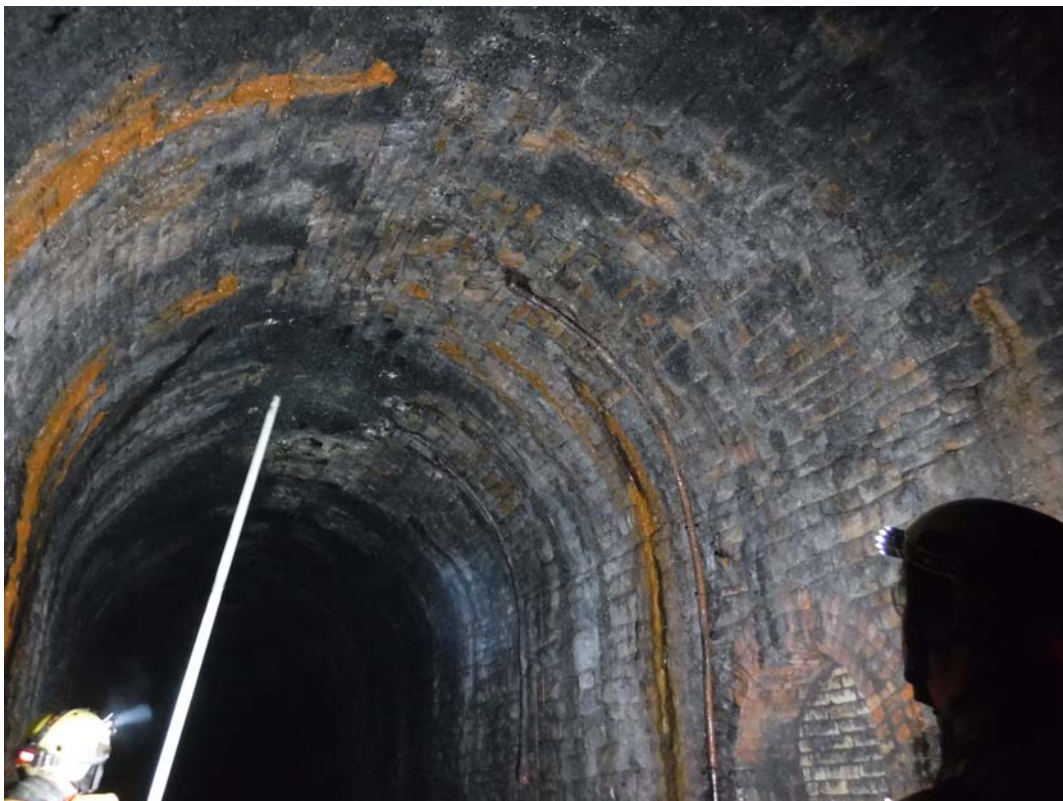
Photo No.10 : 016+18 Sidewall & Haunch Down, Stonework, 2No. downpipes fitted to Haunch with running water. Possible Hidden Shaft.

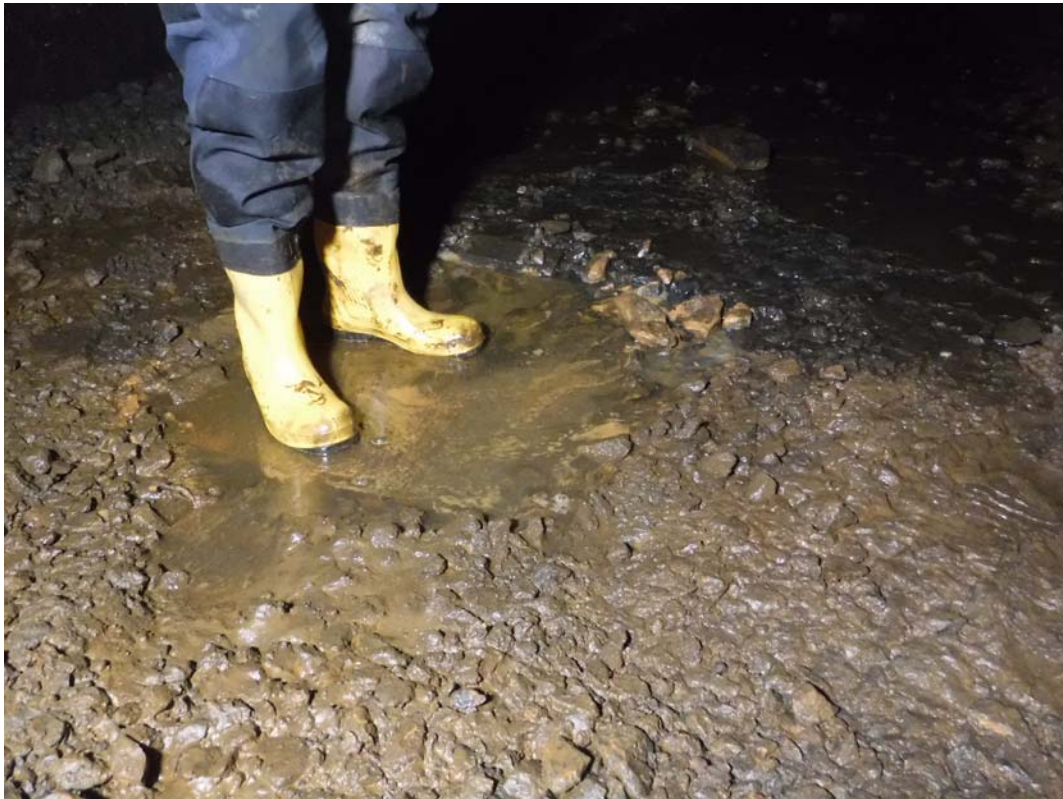
Photo No.11 : 038+20 Solum, Stream flowing nearly 1/2 mile long from the South Portal to an open catch-pit at 038+20.

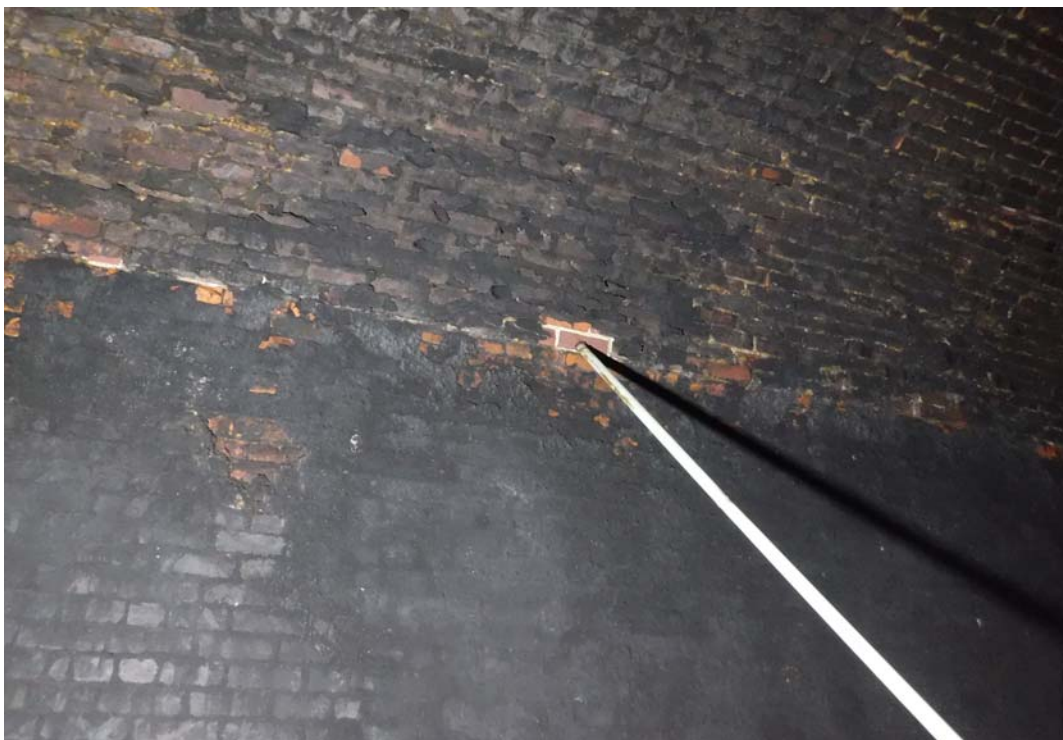
Photo No.12 : 042+13 to 043+20 Low Haunch Up & Down, Brickwork, longitudinal cracking, width 1mm, length 27m. Various bricks crushed and spalled to downside, depth 25mm, area 3sq.m.

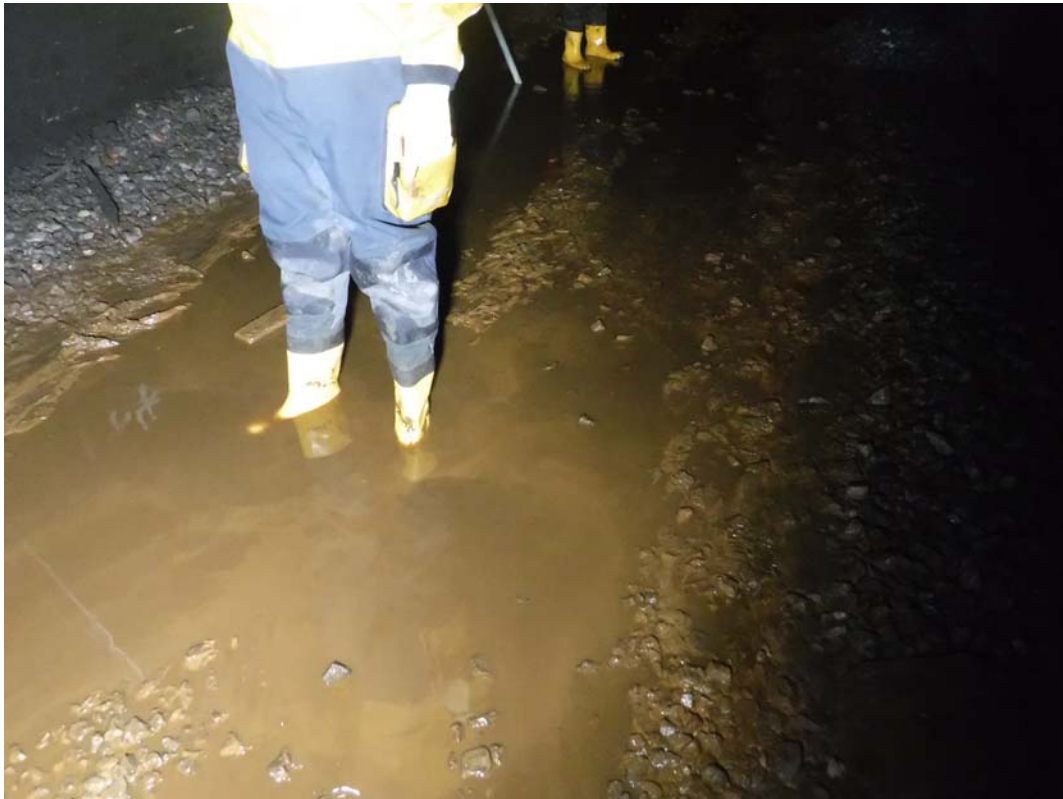
Photo No.13 : 043+17 Solum, Open Catch-pit to six-foot blocked, new flooding from 040+15 to 050+11 flowing northwards.

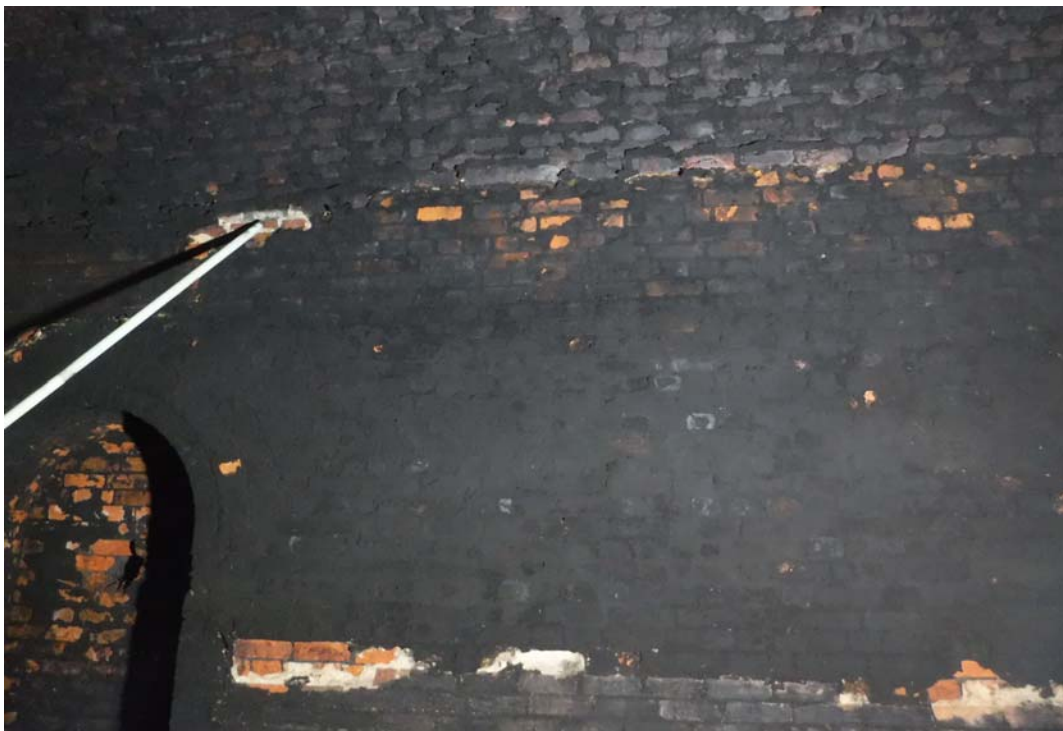
Photo No.14 : 046+00 to 048+20 Sidewall & Haunches Up & Down, Brickwork, bulging 75mm with random vertical and longitudinal fractures, max. width 1mm, hollow, area 20sq.m.

Location	Defect	Action
045+05 Haunch Up & Down	Brickwork, spalling, depth 50mm, area 2sq.m. Shelling removed from lining during the examination.	
046+00 to 048+20 Sidewall & Haunches Up & Down	Brickwork, bulging 75mm with random vertical and longitudinal fractures, max. width 1mm, hollow, area 20sq.m.	14 Recommend profile be monitored at annual intervals.
046+10 Refuge Down	Brickwork, spalling, depth 100mm, area 2sq.m., vertical fractures, length 1.6m to both Quoins, hollow.	15 Recommend brickwork be replaced, Priority 1; work be completed by 05/02/2020.
047+14 Refuge Down	Brickwork, Quoins, vertical fractures, length 1m, hollow.	Recommend brickwork be replaced, Priority 3; work be completed by 05/02/2022.
048+13 to 050+07 Full Profile Up & Down	Construction Stonework.	
049+02 to 050+14 Full Profile Up & Down	Stonework and Brickwork, wet/damp, area 210sq.m.	
049+11 to 050+11 Sidewall & Low Haunches Up & Down	Stonework, perished mortar, depth 75mm, area 80sq.m., wet, medium.	Recommend mechanical pointing, Priority 3; work to be completed by 05/02/2022.

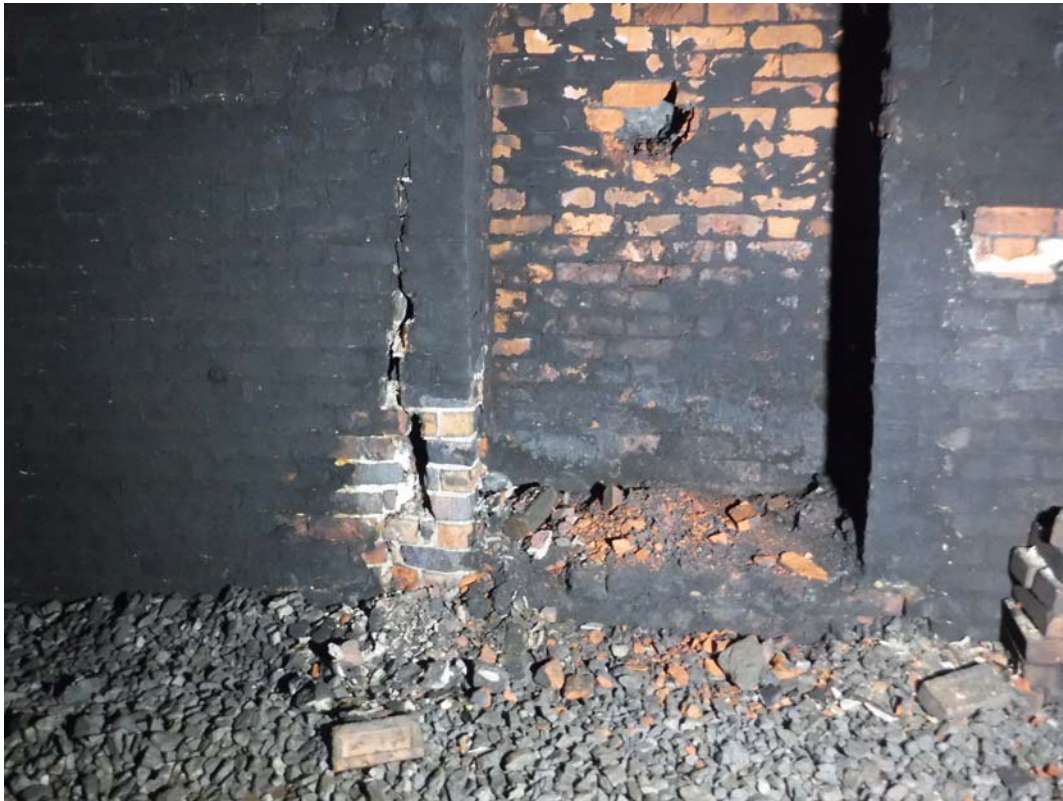
Photo No.15 : 046+10 Refuge Down, Brickwork, spalling, depth 100mm, area 2sq.m., vertical fractures, length 1.6m to both Quoins, hollow.

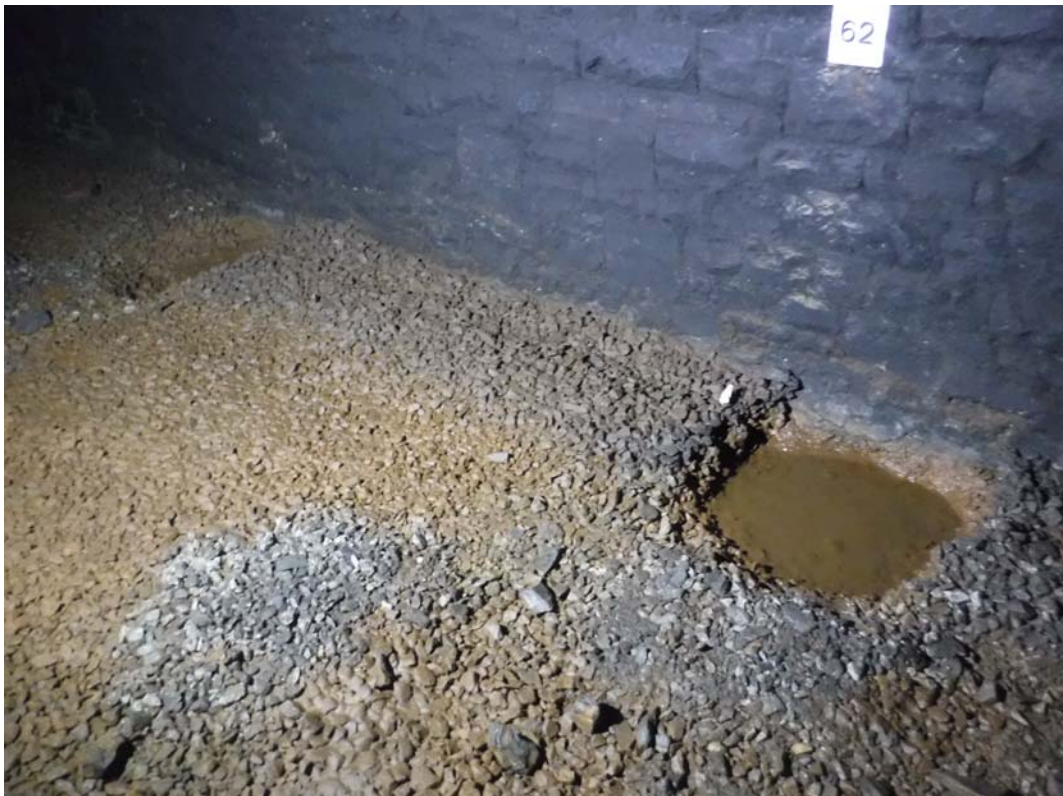
Photo No.16 : 061+19 to 062+00 Solum Down, 2No. trial pits.

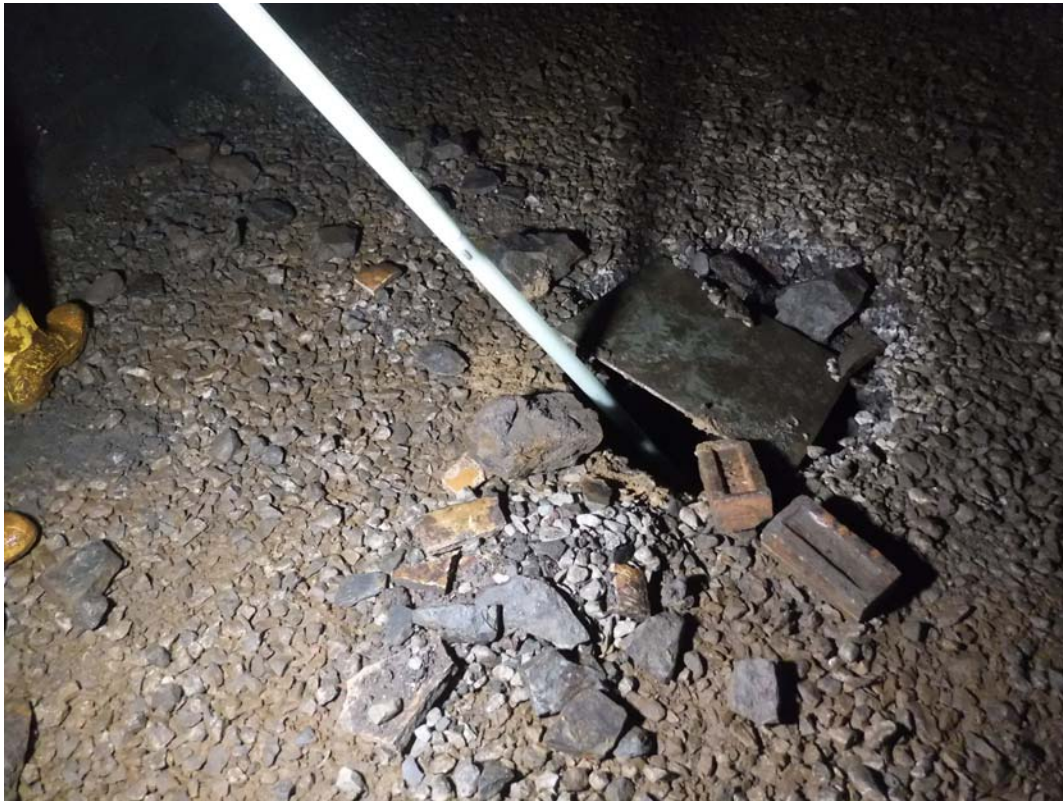
Photo No.17 : 042+063+10 Solum, Open catch-pit to six-foot with water welling up from inside. New cover fitted but displaced/ill-fitting.

Location	Defect	Action	
063+10 Solum	Open catch-pit to six-foot with water welling up from inside. New cover fitted but displaced/ill-fitting.	17	Recommend catch-pit cover be replaced with appropriate type of cover, Priority 1; work be completed by 05/02/2019.
066+15 to 073+05 Full Profile Up & Down	Stonework, wet/damp with ochre deposits and stalactites.		
070+10 Sidewall Down	Brickwork, old repaired lining, spalling and hollow, depth 100mm, area 0.5sq.m.		Recommend brickwork be replaced, Priority 3; work be completed by 05/02/2022.
072+00 to 072+15 Solum Up & Down	Mud and flooding, depth 3".	18	Recommend complete the track drainage mtce/repair works, Priority 1; work to be completed by 05/02/2020.
073+05 Portal Up & Down	View of blocked up North Portal from inside tunnel.	19	
073+05 Portal Location	North Portal, road running above portal.	20

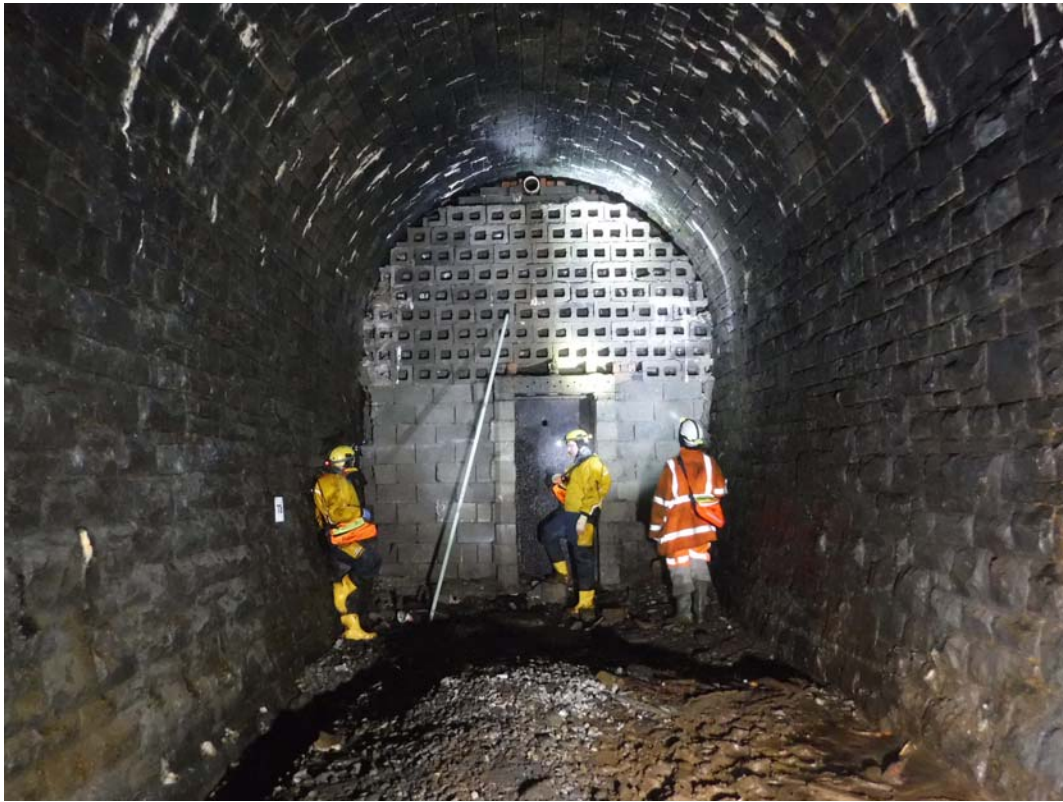
Photo No.19 : 073+05 Portal Up & Down, View of blocked up North Portal from inside tunnel.
