**TUNNEL EXAMINATION REPORT
PHOTOGRAPHS OF STRUCTURE**

Balfour Beatty Rail, Manchester**Caerau (Cymmer) Tunnel****ELR: BAL/10m17ch****Examined: 05/02/2019**

Balfour Beatty Rail, Manchester**Pen-Cae-Drain Tunnel****ELR: VON/28m 65ch****Examined: 30/07/2019**

Balfour Beatty Rail, Manchester
Penar Tunnel
ELR:HRD2/4m 42ch Examined:14/10/2019

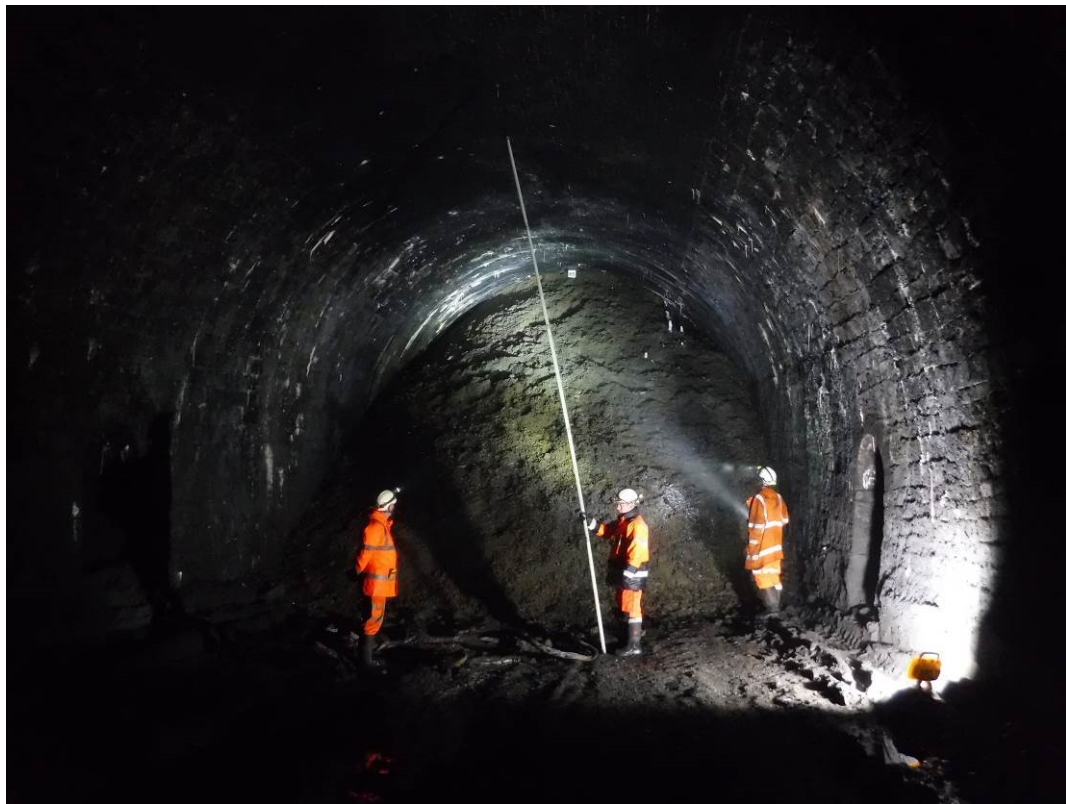
Photo No.1: 065+00 Portal Up & Down, Pontypool Portal, infilled, voussoirs visible to the top of the mound.

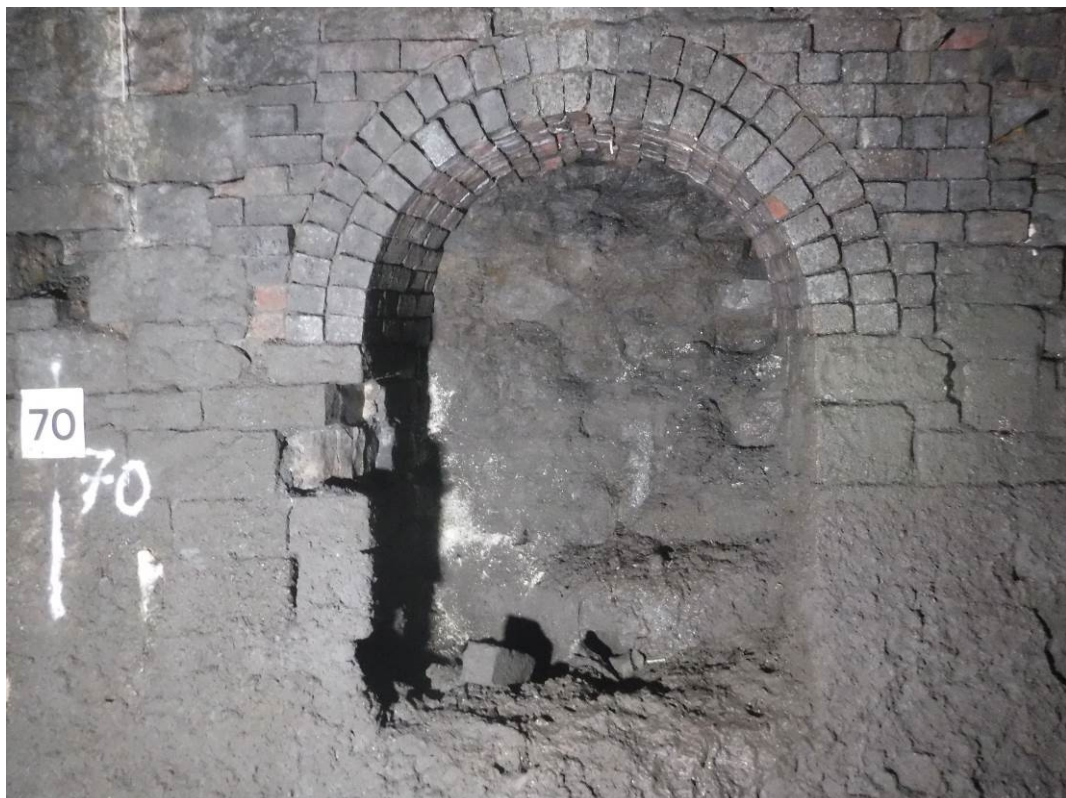
Photo No.2: 069+20 Refuge Up, Brickwork, Arch, hollow, area 0.5sq.m. Stonework, Neath Quoin missing/loose blocks, area 1sq.m.

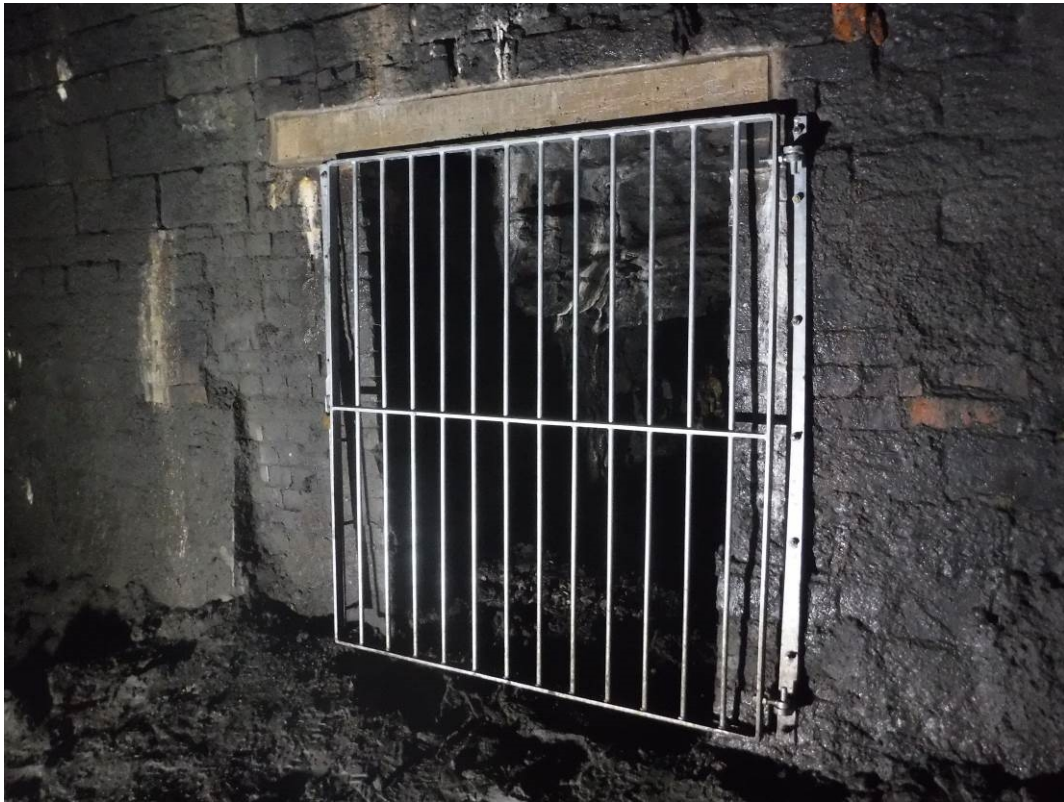
Photo No.3: 072+06 Sidewall Up, Side gallery, locked security gate.

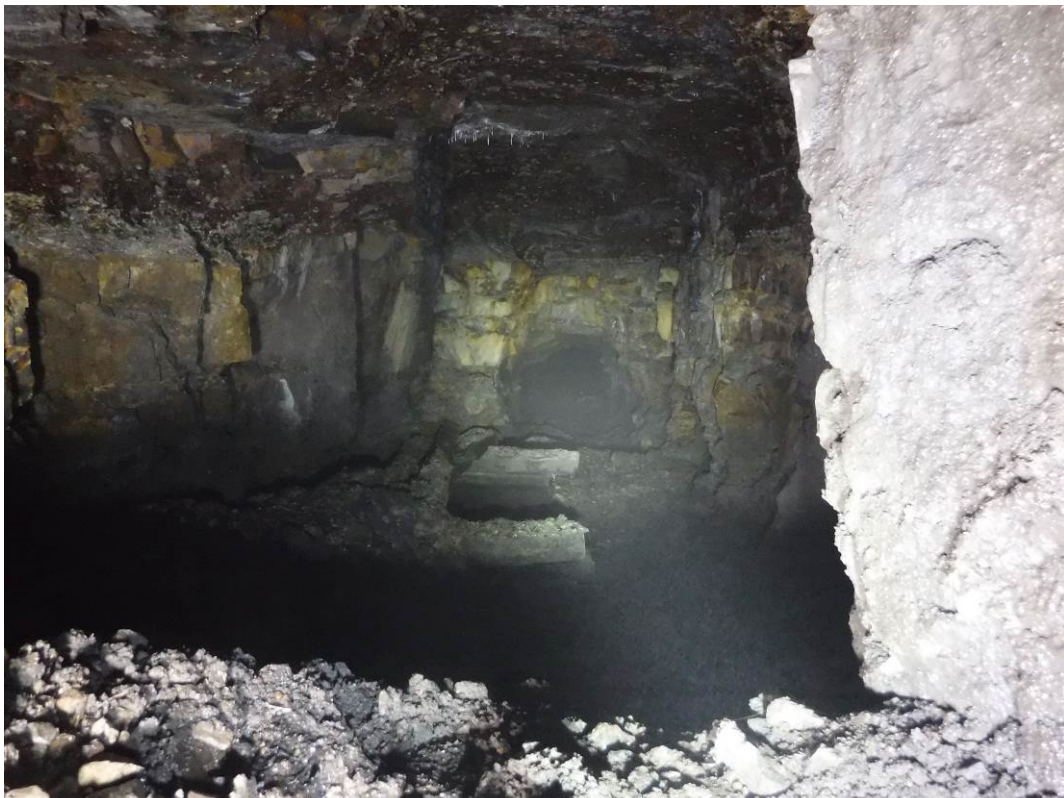
Photo No.4: 072+06 Sidewall Up, Side gallery with daylight showing to end of adit, roof is poorly supported and natural rock roof is friable so entry was not gained. No daylight could be seen at this examination.

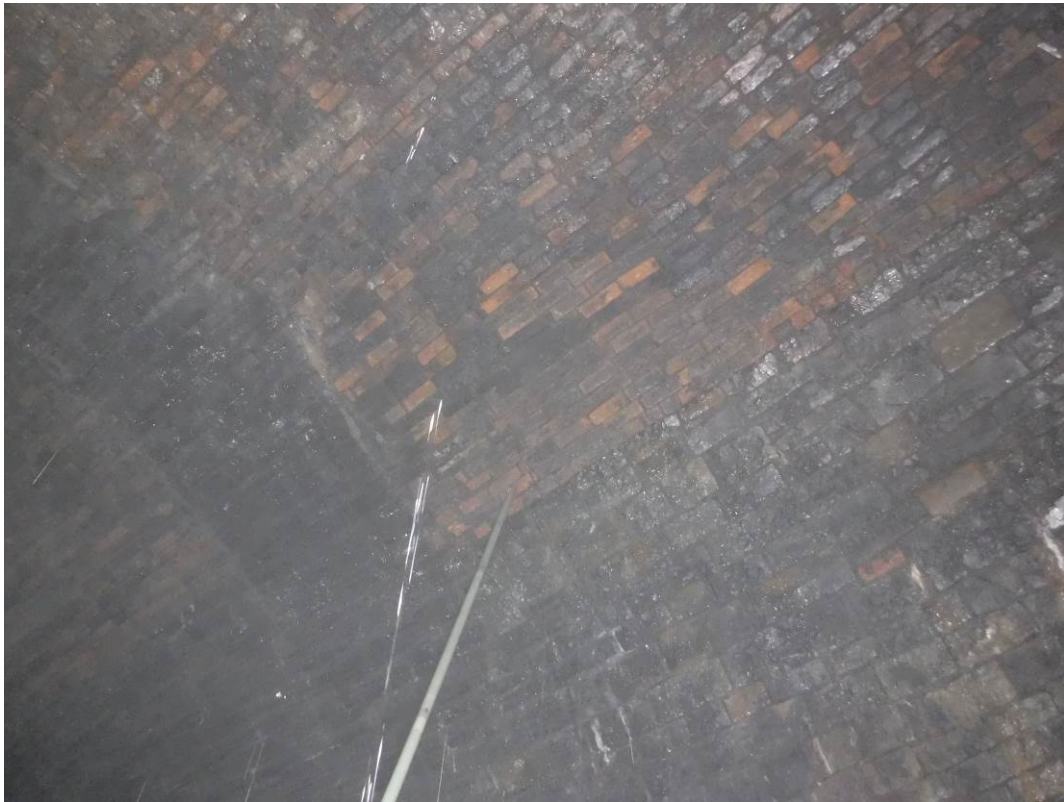
Photo No.5: 076+10 High Haunch Up, Brickwork, spalling, depth 100mm, area 1sq.m., hollow, spalled bricks removed at this examination, hollow, area 4sq.m., wet.

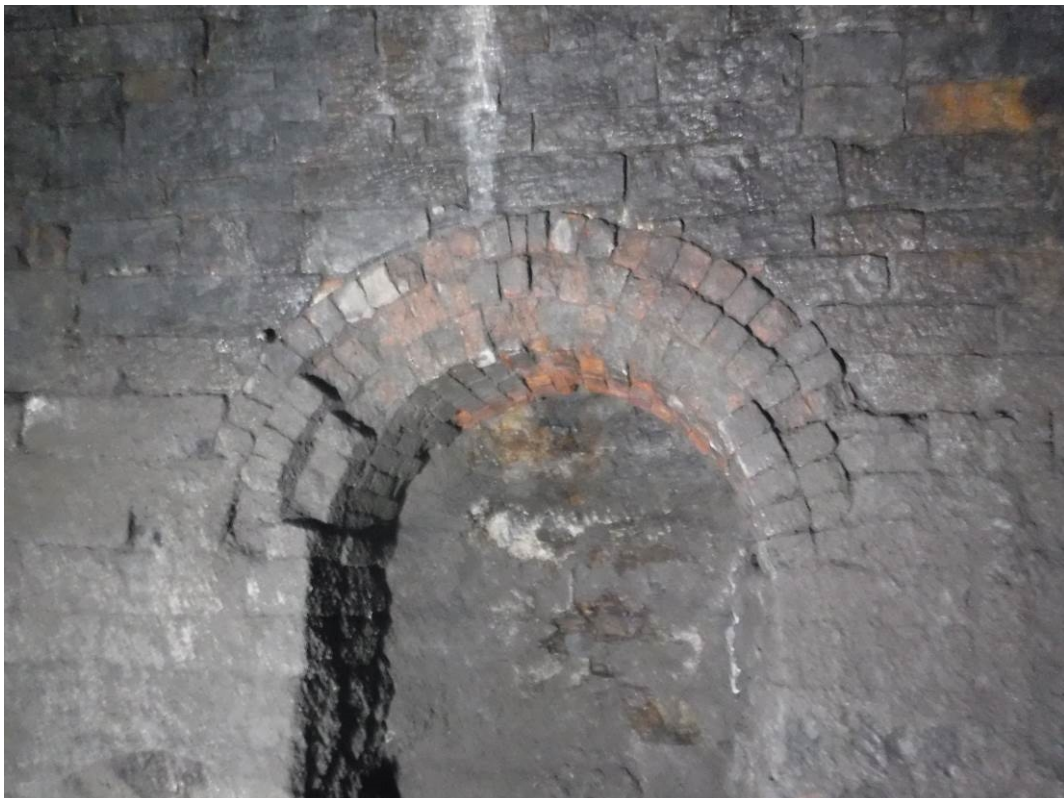
Photo No.6: 000+14 Refuge Up, Brickwork, Arch, spalling, depth 100mm, area 1sq.m.

000+12 Crown Down	Brickwork, spalling, depth 1", area 1sq.m., hollow, spalled bricks removed at this examination.	
000+14 Refuge Up	Brickwork, Arch, spalling, depth 100mm, area 1sq.m.	6 Recommend brickwork be replaced, Priority 1; work to be completed by 30/07/2020.
000+16 Sidewall Up	Stonework, open joints and wet, depth 100mm, area 2sq.m., sparse.	
001+08 Refuge Up	Brickwork, Arch, spalling, depth 100mm, area 0.5sq.m.	7 Recommend brickwork be replaced, Priority 1; work to be completed by 30/07/2020.
002+11 to 003+11 Sidewall Up	Stonework, open joints and wet, depth 75mm, area 60sq.m., sparse.	
002+13 Refuge Up	Brickwork, arch, spalling, depth 75mm, area 0.5sq.m., damp.	Recommend brickwork be replaced, Priority 2; work to be completed by 30/07/2021.

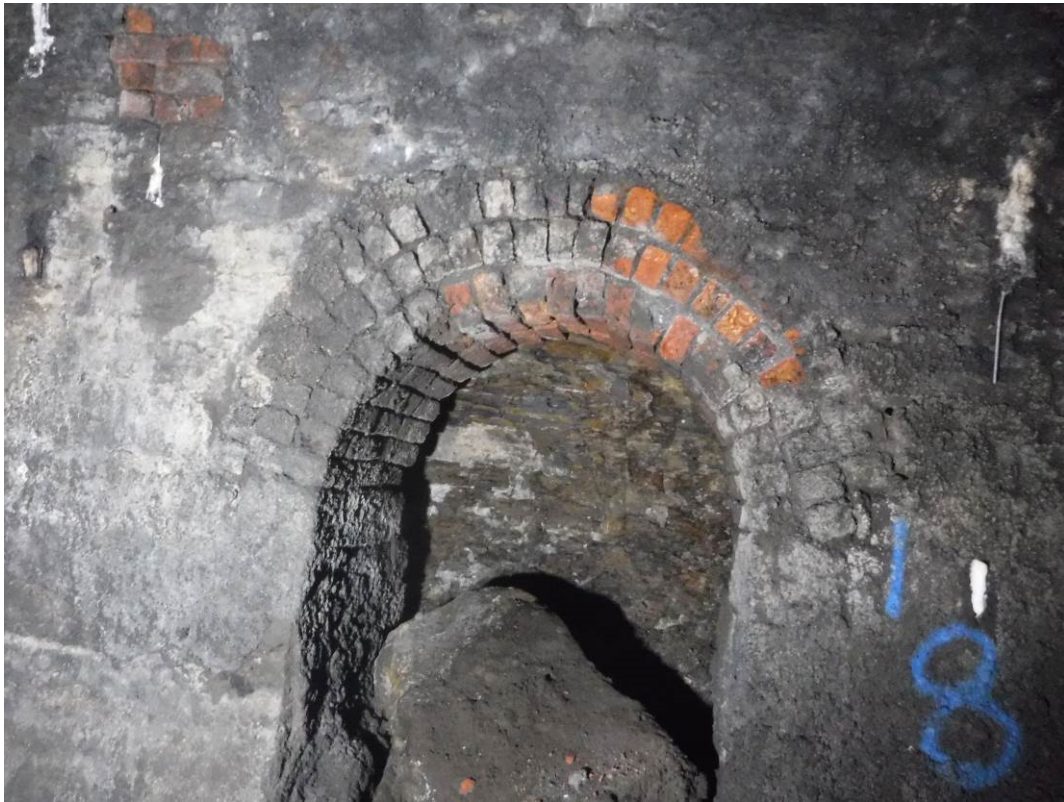
Photo No.7: 001+08 Refuge Up, Brickwork, Arch, spalling, depth 100mm, area 0.5sq.m.

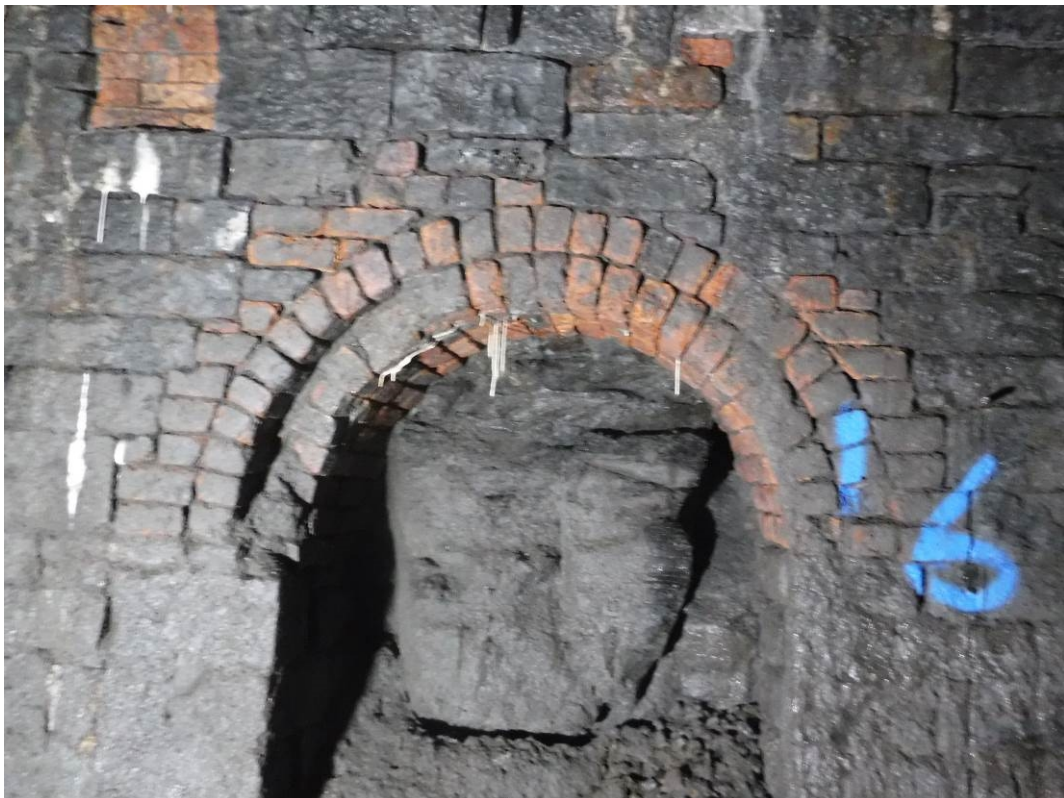
Photo No.8: 003+06 Refuge Up, Brickwork, Neath Arch, spalling/missing, depth 100mm, area 0.5sq.m.

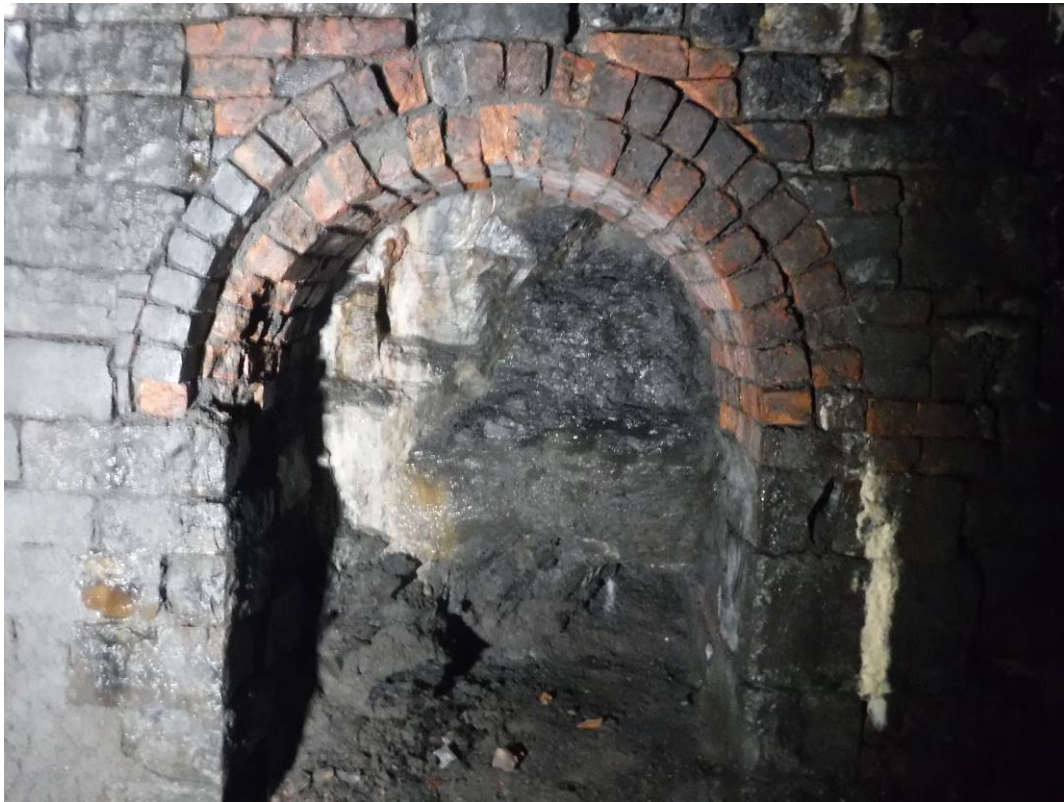
Photo No.9: 006+10 Refuge Up, Brickwork, Neath Arch, spalling/missing and damp, depth 100mm, area 0.5sq.m.

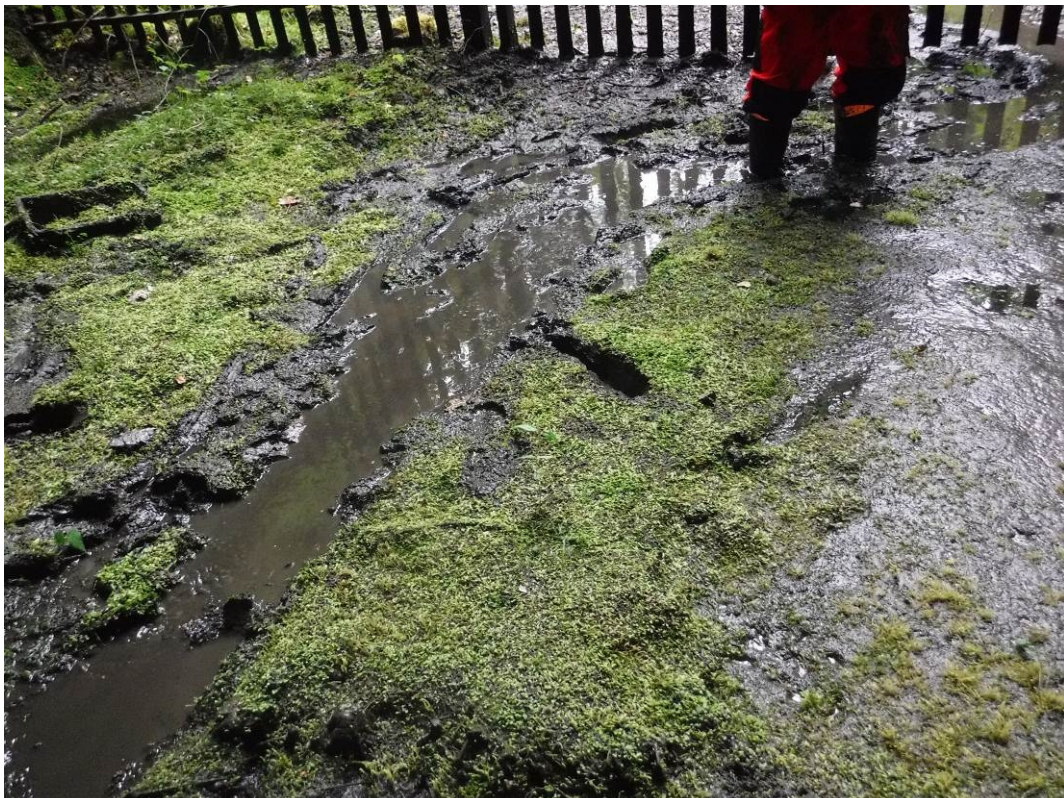
Photo No.10: 008+20 to 009+07 Solum Up & Down, Flooding and mud to solum, depth 300mm (less extent at this examination).

008+11 to 009+07 Sidewall Up & Down	Stonework, vegetation, area 100sq.m., light	
008+20 to 009+07 Solum Up & Down	Flooding and mud to solum, depth 300mm (less extent at this examination).	10 Recommend standing water and mud be removed and water controlled, Priority 1; work to be completed by 30/07/2020.
009+07 Portal Up & Down	Neath Portal, oiling gate padlock.	11
009+07 Portal Up & Down	Neath Portal, oiling hinges.	12
009+07 Portal Up & Down	Neath Portal, fall hazard from parapet.	13 Recommend erect fence, Priority 1; work to be completed by 30/07/2020.
009+07 Portal Down	Neath Portal, Stonework, Parapet, open joints, depth 75mm, area 10sq.m. Tree root damage to parapet with displaced and missing blocks.	14 Recommend tree roots be removed and stonework repaired, Priority 1; work to be completed by 30/07/2020.

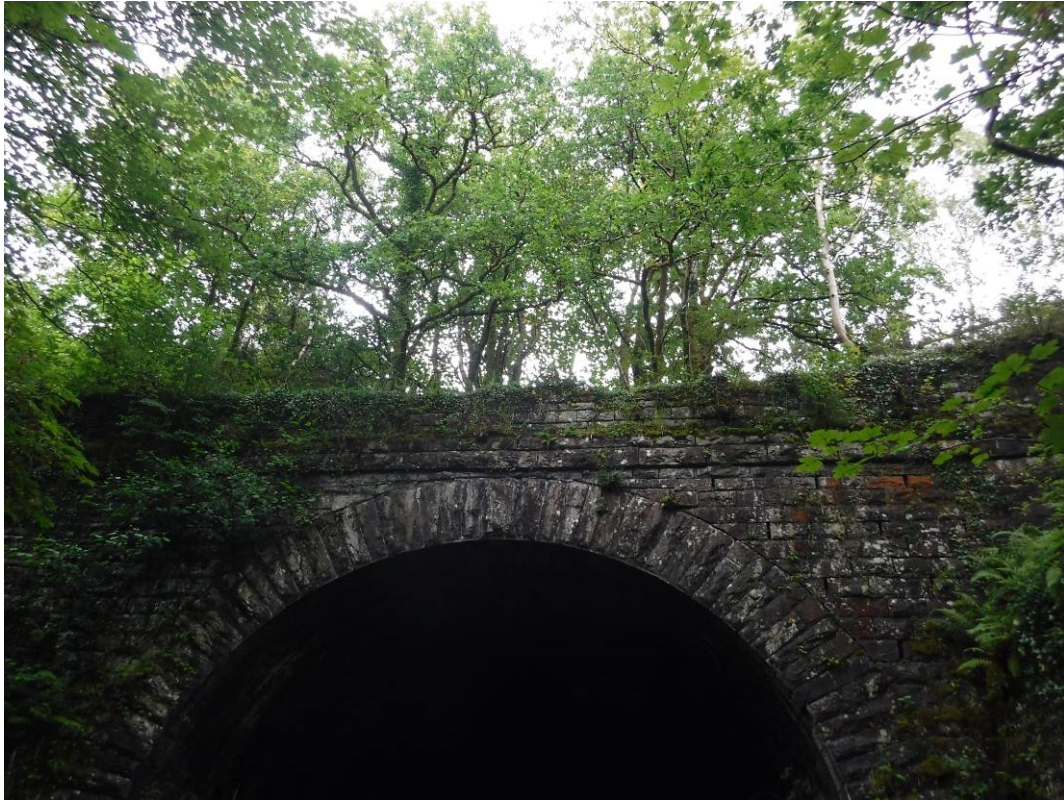
Photo No.13: 009+07 Portal Up & Down, Neath Portal, fall hazard from parapet.

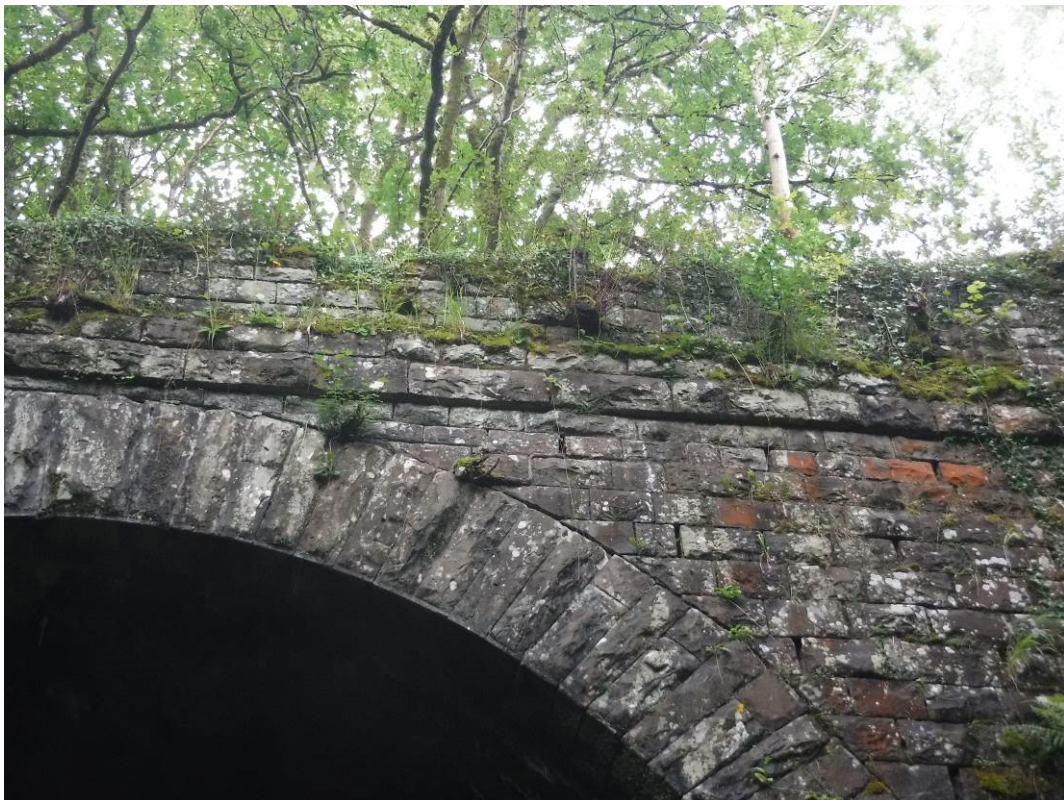
Photo No.14: 009+07 Portal Up & Down, Neath Portal, Stonework, Parapet, open joints, depth 75mm, area 10sq.m.
Tree root damage to parapet with displaced and missing blocks.

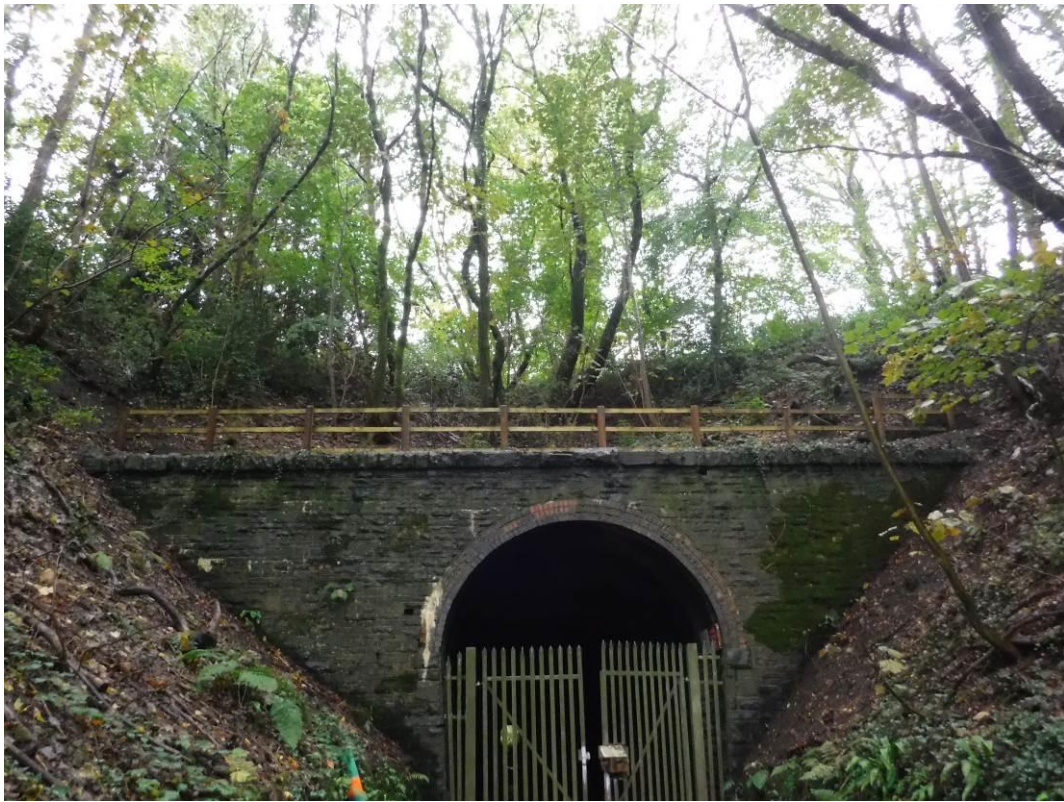
Photo No.1: London Portal, Stonework, no safety fence fitted to top of Parapet, this is a fall hazard. Fence erected since last examination.

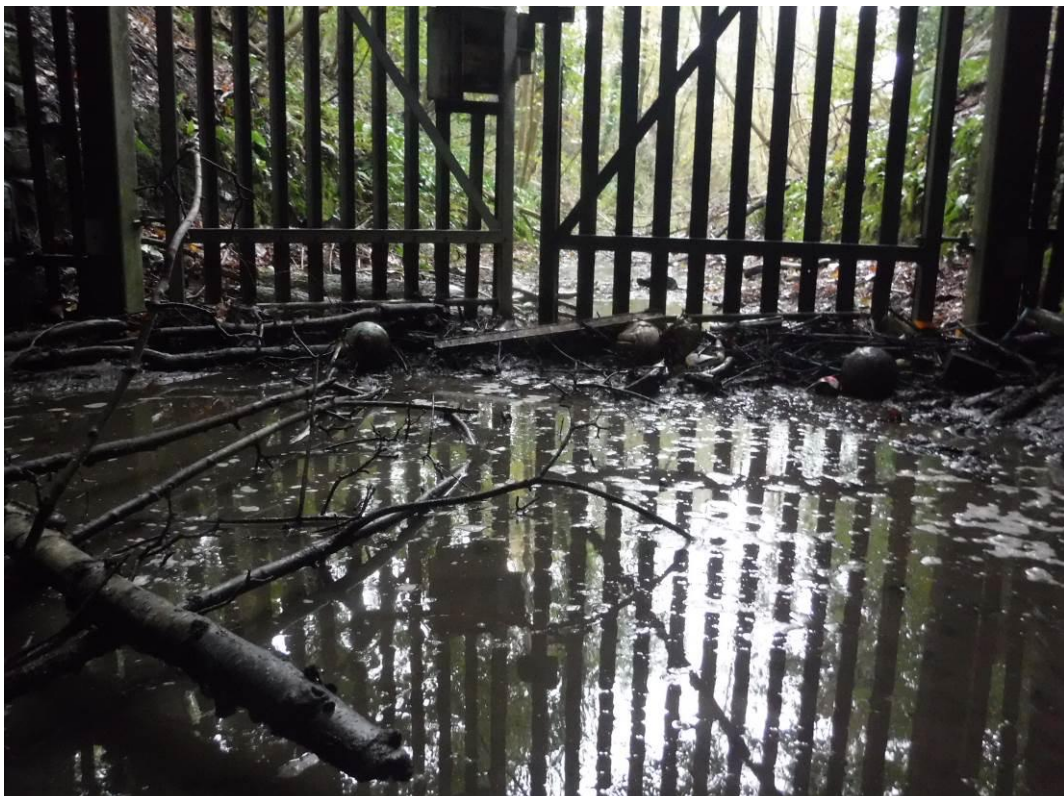
Photo No.2: London Portal, new debris from flood piled against security gates.

000+00 Portal Up & Down	London Portal, new debris from flood piled against security gates.	2	Recommend remove debris, Priority 1; work to be completed by 14/10/2020.
000+00 Portal Up & Down	London Portal, oiling gate padlock.	3	
000+00 Portal Up & Down	London Portal, oiling gate hinges.	4	
000+00 to 010+20 Solum Up & Down	New stream flowing throughout the length of the tunnel eastwards from outside Country Portal to outside London Portal. Flooding and mud, max. depth 8" at the London end.	5	Recommend unblock drainage and remove mud, Priority 1; work to be completed by 14/10/2020.
000+00 to 002+06 Full Profile Up & Down	Stonework Sidewalls, Brickwork Arch, damp, area 500sq.m., medium.

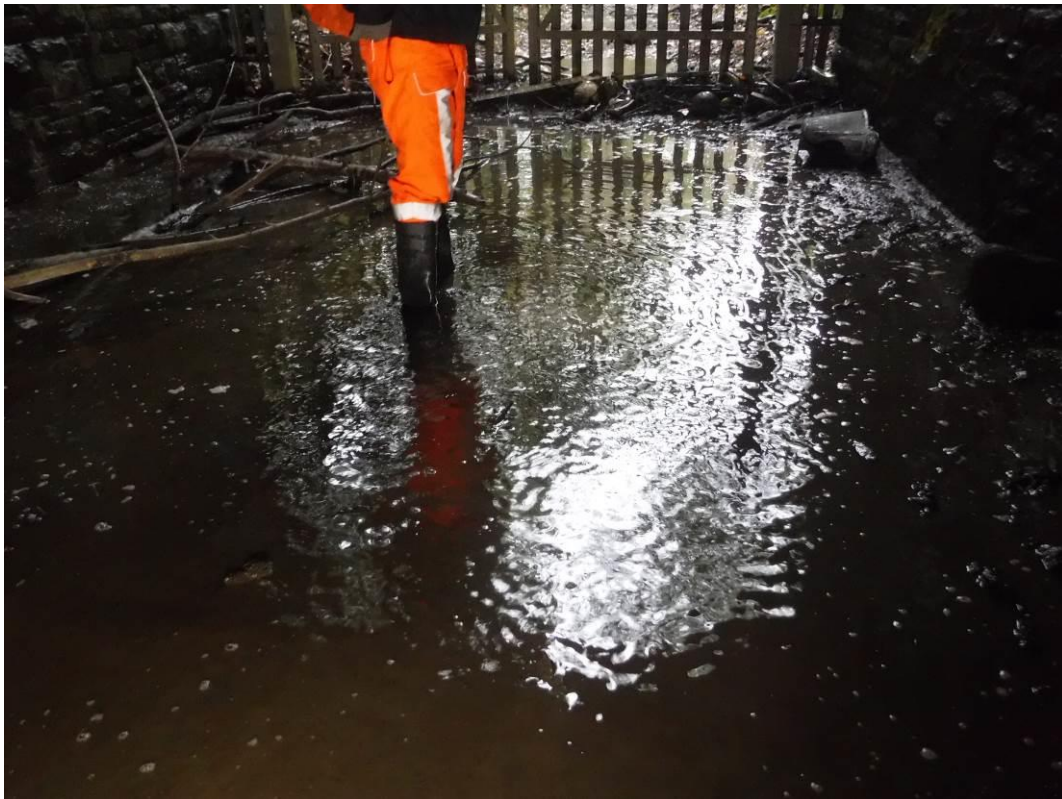
Photo No.5: 000+00 to 010+20 Solum Up & Down, New stream flowing throughout the length of the tunnel eastwards from outside Country Portal to outside London Portal. Flooding and mud, max. depth 8" at the London end.

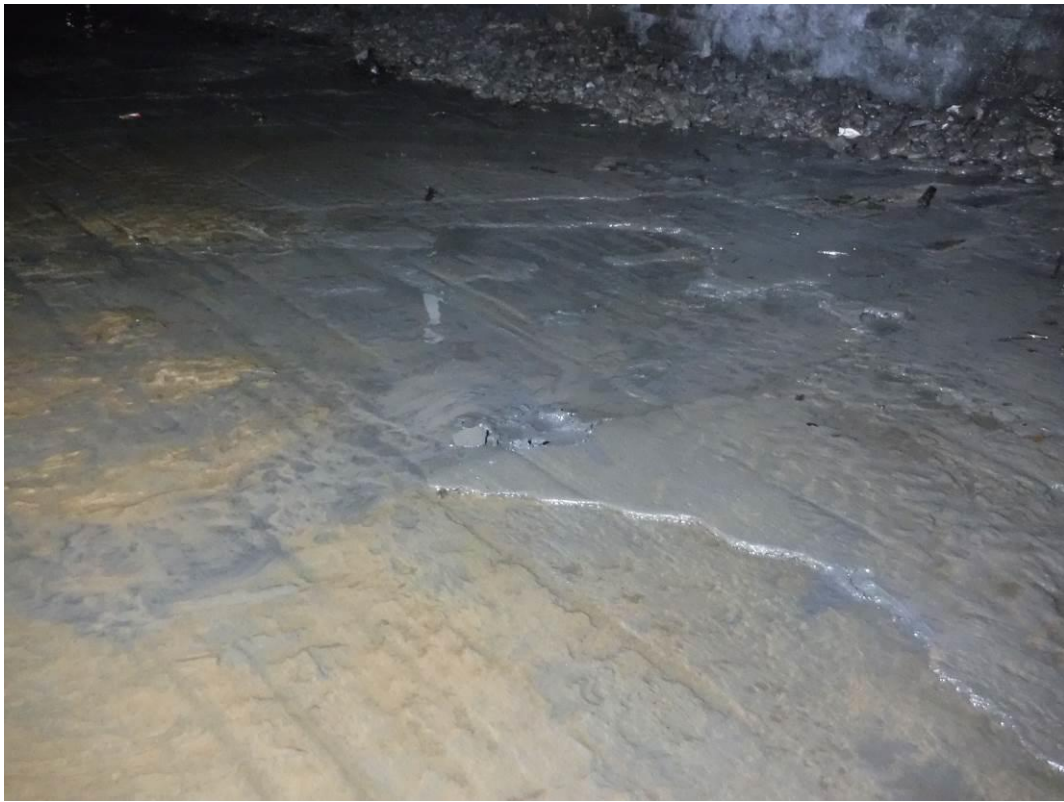
Photo No.7: 003+01 Sidewall Down, Stonework, base, weep hole, water washing fines onto solum and diffusing eastwards.

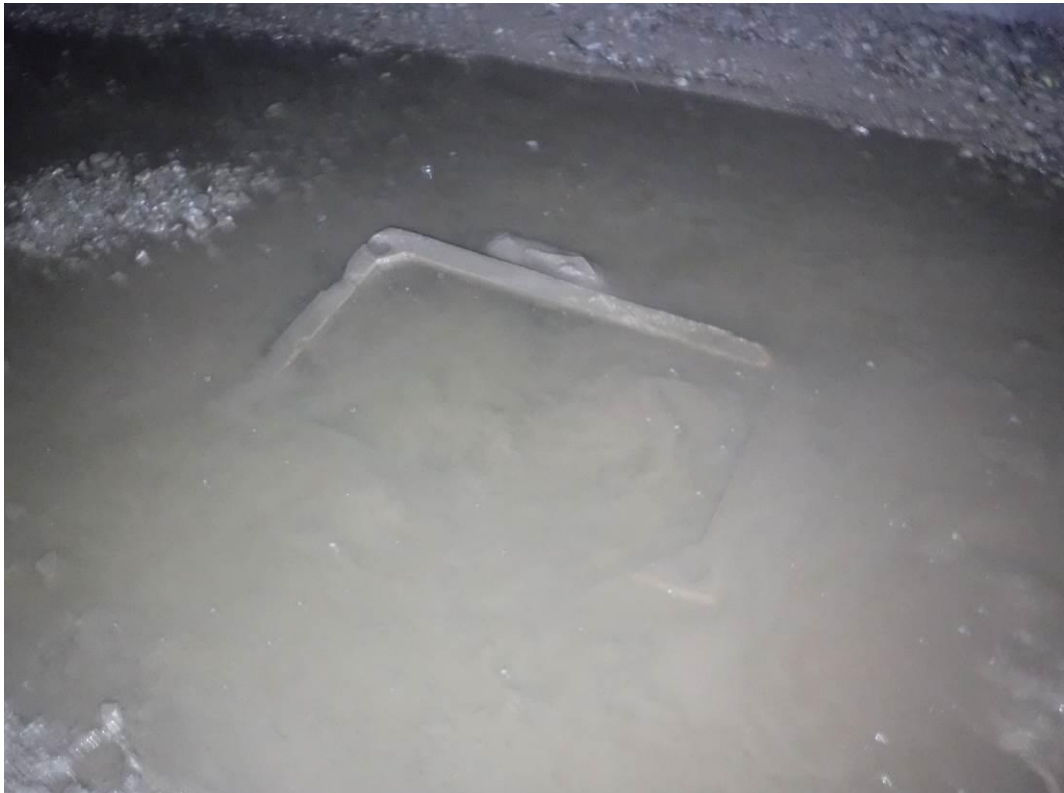
Photo No.8: 004+15 Solum Up & Down, Open catch-pit to six-foot, trip hazard.

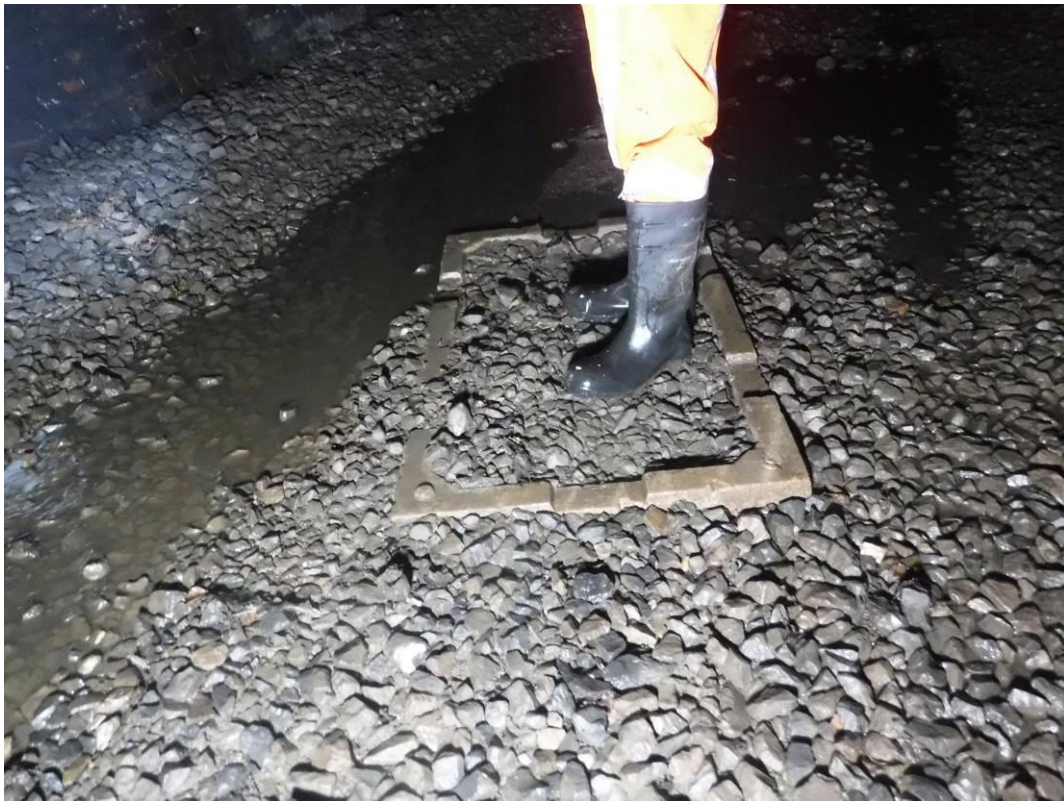
Photo No.9: 005+15 Solum Up & Down, Open catch-pit to six-foot, trip hazard.

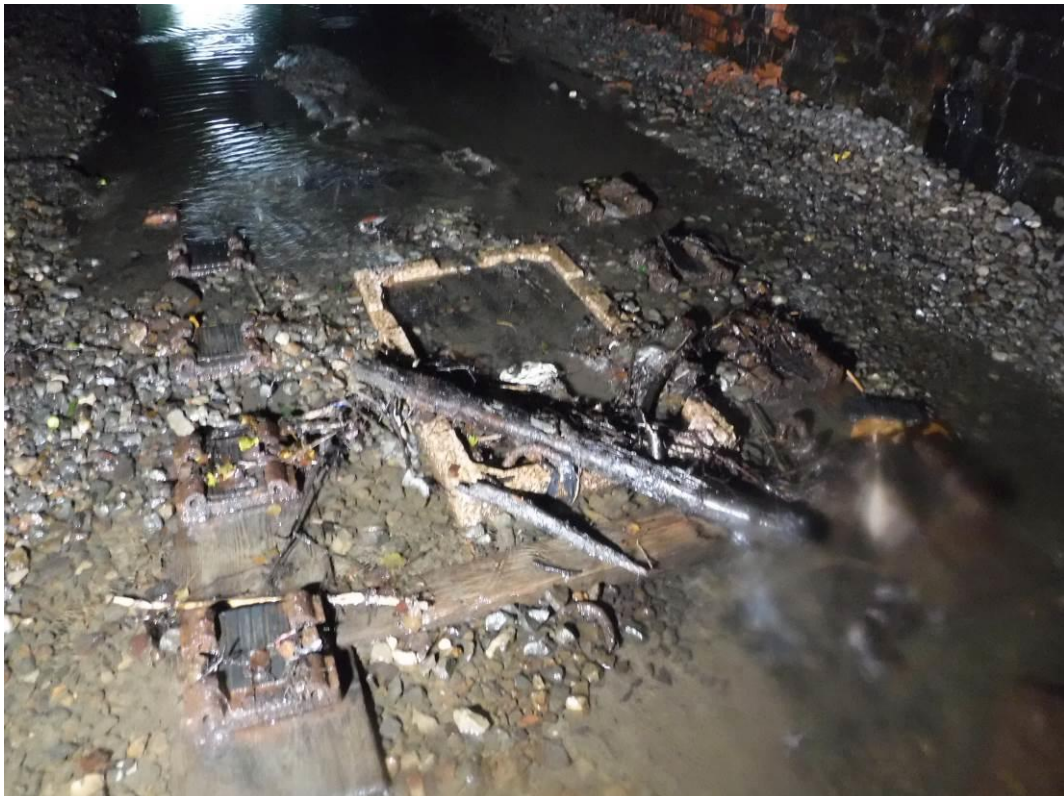
Photo No.10: 008+18 Solum Up & Down, Open catch-pit to six-foot, trip hazard.

007+11 to 010+20 Full Profile Up & Down	Brickwork, damp/wet, area 1000sq.m., medium.		
008+11 Crown Down	Brickwork, hollow, area 1sq.m., damp.		
008+18 Solum Up & Down	Open catch-pit to six-foot, trip hazard.	10	Recommend catch-pit be repaired, Priority 1; work to be completed by 14/10/2020.
008+20 to 010+20 Sidewall Up & Down	Brickwork, spalling and wet, depth 50mm, area 200sq.m., light.		
009+11 Sidewall Up	Brickwork, spalling, depth 100mm, area 0.5sq.m.	11	Recommend brickwork be replaced, Priority 1; work to be completed by 14/10/2020.

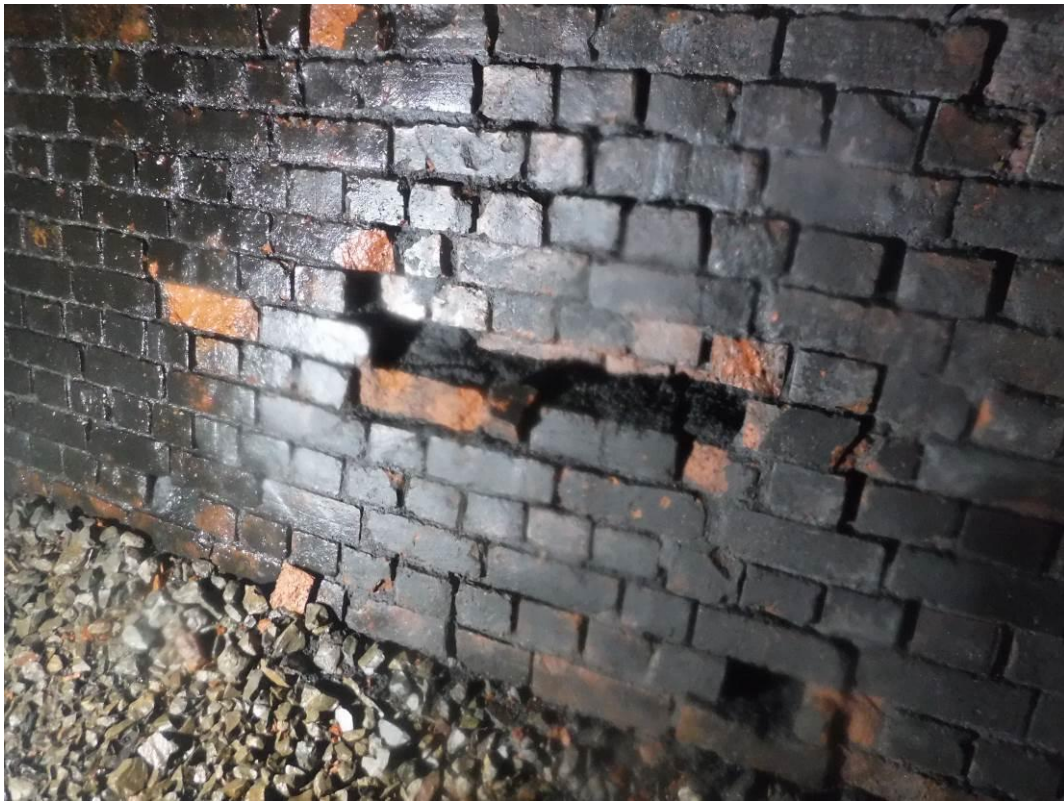
Photo No.11: 009+11 Sidewall Up, Brickwork, spalling, depth 100mm, area 0.5sq.m.

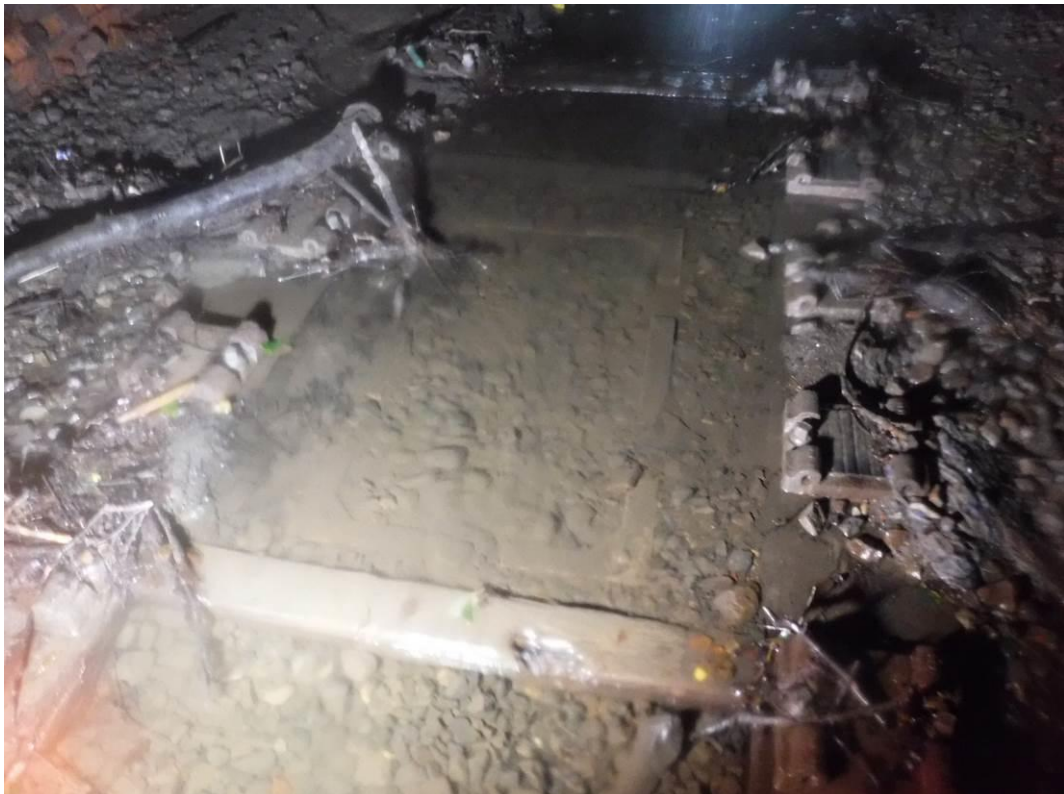
Photo No.12: 009+18 Solum Up & Down, Open catch-pit to six-foot, trip hazard.

Location	Defect		Action
009+18 Solum Up & Down	Open catch-pit to six-foot, trip hazard.	12	Recommend catch-pit be repaired, Priority 1; work to be completed by 14/10/2020.
009+21 to 010+20 Low Haunch Up & Down	Brickwork, spalling and wet, depth 50mm, area 60sq.m., sparse.		
010+03 Sidewall Up	Brickwork, spalling, depth 125mm, area 3sq.m., light.	13	Recommend brickwork be replaced, Priority 1; work to be completed by 14/10/2020.
010+06 Refuge Up	Country Quoin, brickwork, spalling, wet and hollow, depth 200mm, area 1sq.m., medium.	14	Recommend brickwork be replaced, Priority 1; work to be completed by 14/10/2020.
010+07 Sidewall Up	Brickwork, spalling and wet, depth 120mm, area 2sq.m., medium.	15	Recommend brickwork be replaced, Priority 1; work to be completed by 14/10/2020.
010+12 Sidewall Up	Brickwork, spalling, wet and hollow with loose bricks, depth 200mm, area 1sq.m., medium.	16	Recommend brickwork be replaced, Priority 1; work to be completed by 14/10/2020.

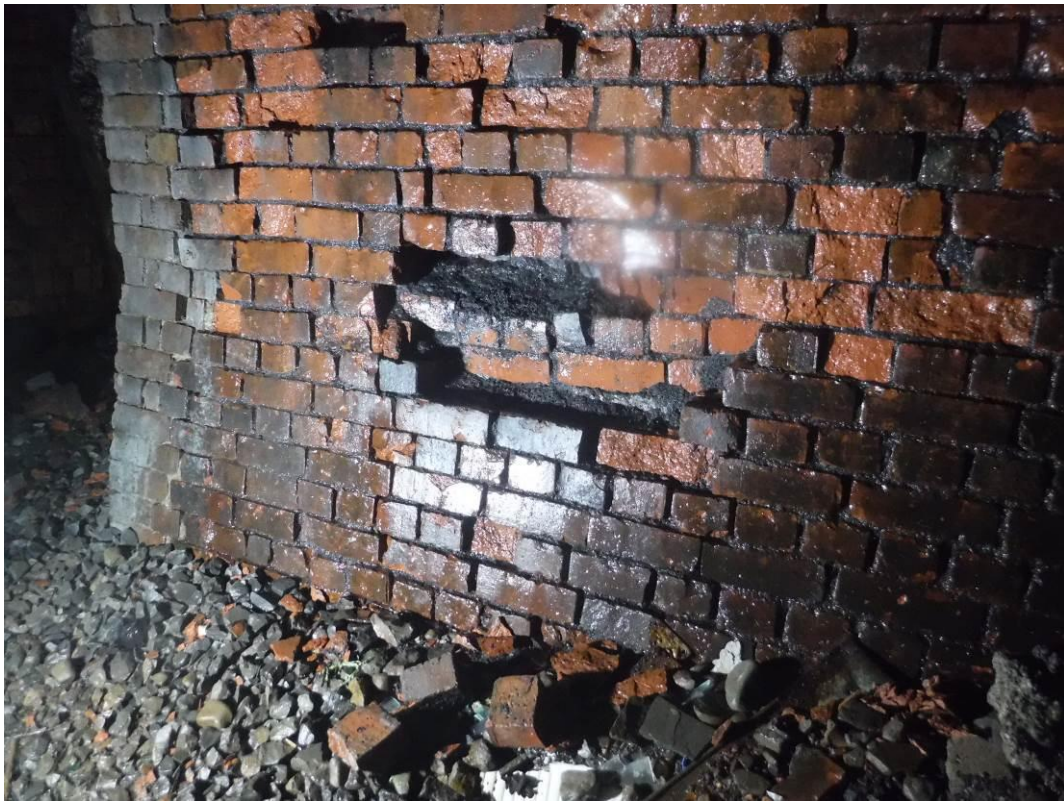
Photo No.13: 010+03 Sidewall Up, Brickwork, spalling, depth 125mm, area 3sq.m., light.

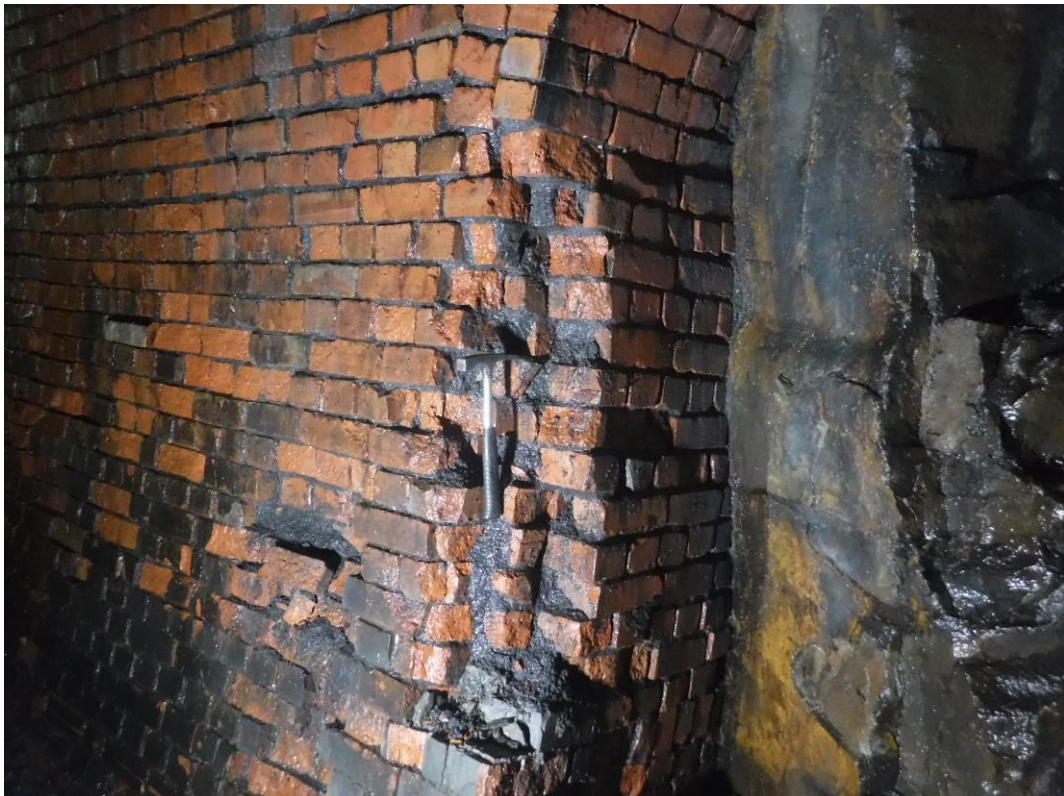
Photo No.14: 010+06 Refuge Up, Country Quoin, brickwork, spalling, wet and hollow, depth 200mm, area 1sq.m., medium.

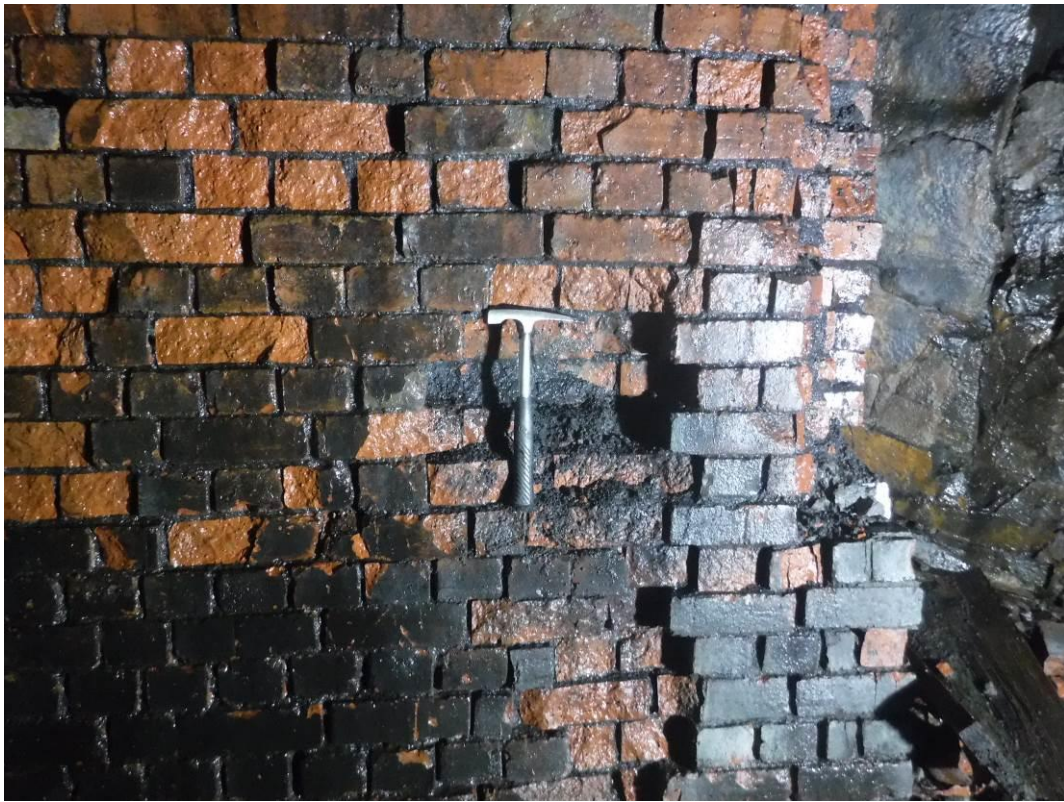
Photo No.15: 010+07 Sidewall Up, Brickwork, spalling and wet, depth 120mm, area 2sq.m., medium.

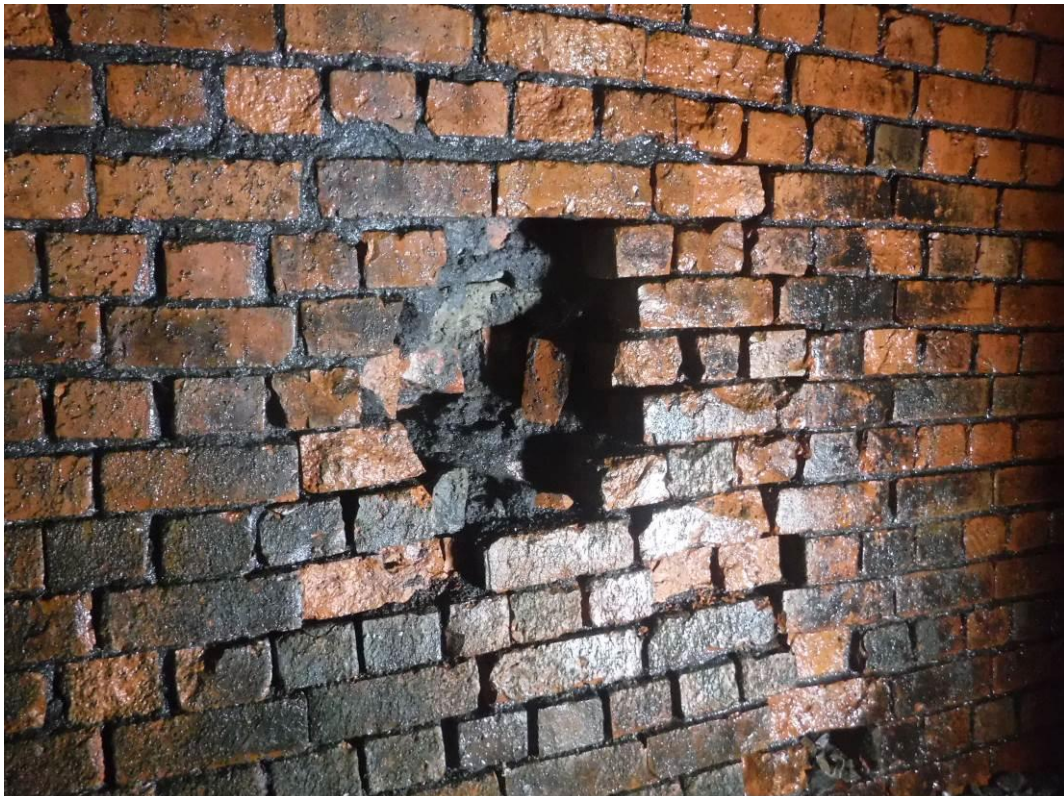
Photo No.16: 010+12 Sidewall Up, Brickwork, spalling, wet and hollow with loose bricks, depth 200mm, area 1sq.m., medium.
