**TUNNEL EXAMINATION REPORT
PHOTOGRAPHS OF STRUCTURE**

Balfour Beatty Rail, Manchester**Caerau (Cymmer) Tunnel****ELR: BAL/10m17ch****Examined: 05/02/2019**

Balfour Beatty Rail, Manchester**Pen-Cae-Drain Tunnel****ELR: VON/28m 65ch****Examined: 30/07/2019**

Balfour Beatty Rail, Manchester
Penar Tunnel
ELR:HRD2/4m 42ch Examined:14/10/2019

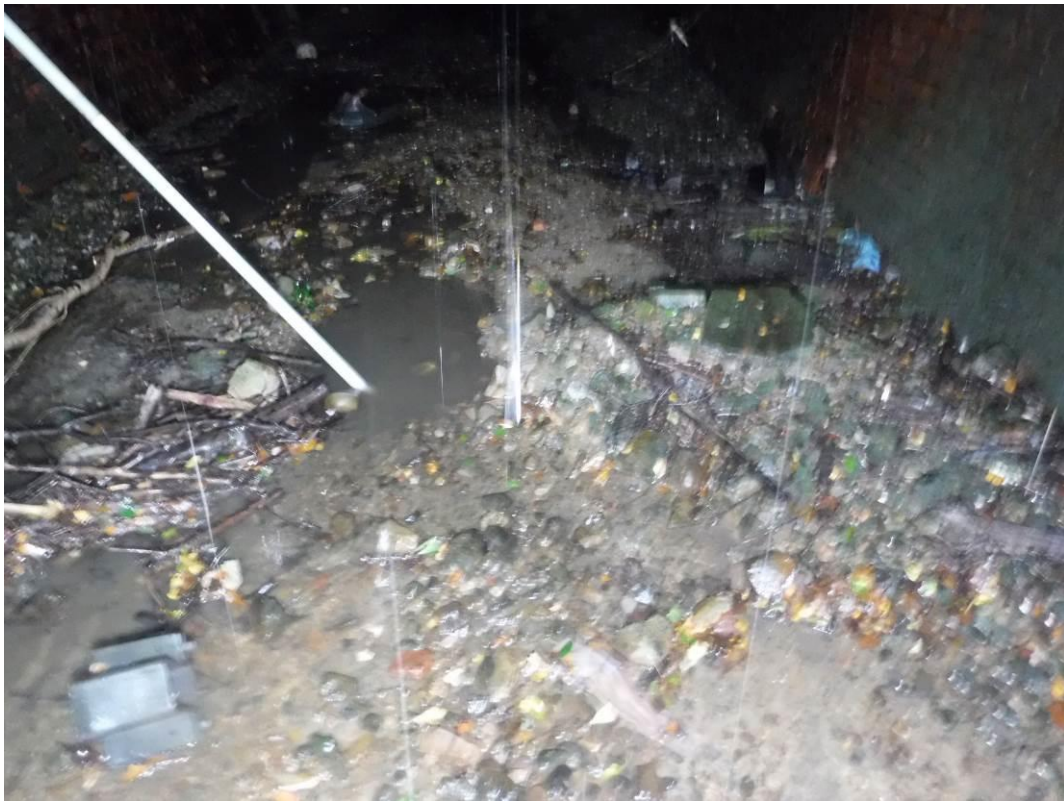
Photo No.17: 010+12 Solum Up & Down, Rubbish and debris scattered throughout solum at the end of the tunnel.

010+12 Solum Up & Down	Rubbish and debris scattered throughout solum at the end of the tunnel.	17	Recommend rubbish and debris be removed, Priority 1; work to be completed by 14/10/2020.
010+19 Haunch Up	Brickwork, circumferential fracture, length 2m, width 15mm. Old standing.		Recommend fracture be pointed to enable visual monitoring, Priority 3; work to be completed by 06/05/2019.
010+19 Full Profile Down	Brickwork, circumferential fracture, length 5m, width 15mm. Old standing.		Recommend fracture be pointed to enable visual monitoring, Priority 3; work to be completed by 06/05/2019.
010+20 Portal Up & Down	Country Portal, oiling gate padlock.	18	
010+20 Portal Up & Down	Country Portal, oiling gate hinges.	19	
010+20 Portal Down	Country Portal, gap under gates allowing trespass.	20	Recommend concrete footing be extended beneath whole length of security fence/gates, Priority 1; work to be completed by 14/10/2020.

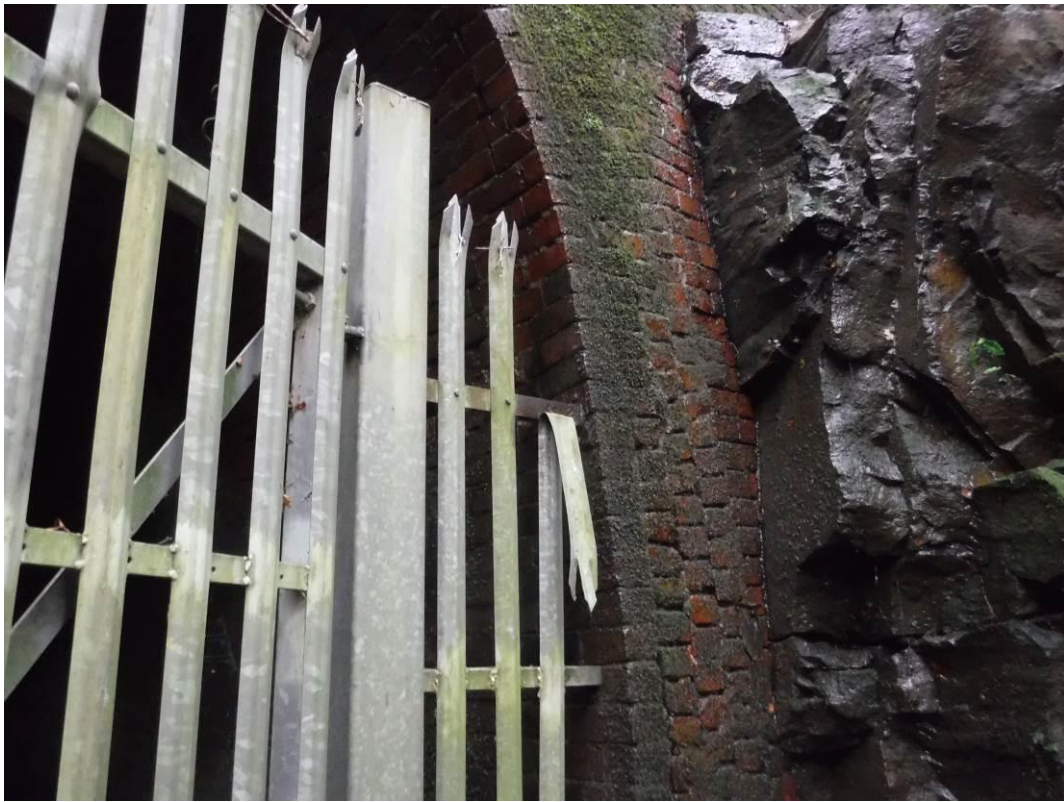
Photo No.21: 010+20 Portal Down, Country Portal, vandalised top of paling.

Location		Defect	Action	
010+20 Portal Down	Country Portal, vandalised top of paling.		21	Recommend paling be repaired and reinforced, Priority 1; work to be completed by 14/10/2020.
010+20 Portal Up	Country Portal, Stonework, 2m long section of copings missing.		22	Recommend copings be replaced, Priority 1; work to be completed by 14/10/2020.
010+20 Portal Up & Down	Country Portal, Brickwork, open joints, depth 50mm, area 8sq.m., light.

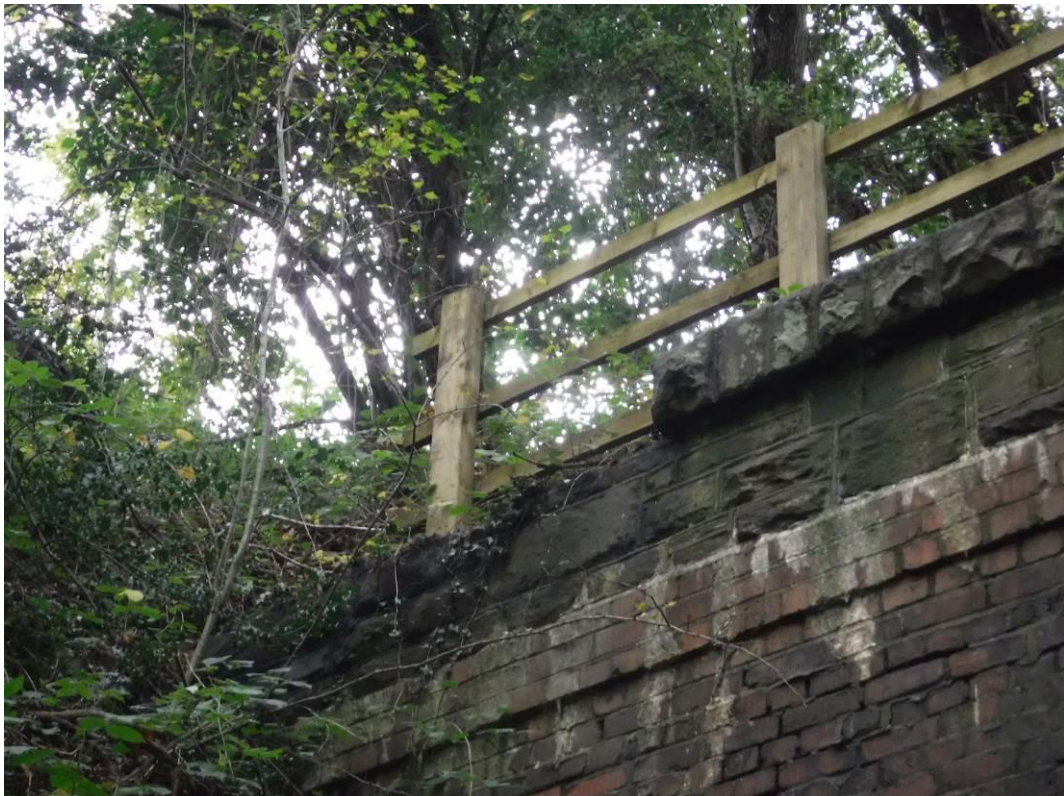
Photo No.22: 010+20 Portal Up, Country Portal, Stonework, 2m long section of copings missing.
