**FEASIBILITY REPORT
FOR FOOTPATH AT
WHALE CHINE,
CHALE**

WHALE CHINE FOOTPATH,

CHALE, ISLE OF WIGHT

Date: 22 April 2009
Reference: 7110/APT
Status: REVISION 0

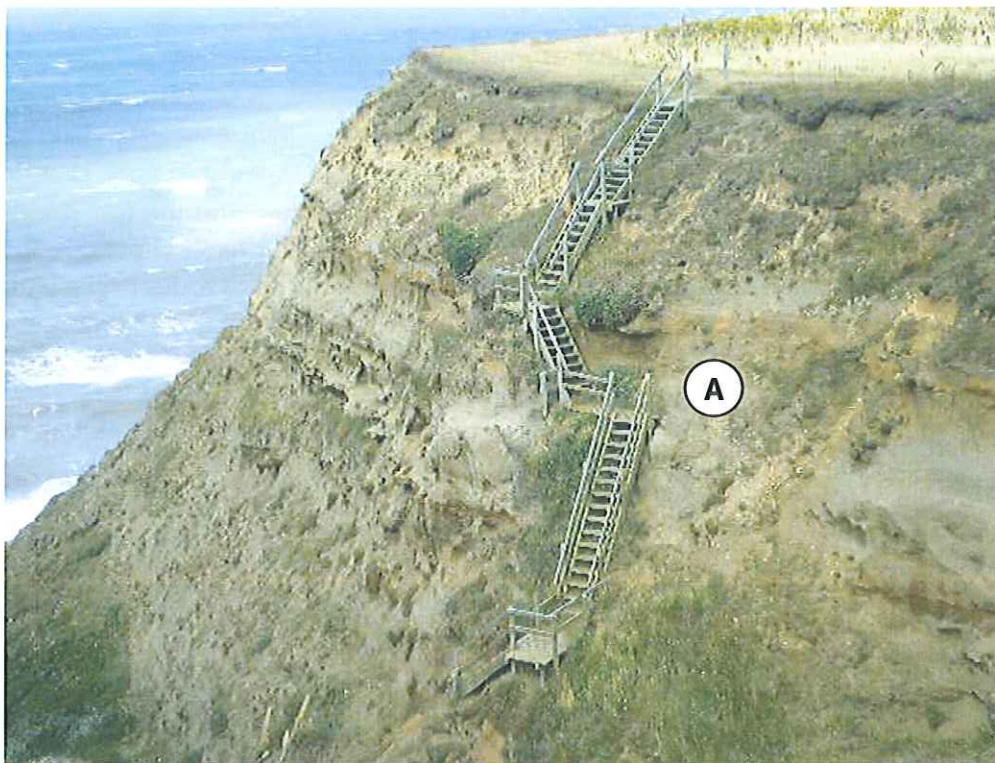
1 Section A remaining upper stair flights

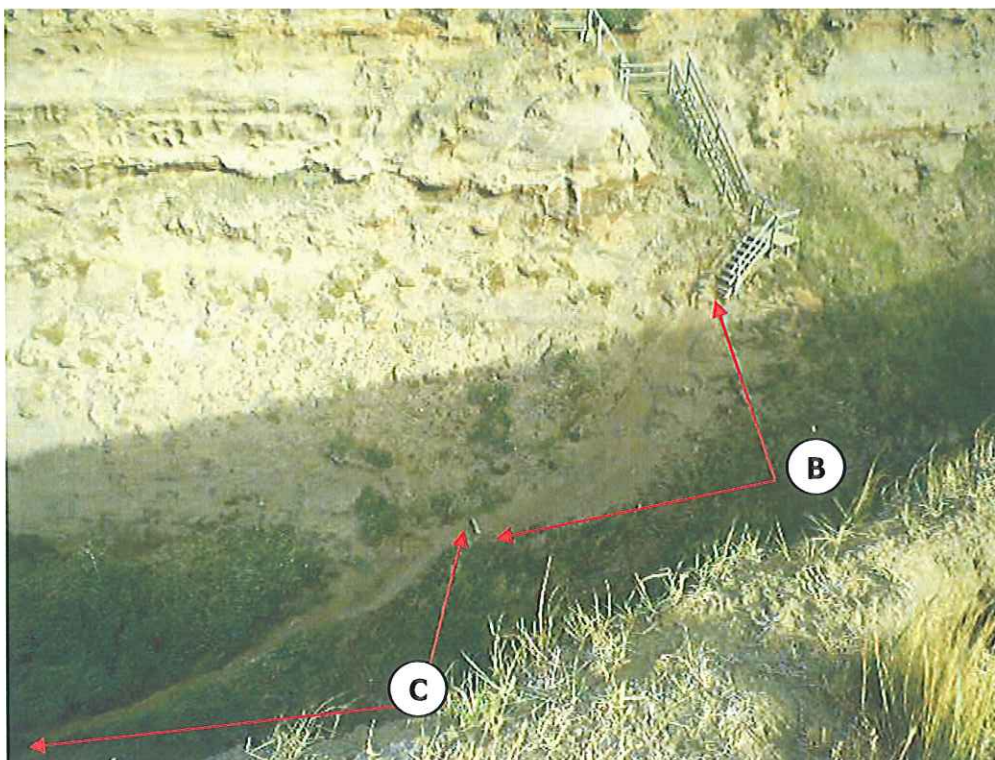
2 Section B missing stair flight and path section C

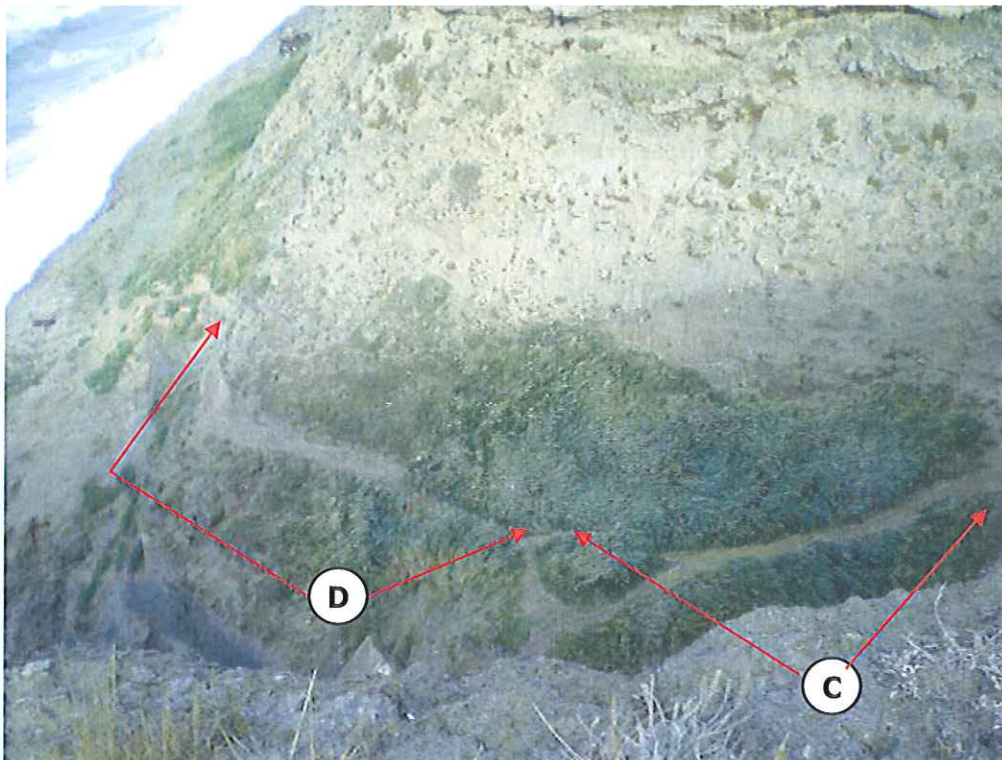
3 Path section C, and section D over ravine washout and around bluff
Note collapsed WWII tank defence below D marker tab

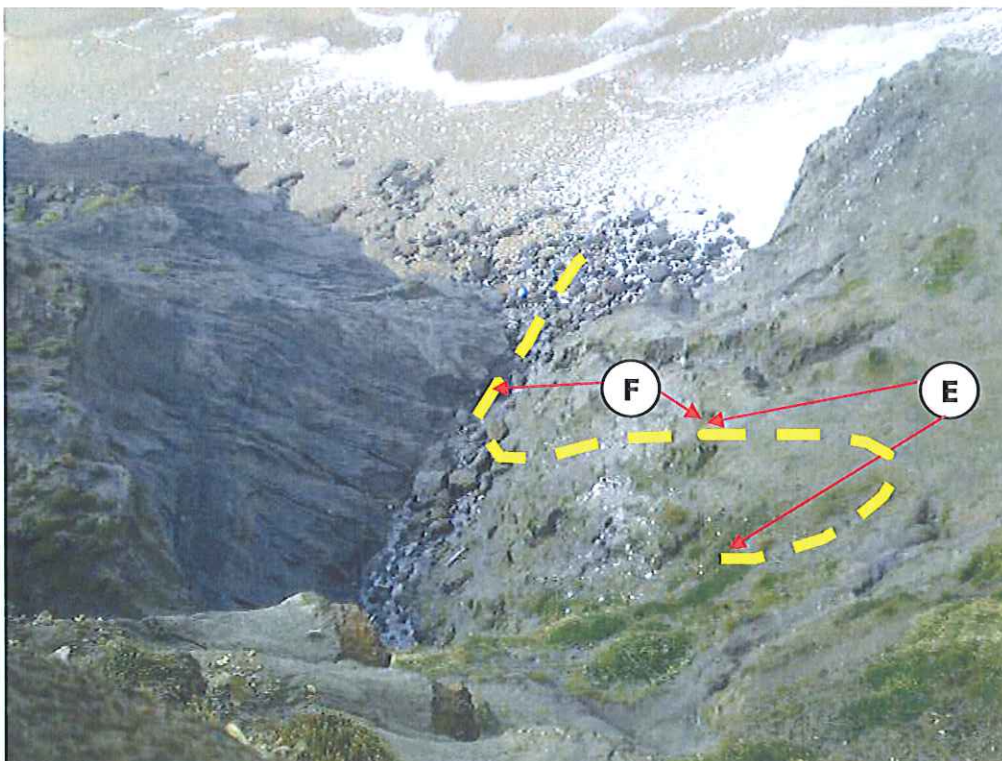
4 Path section E descent to terrace and section F down ravine side & base

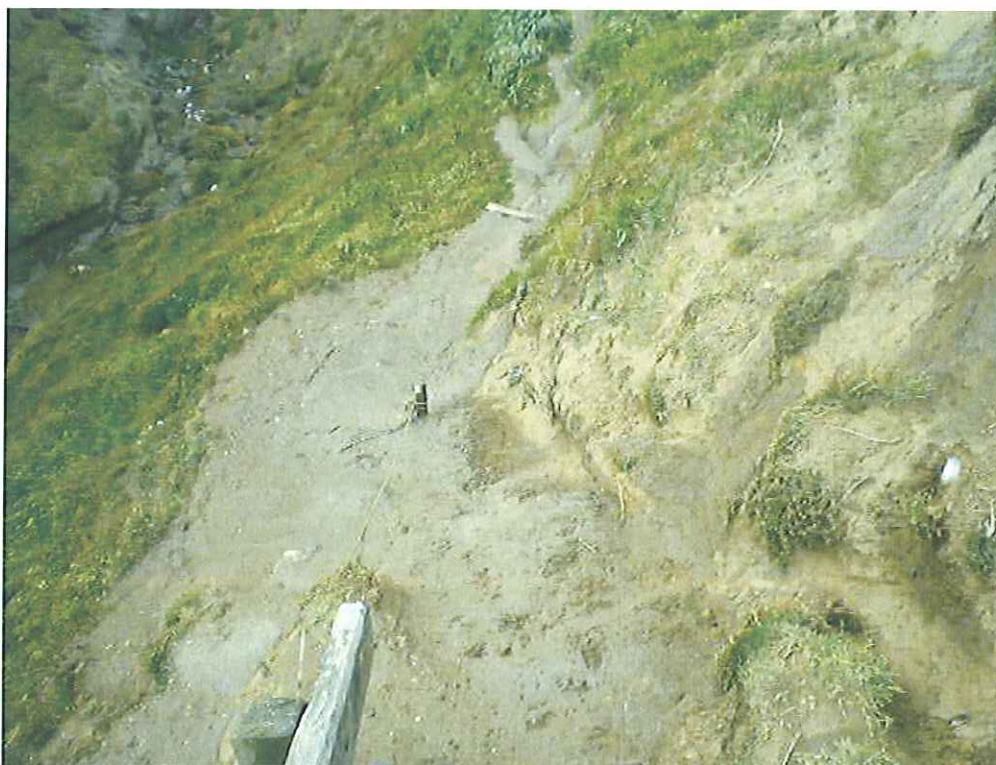
5 View down section B (from bottom of steps)

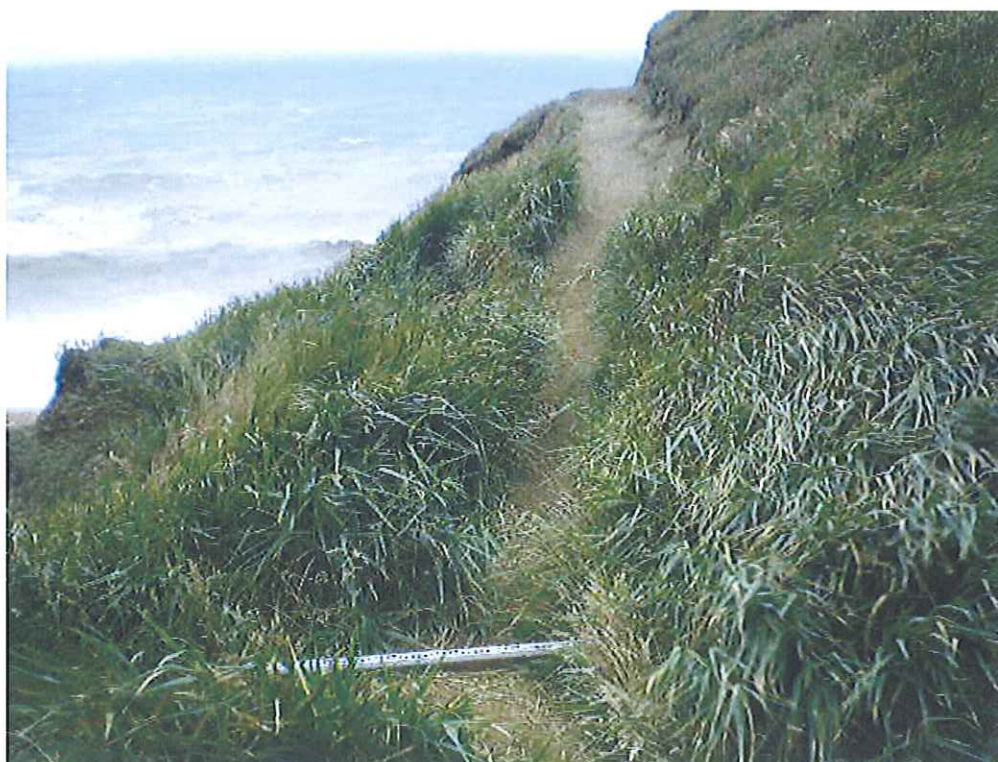
6 View along path section C

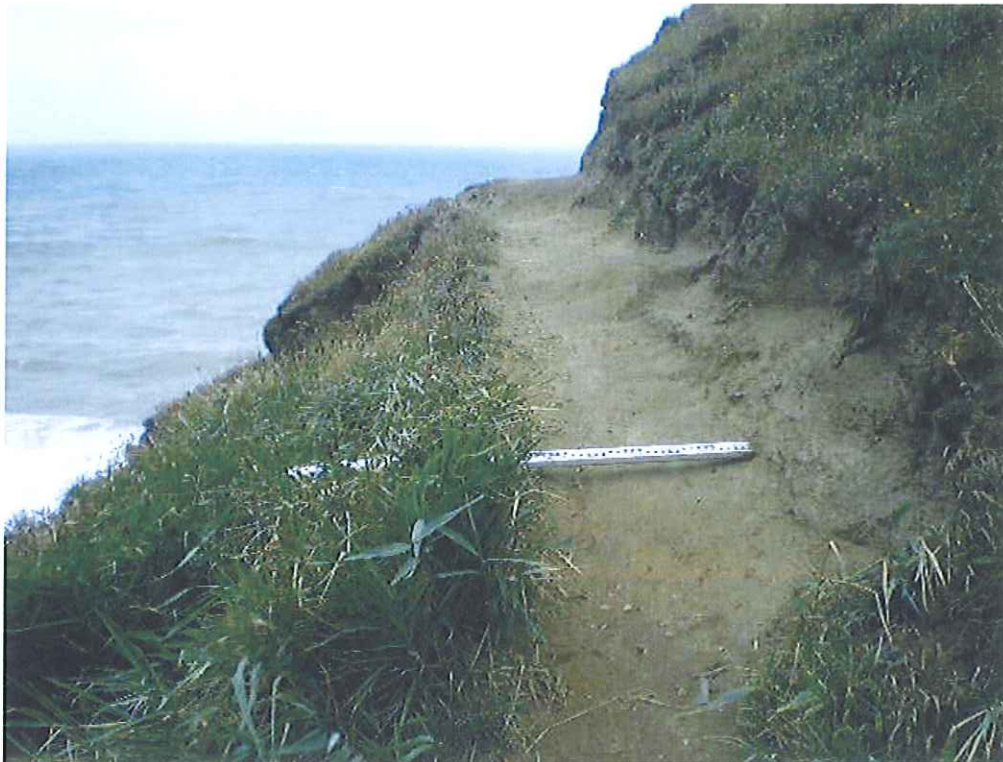
7 view along path section D

Note proximity of edge drop into ravine and also cut into talus slope

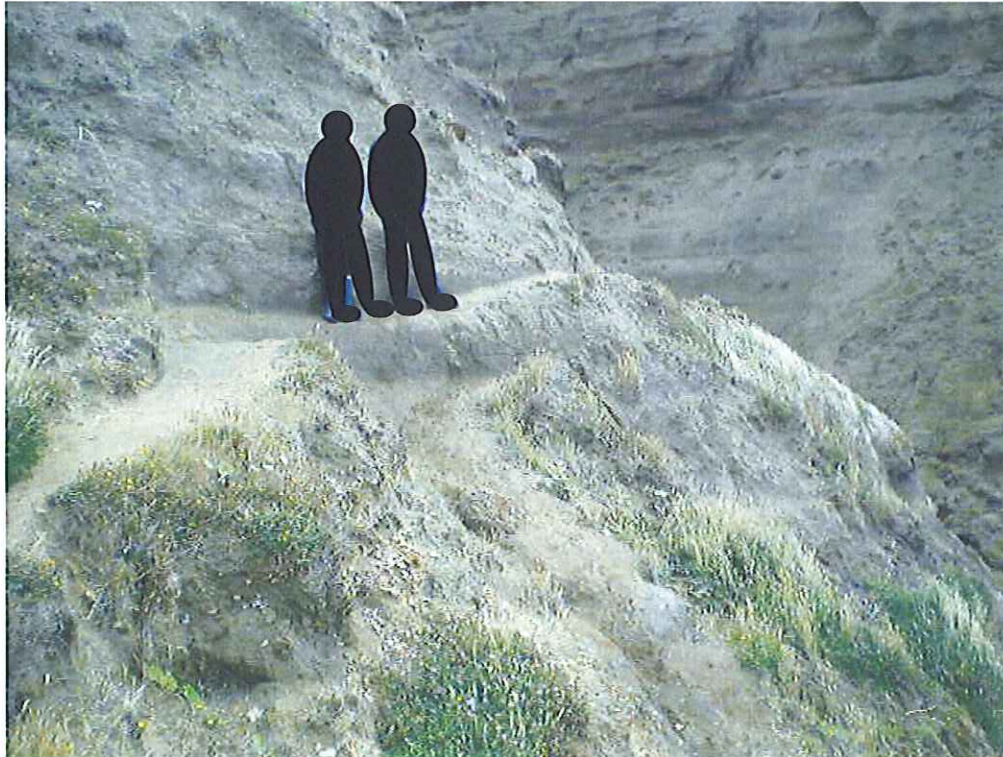
8 section D coastal face of bluff

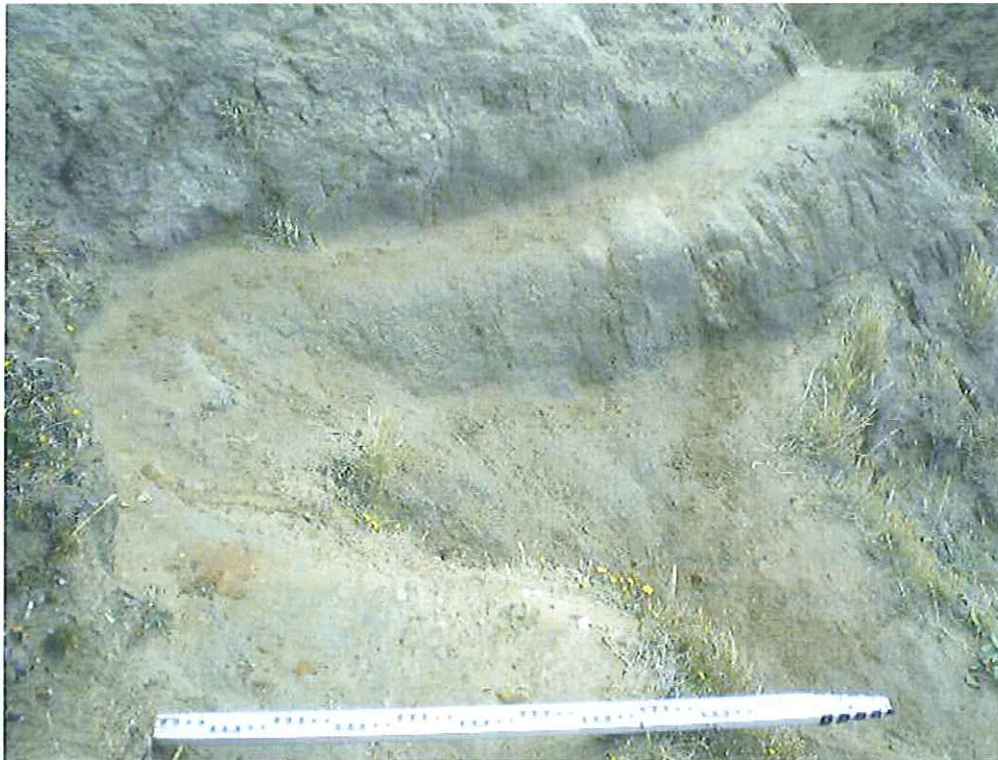
9 Detail view of existing ledge round bluff

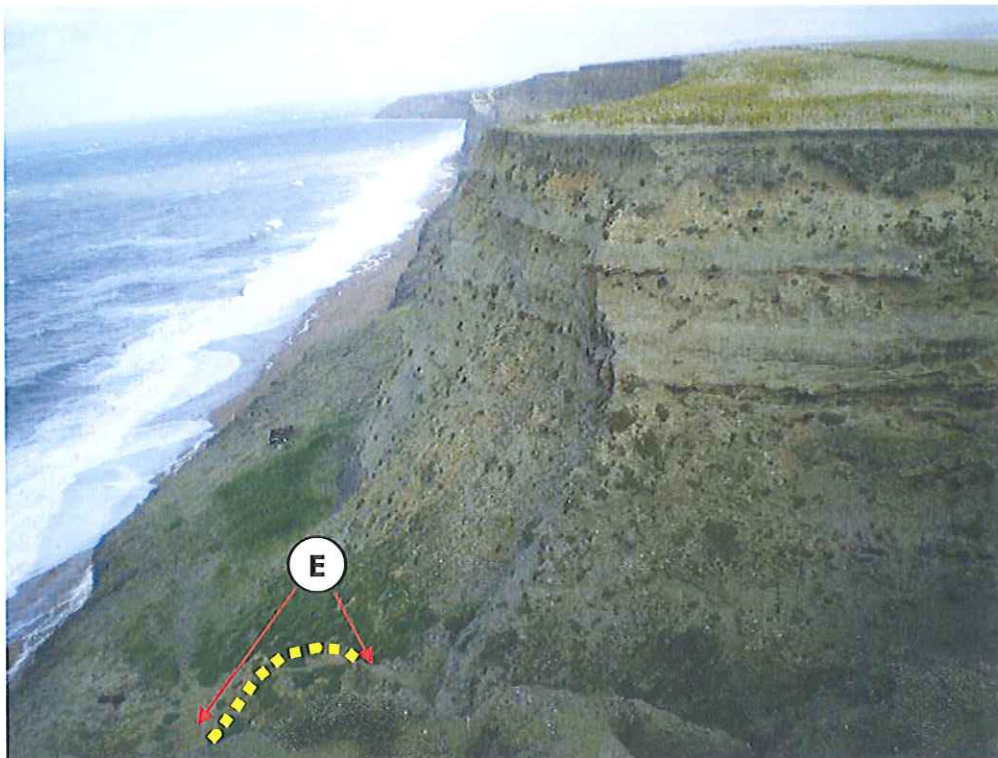
10 Overview of cliff profile and lower terrace

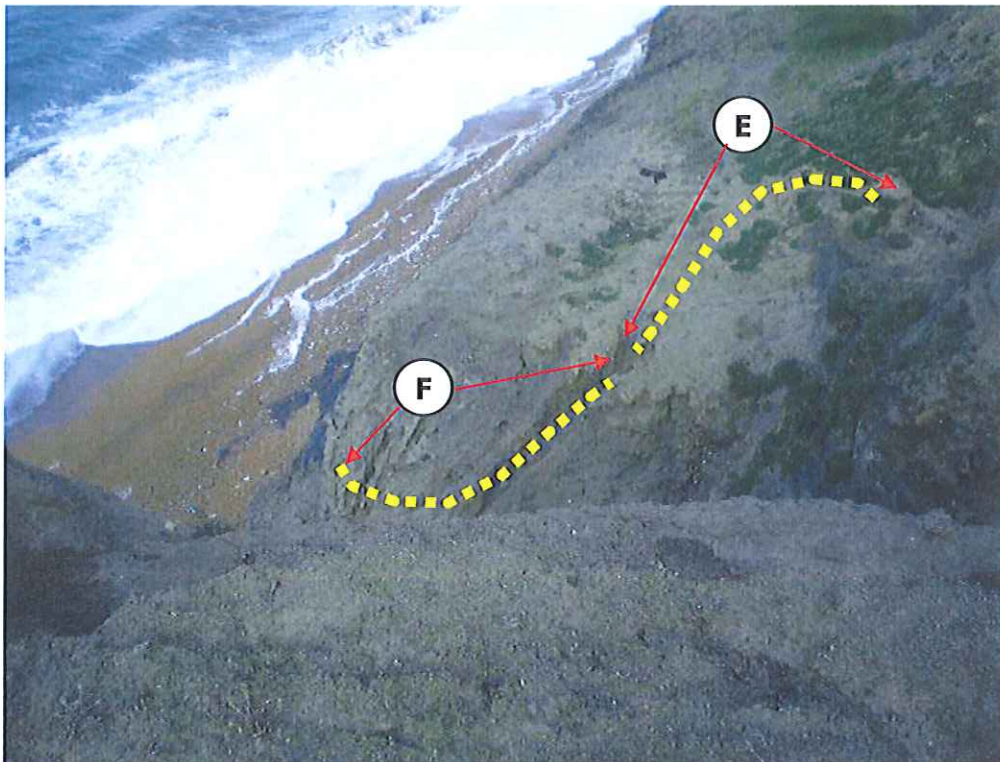
11 Path descent section E and ravine section F

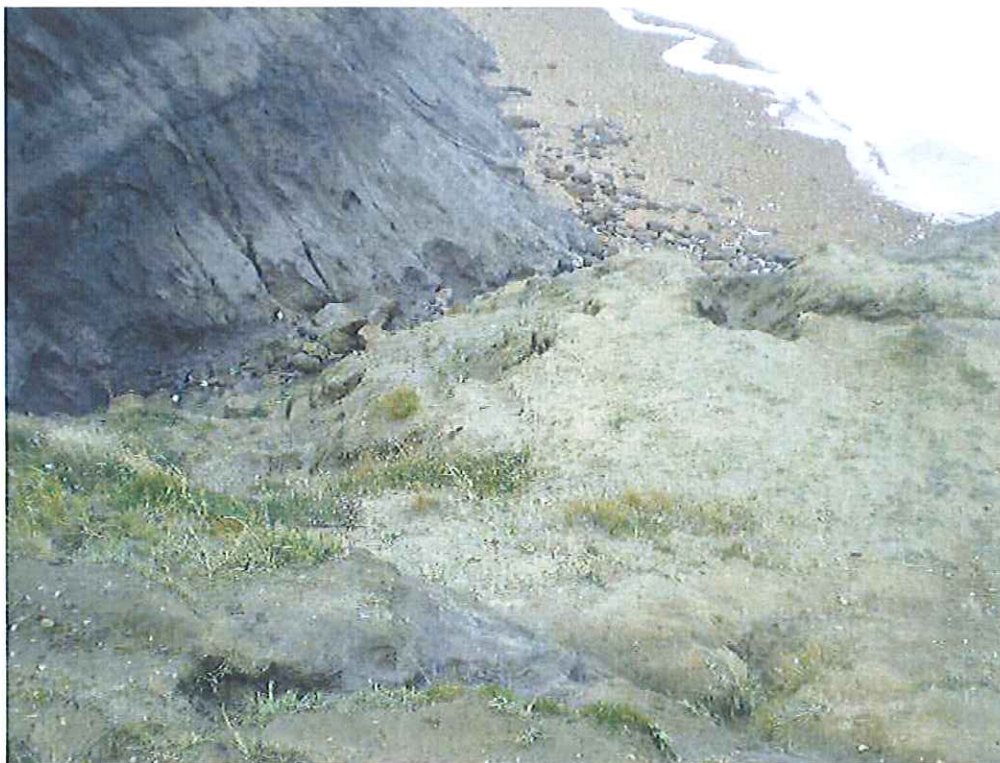
12 View of lower terrace and opposite side and bed of ravine

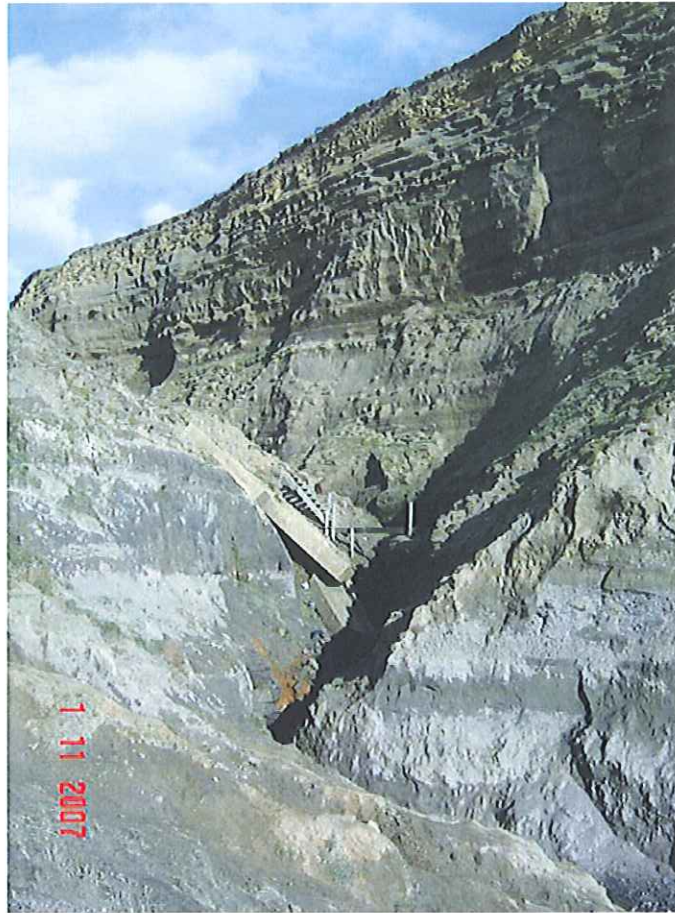
13 Ravine below section D (above and left of frame)
Has subsequently further eroded in last 6 months

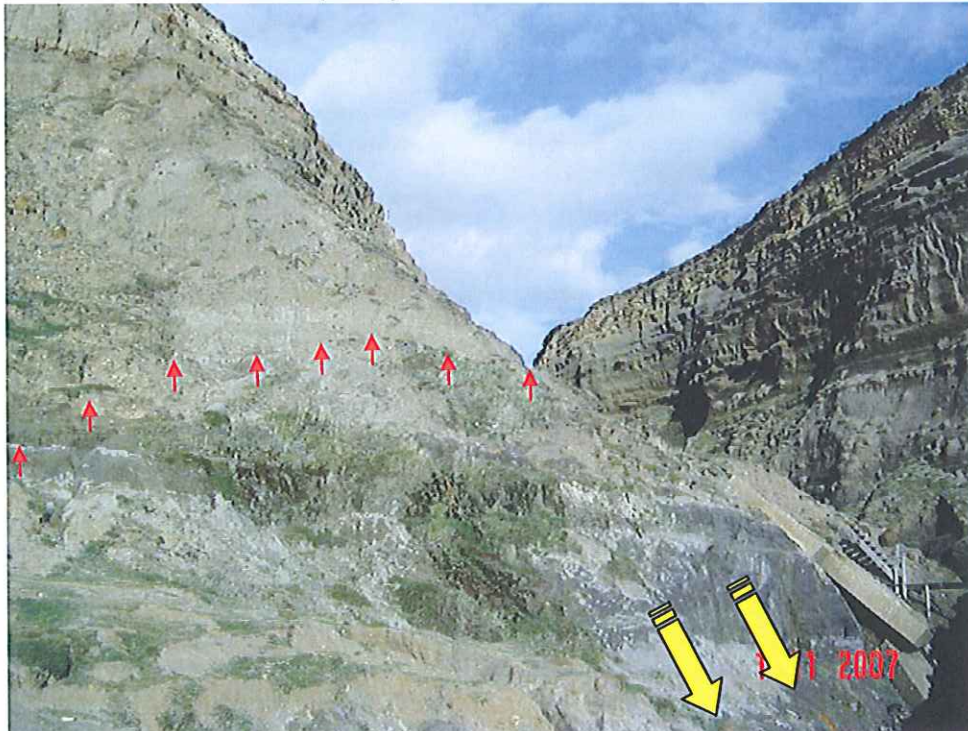
14 Current alignment of section D and location of further collapse winter 2007
