<b>ELR:</b>	SAD	<b>Structure No:</b>	77	<b>Mileage:</b>	19m 52ch	<b>Examination date:</b>	13/06/18
<b>Route:</b>	Somerset and Dorset					<b>OS ref:</b>	ST 615 451
<b>Name:</b>	Windsor Hill New Tunnel					<b>Type:</b>	Tunnel

<p><b>General view of structure: CE portal</b></p>

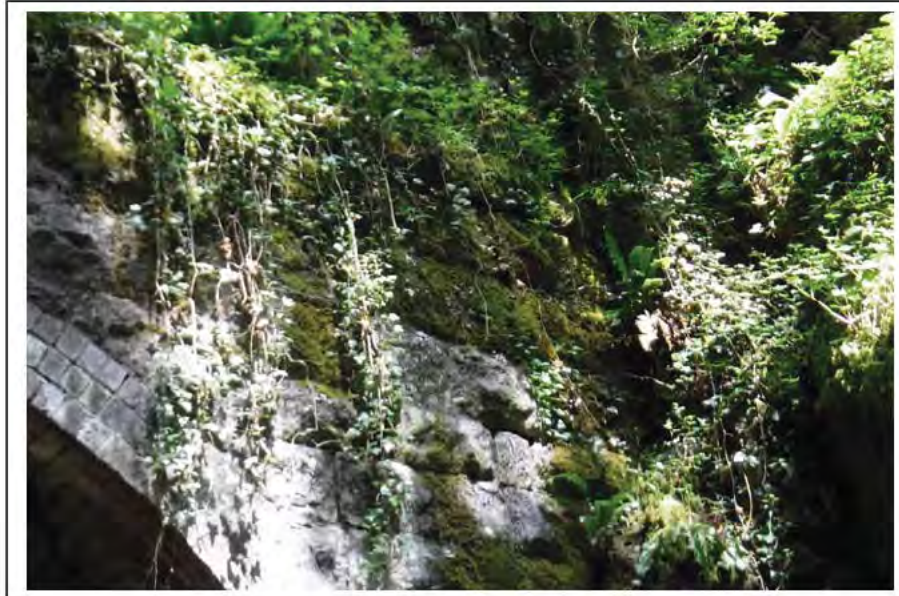
Photograph no 1: Moss, lichen and ivy cover approximately 60% of the DC spandrel

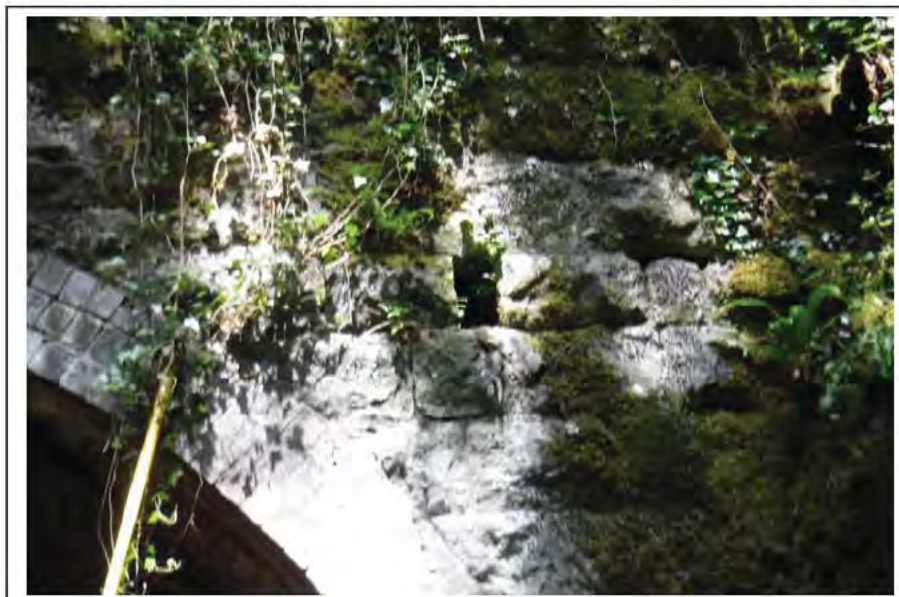
Photograph no 2: Long-standing single masonry unit missing in DC spandrel/ wingwall

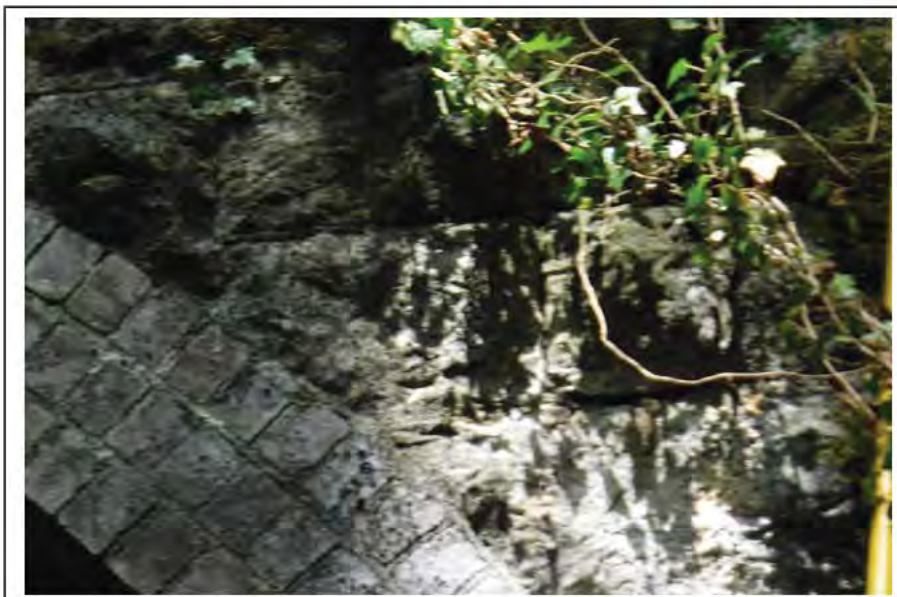
Photograph no 3: Minor diagonal fracture to area above DC mid haunch  
and adjacent to missing unit open 1mm 300mm long

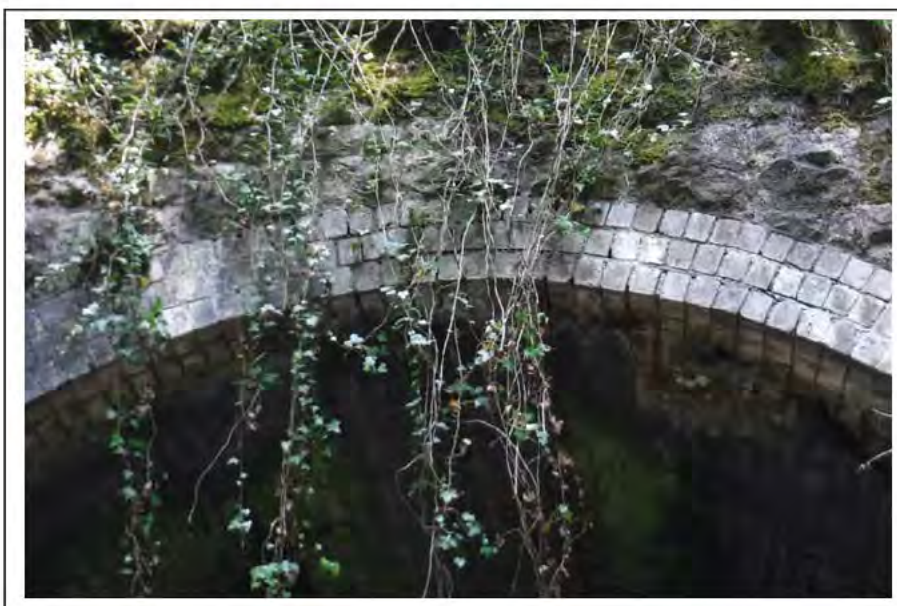
Photograph no 4: CE headwall  
Three brick face rings in good condition with joint loss to 10mm max

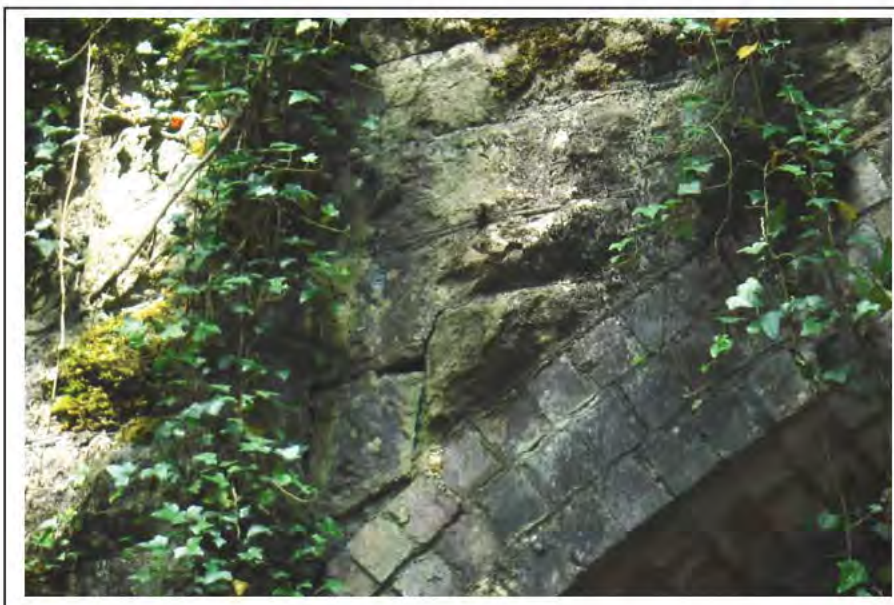
Photograph no 5: CE headwall

Area of open joints to downside spandrel (above barrel) approximately 1.5m<sup>2</sup> up to 50mm deep

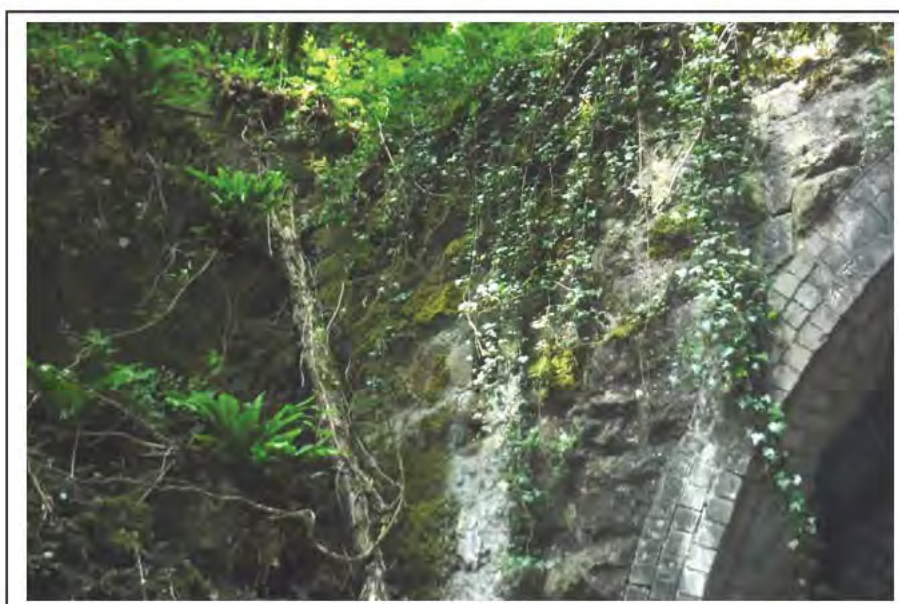
<b>Upside spandrel/ wingwall</b> <p>Wingwall generally found to be in good condition with no significant defects.</p> <p>Moss, lichen and ivy cover approximately 80% of the spandrel (P6).</p> <p>Long-standing single masonry unit missing to spandrel/ wingwall at centre (P7) –firm to hammer</p>

Photograph no 6: Moss, lichen and ivy cover approximately 80% of the UC spandrel

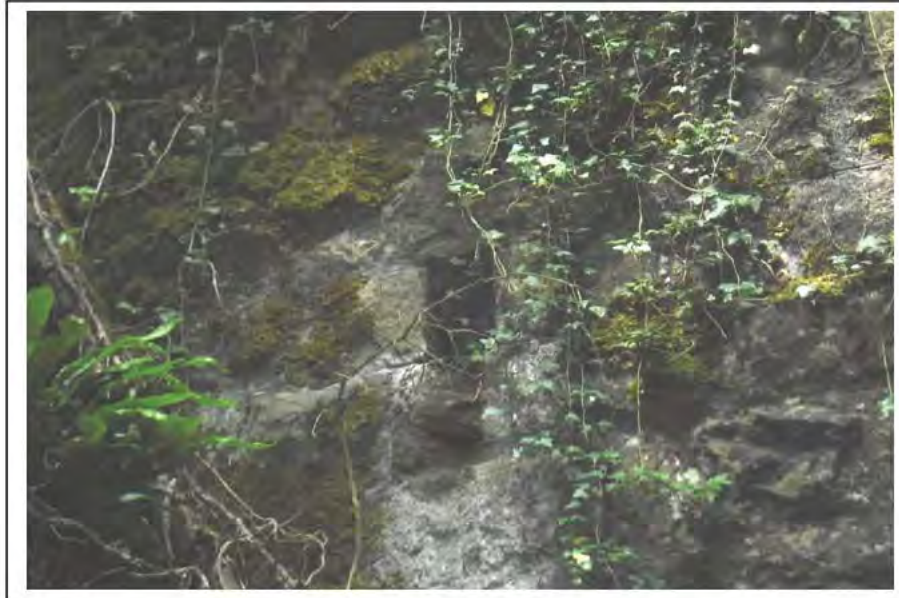
Photograph no 7: Long-standing single masonry unit missing to UC spandrel/ wingwall at centre

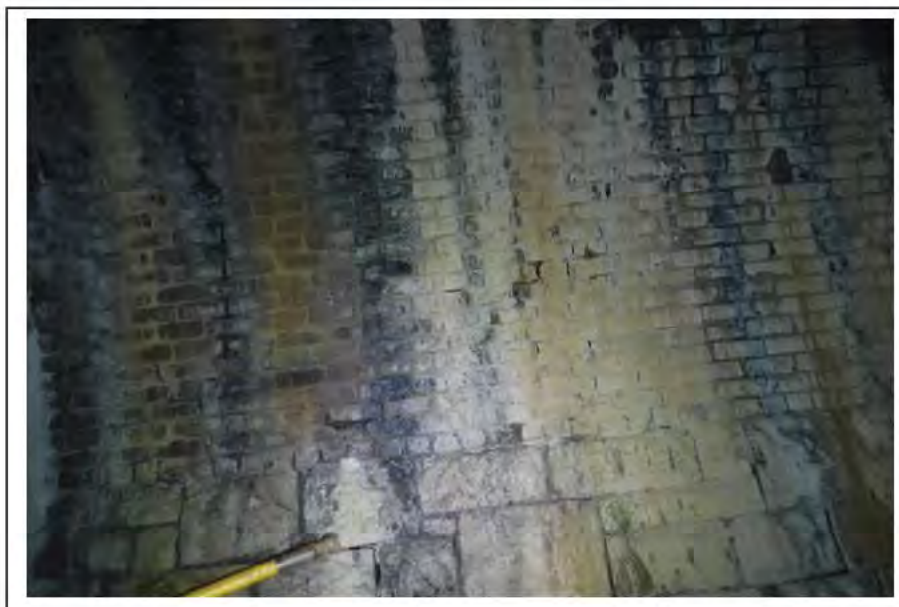
Photograph no 9: Water staining to DS sidewall at 5ch

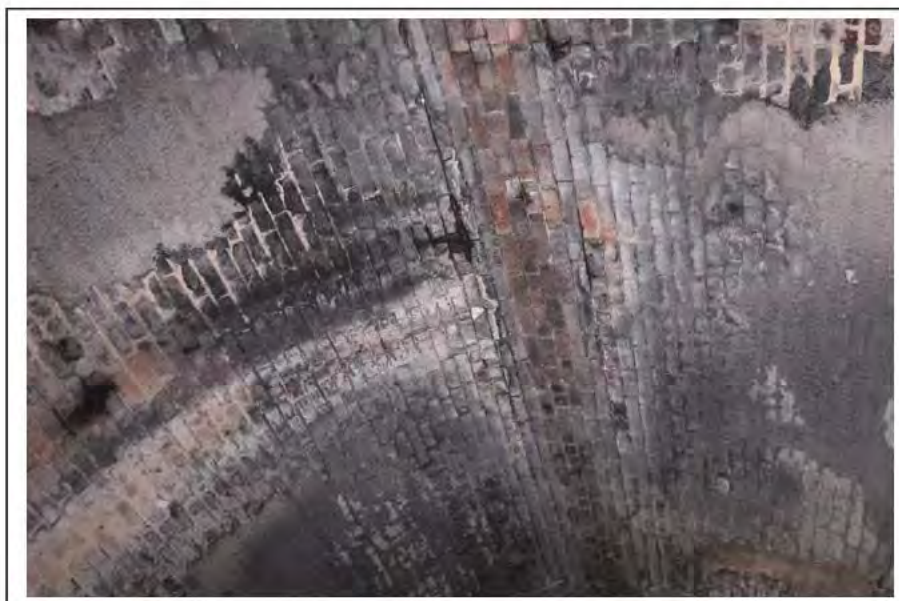
Photograph no 10: Crown at 3.5ch  
Isolated wet patches

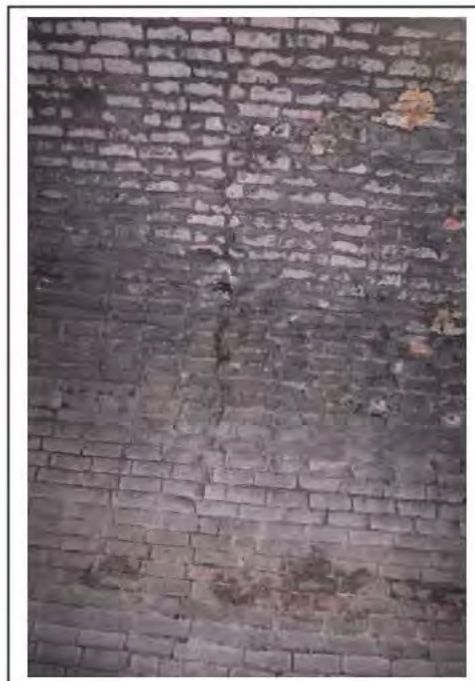
Photograph no 12: Construction joint from haunch to haunch at 0.5m

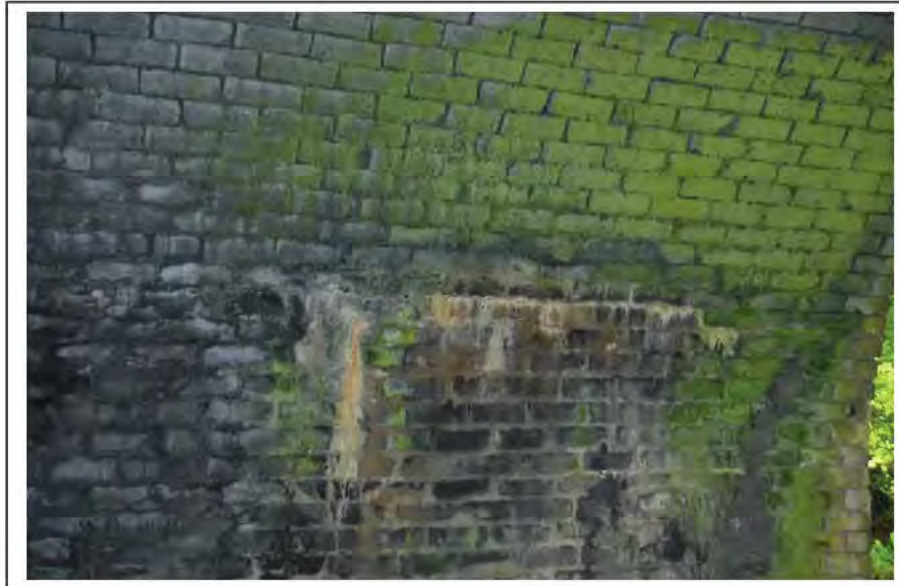
Long-standing transverse fracture (highlighted by salts) to mid haunch of US sidewall at LE portal remains stable (P13).

Photograph no 13: Fracture to U/S haunch at London end 2.5m long

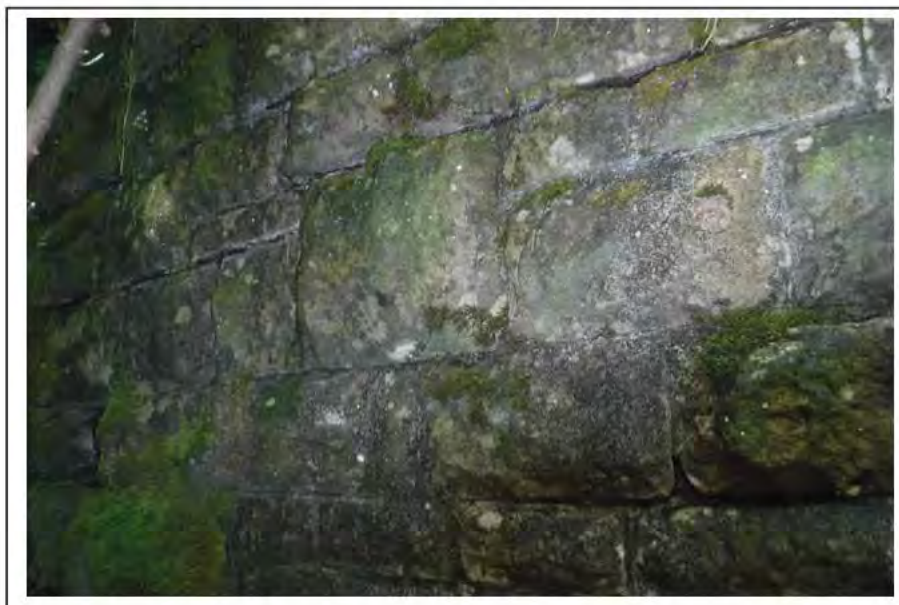
Photograph no 15: DL spandrel/ wingwall: open joints, mainly to bed joints 0.5m<sup>2</sup> to 50mm

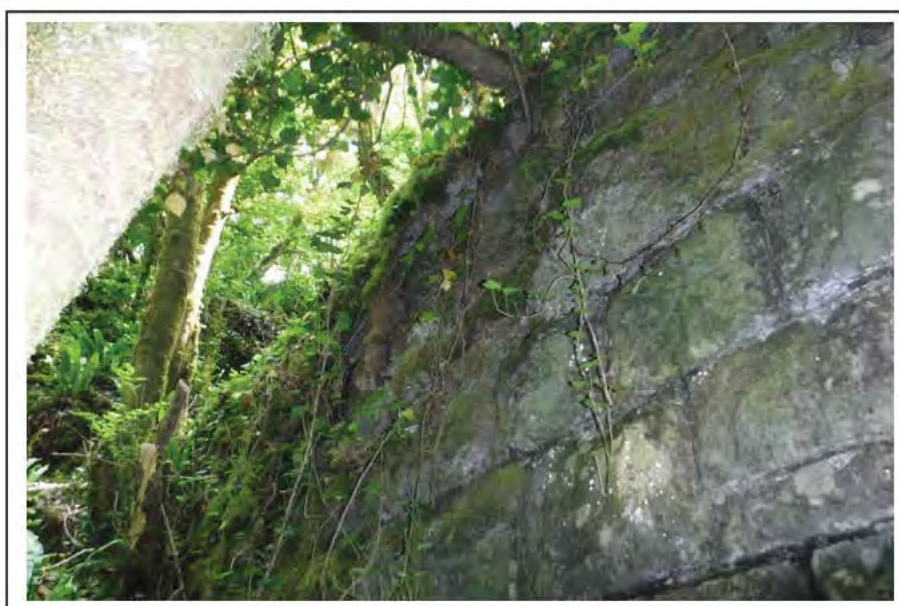
Photograph no 16: DL spandrel/ wingwall: coping course entirely moss covered with fallen tree to rear

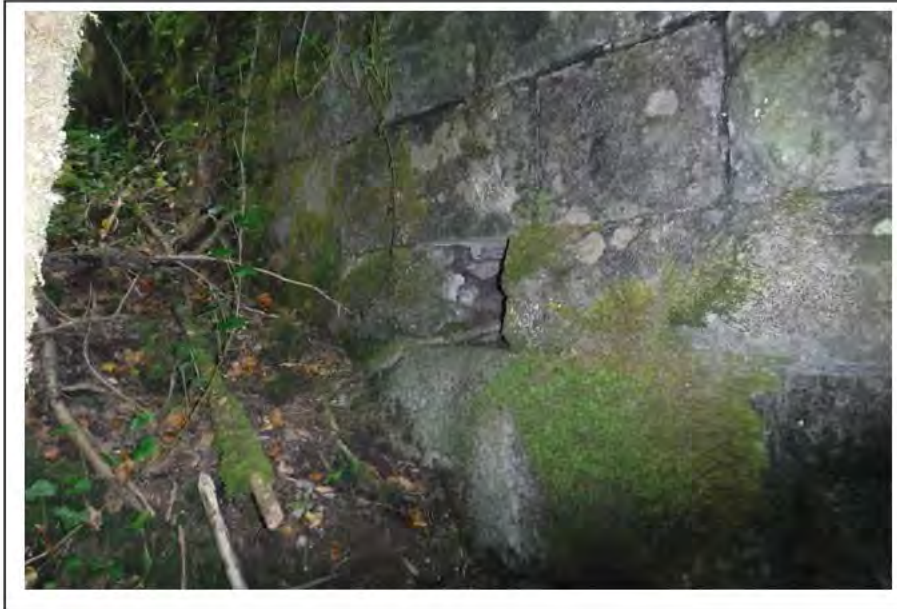
Photograph no 17: Long-standing missing unit to base of DL wingwall

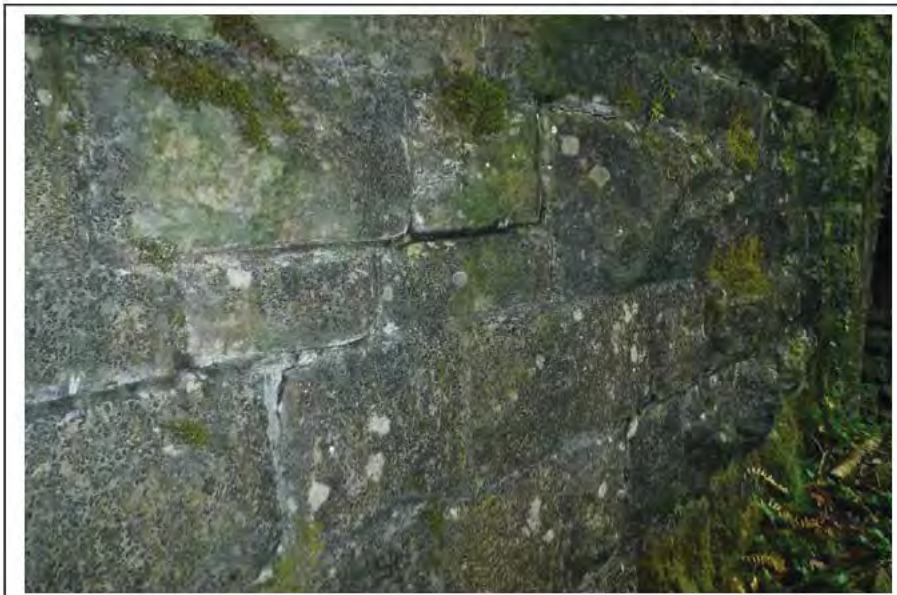
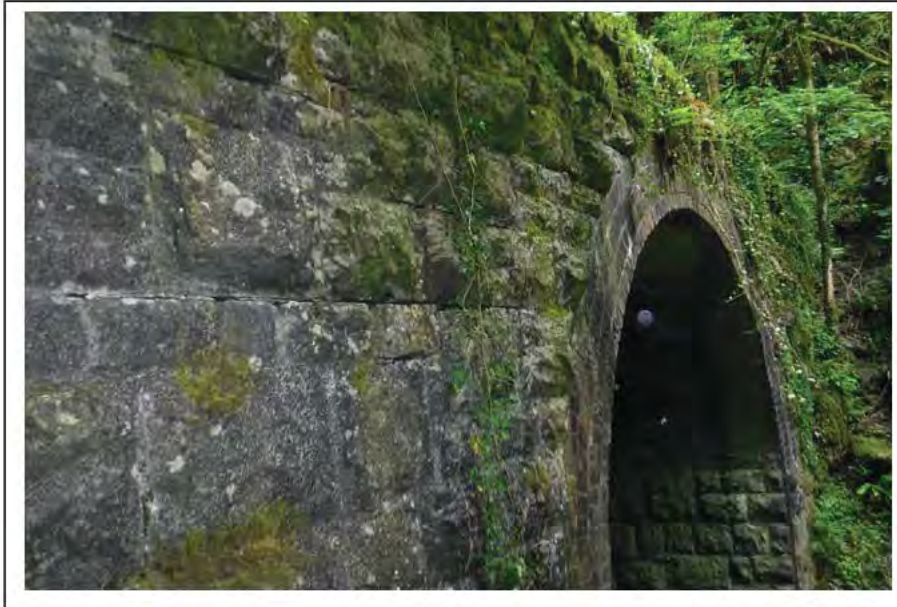
Photograph no 18: Step fracture runs from base of DL wingwall (obscured by moss in places) stepping up 6no courses then as horizontal fracture to mid haunch 2.5m long open 1mm

Photograph no 19: As photo 18

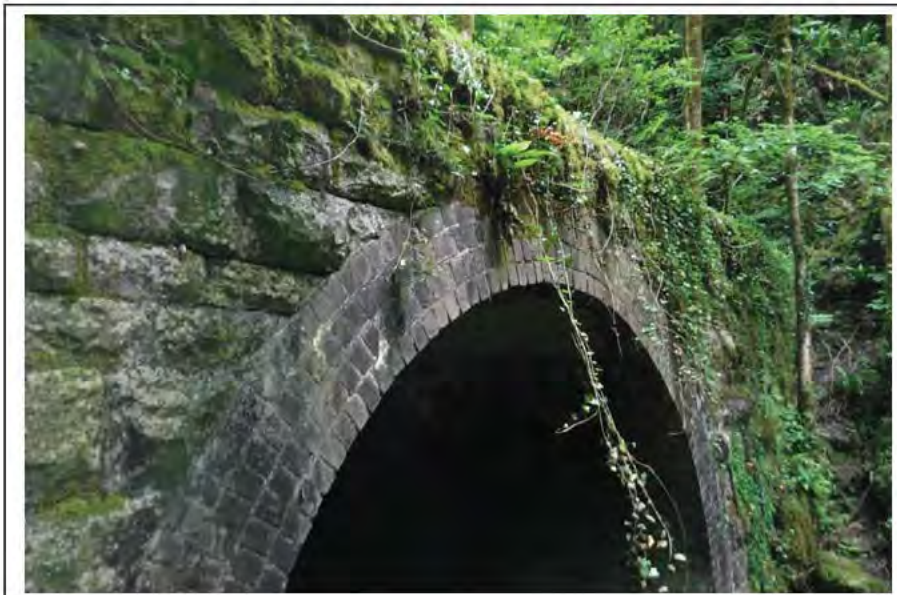
Photograph no 20: LE headwall

Four brick face rings in good condition with minor joint loss to first ring

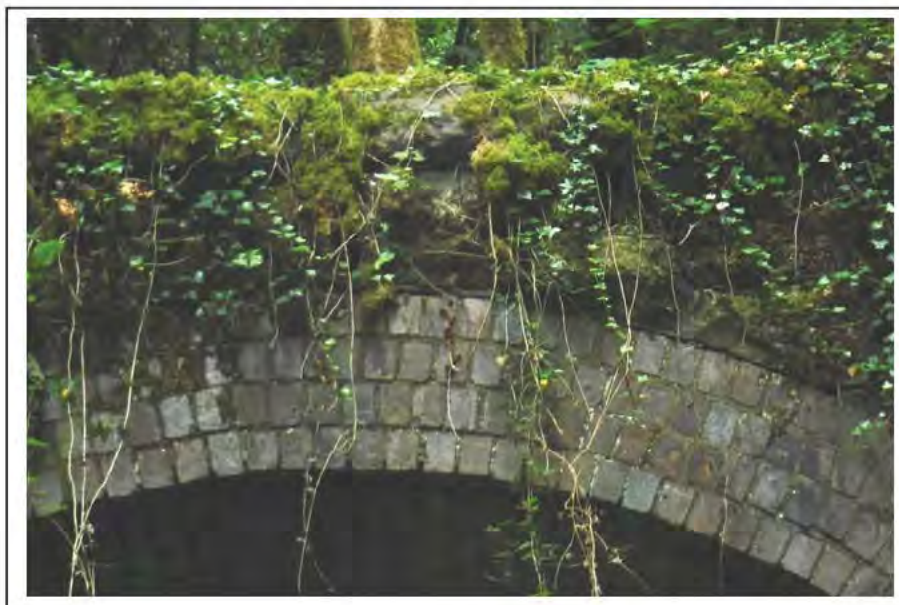
Photograph no 21: LE headwall

Separation fracture (long-standing) runs from DS upper haunch to US mid haunch, open to 2mm between masonry headwall and brick face rings

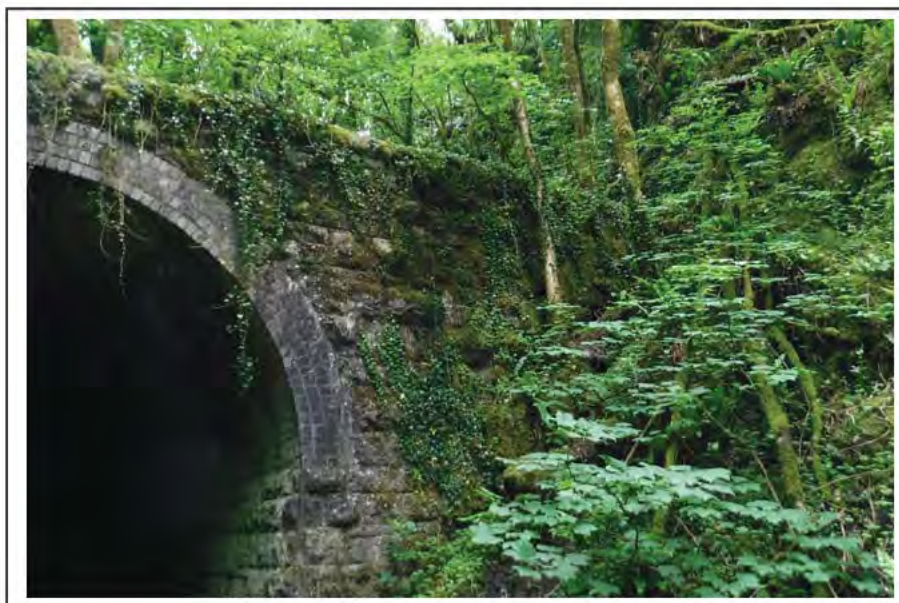
<p><b>Upside spandrel/ wingwall</b></p> <p>Moss, lichen and ivy cover approximately 75% of the spandrel.(P22)</p> <p>Open joints, largely to bed joints, to spandrel approximately 3m<sup>2</sup> up to 40mm deep (P23)</p> <p>Single masonry unit missing (P24) (heavily moss covered)</p>

Photograph no 22: Moss, lichen and ivy cover approximately 75% of the U/L spandrel

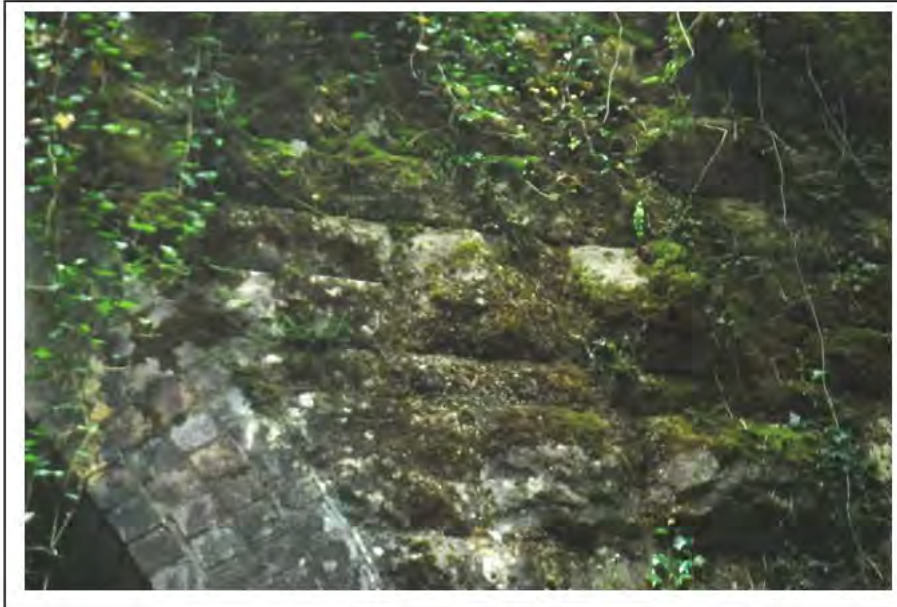
Photograph no 23: Open joints, largely to bed joints, to UL spandrel approximately 3m<sup>2</sup> up to 40mm deep

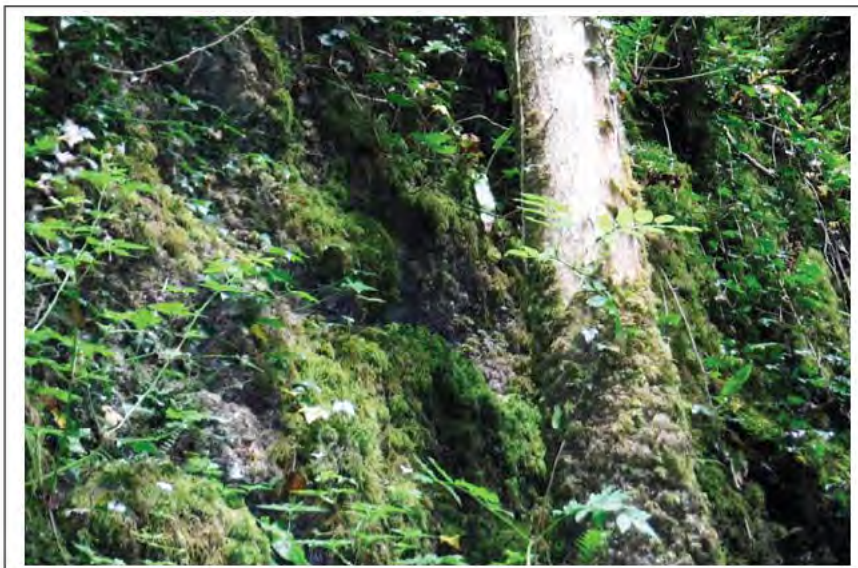
Photograph no 24: Single masonry unit missing (heavily moss covered)

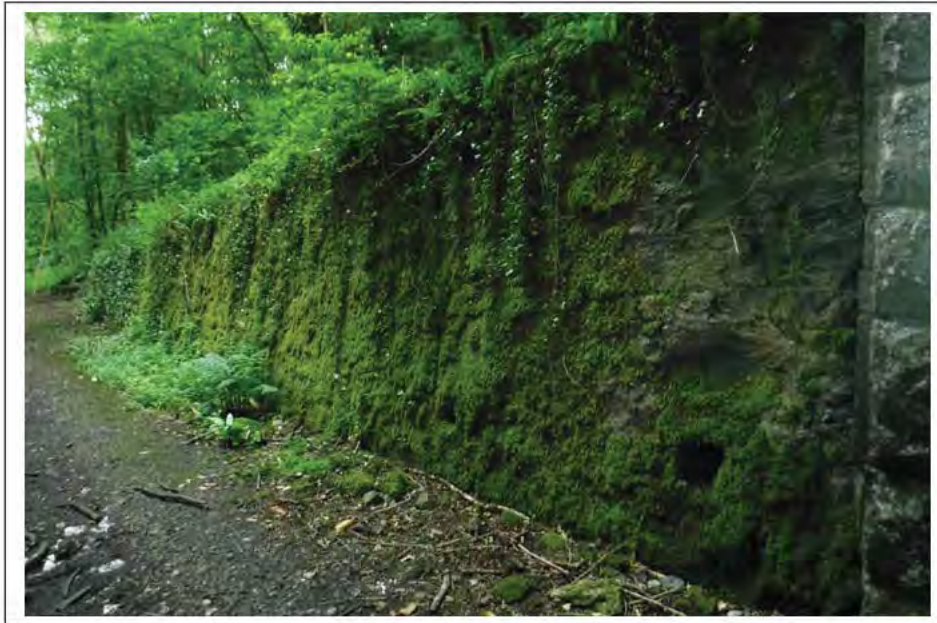
Photograph no 25: DL retaining wall  
Moss and lichen cover 95% of the structure

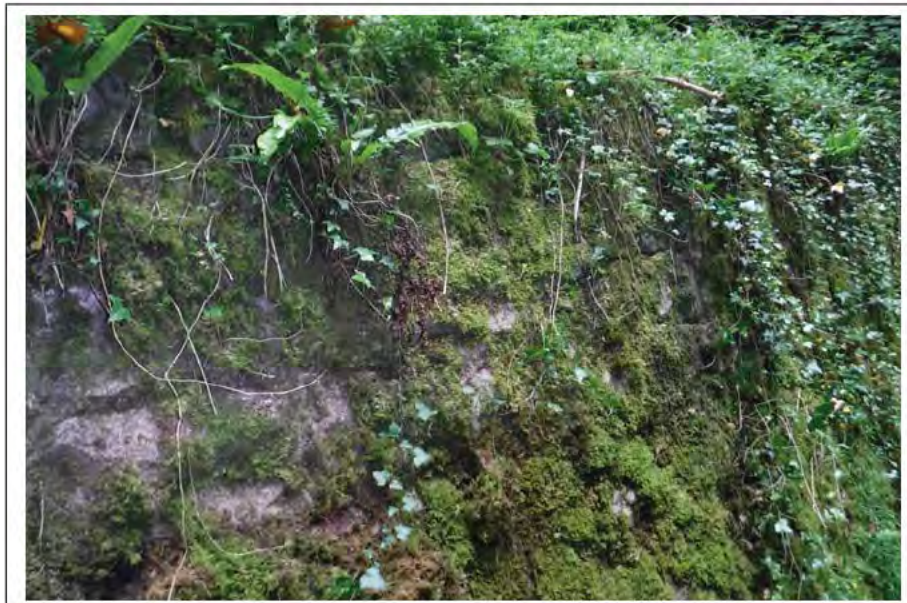
Photograph no 26: Horizontal stepped fracture noted to middle section of DL retaining wall 1.5m above G/L,  
3.5m long, open 5mm

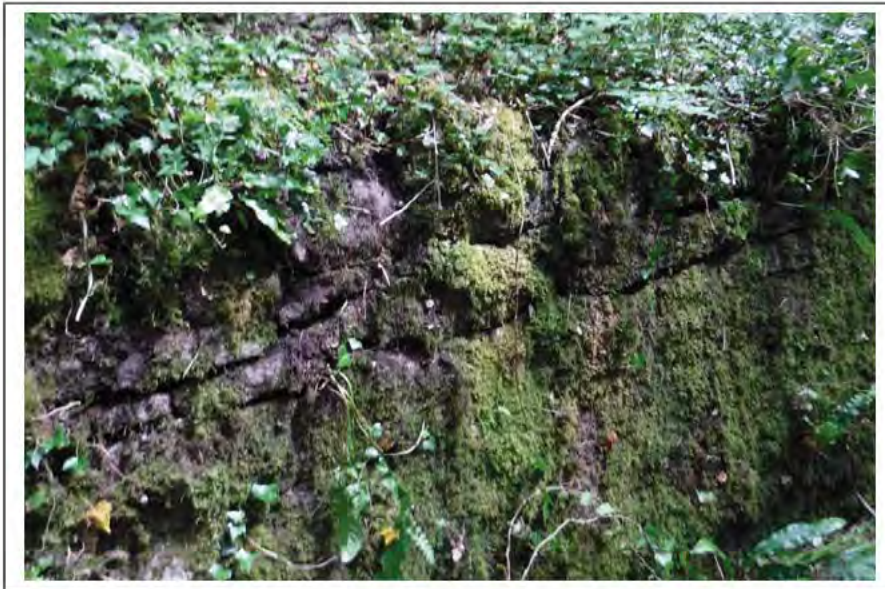
Photograph no 27: DL retaining wall  
Odd open joints up to **90mm** deep from 75mm deep adjacent to quoin to 5 linear metres

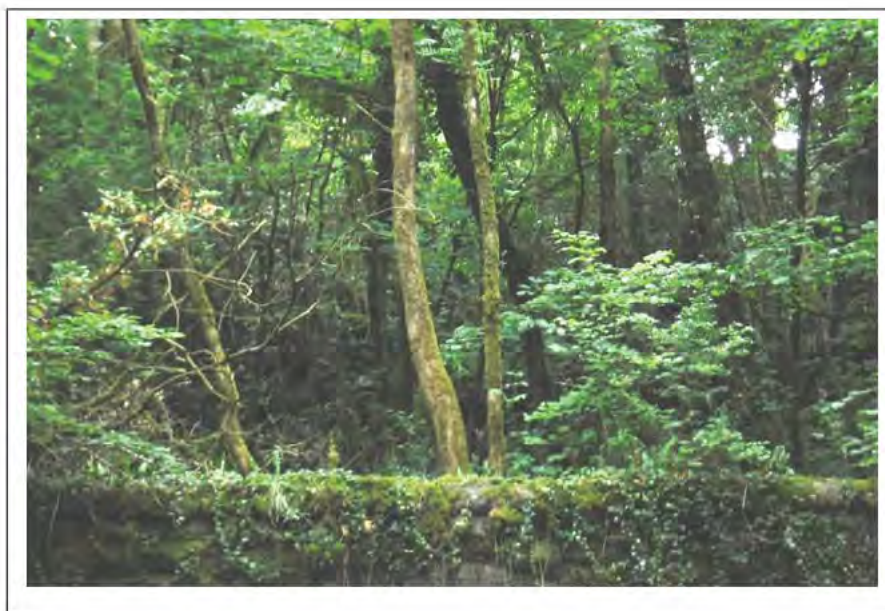
The areas immediately to the rear of the portals are unfenced (P8, P28). Anecdotal evidence, from the owner of [REDACTED] Farm, suggests frequent misuse of the tunnel area. No evidence of this was, or has ever been, found.

Photograph no 28: LE portal is unfenced to rear

Consideration to fencing above portal and to fencing at road level above should be made - P1 £15k.

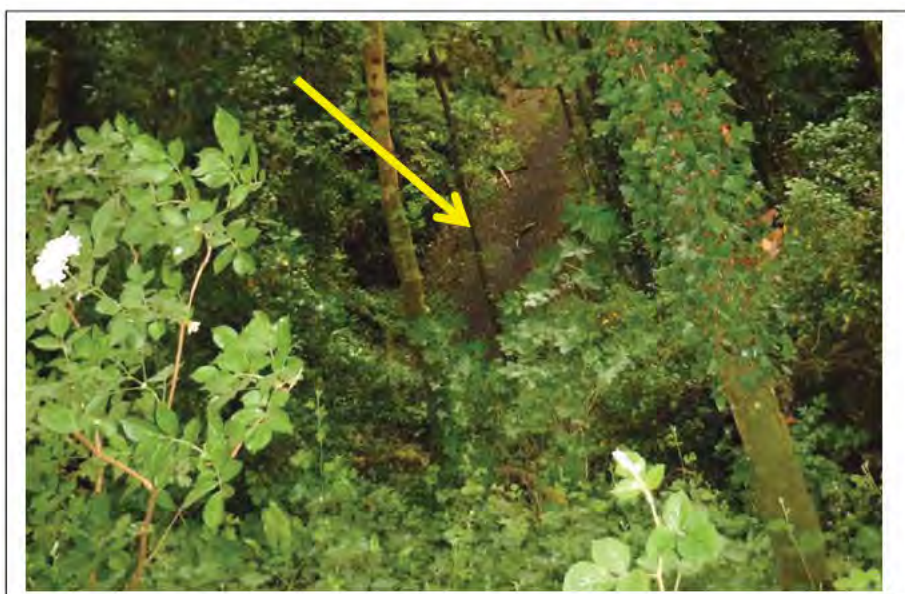
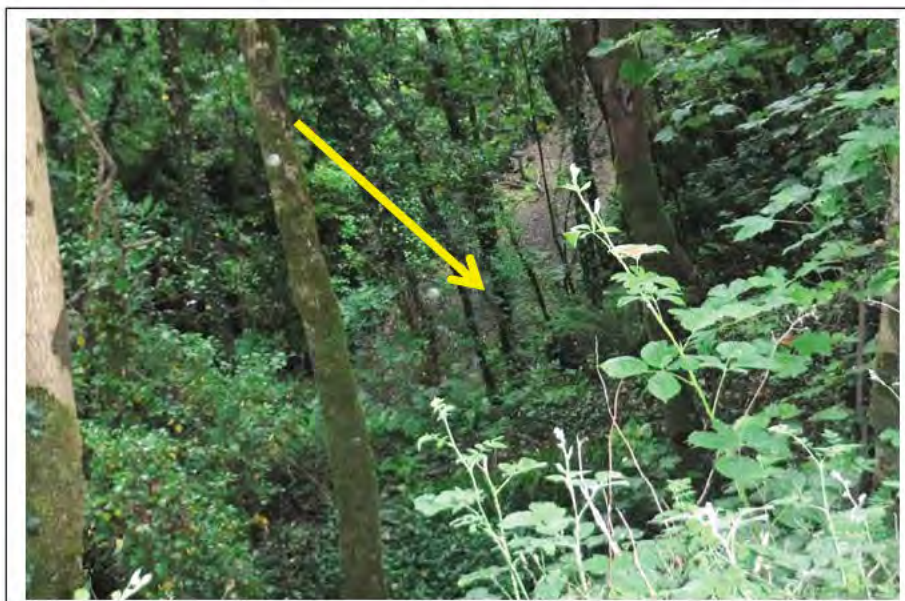
The structure carries agricultural land, woodland, and a single carriageway unclassified road. No deformation or subsidence of the road surface was observed (P32). Walkover survey not fully completed due to dense vegetation, underfoot conditions and fallen trees. The post and wire boundary fence above the CE portal has partially failed (P31). This old fence line is 5m from road with 12m drop beyond the fence line (P29, P30). The LE portal is in remote woodland (P33).

Photograph no 29: The post and wire boundary fence above the CE portal has partially failed  
This old fence line is 5m from road with 12m drop beyond the fence line to formation level (arrowed)

Photograph no 30: The post and wire boundary fence above the CE portal has partially failed  
This old fence line is 5m from road with 12m drop beyond the fence line to formation level (arrowed)

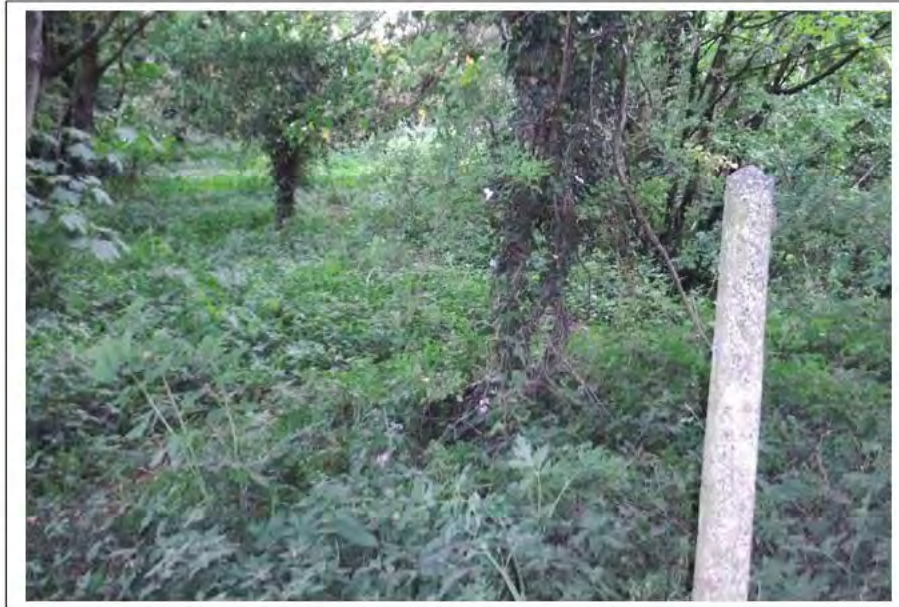
Photograph no 31: The post and wire boundary fence above the CE portal has completely failed (long standing)

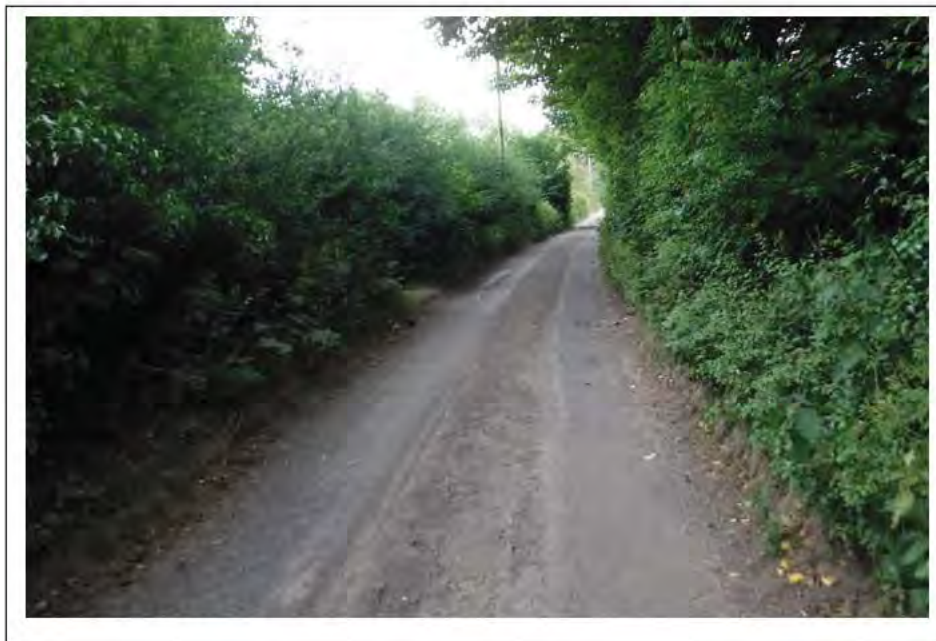
Photograph no 32: The structure carries agricultural land, woodland, and a single carriageway unclassified road. No deformation or subsidence of the road surface was observed

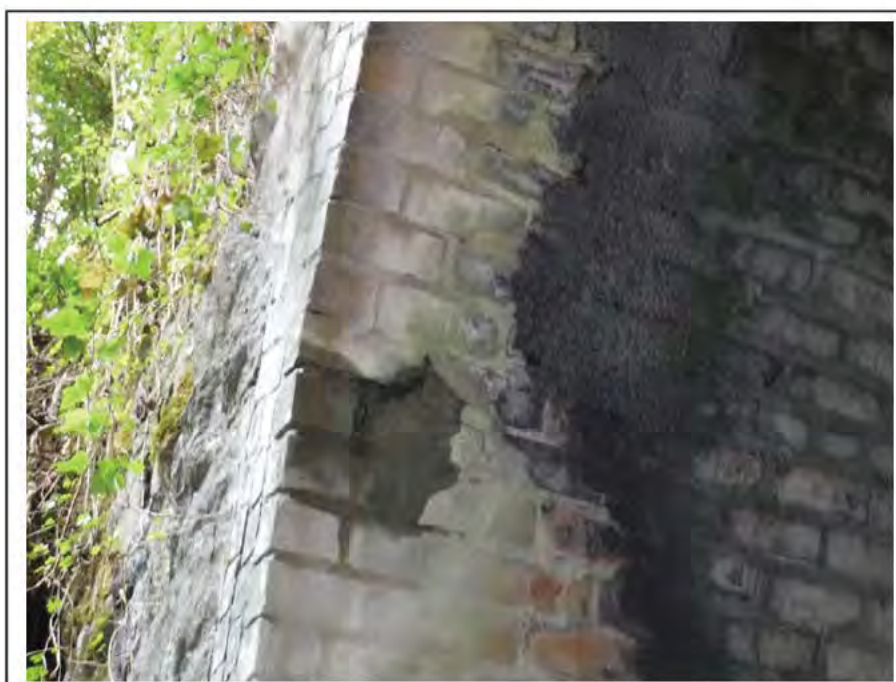
Photograph no 2: No change to minor transverse fracture to UC haunch at CE portal

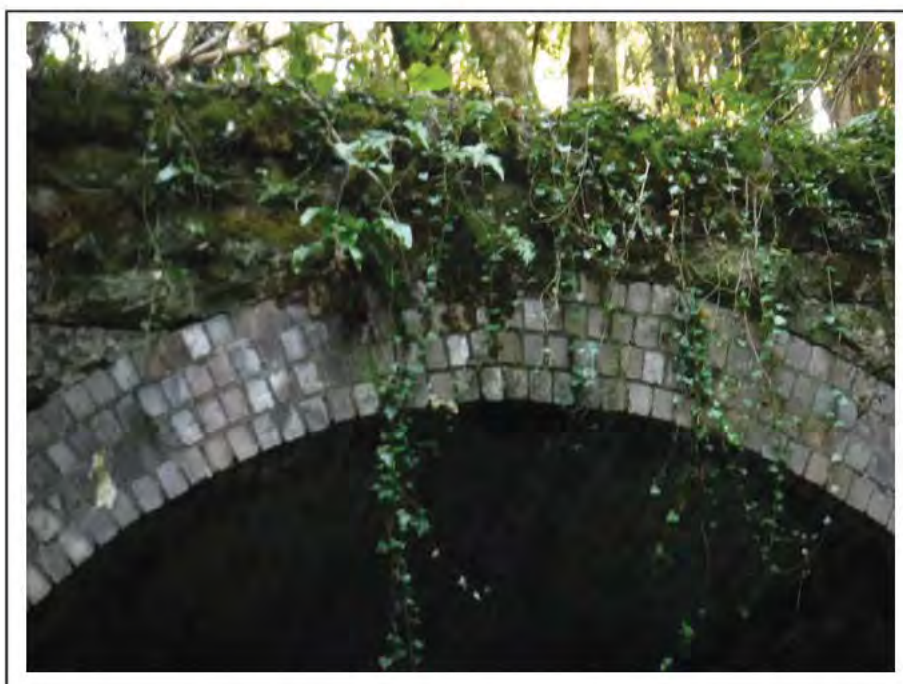
Photograph no 4: Separation fracture at extrados of LE face rings remains open 2mm

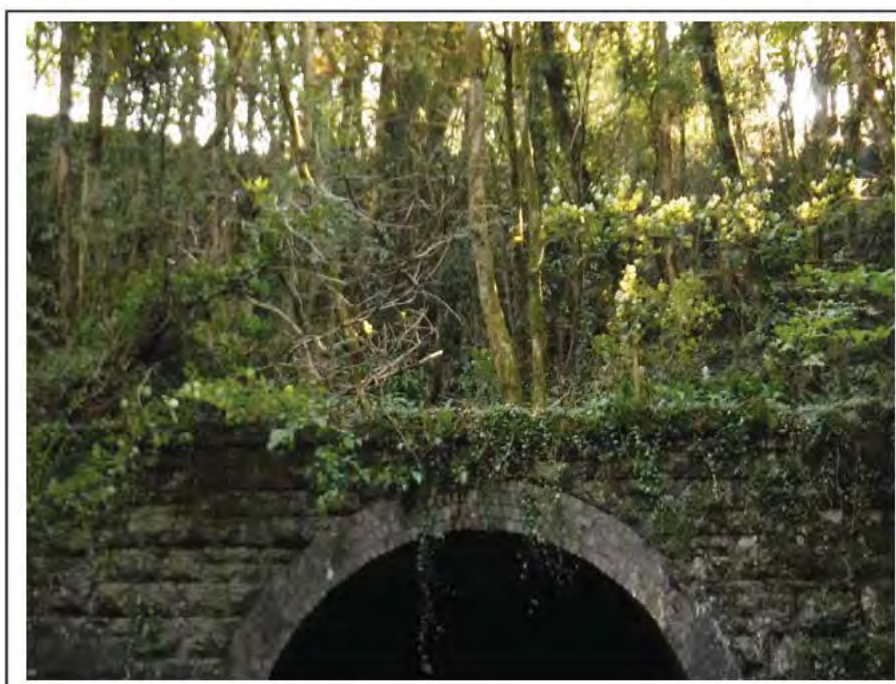
No fencing to rear of LE headwall (remote location although anecdotal evidence may suggest trespass) (p6)

Photograph no 6: No fencing to rear of LE headwall

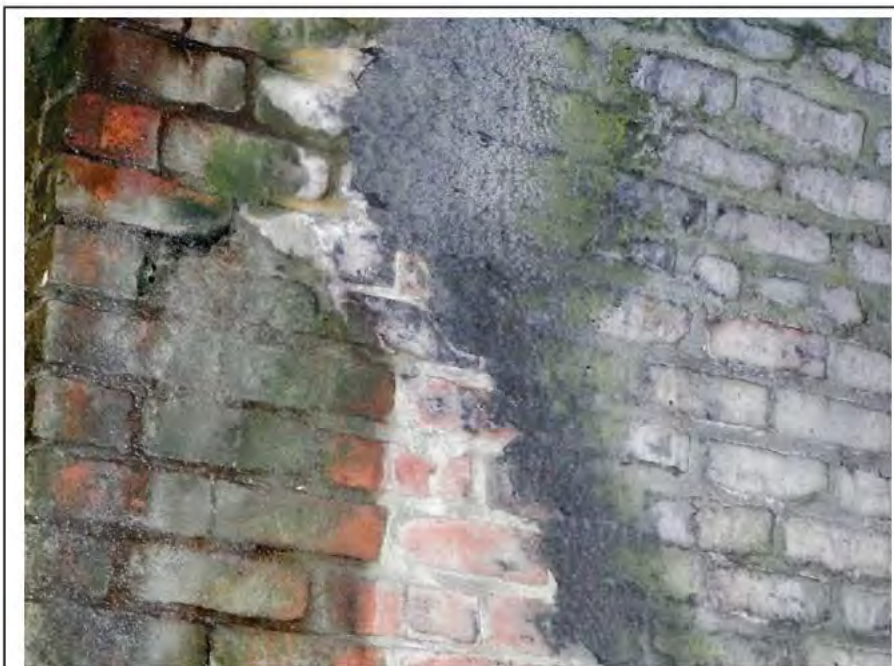
Photograph no 2: transverse fracture to UC haunch shows no change

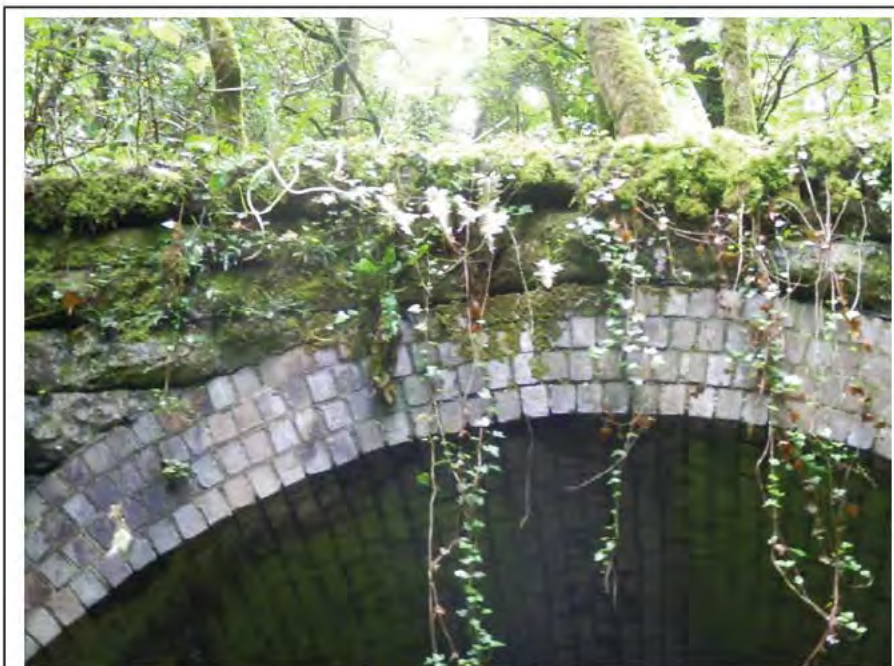
Photograph no 4: separation fracture at LE extrados shows no change

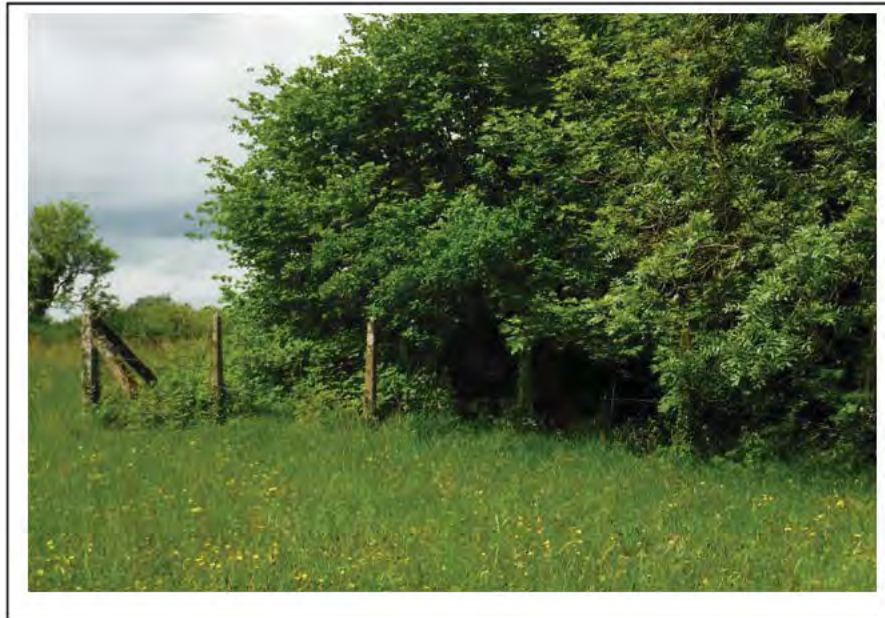
no 5:

Fencing to rear of headwalls and CE and LE has only posts remaining **(P5 and 6)**

Fencing to rear of UL portal – all wires missing

Consider repair of rear fencing above structure (remote location) - P1 £10k.

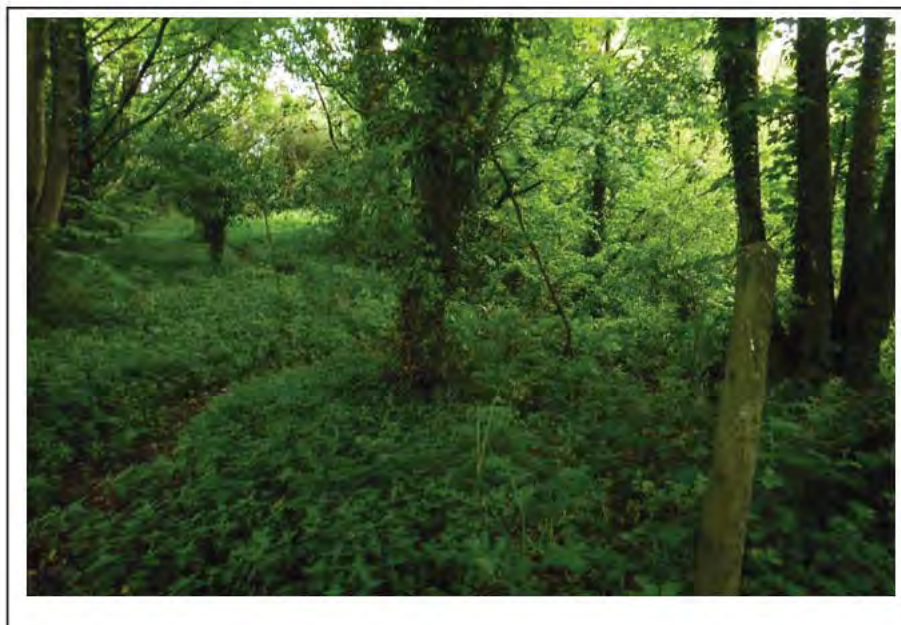
no 6:

Fencing to rear of UC portal – all wires missing

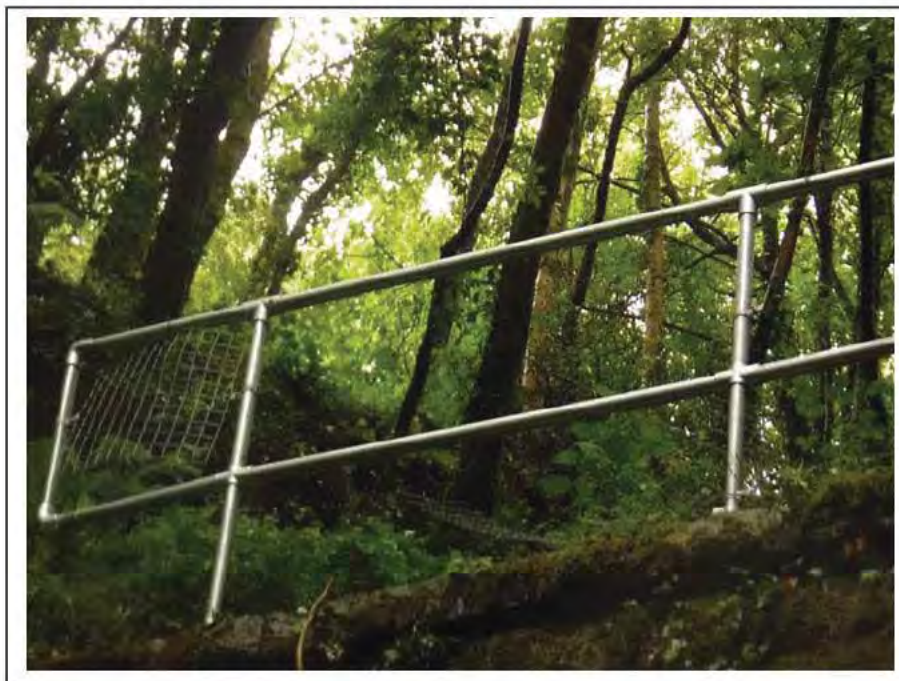
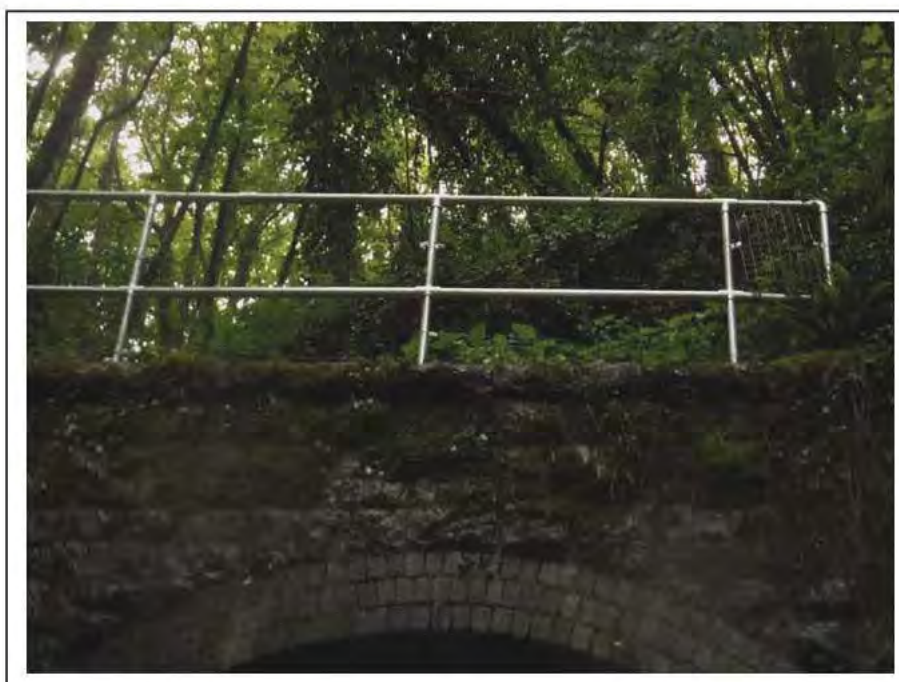
General view of structure: C/e portal	Examiner comments								
	<p>New fencing installed to rear of CE portal (Kee-Klamp): mesh has been removed by vandals (P1, P2) so that only the end mesh panels remain. Damage noted to hinge protection at UC (top hinge) suggests high risk of further vandalism (P9).</p> <p>No change to transverse fracture to UL haunch at portal (P3).</p> <p>Barrel in very good condition and dry throughout (P4).</p> <p>New fencing installed to rear of UC portal is found intact throughout (P6, P7).</p>								
A Visual Examination of this structure has been carried out and any deterioration in condition or development of defects or other factors, which might place at risk the public at large, is recorded in the Examiner's Comments section of this document.	<table><tr><td>Examiner:</td><td> </td><td>Signed:</td><td> </td></tr><tr><td>Date:</td><td>25/6/19</td><td></td><td></td></tr></table>	Examiner:	 	Signed:	 	Date:	25/6/19		
Examiner:	 	Signed:	 						
Date:	25/6/19

Photograph no 1: UC portal fencing

Photograph no 2: UC portal fencing

Repair/renew mesh to CE portal fencing and hinge protection to UC gate - P1 £750.
