<b>ELR:</b>	SAD	<b>Structure No:</b>	77	<b>Mileage:</b>	19m 52ch	<b>Examination date:</b>	13/06/18
<b>Route:</b>	Somerset and Dorset					<b>OS ref:</b>	ST 615 451
<b>Name:</b>	Windsor Hill New Tunnel					<b>Type:</b>	Tunnel

<p><b>General view of structure: CE portal</b></p>

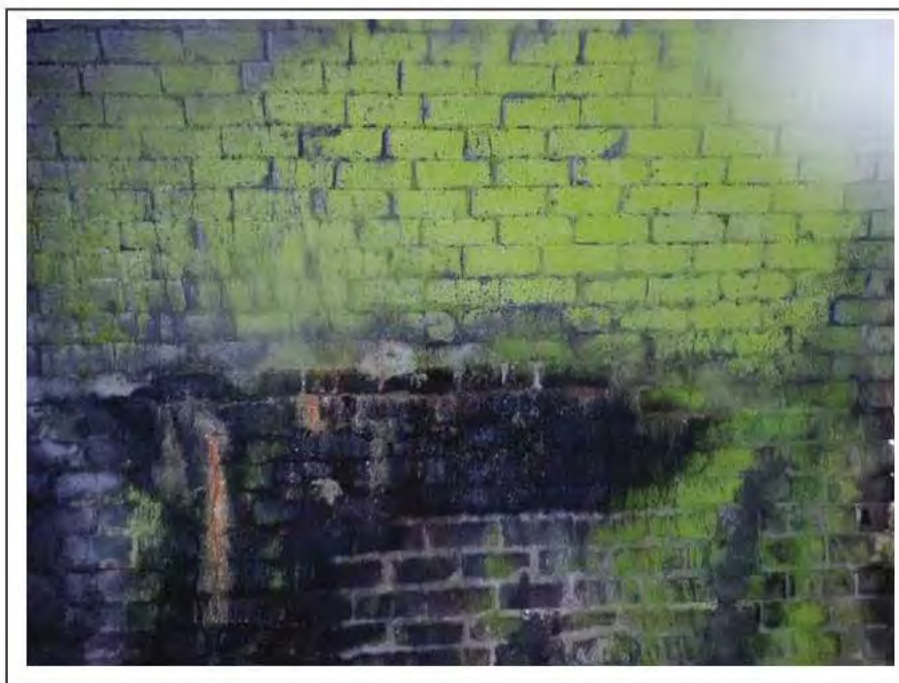
Photograph no 3: Transverse fracture to UL barrel shows no change

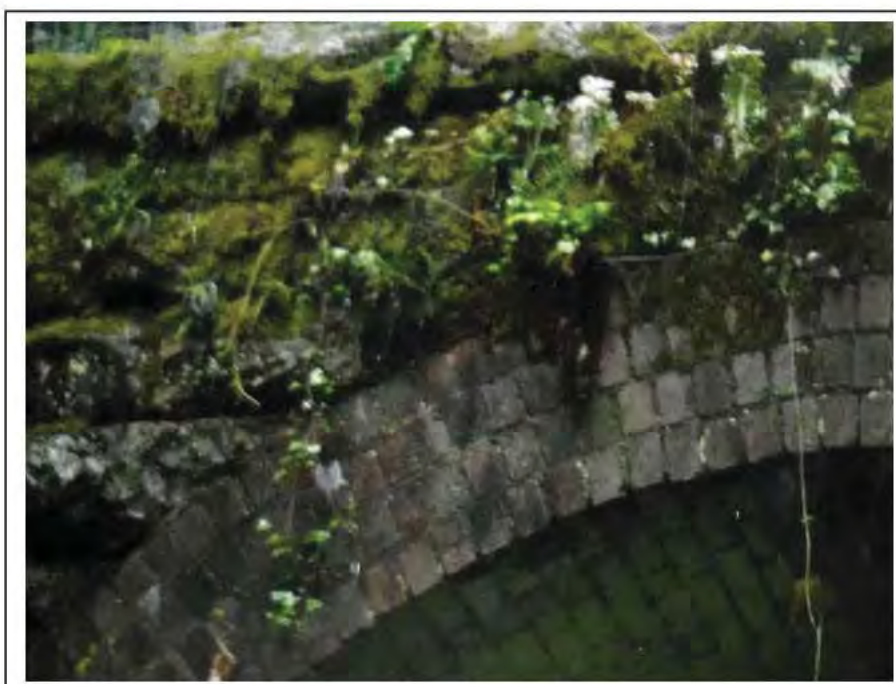
Separation fracture to LE portal extrados shows no change (P8).

Photograph no 8: Separation fracture to LE portal extrados shows no change

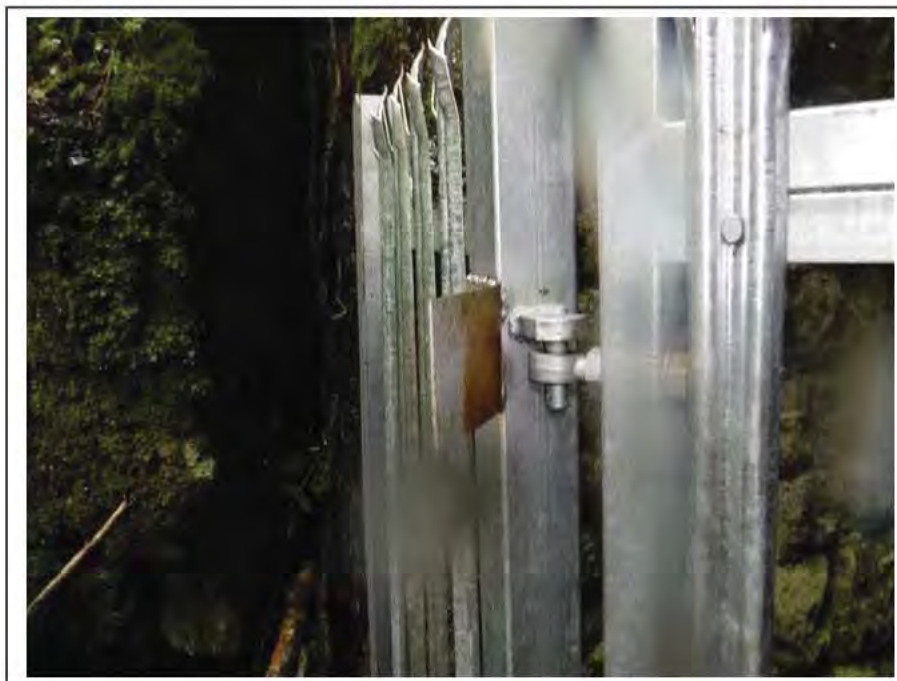
Photograph no 9: Damage noted to hinge protection at UC (top hinge) suggests high risk of further vandalism

Repair/renew mesh to CE portal fencing and hinge protection to UC gate - P1 £750.

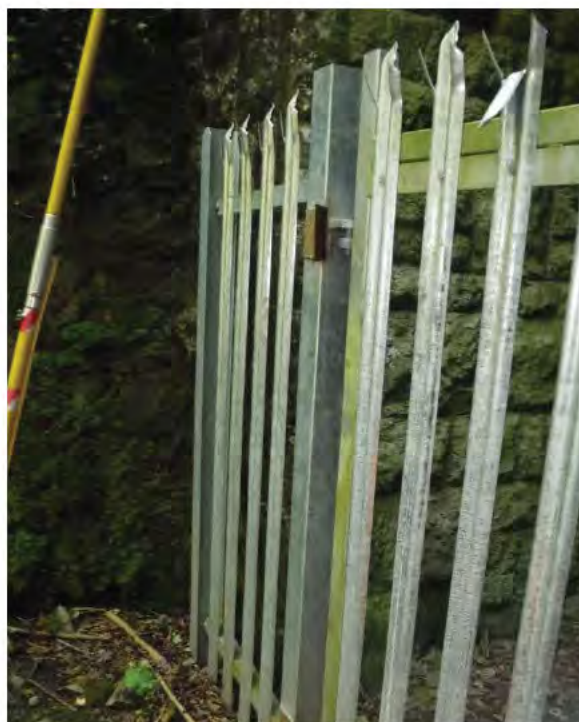
<p>LE fencing at formation level (P1) is found with damage to hinge covers (P2) and to isolated palisade spike (P3). CE fencing is secure throughout (P8). Fencing to rear of LE headwall is found secure (P4). CE headwall fencing remains with mesh largely missing (P9).</p> <p>No change to transverse fracture at UL haunch near portal (P5) or extrados fracture at DL portal.</p> <p>New graffiti noted to DC sidewall (P7)</p> <p>Lon standing bed joint fracture to copings shows no change (P10)</p>	
<p>A <b>Visual Examination</b> of this structure has been carried out and any deterioration in condition or development of defects or other factors, which might place at risk the public at large, is recorded in the Examiner's Comments section of this document.</p>		<b>Examiner:</b>	<b>Signed:</b>
		<b>Date:</b> 28/6/20	
<p><b>Access Hazards:</b> Minor slip/trip hazards. Access at LE via footpath to DC</p>

Photograph no 2:  
Damaged hinge cover to LE gates

<b>Pressure readings</b> LE – 1024.1mb Centre – 1024.1mb CE – 1023.9 mb		<b>Gases</b> O <sub>2</sub> – 20.9% H <sub>2</sub> S – zero CH <sub>4</sub> – zero CO - zero CO <sub>2</sub> – 147ppm	
<p><b>Recommendations:</b>          Repair damage to LE formation fencing and replace mesh to CE portal fencing - P1 £750.</p>			
<b>Signed by Examining Engineer:</b>

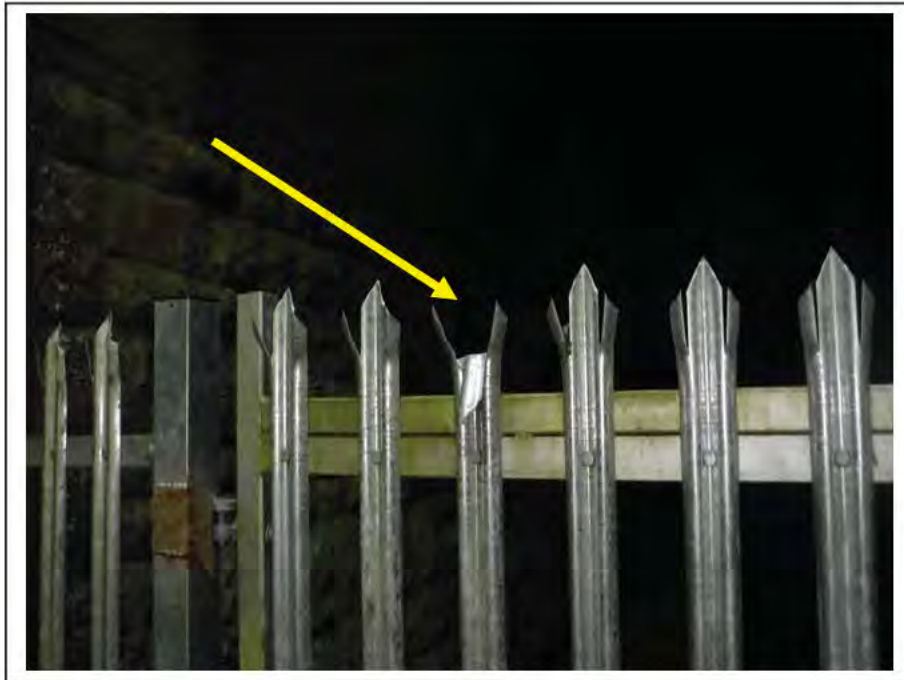
Photograph no 3:  
Bent spike to LE gates

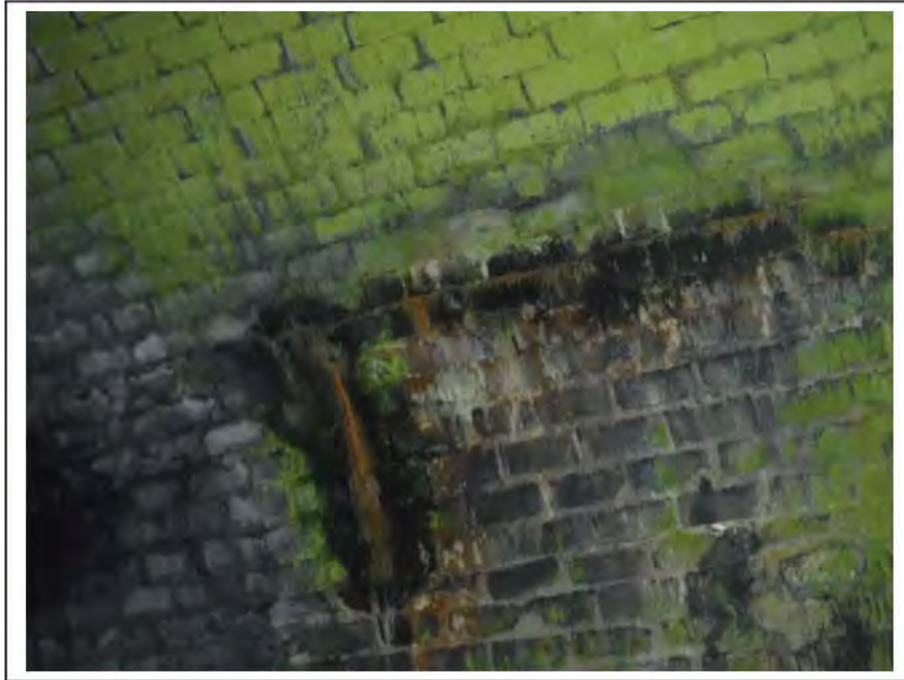
Photograph no 5:  
Transverse fracture to UL haunch shows no change

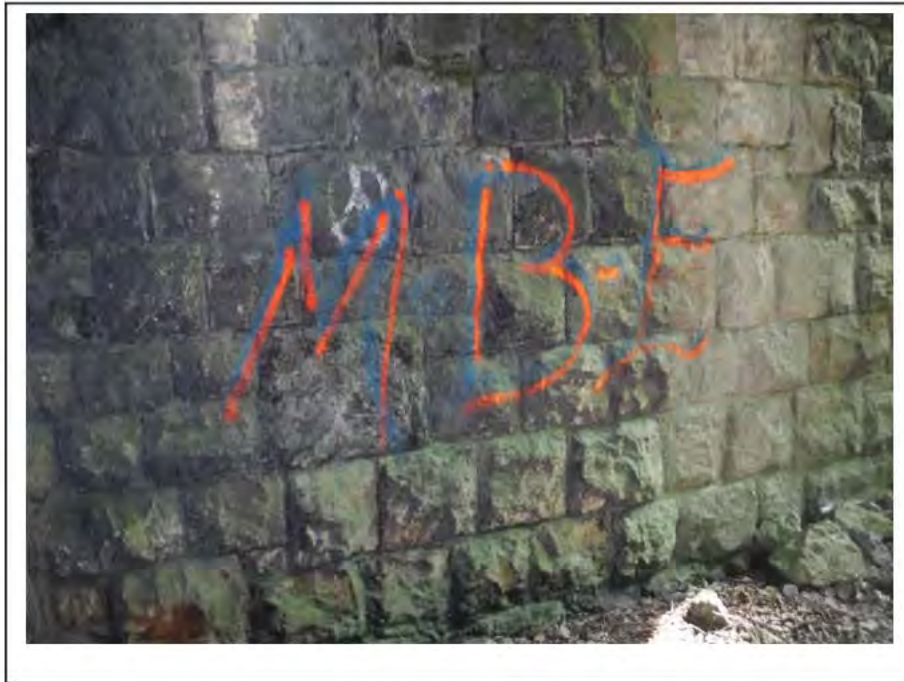
Photograph no 7:  
New graffiti noted to DC sidewall near portal

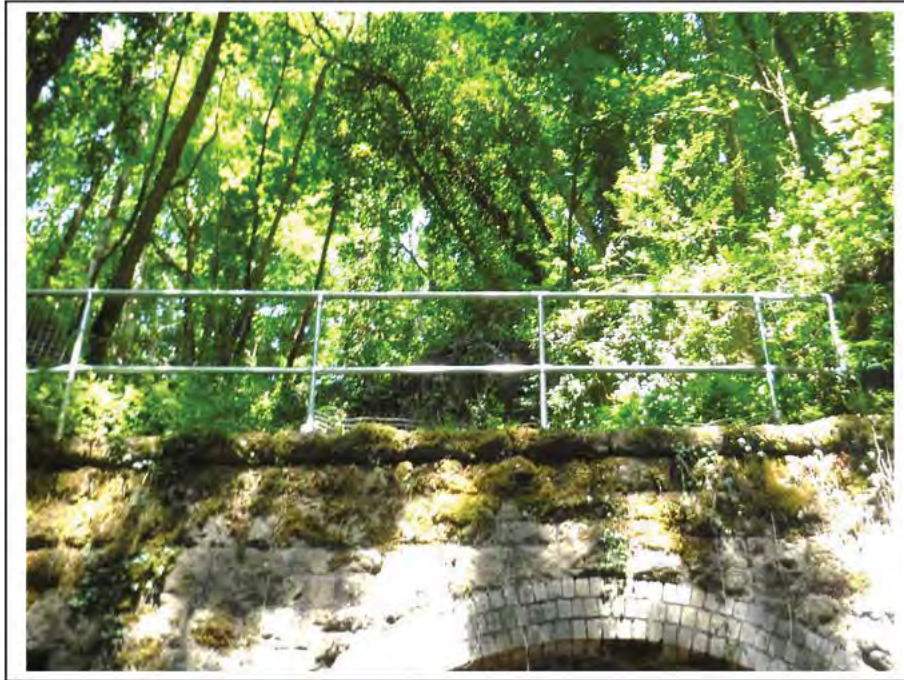
Photograph no 9:  
CE headwall fencing remains with mesh missing

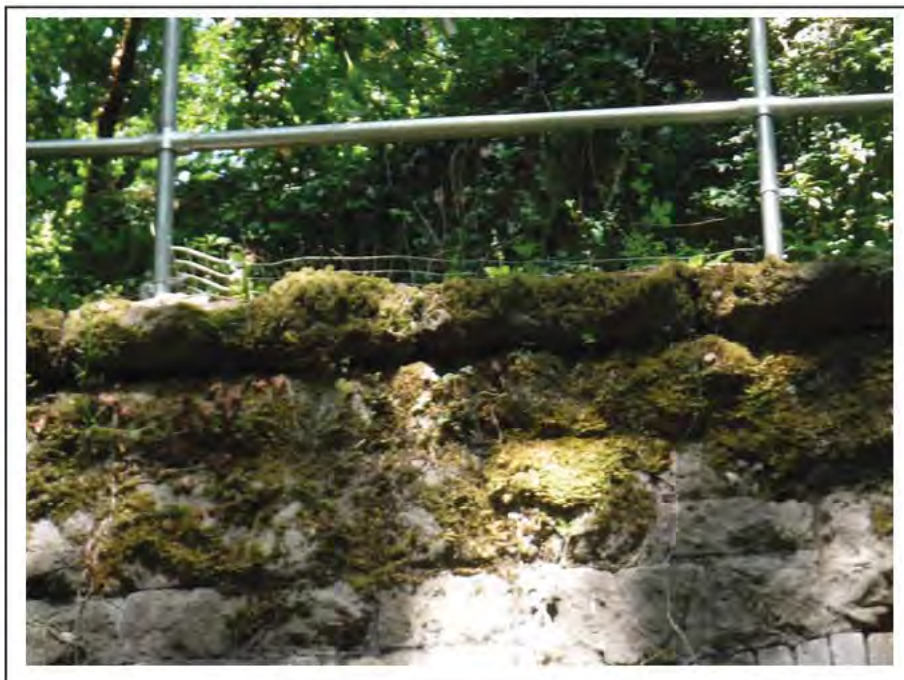
Photograph no 10:  
Long standing bed joint fracture to CE portal copings shows no change
