Job 2: Failure of Gaia 11 kW small turbine at North Petherwyn, North Cornwall. Primary issue due to failure of the holding down bolts.

HSL report approval:	Dr N Corlett
Date of issue:	6 September 2013
Job number:	PH04834
Registry file:	032654
Electronic file name:	K:\mecheng\WORK\HSE\Reactive\Incidents\Inc2013\PH04834 Gaia 11 kW Wind Turbine Failure\Report\Gaia Final Report 6Sept13.pdf

INCIDENT REPORT NUMBER: ES/13/54

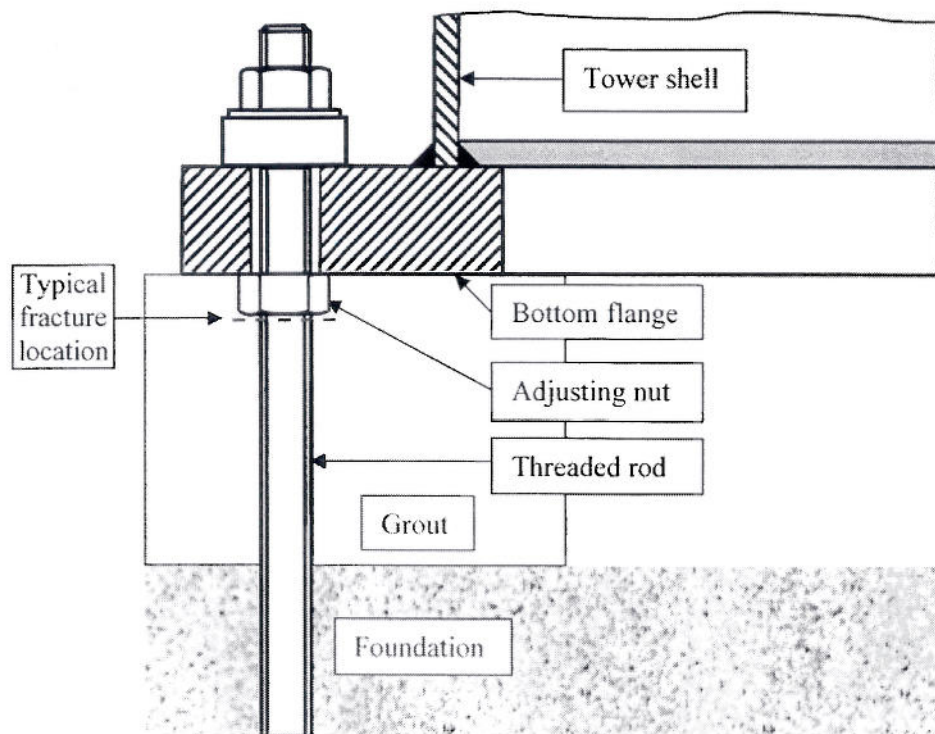
concrete and these are bolted to a flange at the tower base (Figure 2). The tower is levelled by adjusting a nut beneath the flange on each of the threaded rods. As a result of this installation method the threaded rods are not preloaded beneath the levelling nuts. Grout is applied between the flange and the foundation.

Figure 2. Sketch of bottom flange arrangement showing typical fracture location.
C Rudall (Not to scale)

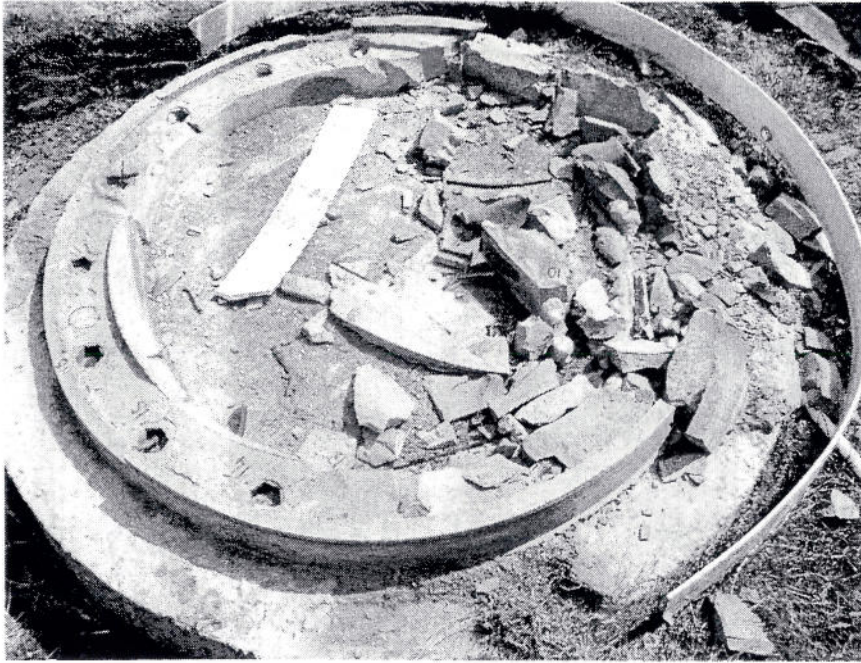
On 7 May 2013 I visited the site of the most recent tower failure at Lindley Hall Farm near Otley, West Yorkshire, with Mr Darren Nash and Mr Steve Simmons-Jacobs. The grouting on this turbine was also found to have been partially displaced by foam (Figures 3 and 4). The foam may have been used to help retain the inner grout former, but it had also partially filled the volume beneath the bottom flange that should have contained only grout. All the rods had failed immediately beneath the lower (levelling) nut (i.e. the nut on the underside of the flange). Figure 5 shows a typical failed rod.

Figure 3. Grouting remains (Lindley Hall Farm).
(Photograph 001.jpg, C Rudall)

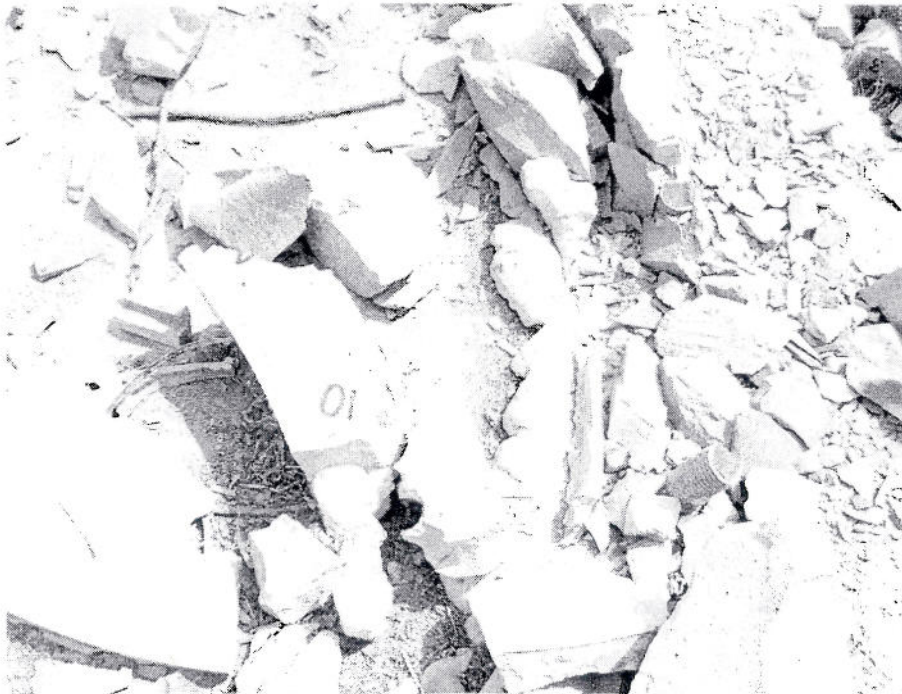
Some of the failures are down to an installation problem where in polyurethane foam has been used internally under the flange face of the tower before some grouting has been used around the outside. This could warrant some attention from ourselves. I have spoken to Paul about possible actions over these issues.

At least two of the failed towers were found to have been inadequately grouted by the same installer. The installer had injected a foam filler around the inside of the base connections, probably to retain the inner formwork while the grout was setting. However the foam had filled some of the volume that should have contained grout. This would have altered the load distribution around the bottom flange.

Figure 4. Grouting remains showing foam filler and failed rod ends (Lindley Hall Farm).
(Photograph 003.jpg, C Rudall)

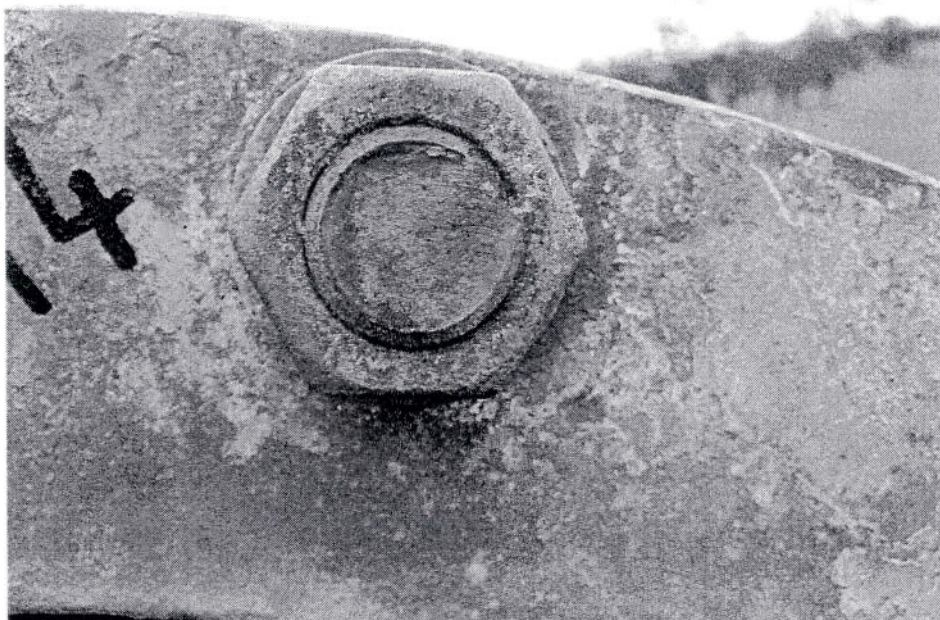
In my opinion the primary cause of failure was uncontrolled fatigue loading acting on the threaded foundation rods.

The overall conclusion from the metallurgical reports (carried out for Gaia by [REDACTED]) on three sets of failed foundation rods was that failure was due to fatigue. A visual inspection on site at the most recent failure (Lindley Hall Farm, Otley) indicated that these rods failed at the same location beneath the adjusting nuts.

Figure 5. Typical rod failure (Lindley Hall Farm).
(Photograph 012.jpg, C Rudall)

- 1) That Gaia should be encouraged to improve the fatigue design of the tower bottom connection, for example by preloading the threaded foundation rods as described in their report [REDACTED] R12(5)(e)
- 2) That the quality and consistency of the heat treatment and galvanising of the threaded rods should be carefully monitored.

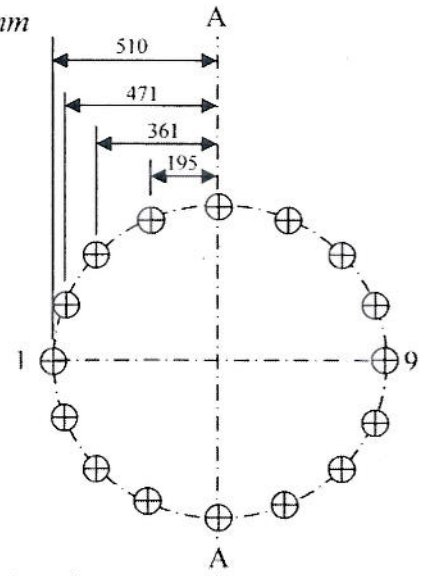
Figure B2
1st generation
rod layout

$$\sigma_{ax,1stgen,max} = \frac{F_{1,9}}{As_{M27}} = \frac{93055}{459} = 202.7 \text{ N/mm}^2 \quad (\text{Rigid flange assumed})$$
