Quay Wall Survey

Watchet Marina 08/11/18

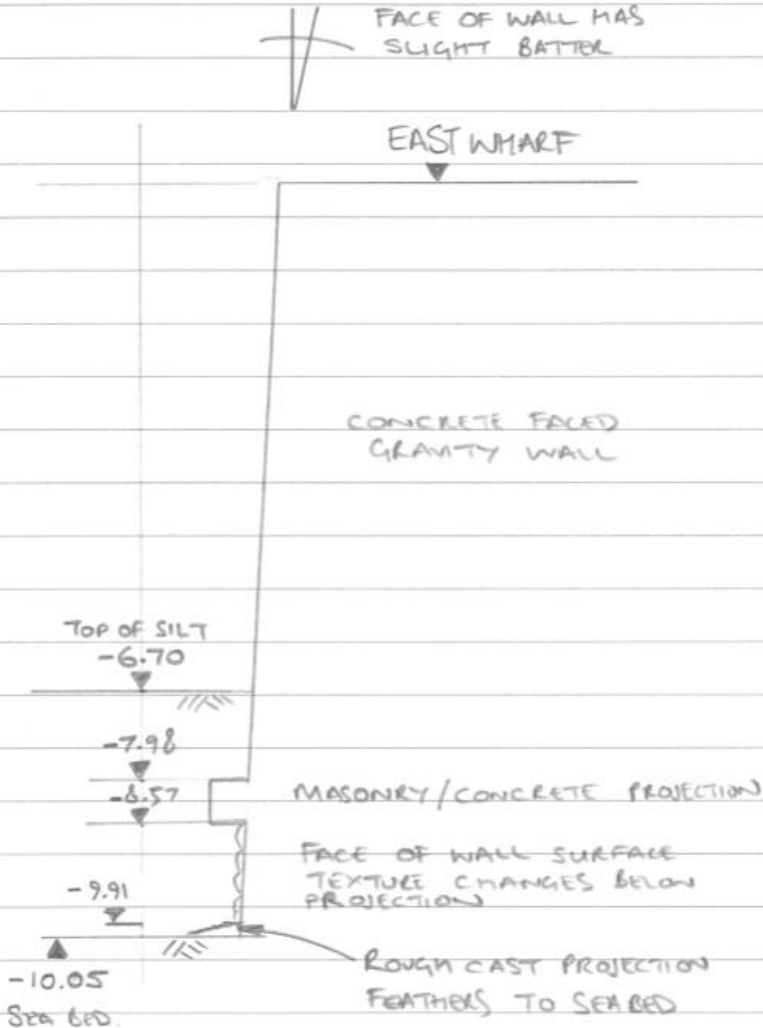
Hole 1

<ul style="list-style-type: none"> • NO EVIDENCE OF SCOUR AT TOE OF WALL • NO EVIDENCE OF 'SHEAR KEY' INTO SEA BED AT TOE

The diver spent 4 hours removing silt from the base of the wall to uncover the toe configuration at the bottom. the depth of silt removed from this hole was 3.35 meters.

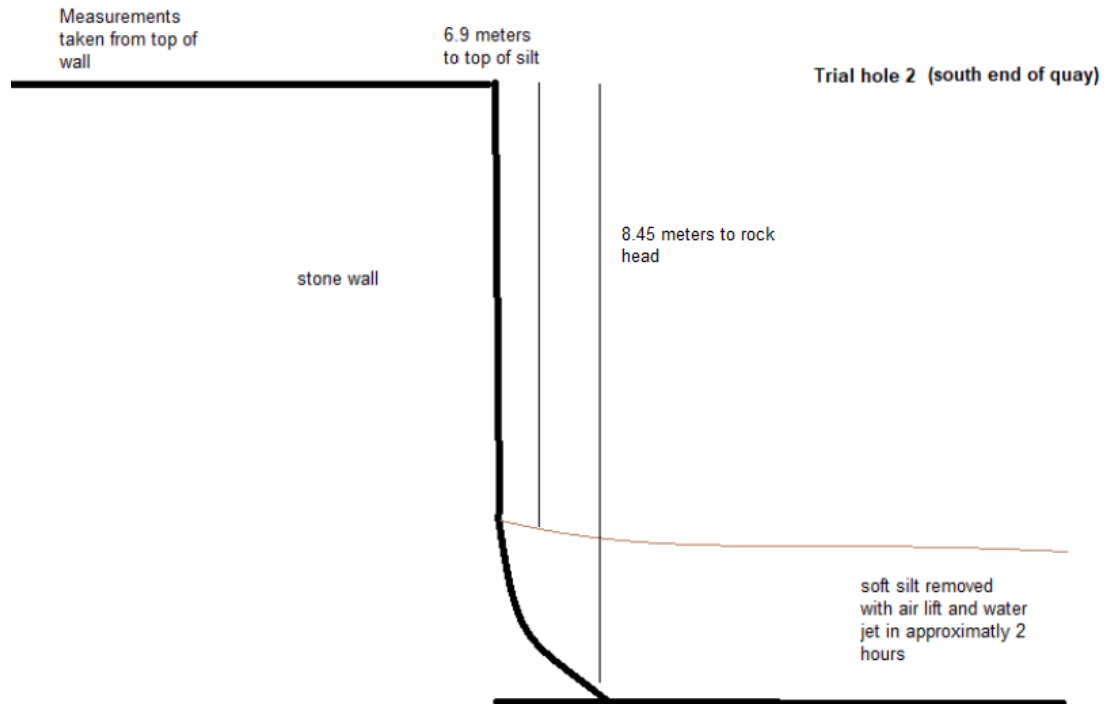
Hole 2

The diver spent 2 hours removing 1.55 meters of silt to uncover the toe of the wall. The diver reported that the construction of the wall remained the same all the way to the rock head (large stone blocks). The diver reported that the wall curved out at the base (400mm) before terminating on to bed rock. The diver also reported that, after digging away at some hard material, he could squeeze his fingers under the masonry work where it sat on the sea bed. The diver found no evidence of any concrete footing or “key way” that bound the wall to the seabed.

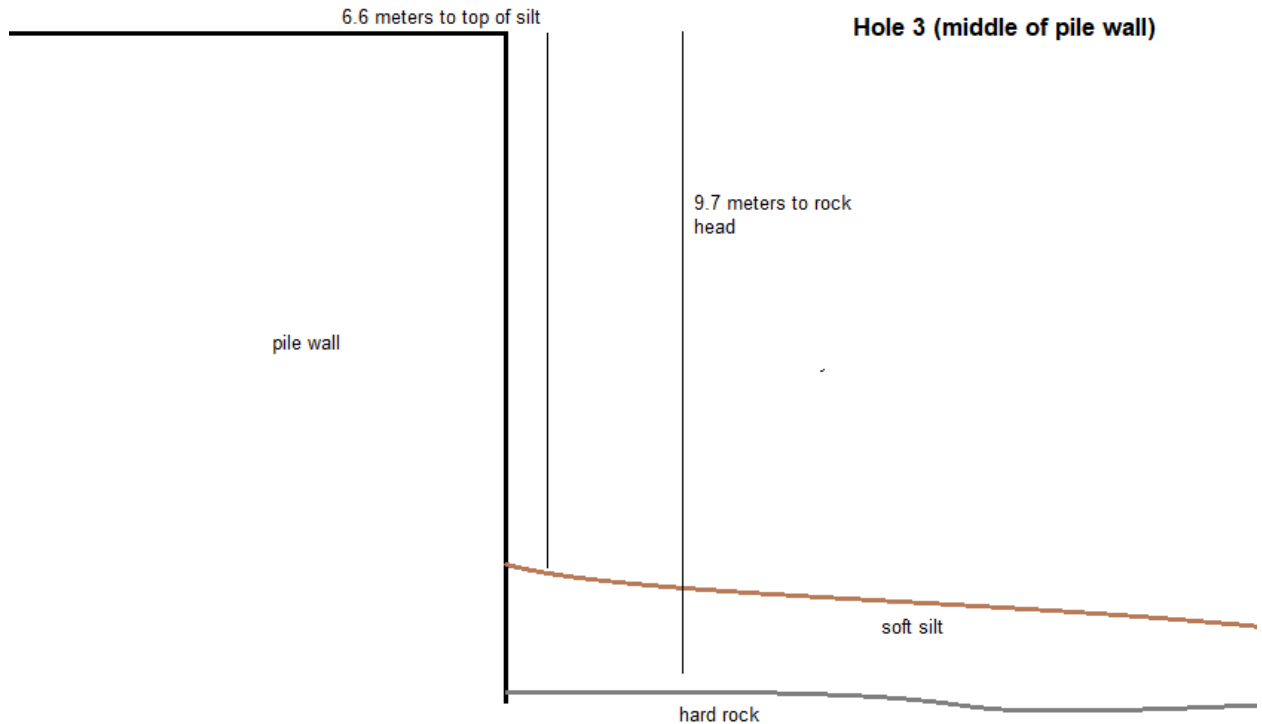
Hole 3

The diver reported that the material removed from in front of the pile wall was soft silt that was easily removable with the airlift. The diver followed the pile down 3.1 meters into the silt and reported that he had found the rock head. It appeared to the diver that the pile entered the rock head and continued, however, the diver could not inform on how much embedment the pile may have into the rock.

The diver reported that the piles had large sections of rust that would flake off the pile as he knocked it with the airlift. The diver reported these rust flakes to be numerous. The diver reported finding formed holes in the piles at random locations. The holes looked like they had been cut and the steel was still 12mm to 16mm around the edges.

An Ultra Sonic thickness survey of the piles would give more detail on their condition.
