Re: A404 Bisham Roundabout PPP (De-scoped scheme) – Stage 1 Road Safety Audit – LNMS/508/2013

A404 Bisham Roundabout PPP (De-Scoped Scheme)

Stage 1 Road Safety Audit

LNMS/508/2013

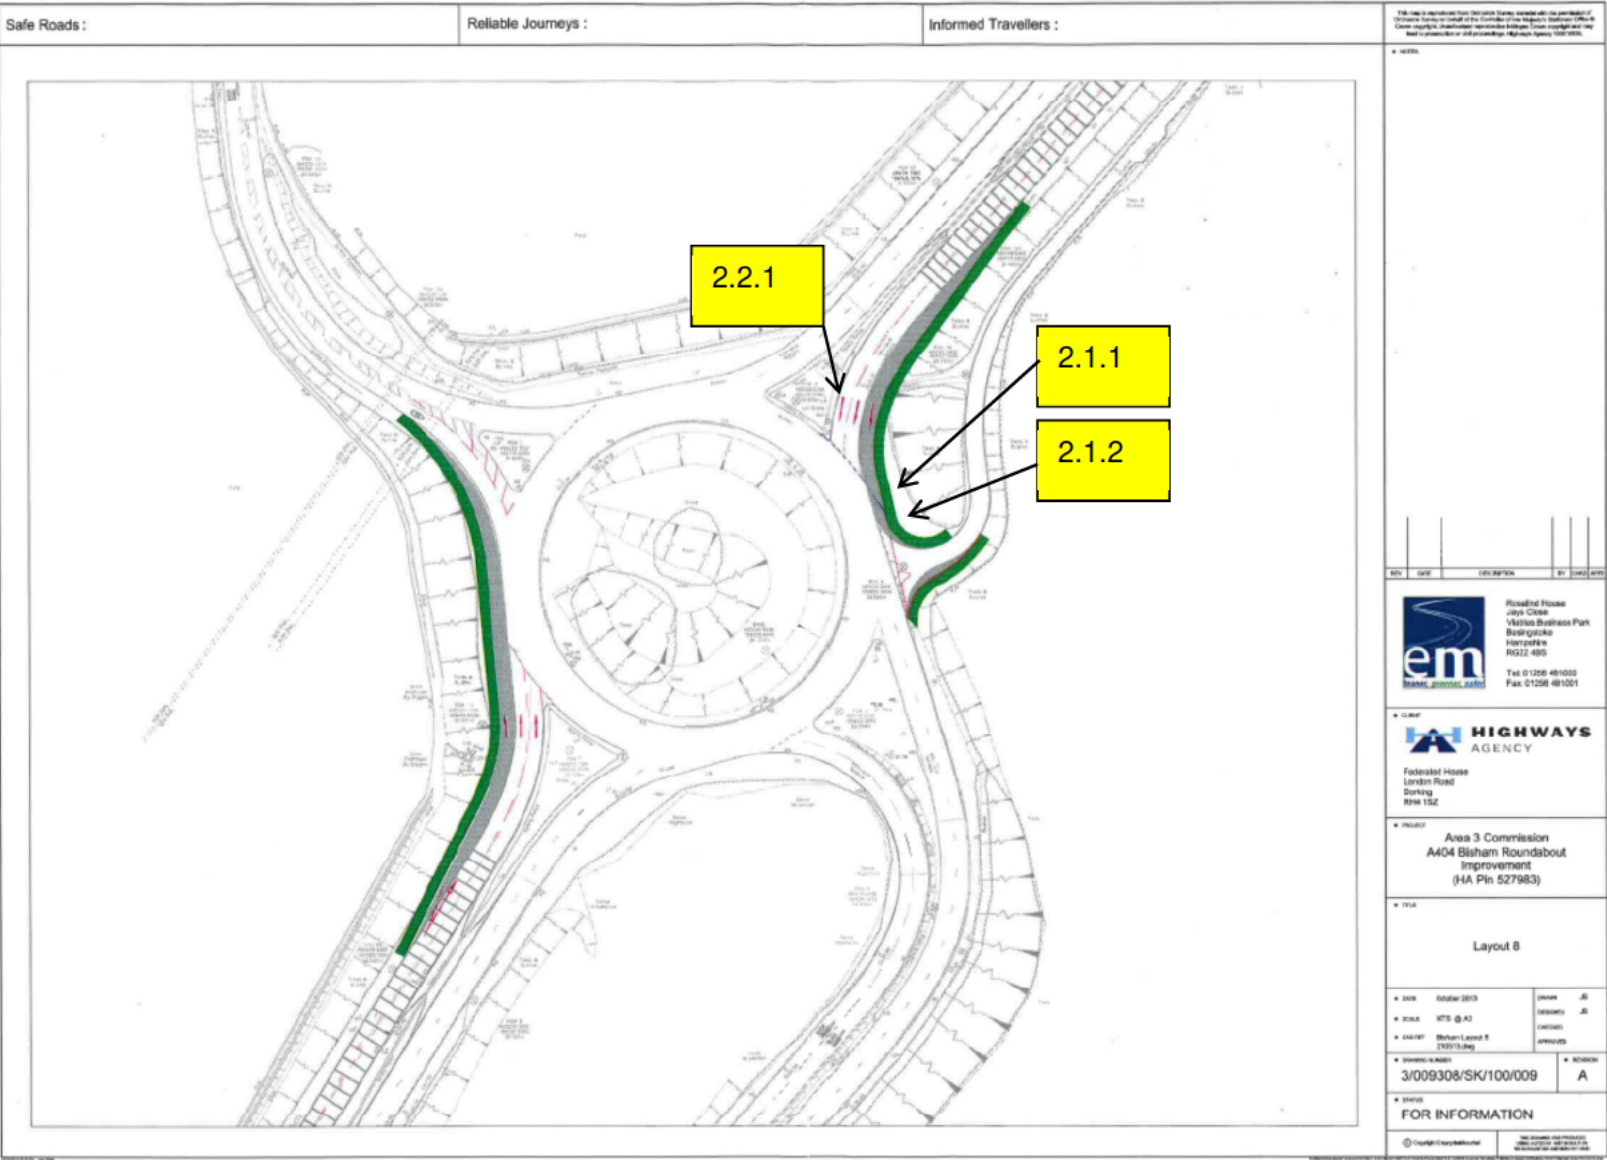
Problem Location Plan -

Location: Southbound approach to Bisham Roundabout and Entrance/Exit to Under the Wood

Summary: The proposed plans show the new lane 1, left turn only, to be in close proximity of Under the Wood, this could lead to unexpected vehicle manoeuvres resulting in conflict.

Details: The proposed plan given to the audit team, shows a new lane 1, left turn only being constructed, this is in very close proximity to the entrance/ exit to Under the Wood and appears to have little deflection to slow vehicles down. The audit team are concerned that this may become a free-flow lane (see item 2.1.2) if the majority of the traffic is travelling on the A404. Also with this new lane being in close proximity to Under the Wood, it leaves very little time for vehicles to exit from Under the Wood, which could lead to sideswipe incidents. Vehicles turning left from the A404 towards Marlow Road, may not be expecting vehicles to slow into Under the Wood, again conflict will occur.

Location: Southbound approach to Bisham Roundabout

Summary: The proposed plans show the new lane 1, left turn only, however, drivers are positioned that they have to look almost behind them which could lead to conflict

Details: The proposed plan given to the audit team, shows a new lane 1, left turn only being constructed, from the plan, it appears that the motorist in this lane will have to look behind him, to see what is on the roundabout due to the angle of the approach proposed. This could lead to drivers, not spotting vehicles and possibly not stopping at this stop line which would lead to driver conflict.

Location: NMU path/ existing provision north of Bisham Roundabout

Summary: NMU now have to cross three lanes via an uncontrolled crossing, which could lead to conflict.

Details: By adding the extra lane to the exit for the roundabout means that NMU's on the footpath, are now required to cross 3 lanes of busy traffic. With Lane 1 being left turn only and with no deflection, this could lead to a fast exit from the roundabout, motorists will perhaps not be expecting NMU's crossing at this location.

The Audit team recommends that this approach to the roundabout is left as two lanes.

Ensure that motorist have a full clear view of the roundabout with having the need to look behind them.

The Audit team recommends that the approach to the roundabout is left as two lanes.
