DEVELOPMENT & NEIGHBOURHOOD SERVICES

MOUNT LEVEN ROUNDABOUT

ROAD SAFETY AUDIT STAGE 3

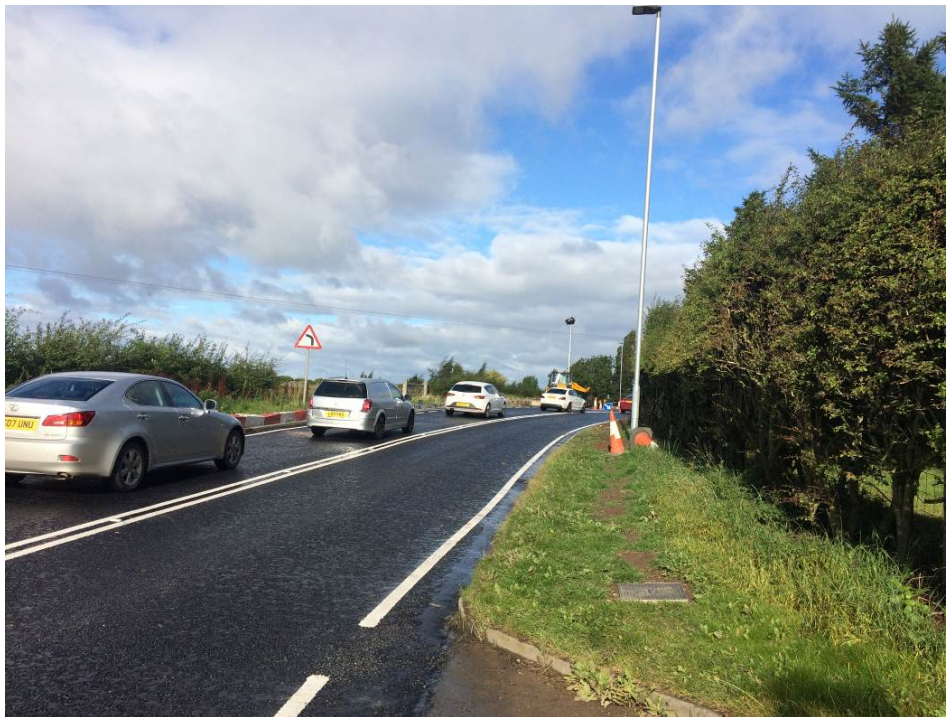
A 2.0 Issue: Sub-standard visibility from Hillcroft

Location: Hillcroft property access, approx. 50m east of the roundabout on the northern side

Summary: Sub-standard visibility to the west for vehicles egressing to travel east or west bound may lead to T bone collisions.

Description: The visibility splay west of the junction is sub-standard for the speed limit of the road according to Manual for Streets. Although the roundabout geometry means approach speeds in excess of 30mph are unlikely to be achieved this is still sub-standard. Lack of adequate visibility may lead to 'T' bone type collisions when vehicles leaving Hillcroft are not able to see eastbound vehicles approaching in adequate time. There is also a potential for shunt collisions should a vehicle be turning into Hillcroft.

Designers Response: Recommendation rejected. The historical existing visibility coming from Hillcroft private entrance prior to the construction of the new roundabout was 37m. Since the new junction has been constructed the visibility has increased to 40m.

The new junction has introduced a traffic calming measure reducing vehicle speeds in the form of the roundabout island. Street lighting has also been installed as part of the junction works which will increase visibility in the hours of darkness.

Speed surveys were undertaken prior to the junction being built and also once it was fully operational. These speed surveys have confirmed that the 85% speed has reduced from 40.5mph to 33.3mph.

A combination of the reduction in speed, addition of street lighting and an increase in visibility from what was previously available albeit a small increase, improves the situation and provides adequate mitigation.

Auditors Additional Comments: No longer considered an issue. The increase in visibility and other mitigation measures described in the designers' response provides adequate mitigation.

Recommendation: Improve visibility to the west to achieve visibility of the roundabout by removing hedge and coniferous trees along property boundary.
