## Mount Leven Roundabout, Stockton-on-Tees

Stage 3 Road Safety Audit

25<sup>th</sup> October 2017

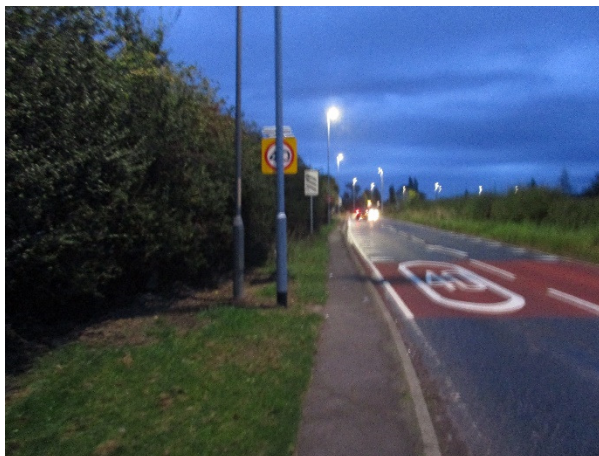
**SUMMARY:** *Partially obscured speed limit sign*

A street lighting column has been installed directly in front of the nearside 30mph speed limit sign on the eastbound approach to the roundabout. Due to its close proximity, the column partially obscures the sign face.

**Photograph 1: Lamp column obscuring speed limit sign**

Whilst the Audit Team recognise that an equivalent speed limit sign is positioned in the southern verge area, the majority of road users are more likely to observe signs placed in the nearside verge, therefore some drivers may fail to appreciate the change in speed limit. Road users approaching the roundabout at inappropriate speeds may find themselves braking late, potentially leading to a loss of control collision.

**RECOMMENDATION:** Re-position the lighting column to the rear of the speed limit sign.

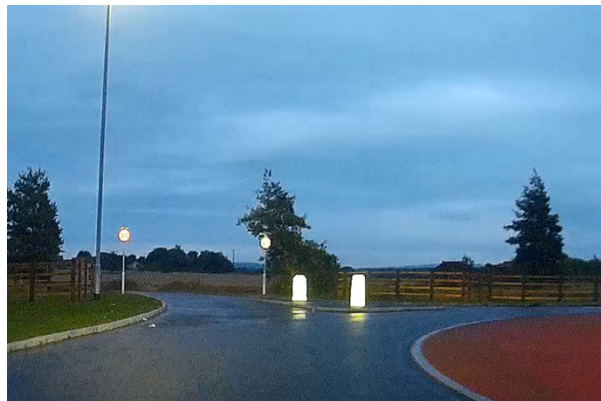
**SUMMARY:** *Limited warning of stopped-up exit arm*

The new roundabout includes a northern exit arm which is currently stopped up. Soil mounds have been placed across the arm to prevent vehicles from using the arm. However, during the hours of darkness, the soil mounds are not clearly visible.

**Photograph 2: Driver perspective of stopped up arm and soil mounds**

Drivers not familiar with the road layout could misinterpret the exit arm as a viable route and potentially collide with the soil mounds. Alternatively, drivers observing the stopped up route whilst negotiating the roundabout may make a late manoeuvre, potentially into the path of another vehicle.

**RECOMMENDATION:** Increase the conspicuousness of the stopped up nature of the roundabout arm by placing retroreflective barriers immediately in front of the soil mounds.
