Management Survey
Survey, Sampling and Assessment
of Asbestos Containing Materials

At
Lumbertubs Primary NS23
Tonmead Road
Northampton
NN3 8HZ

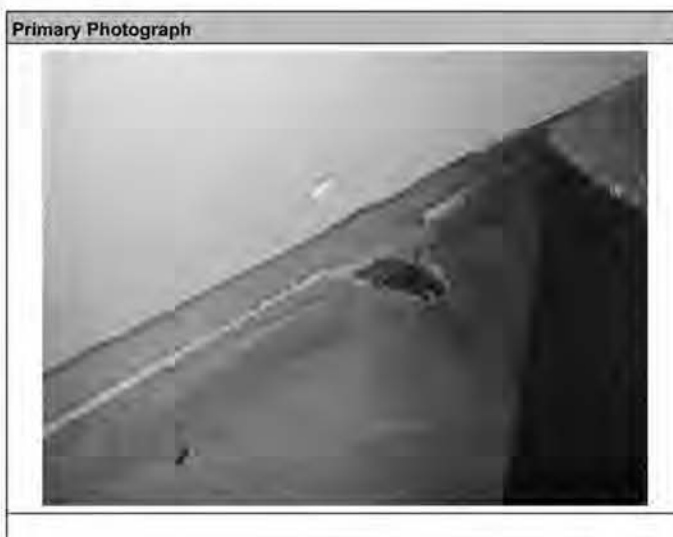
Sample Information	
Site Name/Building Name	Lumbertubs Primary NS23 / Lumbertubs Primary School
Location	Quiet Room
Floor	Ground
Position	Under carpet to floor
Description	Vinyl tiles
Product Type	Vinyl
Extent (actual)	9.00m ²
Identification	Sampled
Sample Ref	1609295/0014
Visually Similar to Sample

Material Risk Assessment	As Per HSG 264
Product Category	1 - Vinyl
Damage/Deterioration	1 - Low
Surface Treatment	0 - Reinforced - Composite Materials
Asbestos Type(s)	1 - Chrysotile, No Asbestos Detected
Material Score	3
Material Risk Category	Very Low

Priority Risk Assessment	Mean Scores Only, Calculated as per HSG 227.
Normal Occ Activity	1
Likelihood Disturbance	1
Human Exposure Potential	1
Maintenance Activity	1
Priority Score	4

Management Actions	Date Due
Monitor Condition of ACM	30-04-2013
Inform Staff/Tenants/Contractors	04-06-2012
Label with Warning Stickers	04-06-2012

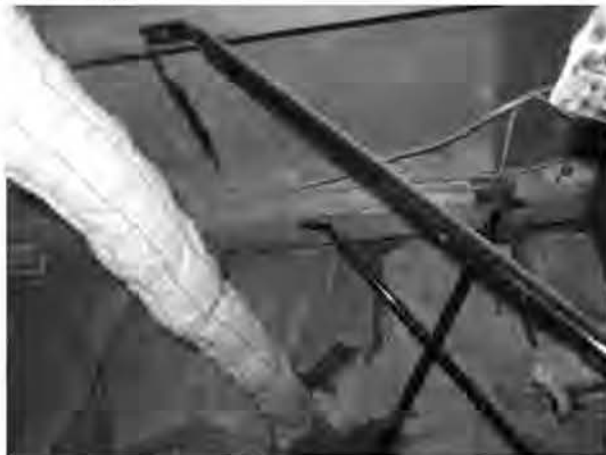
Primary Photograph

Sample Information	
Site Name/Building Name	Lumbertubs Primary NS23 / Lumbertubs Primary School
Location	25 Store
Floor	Ground
Position	Ceiling void to pipework
Description	Thermal insulation
Product Type	Thermal Lagging
Extent (actual)	4.00m Run
Identification	Visually Similar To
Sample Ref	NO SAMPLE TAKEN
Visually Similar to Sample	1609295/0017

Material Risk Assessment	As Per HSG 264
Product Category	3 - Thermal Lagging
Damage/Deterioration	1 - Low
Surface Treatment	3 - Unsealed Spray/Lagging/Textile
Asbestos Type(s)	0 - No Asbestos Detected
Material Score	0
Material Risk Category	Non asbestos

Priority Risk Assessment	Mean Scores Only, Calculated as per HSG 227.
Normal Occ Activity	0
Likelihood Disturbance	0
Human Exposure Potential	0
Maintenance Activity	0
Priority Score	0

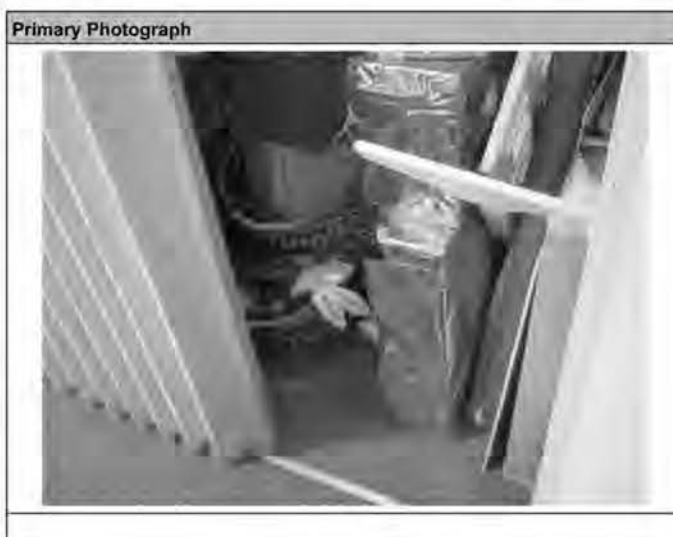
Sample Information	
Site Name/Building Name	Lumbertubs Primary NS23 / Lumbertubs Primary School
Location	54 Store
Floor	Ground
Position	Under Carpet
Description	Adhesive
Product Type	Bitumen
Extent (actual)	4.00m ²
Identification	Visually Similar To
Sample Ref	NO SAMPLE TAKEN
Visually Similar to Sample	1609295/0015

Material Risk Assessment	As Per HSG 264
Product Category	1 - Bitumen
Damage/Deterioration	1 - Low
Surface Treatment	0 - Reinforced - Composite Materials
Asbestos Type(s)	1 - Chrysotile
Material Score	3
Material Risk Category	Very Low

Priority Risk Assessment	Mean Scores Only, Calculated as per HSG 227.
Normal Occ Activity	1
Likelihood Disturbance	1
Human Exposure Potential	1
Maintenance Activity	1
Priority Score	4
