East of England Ambulance Service NHS Trust

Date of Final Report: 23 January 2014

Incident Type: Medication Incident

Incident Level: Level 1 Concise Investigation

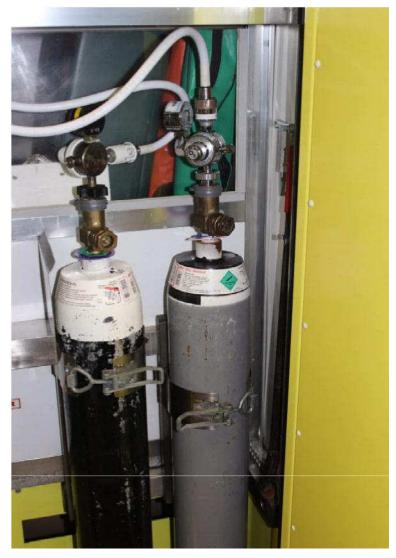
Illustration 1.

These incidents related to the use of Medical Air in an ambulance in error. The cylinder was marked as Medical Air and was connected to the vehicle oxygen system via an oxygen regulator. Historically oxygen cylinders are universally coloured black with a white top, by 2025 these cylinders will be painted white with the name of the name of the gas stencilled on the cylinder. Currently, medical air cylinders are grey with a black and white quartered top; again by 2025 these cylinders will be painted white with the name of the gas stencilled on the cylinder.

Illustration 1 shows that visually these cylinders are very different at present, however when the cupboard is closed, only the contents gauge is visible. If staff check only the volume of gas in the cylinder, there is no need to open the cupboard therefore different cylinders wouldn't be recorded.
