Stanley Park Lake Revival Lake Engineering Study

Draft Report (V1.0)

APEM Ref: P00003679

Blackpool Council

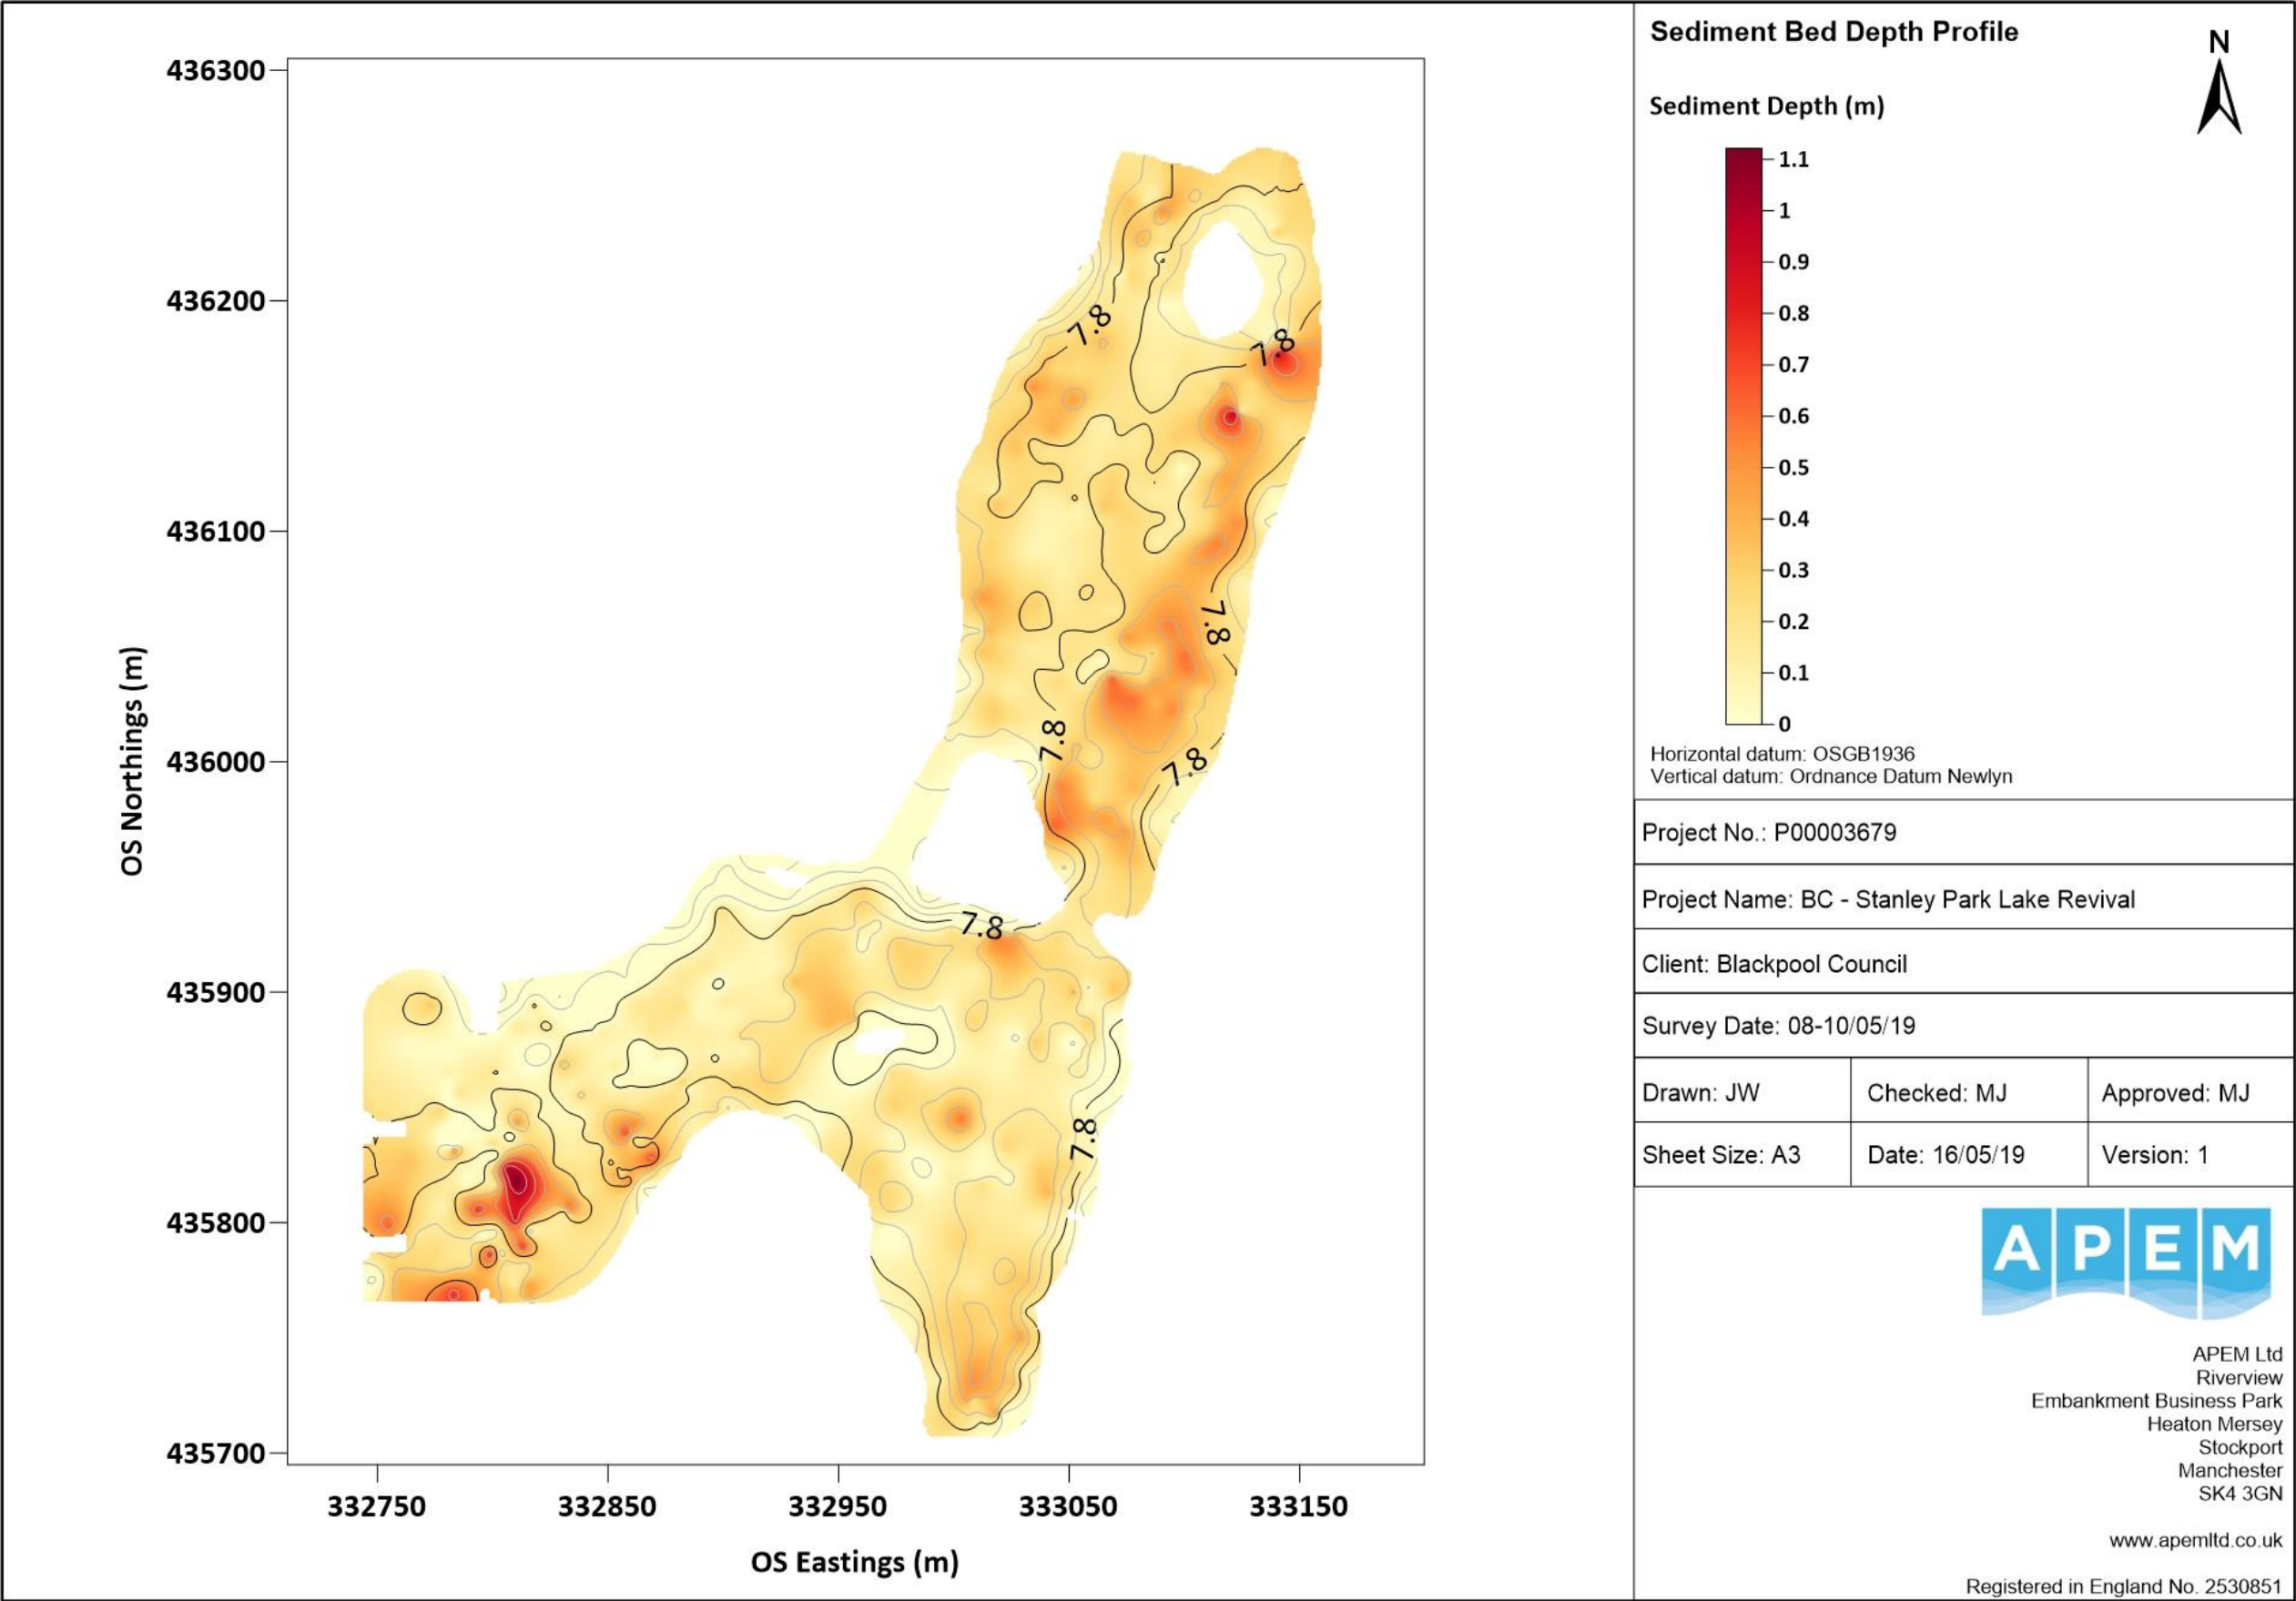
Figure 8 Stanley Park lake sediment depth model.

In terms of spatial distribution of sediment, there are ~1m pockets of silt to be found in the south-west section of the south basin and along the east bank of the north basin (Figure 8).

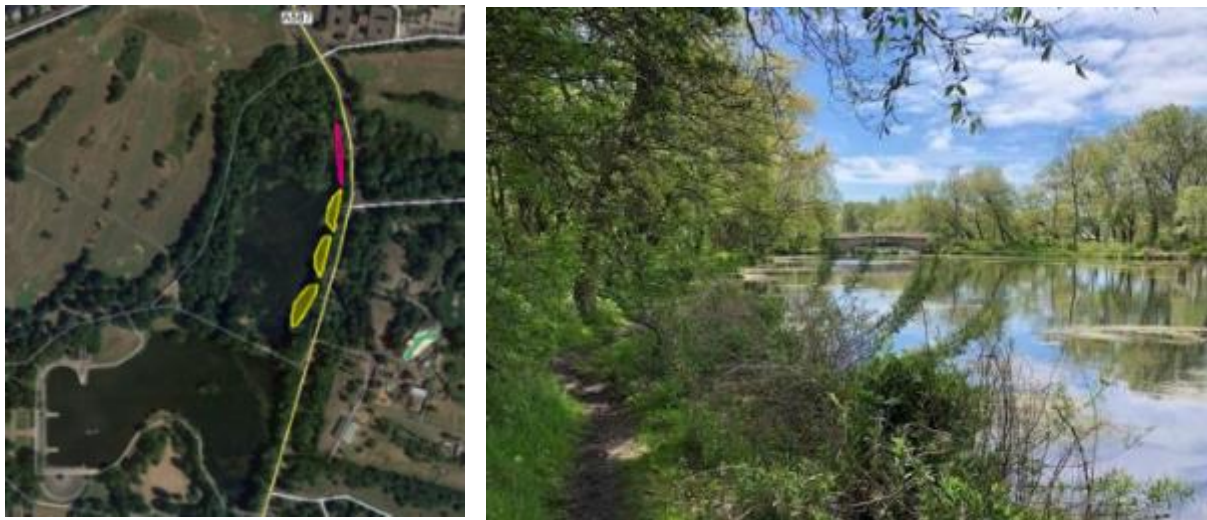
Figure 9: L-Indicative locations of Nicospan ‘half-moons’ (yellow in north basin; pink in the conservation area); R-photograph of current condition.

On the East bank of the north basin, we recommend that three half-circle nicospan revetments (Figure 9) are created and back-filled using silt. The banks will also be topped up in this way. In the conservation area a similar revetment could be installed to house the silt there. The total area of these areas would be approximately 2,782m² and these would be filled to an approximate average depth of 0.6m (some areas greater). Once this is backfilled, wetland plugs (native marginal macrophyte species) and/or coir can be used to create large riparian habitat areas. This solution would retain the silt in the footprint of the lake, saving on transport costs, while improving the abundance and diversity of marginal plant species/habitat in the lake. This disposal solution would create habitat improvements that are complementary to the existing management of the north basin.

This on site ‘receptor’ solution would provide a total of 1,669m³ silt retention volume. The nicospan areas could be altered to accommodate more or less silt. It would be at the council’s (and other park stakeholders) discretion as to the amount of water area they would be prepared to lose, although it is suggested that this proposed solution would enhance rather than detract from the existing amenity function of the lake. In the suggested example, the revetments extend approximately 10m into the lake at their widest points. Associated method statements and costs are provided as Appendix VII.

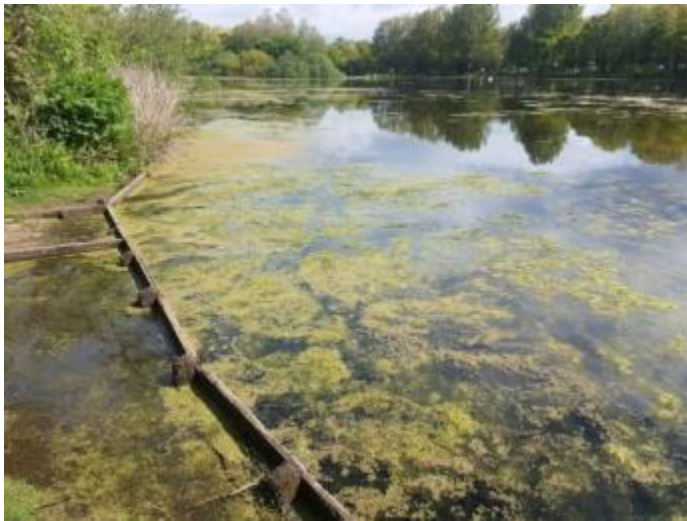
It is noted that much of the erosion on the west bank will have been caused by extensive footfall and if specific margin locations are to be retained for access on foot (silt deposits would have to be at least in the short-term fenced off) then it may be preferable to install a cellular grid paver system in these areas (reseeded with native coarse grasses). Should such a system be installed the potential to incorporate dredged silts would be much reduced. Desilting method statements and costs are provided as Appendix VII.

Figure 10: North basin west bank margin erosion.

We estimate that ~50m³ of silt could be retained in this way.

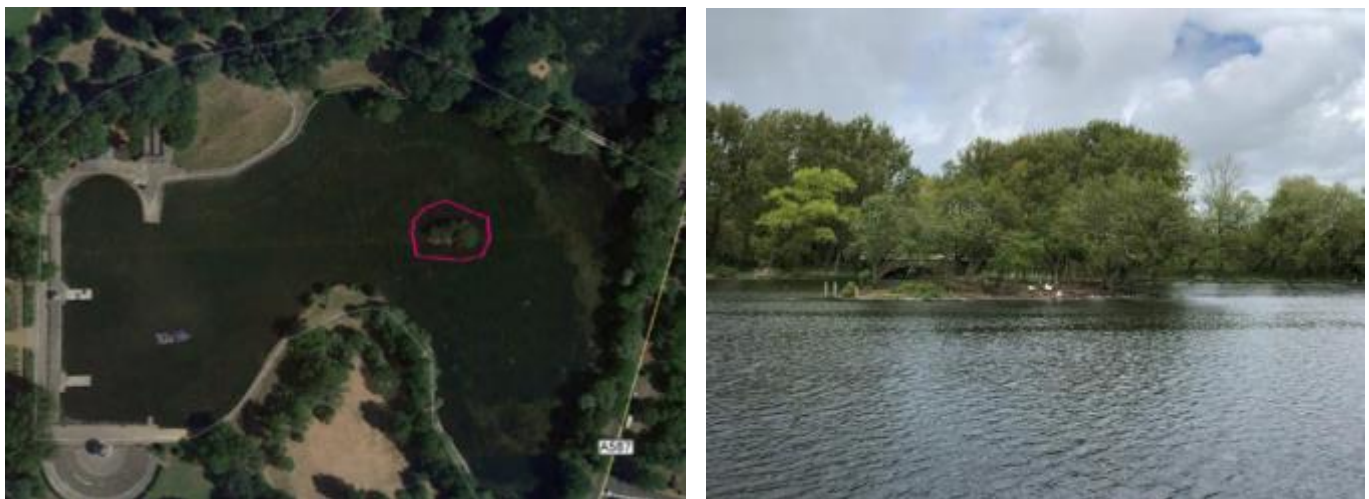
Figure 11 Satellite imagery of the south basin island and the approximate size it would increase to (Pink)(left) and picture of the current state of the island (right).

It is recommended that the island in the center of the south basin is built up as a means of 1) re-accommodating silt in the footprint of the lake, and 2) achieving island margin repairs.

It is suggested that silt can be pushed to the island and an excavator can create a new shape, which can then be planted and/or covered in coir. This would allow the silt to stay within the footprint of the lake and reduce transport costs, while improving the aesthetic and ecological value of the island. We recommend an area of 1,215m² is built up on the island, with average depth of 0.5m throughout the area. When a future planting scheme is developed, consideration should be made to discourage the use of the island by waterfowl (for the wider benefit of water quality); this could be achieved by planting a fringe of emergent reed species for example or alternatively by installing simple waterfowl fencing (e.g. low level wire fencing).

We estimate that 605.7m³ of silt could be retained in this way. The final size of island could be altered to accommodate more or less silt, dependent on the council's (and other park stakeholders) discretion.

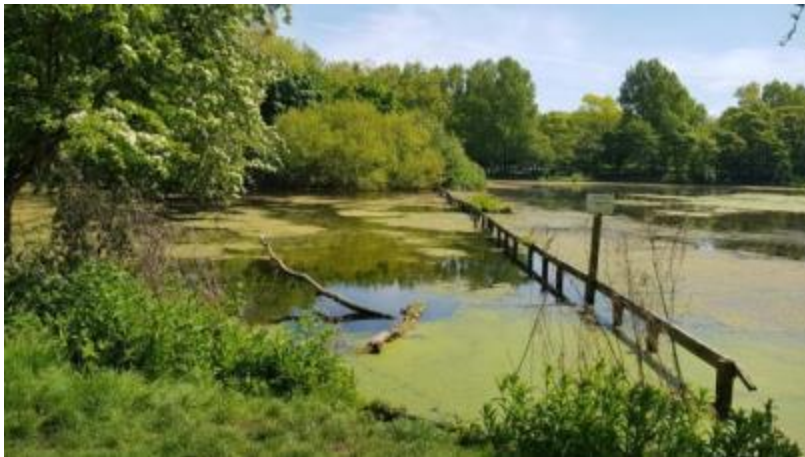
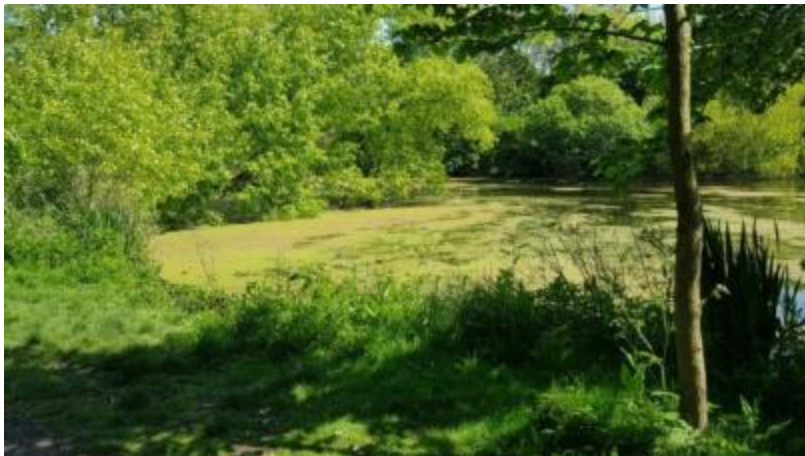
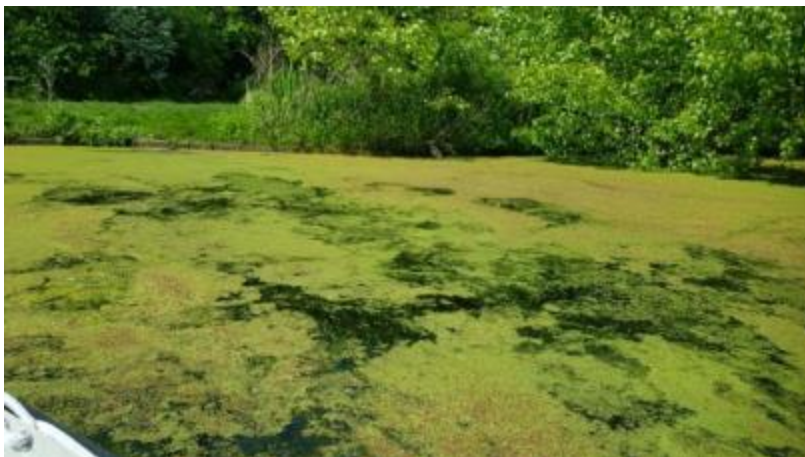
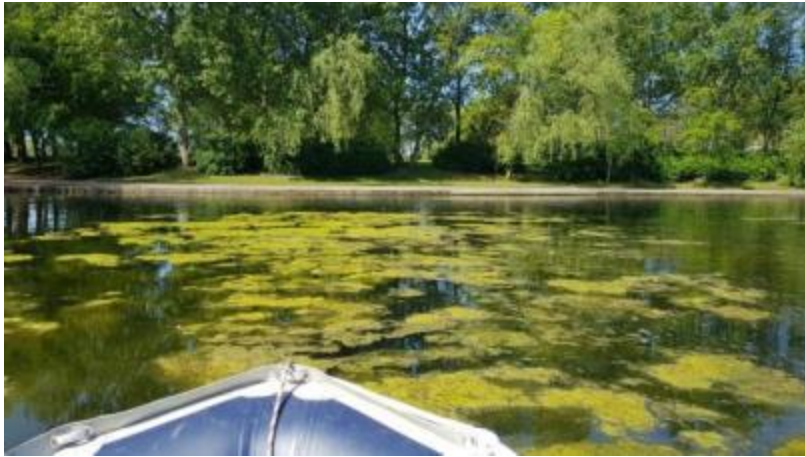
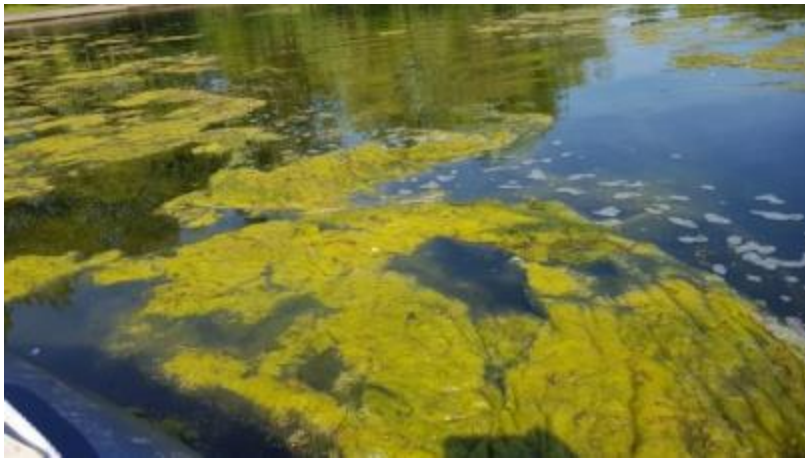
Dense macrophyte growth inhibiting bathymetric survey and navigation

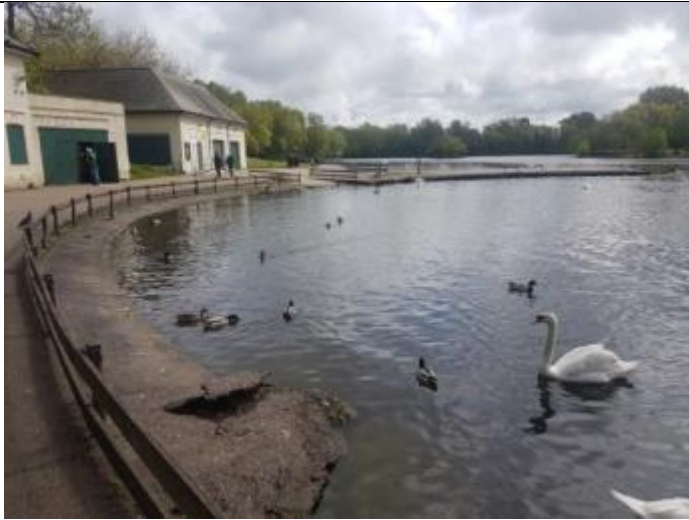
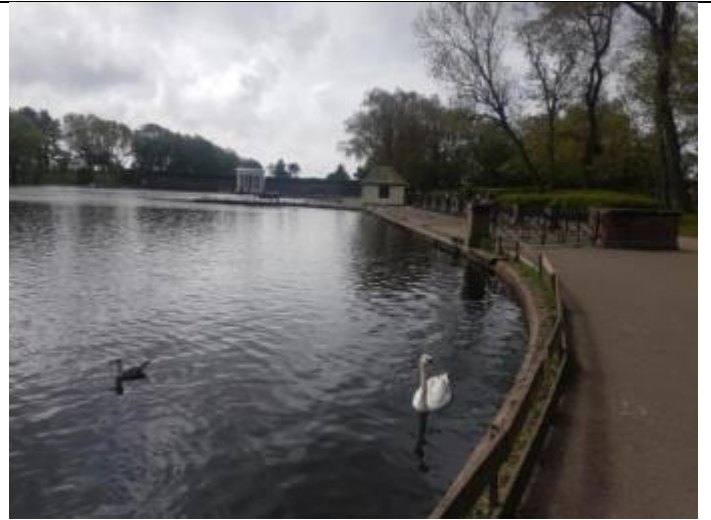
There is a large variety of marginal bank types. Much of the southern basin margins are characterized by (L) sloping concrete marginal aprons or (R) hard edge vertical concrete margins. These provide no potential for marginal macrophytes, however this is consistent with the boating amenity use and the design period (echoes Victorian landscape amenity design focused on open water).

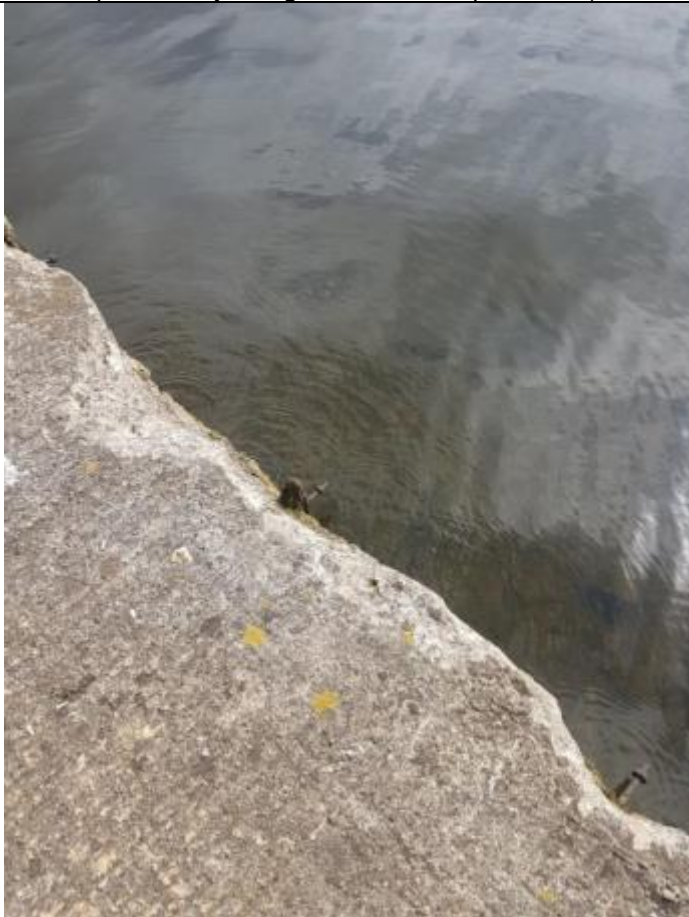
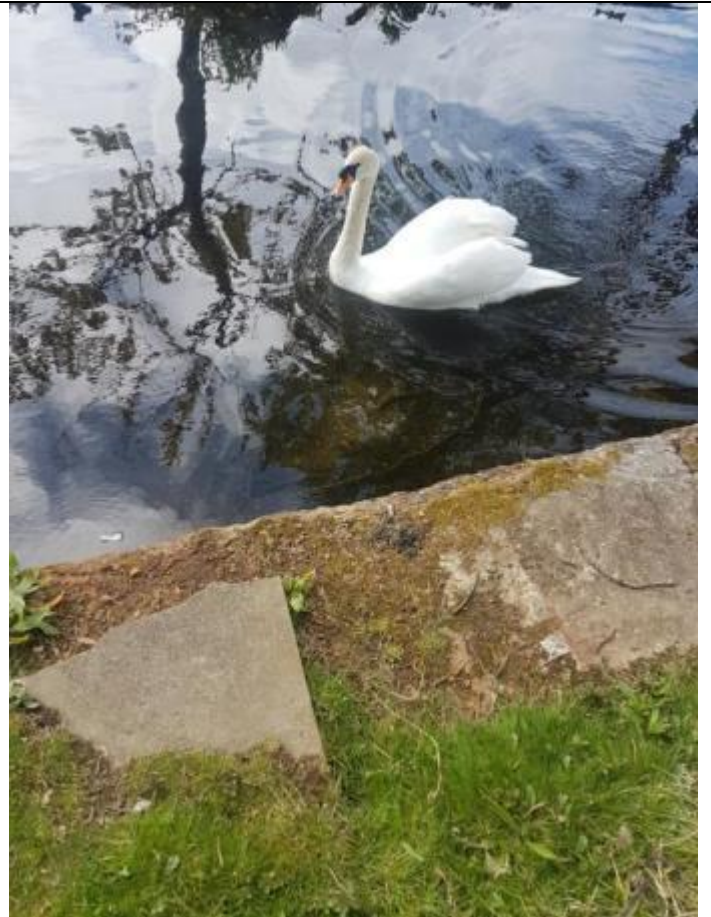
There are multiple locations around the perimeter, most notably in the southern basin hard margins where either (L) concrete margins have eroded/broken, or (R) sections of the perimeter with paving slabs have been vandalized. Repairs to the concrete margins (L) will be very expensive for modest visual gain, however the reinstatement of a

<p>wooden 'running board' would enhance the visual appeal and remove the H&S risk of snagging on the exposed bolts.</p>

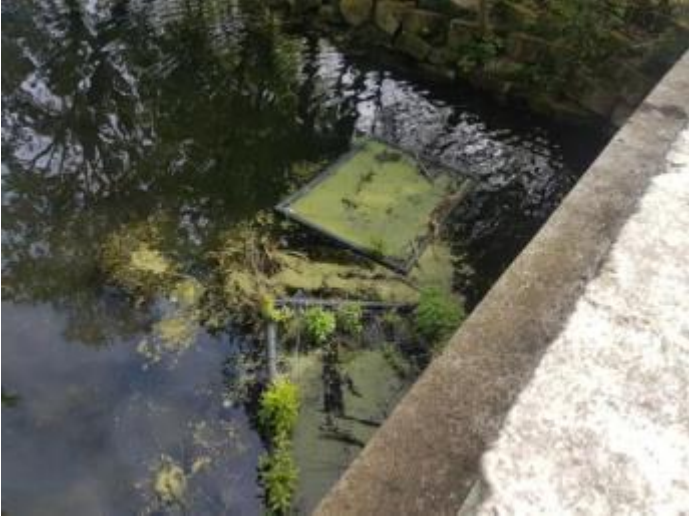
<p>'Floating reedbed' panels were originally installed alongside the dividing post and rail fence (dividing the conservation area from the rest of the north basin), however these are now scattered around the lake. Those that are serving as a barrier between the basins should be retained, with others such as that above (I) removed because they are visually unattractive.</p>

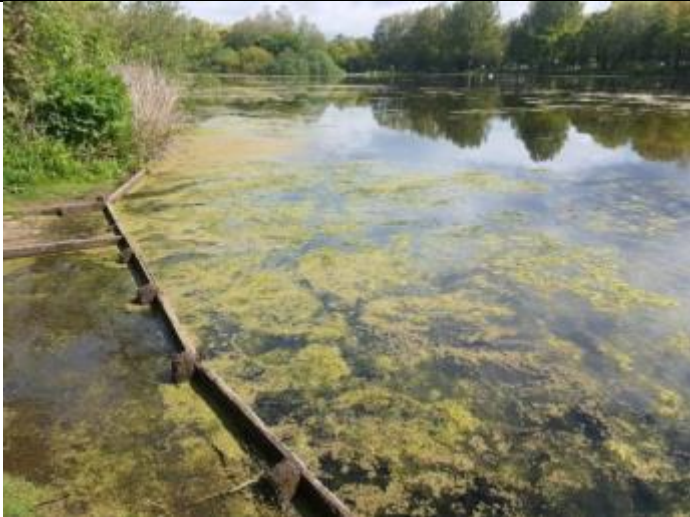
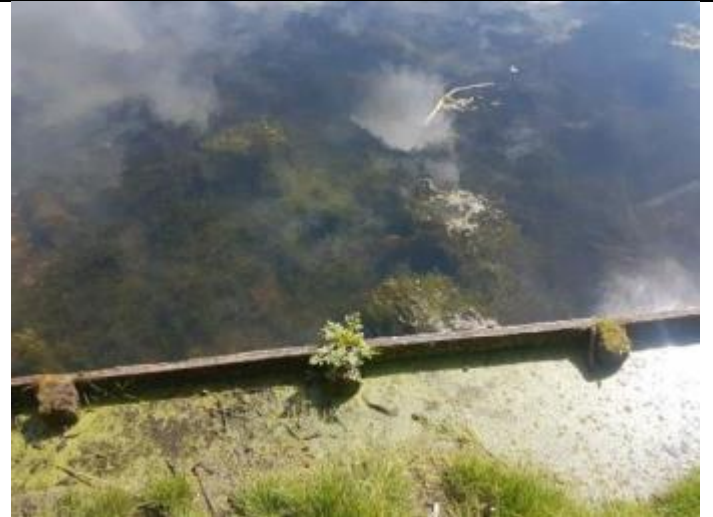
View looking north from west bank of north basin. Noticeable proliferation of filamentous algae. Also notable (foreground) is where bank material has eroded from behind the timber retaining planks. This is a reasonably simple repair with potential for large positive visual improvement – recommend a cellular grid paver is installed (over a granular subbase) and reseeded with native coarse grasses. The cellular grid will help to prevent future erosion in this area of heavy footfall.

Benthic weed – suspected hydrilla genus.

Alternatively this area could be used for a 'spot top-up' receptor area for dredged silts – assuming it were not used so heavily, going forwards, for pedestrian traffic.

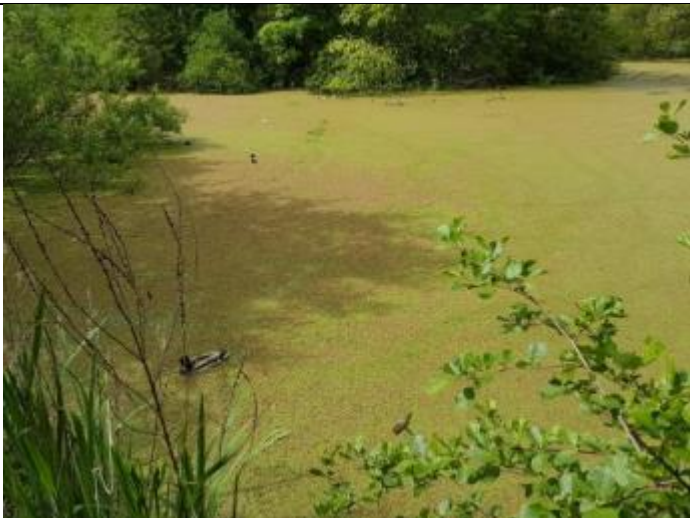
Proliferation of Duckweed at northern end of lake. Surface skimming/netting would be effective given the windblown collection in this area.

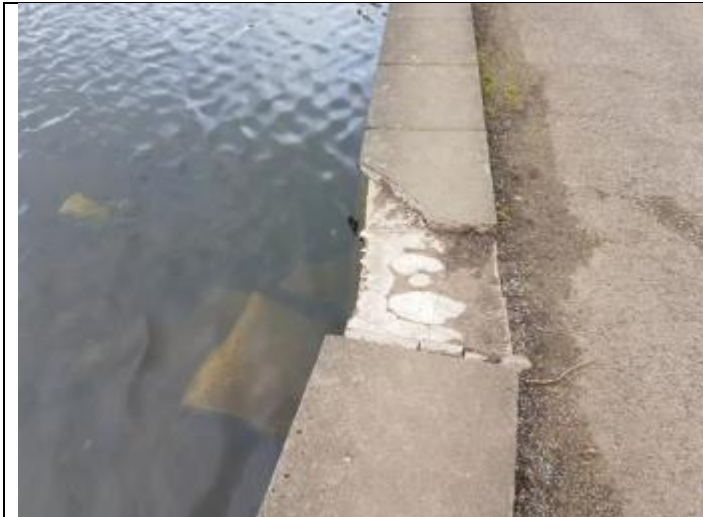
The bankside concrete coping flags would benefit from repair in several places. Note broken flag visible on bed. Repairs are possible from the bankside i.e. would not necessitate an in-lake contractor.

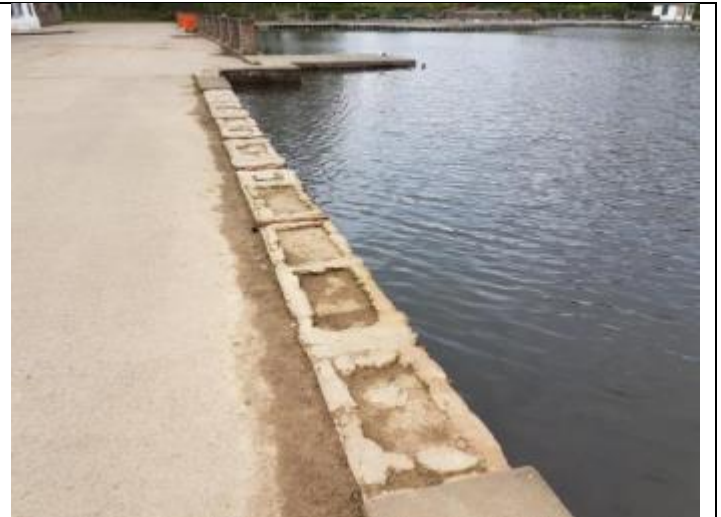
Some longer sections of marginal flagging are missing. There is a mix of different materials used (including mix of different concrete flags for instance).

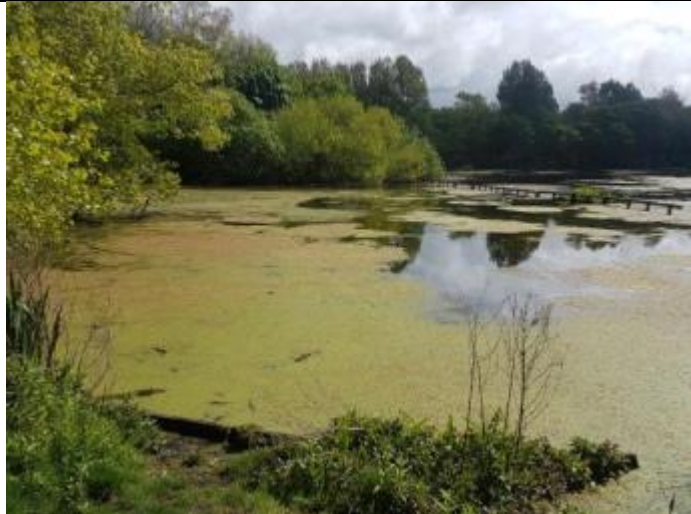
View of the in-lake wooden fence that separates the conservation area from the rest of the north basin. The fence is in poor condition in places however does serve to delineate the area of lake where fishing is prohibited and is regarded by some as a photography opportunity (roosting birds etc). Some posts may need to be removed to gain access by de-silting plant, otherwise it could be retained.

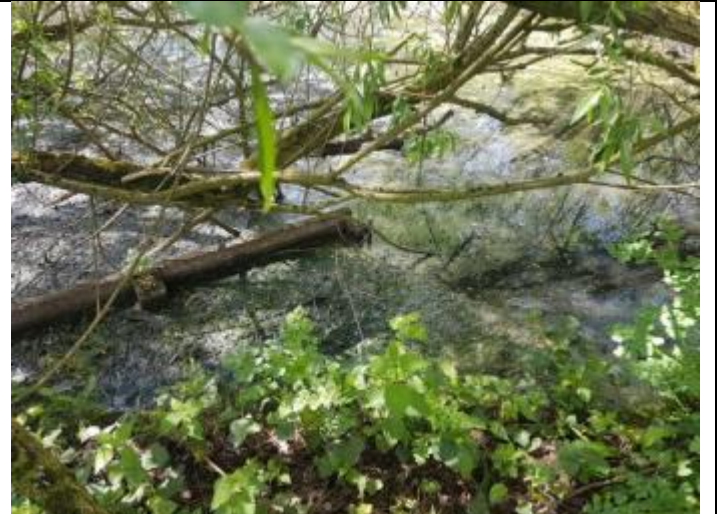
Some tree work is recommended around the margins of the conservation area to a) allow more sunlight and promote diversity of marginal species – note dominance by ivy and nettles above; and b) minimise direct leaf litter potential.
