Turbo Roundabout,

Clapham Road-

**Tavistock Street,**

Stage 1 Road Safety Audit

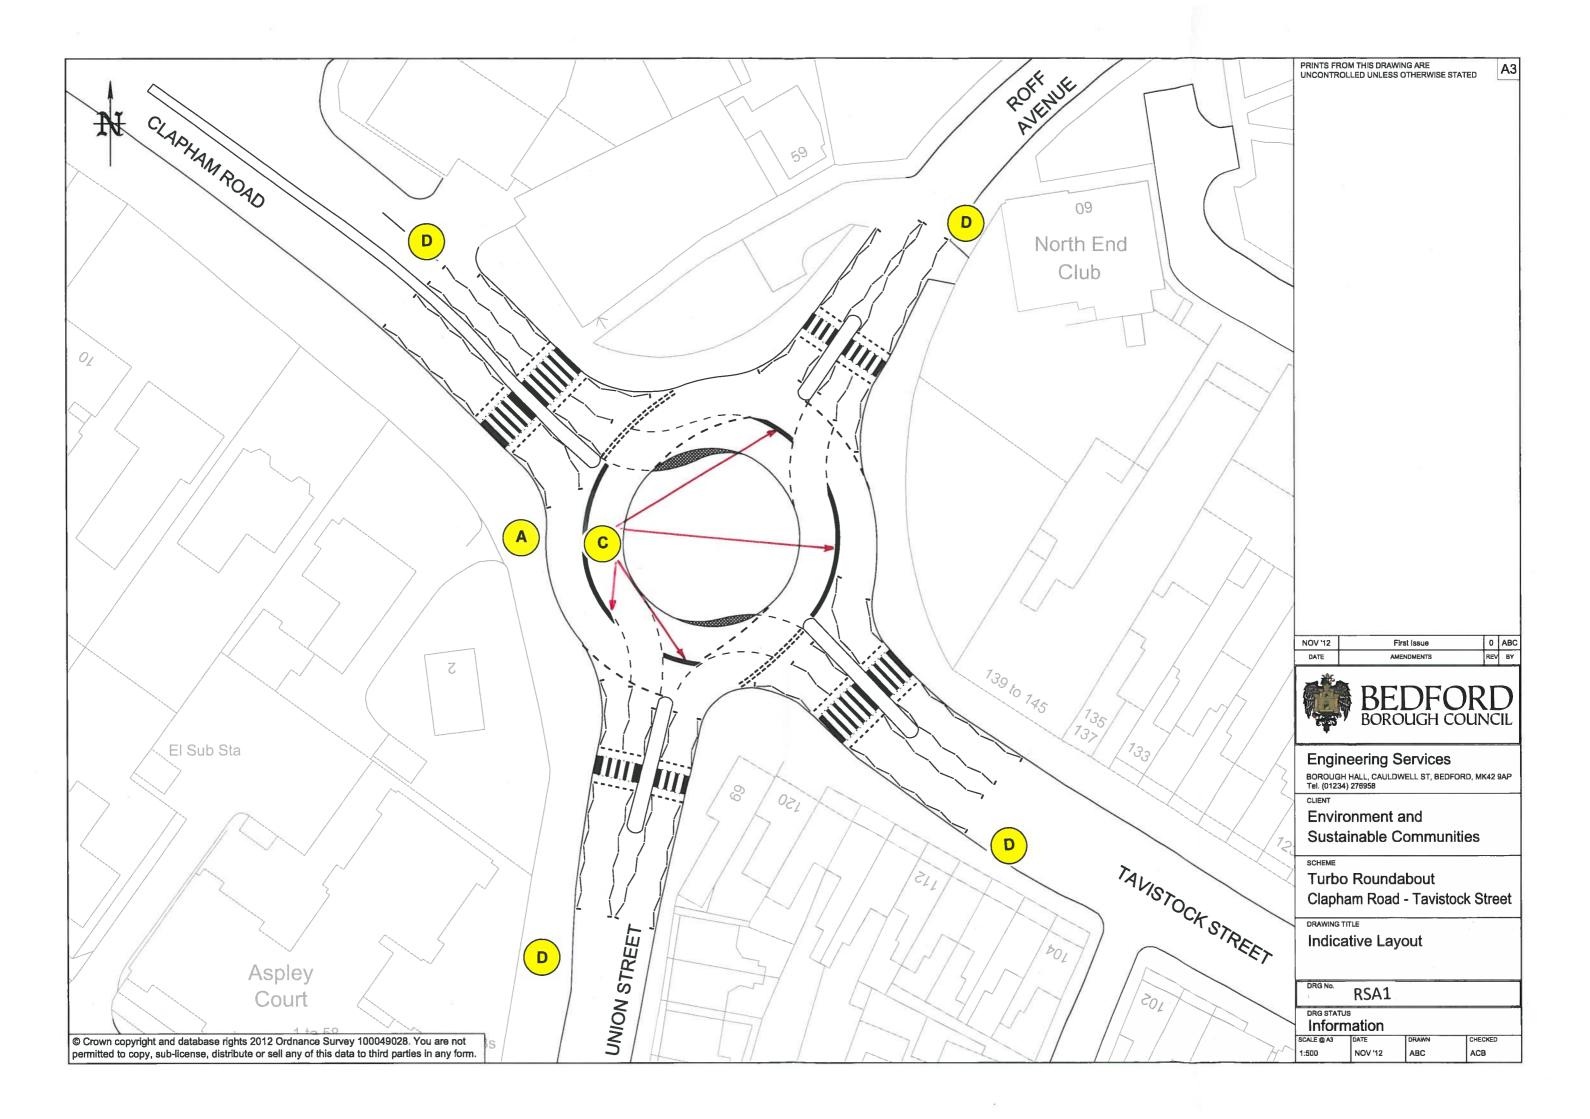
# APPENDIX B PROBLEM LOCATION PLANS

Locations: A (Dwg. No. RSA1)

**Summary:** Private Access crosses combined pedestrian/cycle route.

**Details:** The proposal takes no account of the existing private drive to the property on the corner of Union Street and Clapham Road. This property is a large house converted to flats and has a number of parking places. Therefore it is likely that this access is well used. At present there dropped kerbs onto what is effectively the circulatory carriageway, the access is fairly conspicuous and its presence is highlighted by the change in surfacing from flagstones to tarmac. It is likely that there is some existing interaction between vehicles and pedestrians in this area, however the vehicle drivers will be aware of the presence of pedestrians and the pedestrians should be aware of the presence of the private access. By encouraging cyclists to use the footway in this area additional conflicts are introduced. It is likely that the cyclists will be travelling at higher speeds and therefore drivers entering or exiting the private access may not see the cyclist leading to potential collisions. No details have been provided of the proposed traffic signs for this scheme therefore it is not possible to comment on this aspect of the works.

Locations: General (Dwg. No. RSA1)

**Summary:** Thermoplastic humps may cause problems to powered two wheeled users. Perception of roundabout may cause problems with all users.

**Details:** It is unclear as to the profile of the markings proposed. Powered two wheeled users may not be expecting the circulatory carriageway markings to be full profile and this may cause loss of control incidents.

Location: C (Dwg. No. RSA1)

Summary: Lack of cycle/pedestrian signing.

**Details:** The proposal is to add advisory cycle lanes on all four approaches. In order for the 'Turbo' Roundabout to operate correctly cyclists will not be permitted to enter the roundabout (doing so would require them to negotiate a raised thermoplastic marking. As a result cyclists are required to leave the carriageway prior to each entry. No details of road traffic signs have been provided. It is assumed that this cycleway will be shared with pedestrians and that cyclists will be required to dismount to cross the Zebra Crossings.

Location: D (Dwg. No. RSA1)

Summary: Lack of lane destination signing

It is not possible to ascertain from the information provided what advance signing there will be on each approach. The Dutch have special arrow signs and road markings (as shown below) to indicate that certain movements are not possible from certain lanes. These markings would also require approval if that has not been applied for as part of the overall approval process. Verge mounted signs may also be of assistance.

It is recommended that the presence of the private access is highlighted with some form of road marking. If is felt that this is insufficient then it is recommended that this section of the cycle lane is removed and cyclists dismount signs are installed on this quadrant to ensure that cyclists are not travelling in this area at speed and are therefore not in conflict with any motor vehicles using the access.

Consider using rumble strip type profile markings rather than full profile markings until the concept is understood and accepted. Consider using Dutch style lane arrows and signs (approval will be required).

Clarify the intended use of the cycle route and Zebra Crossings in line with current UK legal framework to ensure that cyclists are clear of their rights, priorities and interaction with other road and NMU users. Ensure that suitable cycle signs are installed indicating where shared use exists and where cyclists should dismount. Provide uncontrolled crossing warning signs where necessary.

Ensure that all drivers are fully aware of the change in the rules of the road at this roundabout. As a minimum a new road layout warning sign should be installed. Consultation with the DfT and reference to the early Dutch trials should be carried out to ensure that all possible measures are taken to make drivers aware of the unique nature of this roundabout. Perhaps some use of the word "Trial" or "Experimental" could be included in the warning sign to alert drivers to this. Monitoring of this junction at Stage 4 would also be advisable to determine
