Report of the Director of Planning and Community Development

CONSTRUCT DETACHED DWELLING AND DOUBLE GARAGE TEMPLE LAKE, KIMBERLEY ROAD, NUTHALL CONSIDERATION OF ENFORCEMENT ACTION

Development Control Committee 15th February 2006

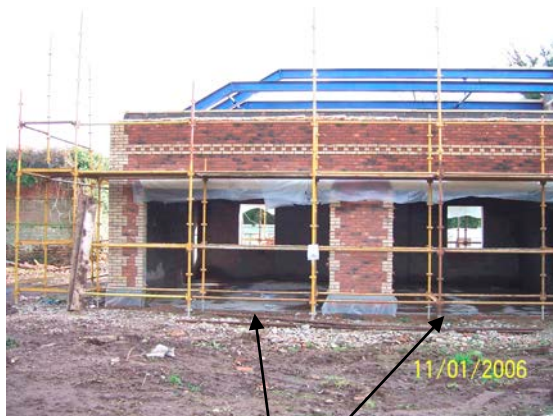
North elevation – Garage section

Two garage doors rather than three as indicated on the approved plans.

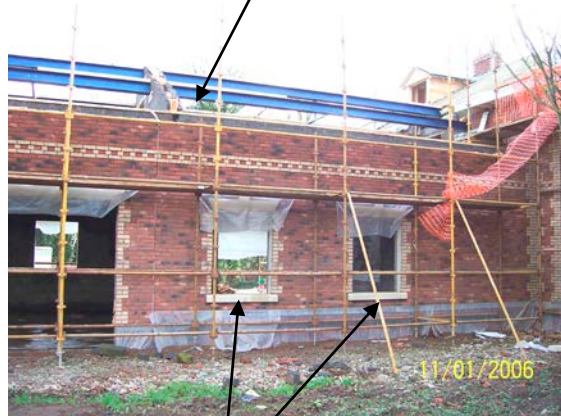
steelwork as currently added would leave the roof at the height proposed, but rejected, in December 2005. Overall this is now 0.2 metres (8 inches) higher than accepted as an amendment in 2004. In discussions following the December 2005 committee the applicant has suggested that the ridge of the roof could be removed to leave a flat roof section along the centre line of the garage. This would leave a pitched roof over the garage with a flat centre section (similar to the house). However, the eaves height of the garage has already been raised by approximately 0.3m and so a lowering of the ridge would leave the pitched roof out of proportion with the brickwork below. It is considered that such a design would be awkward in appearance and out of character with the original design. It is therefore recommended that enforcement action be taken to ensure that the garage roof is constructed to the correct eaves height and to the ridge height as accepted in 2004.

Ridge height of roof higher than permitted.

Two windows on this elevation rather than three as indicated on the approved plans

- (ii) The garage/spa area roof be reduced to the eaves height and the ridge height as approved in September 2003 and amended in July 2004.**
 - (iii) The base of the “porch” to the south elevation and constructed within the green belt be removed.**

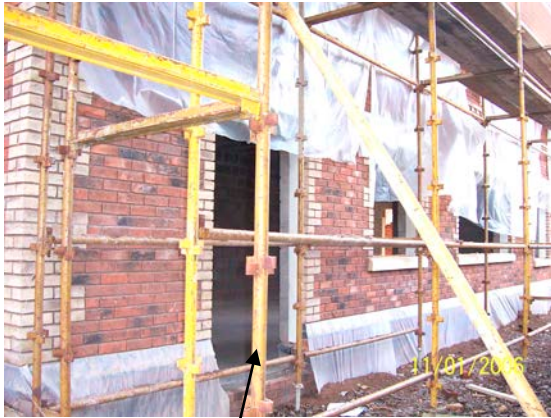
North elevation – Main house

Door opening created
in place of the
window shown on the
approved plans

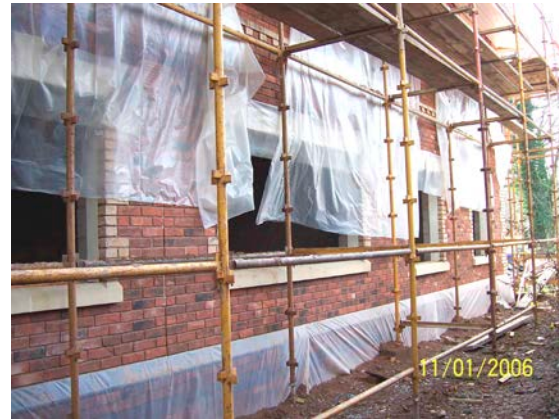
Projecting section
indicated on the
approved plans but not
erected

- Dormers (not shown on photographs) indicated on the approved plans but not erected

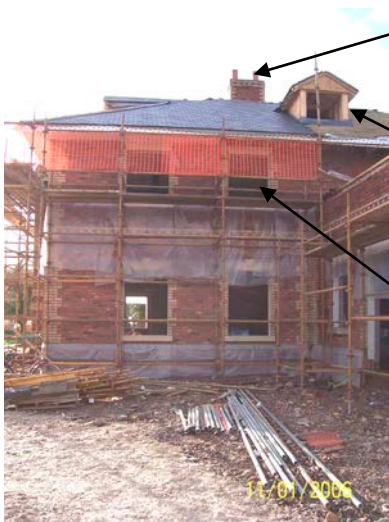
East elevation – Main House

The original approval included two chimneys on the dwelling which were square in appearance. Two chimneys on the roof have been constructed and are rectangular in shape - being approximately twice the width of the approved plans. However, it is not considered that the chimneys as constructed are out of scale or character with the building, or that they have any overbearing effect on neighbouring properties. It is not recommended that any enforcement action be taken in respect of the chimneys.

Chimney larger (double stack) than
the approved plans (single stack)

Dormer window on this elevation not
on the approved plans

First floor window is larger than, and
in a different location to, that which is
shown on the approved plans.

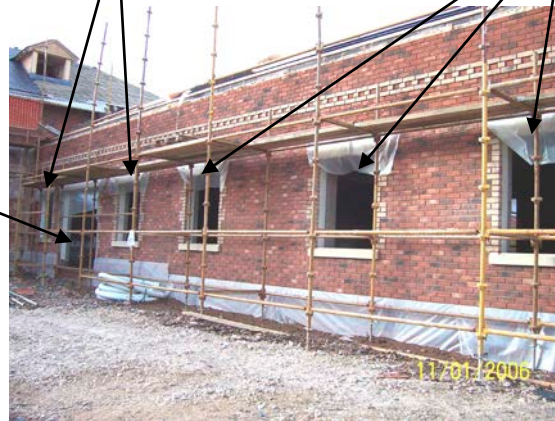
South elevation – garage section

Five windows on this elevation rather than six as indicated on the approved plans

Door inserted into this elevation which was not indicated on the approved plans

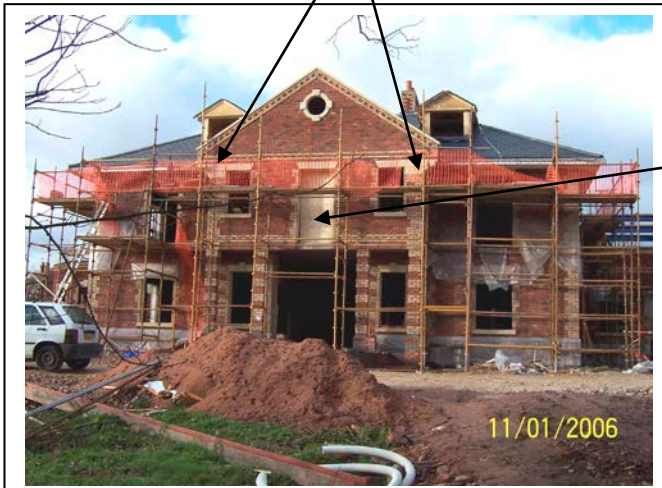
South elevation – Main house

Stone details at eaves level on the projecting section not shown on the approved plans

Door created at first floor level not shown on the approved plans

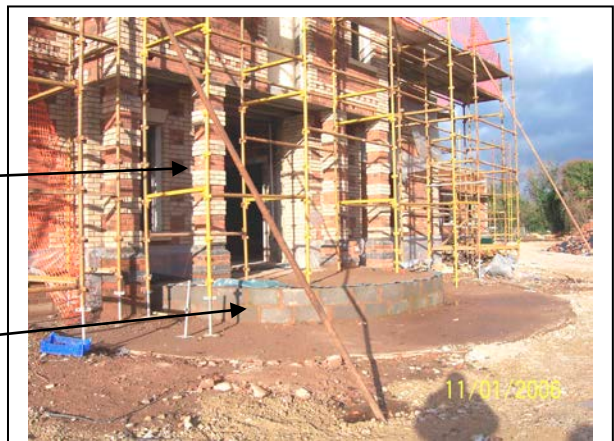
A further issue concerns the construction of the base of the porch which was originally proposed in 2005 as an entrance feature on the south elevation of the property, but was subsequently withdrawn as the development would project into green belt. The base was however constructed without approval and consists of a substantial concrete base some 5.4m in diameter. This is considered to be inappropriate development in the green belt and should be removed. Consequently enforcement action is recommended.

Pillars are square but were round on approved plans

Base of the 'porch' not shown on the approved plans

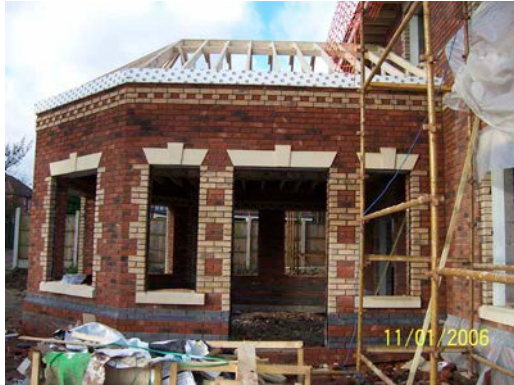
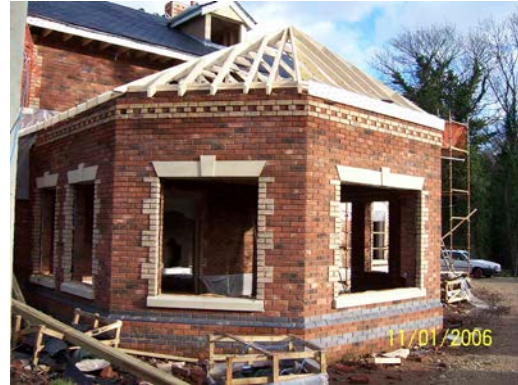
Elevations of conservatory

The conservatory has not been built in accordance with the approved plans. The original plans proposed a mainly glazed structure with pillars supporting the larger window frames and a pitched roof with oversailing eaves (as the house) resting above the top of the window frames. The structure as built contains substantially more brickwork than approved and the window openings are considerably smaller. The structure was initially built with a flat roof (in accordance with the revised plans submitted in 2005 but rejected at committee in December 2005). The structure also contains a brick parapet on which a pitched roof has been constructed that is now higher than approved and does not provide for oversailing eaves. The structure as a whole is therefore totally different to that which was approved and more resembles an additional room to the house than the lighter weight structure intended. It is considered that the entire conservatory as built is not acceptable and enforcement action is recommended to ensure compliance with the original approval.

Conservatory not built in accordance with the approved plans.

- 1. Enforcement notice is issued in respect of the dwellinghouse at Temple Lake requiring:**
 - (i) The demolition of the conservatory and construction in accordance with the plans approved in September 2003.**
