Canal &
River Trust

Lock 12, Aylesbury Canal

Review of Potential Causes of Failure

Author	C. Frampton
Checker	K Raven
Approver	T Storr
Report No	5005-UA005938-UP31R-01
Date	October 2013

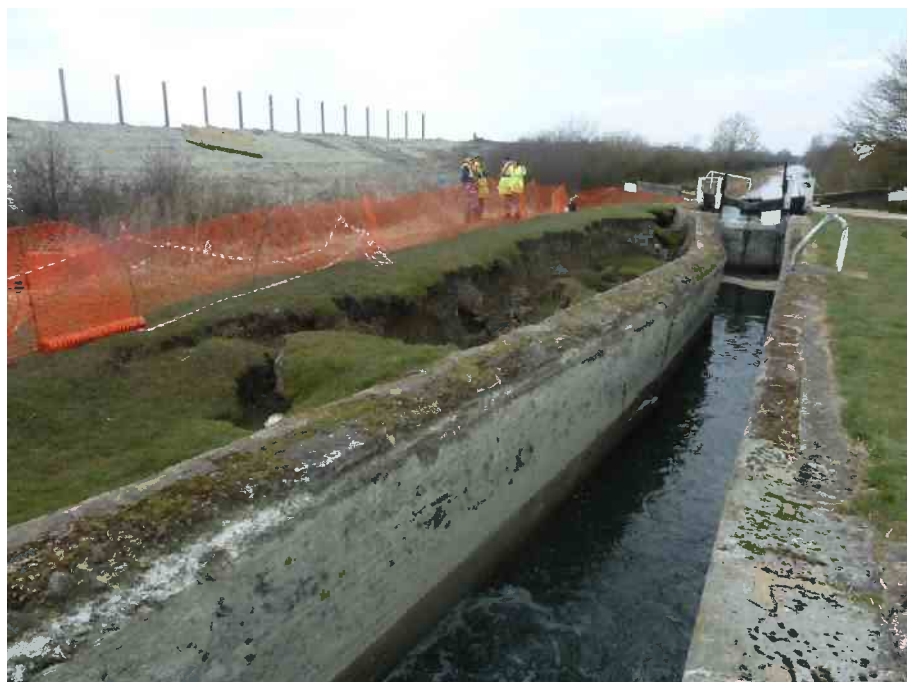
Figure 3 – Lock 12 Post-Failure

In the early afternoon of Thursday 28th March 2013, the South East Waterway engineering team were advised by local bankstaff that the south wall of Lock 12 had failed. A photograph taken immediately after the failure is reproduced in Figure 3 above

It is considered that the deterioration of the south lock wall, possibly in part due to progressive damage caused by the shrinkage and swelling of the Gault Clay materials, and the exceptionally high porewater pressures likely to be in operation in the soils behind the retaining wall in Spring 2013, due to the very wet proceeding Summer and Autumn 2012, has been the primary cause of the overturning and structural failure of the wall.

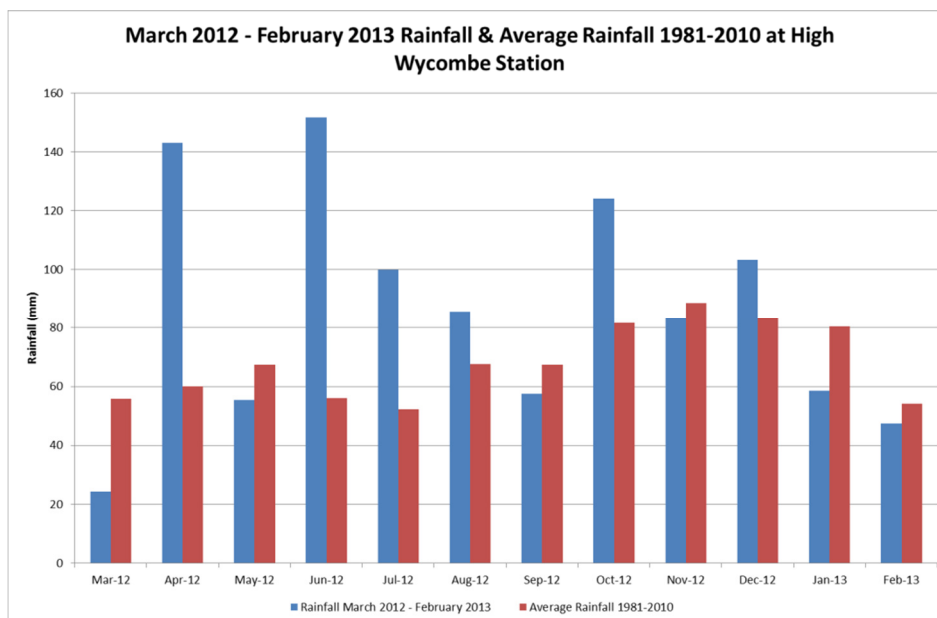
Figure 4 – Average Rainfall vs Rainfall Spring 2012 to Spring 2013

Information was obtained from the Met Office, which includes average monthly rainfall levels from 1981– 2010, taken from a Meteorological Station located at High Wycombe, approximately 20 km from the site. This is the closest station containing historical data available on the website (Met Office, 2013). This has been compared to rainfall in the 12 months preceding the failure of the south wall of Lock 12 within Figure 4.

The data clearly indicates rainfall had been much greater than average, particularly over the period Spring to Autumn 2012, with several months receiving over twice the average rainfall.

- Almost double the average rainfall over the previous summer and autumn has been recorded. This can have a detrimental impact both by increasing water pressures in the retained soils behind the lock walls but can also increase loads by causing swelling of the highly expansive Gault Clay material.

Typically, water pressures in the ground reach a maximum in March/April and they would have been much higher than normal in the Spring of 2013, which coincides with the timing of the wall failure.
