Rattlechain Lagoon – North Slope
Improvement Works.

Information for the Environment Agency

April 2013

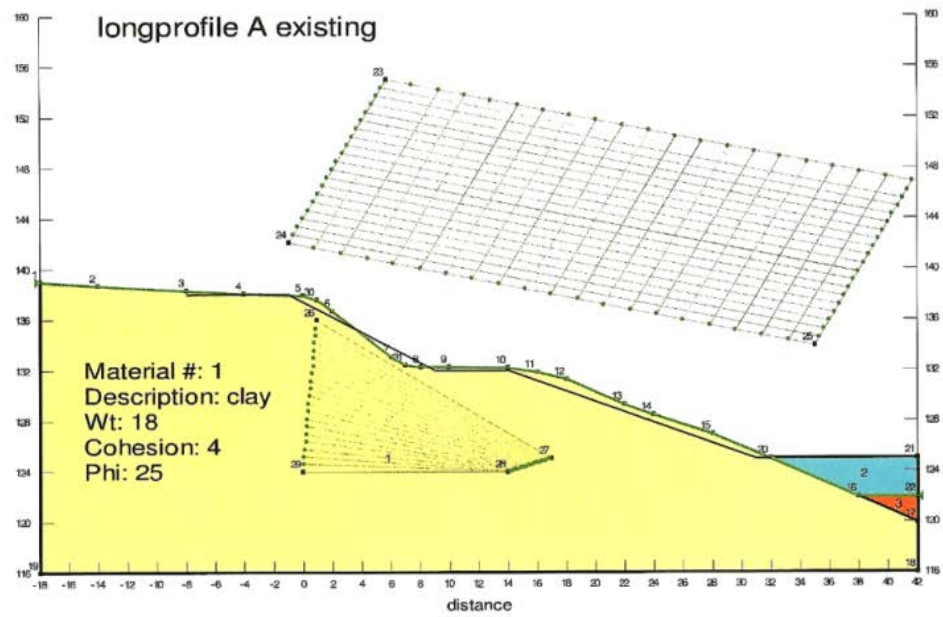
Slope Profile A

result : $F = 1,1$ (estimated)

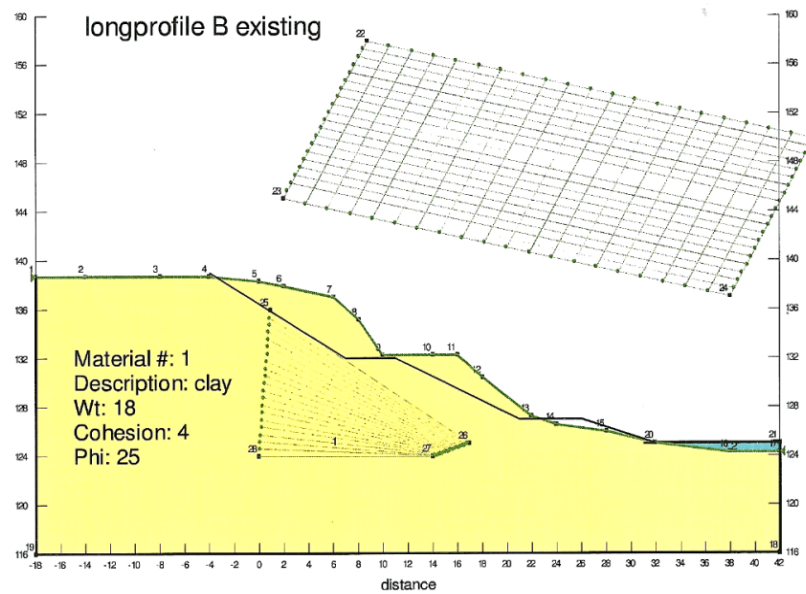
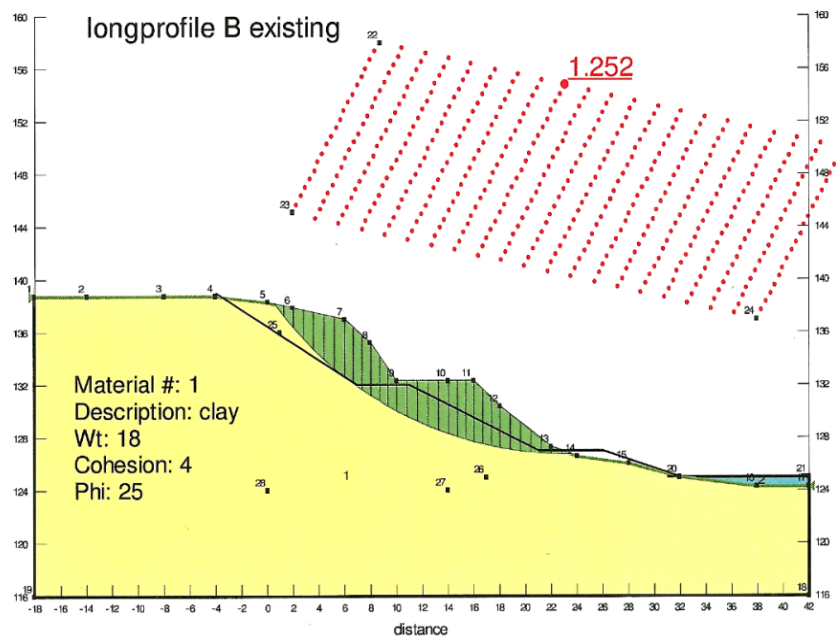
longprofile B existing :

result : 1,25

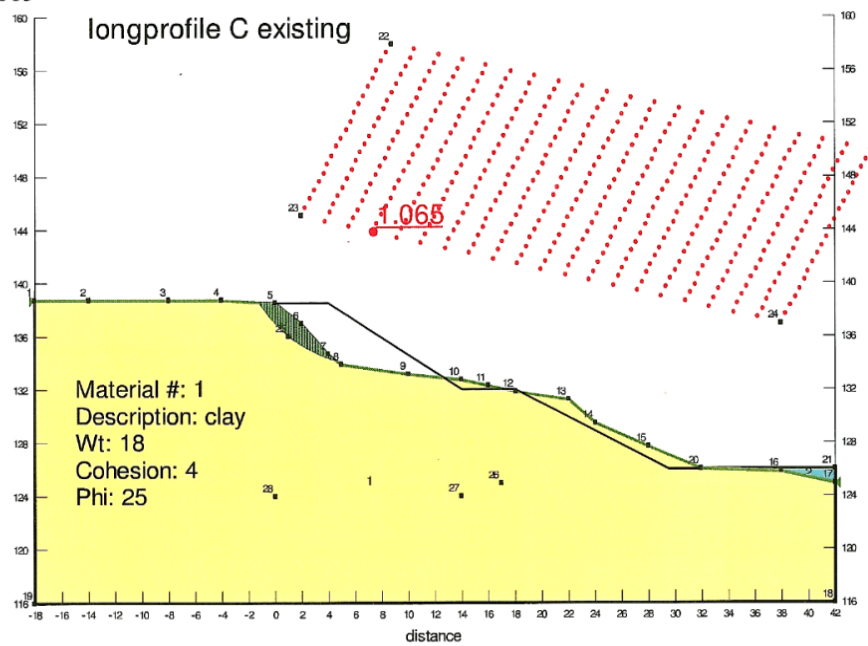
longprofile C existing :

result : 1,065

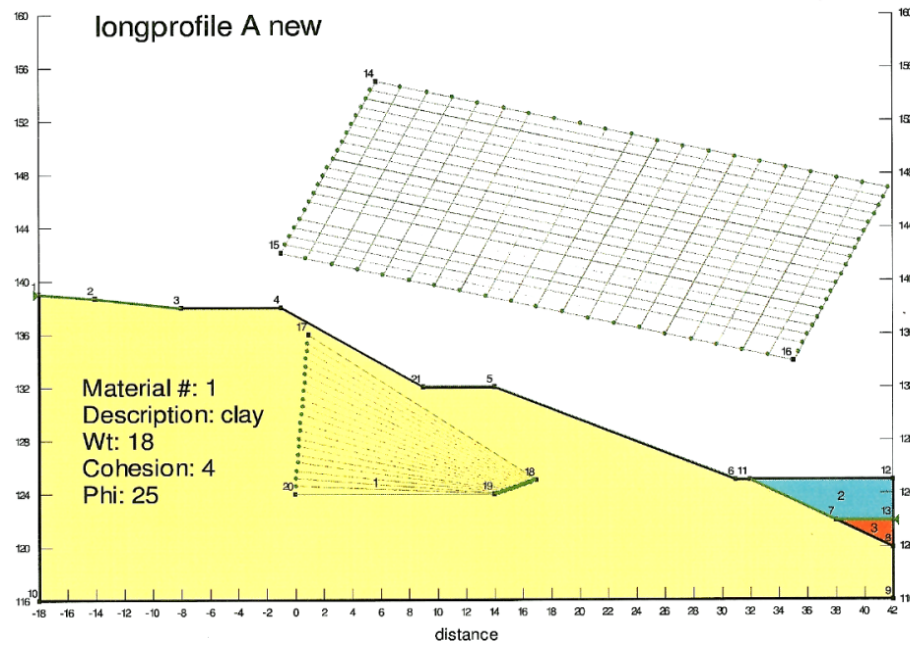
Option A: New designed A slope without artificial anti-erosion structure :

result : $F = 1,3$ instead of $1,1 = + 20 \%$

The re-profiled slope has now a slope safety factor of 1.3 instead of 1.1 this means an increase of 20 % in the slope stability.

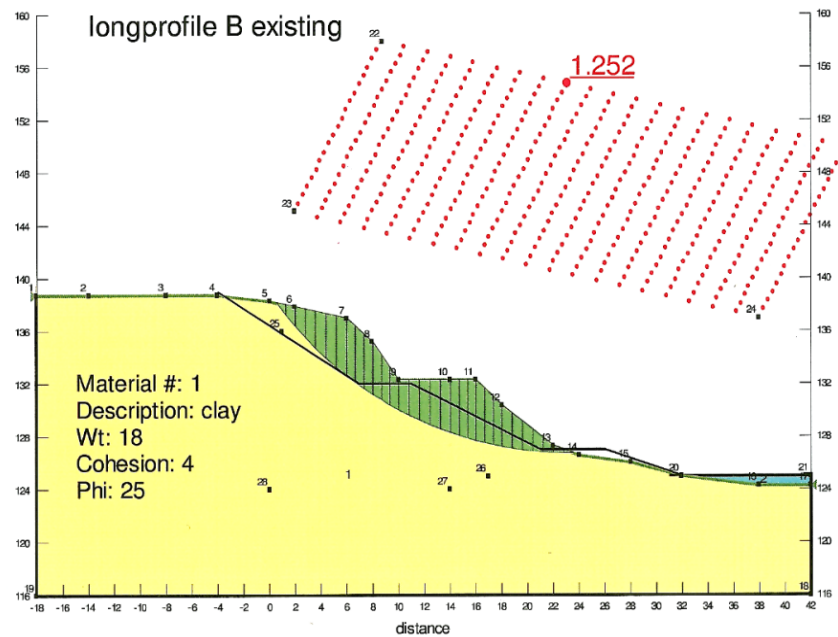
longprofile B existing :

result : 1,25

The slope stability factor on the existing slope profile is 1.25 but when the slope is slipping the total soil movable mass is large due to the quite deep slip surface. The bigger the shaded green area the bigger the impact of the slope

collapse can be. Here it is very clear, if such a great volume of earth goes down it will have a devastating effect on the installed capping, if it occurs.

From the existing simulated profile B it is clear, that if a slope collapse occurs, the impact will be devastating on any installed capping. By re-profiling the slopes the physical impact of a collapse on the capping would be strongly reduced.

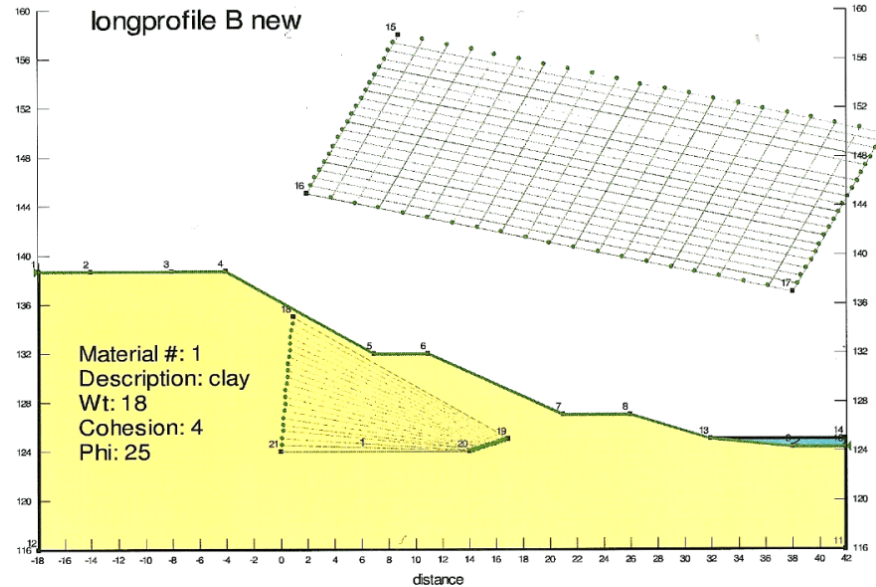
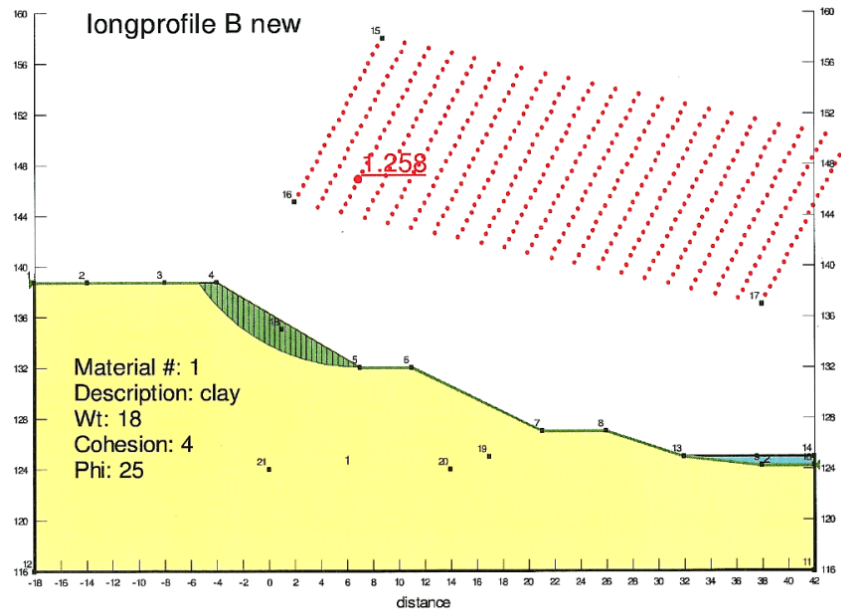
longprofile B new :

result : 1,26 (unchanged, but smaller and higher position)
global stability of the same slipzone as existing : 1,55 (see next page)
thus here also an important gain in stability.

The new slope safety factor of 1.26 is almost unchanged but the volume of the slip area is far reduced and is only situated at the top part of the slope. If a collapse would happen only a small un-deep part of the upper slope would be impacted and the damage to the capping would be limited. To have an

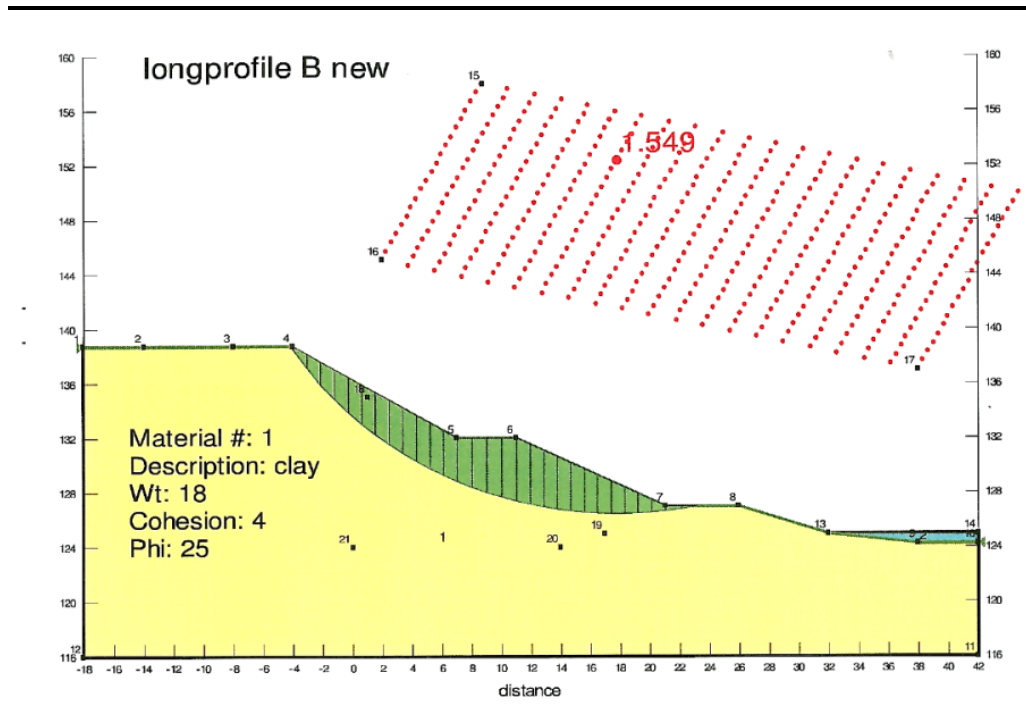
Longprofile B New

Finally the safety factor of the original same slip surface increase from 1.25 to 1.55 or an increase of 20%.

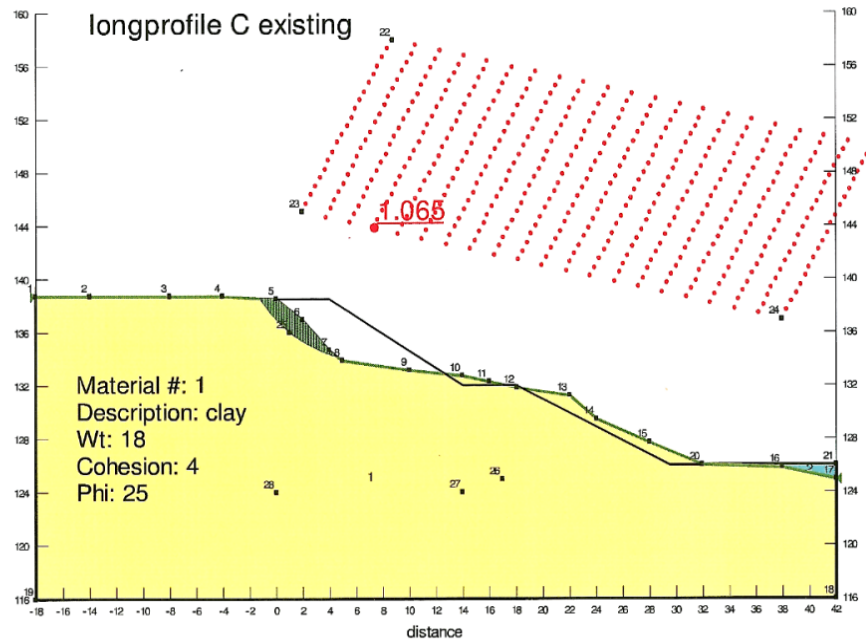
longprofile C existing :

result : 1,065

The slope safety factor of the existing slope is 1.06 very near to 1. The bad thing is that there is almost a permanent risk of a slope sliding in the upper part of the slope but the impact will be moderate due to the un-profound depth of the slip surface. Only the fence of the side would be probably impacted.

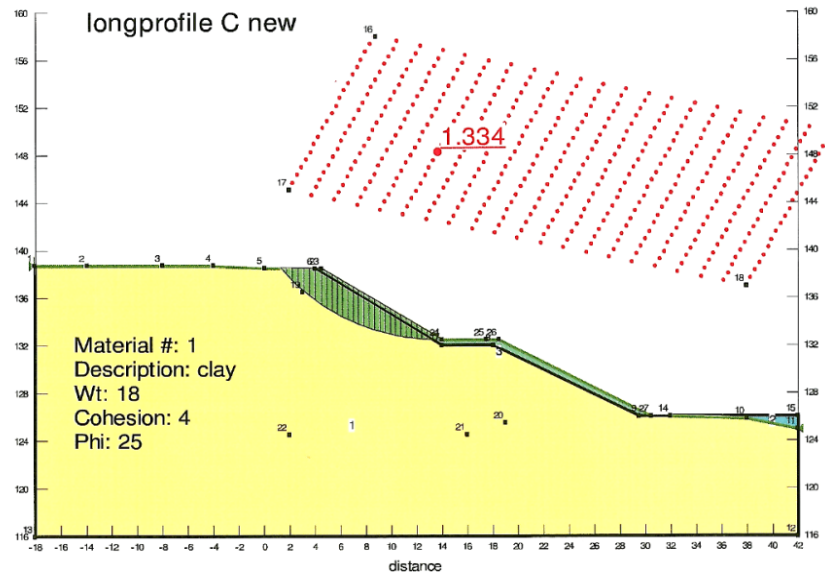
longprofile C with cover :

result : 1,33 , an additional 10 %
estimated 5 % with matmac

The anti-erosion structures (Geocells) have now a computed slope factor of safety of 1.33 or an additional increase of 10 % on the re-profiled slope. The factor of safety for utilising MacMat-R is about 1.28 or a 5 % increase on Option A.

From the two calculated situations is clear that the most critical sliding zone (shaded green) remains within the Rattlechain boundary and does not affect the canal and railway.

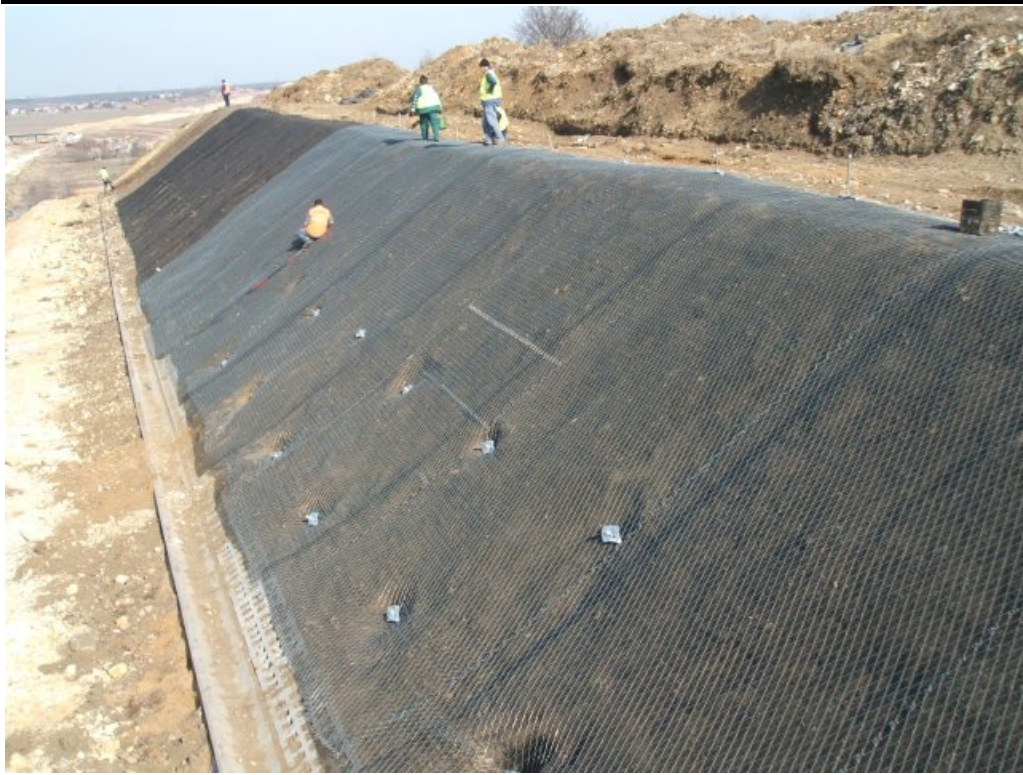
Once the slope has been shaped then a layer of topsoil of 10 cm is placed on the compacted slope. Then the MacMat-R is unrolled and nailed on the slope. Finally a thin layer of 5 cm topsoil will be placed on the anti-erosion structure. With the help of the rain topsoil will infiltrate and be captured in the monofilaments. Finally we will seed grass and for every square meter a bush will be planted. In annex you will find more general information concerning the MacMat-R anti-erosion artificial geostructure.

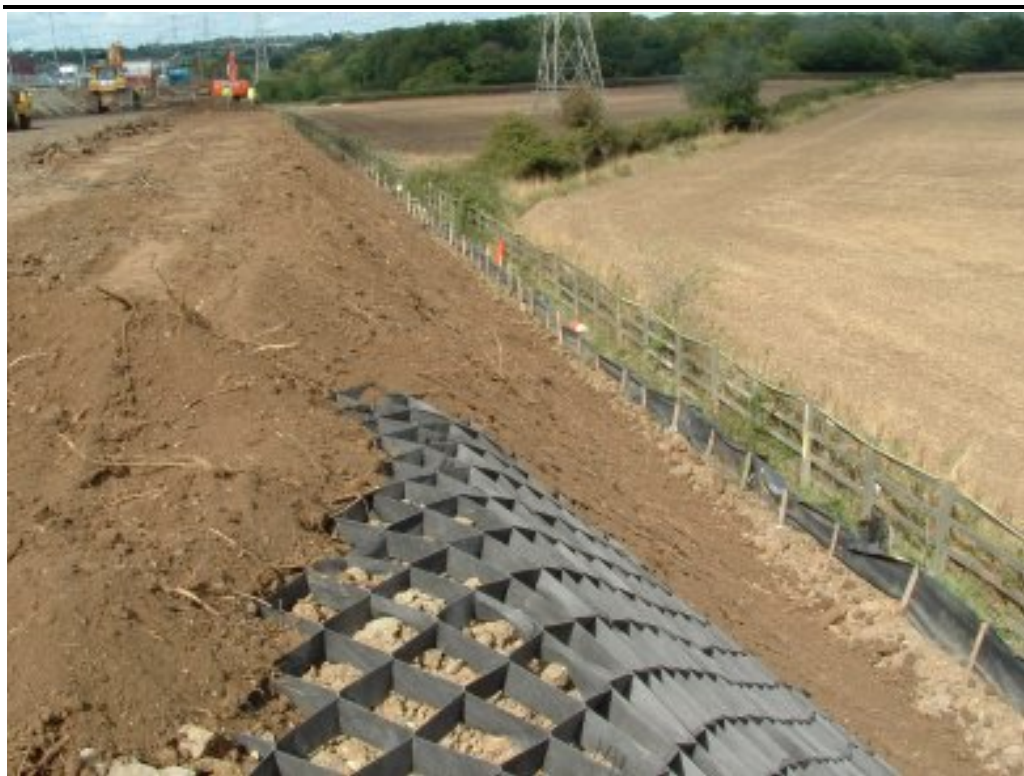
Taking in account that the angle of internal friction (φ) for loose topsoil is about 30° and that we would like to have topsoil layer of 10 cm over the complete cell then we have to take cells of 150 mm depth. Taking in account the height of the slope 11 m, the future slope angle would be about 34° , the angle of internal friction for loose topsoil is 30° and knowing the behaviour of the current slope we are coming to the conclusion to select a 20 Geocells structure per square meter with a depth of 150 mm.

The Geocells are perforated which gives the advantage that future grass and bushes roots will grow through resulting in the artificial anti-erosion structure being woven into the roots increasing slope stability. The Geocells will be placed and nailed/anchored on the slope and filled with good topsoil. Once the topsoil has been placed, grass will be seeded on the fertile soil and for every square meter a bush will be planted. In annex xx further information is provided in relation to Geocells.
