ELR:	EXR	Structure No:		Mileage:	4m 08ch	Examination date:	15/12/17
Route:	Exeter Railway					OS ref:	SX 864 903
Name:	Perridge Tunnel					Type:	Portals

Examiner Comments on Structure condition

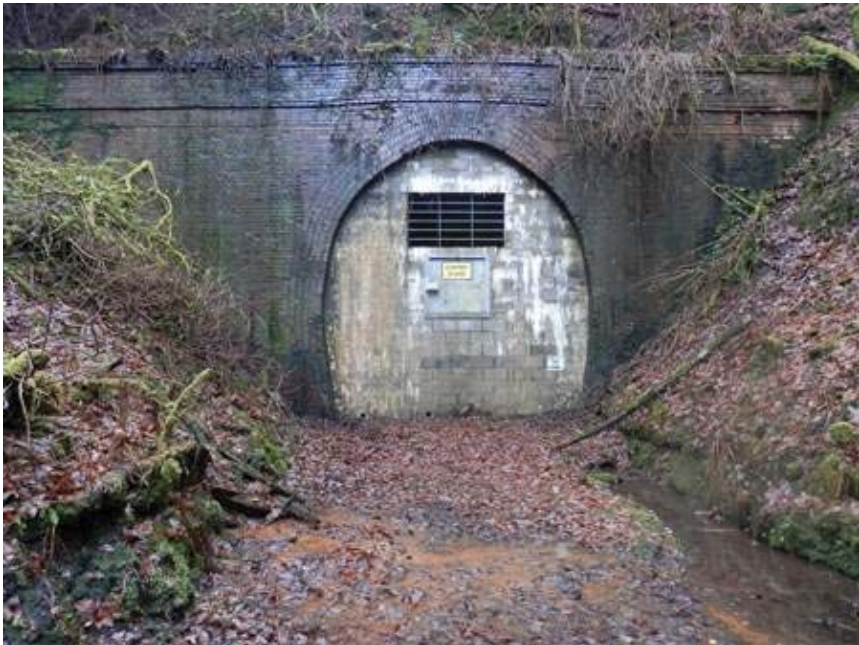
General view of structure: L/e portal	Examiner comments

<p>Services</p> <p>There is no evidence in the HE (HRE) Health and Safety File, previous examination reports nor as noted on site to confirm the presence of any statutory services affecting the structure</p> <p>The structure shows no change since the 2016/17 detailed report.</p> <p>Limited access to C/e portal due to deep water</p> <p>Main defects are noted on page 2.</p>				
<p>A Visual Examination of this structure has been carried out and any deterioration in condition or development of defects or other factors, which might place at risk the public at large, is recorded in the Examiner's Comments section of this document.</p>	<table border="1"> <tr> <td></td><td>Signed:</td></tr> <tr> <td></td><td></td></tr> </table>		Signed:		
	Signed:

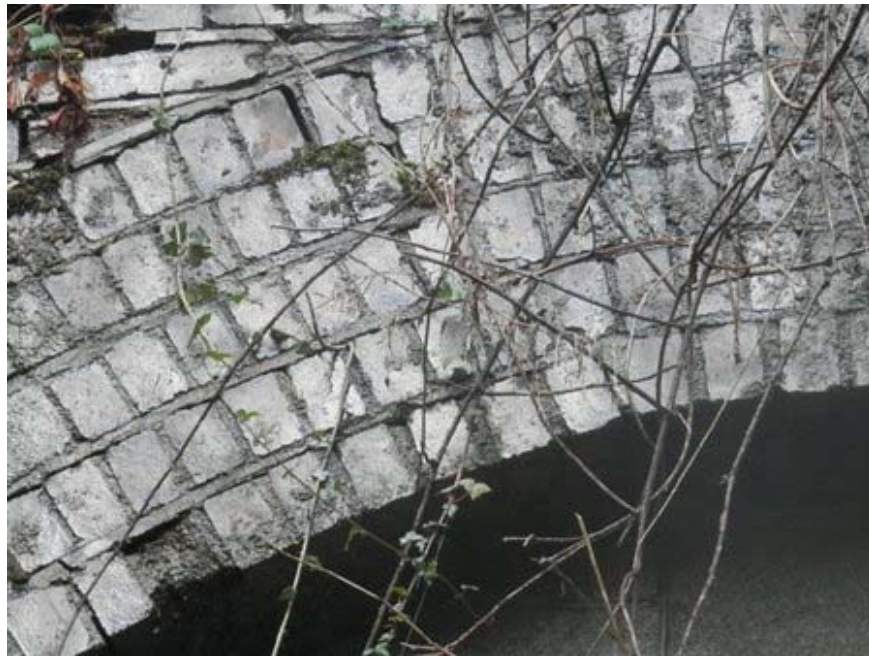
Photograph no 3:
D/L arch rings

0.5m² deep open joints to 100mm, 4mm wide stepped joint trough all rings 1m from crown to D/L arch rings **(P3)**

Both the above are longstanding but were not noted in last year's detailed report.

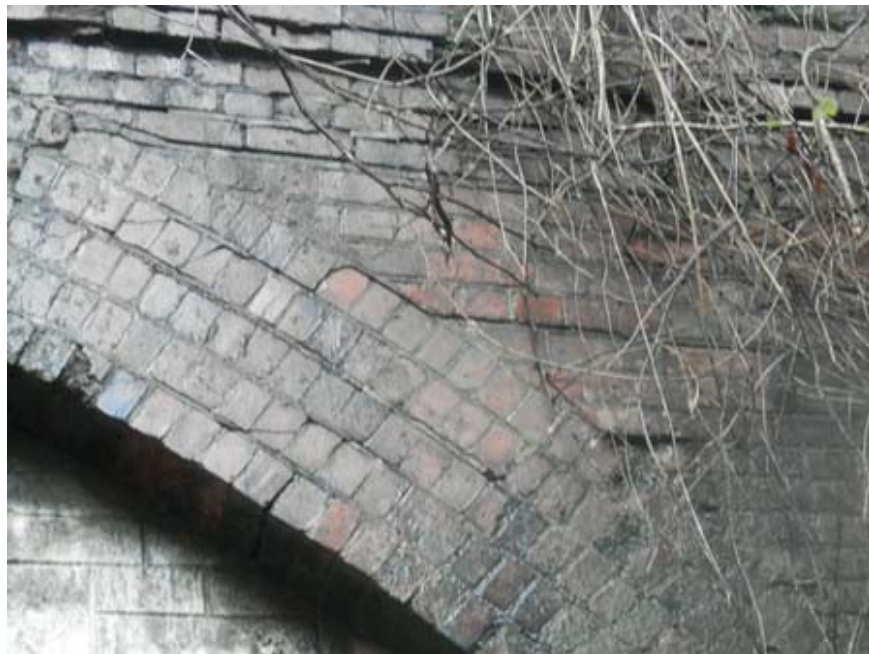
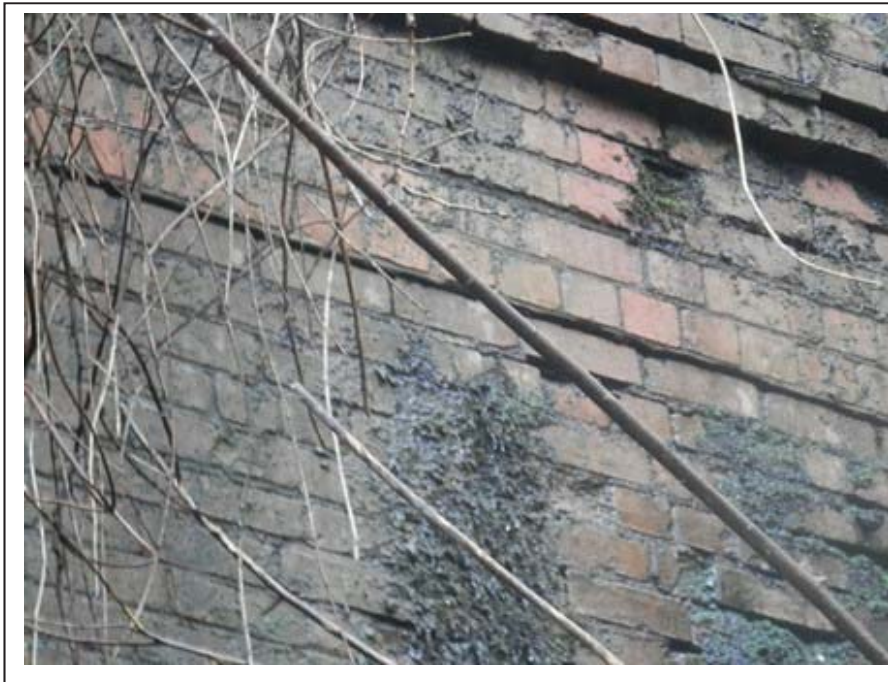
Photograph no 4:
U/L portal

Section of brickwork oversailing 5mm 5no courses below string course 4m long from quoin, 3mm wide horizontal joint fracture 7no courses below string course 3m long from arch rings (continuation of arch ring fracture) to U/L portal **(P4&5)**

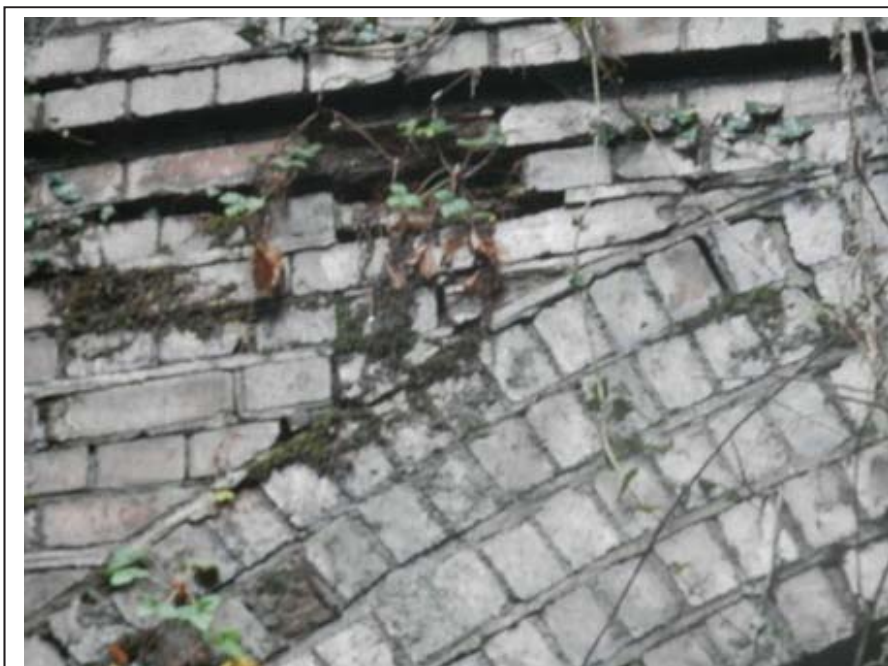
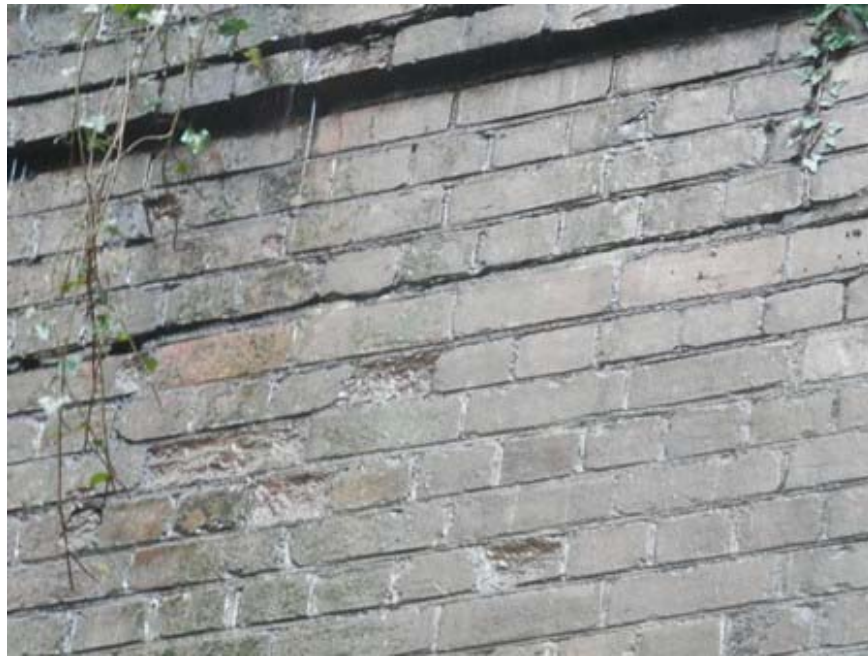
Photograph no 6:
D/L portal

1m² spalling 20mm, brickwork oversailing 7mm 4no courses below string course 6m long from quoin and 0.7m² irregular brickwork adjacent to arch rings with loose mortar to D/L portal **(P6&7)**

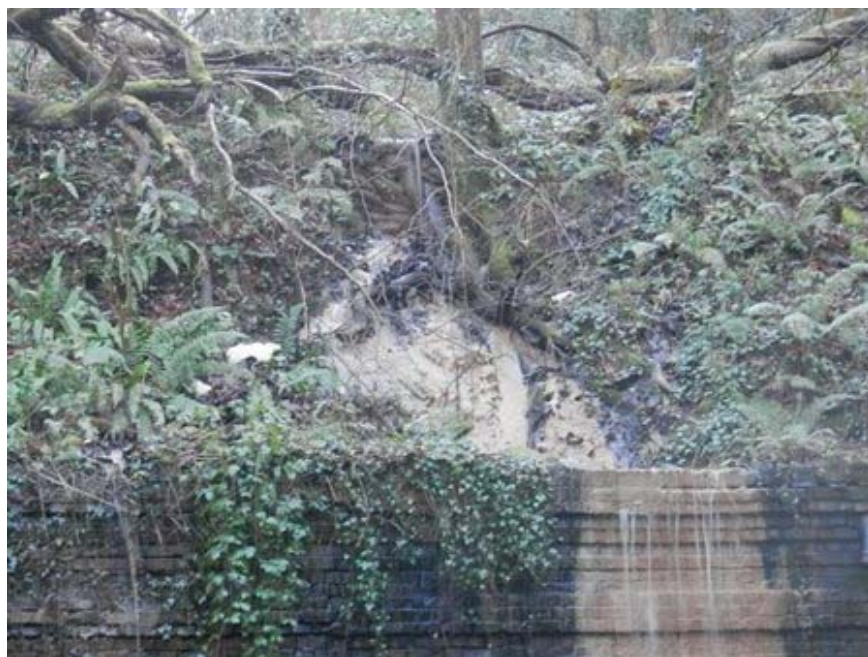
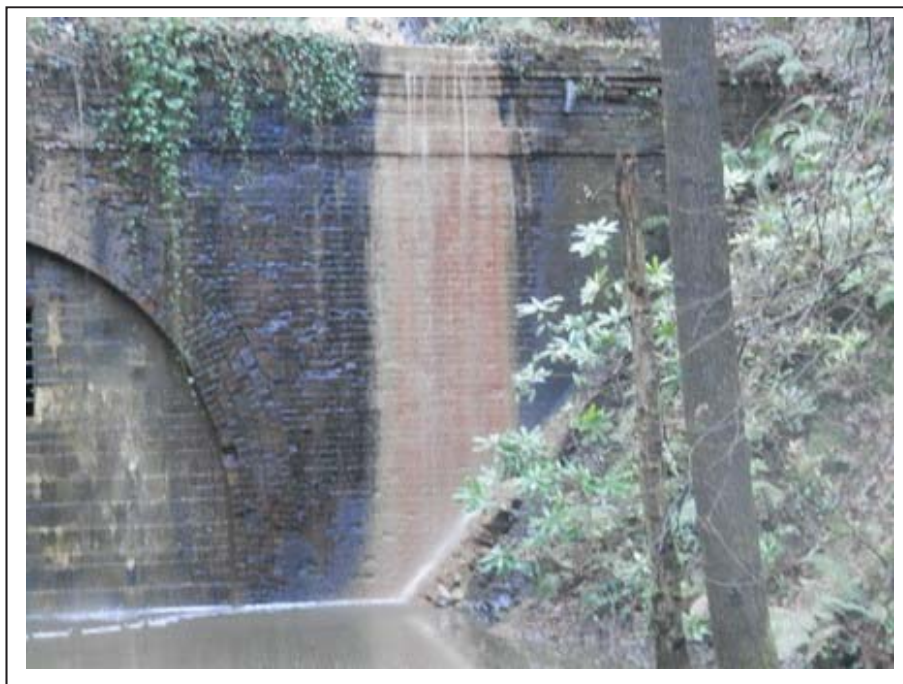
Photograph no 8:
D/C parapet

Large volumes of water flowing over D/C parapet **(P8&9)**

Resolve access problem to rear of DC headwall and unblock drain - P1 £750.
