# Phase One Desk-Based Study

November 2015

Development Securities (Lichfield) Limited a wholly owned subsidiary of U+I Group PLC

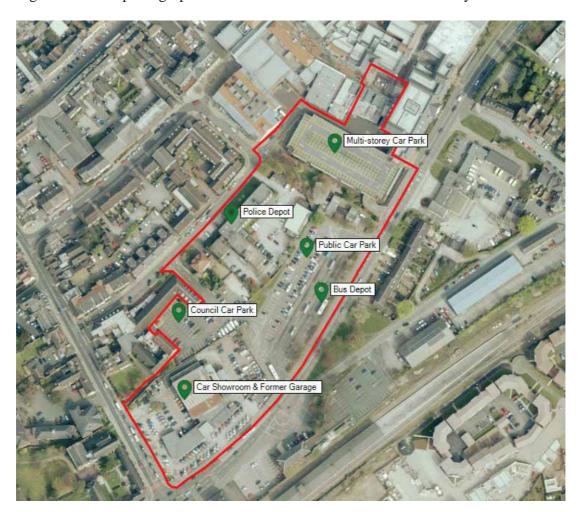
Figure 1: Aerial photograph of the site labelled with annotations of key site features.

An aerial photograph of the site, obtained from the Landmark Analysis tool, is included in Figure 1 below, which includes annotations of the key land-uses present at the site at the time of our walkover.

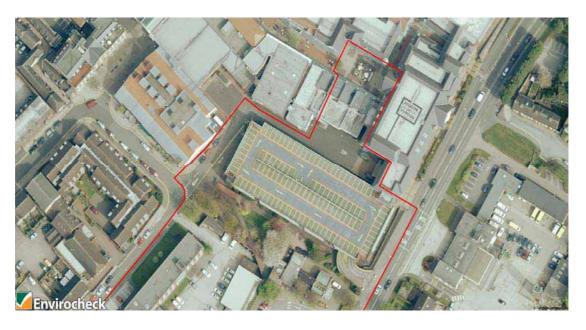
Figure 2: Aerial photograph of northern site area.

An aerial image of the northern area of the site, including the multi-storey car park, toilet block, newspaper kiosk, and existing retail units is provided in Figure 2 below.

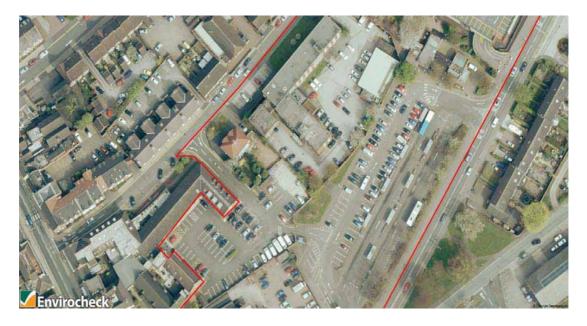
Figure 3: Aerial photograph of central site area.

An aerial image of the central part of the site, including the bus depot, off-street public car park, the police depot, existing residential dwellings and the Council car park is provided in Figure 3 below.

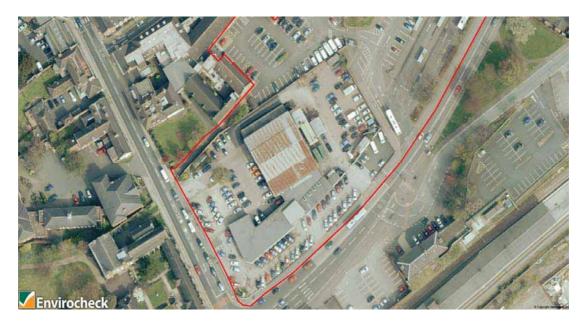
Figure 4: Aerial photograph of southern site area.

An aerial image of the southern part of the site, centred on the existing car showroom and former garage, is provided in Figure 4 below.

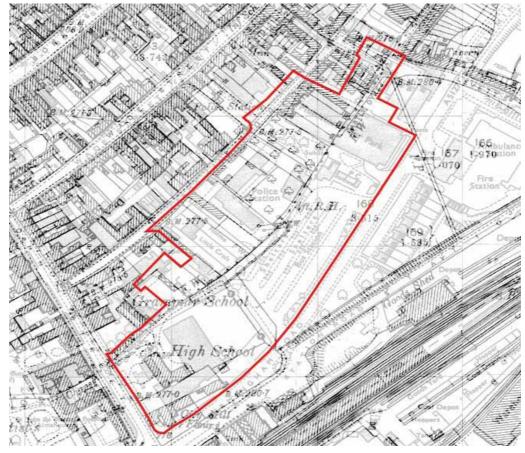
Figure 5: Historical map overlay of the 1902 and 1975 map sheets

Based on the historical map review included in Section 2.2, selected maps have been overlaid in order to provide a visual depiction of the key issues highlighted within the historical review. Figures 5 and 6 show the key historical features identified at the site.

The foregoing images show the Above-ground Storage Tanks (ASTs) present within the former garage in the southern part of the site, as well as the possible canopy to a former fuel filling area near to the sites southwestern boundary. Former buildings or structures are also locally indicated on the earlier historical plans, including the former High School and residential dwellings in the sites northern extent (seemingly removed to facilitate construction of the multi-storey car park).

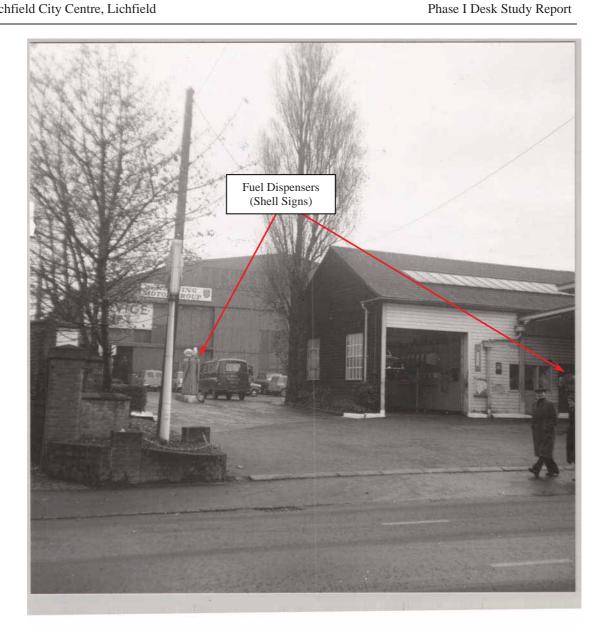
As part of the desk study we have undertaken an internet search for Kennings Ltd Lichfield, and have found the following undated photograph pertaining to this former land-use at the site (source: www.pinterest.com/pin/3987978418318).

The photograph is looking into the southwestern corner of the site from St John Street, towards the existing vehicle servicing and maintenance area. The photograph clearly shows that this area has also been historically utilised for vehicle servicing, and also reveals the presence of various fuel dispensers in the sites southwestern extent (as annotated on the photograph).

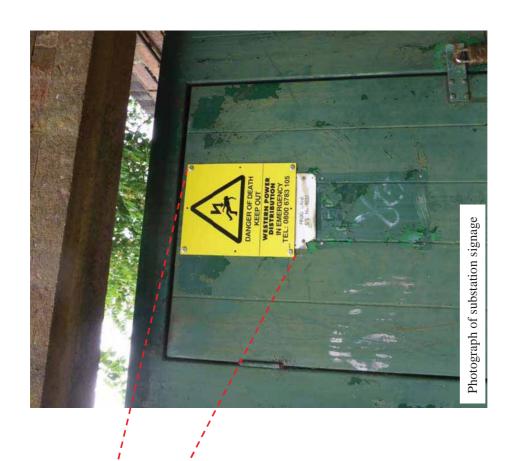
Photographs of electricity substation in northeastern part of site

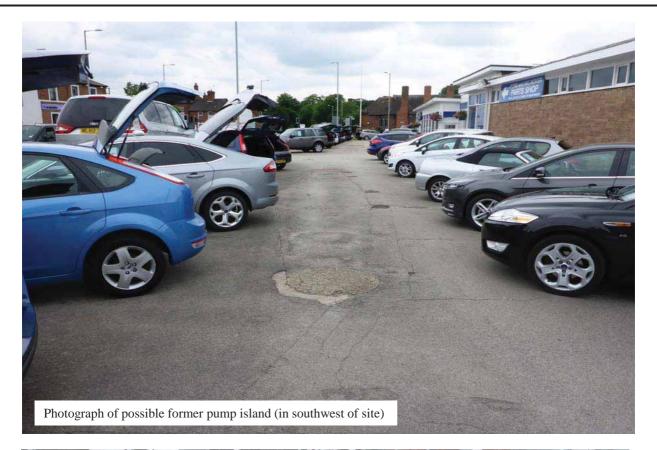
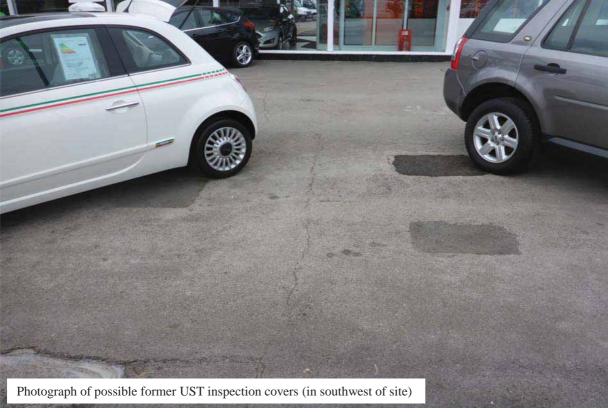
Project No.	15052	Drawn	DJH
Client	Development Securities (Lichfield) Limited a	Checked	
	wholly owned subsidiary of U + I Group PLC	Approved	
Project	Lichfield City Centre	Scale	NTS
	Lichfield	Date Drawn	27.08.15
Title	Photographs of possible former UST features	Rev.	
		Plate No.	2

A further series of USTs, again anecdotally inferred to be decommissioned by infilling with concrete, appear to have historically been situated at the southern edge of the site. The concrete scarring to the infilling of former manhole covers was evident in this area. A small soft landscape area formed the most southerly extent of the site, within which a concrete base was observed (anecdotally inferred to comprise the base to former fuel price signage). Whilst not visible at our visit, a drainage interceptor has been identified adjacent to the southern boundary by previous site inspections undertaken by WSP.

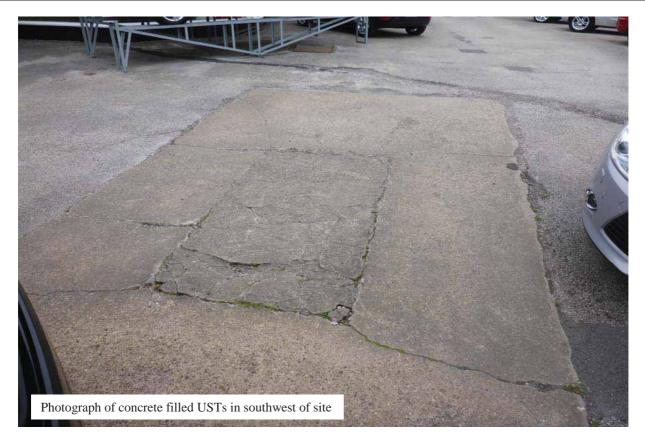
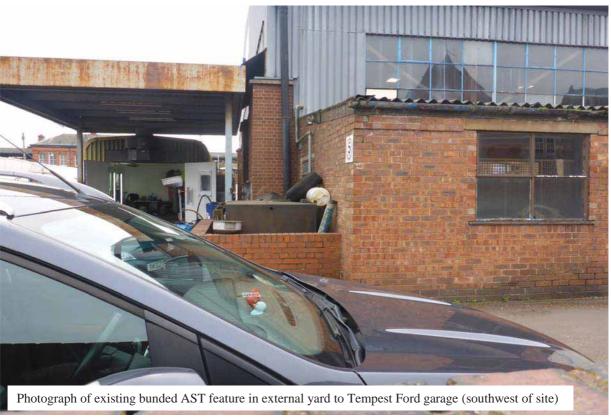
Plate No.	3
Title	Photographs of fuel storage features	Rev.	
	Lichfield	Date Drawn	27.08.15
Project	Lichfield City Centre	Scale	NTS
	wholly owned subsidiary of U + I Group PLC	Approved	
Client	Development Securities (Lichfield) Limited a	Checked	
Project No.	15052	Drawn	DJH

To the north of the main car showroom/garage, a relatively large yard area was situated, which we understand is utilised for both staff car parking and for the storage of vehicles undergoing maintenance and repair. Within this yard area, and adjacent to the northern face of the main building, an AST was located. The AST was housed within a brick bund. Additional ASTs (both historical and current) may have been present within the garage site.
