Phase I & II Geo-Environmental Assessment

Station Road/Blyth Road

Southwold
IP18 6AX

EPS Reference Number:	UK18.3076
Date Issued:	10 th May 2018
Report Status:	Issue 1

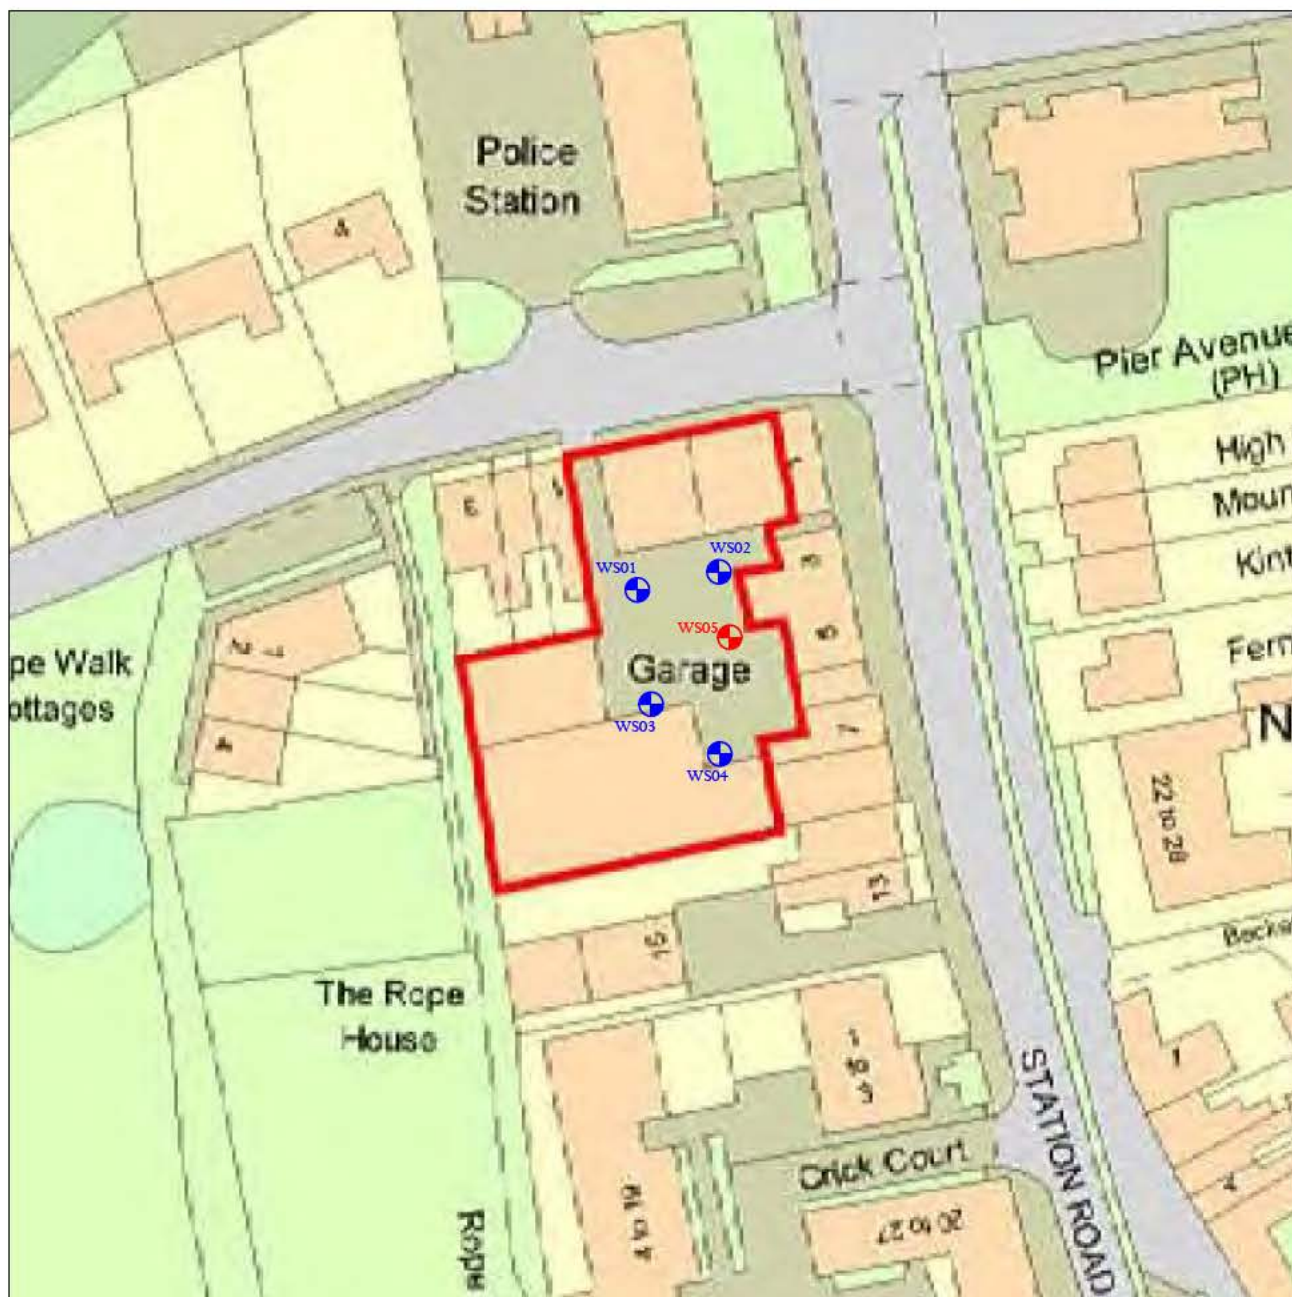
Dwg No: Southwold/0418/04

Approximate Site Boundary —

Approximate EPS Borehole Locations WS1

Each borehole was logged for ground conditions encountered and inspected for any physical evidence of contamination, such as soil staining, odour and the presence of separate phase liquids on a precautionary basis. Borehole logs are presented in Appendix G.

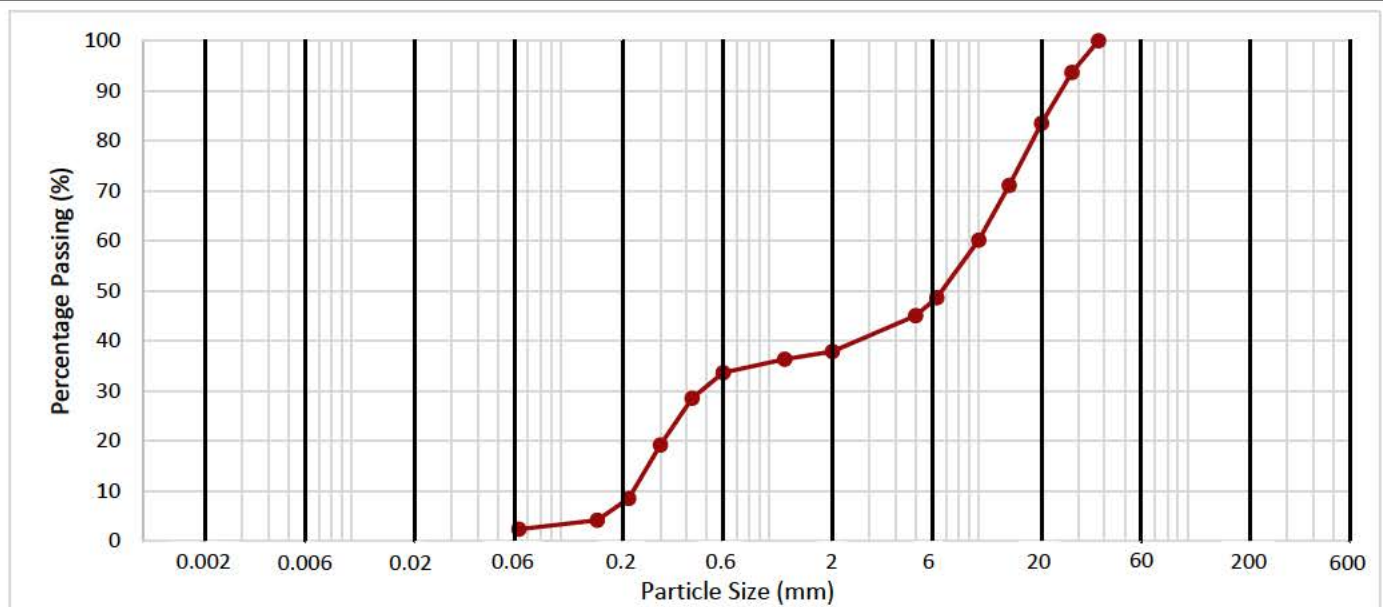
CLAY	Fine	Medium	Coarse	Fine	Medium	Coarse	Fine	Medium	Coarse	COBBLES	BOULDERS
	SILT			SAND			GRAVEL

Hydrometer	Particle Size (mm)	Passing (%)	Silt by Dry Mass (%)
	Particle Size (mm)	Passing (%)	Clay by Dry Mass (%)

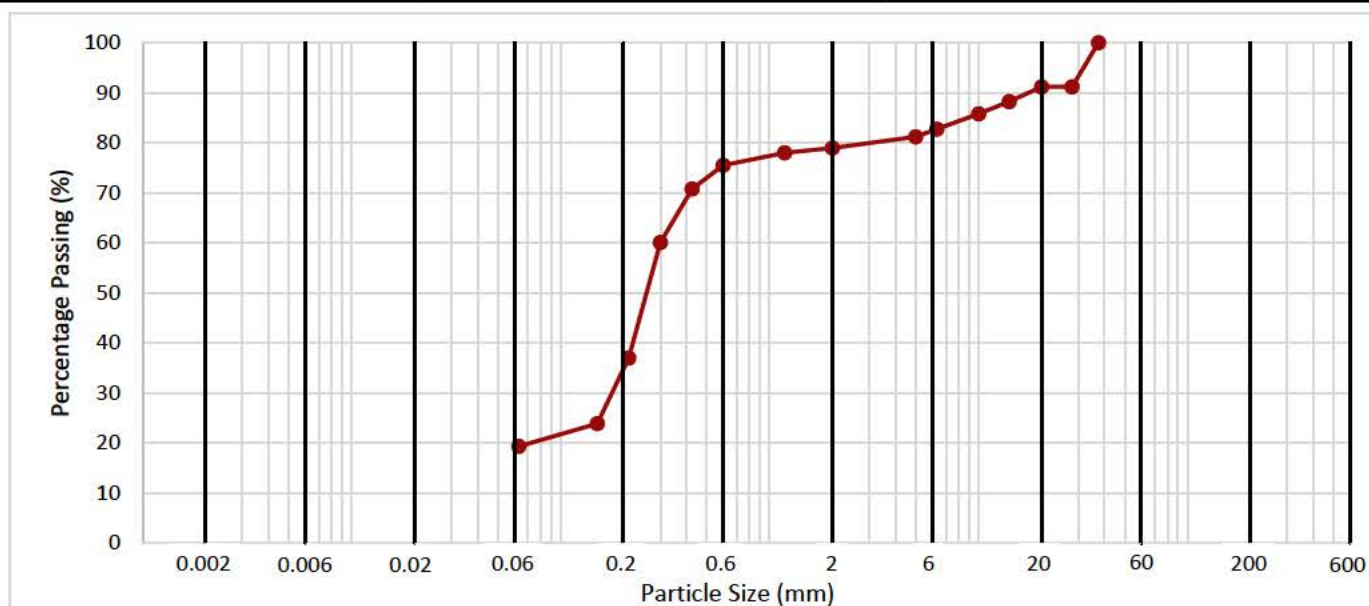
CLAY	Fine	Medium	Coarse	Fine	Medium	Coarse	Fine	Medium	Coarse	COBBLES	BOULDERS
	SILT			SAND			GRAVEL

Hydrometer	Particle Size (mm)	Passing (%)	Silt by Dry Mass (%)
	Particle Size (mm)	Passing (%)	Clay by Dry Mass (%)

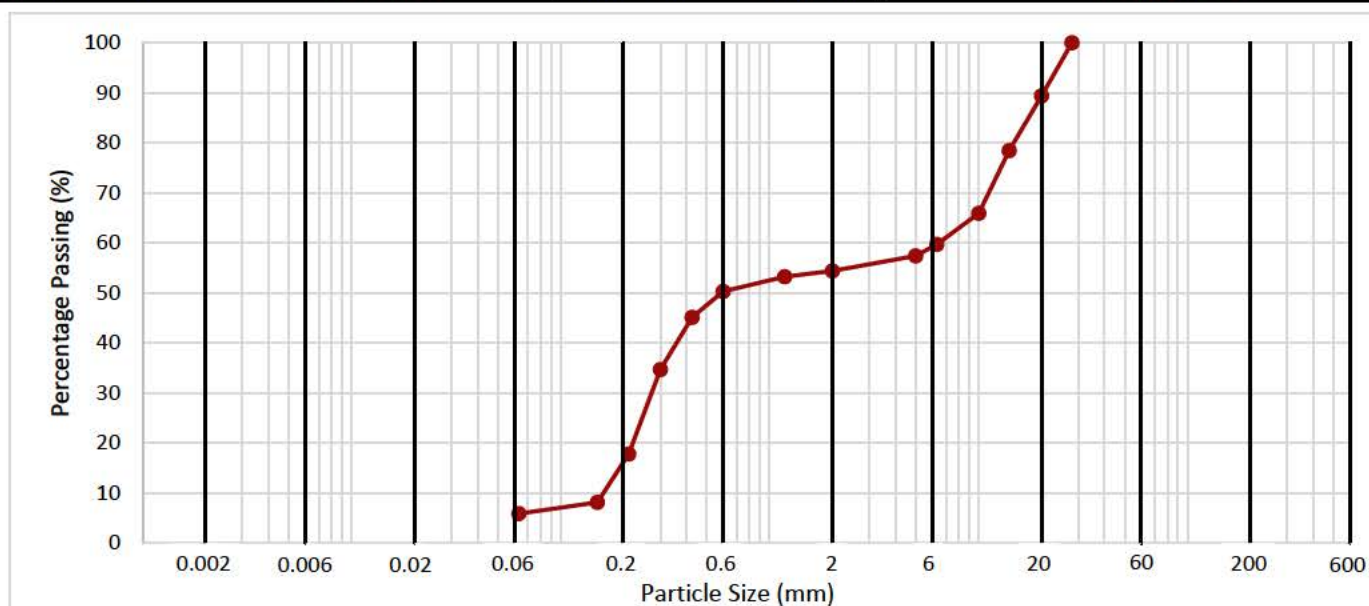
CLAY	Fine	Medium	Coarse	Fine	Medium	Coarse	Fine	Medium	Coarse	COBBLES	BOULDERS
	SILT			SAND			GRAVEL

Hydrometer	Particle Size (mm)	Passing (%)	Silt by Dry Mass (%)
	Particle Size (mm)	Passing (%)	Clay by Dry Mass (%)
