2nd May 2018

RE: Protected species inspection of buildings at Station Road, Southwold

Wild Frontier Ecology were commissioned to evaluate the protected species potential of buildings which are proposed to be demolished and replaced at Station Road, Southwold. The plan below shows the buildings concerned outlined in red.

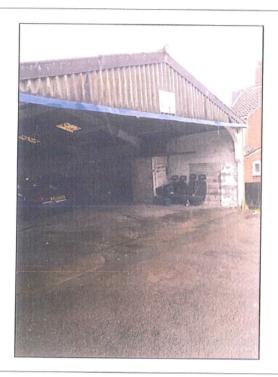
Photo 1 - Industrial building 1 - exterior

- Industrial building 1 (photo 1) is an open-fronted shed with breeze block walls and a cement-fibre roof, supported by a concrete-steel frame. There are roof lights.
- Industrial building 2 (photo 2) is an enclosed shed with cement-fibre walls and roof, and a steel frame. There are large roof lights.
- Industrial building 3 (photo 3) is a two storey corrugated metal walled construction, with large lights in the corrugated roof.
- The cycle hire and vehicle garage (photo 4) is a compartmentalised two storey shed with cement fibre walls and roof. The roof has large lights. On the rear of this building is a small section of weatherboarding (photo 5).

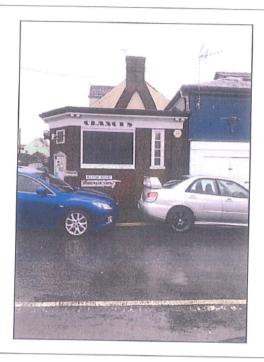
Photo 5: General store exterior

The general store is a flat-roofed brick building, with sealed eaves, and is still in use (photo 6).
