# **Asbestos Material & Priority Assessment Report**

**011 - Brooklands Parade TAJ78**

**Survey Report Number** J099848

## Brooklands Parade TAJ78

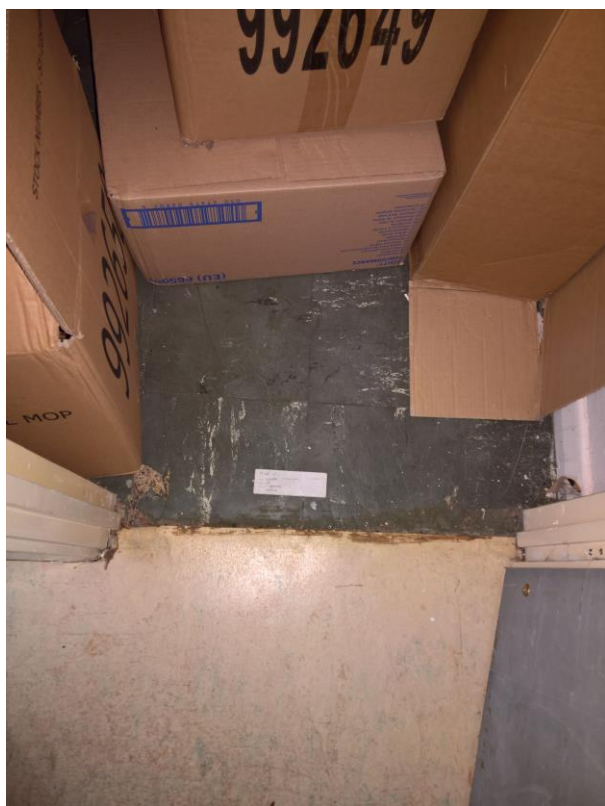
**Sample Record Number:** FD001552

Inspection Date	15/9/2016		
Component:	<b>Grey Floor Tiles</b>	Sample No.	<b>FD001552</b>
Survey Type	Type 2	Surveyor	Richard Farmer
Asbestos type	<b>Chrysotile</b>		
Quantity of Material	<b>2m<sup>2</sup></b>

Material	1	Extent of Damage	1
Surface Treatment	0	Asbestos Type	1
<b>Material Assessment Total:</b>	<b>3</b>	<b>D</b>

Some broken edges to floor tiles near to the store cupboard door. Incorporate ACM into management plan until removal.

<b>Actions Arising</b>	<b>Due Date</b>	<b>Est. Cost</b>
Label & Manage	9-11-2016	£0

<b>Re-Inspection Schedule:</b>	<b>Status</b>	<b>Due Date</b>
	Due after six Months	15-9-2017

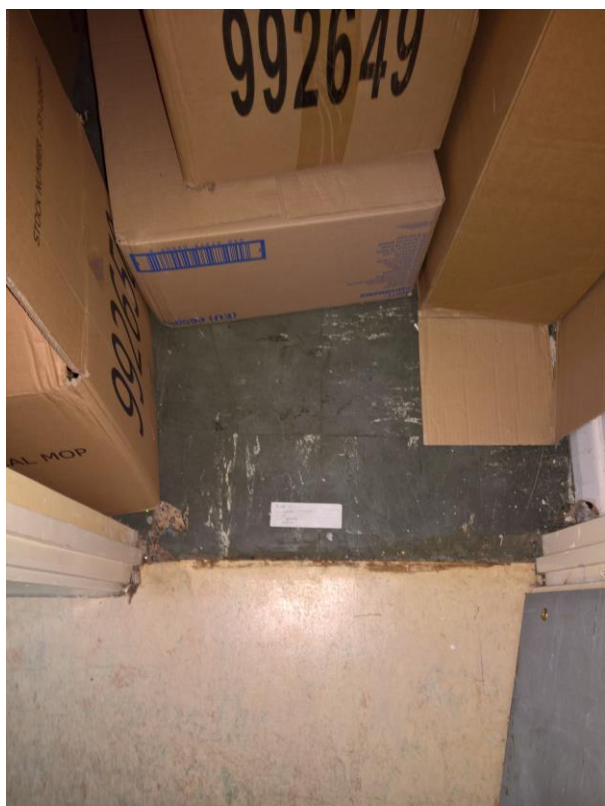
**Sample Record Number:** FD001552a

Inspection Date	15/9/2016		
Component:	Bitumen adhesive	Sample No.	FD001552a
Survey Type	Type 2	Surveyor	Richard Farmer
Asbestos type	Chrysotile		
Quantity of Material	2m <sup>2</sup>

Material	1	Extent of Damage	1
Surface Treatment	0	Asbestos Type	1
<b>Material Assessment Total:</b>	<b>3</b>	<b>D</b>

Broken edges to floor tiles near to the store cupboard door. Incorporate ACM into management plan until removal.

Actions Arising	Due Date	Est. Cost
Label & Manage	9-11-2016	£0

Due after six Months	15-9-2017
