Proposed Biggins Wood Development, Folkestone.

Interim Generic Quantitative Environmental Risk Assessment

June 2016

Waterman Infrastructure & Environment Limited

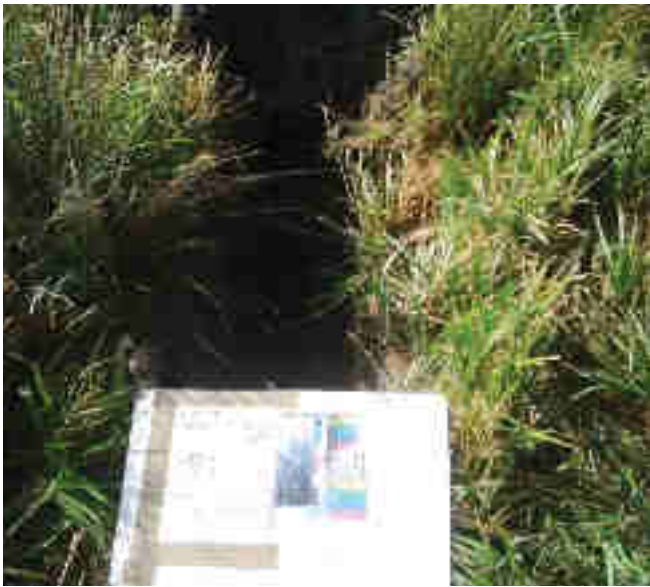
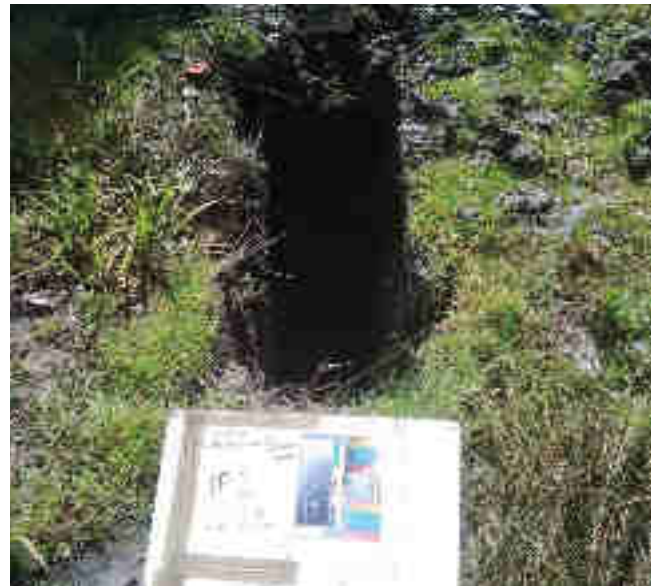
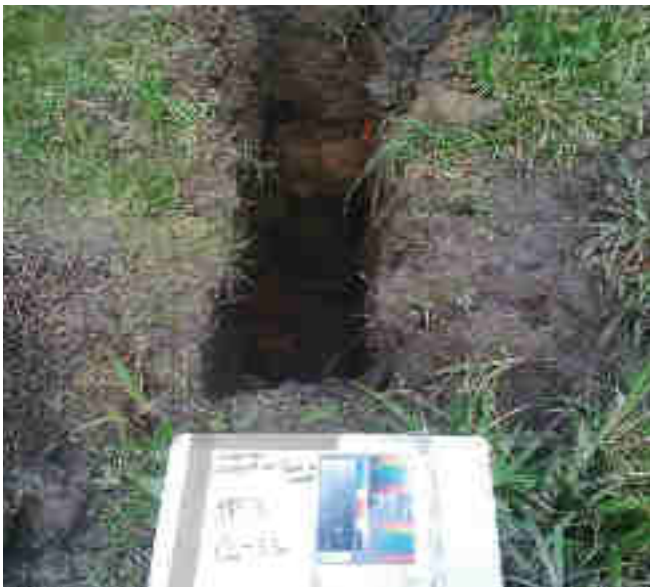
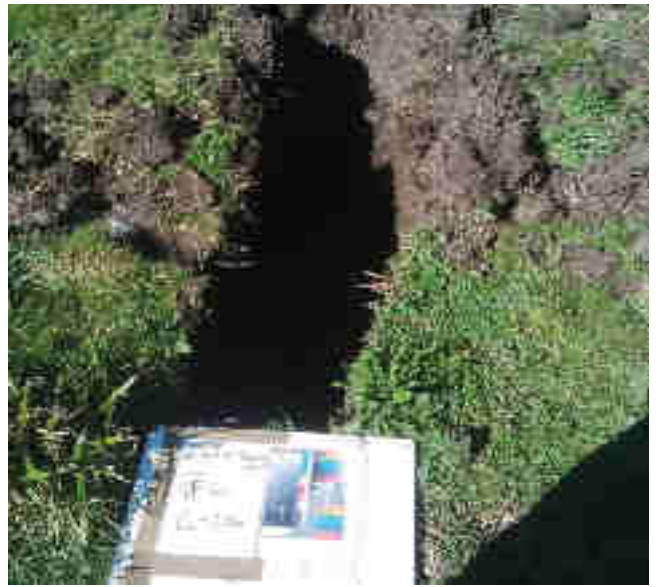
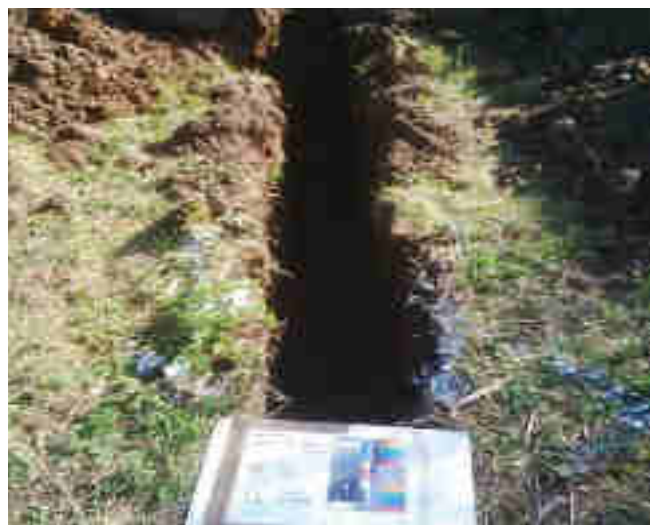
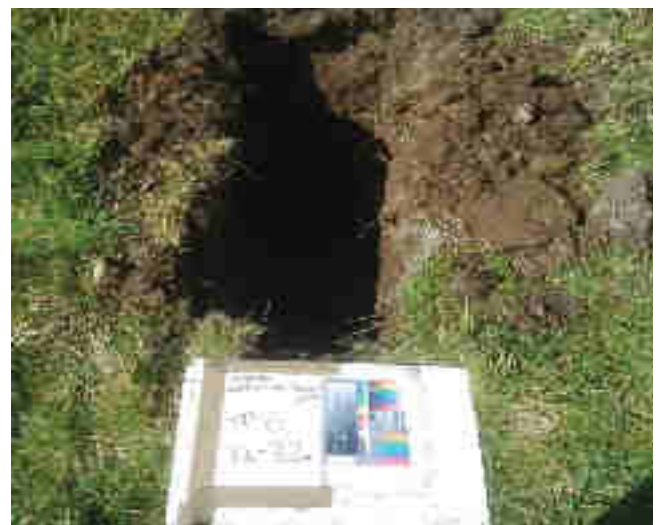
BOREHOLE TP18 - 11/04/16 - 425.00

Boring Progress and Water Observations						Chiselling			Water Added		GENERAL REMARKS
Date	Time	Depth	Casing Depth	Obs. Time	Water Depth	From	To	Hours	From	To	
											Test hole terminated at 1.30m. Excavation remained open and dry on completion.
All dimensions in metres Scale 1:25.75			Client Engineer Jon Croucher			Machine Plant Used JCB 300K			Logged By Darran Comer
