LBPN Lambeth

Review of Clapham Park Road
Eastbound Bus Lane

May 2007

JOB NUMBER: 4411274.514			DOCUMENT REF: Clapham Pk Rd - Bus Lane Review - Report RevA.doc			
A	Revised Draft Report	KK/KS	TKG	EC	SH	May 07
-	Draft Report	KK/ST	KK	SH	TKG	Mar 07
		Originated	Checked	Reviewed	Authorised	Date
Revision	Purpose Description	ATKINS

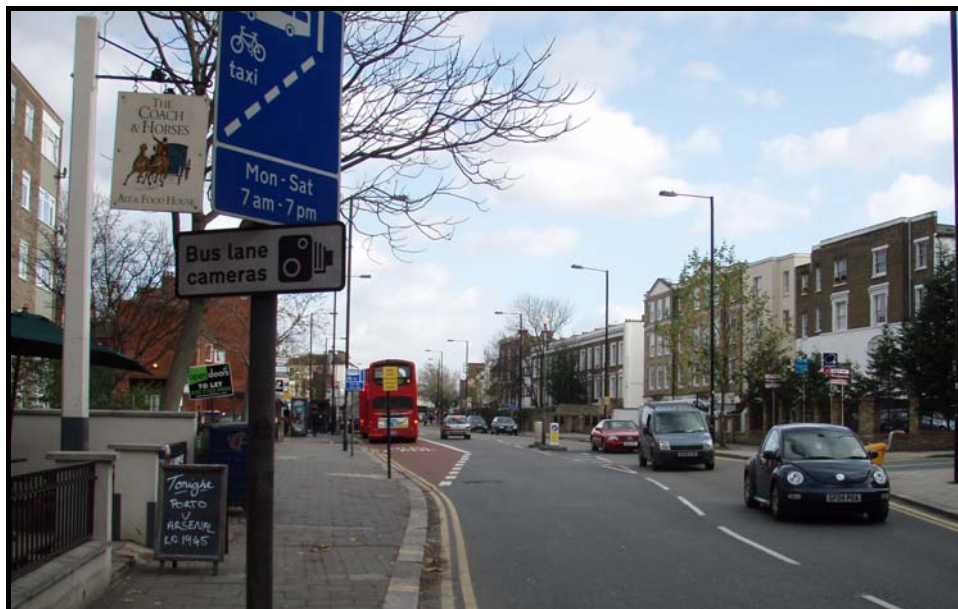
Figure 1.2 – View of the Approach to the Bus Lane

- 1.5 The bus lane is currently located on Clapham Park Road in an eastbound direction between Northbourne Road and the approach to Bedford Road. The bus lane, first introduced in March 1986, is approximately 55 metres long and operates on Monday to Saturday between 7am and 7pm. Buses that utilise this bus lane include Routes 35, 37, 137 and 417.
- 1.6 The bus lane incorporates one bus stop and has a 'No Waiting and No Loading At Any Time' restriction indicated over the full length.
- 1.7 Both pedal cycles and taxis are permitted to use the bus lane.
- 1.8 A general view of the approach to the bus lane is shown in Figure 1.2 below.

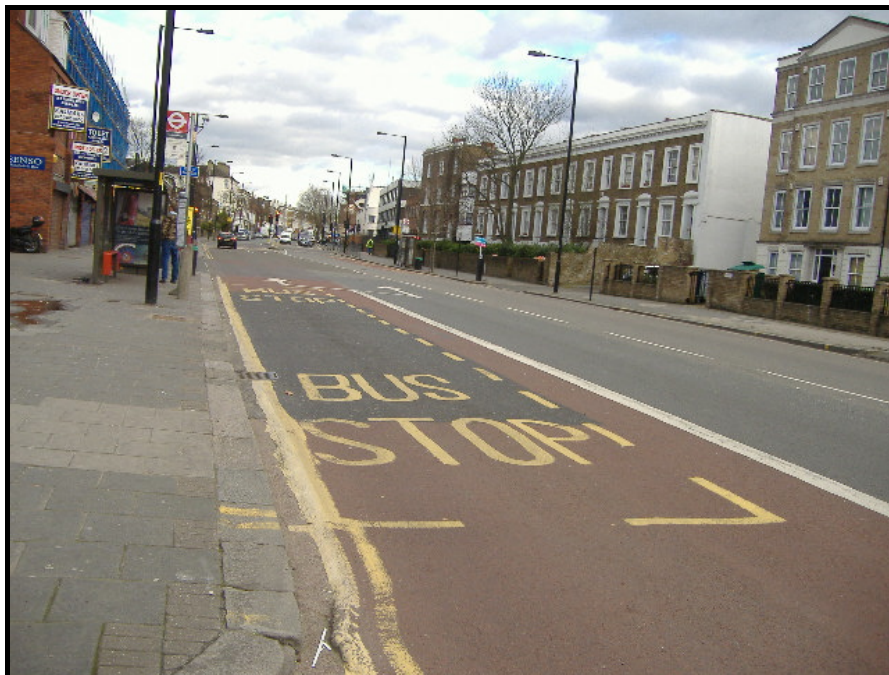
Figure 2.1 – View of the Missing Red Surface within the Bus Cage

- 2.1 A site assessment was undertaken in December 2006. Details of all linemarking and signage were recorded in both directions on-site between Northbourne Road and Bedford Road.
- 2.2 An existing layout is shown on drawing number 4411274/514/001 in Appendix A.
- 2.3 There is an inset parking bay downstream of the bus lane which enables parking, without causing delays to buses.
- 2.4 The site assessment identified that a section of red surface marking within the bus cage was missing. Part of the solid white line demarcating the bus lane, of approximately 4.3 metres long, has been removed after the bifurcation arrow linemarking and bus cage, however, it is still partially visible. The red surface continues for the 4.3 metres. These issues are highlighted in Figure 2.1 and Figure 2.2.

- 4.1 The existing bus lane markings terminate three metres short of that defined in the TMO however, the bus lane is still enforceable. There is red surfacing and a faintly visible solid linemarking which extends for 4.3 metres beyond the existing bus lane marking. There is also a section of red surfacing that is missing in the middle of the bus lane.

- 4.12 Although the bus lane is currently enforceable, it is recommended that the faded solid linemarkings at the end of the bus lane be permanently removed by sandblasting and the additional 1.3 metres of red surface dressing be removed. This will eliminate any confusion at the end of the bus lane.

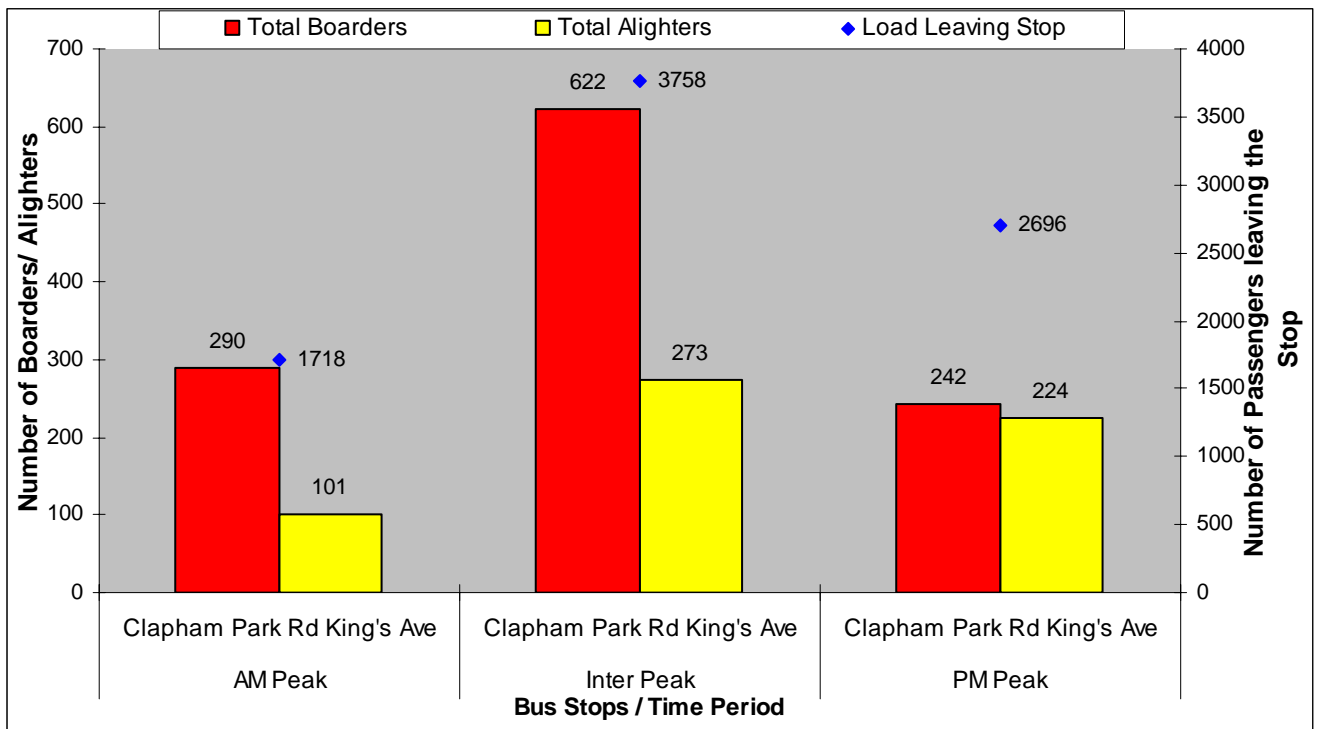
Figure 3.1 – Summary of the Passenger Activity at the Bus Stop in the Bus Lane

- 3.15 All surveys have been factored up to 2006 values based on passenger journeys provided by TfL¹.
- 3.16 A summary of passengers boarding, alighting and leaving the bus stop within the bus lane is shown in Figure 3.1. The results show that there are more boarders than alighters in all peak periods, with the Inter-Peak period having the greatest number. The particularly high number of boarders during the Inter-Peak suggests that these routes are serving the local residents well outside the peak hours.
- 3.17 It is significant that during the Inter-Peak the load leaving is relatively higher along the route than during the peak periods. This could indicate that this route is better serving the local community undertaking shorter daytime journeys rather than longer commuter trips to work.
