DEMOLITION ASBESTOS SURVEY
OF
BUILDING 145,
HMS DAEDALUS,
BROOM WAY,
LEE ON SOLENT,
HAMPSHIRE
PO13 9YA
ON BEHALF OF
HOMES & COMMUNITIES AGENCY

A demolition asbestos survey was carried out at Building 145, HMS Daedalus, Broom Way, Lee on Solent, Hampshire, PO13 9YA. To carry out a R & D survey of the building

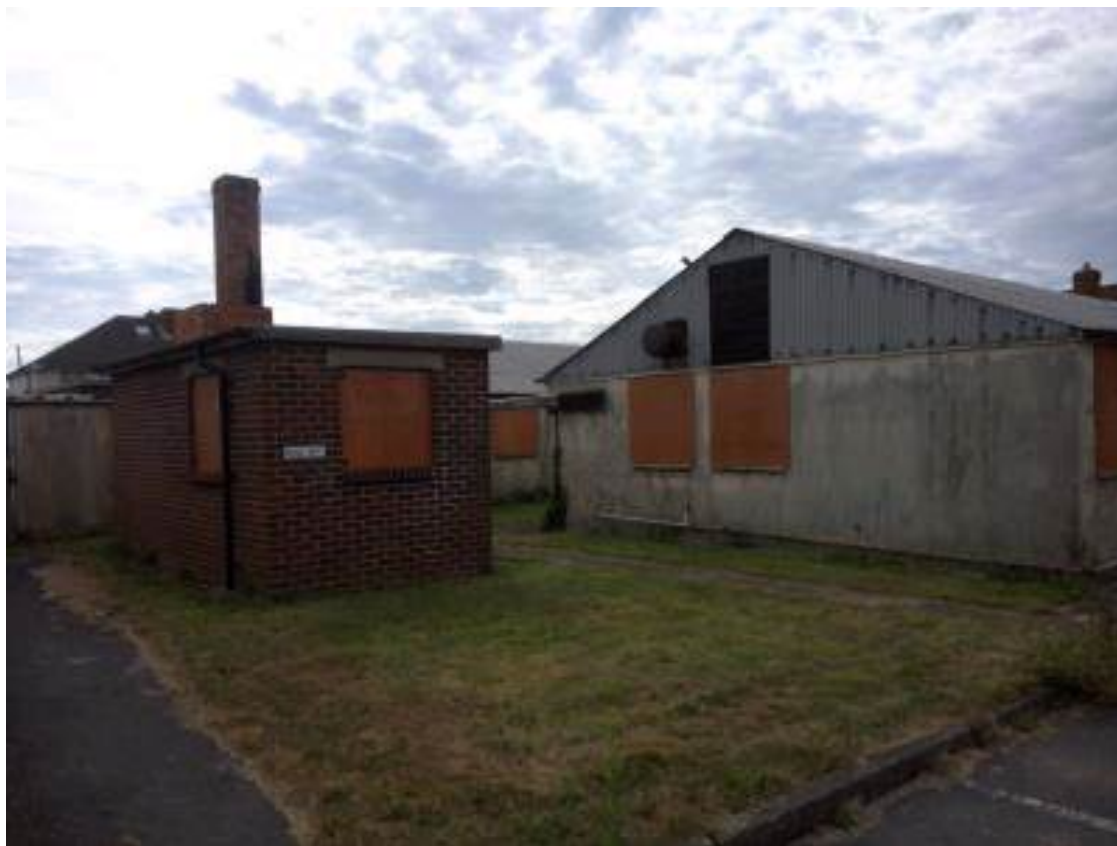
Externally the building is constructed of brick/concrete walls, damp proof course to brick walls, metal sheets to pitched roofs, cement sheeting to roof above room 001, asphalt to flat concrete roof above room 005, lead flashing to roofs, concrete window sills, metal window frames, wooden fascia boards, plastic guttering and downpipes, felt covering to high level windows, metal vents to walls, metal sheeting to fascias of pitched roofs to roof apexes, MMMF insulation to metal pipework.

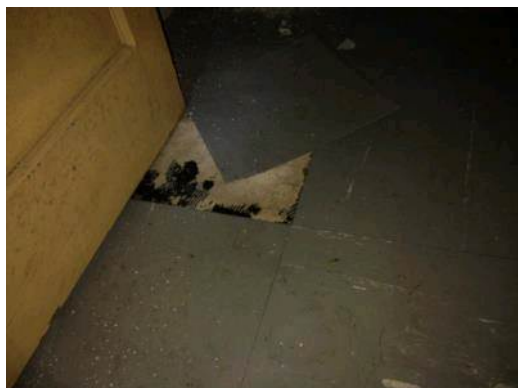
Sample 6: Building 145. Ground Floor. Room 013. Vinyl floor tiles (green) and bitumen adhesive beneath to concrete floor

SAMPLE NUMBER	SAMPLE DESCRIPTION	PRODUCT TYPE	ACTION REQUIRED
Sample 6	Building 145. Ground Floor. G.03 Room 013, Vinyl floor tiles (green) and bitumen adhesive beneath to concrete floor	Vinyl tile & adhesive	Removal of non-licensed ACMs (Remove (non-licensed))
Ref. Sample 6	Building 145. Ground Floor. G.04 Room 014, Vinyl floor tiles (green) and bitumen adhesive beneath to concrete floor	Vinyl tile & adhesive	Removal of non-licensed ACMs (Remove (non-licensed))
Sample 8	Building 145. Ground Floor. G.05 Room 015, Dampener and drainer pads beneath sink and drainer	Bitumen	Removal of non-licensed ACMs (Remove (non-licensed))
Sample 10	Building 145. Ground Floor. G.07 Room 017, Woven expansion sleeves to x2 metal ducting to ceiling	Woven	Removal of non-licensed ACMs (Remove (non-licensed))
Sample 15	Building 145. Ground Floor. G.13 Room 001, Cement sheets and associated debris to floor throughout	Asbestos Cement	Removal of non-licensed ACMs (Remove (non-licensed))

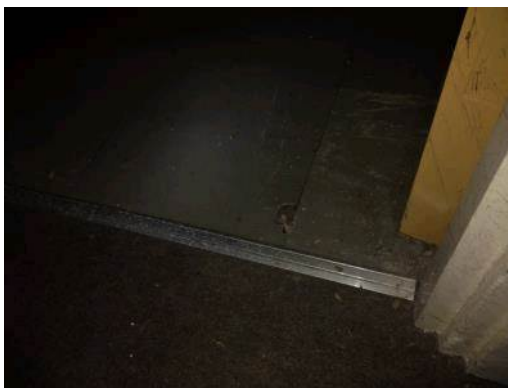
Ref. Sample 6: Building 145. Ground Floor. Room 014. Vinyl floor tiles (green) and bitumen adhesive beneath to concrete floor

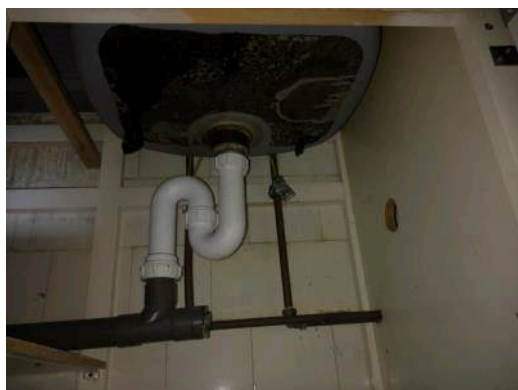
Sample 8: Building 145. Ground Floor. Room 015. Dampener and drainer pads beneath sink and drainer

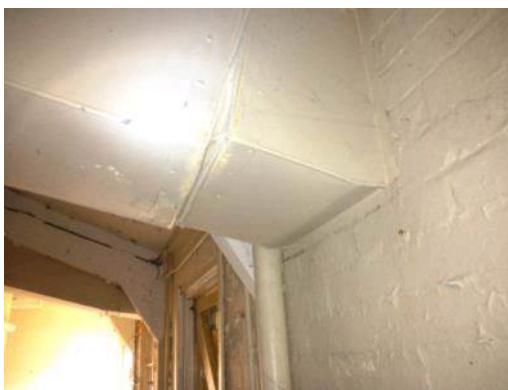
Sample 10: Building 145. Ground Floor. Room 017. Woven expansion sleeves to x2 metal ducting to ceiling

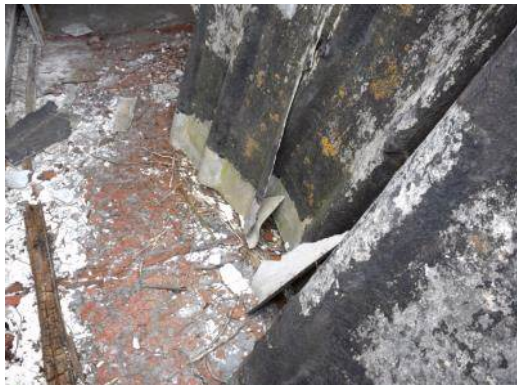
Sample 15: Building 145. Ground Floor. Room 001. Cement sheets and associated debris to floor throughout

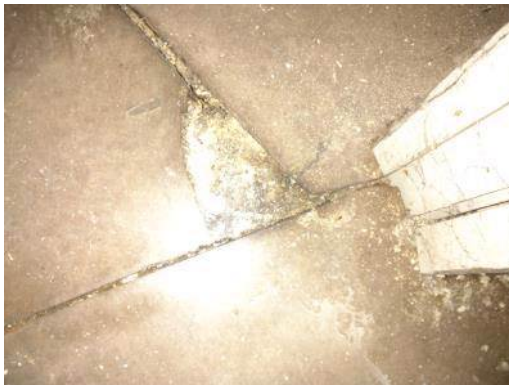
Sample 21: Building 145. Ground Floor. Throughout. Screed to concrete floor beneath carpet and vinyl lay throughout

Sample 21	Building 145. Ground Floor. G.22 Throughout, Screed to concrete floor beneath carpet and vinyl lay throughout	Bitumen	Removal of non-licensed ACMs (Remove (non-licensed))
Sample 29	Building 145. External. E.02 Boiler House, Typical gasket to pipework joints throughout	Gasket	Removal of non-licensed ACMs (Remove (non-licensed))
Sample 30	Building 145. External. E.01 External, Corrugated cement roof sheets above room 001	Asbestos Cement	Removal of non-licensed ACMs (Remove (non-licensed))

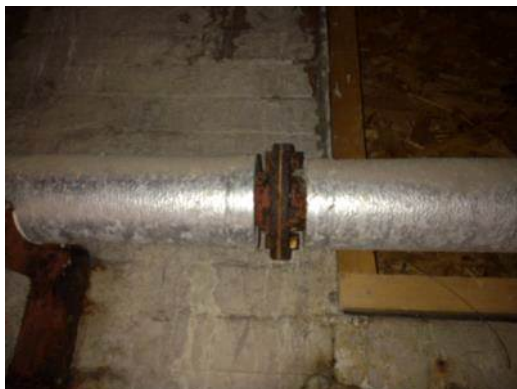
Sample 29: Building 145. External. Boiler House. Typical gasket to pipework joints throughout

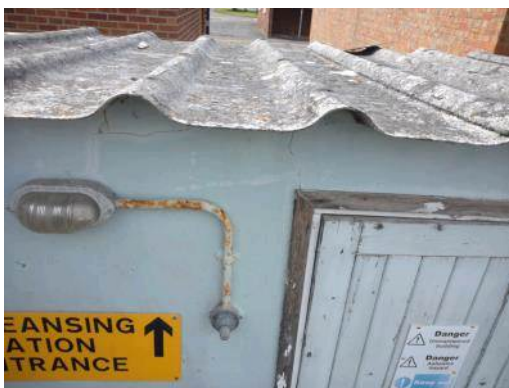
Sample 30	Building 145. External. E.01 External, Corrugated cement roof sheets above room 001	Asbestos Cement

Sample 30: Building 145. External. External. Corrugated cement roof sheets above room 001
