DEMOLITION ASBESTOS SURVEY
OF
BUILDING 146,
HMS DAEDALUS,
BROOM WAY,
LEE ON SOLENT,
HAMPSHIRE
PO13 9YA
ON BEHALF OF
HOMES & COMMUNITIES AGENCY LTD

Asbestos Fibre Identification Report

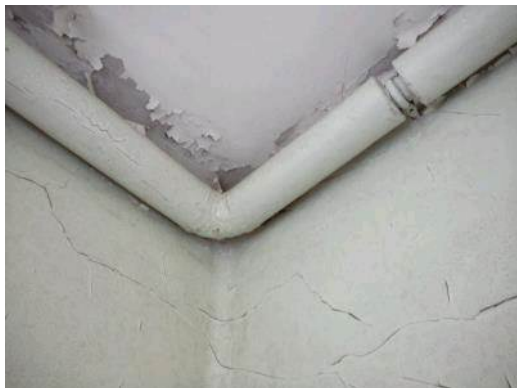
Sample 5: Building 146. Ground Floor. Room 005. Insulation to high level pipework bend/knuckle

SAMPLE NUMBER	SAMPLE DESCRIPTION	PRODUCT TYPE	ACTION REQUIRED
Sample 5	Building 146. Ground Floor. G.05 Room 005, Insulation to high level pipework bend/knuckle	Asbestos Insulation/Coating	Removal of licensed ACMs (Remove (licensed))
Ref. Sample 5	Building 146. Ground Floor. G.09 Room 009, Insulation to high level pipework bend/knuckle above doorway	Asbestos Insulation/Coating	Removal of licensed ACMs (Remove (licensed))
Ref. Sample 5	Building 146. Ground Floor. G.13 Room 013, Insulation to x2 high level pipework bends/knuckles above doorway	Asbestos Insulation/Coating	Removal of licensed ACMs (Remove (licensed))
Sample 8	Building 146. Ground Floor. G.08 Room 008, Dampener and drainer pad beneath sinks and drainer	Bitumen	Removal of non-licensed ACMs (Remove (non-licensed))
Sample 10	Building 146. Ground Floor. G.12 Room 012, Insulation board panels to front of door leading into Room 013	Asbestos Insulating Board	Removal of licensed ACMs (Remove (licensed))

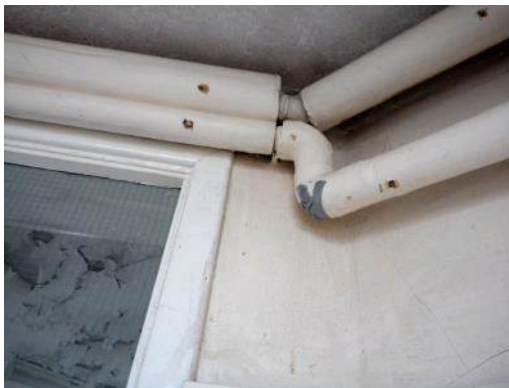
Ref. Sample 5: Building 146. Ground Floor. Room 009. Insulation to high level pipework bend/knuckle above doorway

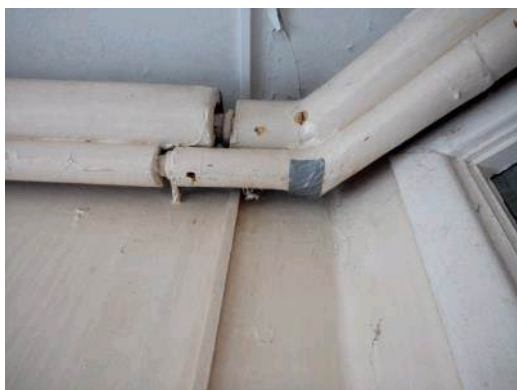
Ref. Sample 5: Building 146. Ground Floor. Room 013. Insulation to x2 high level pipework bends/knuckles above doorway

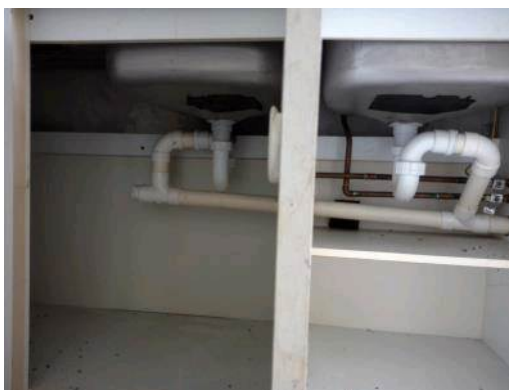
Sample 8: Building 146. Ground Floor. Room 008. Dampener and drainer pad beneath sinks and drainer

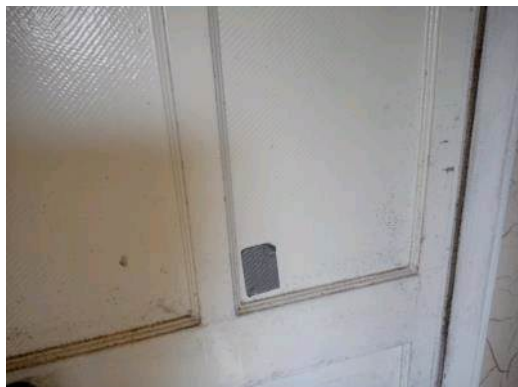
Sample 10: Building 146. Ground Floor. Room 012. Insulation board panels to front of door leading into Room 013

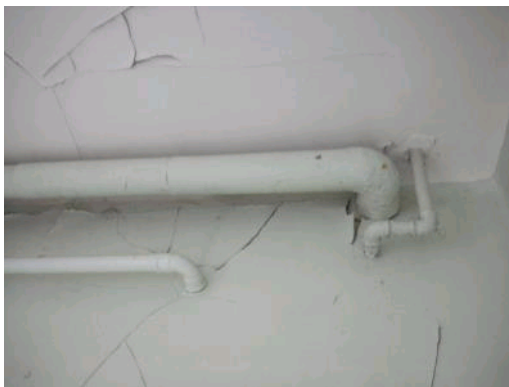
Sample 14: Building 146. Ground Floor. Room 018. Insulation to high level pipework bend/knuckle adjacent to doorway

Sample 14	Building 146. Ground Floor. G.15 Room 018, Insulation to high level pipework bend/knuckle adjacent to doorway	Asbestos Insulation/Coating	Removal of licensed ACMs (Remove (licensed))
Ref. Sample 14	Building 146. Ground Floor. G.18 Corridor 015, Insulation to high level pipework bend/knuckle within linen cupboard	Asbestos Insulation/Coating	Removal of licensed ACMs (Remove (licensed))
Sample 16	Building 146. Ground Floor. G.16 Room 019, Vinyl floor tiles (cream) and bitumen adhesive below to concrete floor, bottom layer	Vinyl tile & adhesive	Removal of non-licensed ACMs (Remove (non-licensed))
Sample 31	Building 146. Ground Floor. G.24 Room 029, Vinyl floor tiles (blue) and bitumen adhesive below to concrete floor	Vinyl tile & adhesive	Removal of non-licensed ACMs (Remove (non-licensed))
Ref. Sample 31	Building 146. Ground Floor. G.26 Room 031, Vinyl floor tiles (blue) and bitumen adhesive below to concrete floor	Vinyl tile & adhesive	Removal of non-licensed ACMs (Remove (non-licensed))

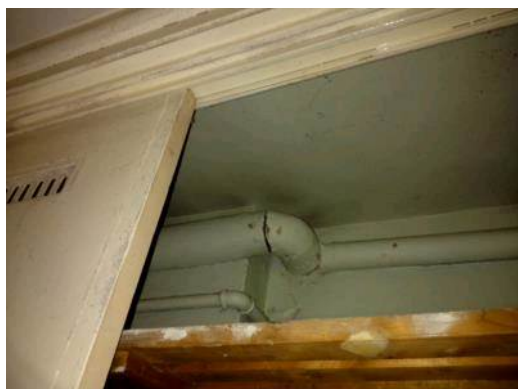
Ref. Sample 14: Building 146. Ground Floor. Corridor 015. Insulation to high level pipework bend/knuckle within linen cupboard

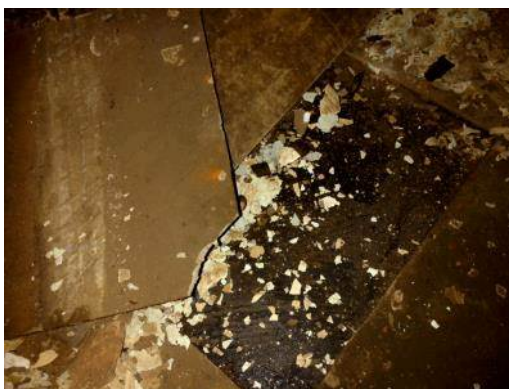
Sample 16: Building 146. Ground Floor. Room 019. Vinyl floor tiles (cream) and bitumen adhesive below to concrete floor, bottom layer

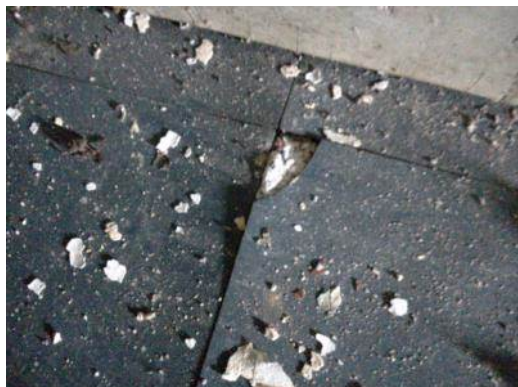
Sample 31: Building 146. Ground Floor. Room 029. Vinyl floor tiles (blue) and bitumen adhesive below to concrete floor

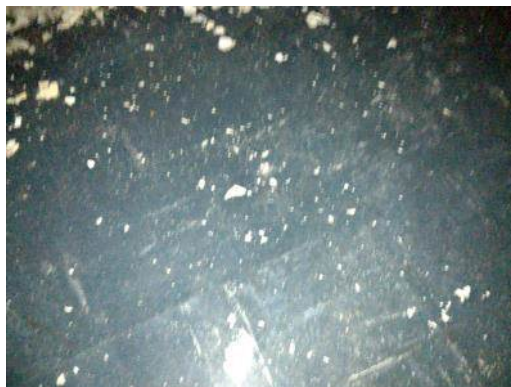
Ref. Sample 31: Building 146. Ground Floor. Room 031. Vinyl floor tiles (blue) and bitumen adhesive below to concrete floor

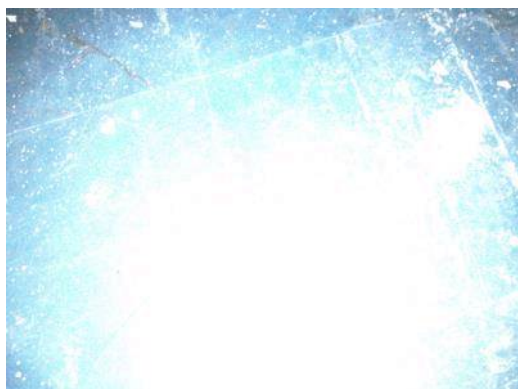
Sample 33: Building 146. Ground Floor. Room 033. Vinyl floor tiles (blue) and bitumen adhesive below to concrete floor

licensed)
Sample 33	Building 146. Ground Floor. G.28 Room 033, Vinyl floor tiles (blue) and bitumen adhesive below to concrete floor	Vinyl tile & adhesive	Removal of non-licensed ACMs (Remove (non-licensed)
Ref. Sample 33	Building 146. Ground Floor. G.29 Room 034, Vinyl floor tiles (blue) and bitumen adhesive below to concrete floor	Vinyl tile & adhesive	Removal of non-licensed ACMs (Remove (non-licensed)
Sample 38	Building 146. Roof Void. R.01 Roof void, Dust and debris to floor throughout roof void	Dust/Debris	Removal of licensed ACMs (Remove (licensed)
Sample 42	Building 146. External. E.01 External, Corrugated cement roof sheets to rear bike shed	Asbestos Cement	Removal of non-licensed ACMs (Remove (non-licensed)
Sample 43	Building 146. External. E.01 External, Cement guttering and downpipe to rear bike shed	Asbestos Cement	Removal of non-licensed ACMs (Remove (non-licensed)
Visual 1	Building 146. External. E.01 External, Gasket to top of high level vertical pipe to right hand side of building exiting boiler house (to high to access)	Asbestos Textiles/Paper	Removal of non-licensed ACMs (Remove (non-licensed)

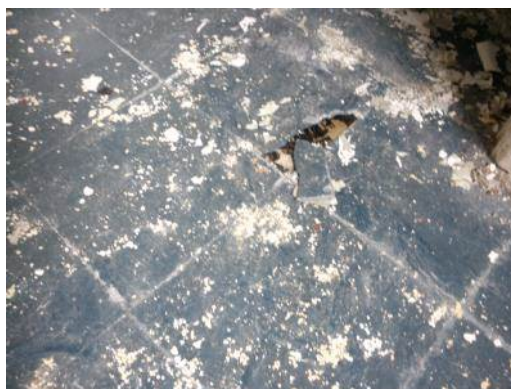
Ref. Sample 33: Building 146. Ground Floor. Room 034. Vinyl floor tiles (blue) and bitumen adhesive below to concrete floor

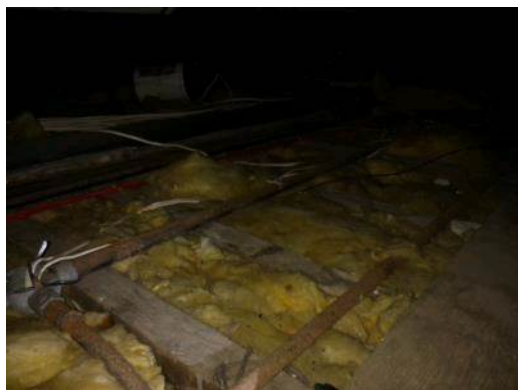
Sample 38: Building 146. Roof Void. Roof void.
Dust and debris to floor throughout roof void

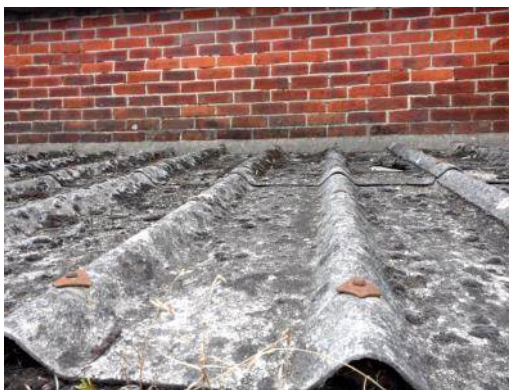
Sample 42: Building 146. External. External.
Corrugated cement roof sheets to rear bike shed

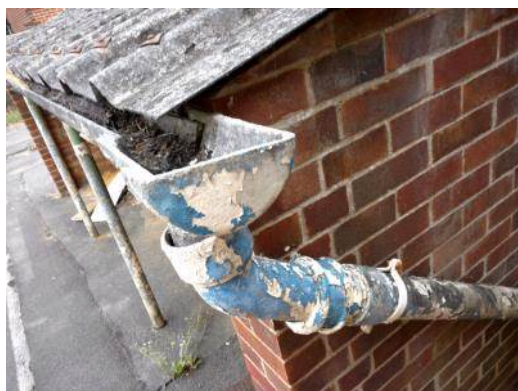
Sample 43	Building 146. External. E.01 External, Cement guttering and downpipe to rear bike	Asbestos Cement

Sample 43: Building 146. External. External.
Cement guttering and downpipe to rear bike shed

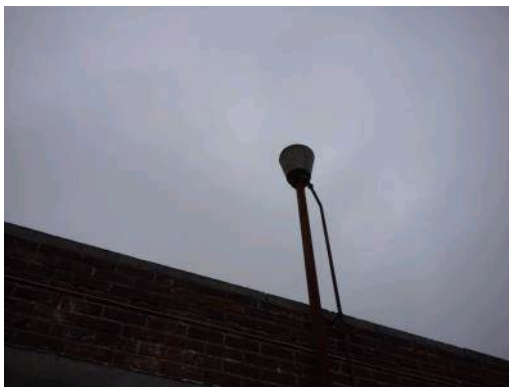
shed	
Visual 1	Building 146. External. E.01 External, Gasket to top of high level vertical pipe to right hand side of building exiting boiler house (to high to access)	Asbestos Textiles/Paper

Visual 1: Building 146. External. External.
Gasket to top of high level vertical pipe to right hand side of building exiting boiler house (to high to access)
