## **DEMOLITION ASBESTOS SURVEY**

**BUILDING 7,  
HMS DAEDALUS,  
BROOM WAY,  
LEE ON SOLENT,  
HAMPSHIRE  
PO13 9YA**

**HOMES & COMMUNITIES AGENCY (BRISTOL)**

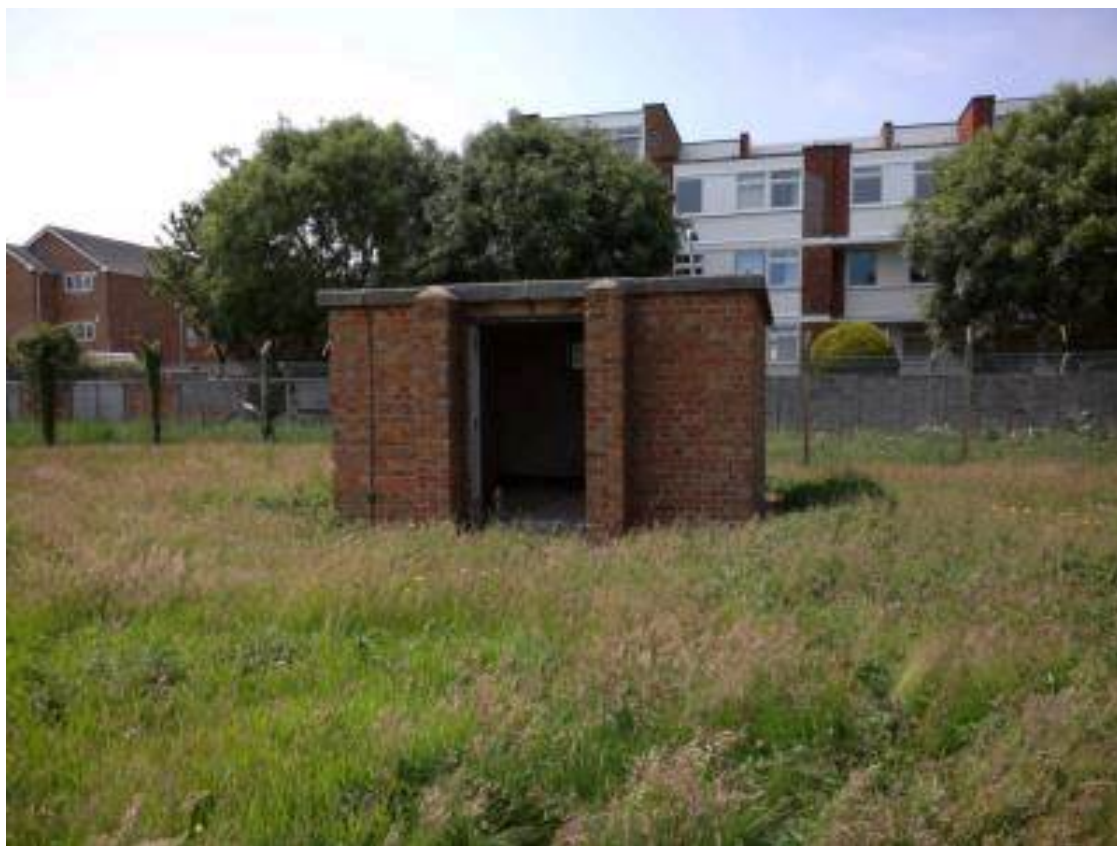
Externally the building is constructed of brick walls, damp proof course to brick walls, asphalt to flat concrete roof, metal window frame.

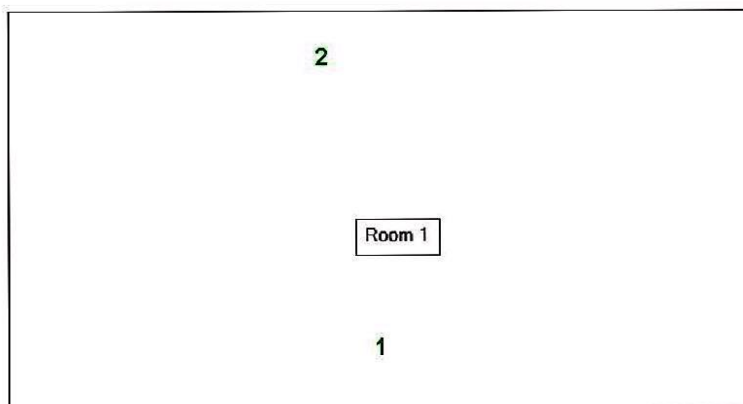
Client: Homes & Communities Agency (Bristol)  
Site: Building 7  
HMS Daedalus  
Broom Way  
Lee on Solent  
Hampshire  
PO13 9YA

Key: 1 Asbestos identified  
1 No asbestos identified
