## **DEMOLITION ASBESTOS SURVEY**

**BUILDING 14,  
HMS DAEDALUS,  
BROOM WAY,  
LEE-ON-SOLENT  
PO13 9YA**

**HOMES & COMMUNITIES AGENCY (BRISTOL)**

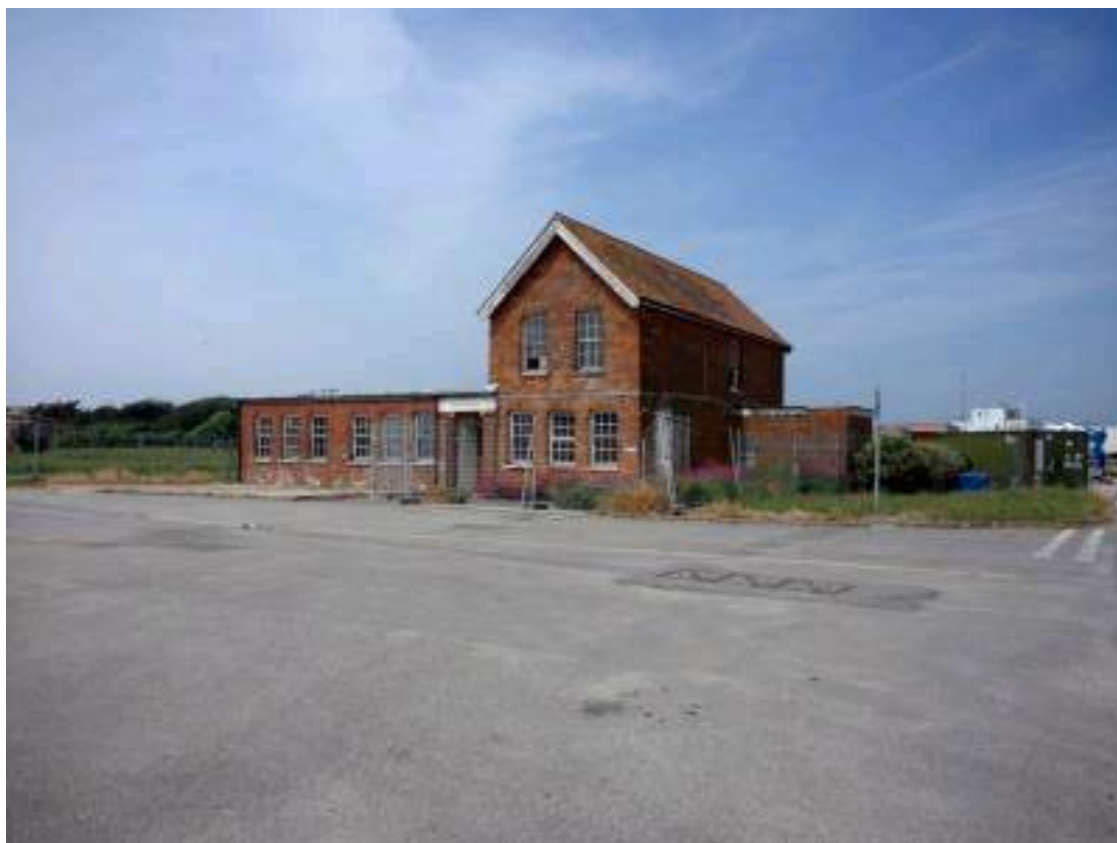
Externally the building is constructed of brick wall, wooden walls to rear entrance canopy, asphalt to flat concrete roof to ground floor, clay tiled pitched roof, lead flashing to roofs, roofing felt to flat roofs to compressor house and external cupboard, plastic sheet roof to rear entrance canopy, wooden soffit and fascia boards, concrete and wooden window sills, wooden window frames, wooden doors and door frames, plastic guttering and downpipes, metal flue exiting roof, metal sheet walls and roof to external emergency shower cubicle.

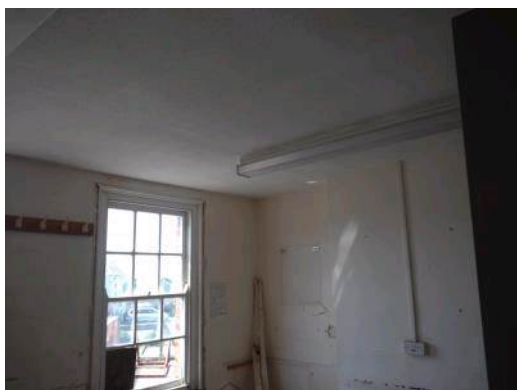
**Sample 2:** Building 14. First Floor. Room 1.  
Textured coating to ceiling

SAMPLE NUMBER	SAMPLE DESCRIPTION	PRODUCT TYPE	ACTION REQUIRED
Sample 2	Building 14. First Floor. 1.01 Room 1, Textured coating to ceiling	Artex	Removal of non-licensed ACMs (Remove (non-licensed))
Ref. Sample 2	Building 14. First Floor. 1.02 Room 2, Textured coating to ceiling	Artex	Removal of non-licensed ACMs (Remove (non-licensed))
Ref. Sample 2	Building 14. First Floor. 1.03 Toilet, Textured coating to ceiling	Artex	Removal of non-licensed ACMs (Remove (non-licensed))
Sample 8	Building 14. First Floor. 1.04 Room 3, Textured coating to ceiling	Artex	Removal of non-licensed ACMs (Remove (non-licensed))
Ref. Sample 8	Building 14. First Floor. 1.05 Landing and staircase to ground floor, Textured coating to ceiling	Artex	Removal of non-licensed ACMs (Remove (non-licensed))
Sample 15	Building 14. Ground Floor. G.02 Room 1, Textured coating to ceiling and associated debris to floor	Artex	Removal of non-licensed ACMs (Remove (non-licensed))

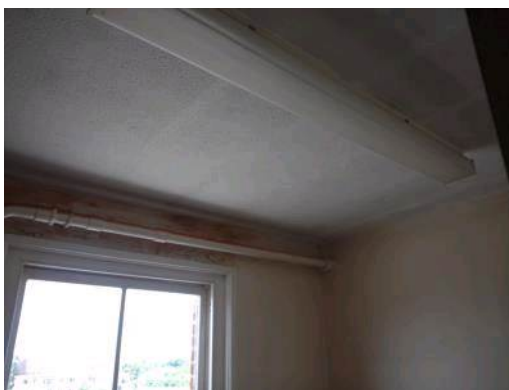
**Ref. Sample 2:** Building 14. First Floor. Room  
2. Textured coating to ceiling

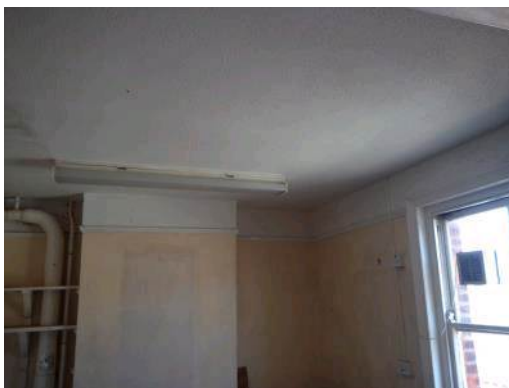
**Sample 8:** Building 14. First Floor. Room 3.  
Textured coating to ceiling

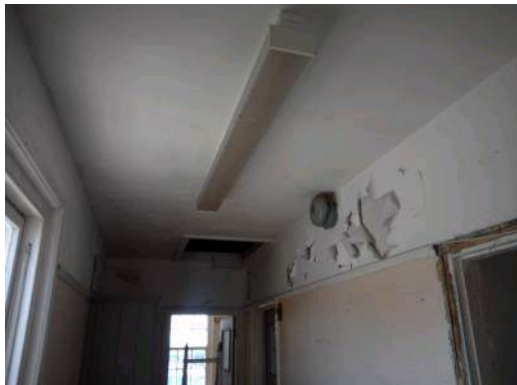
**Ref. Sample 8:** Building 14. First Floor. Landing and staircase to ground floor. Textured coating to ceiling

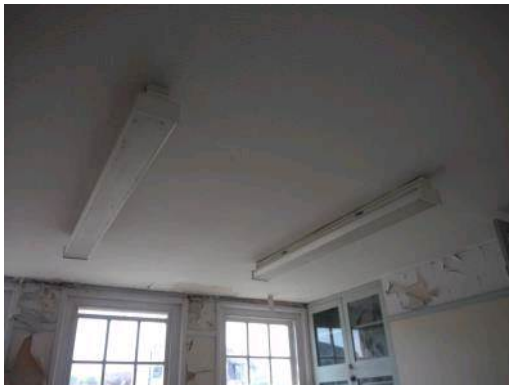
**Sample 15:** Building 14. Ground Floor. Room 1. Textured coating to ceiling and associated debris to floor

Ref. Sample 15	Building 14. Ground Floor. G.05 Room 2, Textured coating to ceiling and associated debris to floor	Artex	Removal of non-licensed ACMs (Remove (non-licensed))
Sample 20	Building 14. Ground Floor. G.10 Kitchen 2, Dampener and	Bitumen	Removal of non-

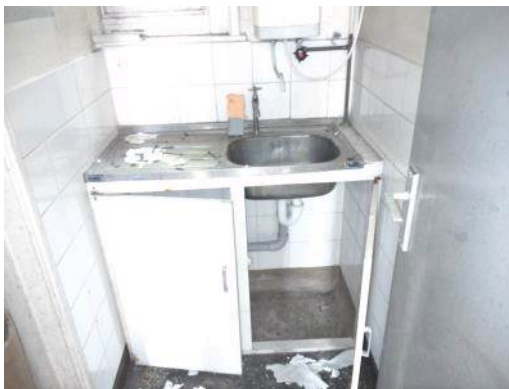
**Sample 20:** Building 14. Ground Floor. Kitchen 2. Dampener and drainer pads beneath sink and drainer

drainer pads beneath sink and drainer		licensed ACMs (Remove (non-licensed))
Sample 22	Building 14. Ground Floor. G.11 Room 6, Textured coating to walls and associated debris to floor	Artex	Removal of non-licensed ACMs (Remove (non-licensed))
Ref. Sample 22	Building 14. Ground Floor. G.12 Room 7, Textured coating to walls and associated debris to floor	Artex	Removal of non-licensed ACMs (Remove (non-licensed))
Sample 23	Building 14. Ground Floor. G.11 Room 6, Textured coating to ceiling and associated debris to floor	Artex	Removal of non-licensed ACMs (Remove (non-licensed))
Ref. Sample 23	Building 14. Ground Floor. G.12 Room 7, Textured coating to ceiling and associated debris to floor	Artex	Removal of non-licensed ACMs (Remove (non-licensed))
Sample 30	Building 14. External. E.02 Boiler House, Insulation to metal pipe section to joint (larger diameter pipe exiting left hand side brick wall and joining pipe to boiler)	Asbestos Insulation/Coating	Removal of licensed ACMs (Remove (licensed))

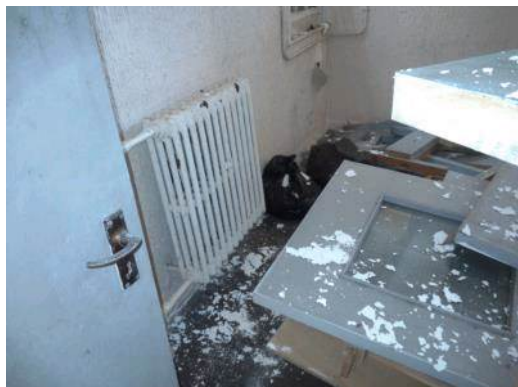
**Sample 22:** Building 14. Ground Floor. Room 6.  
Textured coating to walls and associated debris  
to floor

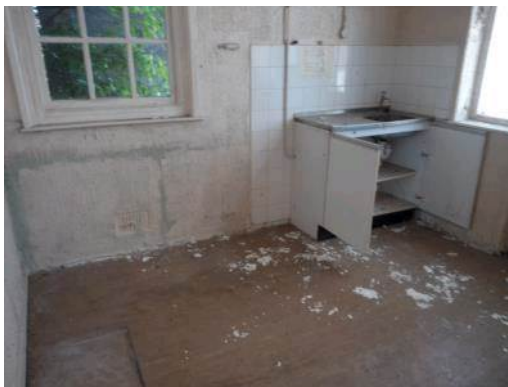
**Ref. Sample 22:** Building 14. Ground Floor.  
Room 7. Textured coating to walls and  
associated debris to floor

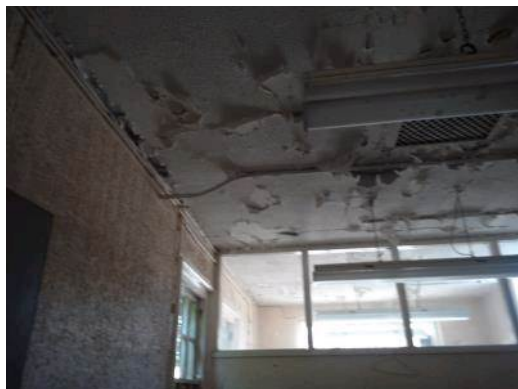
**Sample 23:** Building 14. Ground Floor. Room 6.  
Textured coating to ceiling and associated debris  
to floor

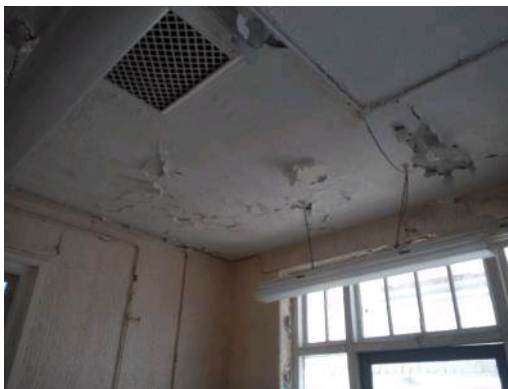
**Ref. Sample 23:** Building 14. Ground Floor.  
Room 7. Textured coating to ceiling and  
associated debris to floor

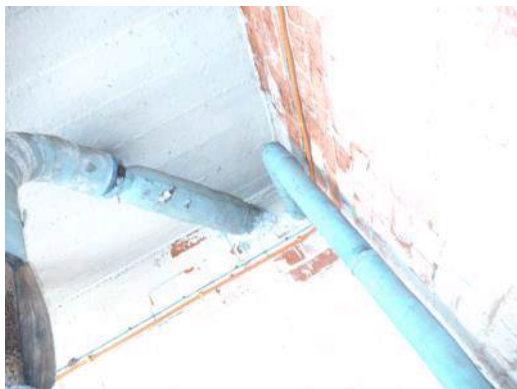
**Sample 30:** Building 14. External. Boiler House. Insulation to metal pipe section to joint (larger diameter pipe exiting left hand side brick wall and joining pipe to boiler)

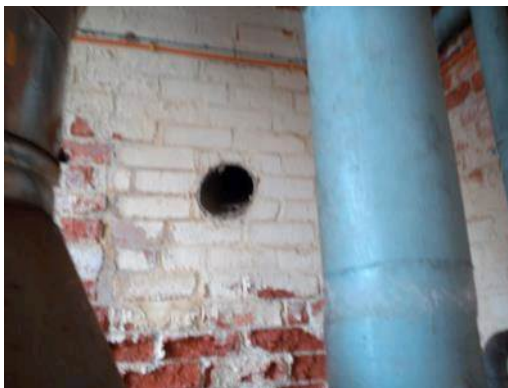
Sample 31	Building 14, External. E.02 Boiler House, Cement flue pipe section within left hand side brick wall (penetrating through wall). Presume flue pipe continues up into brick chimney (limited access in chimney due to structural hazard)	Identified	Cement	Chrysotile	1no.
Sample 33	Building 14, External. E.02 Boiler House, Woven rope gasket seal around flue attachment to boiler beneath cement jointing	Identified	Woven	Chrysotile	11m
Sample 34	Building 14, External. E.02 Boiler House, Paper insulation lining to metal walls and top within boiler	Identified	Asbestos Insulation/Coating	Chrysotile	3m <sup>2</sup>

**Sample 31:** Building 14. External. Boiler House. Cement flue pipe section within left hand side brick wall (penetrating through wall). Presume flue pipe continues up into brick chimney (limited access in chimney due to structural hazard)

Sample 31	Building 14. External. E.02 Boiler House, Cement flue pipe section within left hand side brick wall (penetrating through wall). Presume flue pipe continues up into brick chimney (limited access in chimney due to structural hazard)	Cement	Removal of non-licensed ACMs (Remove (non-licensed))
Sample 33	Building 14. External. E.02 Boiler House, Woven rope gasket seal around flue attachment to boiler beneath cement jointing	Woven	Removal of non-licensed ACMs (Remove (non-licensed))
Sample 34	Building 14. External. E.02 Boiler House, Paper insulation lining to metal walls and top within boiler	Asbestos Insulation/Coating	Removal of licensed ACMs (Remove (licensed))
Sample 35	Building 14. External. E.02 Boiler House, Dust and debris to concrete plinth floor beneath boiler (it must be presumed to be as throughout boiler house. Floor cannot be accessed as submerged beneath water.)	Dust	Removal of licensed ACMs (Remove (licensed))

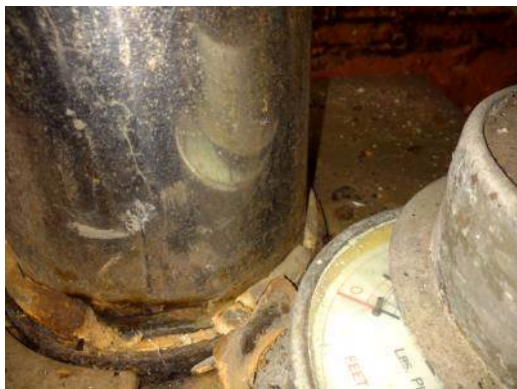
**Sample 33:** Building 14. External. Boiler House. Woven rope gasket seal around flue attachment to boiler beneath cement jointing

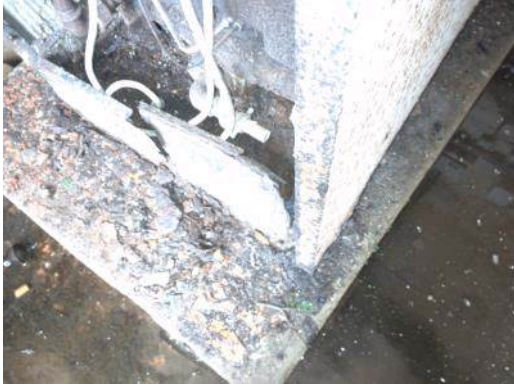
Sample 35	Building 14. External. E.02 Boiler House, Dust and debris to concrete plinth floor beneath boiler (it must be presumed to be as throughout boiler house. Floor cannot be accessed as submerged beneath water.)	Dust
-----------	--	------

**Sample 35:** Building 14. External. Boiler House.  
Dust and debris to concrete plinth floor beneath boiler (it must be presumed to be as throughout boiler house. Floor cannot be accessed as submerged beneath water.)
